# Cassidy's Complex Monasterevin, Co. Kildare.

## Conservation Management Plan

for Kildare County Council  
March 2024

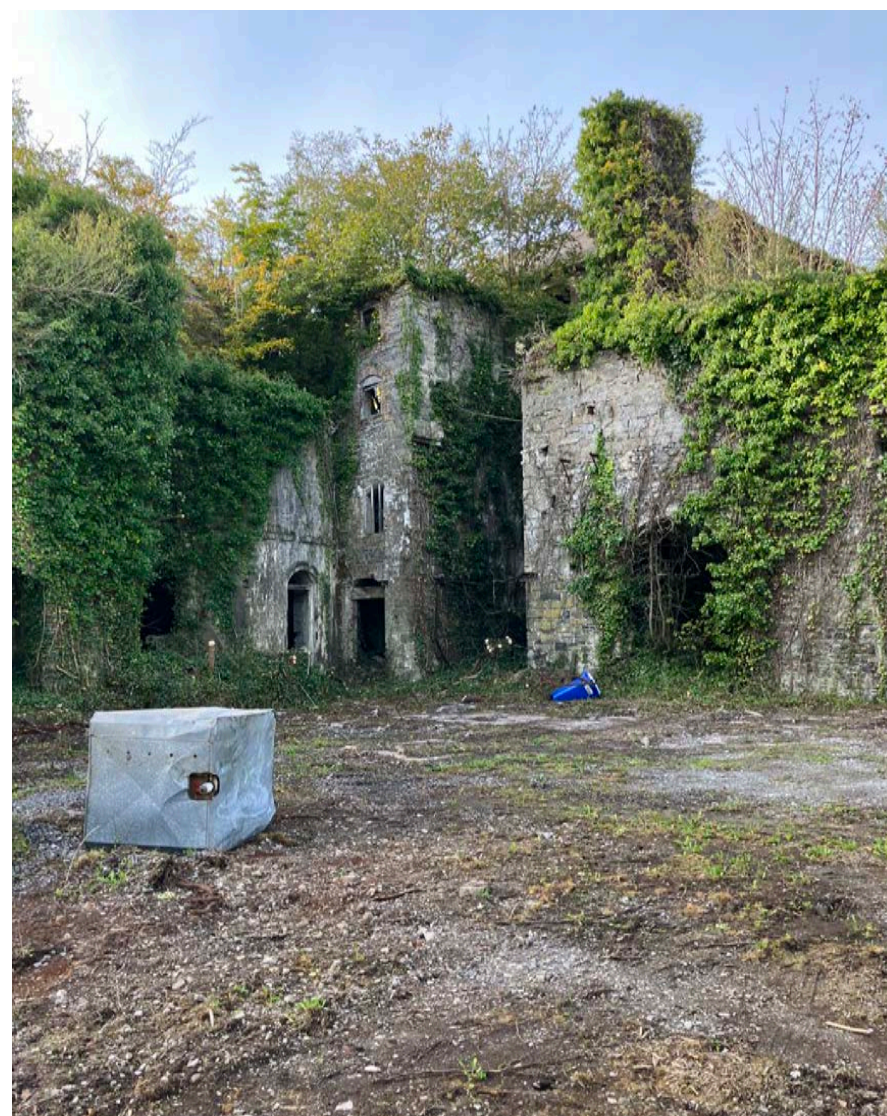
Figure 36 - Former engine house invaded by trees and shrubs.

This former engine house, which on plan measures 7m x 16m, is in a very poor state of repair, with the roof now missing. The slender, square chimney was originally the highest chimney in the complex, however, only the lower section of this elegant structure survives, and this too is also in a poor condition. Invaded by trees and shrubs the structure is currently hard to interpret, but is highly attractive and constructed of rubble limestone, with wide, arched openings on the ground floor. One of these, on the south side, has an opening directly above, formed with a flat stone lintols, that was most likely a first-floor loading bay. However, despite the poor structural condition and invasive vegetation, it is likely that the chimney and external walls could be repaired and the structure given a new roof to allow it to serve another useful purpose.

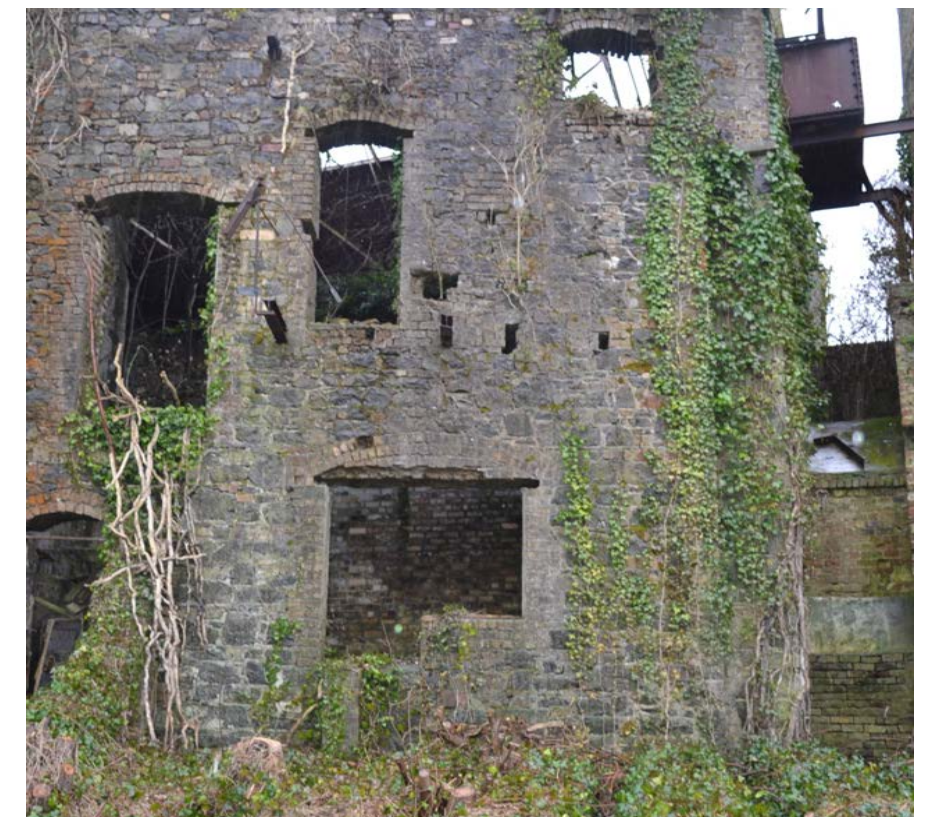
Figure 51 - Still house view from the west

The still house measures approximately 12m x 17m on plan and connects to the south side of the mash house. Similar in height to the mash house and back room, the structure is covered with a corrugated iron sheeting on a light-weight steel roof. What appears to be the frame of a large skylight runs along the ridge stopping one bay short of the mash house. This roof may well be a late nineteenth-century replacement for an earlier roof structure as the building itself looks older. The east side of the building, which faces onto the distillery yard, contains several large openings. Two arched openings exist at ground floor level and several window openings at first floor level. An interesting engraving appears in Barnard's *'Whisky Distilleries of the United Kingdom,'* which shows the eastern side of the building, the rooflight and the great mash house behind. In contrast to the east bay, the south gable is largely blank, with several former openings now blocked. As with most of the buildings on site, the still house was constructed in rubble limestone with dressed quoins. Internally the space is divided by a range of spectacular cross walls and great masonry arches that resemble flying buttresses. Much of the masonry has fallen and together with other debris makes the internal levels and purpose of the building unclear. It is described as a still house, on the old maps and would most likely have housed the large copper stills in which the whisky was distilled. From the junction between the still house and the mash house, it is clear that the mash house was constructed at an earlier date. The interior of the still house is monumental and spacious, with the generous top lighting and a very complex special arrangement. Unfortunately, this structure is not in good

condition with significant cracks in the external walls and will require temporary stabilization prior to clearing out. Where the north end of the still house engages with the circular masonry of the mash house there is a significant gap in the original construction, with no attempt to create any bonding. As a result, there is a major crack in the masonry of the still house. There are also cracks in the mash house at this junction where one of the flying buttresses of the still house, bears onto the masonry of the mash house.

Two small-paned, cast iron windows survive and should be put aside and carefully preserved to provide evidence for future restoration. Like the mash house, back room and mill and grain store buildings, this structure is impressive in scale and spatial complexity and when restored will be spectacular. On the west side of the still house are two rectangular structures measuring 5m x 7m and 6.5m x 10.5m. The smaller is a plain rubble structure, not dissimilar to the masonry of the water tower, however, no tank remains. In contrast with, the main still house structure, these have a number of door and window openings at several levels on the western side. The purpose of these two latter wings is unclear, but was probably associated with the still house to which it is attached. Of the two structures the latter is in poor condition.

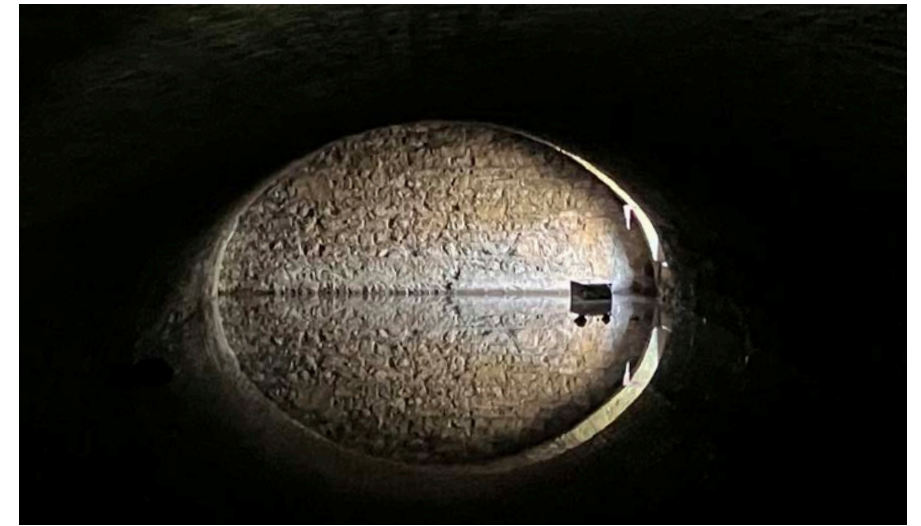
Figure 58 - Bonded warehouse flooded west end.

that is now contained within the workshop there are two cut stone door surrounds leading into the structure. One of these is at ground level, the second, now altered, was originally at first floor level, which confirms that the structure originally had a first floor level, part of which was later removed. Unfortunately, another larger opening has been formed, somewhat crudely with a series of steel beams inserted, which are now rusting. Steel ties have also been inserted across the vault to counteract the instability caused by this insertion into the vaulted masonry. Given the robust masonry construction of this tripartite vaulted construction, the superstructure appears to be reasonably sound, with the exception of the opening formed within the workshop. However, the exposed crowns of the first-floor vaults will have become saturated due to their exposure to the elements, which has led to a small plantation of self-seeded trees and shrubs.

All vegetation should be removed as a matter of urgency and the vaults protected with a limecrete slab to prevent any serious damage occurring to this singular structure. The western end of the structure is currently filled with water, the cause of which is not clear and may be caused by either a high water table or a build-up of rainwater. Some of the ground floor vaults are filled with soil and others with accumulated rubbish. All should be cleared out as soon as possible to allow for a closer inspection of the interior of the vaults. A hoist or long ladder would also allow access for a similar close inspection of the first and second floor levels. This bonded warehouse is one of the most interesting, and architecturally sophisticated structures in the former Cassidy's Complex. It is hard to imagine a future use for it, other than for the purpose originally intended, to store barrels of whiskey in a cool, environmentally stable and secure place.

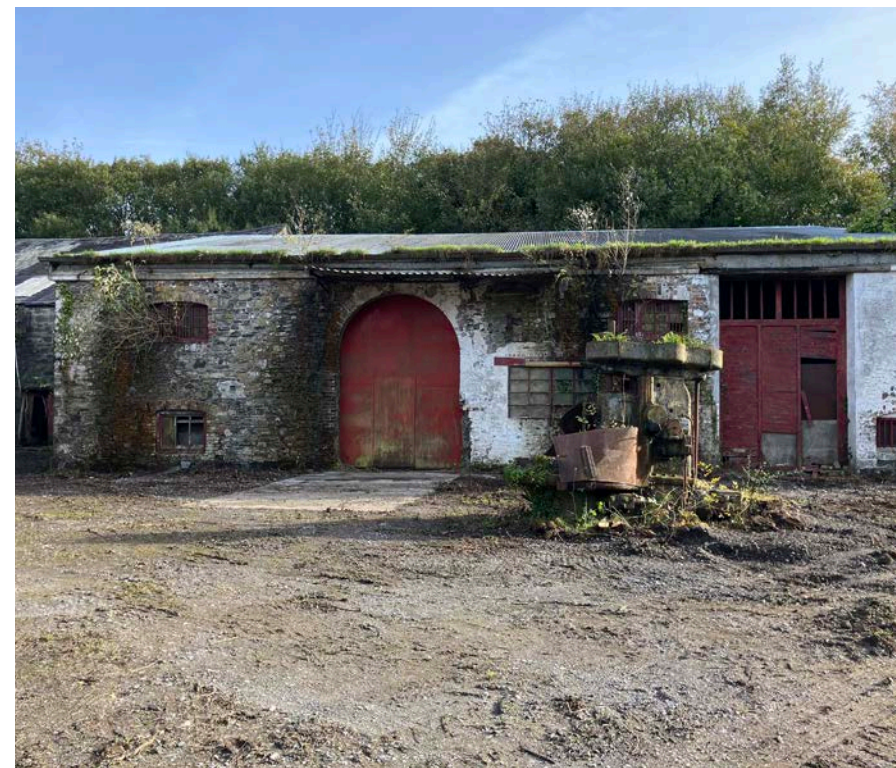
Figure 59 - Workshop exterior view from the north.

This two-storey building, which measures 21m x 23m on plan, combined several historic structures over which a lightweight steel roof, covered with corrugated iron sheeting has been constructed. In more recent times as an engineering works, the building served as the heavy workshop, and contained a collection of cutting, drilling, grinding, profiling and threading machines. On the Longfield survey a building in this location is labelled 'bullock house/occasionally used as a turf store', but it is unclear if any part of this earlier structure survives. The rear wall is built into the boundary wall on the south side, while the north-facing wall addresses the former distillery yard. Constructed of rubble stone with dressed stone quoins and brick dressings to the windows, the external walls and some of the internal walls are in a reasonable state of repair. The north-facing entrance front contains shallow-arch headed windows at high and low level, together with two large openings. One is an original, tall arched opening; the second is a more recent intervention, consisting of a crude, two-storey opening formed by the insertion of steel beams, with shuttered concrete jambs. These unsightly alterations should be reversed and the masonry restored. Another unfortunate intervention is where the substantial opening has been made into the side of the two-storey brick structure of the bonded warehouse (10) as mentioned previously. As this warehouse is one of the most interesting structures in the complex,

both historically and technically, it should certainly be restored. While the current roof is keeping most of the water out it will need to be replaced and the existing shallow trusses strengthened or replaced with a more substantial roof structure. There is a lot of old machinery and other debris, now stored within this structure and a clearer picture will no doubt emerge for the future use of this space after these have been removed.

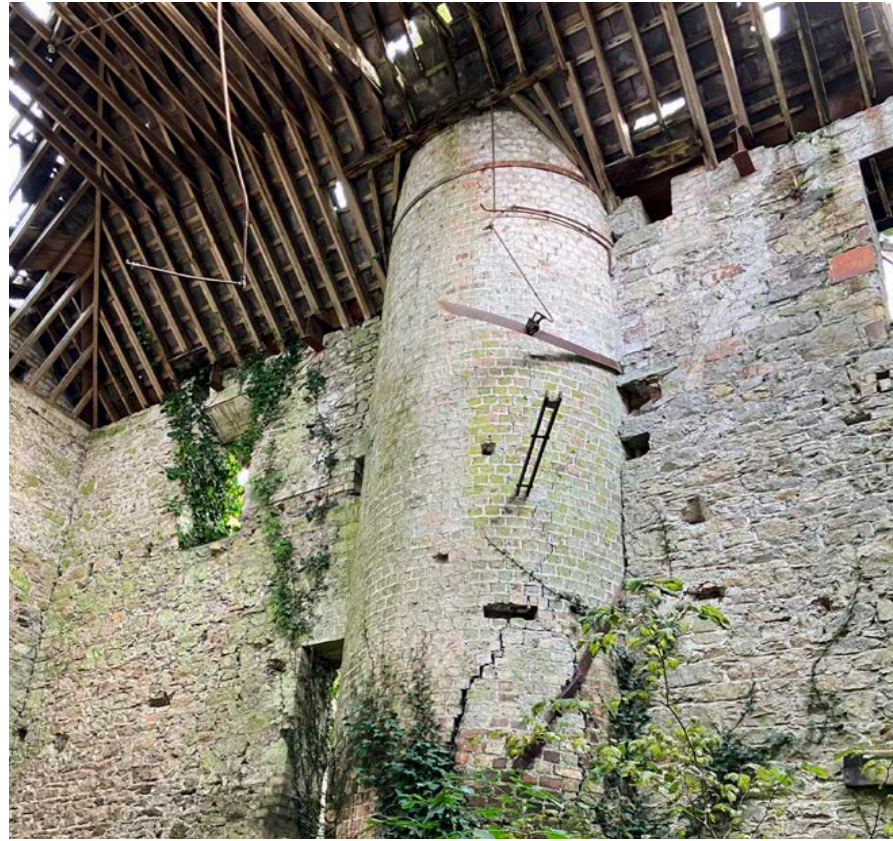
Figure 71 - Kiln/engine house structural damage to cross wall.

Where the western arch has been rebuilt in the north façade there are some large, vertical cracks rising above, which have caused serious instability. Old iron pattress plates and ties in this façade suggest previous structural movement and repair. Internally, the structure is also very badly damaged. There are significant vertical cracks in the chimney that is not bonded structurally with the spine wall. Pockets in the internal walls, suggest that there were formerly two intermediate floors, the structures of which would have helped tie the walls together, but are now totally gone. The roof is also in a very poor state with many large areas of missing slate and much distortion in the roof carpentry. With the high risk of falling slates, combined with the fragile structure condition, this is a very dangerous building and should be fenced off to prevent unauthorised access. In the west façade of the northern range, there is a large brick arch within which the wall thickness diminishes. Where the spine wall connects to the western façade it clashes with the spring of the

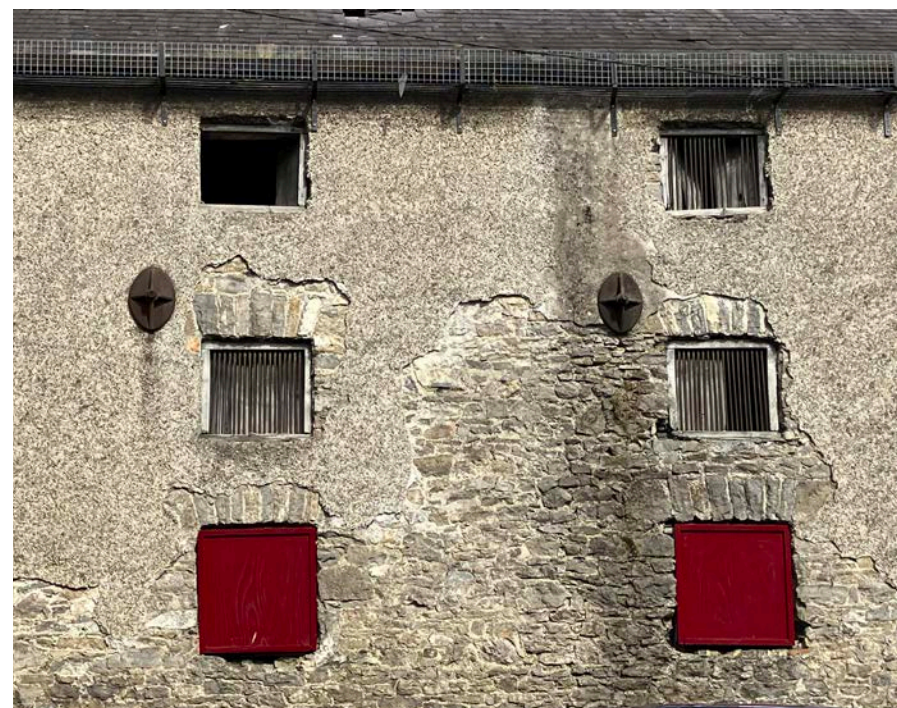
Figure 83 - Malt house detail of south facade.

The interior of the Cassidy's Malt House on Dublin Road is only safely accessible at ground floor level, due to the unstable conditions of the upper floors and simple timber staircases, which survive in a very good

state of preservation, but very poor state of repair. With the relatively modest depth of the building, the floors and roof structures are supported off the two long walls, running east to west parallel with the road. At the eastern end a large tank extends the full depth of the building, constructed in rendered masonry. This is known as a 'steep' in which the barley was soaked in water before being spread out on the floors to sprout. In addition to the badly damaged roof, the gutters are completely blocked with debris and plant growth. On the north side of the building the gutters are also blocked and there is a significant buildup of ivy growing up the walls and along the eaves. Roofs and rainwater goods should be repaired as a matter of urgency, together with the removal of all vegetation that has become established on the building, if the valuable historic fabric contained in the roof, internal floors and staircases, is not to be lost. In the long term the single-storey lean-to extension at the eastern end of the building, which is constructed of mass concrete and is little more than an open canopy, should be removed as it is in a very poor structural state and detracts from the historic character of the place.

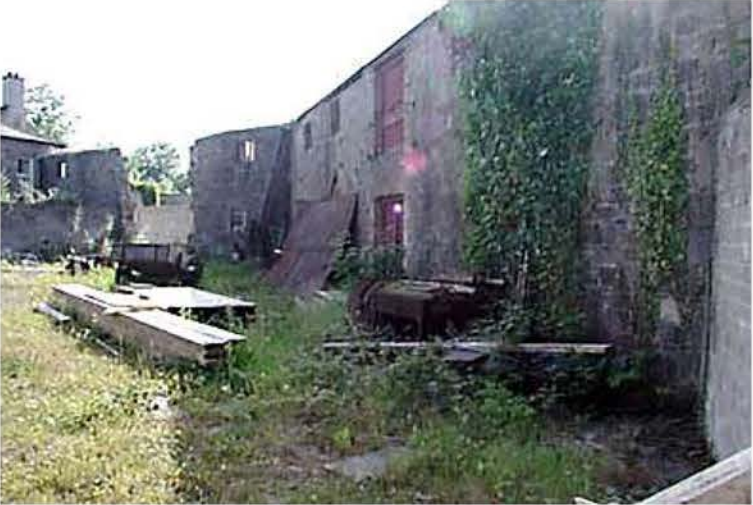
<p>Picture from NIAH 2002 - the furthest 4 bay structure is now fallen</p> <p><b>Proposed Repairs:</b> Clear out all debris Assess remaining upstanding walls Repair walls to southwest end and re-roof</p>
