# TO 268 Leinster Bridges Rehabilitation Contract No. 2 Part 2 Carlow and Wexford Bridges - Change Order No. 1

## Inspection and Rehabilitation Report

**Inspection and Rehabilitation Report**

**Document No:** ..... 15.135.10 Pt2 CO1- IR

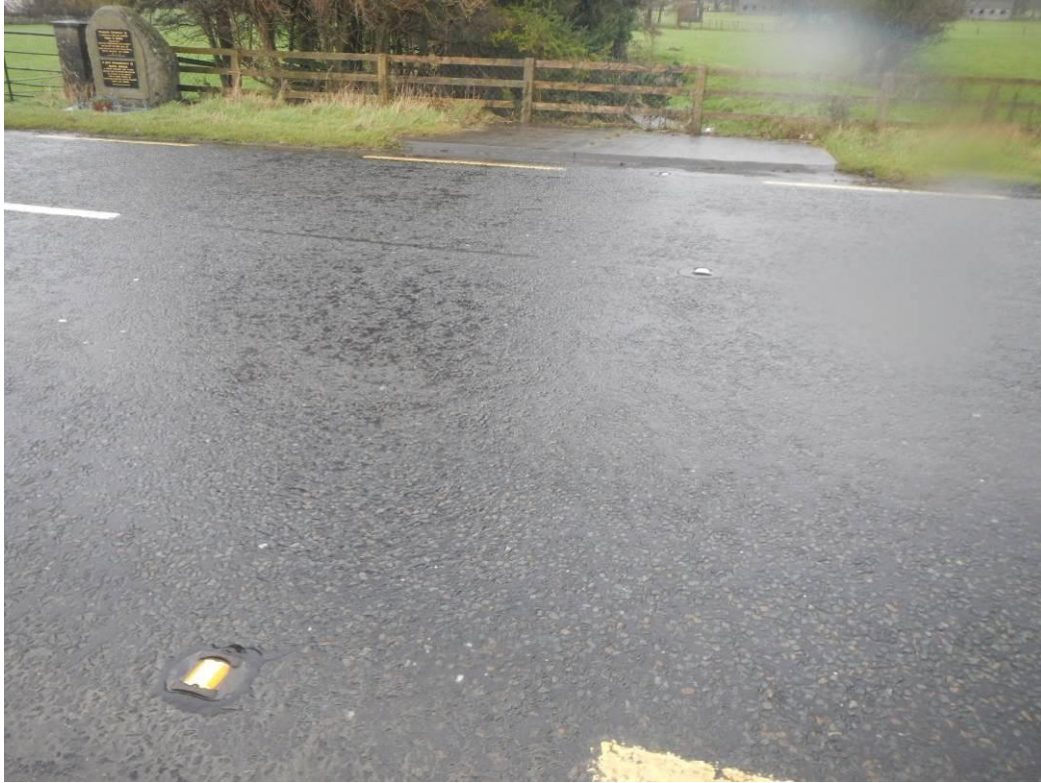
The HRA bridge surfacing was observed to be in good condition with no evidence of rutting, settlement or loss of surface texture (see Photograph 1). There is a narrow strip of DBM surfacing along the front face of the raised verge kerblines which appears to have been laid as part of the installation of the concrete raised verges. Concrete verges have been constructed between the edge of carriageway and parapets to replace soft verges and were found to be in good condition with only routine maintenance required to clear the open channel drains. The bridge carries a relatively straight section of the N80 with only gentle horizontal curves on approaches. No safety barriers are provided on approaches with timber post and rail fencing demarking the road boundary. 2 no. field accesses exist on the east side of the carriageway, one either side of the bridge. There is also a commemorative plaque located adjacent to the field access on the northeast approach.

**Photo 1 – Structure 1: View of Carriageway Surfacing**

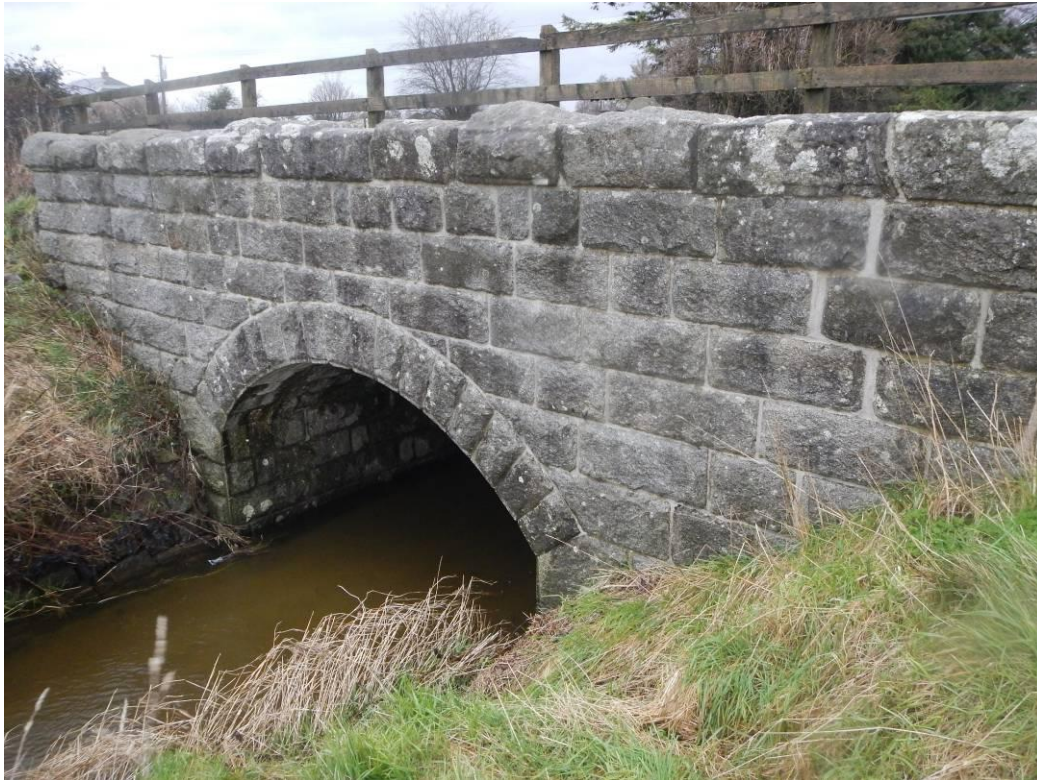
The west spandrel wall and wingwalls consist of finely dressed, quarry-faced square-cut granite stonework. The walls appear to be in very good condition with no evidence of structural distress noted (see Photograph 5). The walls appear to have been recently repointed.

**Photo 5 - Structure 1: Spandrel Wall**

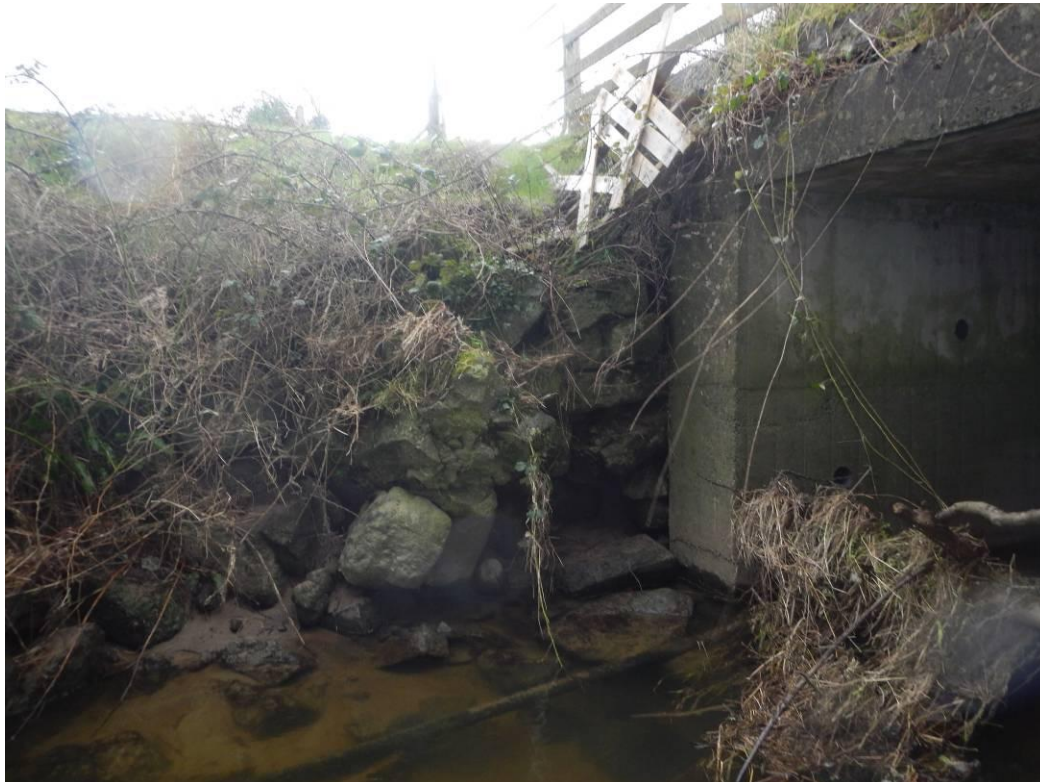
**Photo 6 – Structure 1: Erosion of Southeast Embankment**

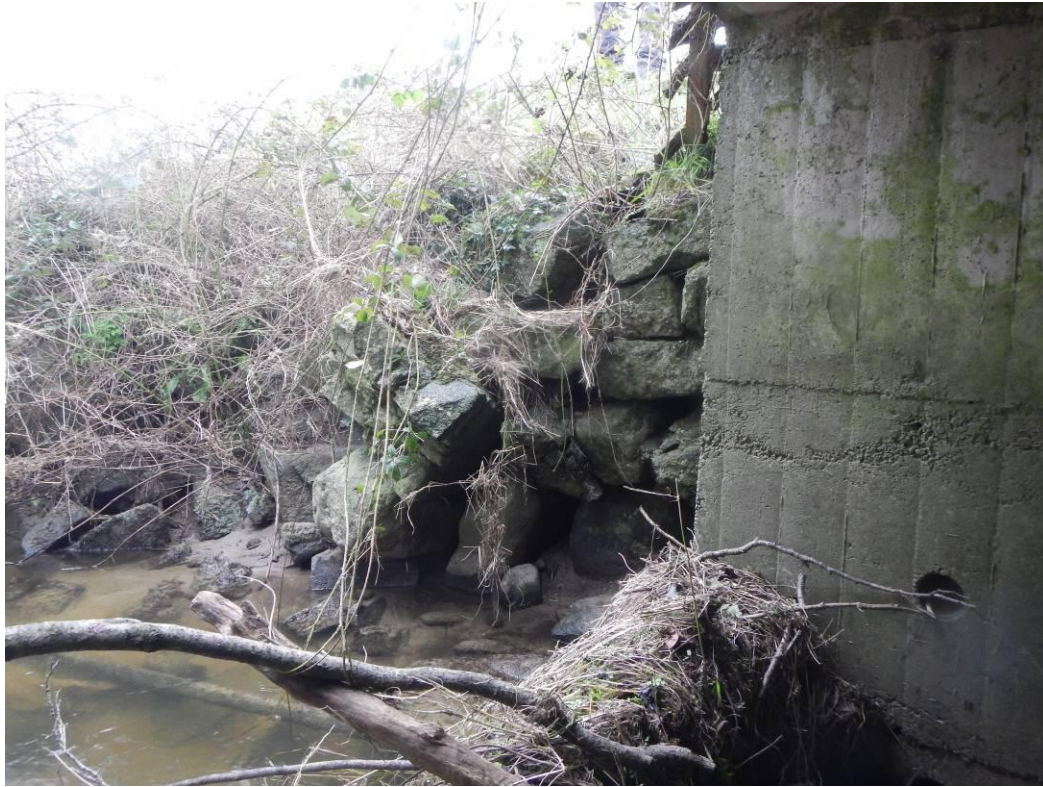
**Photo 7 – Structure 1: Erosion of Southeast Embankment**

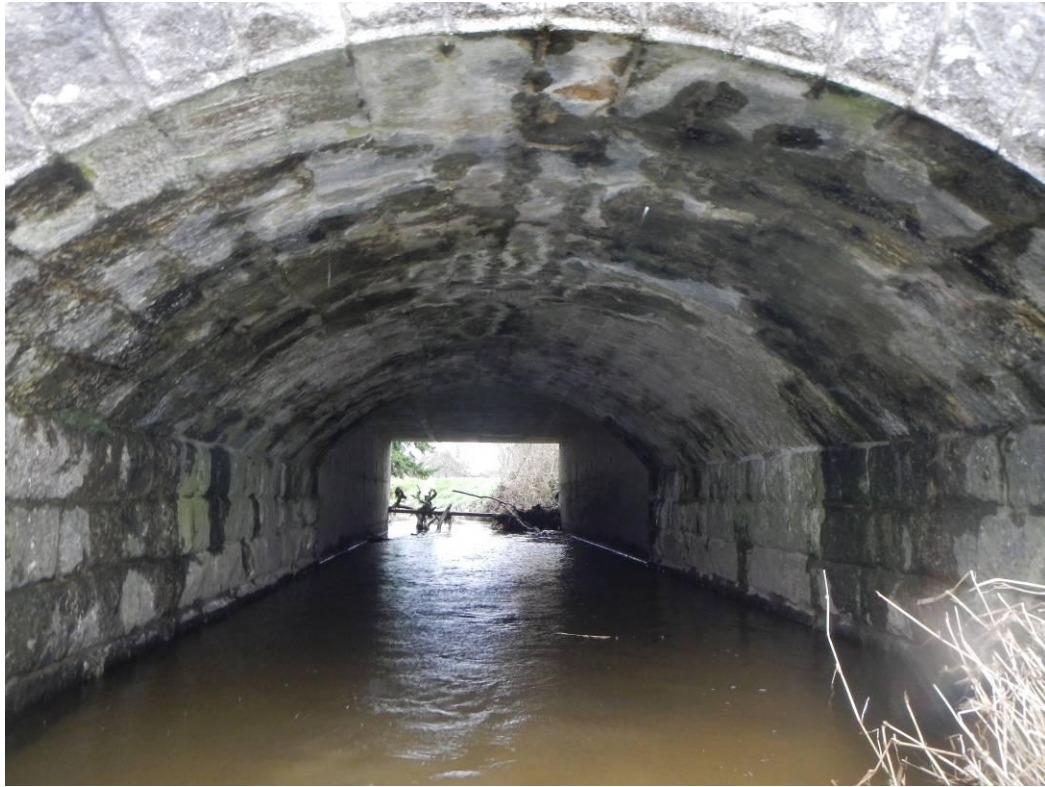
The expressed arch and arch barrel are also constructed from finely dressed quarry faced ashlar masonry and were found to be in very good condition with only minor seepage and resultant staining and calcite deposits noted at the west end of the barrel. The arch shape is very good and there is no evidence of structural distress in the form of cracking, deformation or displaced arch voussoirs. The barrel is well pointed and appears to have been recently repointed (see Photograph 9).

**Photo 9 – Structure 1: View of Arch Barrel facing East**

Based on the findings of the visual inspection, no repointing or masonry repairs are required to the arch barrel, spandrel wall or abutments. In accordance with current best practice it is not proposed to remove calcite deposits from the stonework. These works are potentially damaging and yield no real benefit to the structure. It is likely that the leakage through the arch barrel at the west end of the bridge is associated with the watermain above and therefore it is not proposed to address this issue as part of the proposed works.

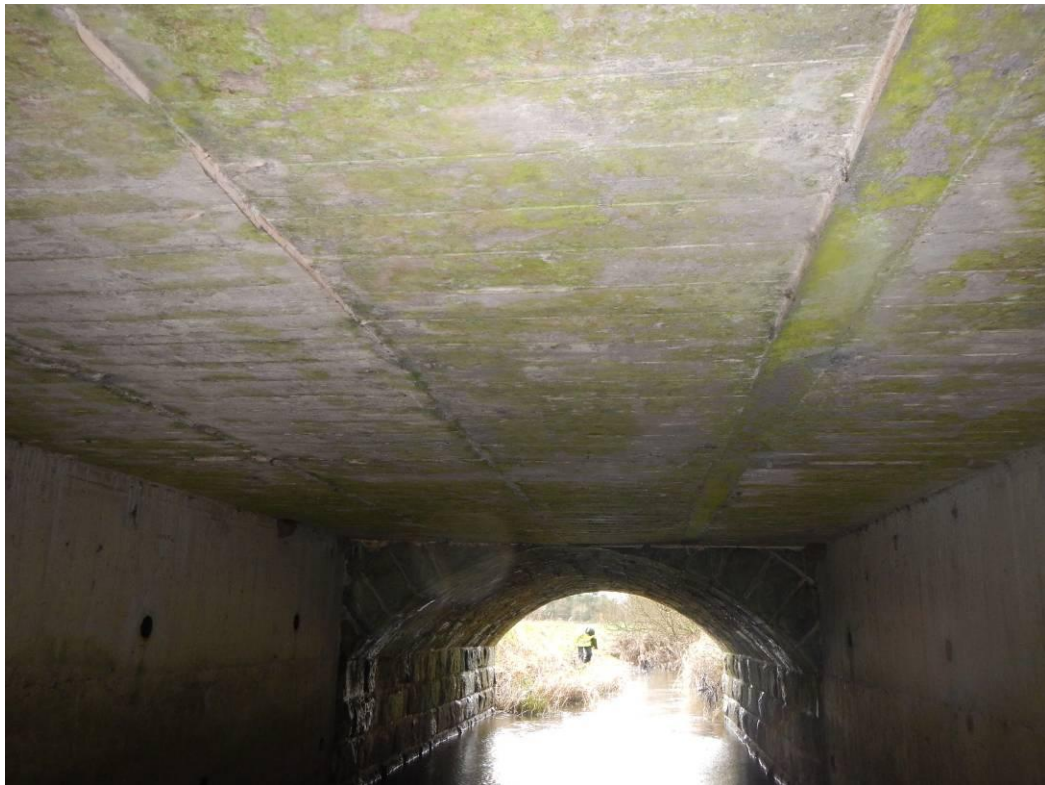
The in-situ reinforced concrete deck appeared to be in good condition with no significant defects noted. The entire soffit was heavily stained indicating that it is regularly wet but was found to be relatively dry at the time of inspection (see Photograph 10).

**Photo 10 - Structure 1: View of Carriageway Surfacing**

No repairs are required to the concrete section of the structure. Damp staining will be addressed via the installation of bridge deck waterproofing and honeycombing to abutments is aesthetic only.

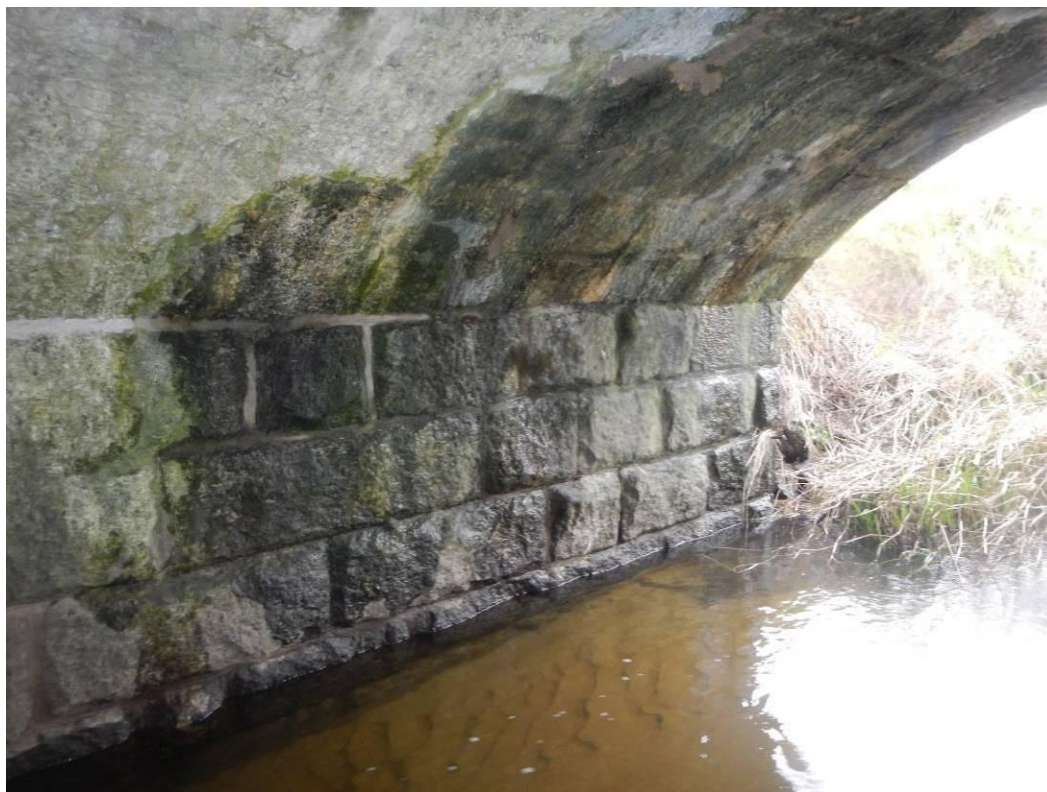
**Photo 11 – Structure 1: Leakage at West End of South Masonry Abutment**

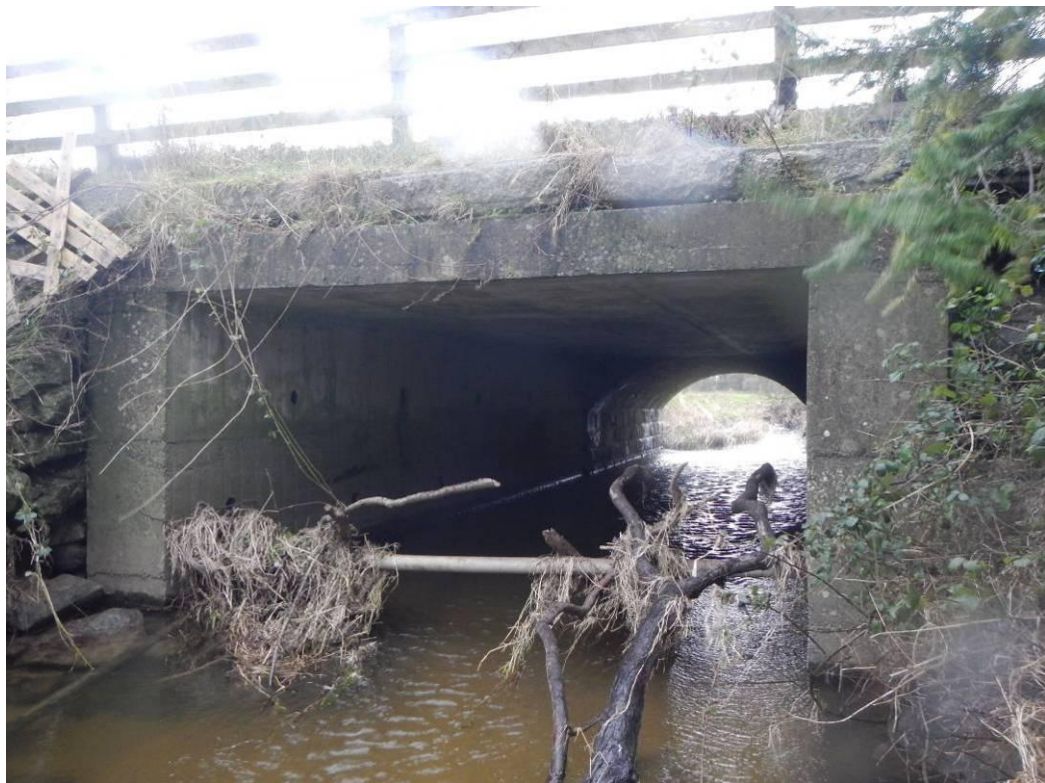
**Photo 14 – Structure 1: East Elevation**

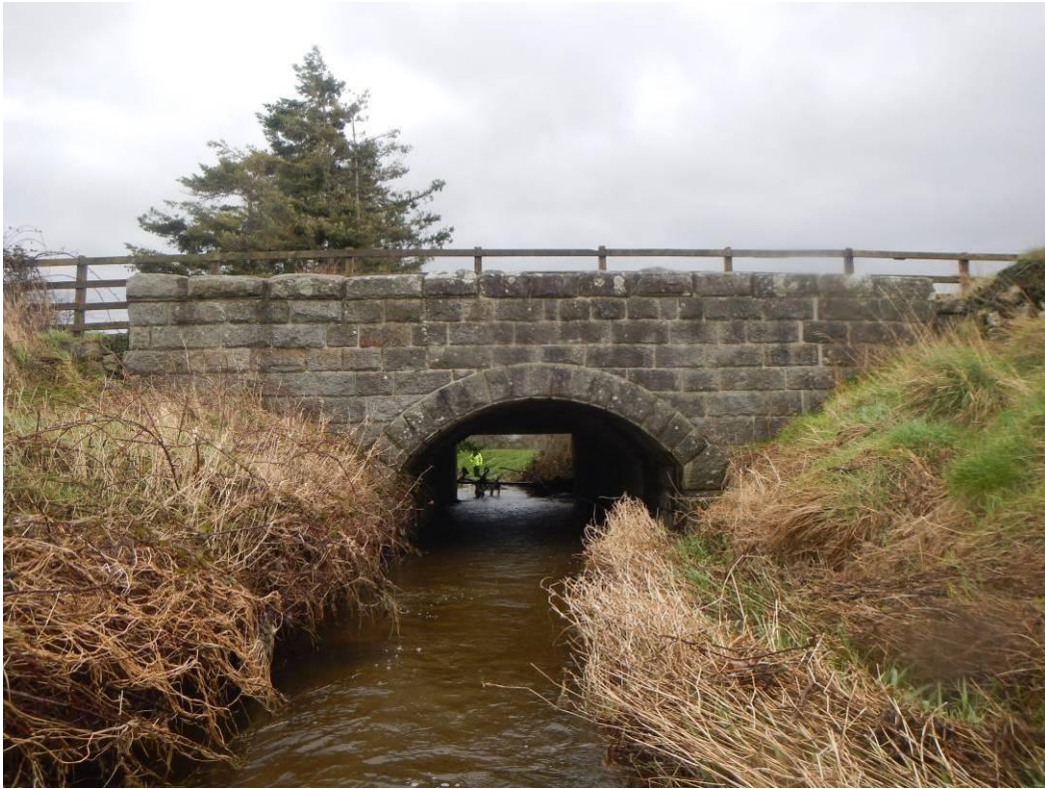
**Photo 15 – Structure 1: West Elevation**

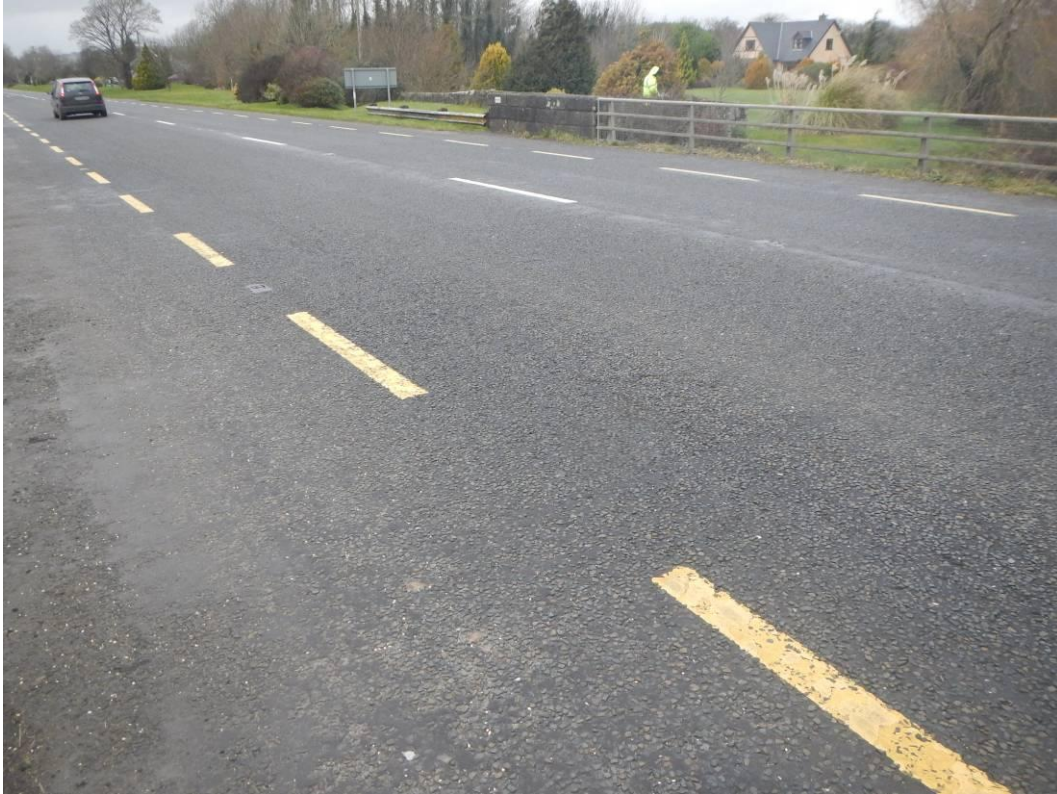
The bridge surfacing was observed to be in good condition with no evidence of rutting, settlement or loss of surface texture (see Photograph 17). The surface course comprises HRA surfacing in the carriageway and hard shoulders with a 300-500mm strip of DBM along the base of the parapets. There are no visible expansion joints on the bridge surface and the record drawings show “20mm Flexcell expansion joint” filling the expansion gap from carriageway level down to the bearing shelf. Flexcell is a bitumen impregnated rigid joint filler board and does conform to the any of the bridge deck expansion joint types outlined in NRA BD 33/94 Expansion Joints for Use in Highway Bridge Decks.

**Photo 17 – Structure 2: View of Carriageway Surfacing**

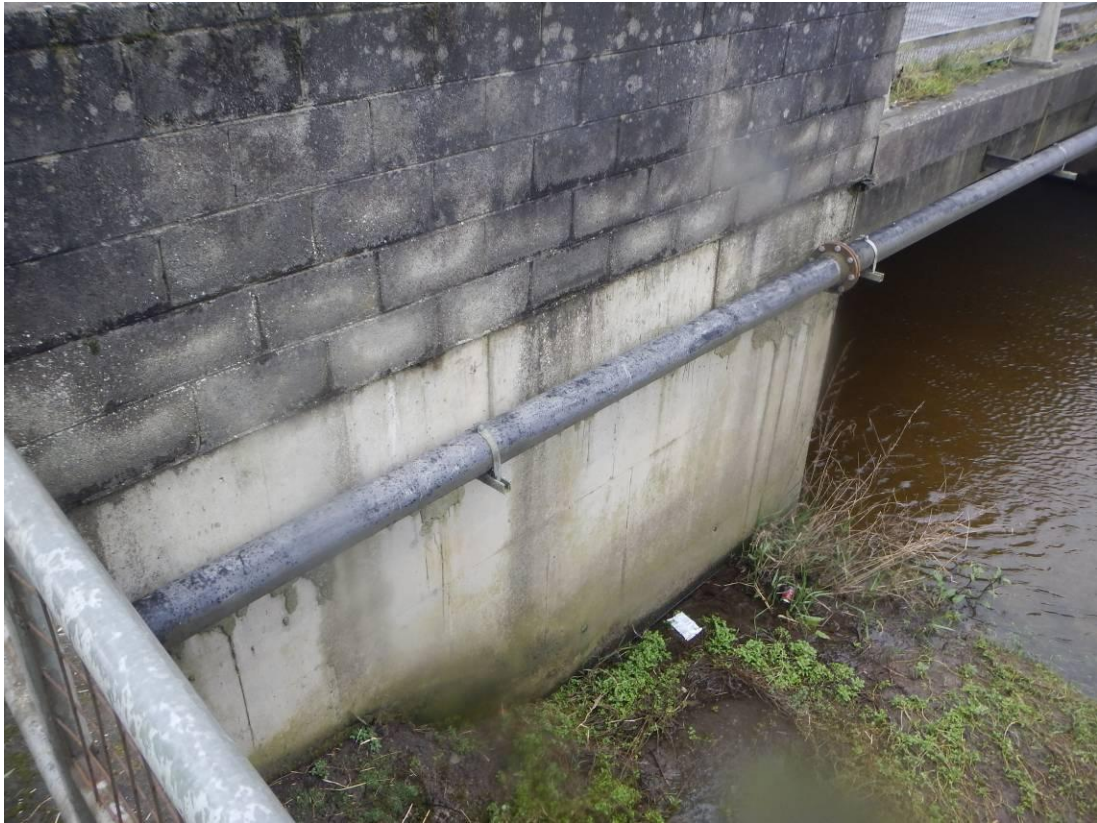
Reinforced concrete wingwalls run perpendicular to abutments on the north side and parallel to abutments on the south side. The walls were found to be in good condition with no significant defects noted (see Photographs 21 and 22). The soffit of the deck (soffits of inverted T Beams), precast edge panels and abutments were inspected and showed no evidence of structural distress (see Photographs 23-25). However, leakage was noted emanating from the bearing shelf and precast edge panels onto the sides of the abutments at all four corners of the deck (see Photograph 26). Furthermore, although abutment faces and beam soffits were dry at the time of inspection, leakage staining was observed in numerous areas indicating that leakage is an ongoing problem (see Photograph 27). These findings are in keeping with the leakage observed during the 2010 Inspection for Assessment. The elastomeric bearings were inspected with a restricted view but appeared to be in good condition.

**Photo 21 – Structure 2: Concrete Wingwall at Northeast Corner**

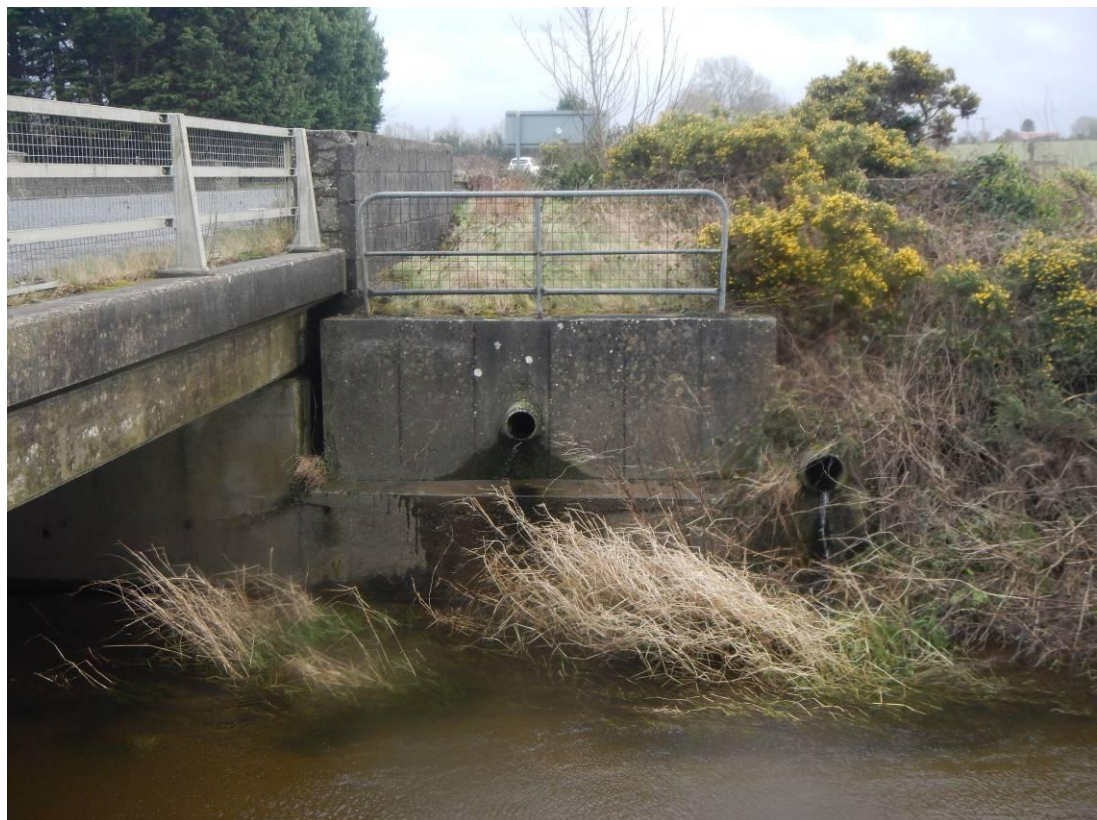
**Photo 22 – Structure 2: Concrete Wingwall at Southeast Corner**

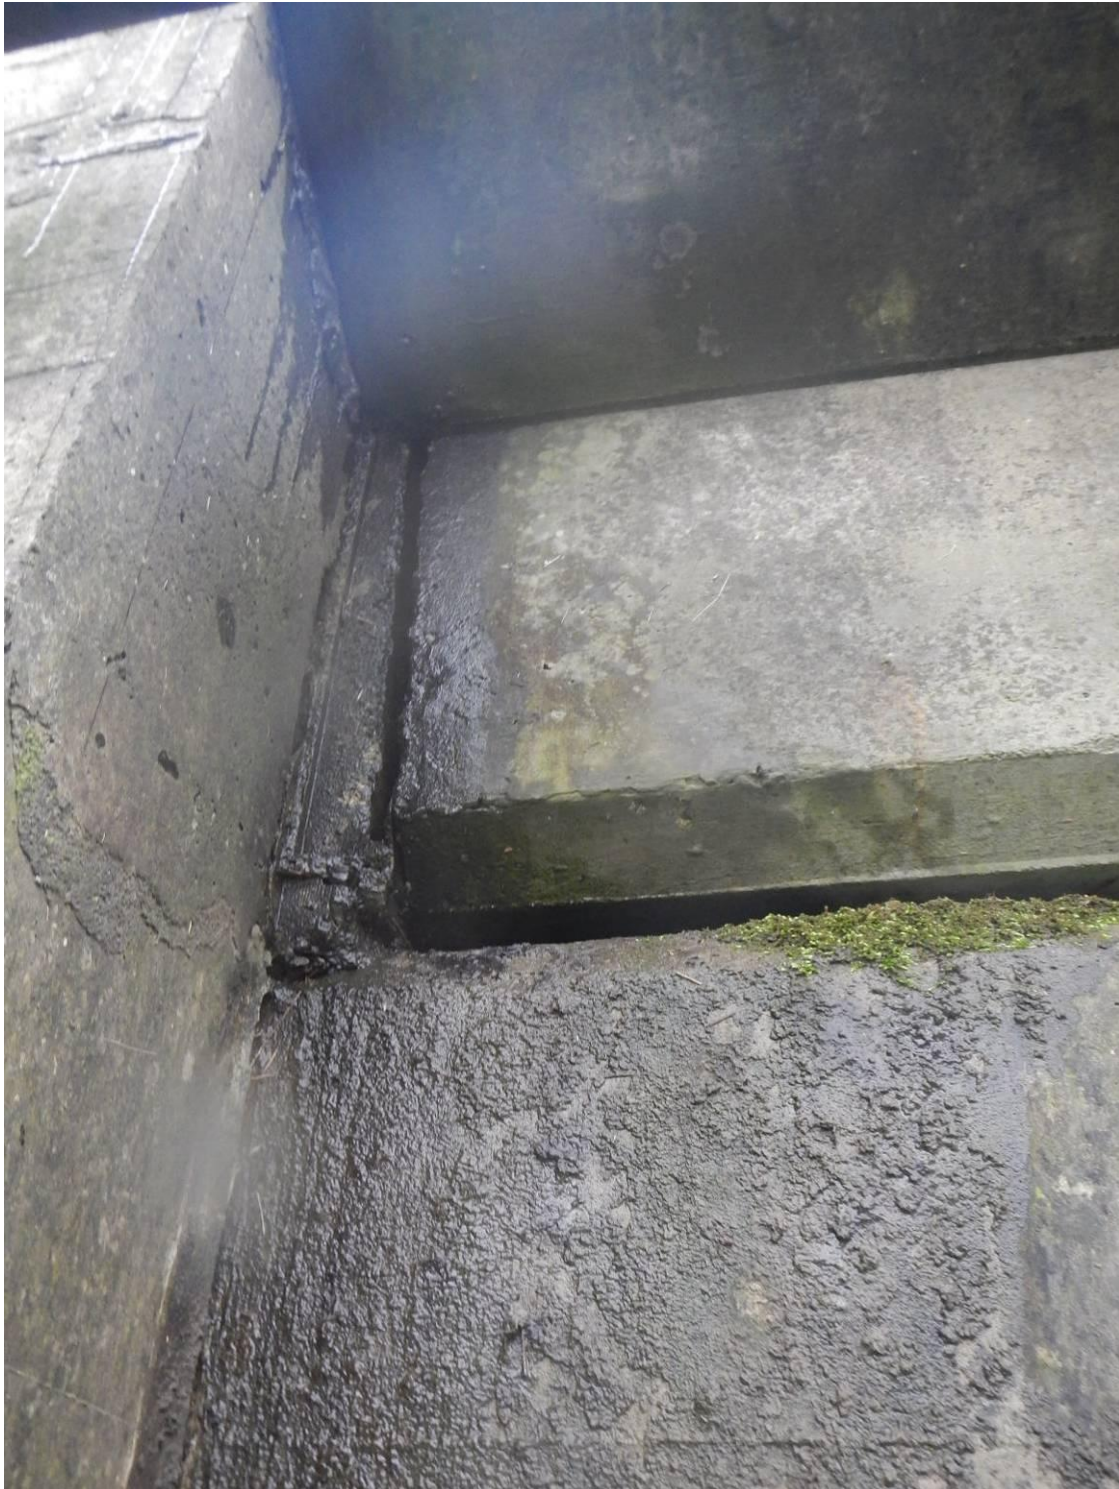
**Photo 26 – Structure 2: Leakage Above Abutment at Northeast Corner**

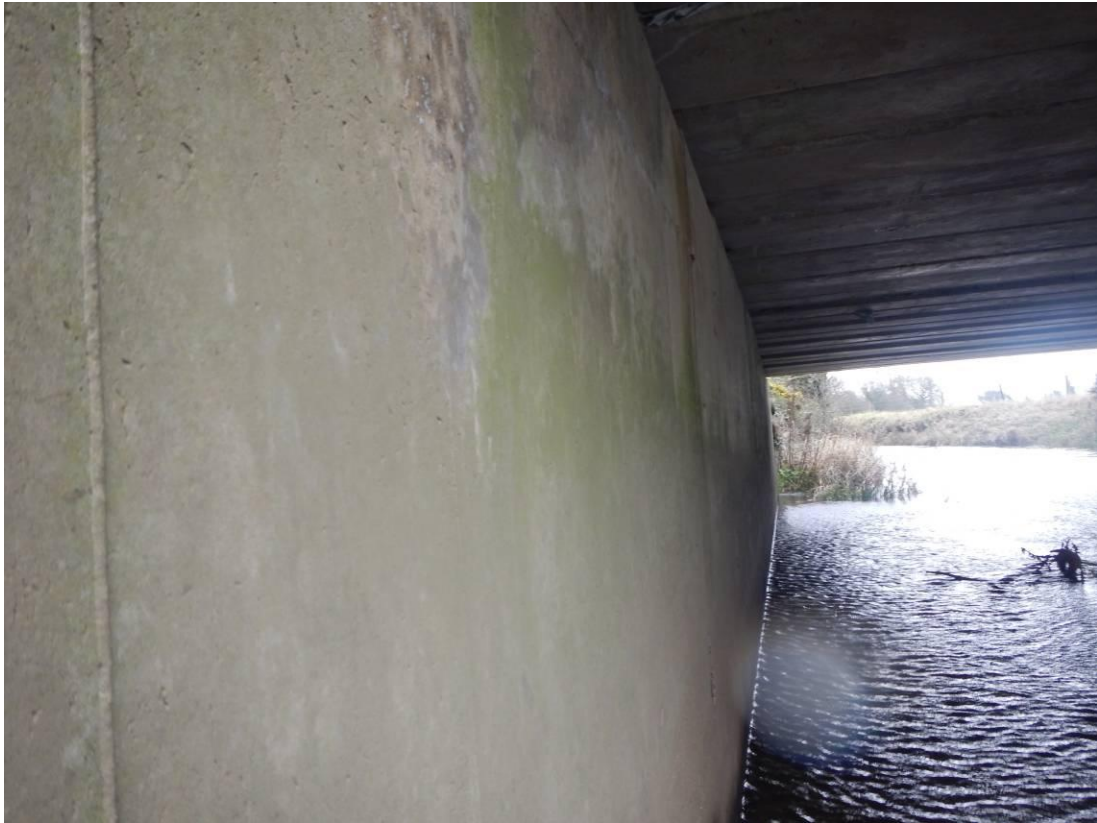
**Photo 27 – Structure 2: Staining on East Abutment**

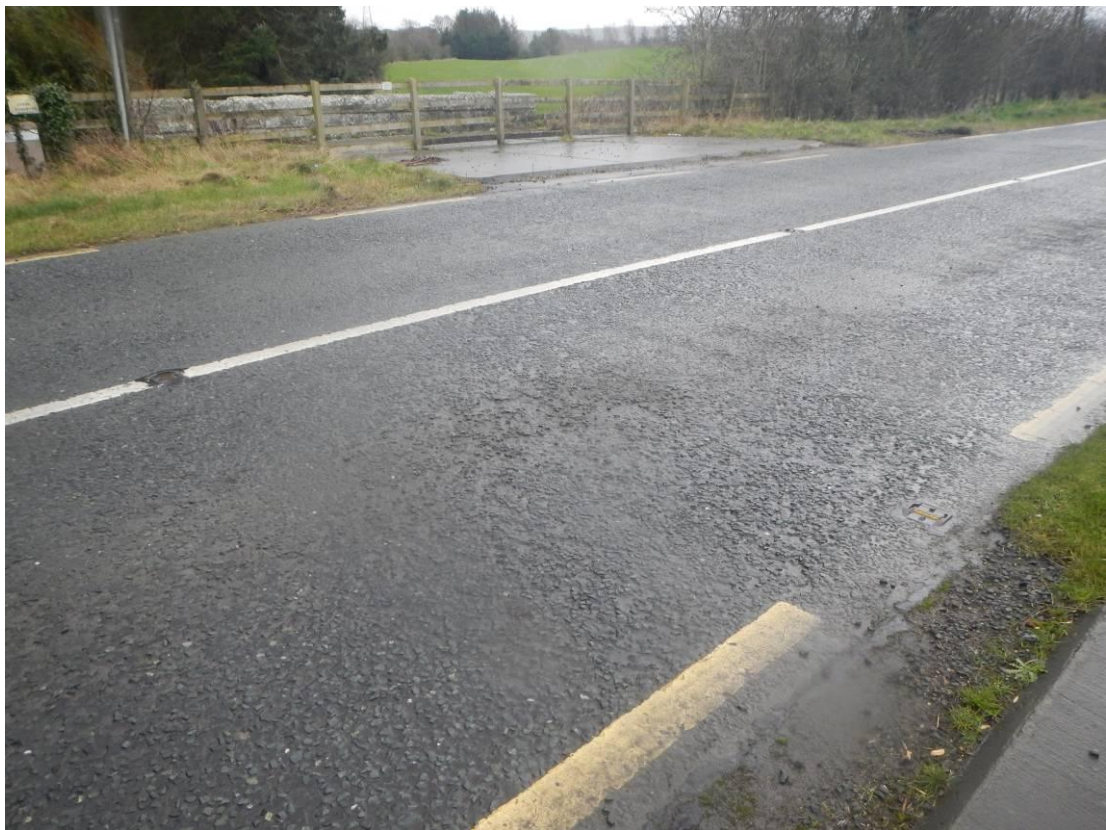
The HRA bridge surfacing was observed to be in reasonable condition with no evidence of rutting or settlement and only minor loss of surface texture on the northbound lane (see Photograph 32). There is a narrow strip of DBM surfacing along the front face of the raised verge kerblines which appears to have been laid as part of the installation of the concrete raised verges. Concrete verges have been constructed between the edge of carriageway and parapets to replace soft verges and were found to be in good condition with only routine maintenance required to clear debris and vegetation from the open channel drains. The horizontal alignment is poor along this section of the N81 with horizontal curves on both approaches. No safety barriers are provided on approaches with timber post and rail fencing demarking the road boundary.

**Photo 32 – Structure 3: View of Carriageway Surfacing**

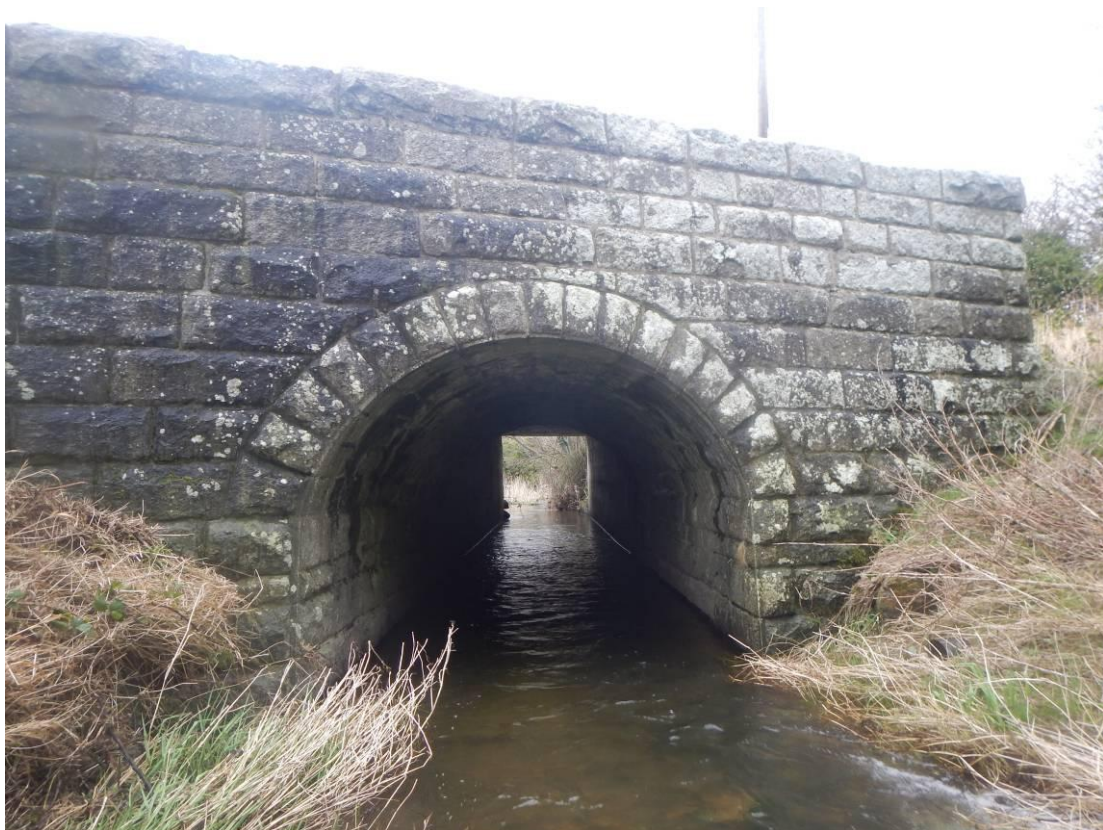
The east spandrel wall and wingwalls consist of finely dressed, quarry-faced square-cut granite stonework. The walls appear to be in very good condition with no evidence of structural distress noted (see Photograph 36). The walls appear to have been recently repointed.

**Photo 36 – Structure 3: East Elevation**

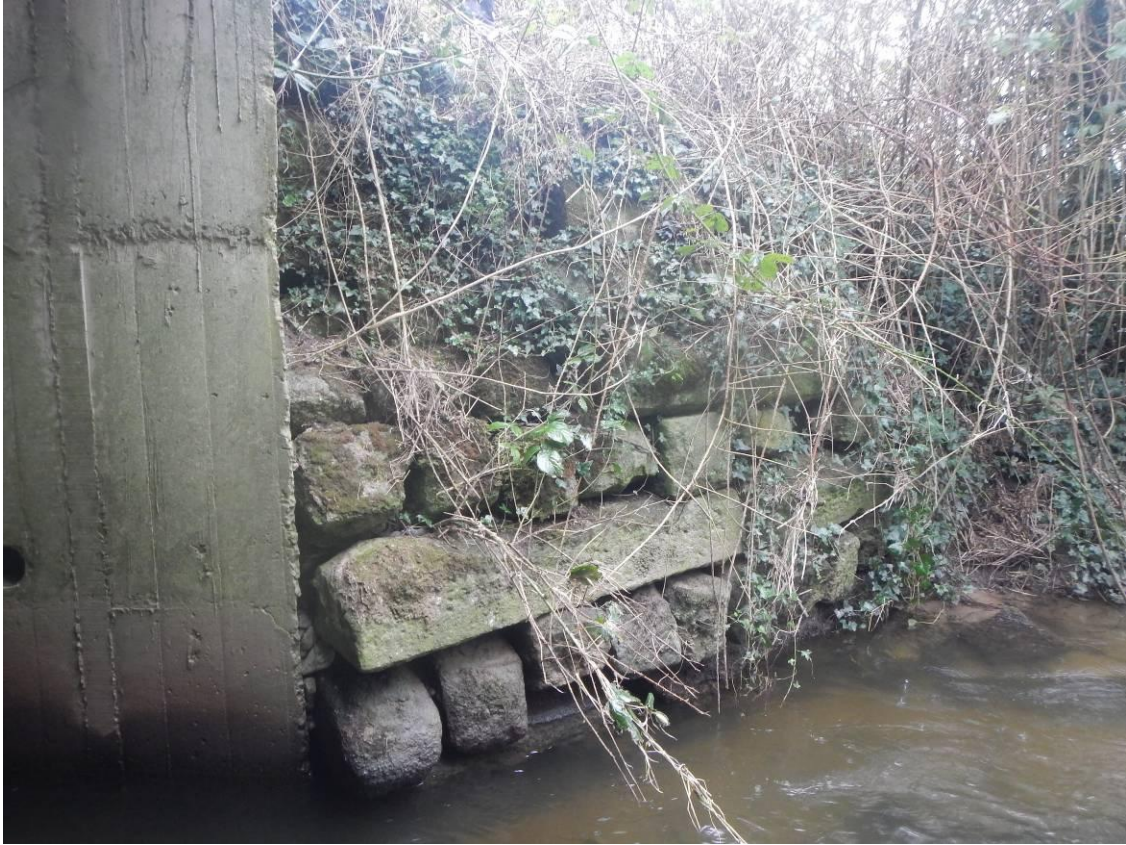
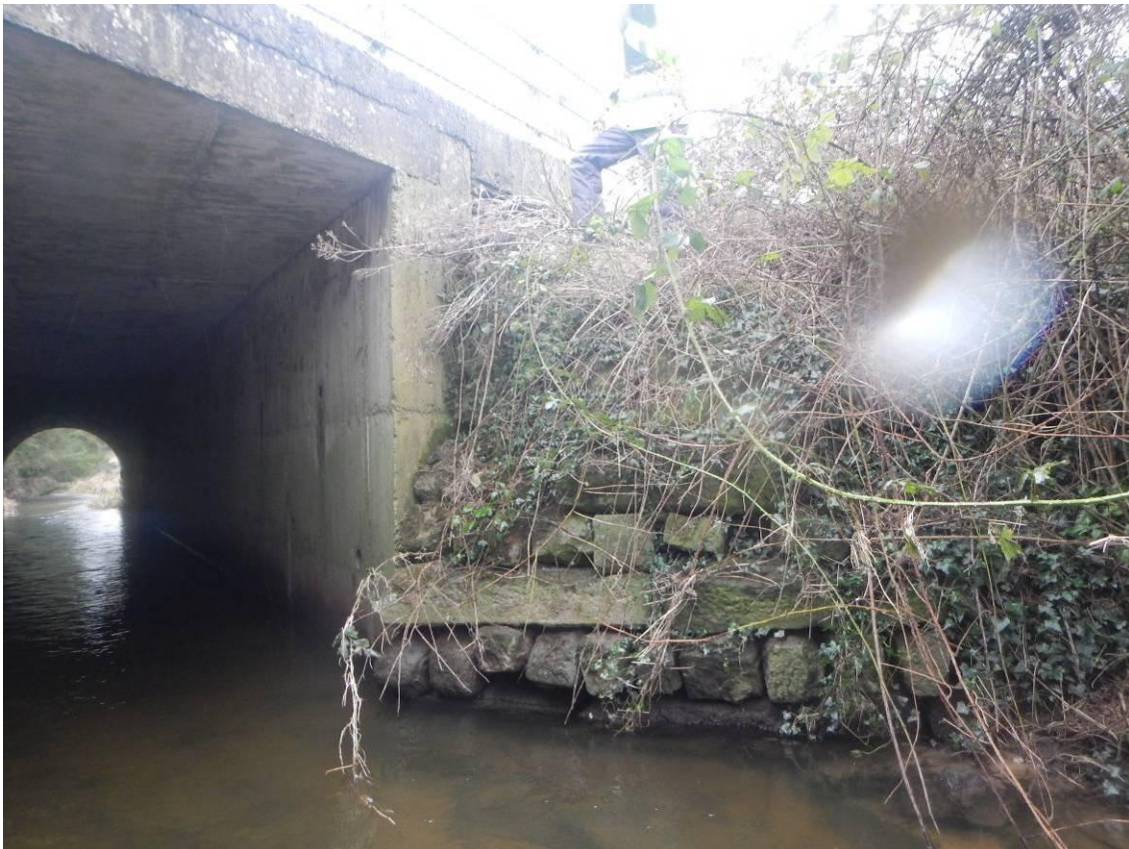
The east embankments are generally well vegetated and stable. However, there is evidence of deformation and bulging of the southwest masonry river training wall. The short section of boulder/drystone masonry wall (approx 2.0m long x 2.0m high) has been undermined and appears to be unstable (see Photographs 37 and 38). The wall will need to be taken down and rebuilt with suitable scour protection, or replaced with an alternative rock armour or gabion basket system.

**Photo 37 – Structure 3: Southwest Masonry River Training Wall**

**Photo 38 – Structure 3: Southwest Masonry River Training Wall**

- Taking down and rebuilt to the existing line and level with suitable rock armour protection to the toe of the wall to prevent recurrence of the defect, or;
- Removal of the existing wall and installation of a gabion basket river training wall.

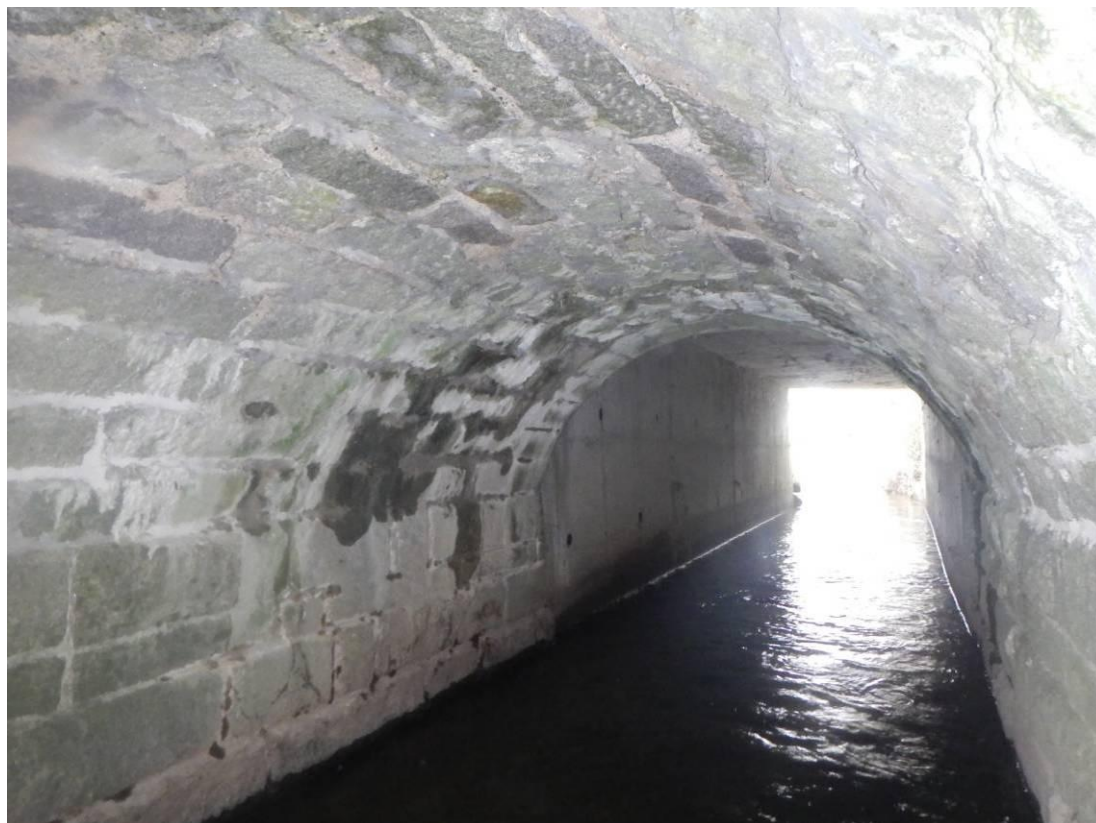
The expressed arch and arch barrel are also constructed from finely dressed quarry faced ashlar masonry and were found to be in very good condition with only minor seepage and resultant staining and calcite deposits noted at either end of the barrel over a length of approximately 1m. The arch shape is very good and there is no evidence of structural distress in the form of cracking, deformation or displaced arch voussoirs. The barrel is well pointed and appears to have been recently repointed (see Photograph 39).

**Photo 39 – Structure 3: View on Arch Barrel**

Based on the findings of the visual inspection, no repointing or masonry repairs are required to the arch barrel, spandrel wall or abutments. In accordance with current best practice it is not proposed to remove calcite deposits from the stonework. These works are potentially damaging and yield no real benefit to the structure. The amount of leakage through the arch barrel is insignificant and therefore we do not propose to address this issue as part of the proposed works.

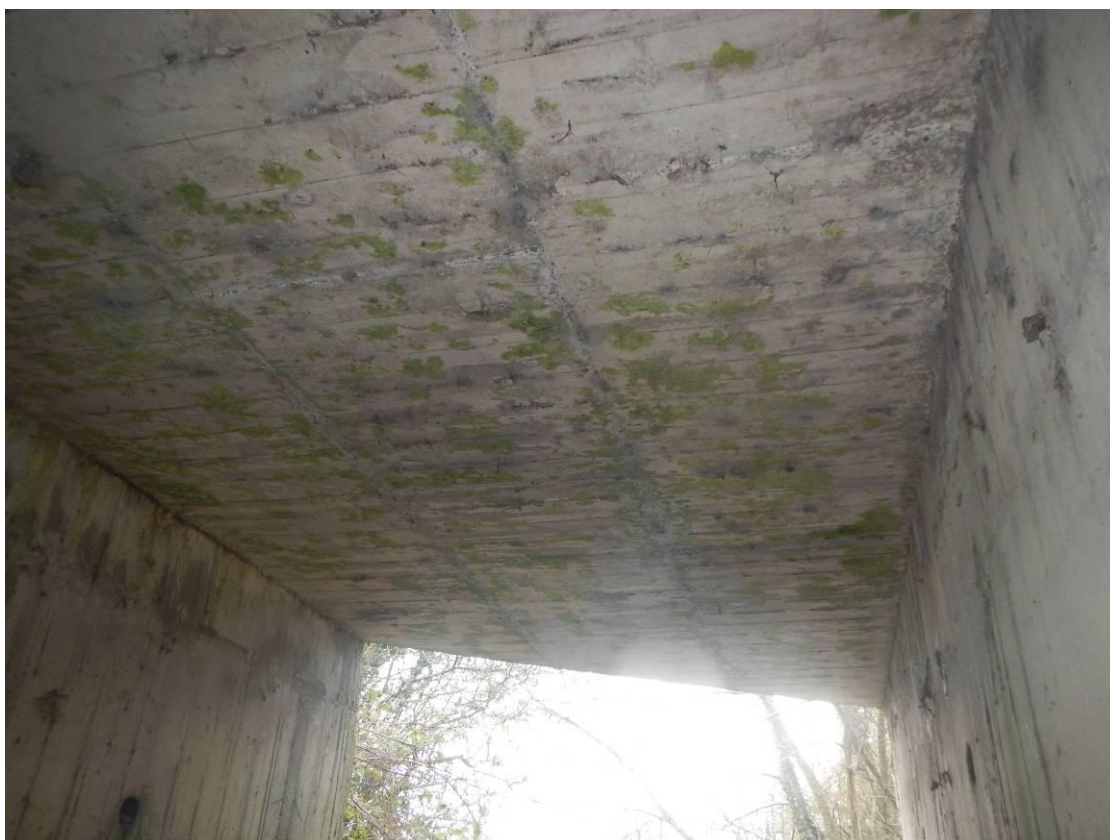
The in-situ reinforced concrete deck appeared to be in good condition with no significant defects noted. The soffit was heavily stained with algal growth over a 3-4m length at the west end of the bridge indicating that it is regularly wet but was found to be relatively dry at the time of inspection (see Photograph 40).

**Photo 40 – Structure 3: Reinforced Concrete Deck**

No repairs are required to the concrete section of the structure. Damp staining will be addressed via the installation of bridge deck waterproofing and the poor finish and staining of abutments is aesthetic only.

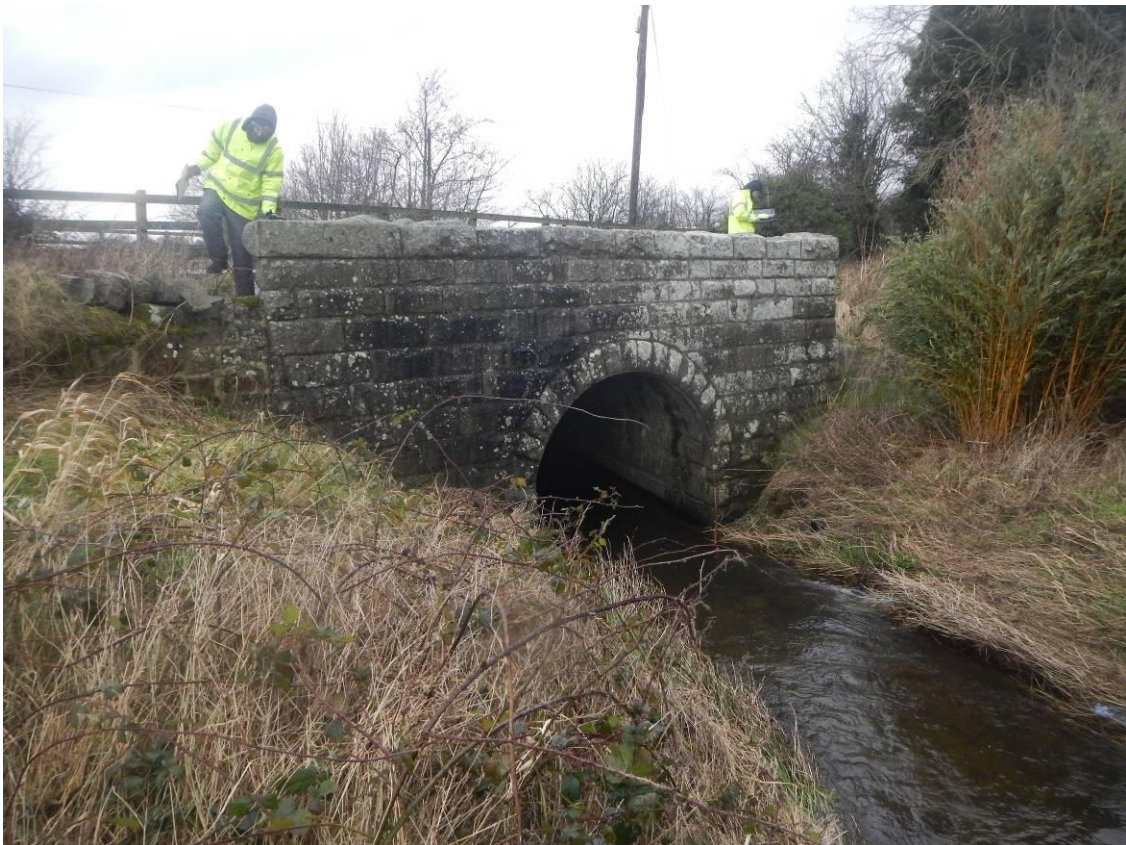
The masonry abutments also consist of granite ashlar masonry. Inspection of the abutments showed that there were no signs of flexural cracking, rotation or differential settlement which would be indicative of structural distress due either to overload or movement of the substructure (see Photograph 41). All visible areas of the masonry abutments are well pointed (see Photograph 42). The concrete abutments were also found to be in good condition and show no evidence of structural distress due to overload or movement. The concrete finish is poor with widespread seepage staining evident throughout (See Photograph 43). Photos of the east and west elevations have been included as photographs 44 and 45 respectively.

**Photo 44 – Structure 3: East Elevation**

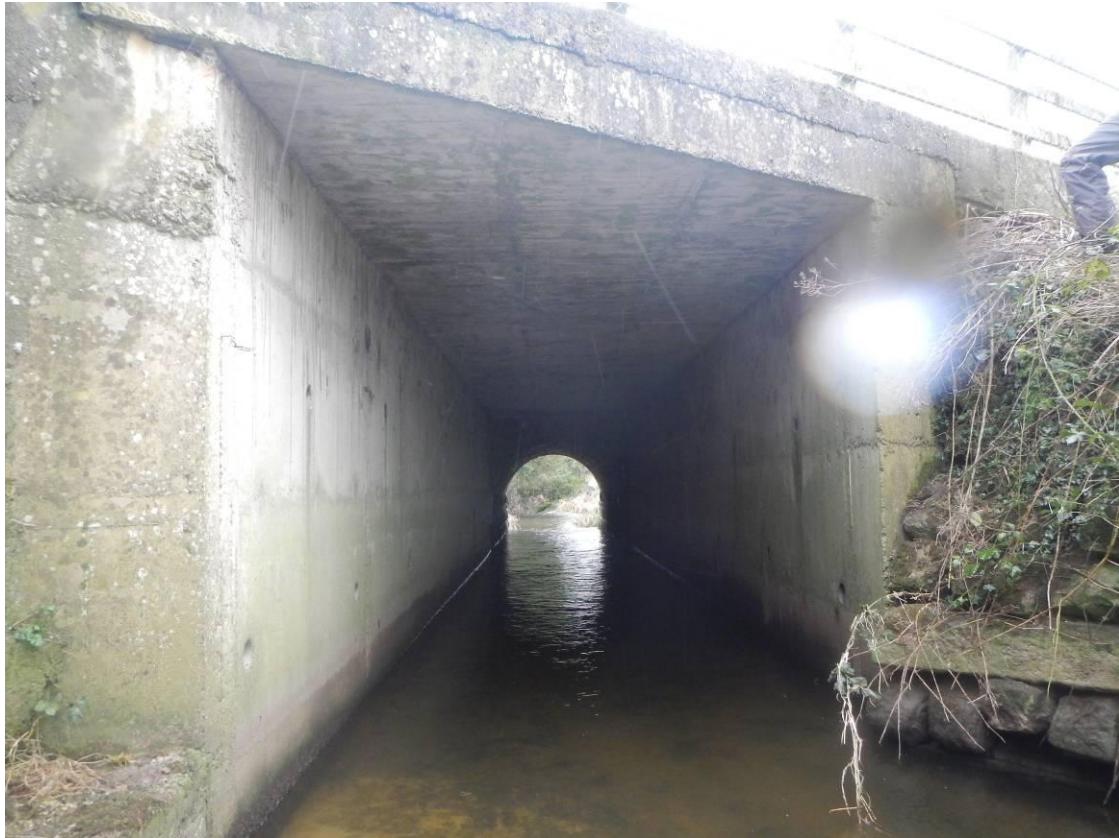
**Photo 45 – Structure 3: West Elevation**
