# TO 268 Leinster Bridges Rehabilitation Contract No. 2 Part 2 Carlow and Wexford Bridges - Change Order No. 1

## Inspection and Rehabilitation Report

**Inspection and Rehabilitation Report**

**Document No:** ..... 15.135.10 Pt2 CO1- IR

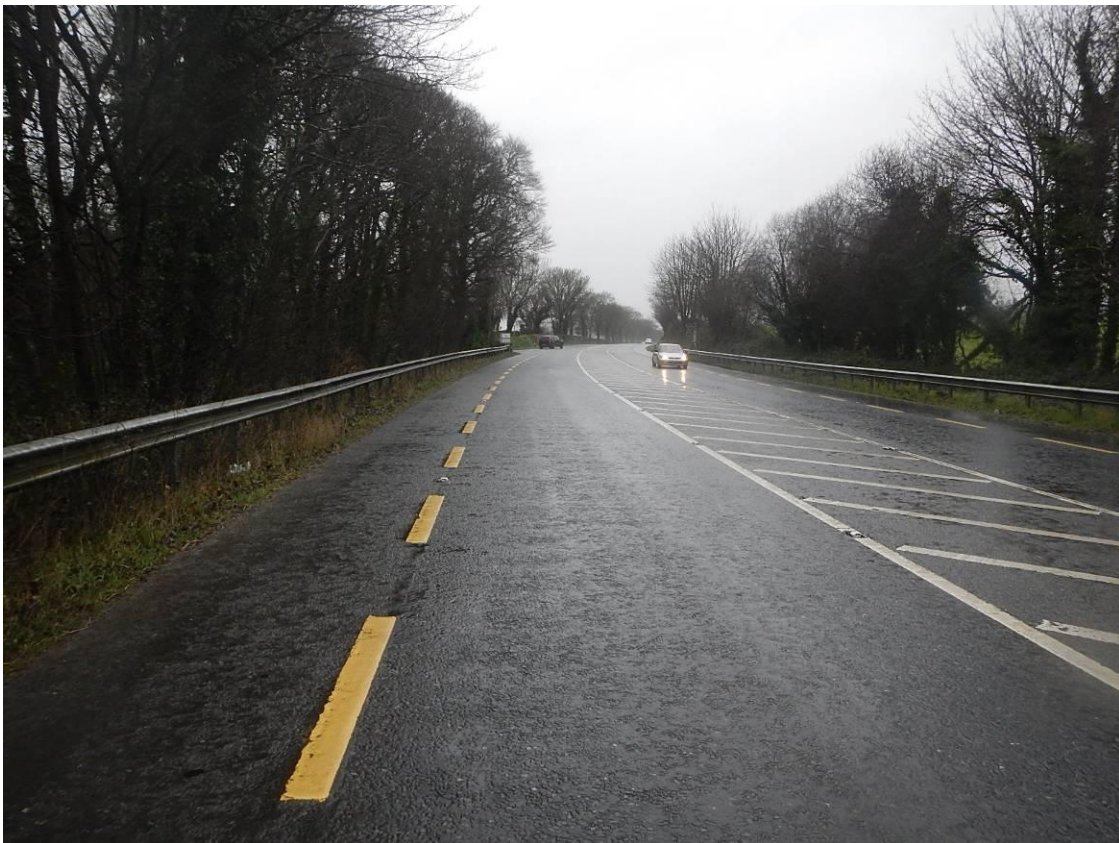
The HRA bridge surfacing was observed to be in good condition with no evidence of rutting, settlement or loss of surface texture (see Photograph 46). The horizontal alignment is reasonably good along this section of the N11 with a gentle horizontal curve on the approach and departure. Safety barriers are provided along either side of the carriageway which appear to be a compliant N2 system and are in good condition. The western safety barrier terminates in a P4 full height terminal approximately 20m south of the bridge. A stone masonry wall borders the carriageway from this point onwards (see Photograph 47). The inlet and outlet of this buried structure are removed from the carriageway by 13m and 11m respectively. Edge protection is provided via a masonry parapet at the outlet. No edge protection is provided at the inlet (see Photographs 48 and 49).

**Photo 46 – Structure 4: View on Carriageway Surfacing**

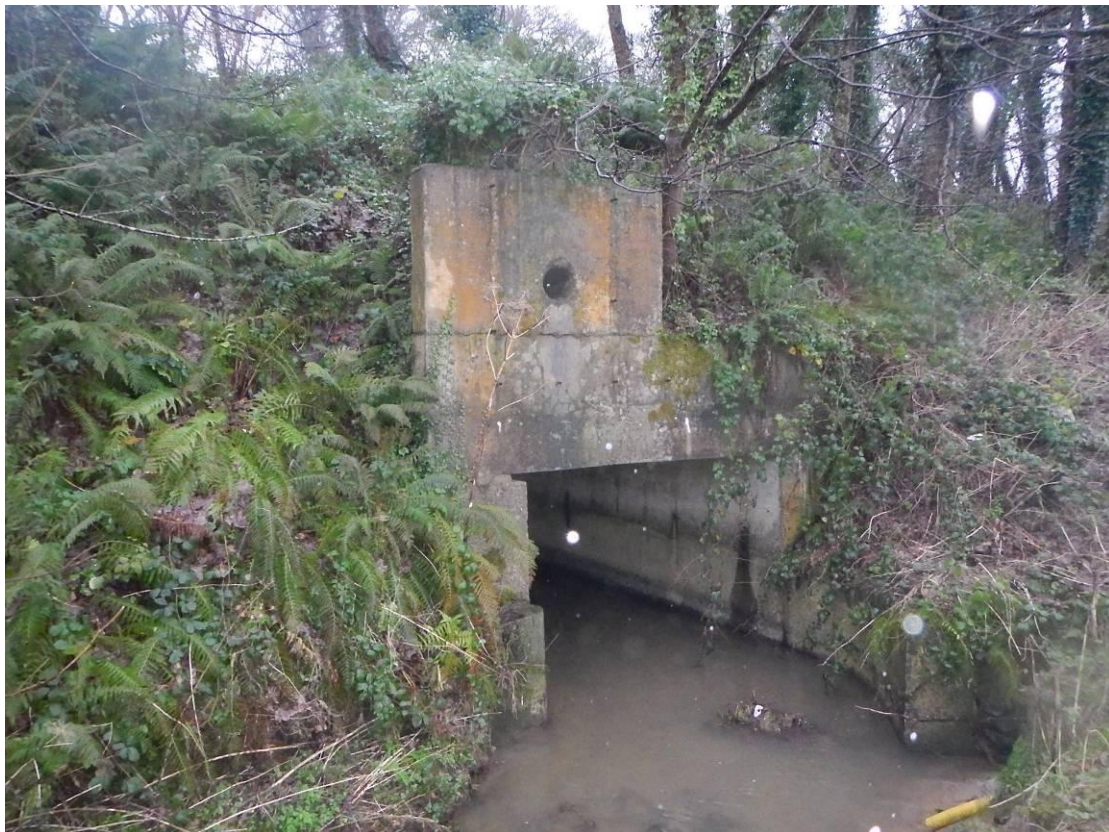
**Photo 48 – Structure 4: View on Eastern Inlet**

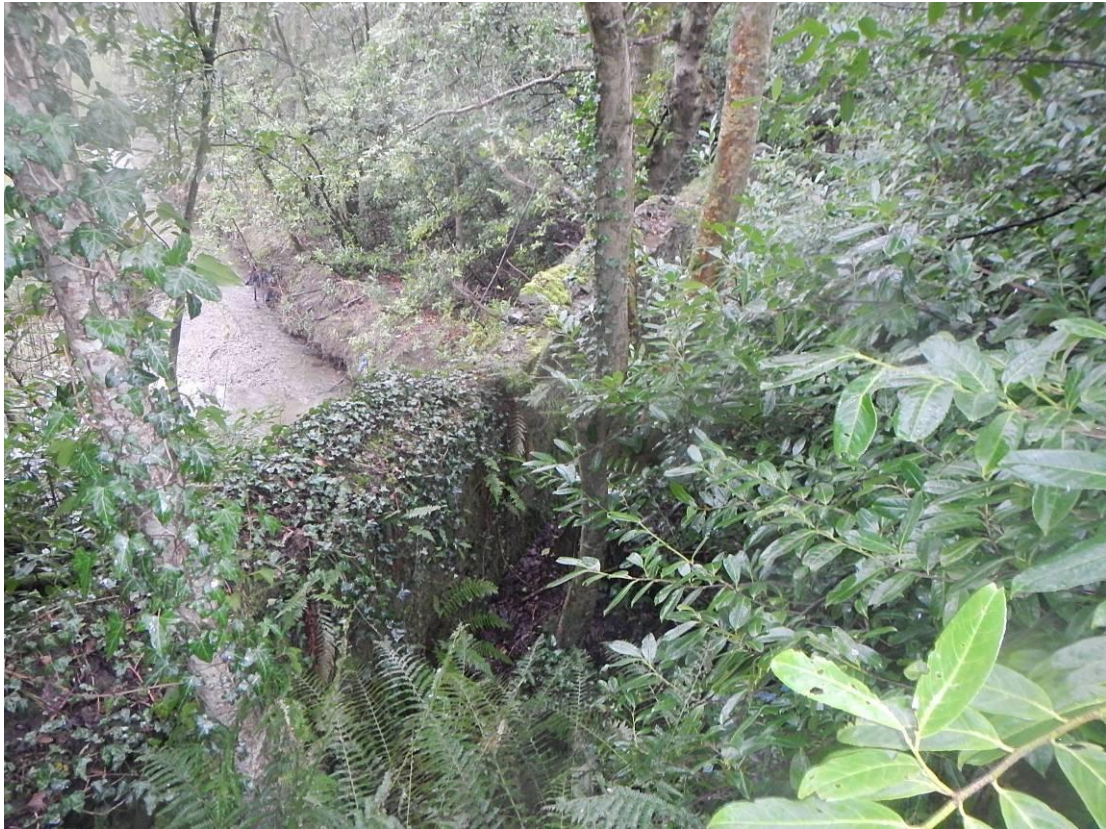
**Photo 49 – Structure 4: View on West Masonry Parapet**

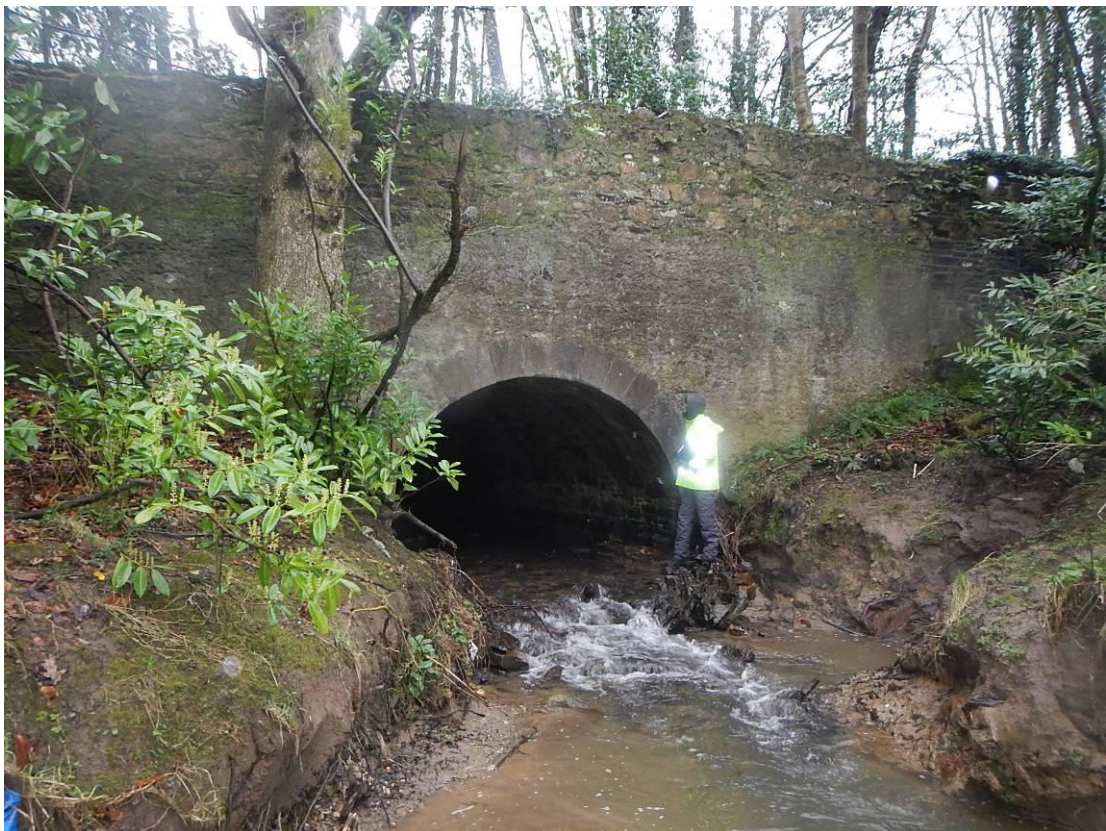
The west spandrel wall and wingwalls consist of random rubble stonework, partially rendered with a sprayed cementitious layer which appears to have come away from the top half of the wall which is now subject to minor vegetation growth. The walls appear to be in reasonably good condition with no evidence of structural distress noted on the west elevation (see Photograph 50).

**Photo 50 – Structure 4: West Elevation**

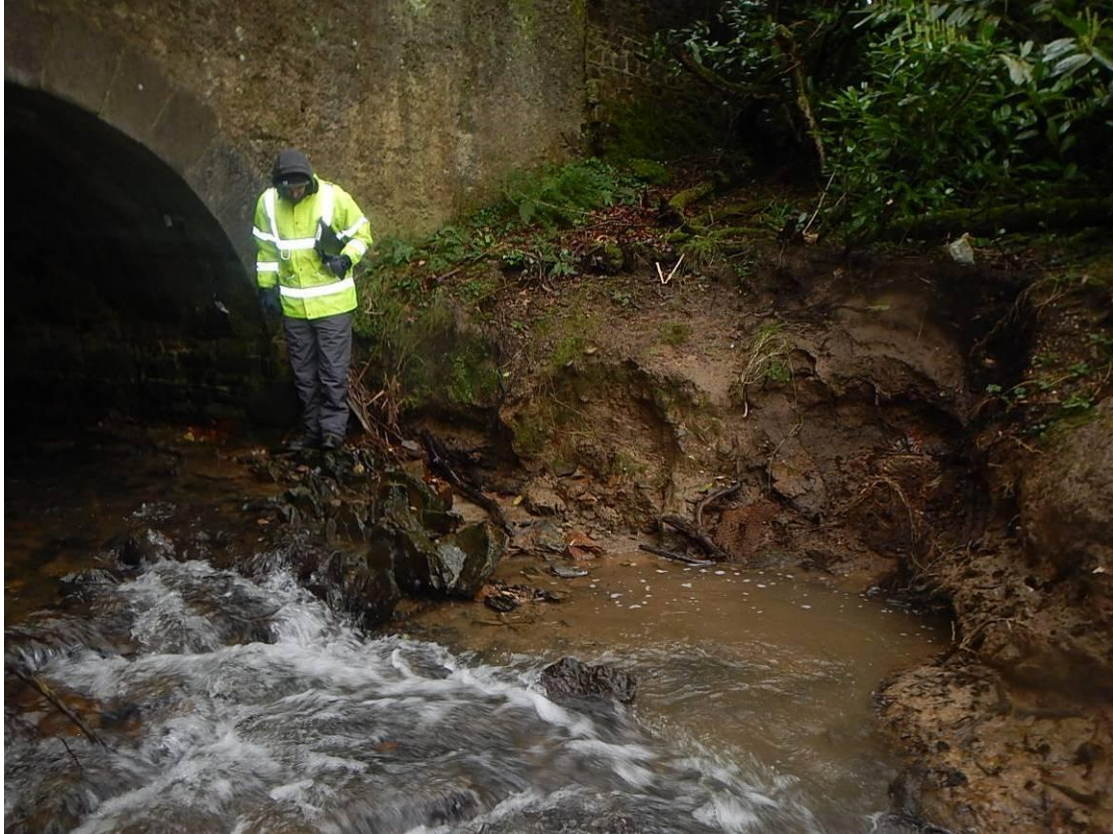
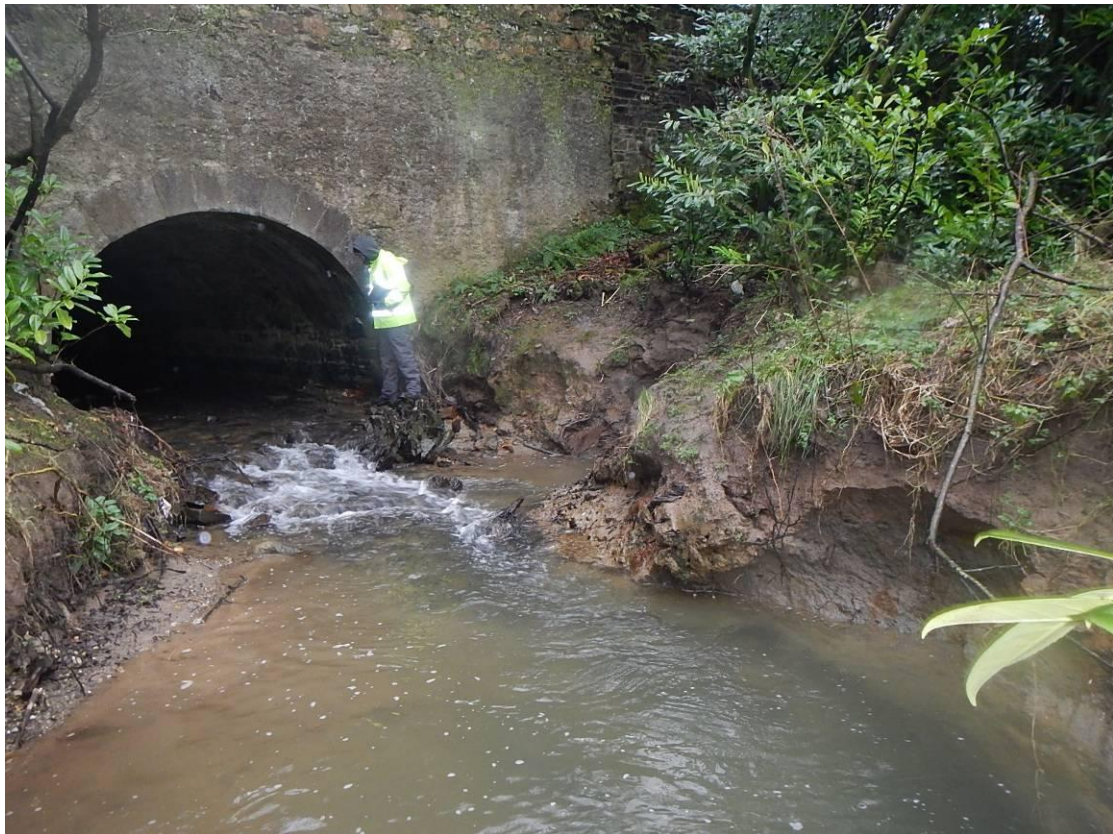
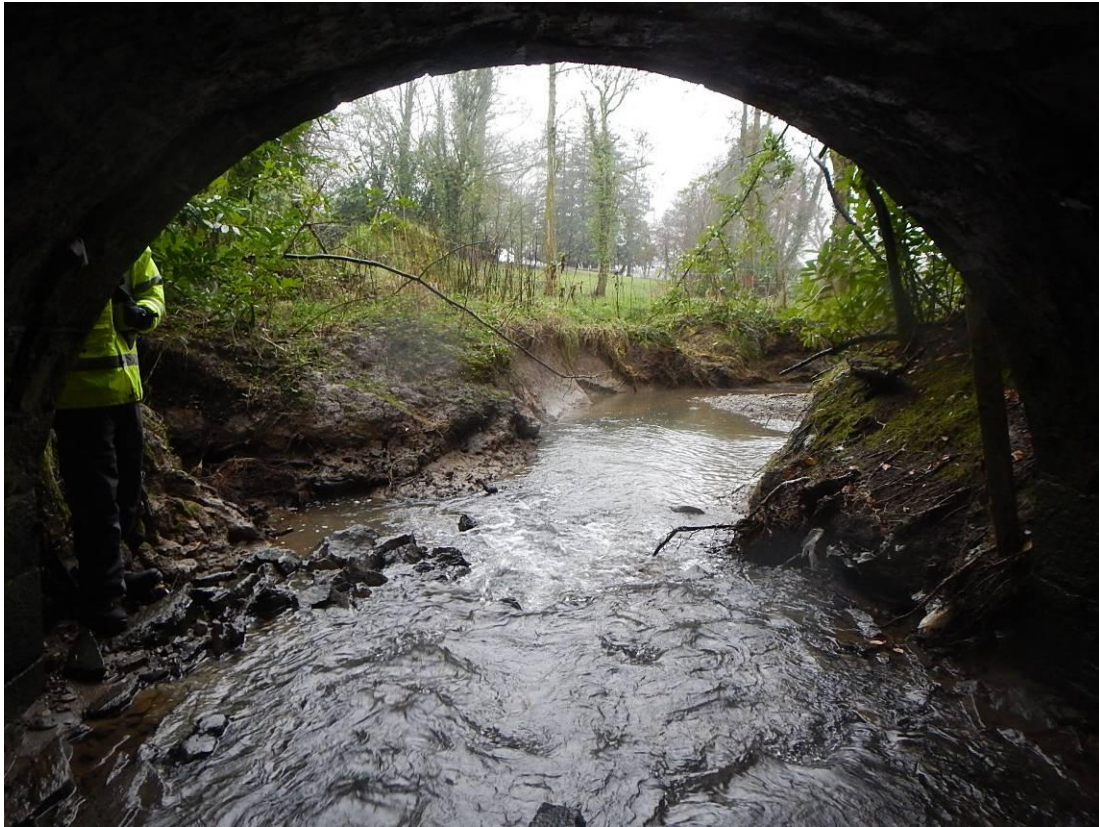
The embankments are overgrown and steep in places but in general appear stable. However, as per the previous Principal Inspection (February 2015), there is evidence of significant erosion and slippage of the southeast riverbank over an 11m length on the outside of the bend as the river turns through 30 degrees at the outlet (see Photographs 51 to 53). The relatively short section (approx 1m) of erosion noted on the northeast embankment was also still evident (see Photograph 54). Regarding and the installation of a suitable embankment protection system to prevent further erosion is required at these locations.

**Photo 51 – Structure 4: Erosion of Southwest Embankment**

**Photo 52 – Structure 4: Erosion of Southwest Embankment**

**Photo 53 – Structure 4: Erosion of Southwest Embankment**

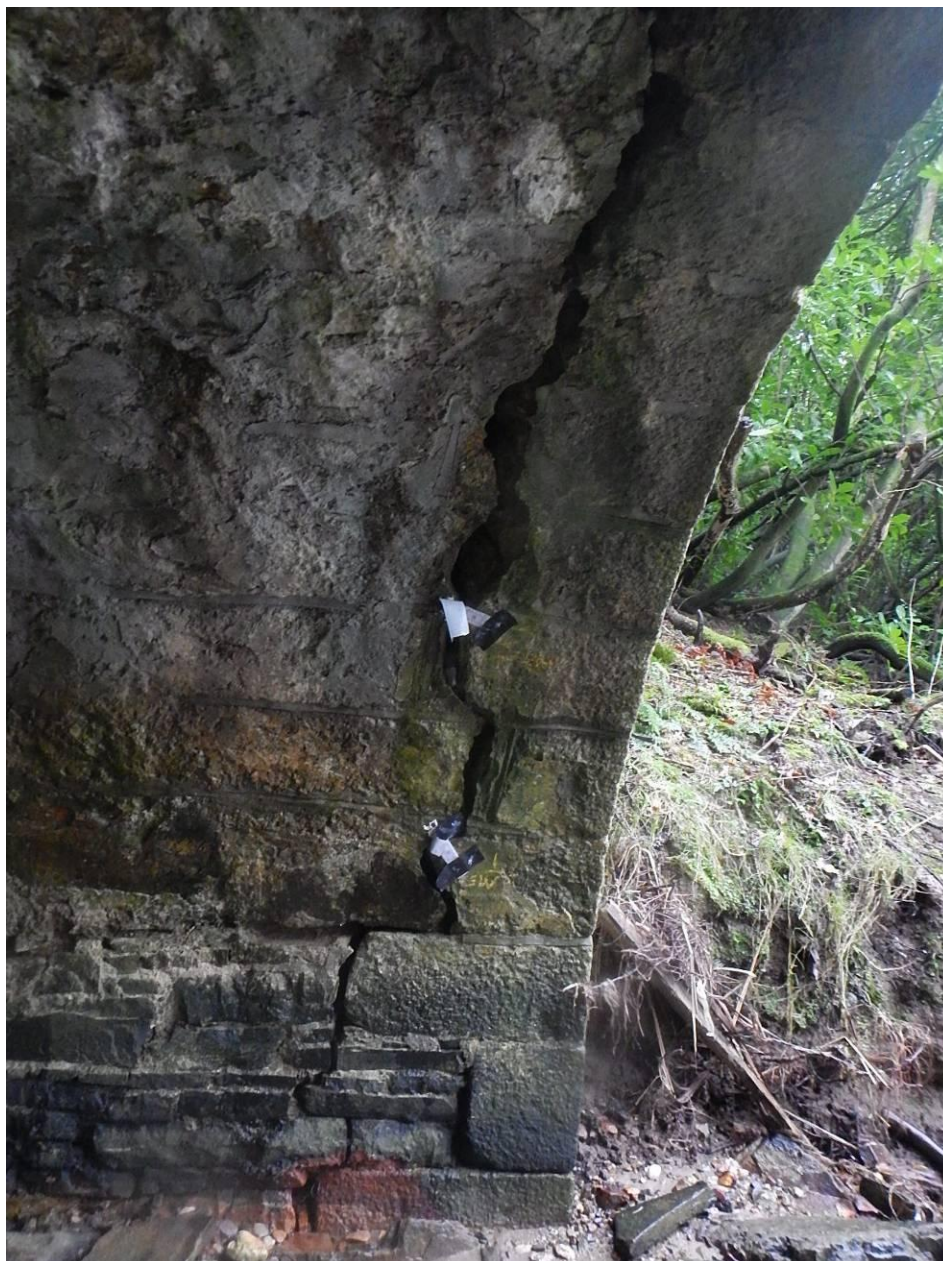
**Photo 56 – Structure 4: Crack on West of Arch**

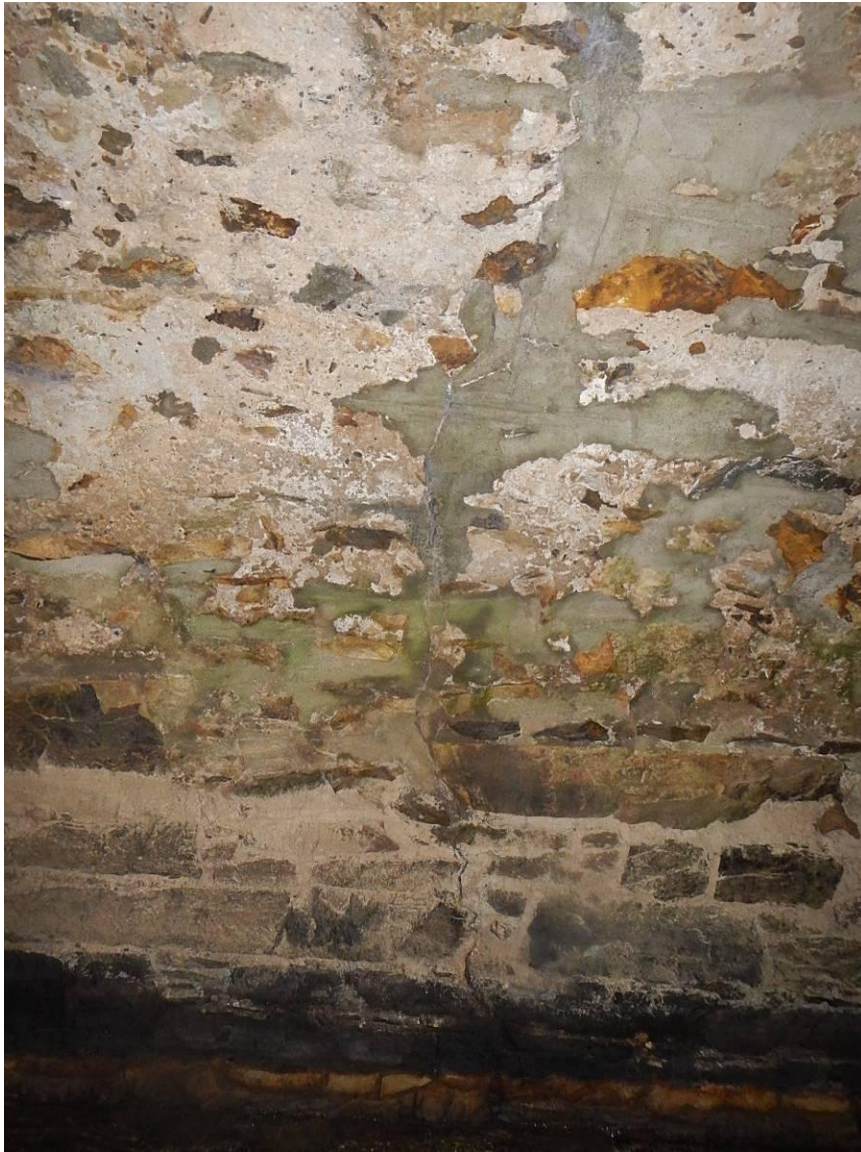
- The second full length circumferential crack is typically 9mm wide and is located approximately 5m from the west elevation. It appears to have been repaired in the past but has reopened (see Photograph 58);

**Photo 58 – Structure 4: Second Full Length Circumferential Crack**

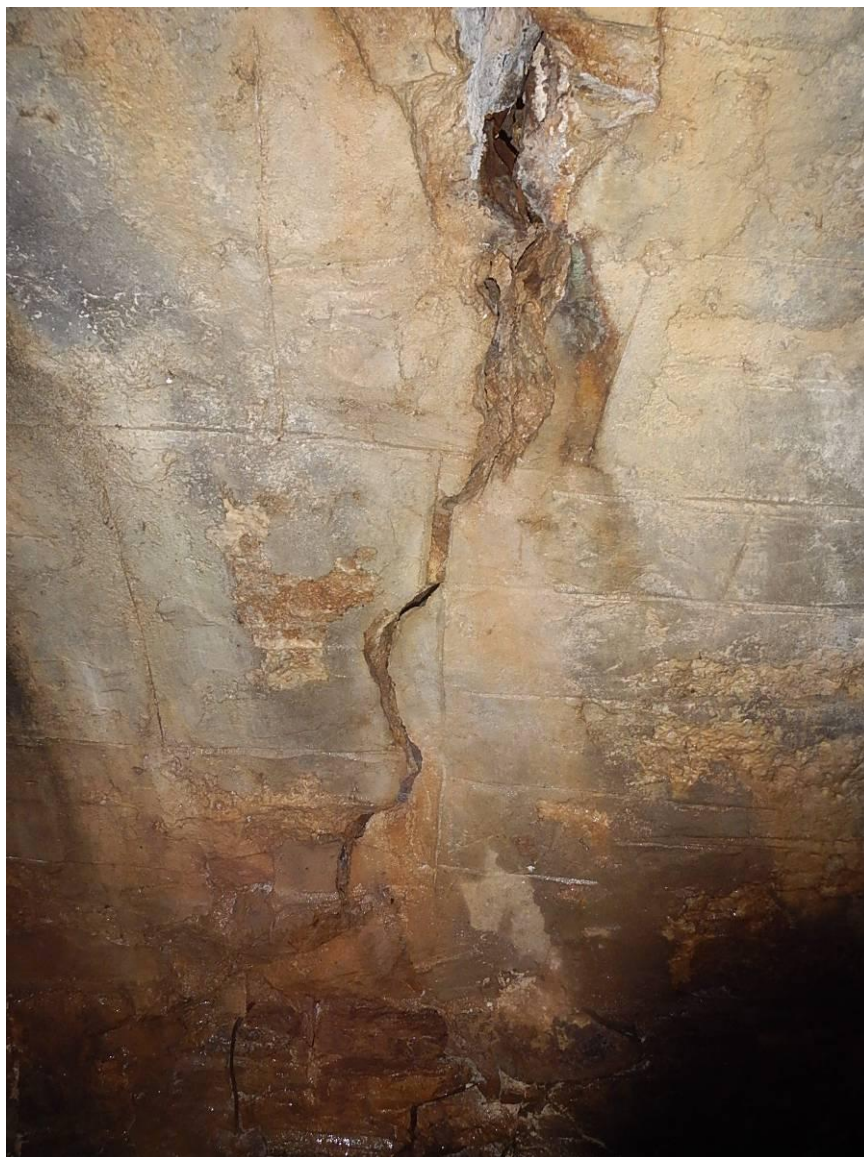
**Photo 59 – Structure 4: Third Circumferential Crack**

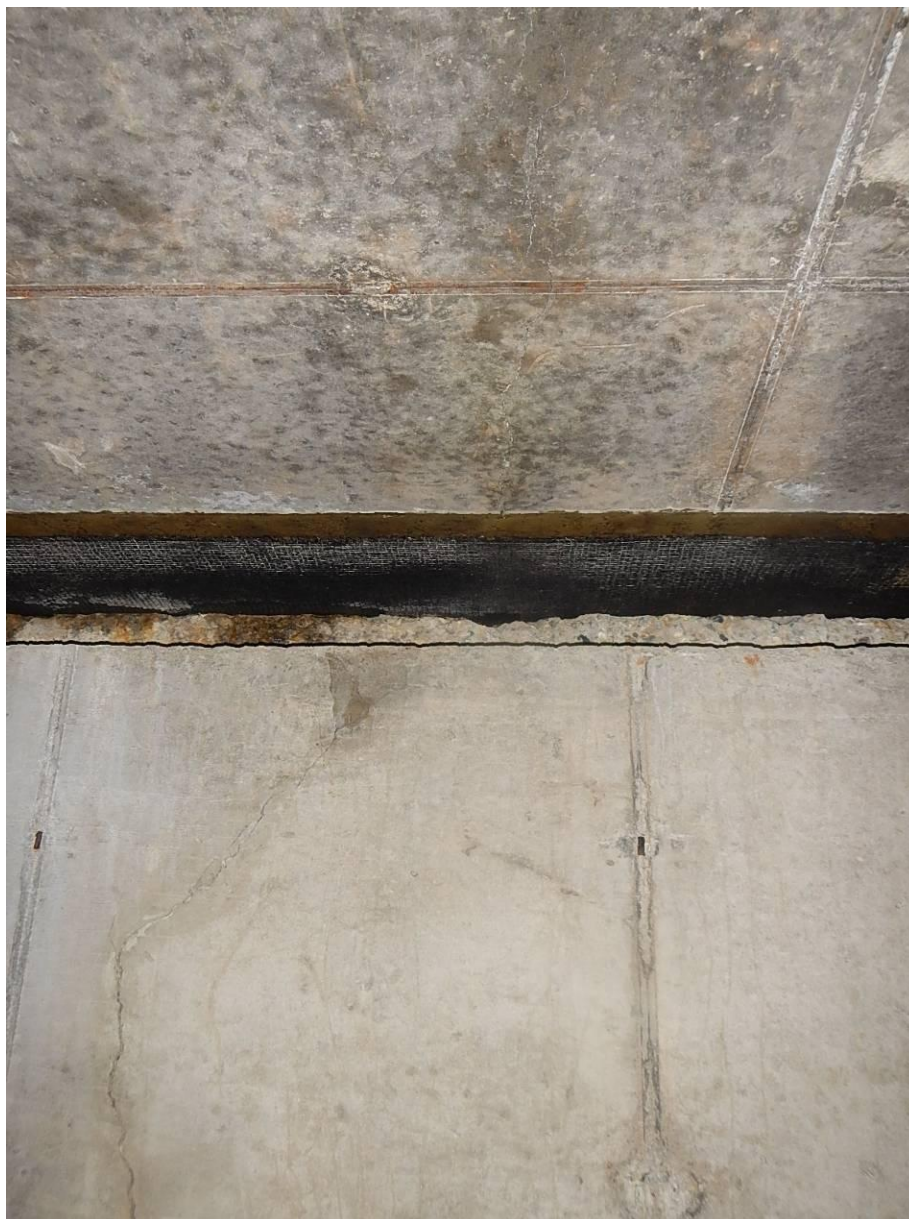
**Photo 61 – Structure 4: Longitudinal Crack**

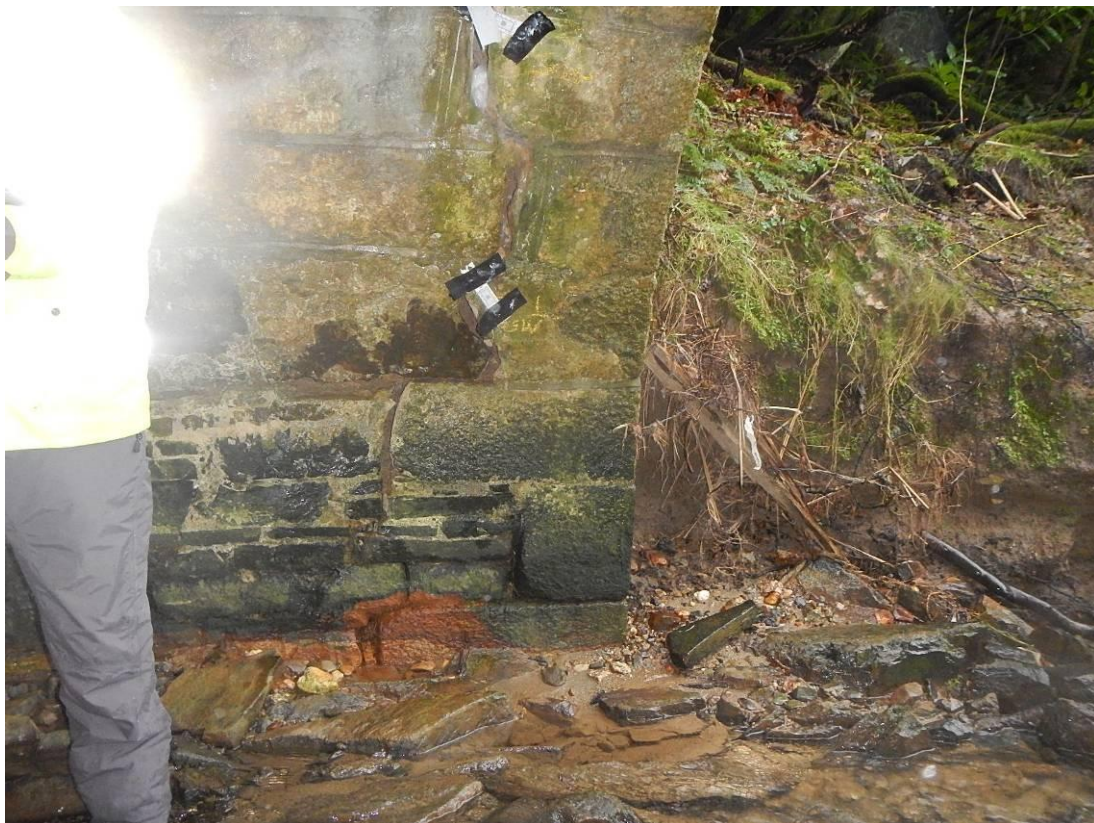
**Photo 63 – Structure 4: Circumferential Cracking to the Arch**

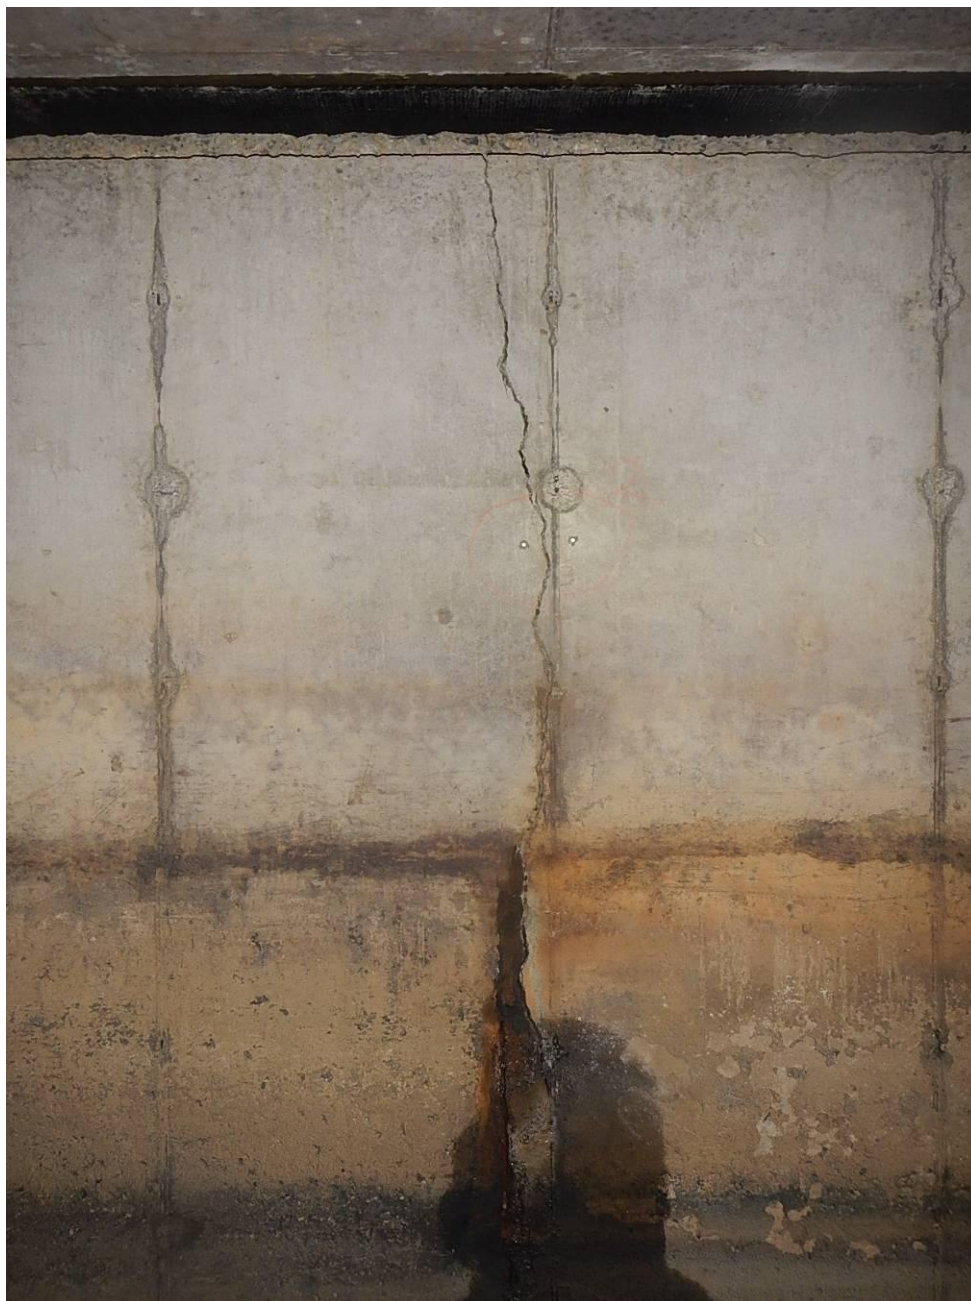
**Photo 65 – Structure 4: Cracking on Abutment**

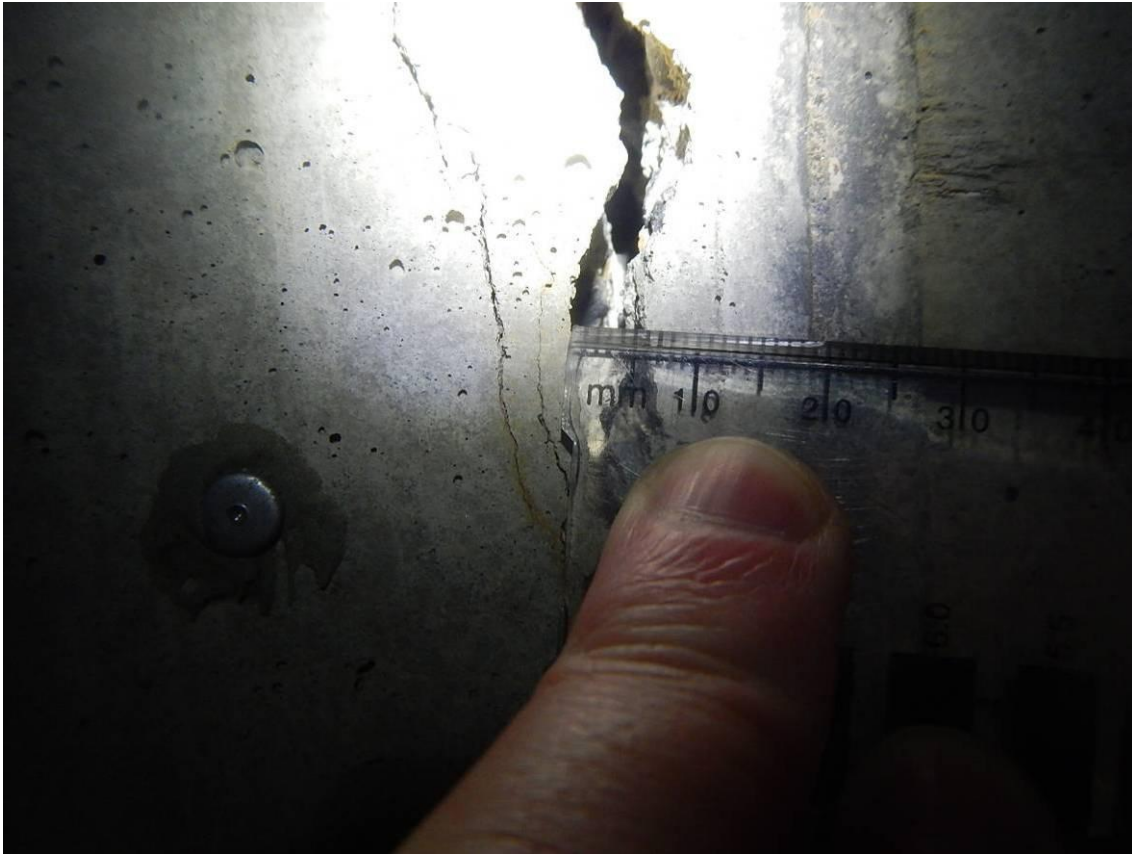
**Photo 66 – Structure 4: Cracking on Abutment**
