Tree Survey Report FOR

Rathangan

CLIENT: Sophia Housing

July 2023

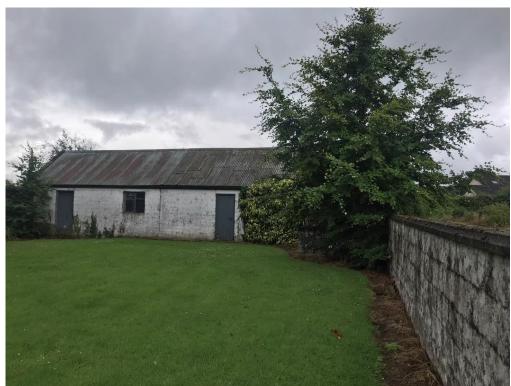
The northern boundary is made up of a barbed wire fence interwoven with unkept vegetation of low quality, the western most part of the northern boundary is made up of a Cherry Laurel hedge which is in good condition, as well as a semi mature Lawson cypress, located outside of the red line boundary. In the corner of the interior wall on the north side of the site within an area of lawn there is a self-seeded *Fagus sylvatica* Beech tree in good condition.

Figure 1: Fagus sylvatica located near the north boundary.

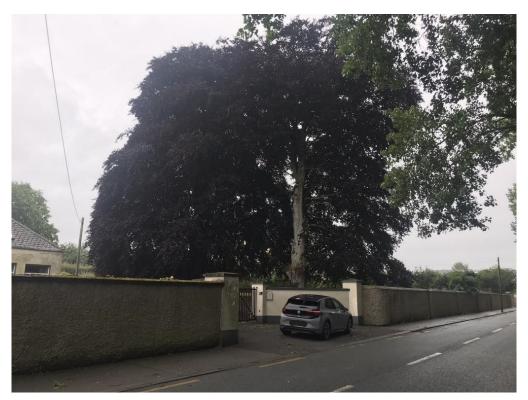
The southern boundary of the site contains a large open space next to the main existing building and its entrance. The open area is divided away from the tarmacadam of the entrance by a small retaining wall about 1 metre in height as the open space is at a higher elevation. The open area contains three trees: a *Prunus cerasifera 'Nigra'* Purple plum, and two *Fagus sylvatica* 'Atropurpurea Group' Copper Beech. The plum tree is in poor condition due to heavy lichen and moss on the bark and will need to be removed for the new design. The two beech trees, although having a few limbs which have been removed and a large amount of decay in them, they are still in very good condition and have grown to a height of between 20-22 metres. These two beech trees are to be retained.

Figure 2: Two beeches at the front of the site

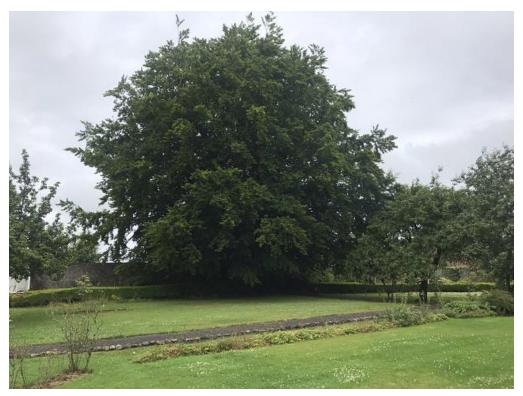
Tree no. 0745 is a large veteran Beech *Fagus sylvatica*. This is an important tree from a cultural and ecological perspective. It has two smaller *Ganoderma lucidum* fungal brackets on the trunk. It is recommended that sonic tomography be used to get a better picture of any internal decay. There is a stone wall existing to the north within the RPA. It is expected that the tree roots do not project beyond this wall, allowing for development to the north

of the wall. A path is proposed in this area and no root protection measures are required in this area.

Figure 3: Beech tree 0745

Impact of development: The site layout has been designed so that there is minimal impact on this tree. Existing pedestrian paths are to be retained in their original alignment. Within the RPA, the surface of these paths may be dressed by hand. There is to be no excavation and no machinery is to encroach within the tree protective fencing alignment/RPA. Follow up surveys every 3 years are recommended.

sonic tomography test be carried out on one of the large Beech trees, tree no. 0746. There

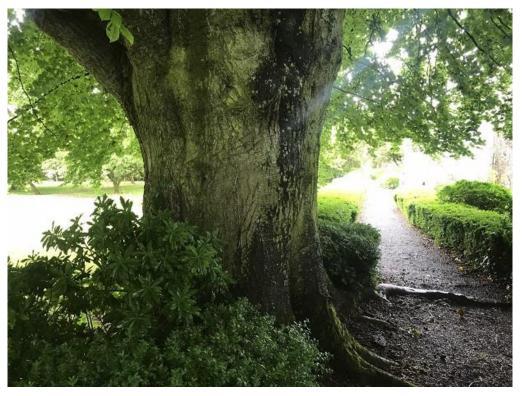
Tree no.'s 0746 – 0758 are orchard trees, species are Apple *Malus* spp. Pear *Pyrus* spp. Plum *Prunus domestica* and Walnut *Juglans nigra*. They create a nice atmosphere in the current use as an enclosed garden. The Walnut *Juglans nigra* has significant basal rot, though would be expected to survive in its current land use. It would be a risk within the proposed development with increased public and residential users passing within falling distance of the tree, making it a potential hazard.

Figure 4: Roots of tree no. 0746 growing in existing path

Impact of the development: The site layout has been designed to retain as many of these trees as possible. Car parking and access road layout will see the removal of tree no.'s 0753 – 0758. Tree numbers 0746 – 0752 will be retained.

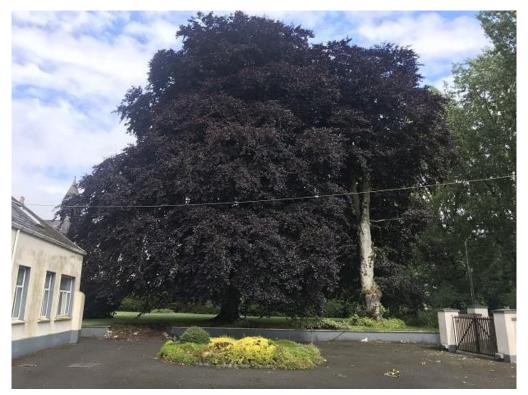
Tree no.'s 0760 & 0761 are champion veteran Copper Beech trees, *Fagus sylvatica* 'Atropurpurea Group'. These trees play an important role in the biodiversity, green infrastructure and cultural heritage of the area. As they are located within the front garden of the existing site, and are visible from the public road and footpath, they contribute greatly to the public realm.

Figure 5: Copper Beech and level change in front garden

No.	Species	Ht	N	S	E	W	Dia	Vigour	Age	Cond	ERC	Comments	Priority
							(DBH)		Class	Class			Action
0761	Copper Beech	20-	6.0m	7.0m	7.5m	11m	990m	N	V	А3	40+	Two large limbs removed from the	Retain,
	Fagus sylvatica	22m										east side-wounds 650x500mm (some	carry out
	'Atropurpurea											occlusion) and 420 x 400mm (no	root
	Group'											occlusion) brown rot and fungal	investigati
												brackets on wounds, small swelling at	on works
												base of wounds, minor bark decay at	
												root buttress beneath wounds,	
												smaller branch removal on north	
												side, occluded 2/3 of the way around,	
												more smaller branches removed	
												north side further up, good occlusion

Impact of the development: The site layout has been designed to allow the retention of these trees. There is an existing garden wall 3-4 from the trunk of these trees. There is a c.400mm drop to a tarmacadamed driveway area. The theoretical RPA of these trees extends into the driveway area. However, in reality it is unlikely that the roots have grown beneath the wall and its foundations and on underneath the tarmacadamed driveway area. It is recommended that site investigation trenches be excavated to determine the presence of tree roots. This work <u>must</u> be supervised by the project arborist. Excavations are to start at the outer edge of the RPA and work gradually inwards until roots are encountered, or the wall is reached. Lighter machinery may travel across the existing tarmacadamed area within the RPA of the tree, provided that tree protective fencing is in place.
