Fire Hydrant Flow & Pressure Testing Report

Company: Malone O'Regan

Location: 17 Connagh Road, Collaghknock Glebe, Kildare R51 C668

Date: 12-Jul-2023

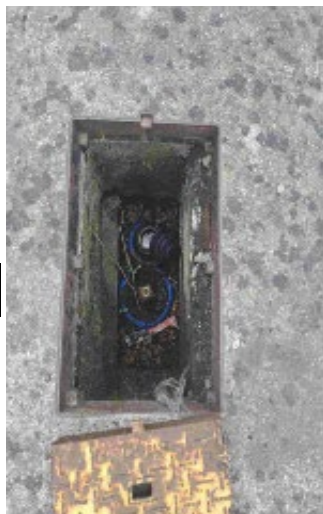
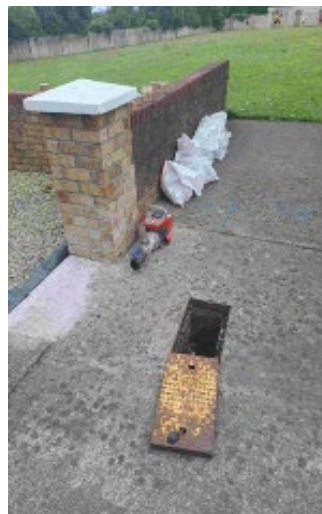
Condition Images:

FH No.	Surface	Cover / Frame	Pit	Type	Depth (mm)	Marker / Plate	Spindle	Canary Yellow	Hydrant Leaking	Hydrant Cap	Comment
FH1	Concrete Footpath	Good	Good	LRT	380mm	No	Good	No	No	Yes

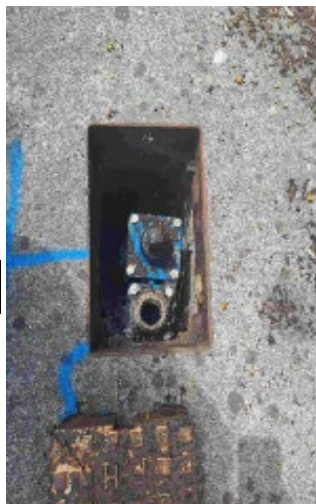
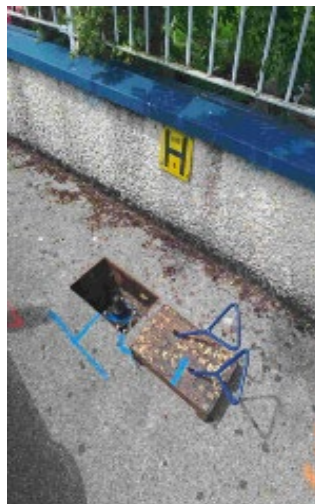
Condition Images:

FH No.	Surface	Cover / Frame	Pit	Type	Depth (mm)	Marker / Plate	Spindle	Canary Yellow	Hydrant Leaking	Hydrant Cap	Comment
FH2	Concrete Footpath	Good	Good	LRT	140mm	Yes	Good	Yes	No	Yes

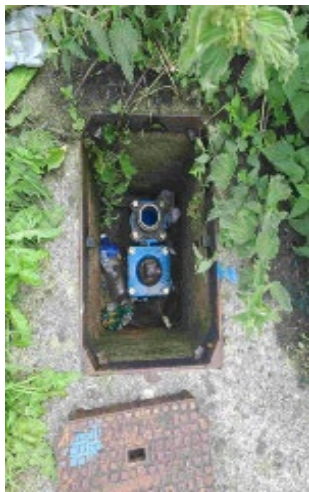
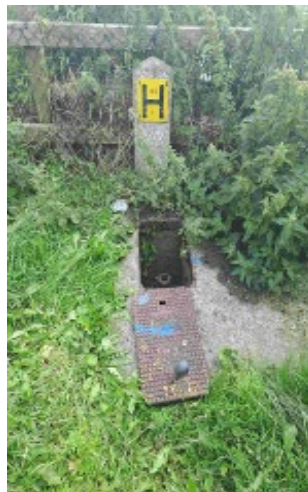
Condition Images:

FH No.	Surface	Cover / Frame	Pit	Type	Depth (mm)	Marker / Plate	Spindle	Canary Yellow	Hydrant Leaking	Hydrant Cap	Comment
FH3	Concrete Footpath	Good	Good	LRT	320mm	Yes	Good	No	No	Missing
