**AN TRIANTÁN,
at STATION ROAD, KILDARE TOWN, CO. KILDARE**

for KILDARE COUNTY COUNCIL
January 2025

REFURBISHMENT FEASIBILITY STUDY

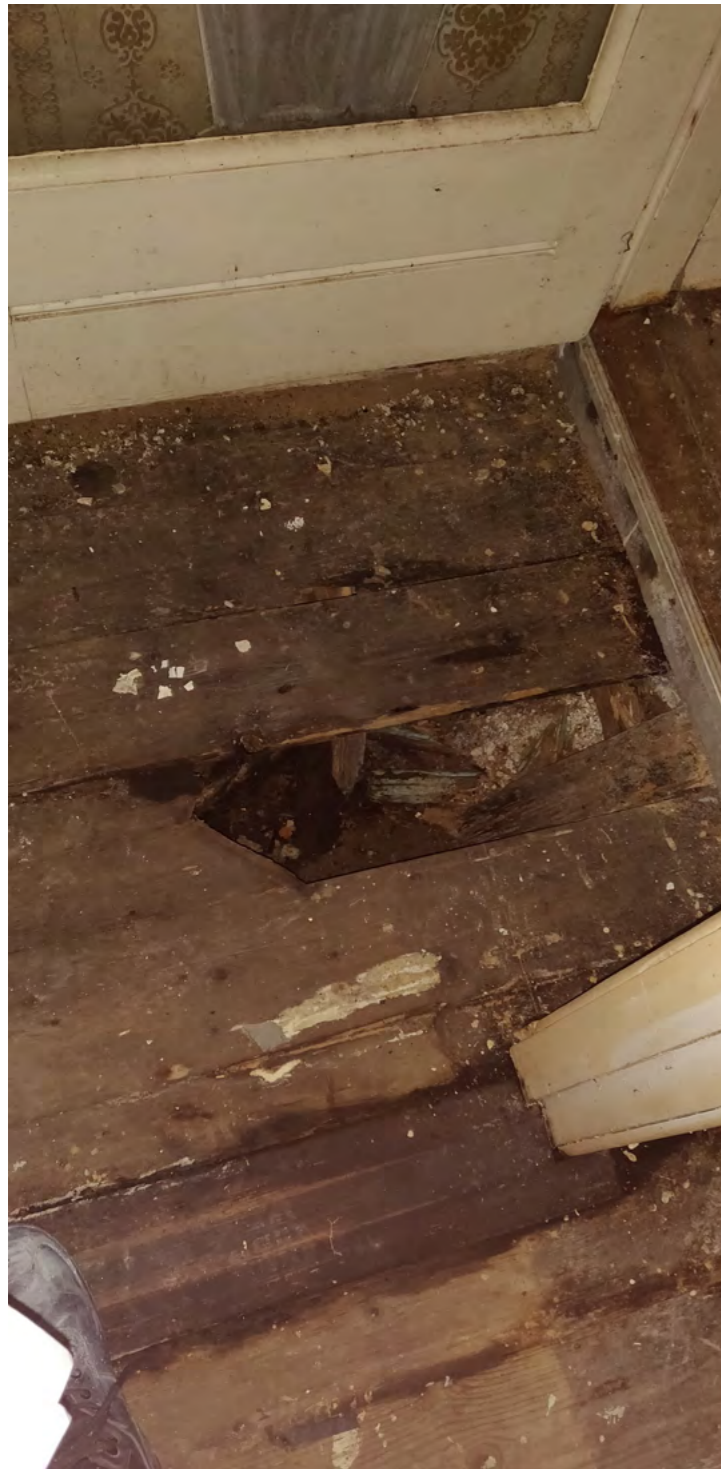
- 2.1.5 Internal suspended floors have been largely replaced with poured concrete slabs. Remaining suspended timber floors are decayed to a dangerous state.

Fig. 4. Photo of suspended timber floor

3.2.4 Existing floor slabs would need to be excavated to insulate and remediate the damp issues. The roof structure would need to be entirely replaced. Chimney breasts would need to be demolished in places to provide suitably sized rooms.

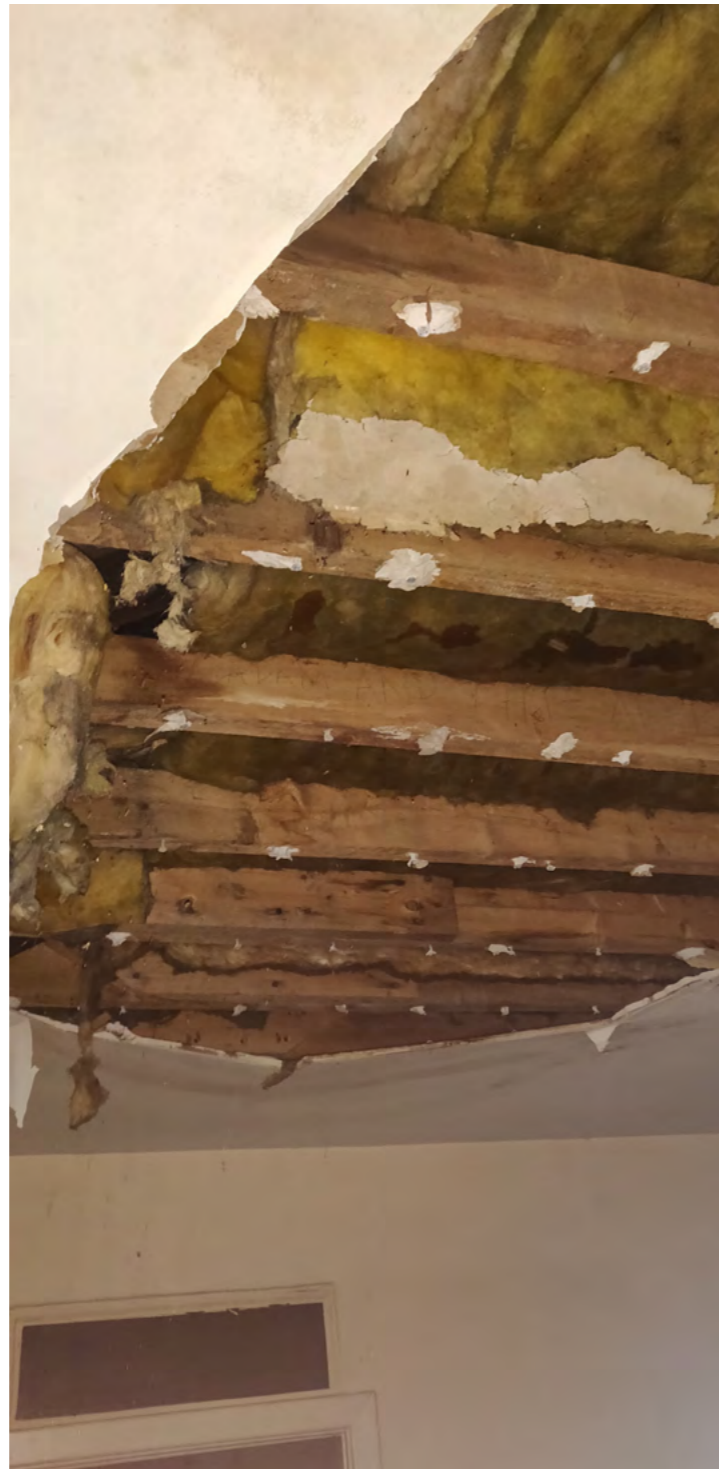
- 2.1.6 Leaks are apparent in the roof, causing partial collapses in the living area and kitchen. Roof covering require replacement and roof structure likely requires same pending inspection.

Fig. 5. Photo of living room ceiling

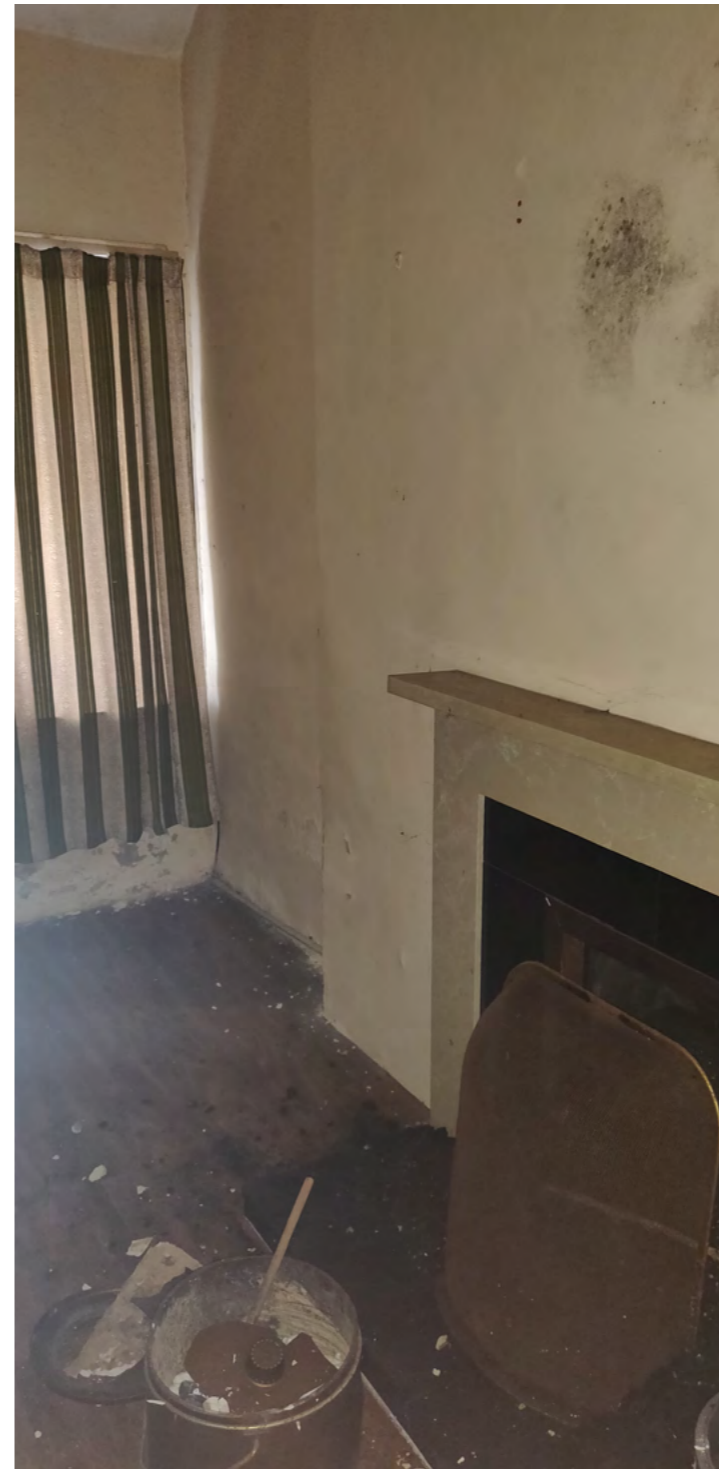
Fig. 6. Photo of bedroom

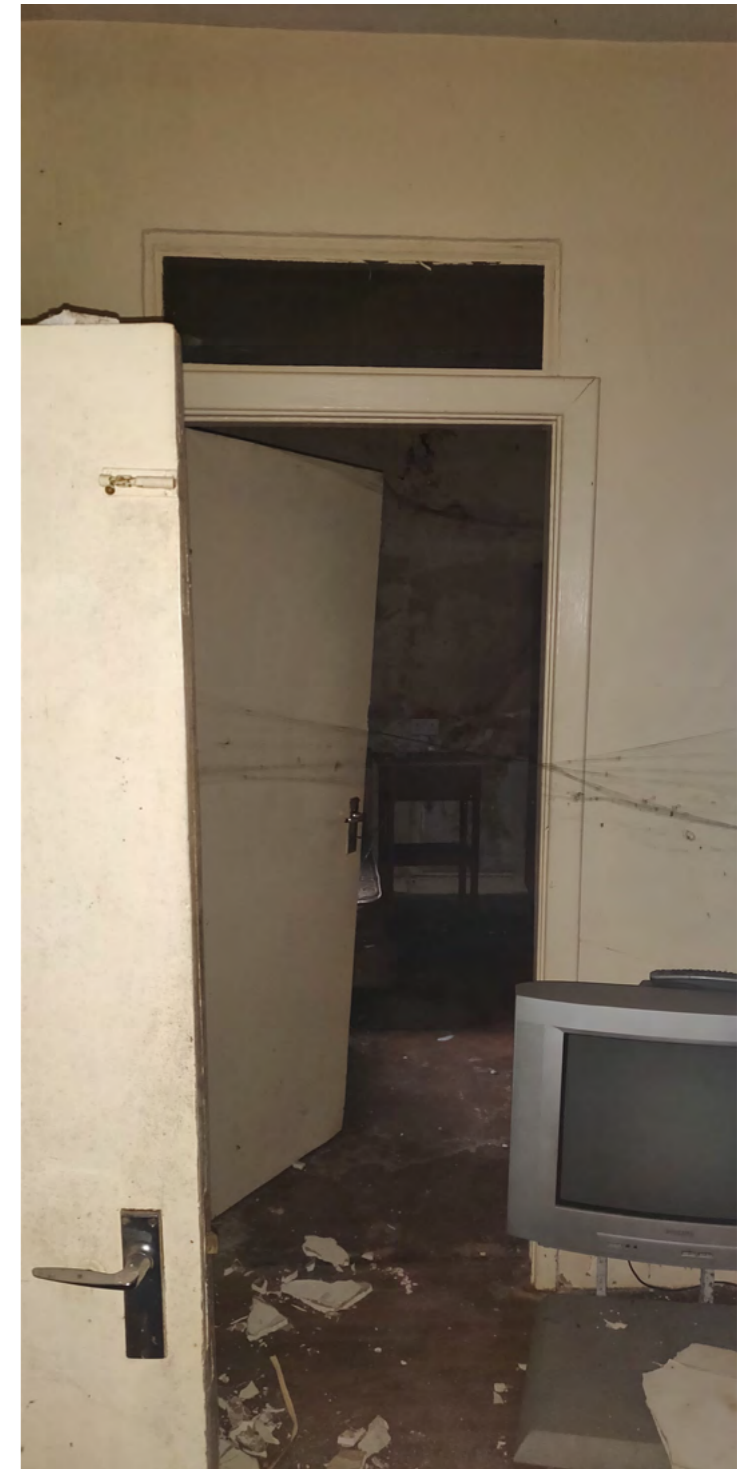
Fig. 7. Photo of bedroom

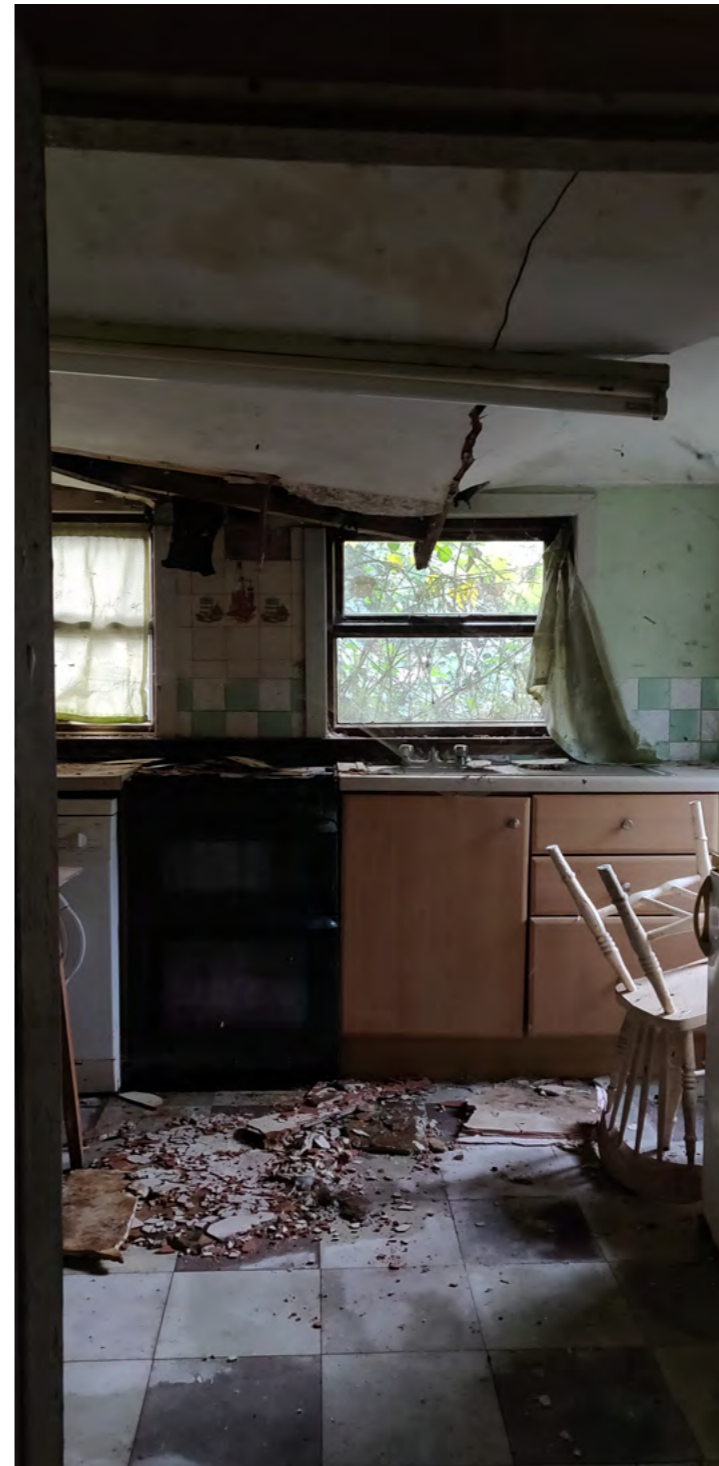
Fig. 10. Photo of rear kitchen annex

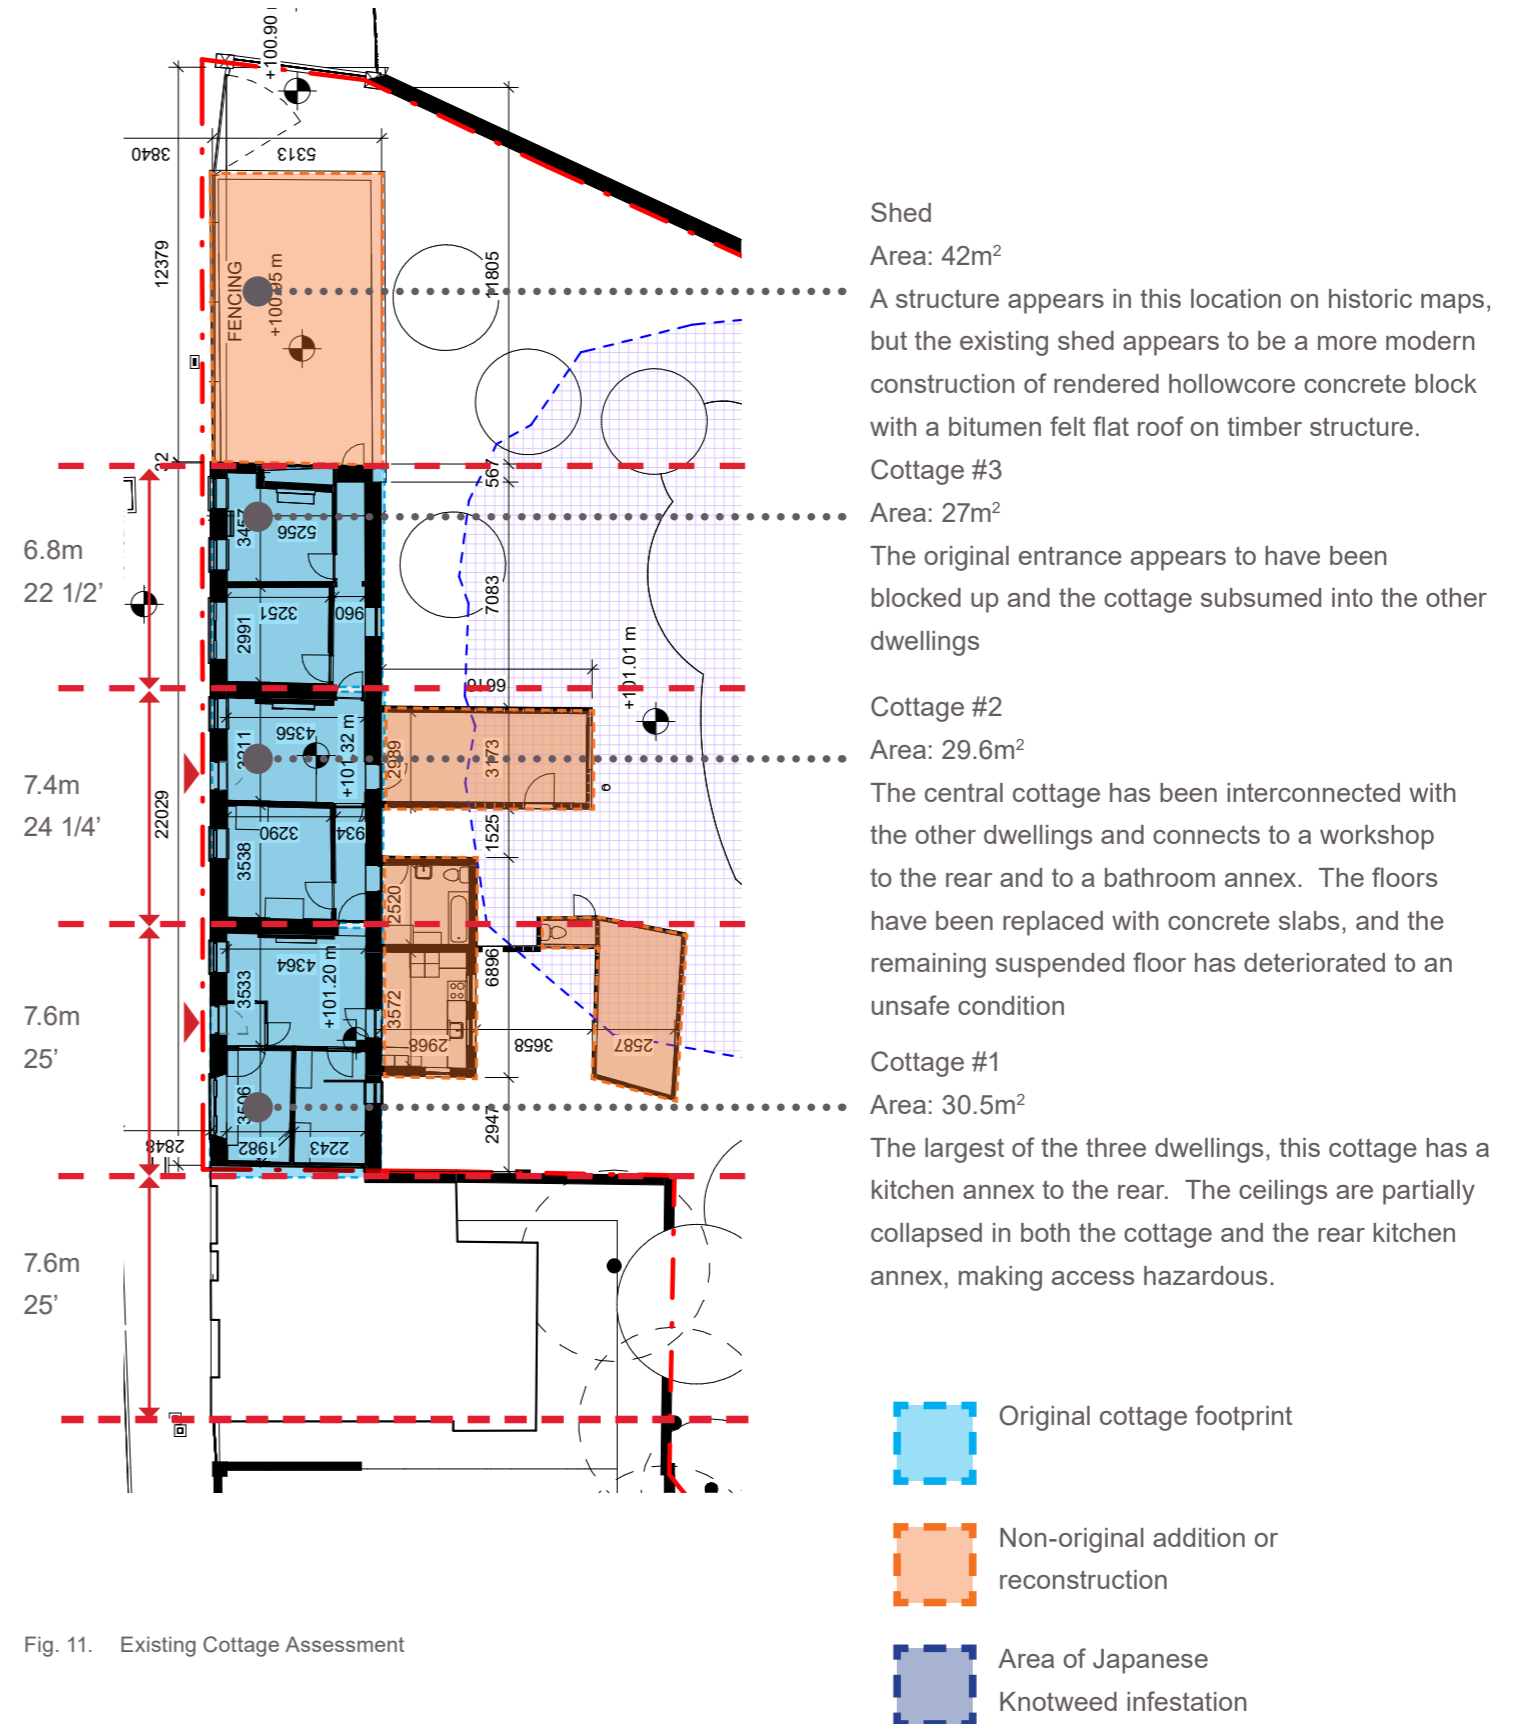
Fig. 11. Existing Cottage Assessment

- 3.1.10 The existing cottages and the Sherry Fitzgerald offices adjacent appear to have been built as a single terrace of two room cottages. Outbuildings and annexes are likely to be later additions and/or rebuilt historic fabric.

- 3.1.11 The roof structure and covering has been replaced with asbestos slates and the interiors altered to amalgamate the dwellings into a single building. The bay width varies across the 4 individual dwellings, with the Sherry FitzGerald office and directly adjacent cottage the widest at 7.6m approximately.

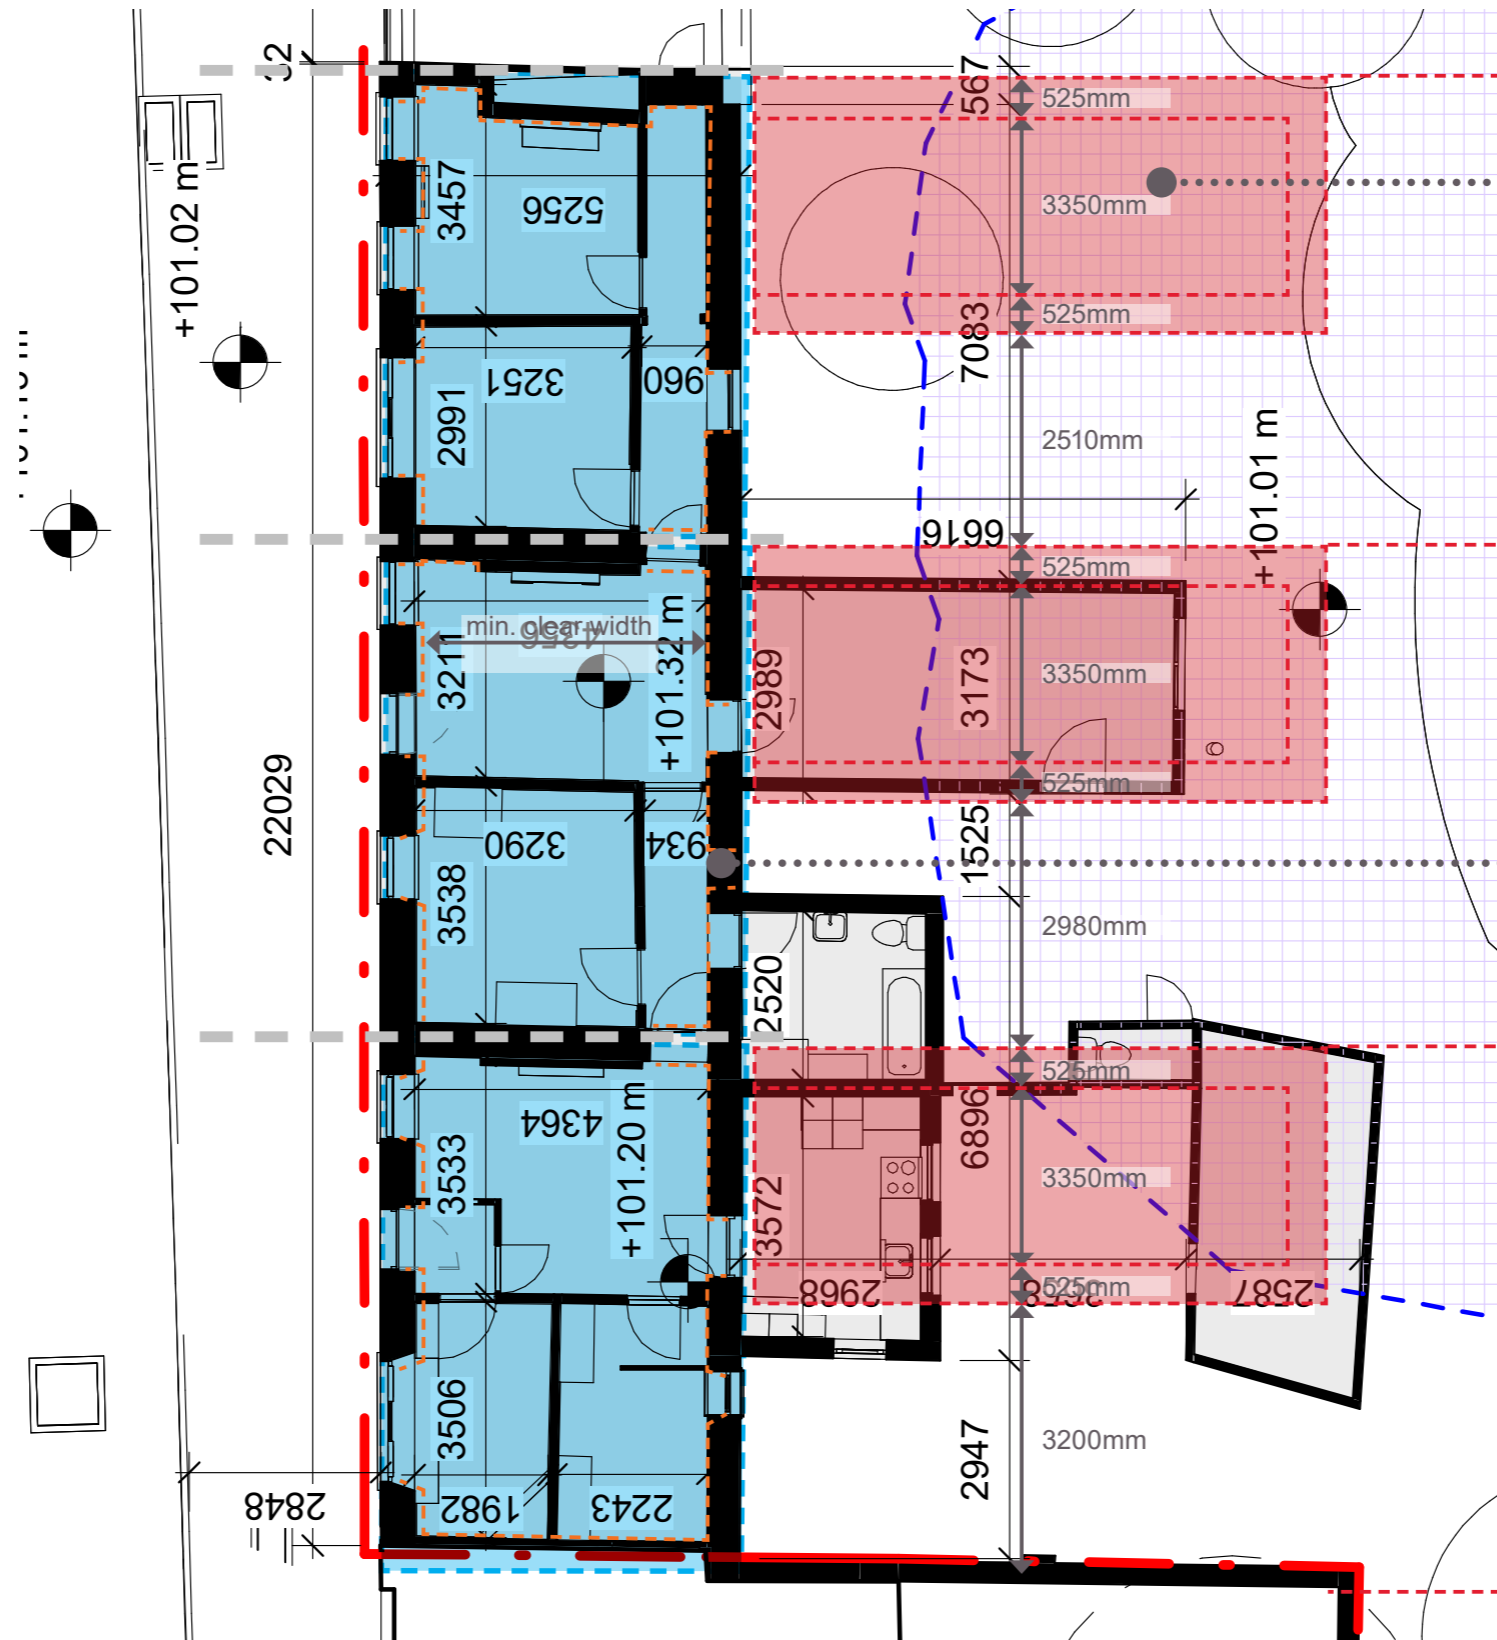
Redesigned entrance required - available clear width of 5300mm is not DMURS compliant and makes no allowance for pedestrian access.

Access involves a blind corner creating a safety hazard for all residents

New extension of approx 30m² required to achieve minimum 1 bedroom unit area - 55m² as per the Kildare County Development Plan 2023-2029.

Orange line indicates extent of required dry lining, minimum thickness 160mm comprising 2no. 70mm breathable insulation boards fully bonded to external walls and finish coat of breathable lime plaster. Approximate loss of habitable area is 2-3m² per unit.
