ASBESTOS SURVEY REPORT

(Refurbishment / Demolition Survey)

**Location: Derelict Houses Site,
Station Road, Kildare Town, Co. Kildare (R51 Y540)**

Report No. PE23-1157

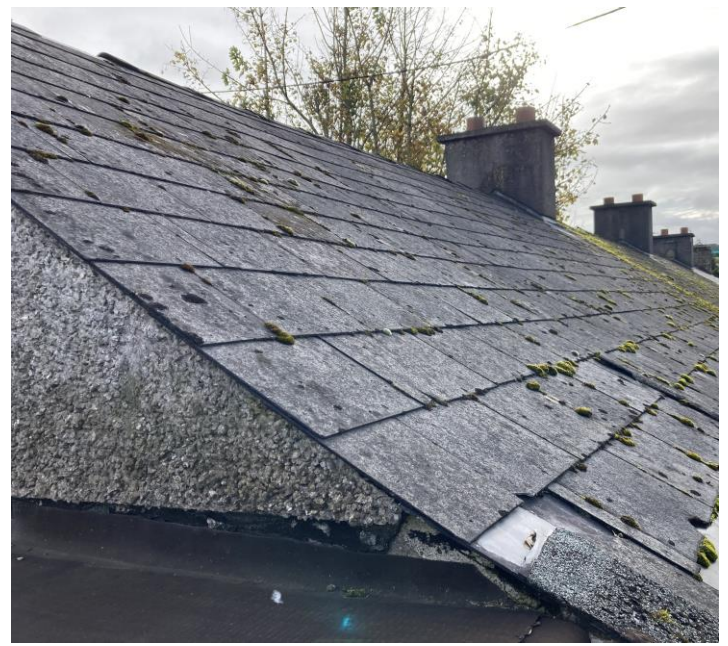
Created By	Andrew Hickey
Date	6 th November 2023
Site Details	Derelict Houses Site, Station Road, Kildare Town, Co. Kildare
Client Name	Kildare County Council
Survey Type	R/D Asbestos Survey
Site Ref	PE 23-1157
Building Ref.	Station road
Location	Main roof
Extent/ Amount	90 m ² approx. floor area

MATERIAL ASSESSMENT		PRIORITY ASSESSMENT
Product type	Cement slates	Normal occupant activity	N/A
Extent of damage	Low	Likelihood of disturbance	N/A
Surface treatment	Unsealed	Human exposure potential	N/A
Asbestos type	Chrysotile & Amosite	Maintenance activity	N/A
	Material assessment score: N/A	TOTAL SCORE: N/A	Priority assessment score: N/A

The cement slates identified on the roof of the houses contain Chrysotile (white) & Amosite (brown) asbestos fibres. Asbestos cement products usually contain between 10-15% asbestos fibres, bound in Portland cement

The asbestos cement slates should be removed by an asbestos removal contractor and disposed of as asbestos waste before demolition works commence.

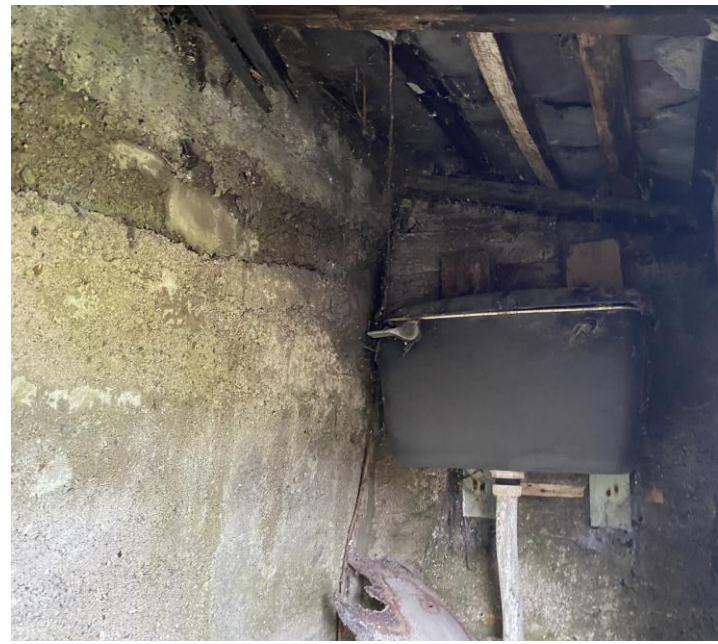
Created By	Andrew Hickey
Date	6 th November 2023
Site Details	Derelict Houses Site, Station Road, Kildare Town, Co. Kildare
Client Name	Kildare County Council
Survey Type	R/D Asbestos Survey
Site Ref	PE 23-1157
Building Ref.	Station road
Location	Rear W/C
Extent/ Amount	1

MATERIAL ASSESSMENT		PRIORITY ASSESSMENT
Product type	Resin toilet cistern	Normal occupant activity	N/A
Extent of damage	Low	Likelihood of disturbance	N/A
Surface treatment	Sealed	Human exposure potential	N/A
Asbestos type	Amosite	Maintenance activity	N/A
	Material assessment score: N/A	TOTAL SCORE: N/A	Priority assessment score: N/A

The resin toilet cistern identified in the W/C in the shed at the rear of the house contains Amosite (brown) asbestos fibres. Resin products may contain between 20-50% asbestos fibres.

The asbestos resin toilet cistern should be removed by an asbestos removal contractor and disposed of as asbestos waste before demolition works commence.

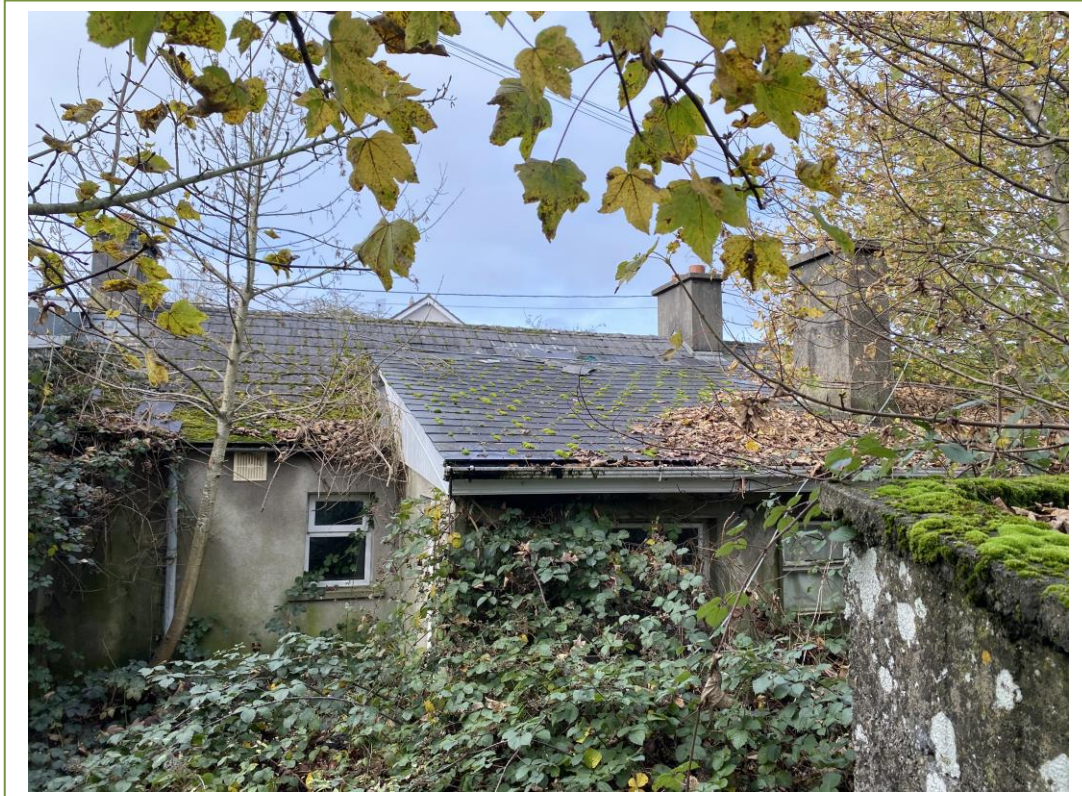
Slates sampled from rear extension

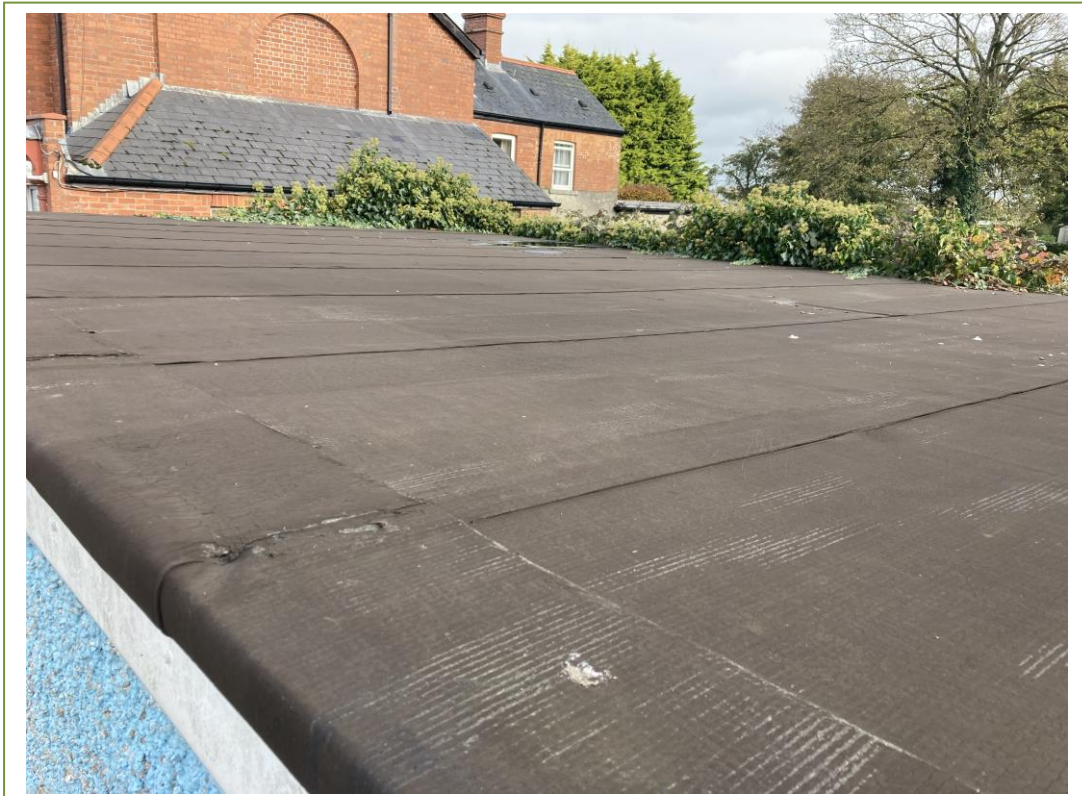
Felt sampled from the roof of the garage

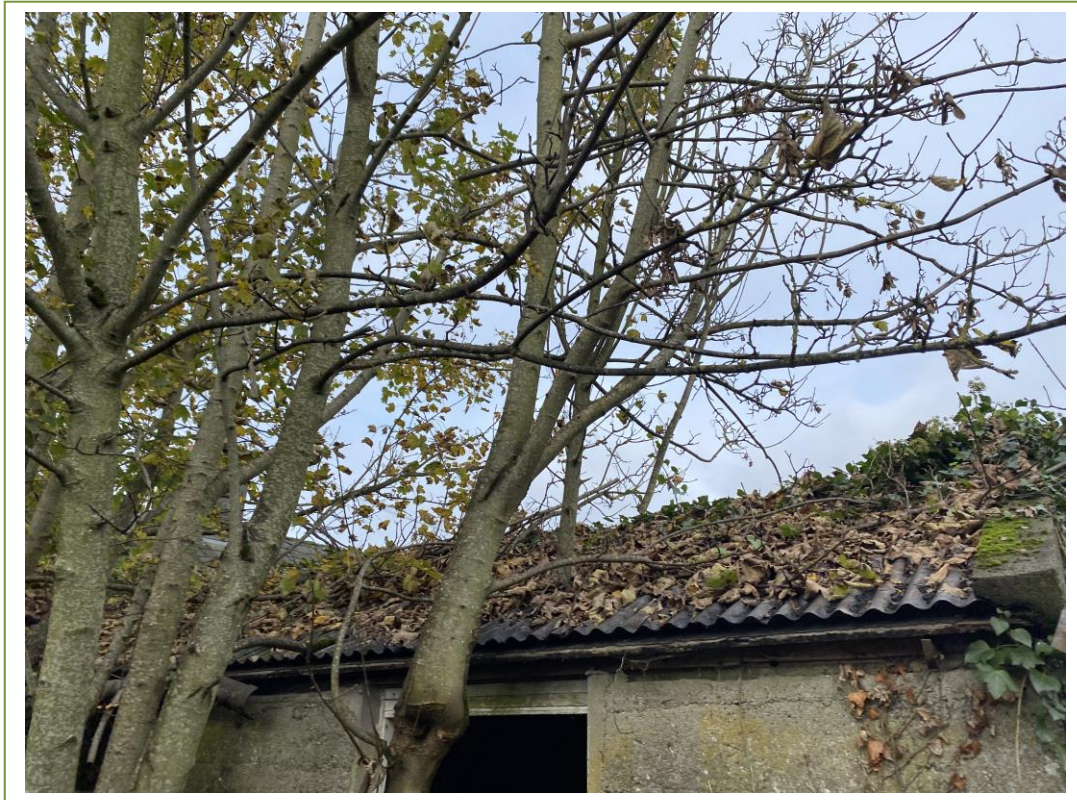
Metal cladding on the roof of the rear shed

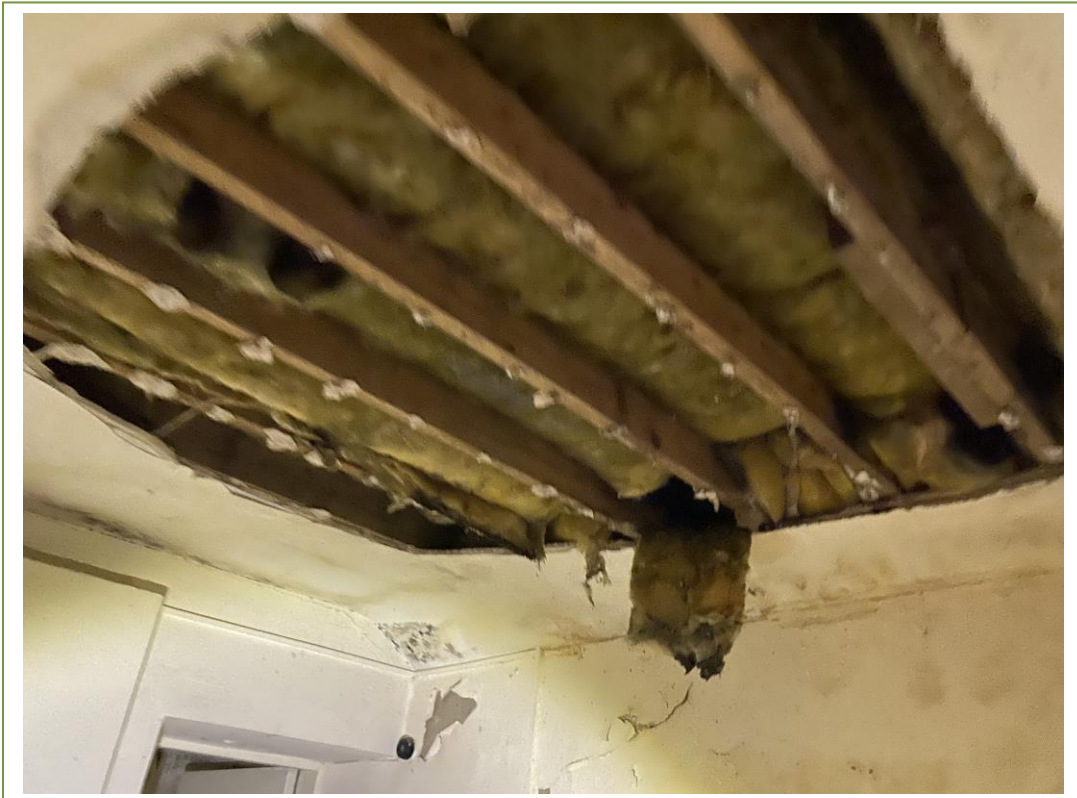
Plasterboard ceilings & fiberglass insulation

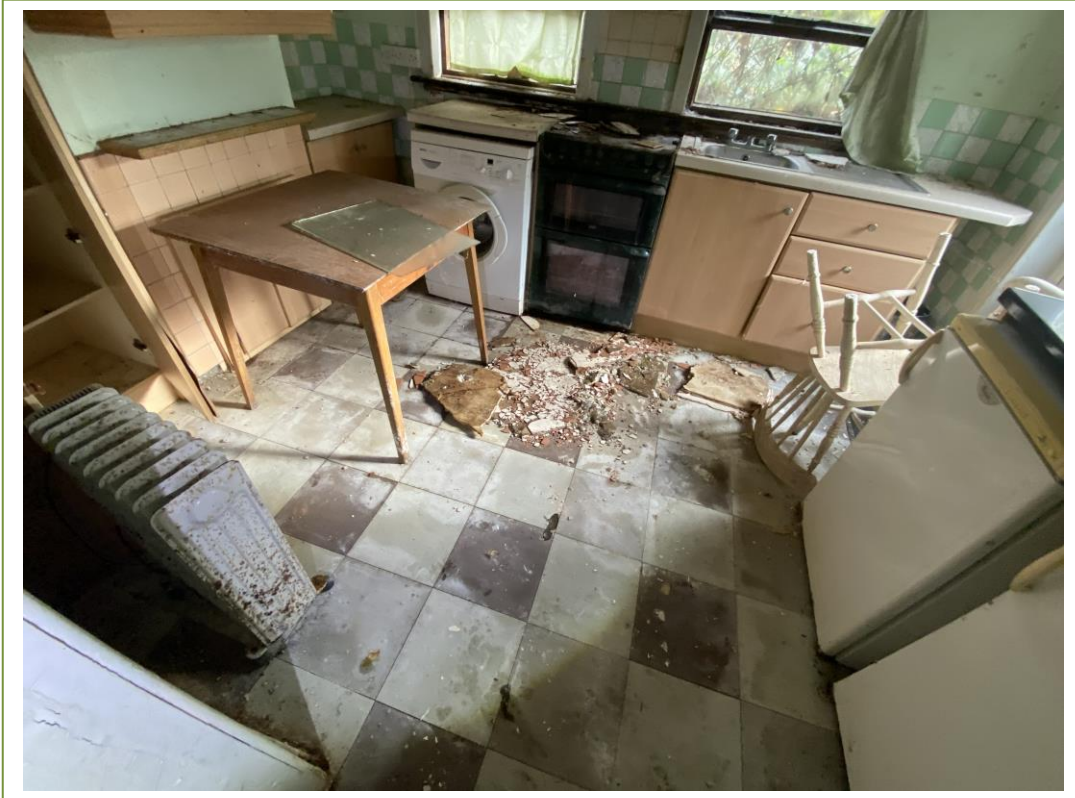
Vinyl floor tile sampled throughout

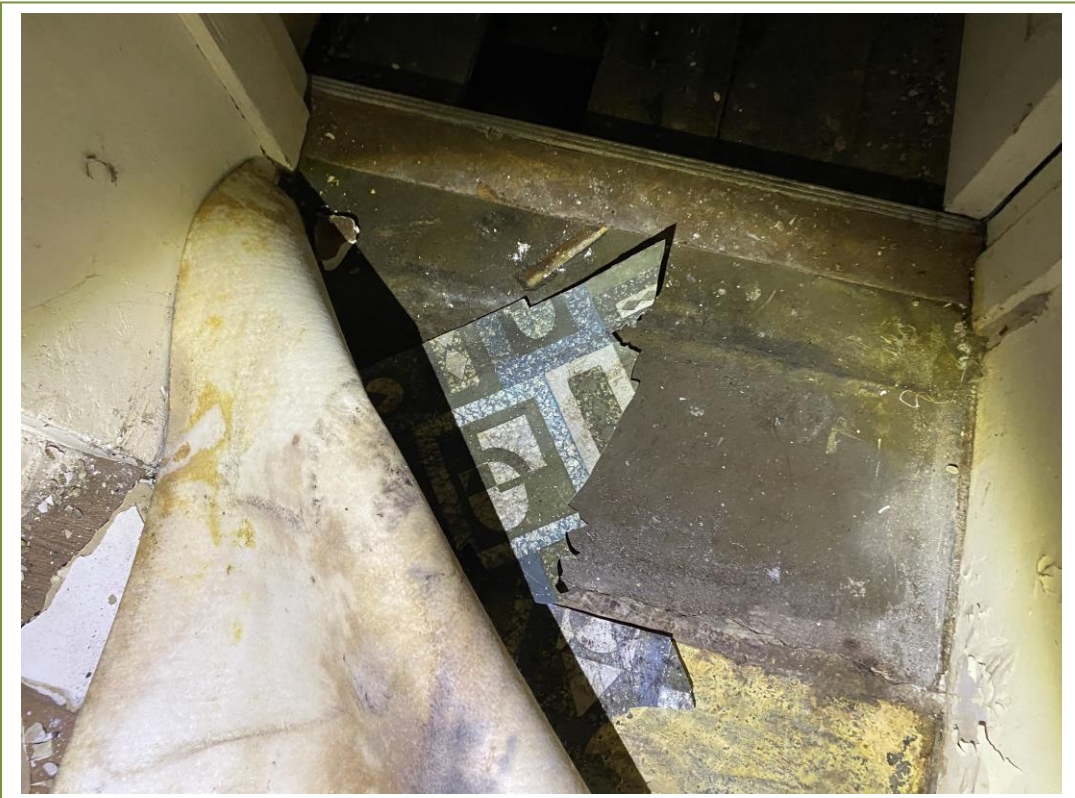
Old linoleum on floor

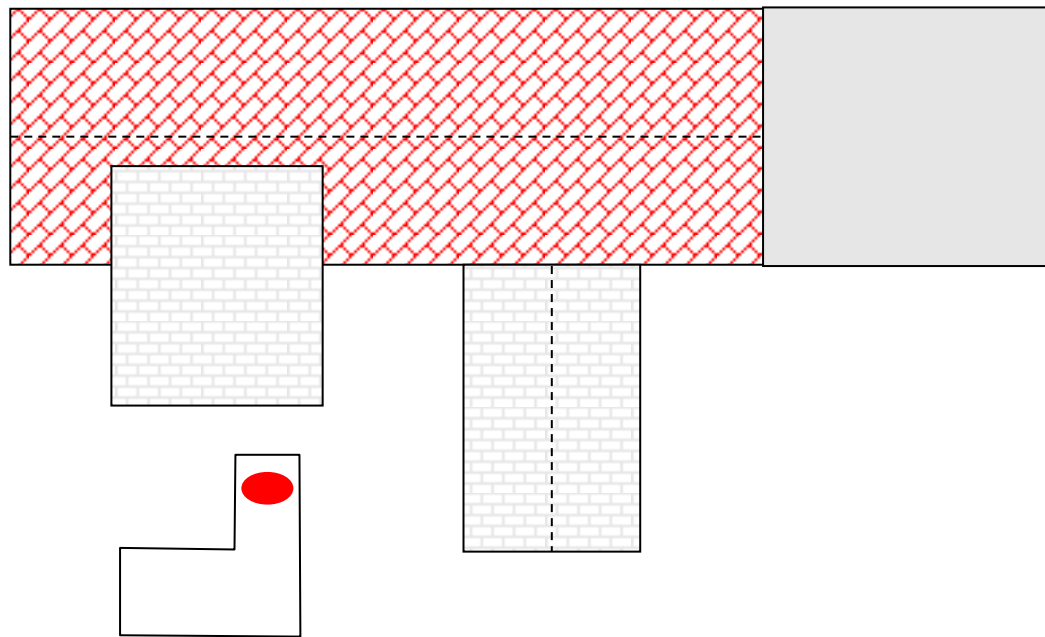
SITE PLAN

Area where asbestos cement slates were identified

Area where asbestos resin toilet cistern was identified
