**Stage 1 Road Safety Audit
Proposed Social Housing at
Craddockstown, Naas, Co. Kildare**

Client:	Hayes Higgins Partnership
Document No:	240978-ORS-XX-XX-RP-TR-13g-001

This report documents the findings of a Stage 1 Road Safety Audit (RSA) carried out with respect to a proposed New Residential Housing Development, Craddockstown, Co. Kildare.

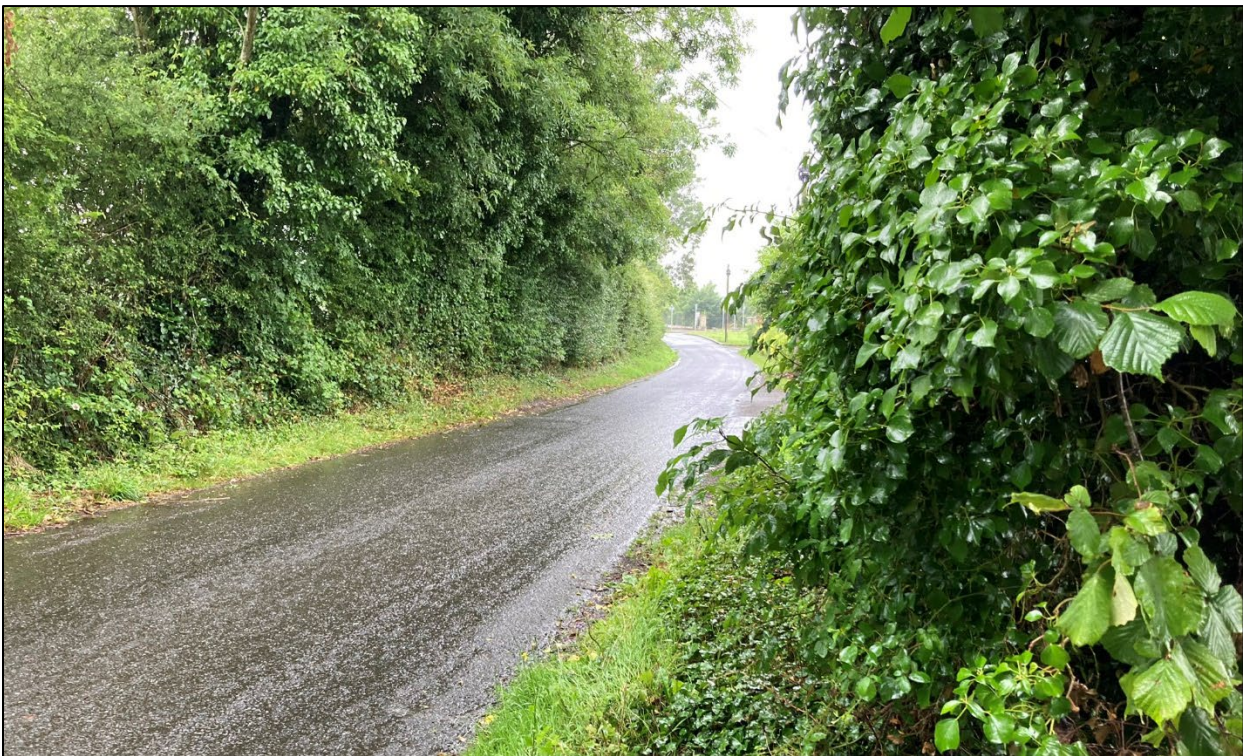
Location: Site Access/Egress Junction

Problem No.01: Overgrown Vegetation

The audit team observed during the site visit that overgrown vegetation along Craddockstown Road, where the proposed site access road is located, compromises visibility at the access junction. If the vegetation is not trimmed back, the line of sight for drivers and pedestrians exiting the proposed development may be obstructed, increasing the risk of accidents due to their inability to see approaching vehicles or pedestrians.

The design team should ensure that overgrown vegetation along Craddockstown Road is removed to establish and preserve clear sightlines at the proposed site access junction, ensuring safety for drivers and pedestrians.

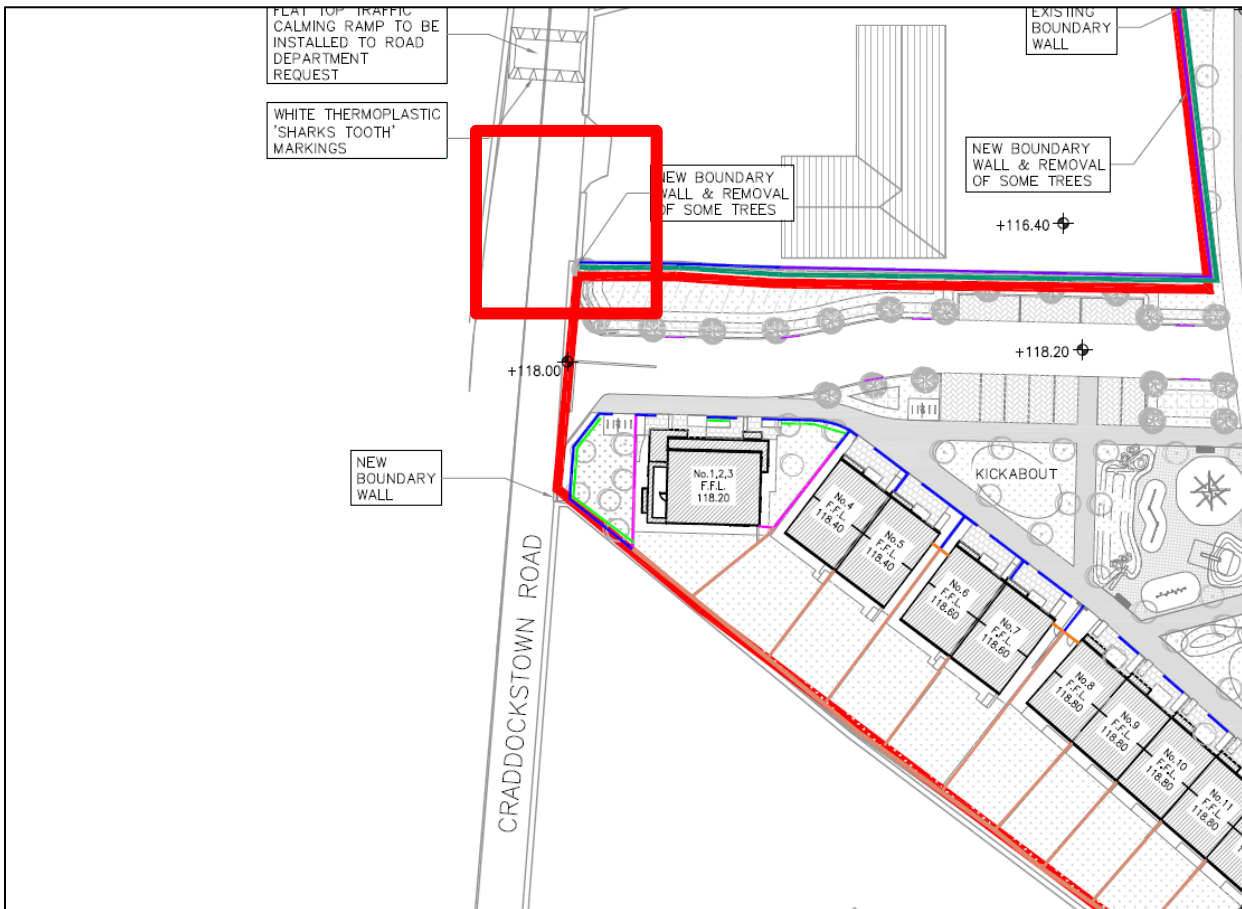
Location: Location Identified

Problem No.02: Tie into the Existing Infrastructure

The audit team notes from the site visit and the drawings provided that there is no existing footpath along Craddockstown Road at the location shown to link to the proposed surfaces. The audit team is concerned that vulnerable road users on the proposed footpath will have to walk onto the carriageway which could lead to collisions between vulnerable road users and vehicles.

The design team should clearly illustrate how the proposed surfaces integrate with the existing infrastructure along Craddockstown Road and ensure that they do not terminate at the edge of the carriageway, where uneven surfaces or proximity to oncoming traffic could create difficulties for pedestrians.

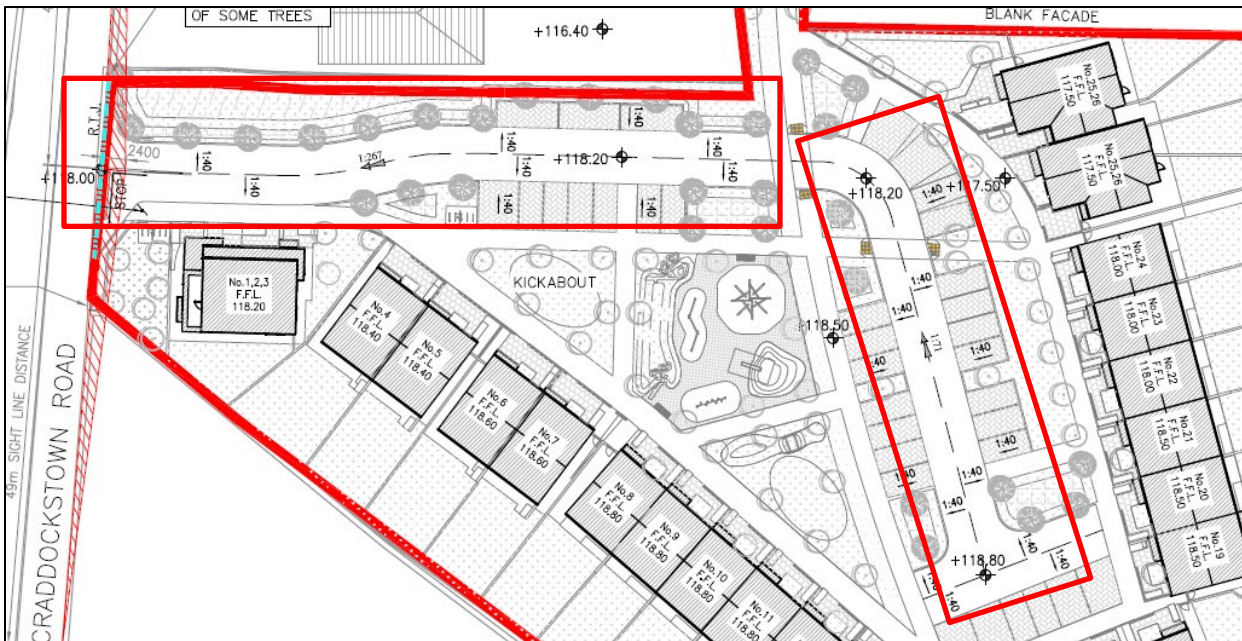
Location: Access Road

Problem No.03: Absence of Speed Control Measures

The audit team has observed from the provided drawings that there is no speed control measures along the length of the main access road. The lack of speed reduction features raises significant concerns regarding the potential for excessive vehicle speeds. This poses a heightened risk to vulnerable road users, such as pedestrians and cyclists, particularly in the event of a collision. The absence of adequate traffic calming infrastructure increases the likelihood of severe injuries among these road users, compromising overall safety within the development.

The design team should ensure that appropriate speed control measures are incorporated within the development to reduced vehicular speeds.

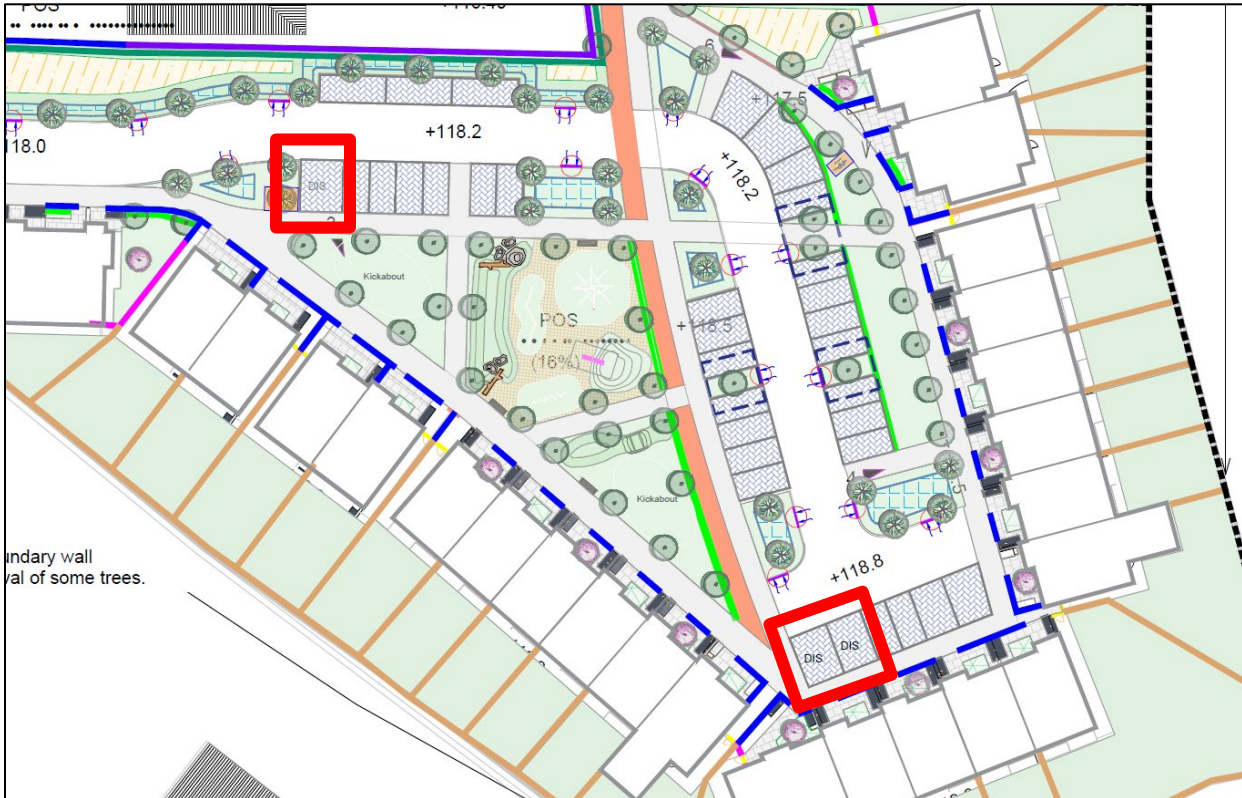
Location: Disabled Parking Spaces Identified

Problem No.04: Accessibility of Disabled Parking Spaces

The audit team note from the drawings provided, that there is disabled parking spaces provided within development. It is not clear from the drawings provided if appropriate dropped kerbing is provided for these spaces at the locations identified below. The audit team are concerned that users of the spaces may not have access to the footpath and may use the closest road to access the footpath resulting in potential collisions between vehicles and vulnerable road users.

The design team should provide adequate provision for users of the spaces to access the footpath safely.

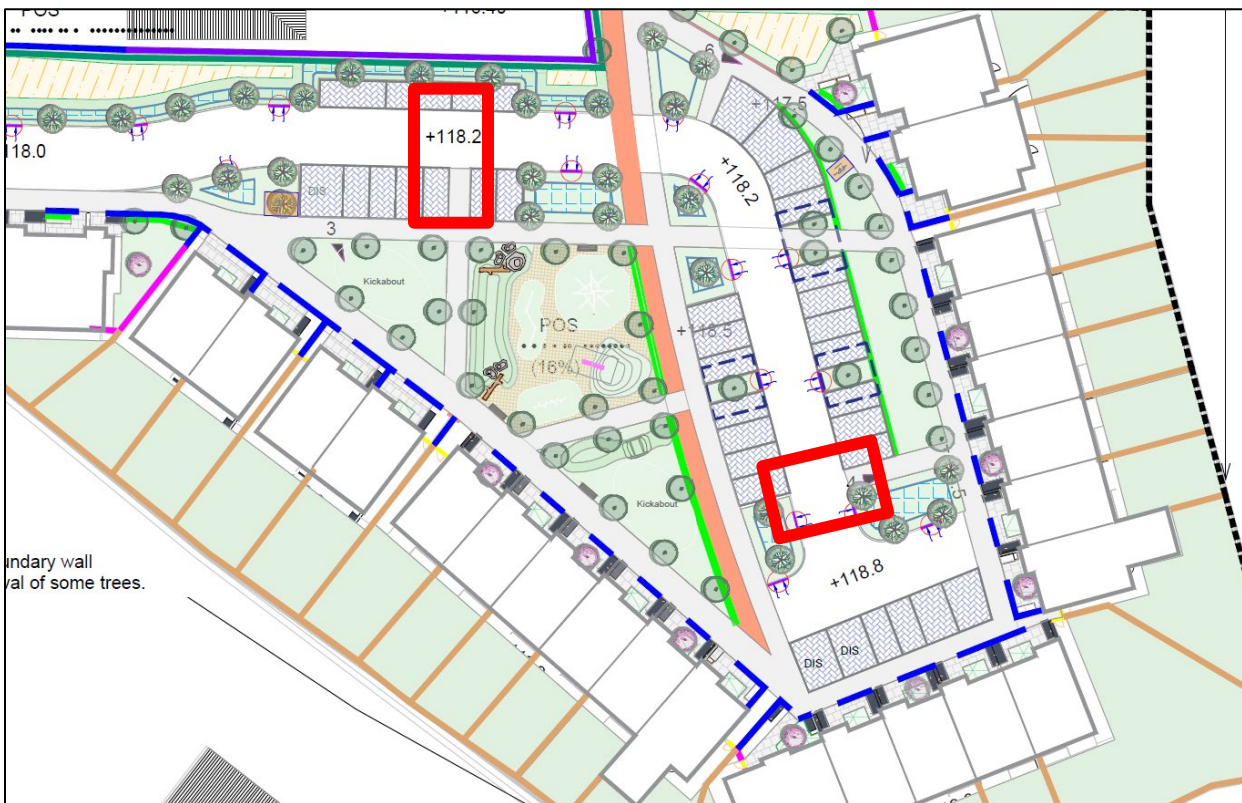
Location: Locations Identified

Problem No.05: Pedestrian Permeability

The audit team notes from the provided drawings that the proposed concrete footpath terminates at an opening onto the vehicular carriageway between two car parking bays. It is unclear from the drawings whether this opening is intended to serve as a pedestrian crossing, as there is no corresponding footpath on the opposite side. Therefore, the audit team finds no clear purpose for this footpath opening directly onto the carriageway. Furthermore, this design could be misinterpreted by pedestrians as a crossing point, potentially leading them to enter the carriageway without a safe route, thereby increasing the risk of pedestrian-vehicle conflicts. The audit team is also concerned about visibility at the crossing point due to the close proximity to the parked vehicles.

The design team should revise the footpaths at the locations identified if it is not intended to use the footpaths as a crossing location and ensure that appropriate visibility can be achieved at all crossing locations.

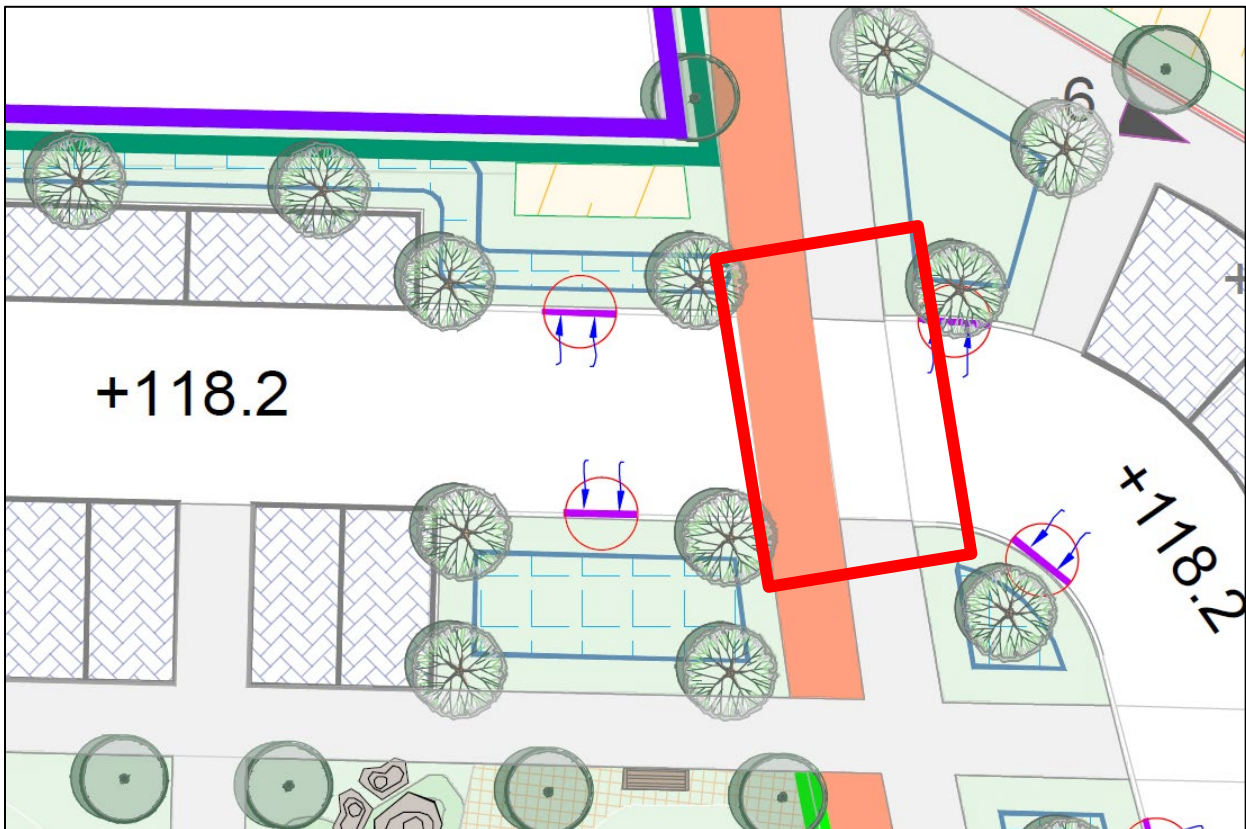
Location: Shared Pedestrian/Cycle Path on Vehicular Carriageway

Problem No.06: Lack of Safe Crossing Infrastructure

The audit team notes from the provided drawings that the proposed Shared Pedestrian/Cycle Path intersects the vehicular carriageway without any controlled or uncontrolled crossing facility, appropriate warning signage, dropped kerbs or tactile paving. This design poses a significant safety risk, as pedestrians and cyclists may continue directly onto the carriageway without stopping, due to the absence of a designated crossing point. Without proper crossing infrastructure and warning signage, there is an increased likelihood of collisions between vehicles and pedestrians/cyclists.

The design team should ensure that this crossing location is appropriately designed including any raised areas, tactile paving and warning signage.

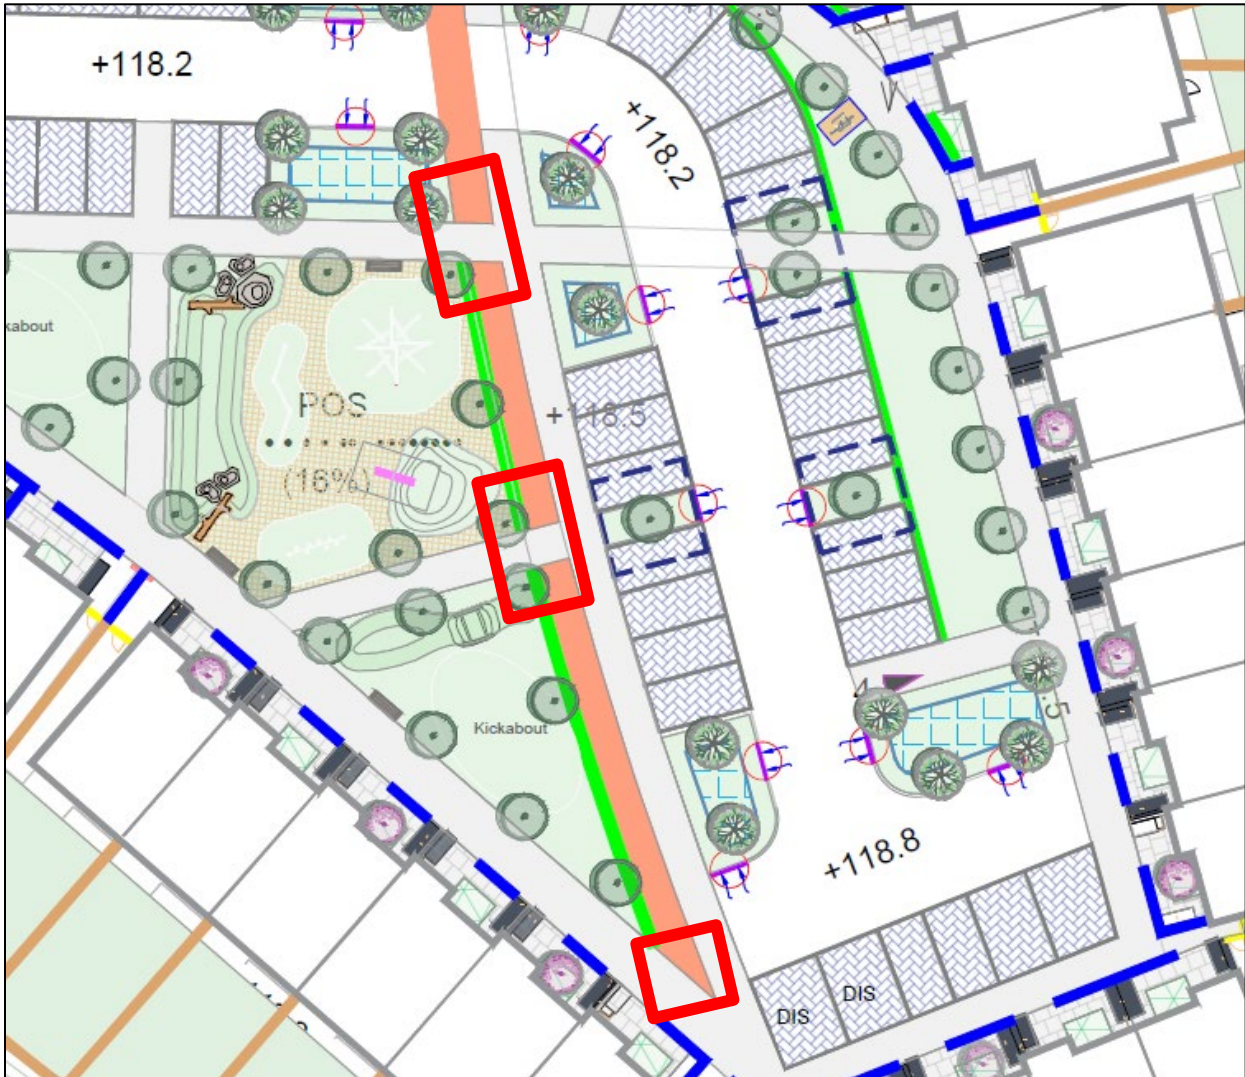
Location: Locations Identified

Problem No.07: Cycle Path/Footpath Intersection

The audit team notes from the provided drawings that the proposed cycle path crosses over the footpath at the locations identified. The Cycle Path intersects the footpath without any controlled or uncontrolled crossing facility, appropriate warning signage or tactile paving. This design poses a safety risk, to pedestrians as cyclists may continue directly onto the footpath without stopping, due to the absence of any warning.

The design team should ensure that this crossing locations is appropriately designed including any tactile paving and warning signage.

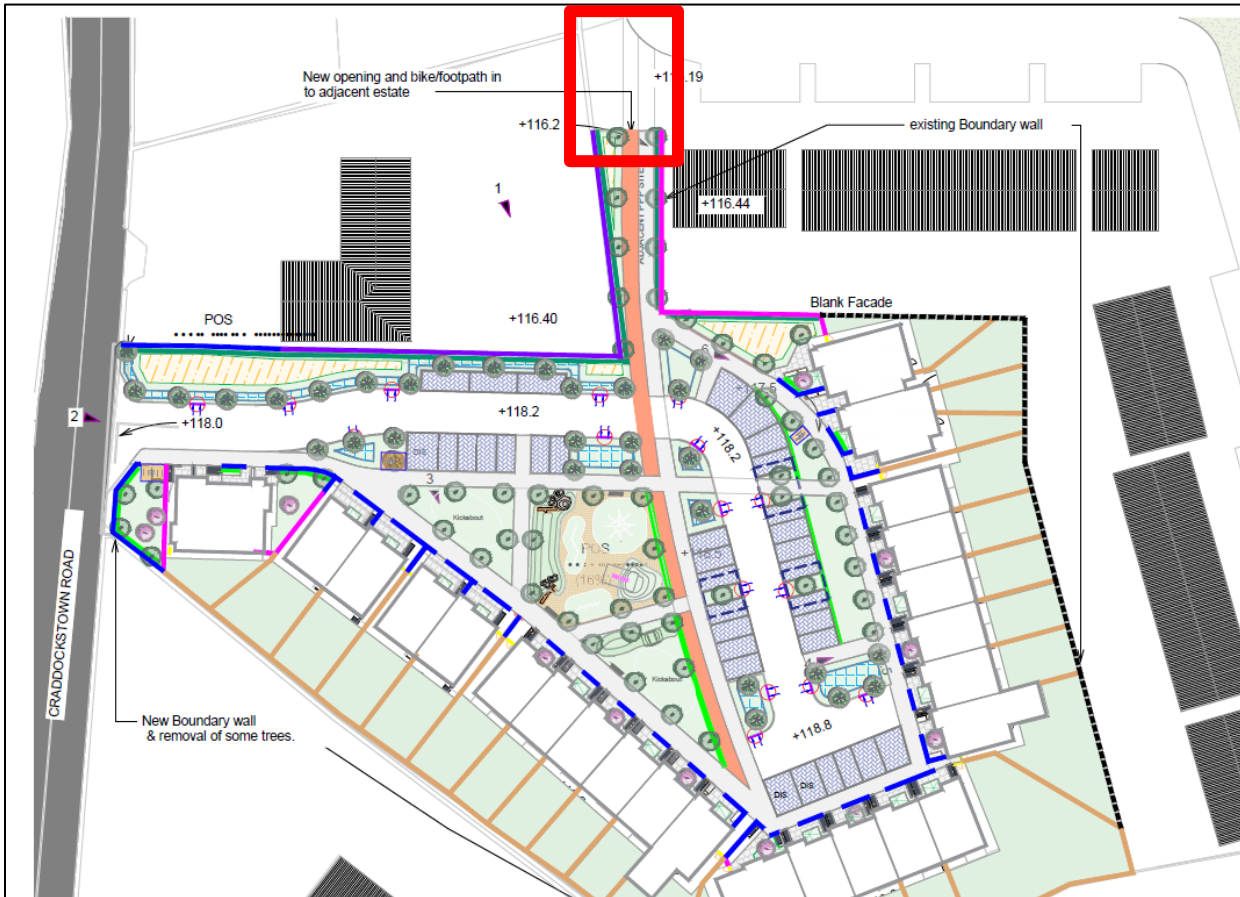
Location: Location Identified

Problem No.08: Tie-in to Existing Cycle Path/Footpath

The audit team note from the drawings provided that there are no details of the existing infrastructure that the scheme ties into at the location identified. Lack of an appropriate tie-in to the existing cycle path/footpath could lead to cyclists, pedestrians discharging into inappropriate infrastructure.

The design team should provide appropriate details at the tie in location and any associated signage, markings and tactile paving.

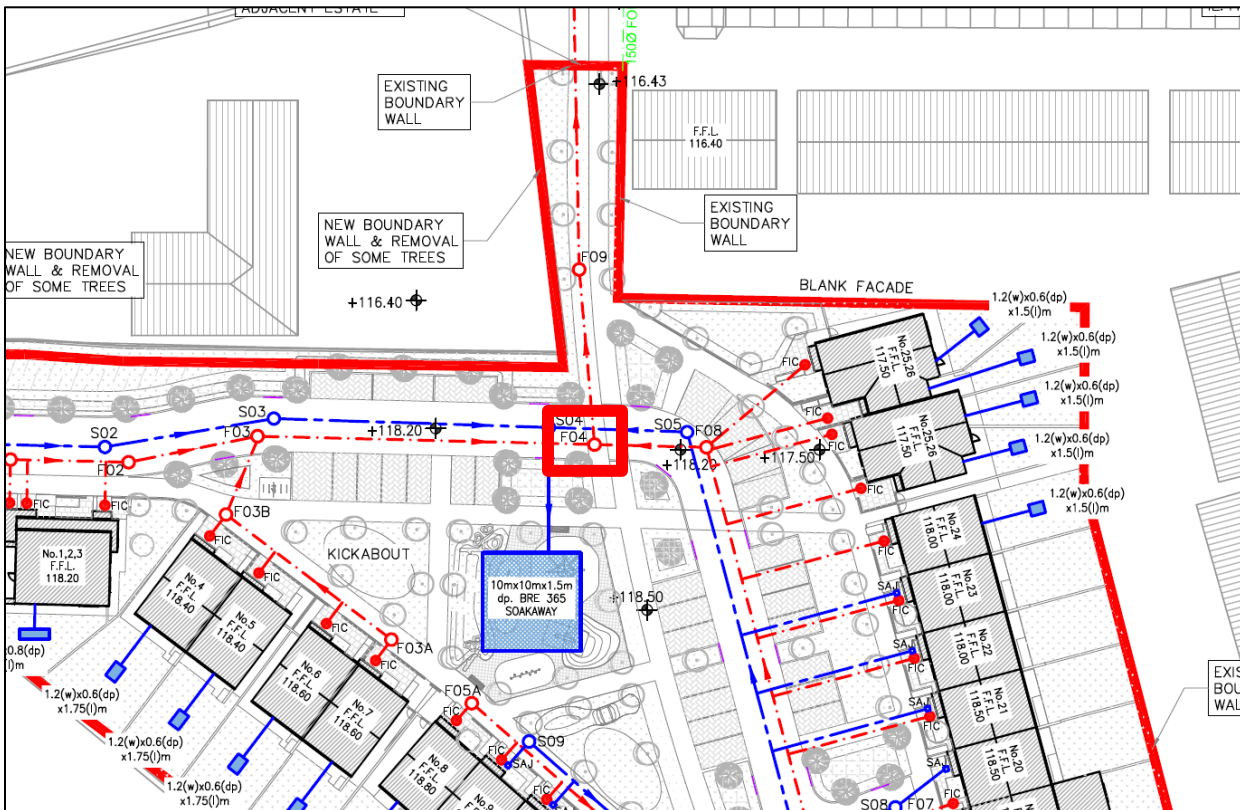
Location: Location Identified

Problem No.09: Manholes on Cycleway Crossing

The audit team has observed from the provided drawings that proposed surface water and foul water manholes are located on the cycle path surface on the crossing at the location identified. If these manholes are not flush with the footpath or if their surfaces are uneven, they pose a significant tripping hazard for cyclists, particularly in wet conditions. This misalignment can lead to increasing the risk of falls and injuries to cyclists on the crossing.

The design team should ensure that all manholes are installed flush with the surrounding footpath surface and apply a non-slip surface treatment on the manholes to enhance traction for cyclists, particularly in wet conditions.
