# Arboricultural Report

BS5837:2012 Trees in Relation to  
Design, Demolition and Construction  
-Recommendations

Craddockstown, Naas, Co.Kildare

**Date:** 21st June 2024

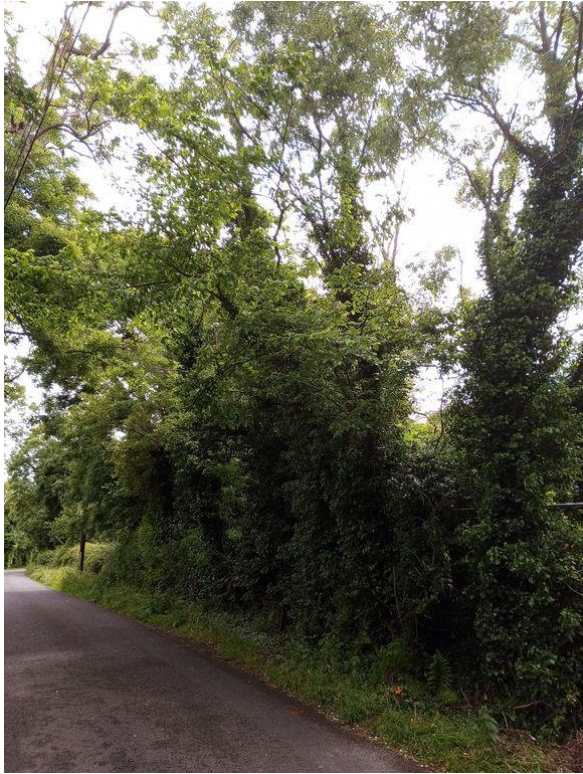
**3.4** The existing site is bordered on the west by Craddockstown Road. There is a semi-mature tree line (fig. 3) adjacent the road consisting of ash, hazel, hawthorn, and wych elm, some of which are dead and collapsing. The western extent of the northern boundary is delineated by a formal cherry laurel hedge (fig. 4) which borders part of the neighbouring property. A semi-mature tree line of beech, pine, ash, and red oak borders the remainder of the neighbouring property, extending east and then northward. A high wall extends eastward for much of the remainder of the northern boundary, then extends southward along the eastern boundary. A sprawling, overgrown, unmanaged agricultural hedgerow of ash, elder, elm, and hawthorn

**Figure 3:** Roadside tree line Craddockstown Rd.

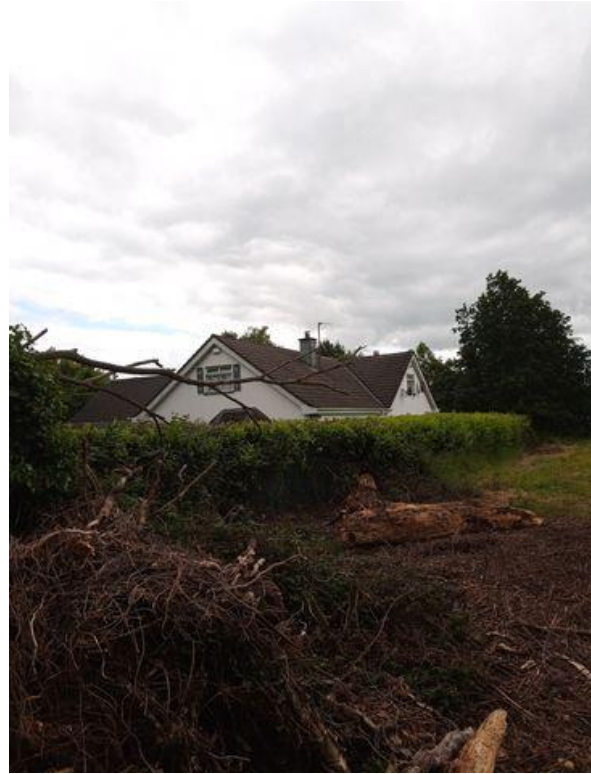
**Figure 4:** H001 cherry laurel hedge at boundary.

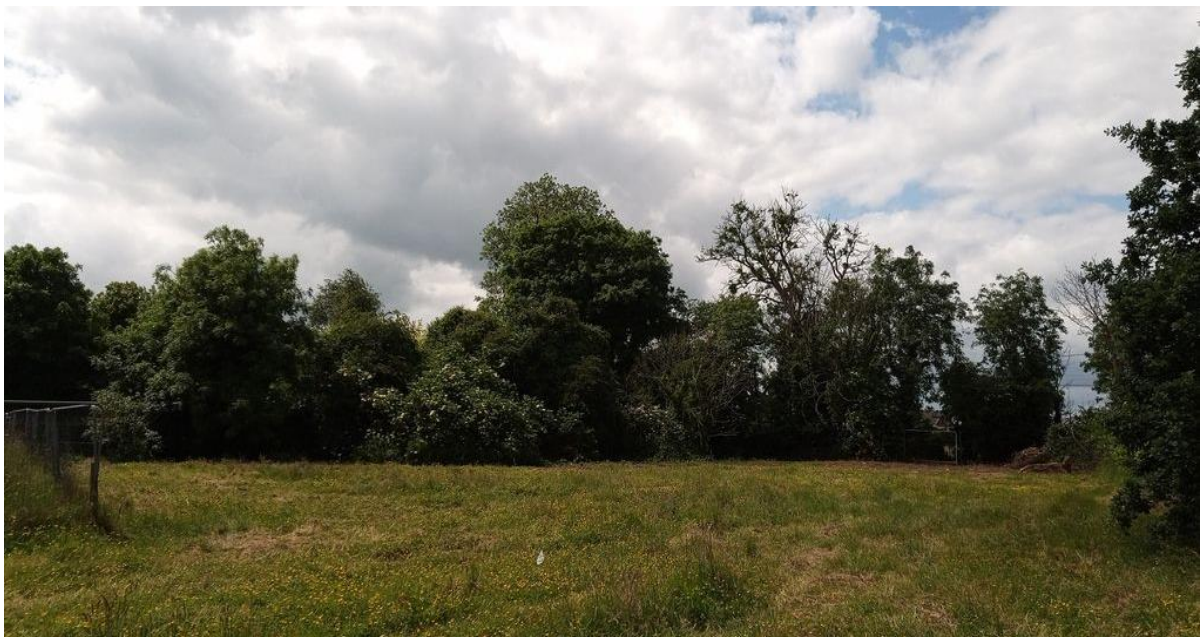
**Figure 5:** G006 sprawling hedgerow at southwestern extent.

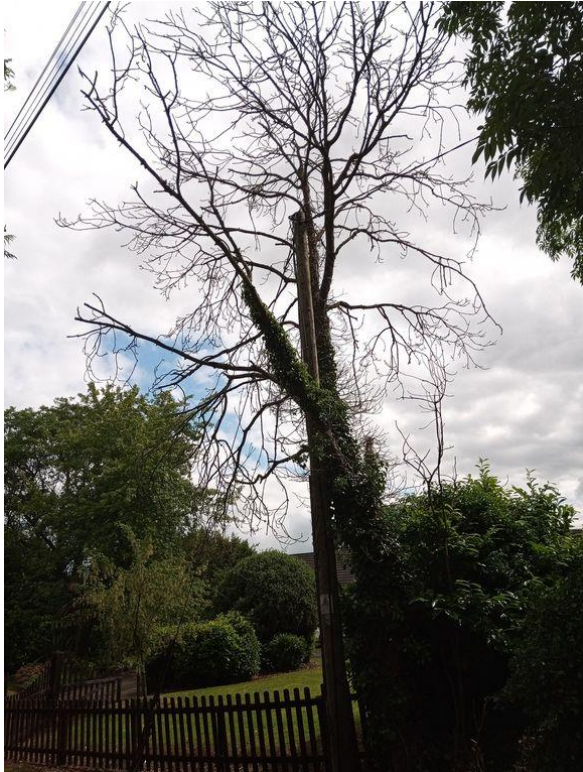
**6.1** Based on the proposed site layout drawings supplied, the arboricultural impact of the proposed development was assessed as follows. The semi mature ash, elm, and hazel trees T1019-T1024 (fig. 6 & 7) and the hedgerow H2 bordering Craddockstown Road are in direct conflict with the proposed plans, necessitating their removal.

**Figure 6:** T1019 dead ash for removal.

T1019	Common ash ( <i>Fraxinus excelsior</i> )	Tree	Height (m): 12 Stem Diam(mm): 380 Spread (m): 5N, 5E, 3S, 3W Crown Clearance (m): 3 Lowest Branch (m): 4(N) Life Stage: Dead	Dead ash tree growing adjacent road and electricity pole. Ivy obscuring stem and main unions.	U	No RPA due to Retention Category of U.	Physiological Condition: Dead Structural Condition: Decaying	Remove tree.
T1020	Common ash ( <i>Fraxinus excelsior</i> )	Tree	Height (m): 9 Stem Diam(mm): 230 Spread (m): 2N, 3E, 3S, 3W Crown Clearance (m): 3 Lowest Branch (m): 4(W) Life Stage: Semi Mature Rem. Contrib.: 10+ Years	Ivy obscuring stem and main unions. Electricity cable through crown. Slightly sparse crown.	C2	Radius: 2.8m. Area: 25 sq m.	Physiological Condition: Fair Structural Condition: Fair	Remove tree.
T1021	Hazel ( <i>Corylus avellana</i> )	Tree 5 stems	Height (m): 5 5 stems (mm): 100,100,100,100,100 Spread (m): 2N, 2E, 2S, 2W Crown Clearance (m): 1 Lowest Branch (m): 1(E) Life Stage: Semi Mature Rem. Contrib.: 10+ Years	Compact tree growing adjacent site entrance.	C2	Radius: 2.7m. Area: 23 sq m.	Physiological Condition: Fair Structural Condition: Fair	Remove tree.

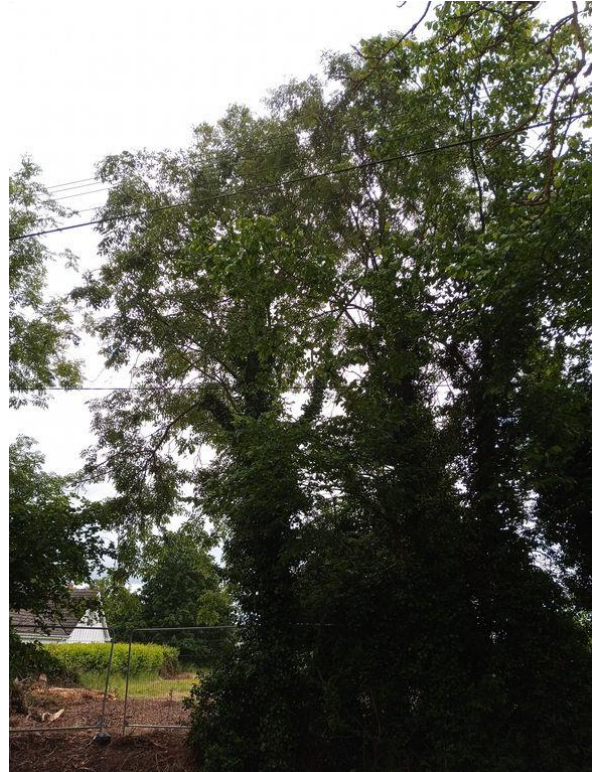
**Figure 7:** T1022 ash for removal.

Ref.	Species	Full Structure	Measurements	Survey Notes	Retention Category	RPA	Tree Condition	Recommendations
T1022	Common ash ( <i>Fraxinus excelsior</i> )	Tree	Height (m): 10 Stem Diam(mm): 240 Spread (m): 4N, 4E, 4S, 3W Crown Clearance (m): 2 Lowest Branch (m): 4(E) Life Stage: Semi Mature Rem. Contrib.: 10+ Years	Ivy obscuring stem and main unions. Deadwood in lower crown overhanging road. Good branch unions where visible.	C2	Radius: 2.9m. Area: 26 sq m.	Physiological Condition: Fair Structural Condition: Fair	Remove tree.
T1023	Common ash ( <i>Fraxinus excelsior</i> )	Tree	Height (m): 11 Stem Diam(mm): 240 Spread (m): 3N, 3E, 2S, 3W Crown Clearance (m): 4 Lowest Branch (m): 4(NW) Life Stage: Semi Mature Rem. Contrib.: 10+ Years	Ivy obscuring stem and main unions.	C2	Radius: 2.9m. Area: 26 sq m.	Physiological Condition: Fair Structural Condition: Fair	Remove tree.
T1024	Wych elm ( <i>Ulmus glabra</i> )	Tree	Height (m): 10 Stem Diam(mm): 260 Spread (m): 5N, 3E, 3S, 4W Crown Clearance (m): 3 Lowest Branch (m): 4(W) Life Stage: Early Mature Rem. Contrib.: 10+ Years	Ivy obscuring stem and main unions. Dead twigs in top of crown indicating onset of Dutch elm disease.	C2	Radius: 3.1m. Area: 30 sq m.	Physiological Condition: Diseased Structural Condition: Fair	Remove tree.

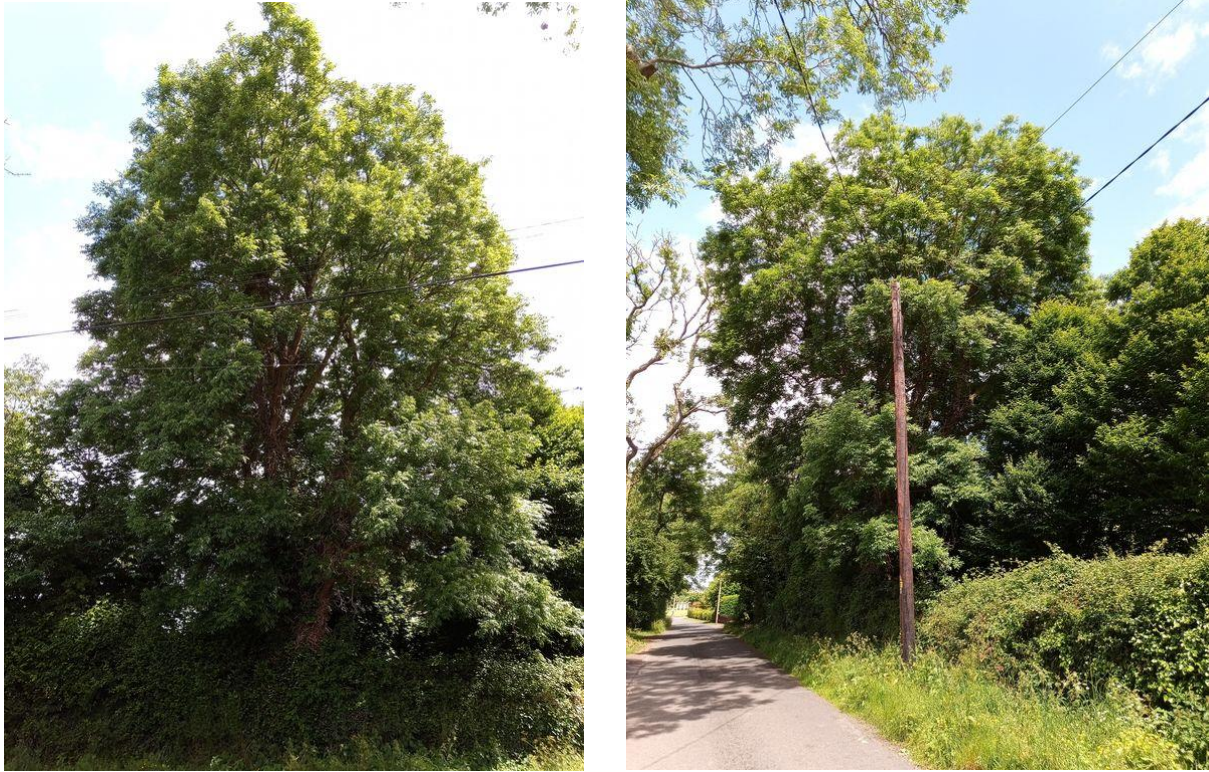
**6.2** The root protection area (RPA) of the mature ash T1025 (fig. 8 & 9) on the neighbouring property to the south extends into the proposed development. Root pruning will have to be performed during site works to limit damage to the tree.

***Figure 8 & 9: T1025 mature ash for retention and root pruning.***

T1025	Common ash ( <i>Fraxinus excelsior</i> )	Tree	Height (m): 18 Stem Diam(mm): 1000# Spread (m): 9N, 9E, 9S, 8W Crown Clearance (m): 2 Lowest Branch (m): 3(SW) Life Stage: Mature Rem. Contrib.: 20+ Years	Growing on bank adjacent road. Well formed buttresses. Unidentified FFB growing from cavity at 1m to east. 3 codominant stems at 1.5m spreading into broad open crown. Dead ivy obscuring main unions. Water shoots on inner crown. Good unions where visible. Good leaf cover.	B2	Radius: 12.0m. Area: 452 sq m.	Physiological Condition: Good Structural Condition: Fair	Pre construction: Root pruning on northeastern side where roots extend into proposed site.  During construction: Protect trees with protective barriers - as shown on plans.  Post construction: No action required.
T1026	Common ash ( <i>Fraxinus excelsior</i> )	Tree 2 stems	Height (m): 10 2 stems (mm): 240,230 Spread (m): 4N, 4E, 3S, 3W Crown Clearance (m): 1 Lowest Branch (m): 1(S) Life Stage: Early Mature Rem. Contrib.: 20+ Years	Tree has fallen and righted itself. Natural bracing on codominant stems. Ivy obscuring stem and much of crown. Good vigour and leaf cover.	B2	Radius: 4.0m. Area: 50 sq m.	Physiological Condition: Good Structural Condition: Fair	Remove tree.

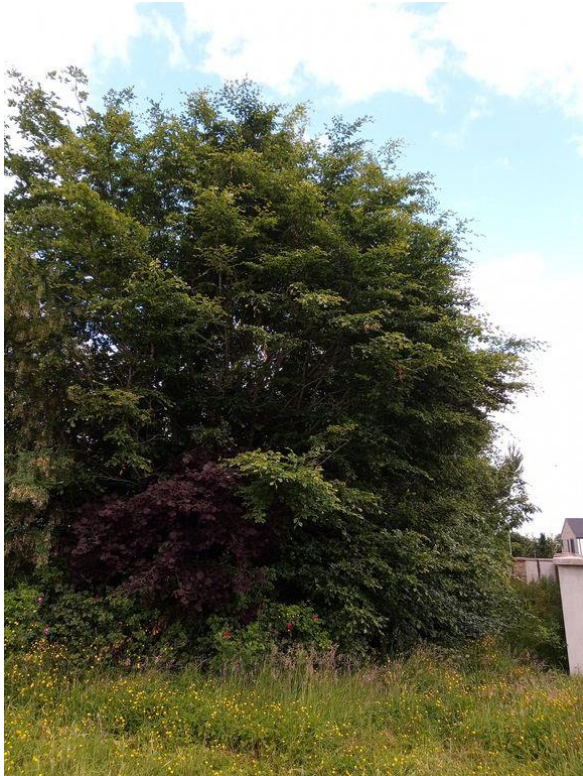
**6.3** The trees T1013-16 & T1018 (fig. 10 & 11) and the group G002 require removal at the request of the owner of the property. The RPAs of these trees extend into the proposed site, and their roots will be damaged during construction of the boundary wall.

**Figure 10:** T1016 beech for removal.

Ref.	Species	Full Structure	Measurements	Survey Notes	Retention Category	RPA	Tree Condition	Recommendations
T1016	Common beech ( <i>Fagus sylvatica</i> )	Tree	Height (m): 11 Stem Diam(mm): 300# Spread (m): 2N, 5E, 4S, 4W Crown Clearance (m): 1 Lowest Branch (m): 1(E) Life Stage: Early Mature Rem. Contrib.: 20+ Years	Overhanging branches into proposed site. Good crown architecture. Good leaf cover.	B2	Radius: 3.6m. Area: 41 sq m.	Physiological Condition: Good Structural Condition: Good	Remove tree.
T1017	Grey willow ( <i>Salix cinerea</i> )	Tree 2 stems	Height (m): 5 2 stems (mm): 100,90 Spread (m): 2N, 3E, 2S, 1W Crown Clearance (m): 1 Lowest Branch (m): 1(E) Life Stage: Semi Mature Rem. Contrib.: <10 years	Bark necrosis at base of stem. Extensive dieback throughout crown.	U	No RPA due to Retention Category of U.	Physiological Condition: Poor Structural Condition: Decaying	Remove tree.
T1018	Pedunculate oak ( <i>Quercus robur</i> )	Tree	Height (m): 12 Stem Diam(mm): 380# Spread (m): 4N, 4E, 5S, 6W Crown Clearance (m): 1 Lowest Branch (m): 2(S) Life Stage: Early Mature Rem. Contrib.: 30+ Years	Branches overhanging proposed site. Good crown architecture. Good vigour and leaf cover.	B2	Radius: 4.6m. Area: 66 sq m.	Physiological Condition: Good Structural Condition: Good	Remove tree.

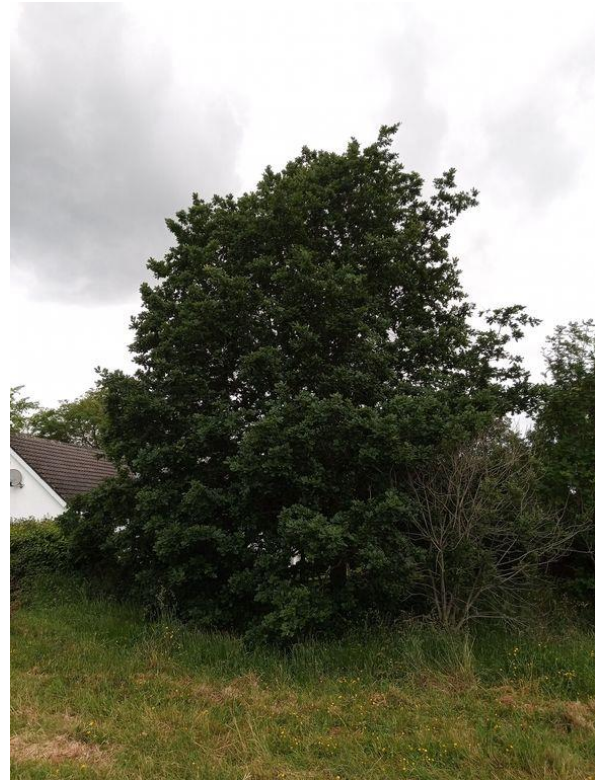
**Figure 11:** T1018 pedunculate oak for removal.

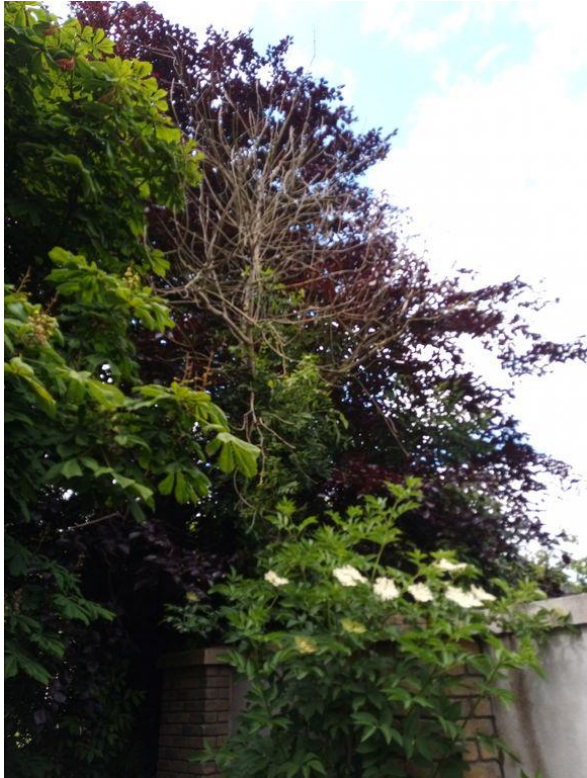
6.4 The trees T1009-T1012 (fig. 12 & 13) are in direct conflict with the alignment of the boundary wall, necessitating their removal.

**Figure 12:** T1009 copper beech for removal.

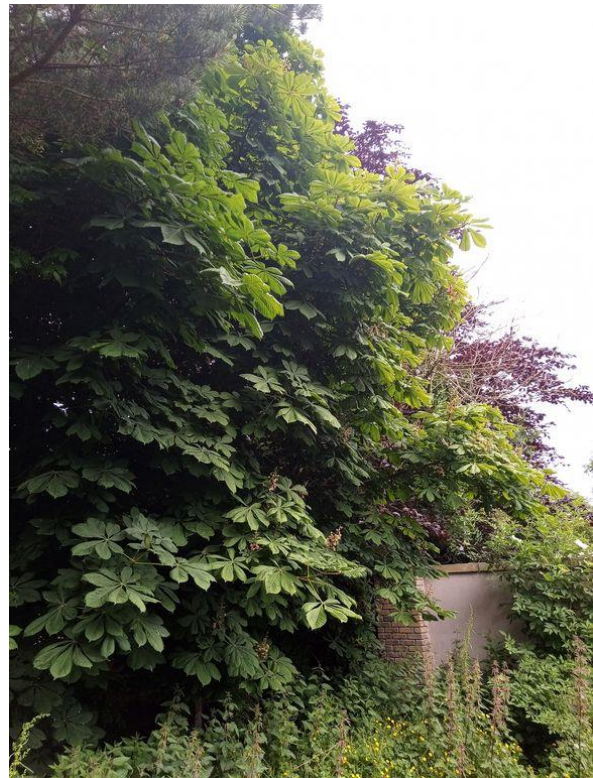
**Figure 13:** T1011 horse chestnut for removal.

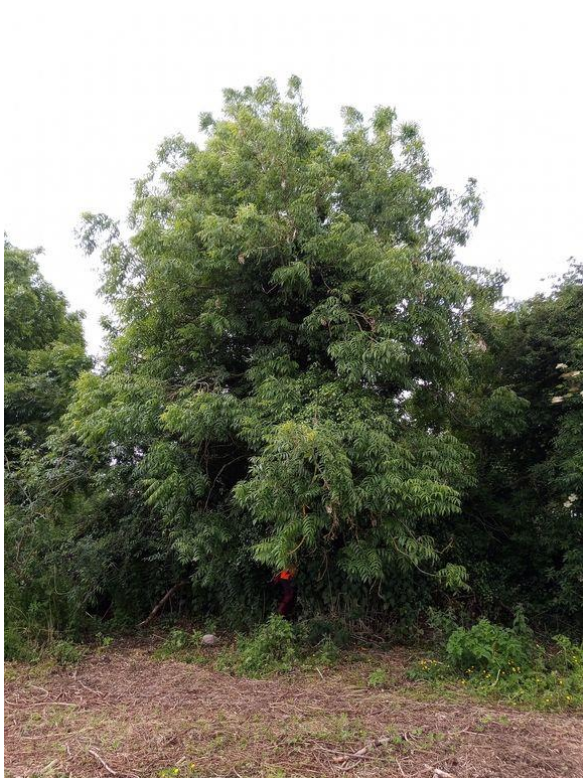
**6.6** The ash T1026 (fig. 14) is within the footprint of the development and while it could be retained in the garden of one of the proposed dwellings, it is not a suitable tree for a small garden.

**Figure 14:** T1026 ash for removal.

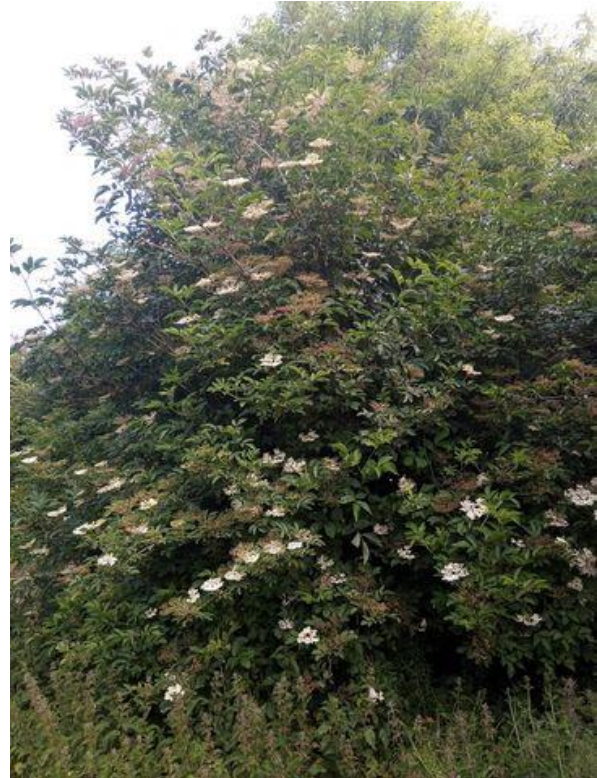
**6.7** The holly T1028 and the elders T1029 (fig. 15) & T1032 which are growing on the boundary with the adjacent property should be retained, as should other trees along the boundary, including the ash T1030 & T1031. The hawthorn group G007, and the wild cherry T1033 require removal.

**Figure 15:** T1029 elder for retention.

T1029	Elder ( <i>Sambucus nigra</i> )	Tree	Height (m): 3 Stem Diam(mm): 100 Spread (m): 2N, 2E, 2S, 2W Crown Clearance (m): 1 Life Stage: Semi Mature Rem. Contrib.: 10+ Years	Growing adjacent neighbouring garden, good leaf and flower cover.	C2	Radius: 1.2m. Area: 5 sq m.	Physiological Condition: Fair Structural Condition: Fair	Pre construction: No action required.  During construction: Protect trees with protective barriers - as shown on plans.  Post construction: No action required.
T1030	Common ash ( <i>Fraxinus excelsior</i> )	Tree	Height (m): 8 Stem Diam(mm): 200# Spread (m): 2N, 2E, 3S, 2W Crown Clearance (m): 1 Lowest Branch (m): 2(S) Life Stage: Semi Mature Rem. Contrib.: 10+ Years	Growing adjacent neighbouring property. Good leaf cover. Ivy obscuring stem.	C2	Radius: 2.4m. Area: 18 sq m.	Physiological Condition: Fair Structural Condition: Fair	Pre construction: Sever ivy at base.  During construction: Protect trees with protective barriers - as shown on plans.  Post construction: No action required.

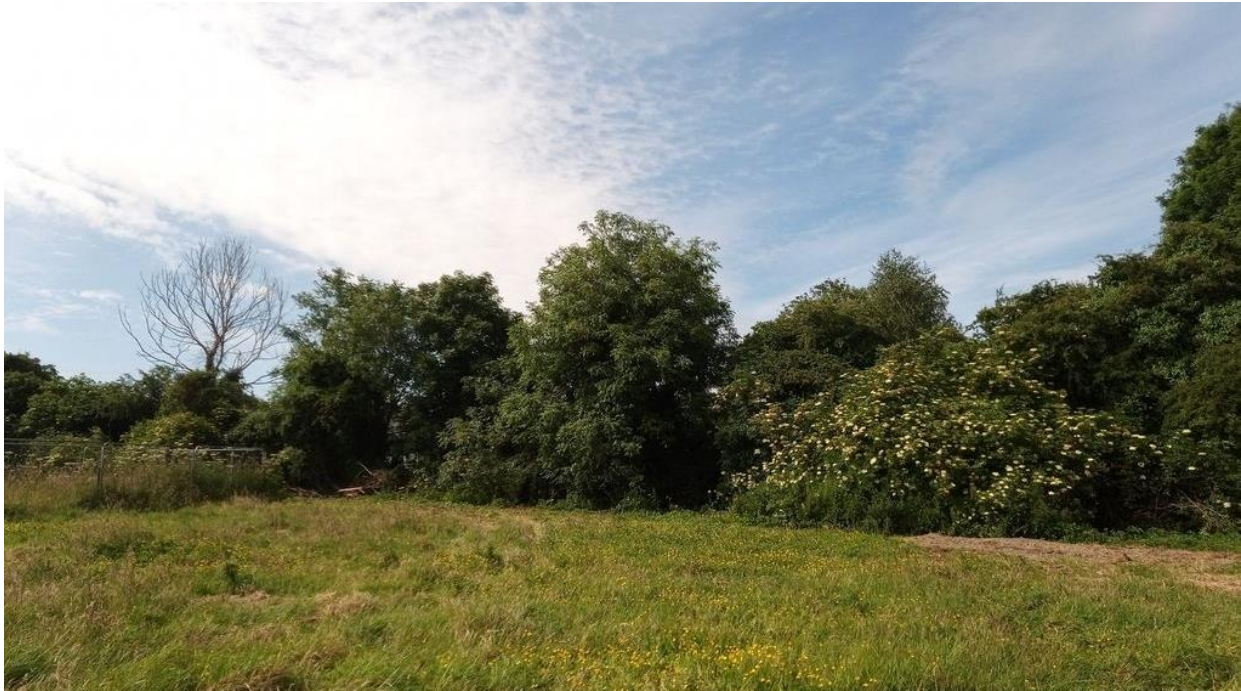
**6.8** The majority of the sprawling overgrown hedgerow G006 (fig. 16) is within the footprint of the proposed dwellings, necessitating its removal.

*Figure 16: G006 mixed species hedgerow for partial removal.*

G006	Common hawthorn x10 ( <i>Crataegus monogyna</i> ) Common ash x2 ( <i>Fraxinus excelsior</i> ) Wych elm x3 ( <i>Ulmus glabra</i> ) Elder x8 ( <i>Sambucus nigra</i> ) Dogrose ( <i>Rosa canina</i> )	Group 24 trees	Height (m): 10 24 stems, avg.(mm): 130 Spread (m): 6N, 3E, 6S, 3W Crown Clearance (m): 1 Lowest Branch (m): 1(NE) Life Stage: Semi Mature Rem. Contrib.: 10+ Years	Sprawling overgrown mixed species hedgerow forming southern boundary. Dead standing and fallen elm scattered throughout. Bramble and ivy proliferating.	C2	Area: 1599 sq m.	Physiological Condition: Fair Structural Condition: Fair	Remove hedgerow group as indicated on Tree Protection Plan.
G007	Common hawthorn x2 ( <i>Crataegus monogyna</i> ) Dogrose ( <i>Rosa canina</i> )	Group 3 trees	Height (m): 8 3 stems, avg.(mm): 200# Spread (m): 2N, 3E, 3S, 3W Crown Clearance (m): 1 Lowest Branch (m): 1(W) Life Stage: Early Mature Rem. Contrib.: 10+ Years	Ivy covered stems, good leaf cover.	C2	Area: 39 sq m.	Physiological Condition: Fair Structural Condition: Fair	Remove trees.
