NAAS LIBRARY

ARCHITECTURAL HERITAGE IMPACT ASSESSMENT

Deaton Lysaght Architects
October 2018

CONDITION REPORT

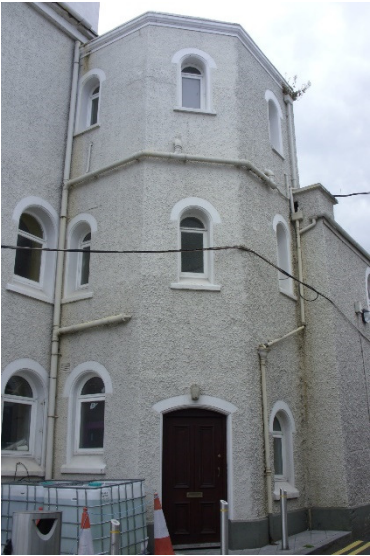
ELEMENT	DESCRIPTION	PROPOSED WORKS	HERITAGE IMPACT	PHOTOGRAPH
Roof	Hipped, slated roof structure, renewed and reslated in 1990s.	Repair of roof in north-east corner in traditional slate, repair/replacement of rainwater gutters and downpipes	Positive – will improve weathertightness of the building	
Plaster	Rough-cast lime plaster	Local repairs where required, finished with further coat of lime plaster	Positive – will improve the weathering characteristics and restore external appearance

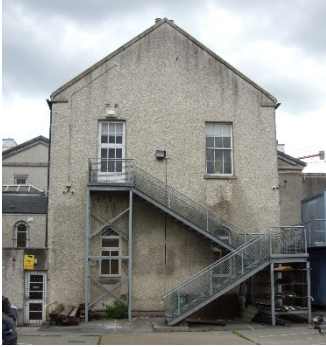
<p>Windows</p>	<p>Sundry replacement of windows</p>	<p>Replacement of inappropriate windows with wooden up-and-down sliding sash windows with double glazing</p>	<p>Positive – will eliminate inappropriate windows and restore original elevational treatment</p>

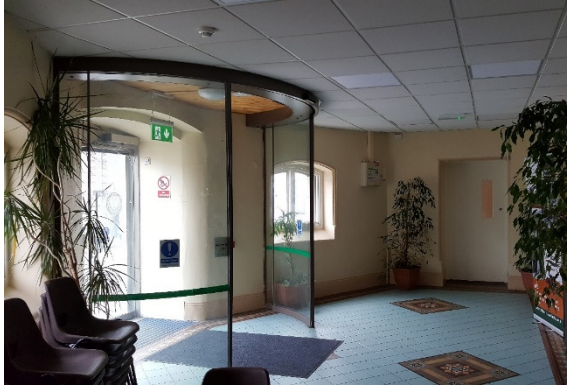
<p>Entrance porch</p>	<p>Removal of circular revolving door inserted in front elevation</p>	<p>Renewal of original door layout in accordance with historic photographs</p>	<p>Positive – existing door is poor modern insertion. New door will restore original aesthetic</p>

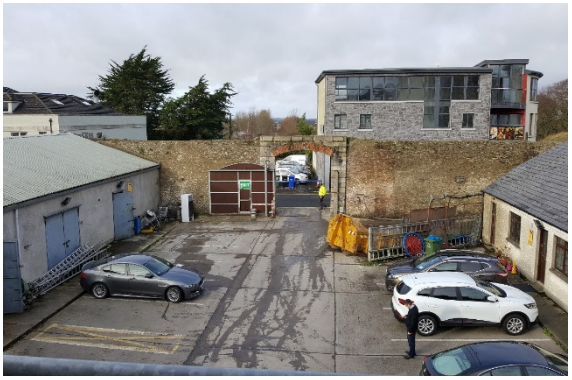
<p>Out-buildings</p>	<p>All out-buildings at rear</p>	<p>Remove all external accretions in courtyard, including all sheds, steel stairs and silo</p>	<p>Positive – will provide enhanced courtyard space and an area for construction of new library building</p>

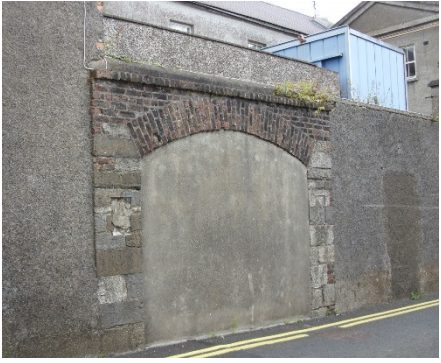
<p>Side entrances</p>	<p>Currently entrances onto both side laneways are blocked up</p>	<p>Remove existing masonry blocks, provide glazed entrance to northern side, and railings to seal ope on southern side</p>	<p>Positive – will enhance and renew exterior treatment to jail walls and provide additional access and permeability of the site</p>

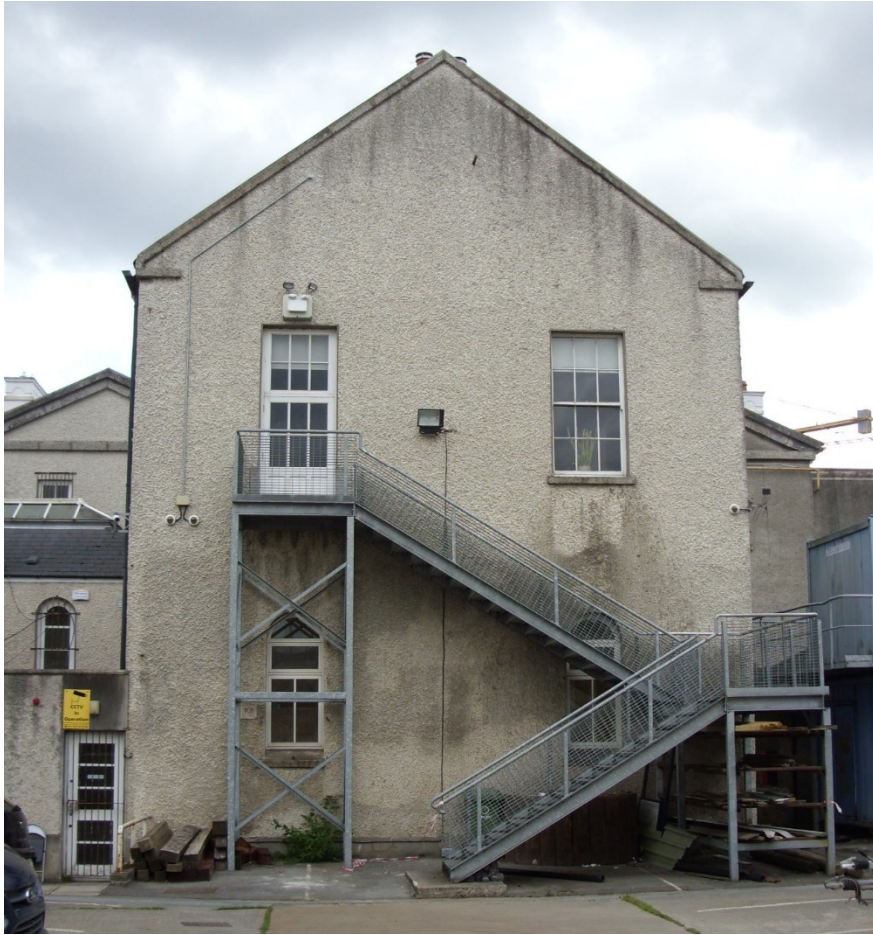
Entrance to original Carnegie Library on Moat Lane
Redundant pipework and cables to be removed
Rough-cast plaster to be repaired and finished with a
further coat of lime plaster

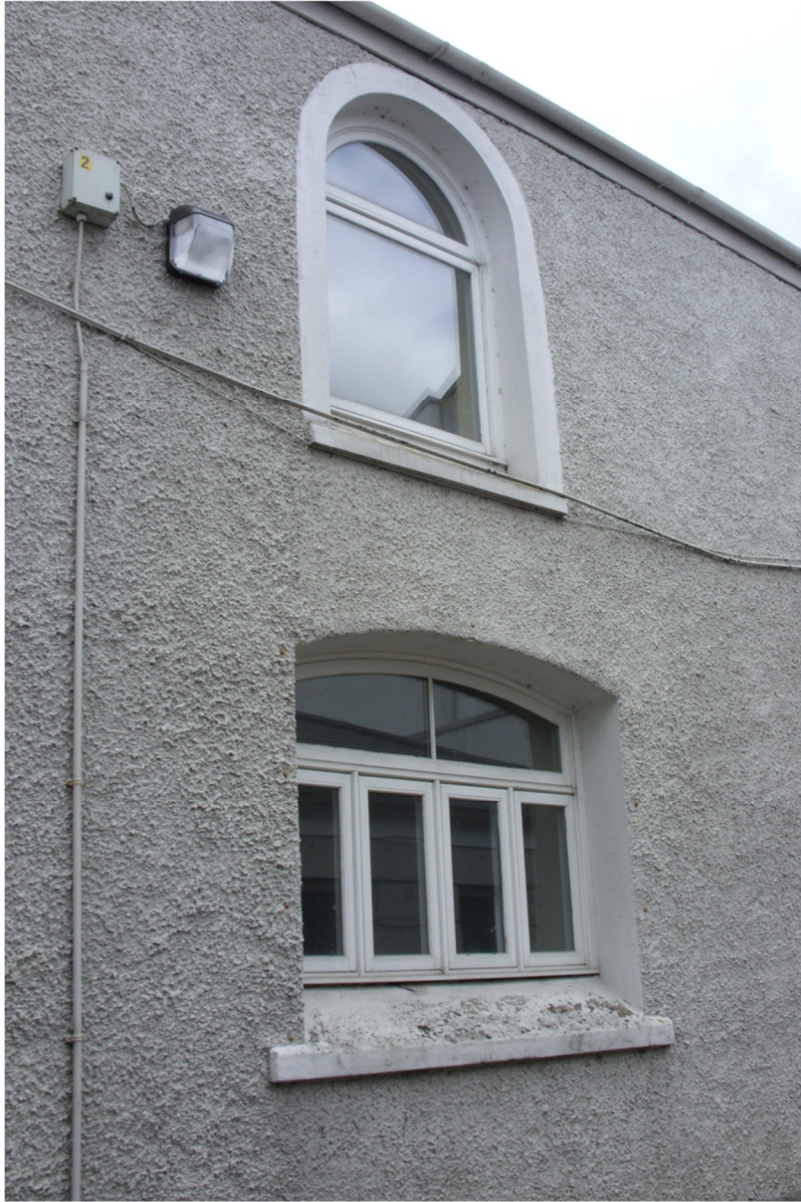
Rear elevation from yard
Replacement of inappropriate windows with up-and-down sliding sashes with double glazing

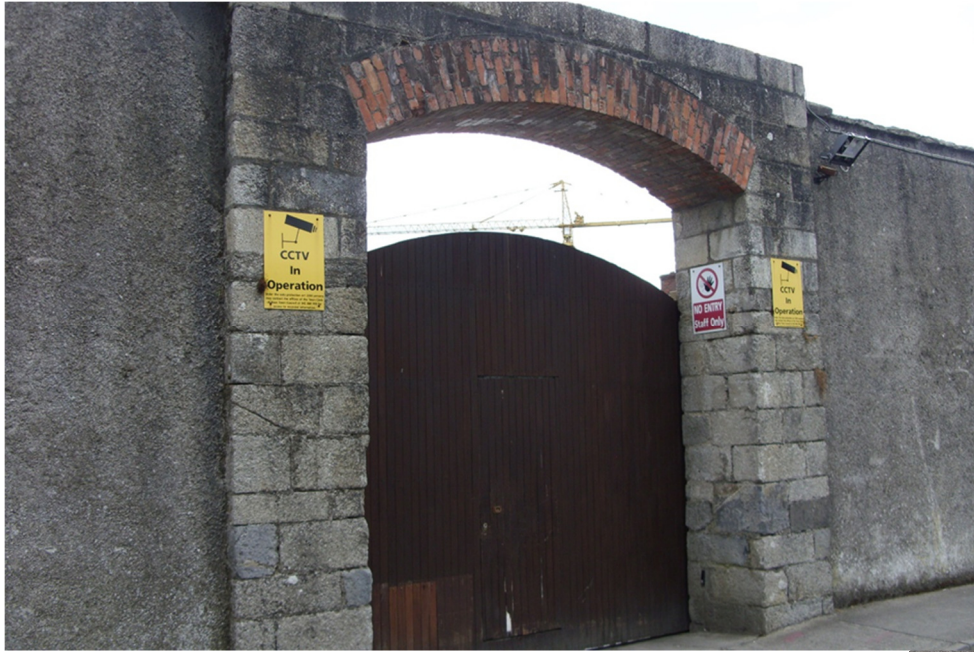
<-
Rear entrance, wooden gate to be replaced
with wrought-iron type gate

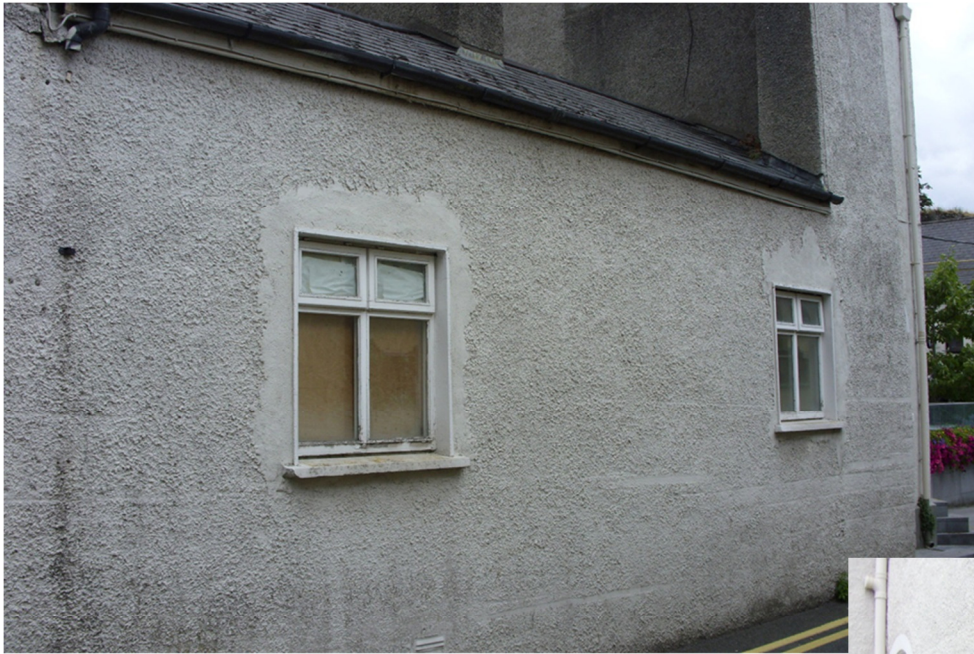
<-
Modern windows onto Town Hall Lane to be blocked up

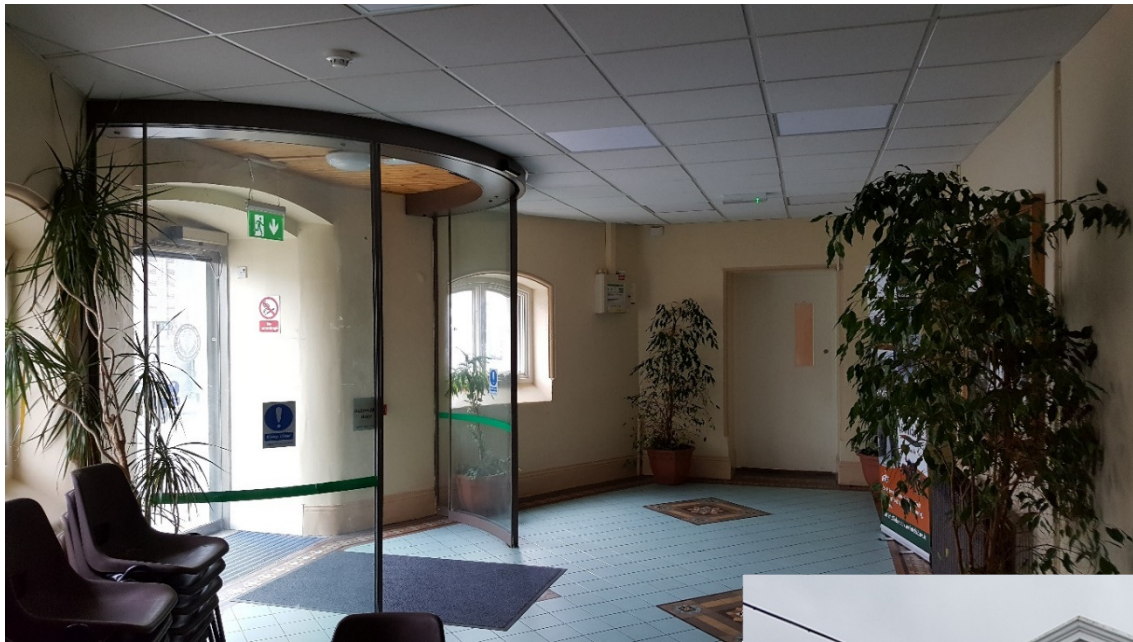
<-
Entrance lobby
Renewal of original door layout
In accordance with historic photographs

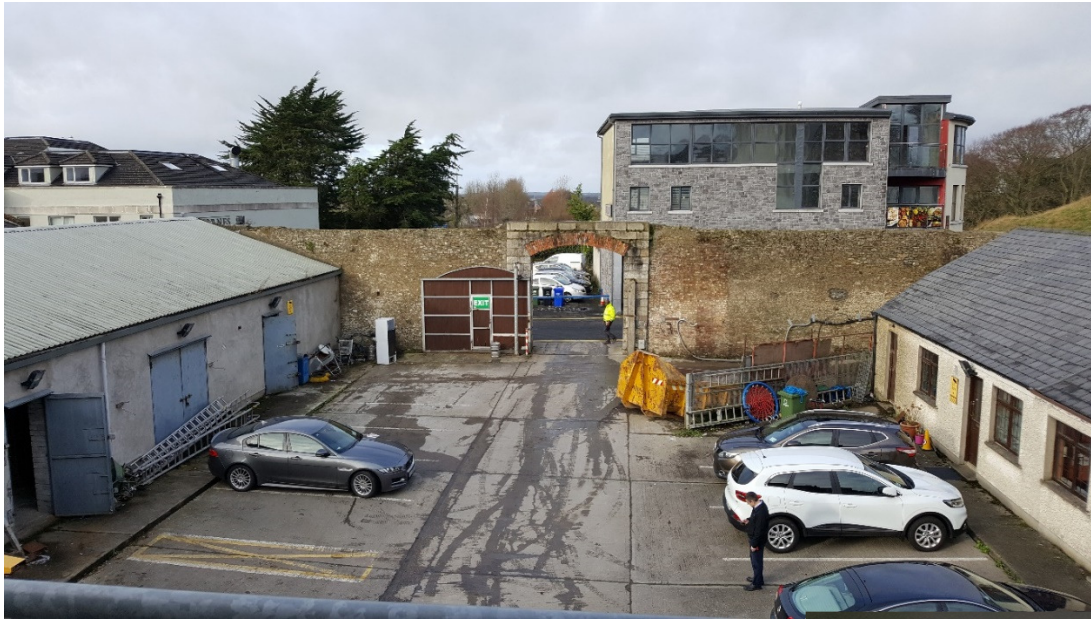
<-
Buildings in rear yard are to be demolished, and original jail wall to be repaired and reinstated as necessary

We have omitted a comment on the condition of the buildings in the rear yard area scheduled for demolition, as these buildings are to be removed to make way for the new development. Where these buildings adjoin the original Jail Wall, the wall is to be carefully repaired and reinstated in masonry and lime mortar to match the original finishes.

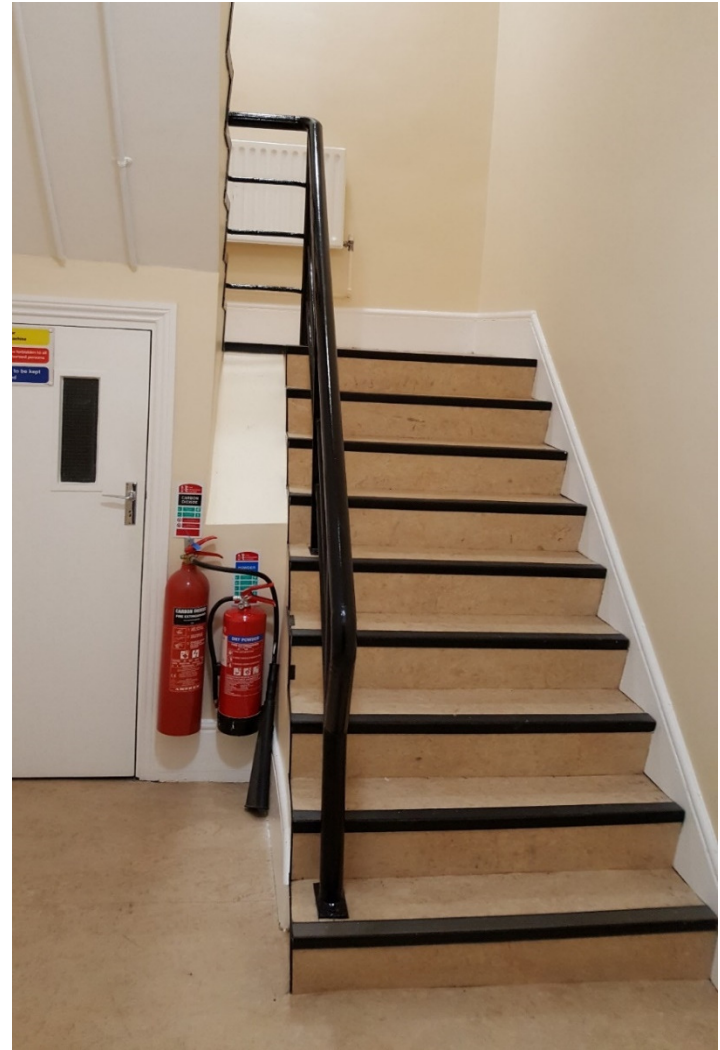
Existing central concrete stairs to be removed, to be replaced with
new stairs to comply with Building Regulations

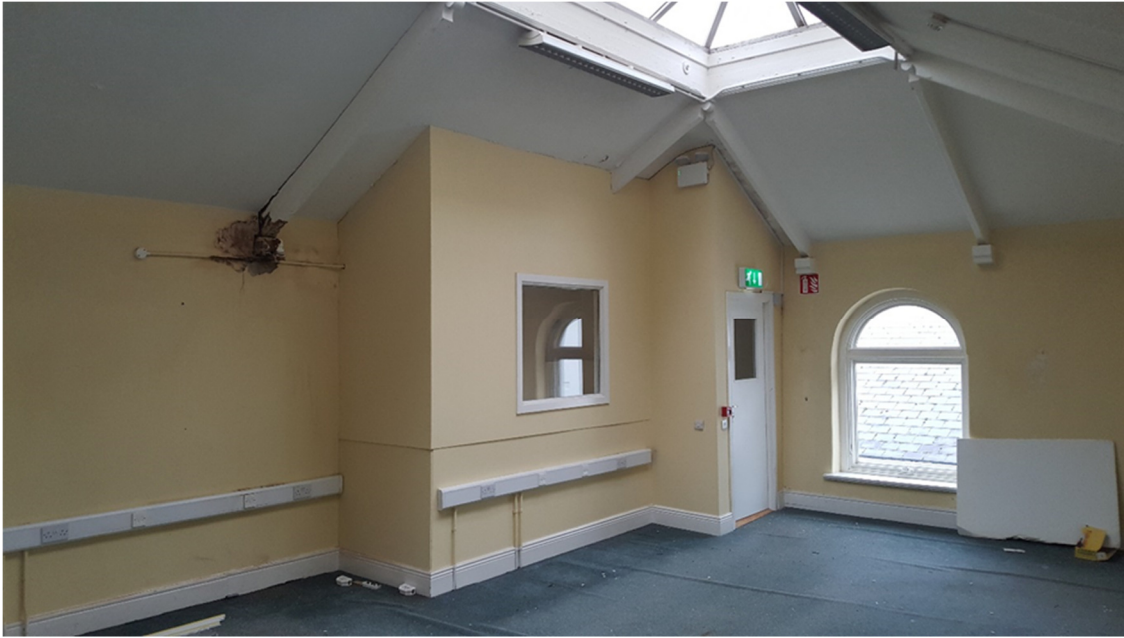
One of the main areas of concern is the outbreak of dry rot in the roof structure of the glazed first-floor office area on the northern side, caused by the ingress of water and defective lead gutters and flashing. This has led to a degradation of the primary structural elements, and this roof will therefore require to be removed on its condition alone, and suitable preservative treatment will be applied to the remaining structure.

Rooflit office RF 07 with dry-rot at truss ends. Roof to be reconstructed.

<p>RF07 and RF08</p>	<p>Removal of existing roof structure and stairwell, preservative treatment to remaining structures, insertion of new partitions to form toilets etc.</p>	<p>Negative – works proposed are required by the brief, and appropriate in view of the condition survey</p>	 
<p>RS01 Lobby</p>	<p>Insertion of new door opens to facilitate access to new stairwell location, removal of existing modern spiral stairs</p>	<p>Positive – restores central axial entrance to RS07, enlarges lobby by removal of obstructive stairs</p>	
<p>RS02 Stairwell and lift</p>	<p>Insertion of new concrete stairwell and lift shaft in original structure</p>	<p>Neutral – these works are incorporated within the 1990s concrete area</p>
