## Kildare County Library, Archives & Cultural Centre

### Conservation & Architectural Heritage Impact Assessment Report

### **Stage 1 Report: Architectural Heritage**

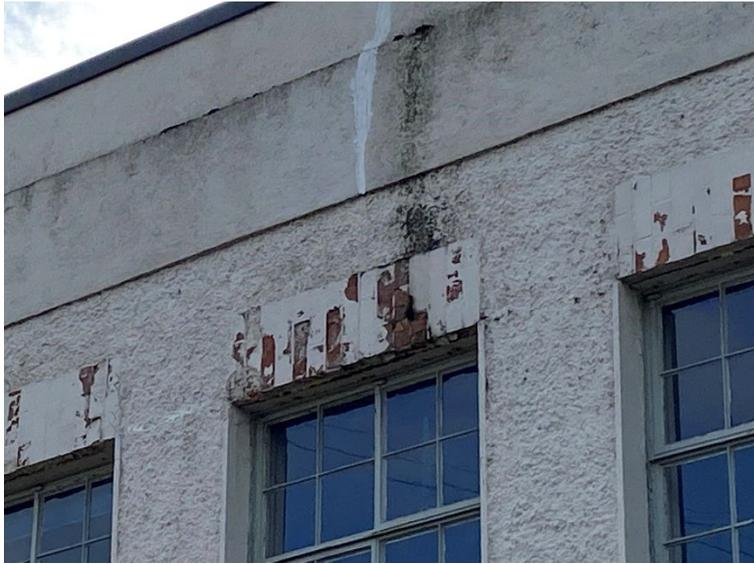
Figure 22: Detail of cracking above first floor windows on north façade

- There is extensive cracking present in the external render. This will require filling with appropriate proprietary conservation products such as *Remmers concrete façade repair system* to prevent water penetration.

- Previous crack stitching was undertaken as recommended by consultants *Carroll & Browne*. This will be reviewed by Aecom engineers who will specify any further work necessary. This previous work is outlined in PJ Barrett & Co. Investigative Report and consists of vertical stitches embedded approx.. 50mm deep.

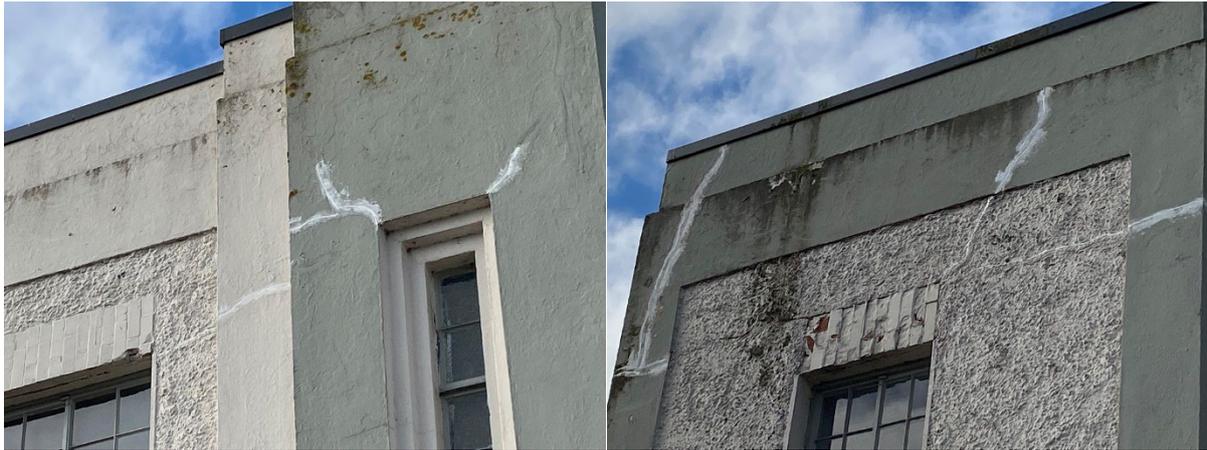
Figure 26: Cracks above windows on Eastern façade

- All internal lintols are concrete and are determined to be in good condition.
- External lintols are steel Catnic type lintols supporting a brick soldier course. Much of the brick surface has spalled and will be repaired with repair mortars to match the brick colour and texture using 'Plastic Repair' techniques. The steel lintols are exhibiting some rusting to their undersides and this will be addressed insitu using rust inhibitors

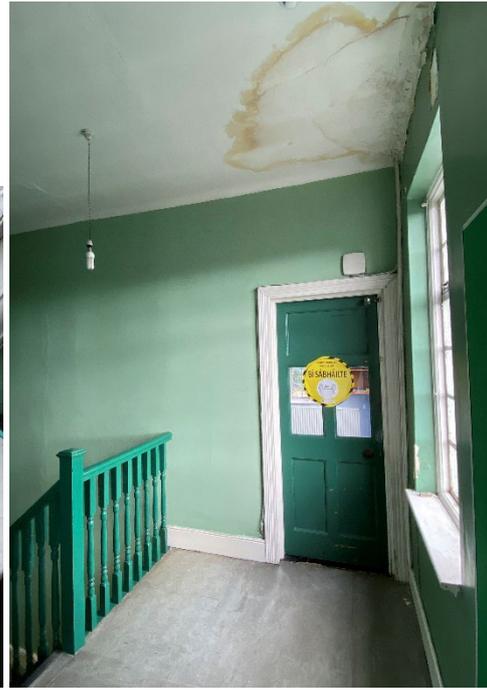
Figure 47: First floor landing, displaying evidence of significant water ingress through parapets and concrete façade, leading to staining of ceilings

- Remove existing pressed metal capping from all parapets
- It is assumed that the original coping has been lost. Allow for new concrete slender copings with maximum 45mm leading edge forming a drip both sides of parapet to prevent wall staining. New copings to be laid on Code 6 lead
- Assume all parapet valley boards and valley support timbers are decayed and allow for replacement in marine grade 23mm plywood. Allow for steps to existing outlets welted in direction of fall. New leadwork to be applied over geotextile to repaired substructure all to Lead Association manual details. Allow for coved upstand at parapet wall
- All existing parapet gutters to be reinstated in Code 6 lead on inodorous laid to falls
- Replace render to inside face of parapet wall: hack off existing render

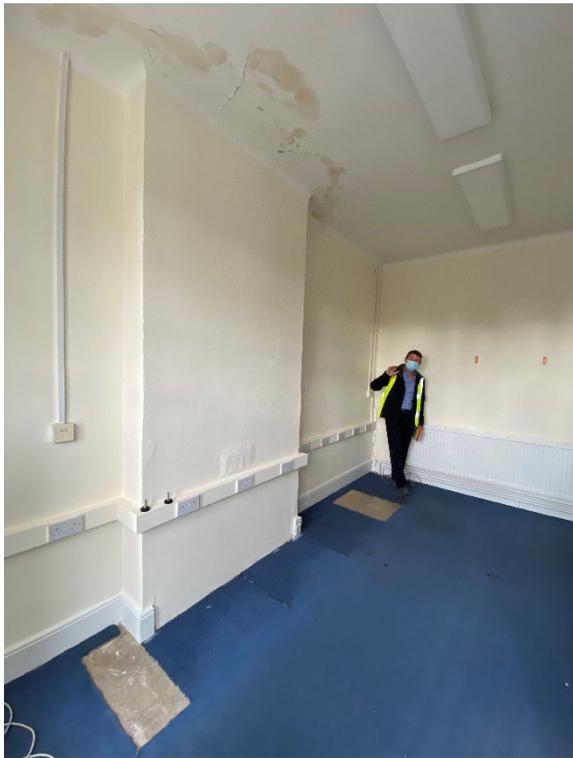
Figure 47: Evidence of significant water ingress around chimney breast at first floor level.

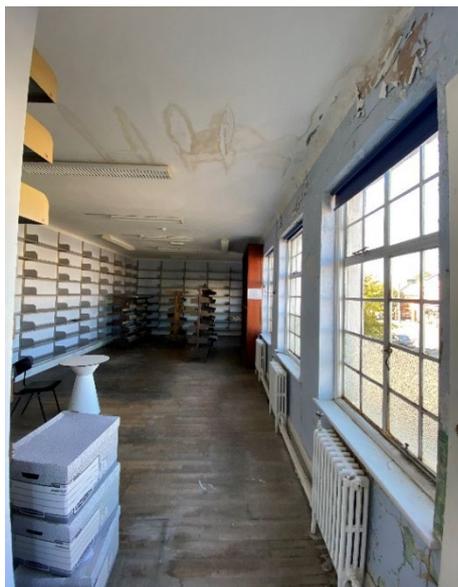
Figure 57: Plaster damage due to water ingress to ceilings at first floor level and above window heads. Note oak floor

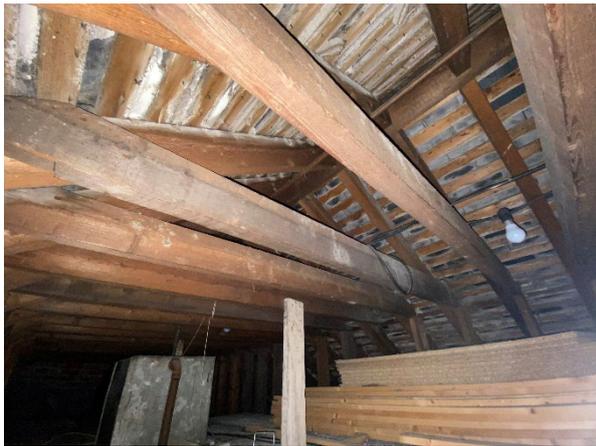
Figure 59: Roof configuration of evenly spaced cut rafters supporting closely spaced slating battens with mortar parging between them, most of which has fallen to the attic floor

- The principal roof structure is generally in good condition and repairs can be carried out insitu.
- Allow for scaffolding to eaves level
- Carefully remove all existing slates and store vertically on timber bearers for reuse
- Remove remnants of mortar parging from between slating battens and from attic floor where the majority has fallen
- Remove slating battens and discard off site
- Stripped areas of roof are to have temporary weathering applied to prevent water entering the building.

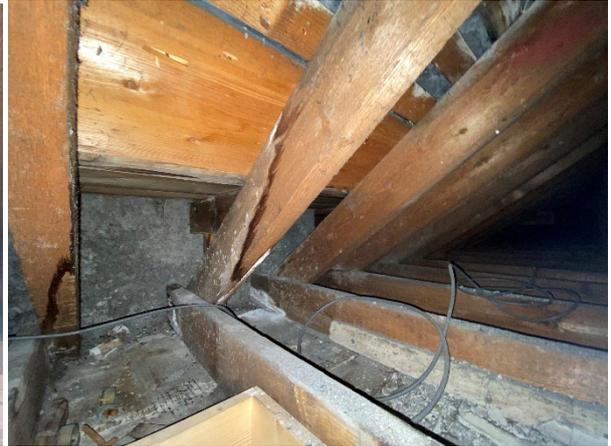
Figure 60: Water staining on lower rafters and valley boarding due to leaks in parapet linings

- Retain all collar rafter roof trusses and allow for repairs of any decayed bearing ends at wall plate level. This will entail cutting back of decayed ends to areas of sound timber and making splice repairs with new treated timber of similar size forming connections with galvanised steel bolts and toothed washers. A detailed roof investigation report has been prepared by *PJ Barrett & Co.* and it is recommended that an allowance is made for repair to 20% of rafter ends.

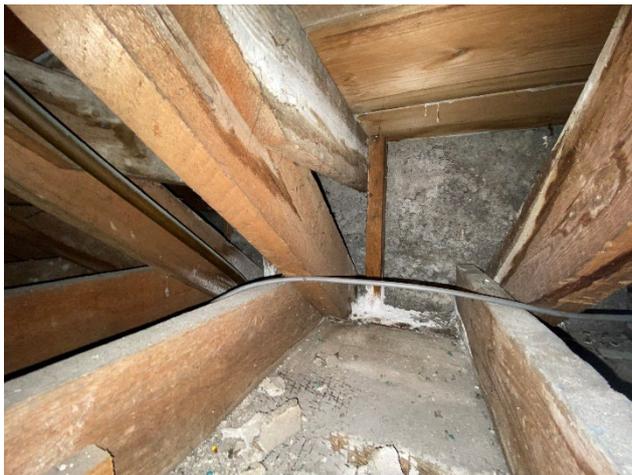
Figure 63: Water staining at wall plate level beneath parapet gutter boarding

- Allow for the replacement of any decayed wall plates with new similar treated wall plates of dimensions 125 x 50mm scarfe joined to areas of sound wall plate. New sections to be wrapped in DPC where in contact with masonry. Allow for any replacement members to be bolted to wall tops and strapped at eaves. A detailed roof investigation report has been prepared by *PJ Barrett & Co.* and it is recommended that an allowance is made for repair to 20% of wall plates using scarfe repairs .

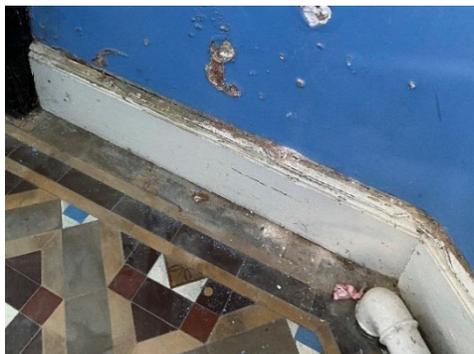
Figure 69: Considerable dampness causing spalling of wall plasters at skirting level on ground floor

Having examined the above options, **Option 2** has been recommended by JCA Architects as the best option to be used where existing plasters have decayed, offering the optimum balance between energy efficiency and minimising impact on the historic character of the building interior.

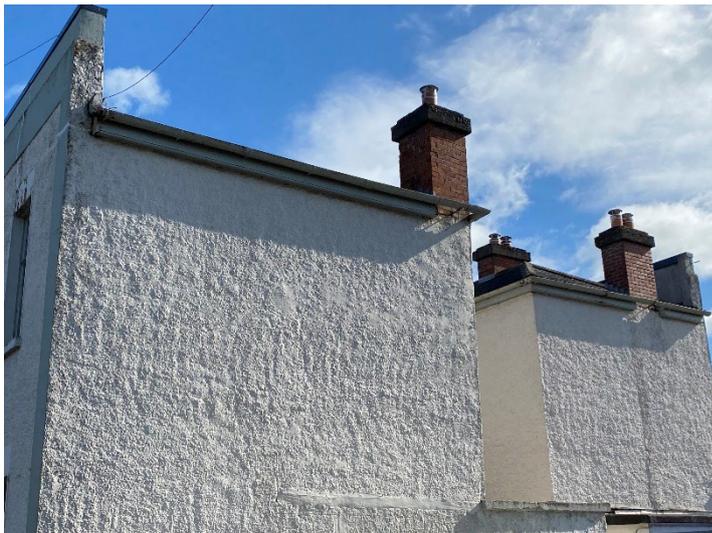
chimney stacks to rear elevation

Figure 72: Roughcast plaster harling and brick

- Allow for raking out all pointing to 3 no. brick chimneys
- Allow for the replacement of spalled bricks with similar matching bricks with new mortar bedding

- Allow for minor surface damage to be repaired with proprietary repair mortars such as Remmers with similar colour match and texture guided by existing brickwork

- Allow for brick masonry to be treated with a breathable water repellent such as Remmers Funcosil or similar approved
- Remove existing damaged flaunching and replace with new limecrete to similar dimensions forming frip at underside. Existing flue pots to be reused and rebedded. Allow missing or damaged pots to be replaced with similar circular clay pots.

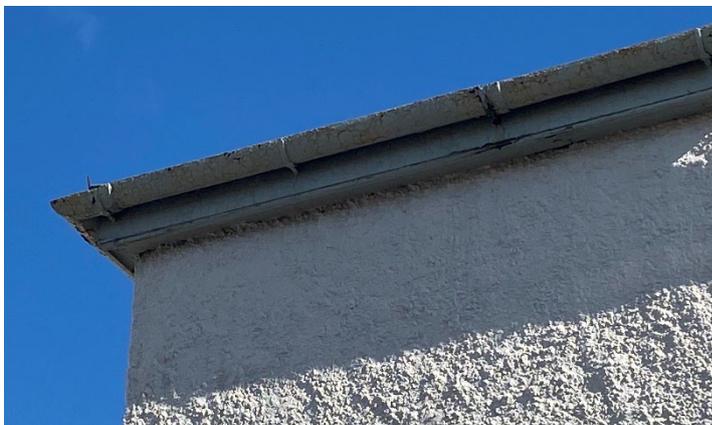
Figure 73: Decayed timber fascia & soffits to rear

- Engage timber decay specialist to advise on strategy for treatment of all timbers with approved insecticide and fungicide
- Allow for new hardwood timber soffit and fascia with half round drip mould, primed for paint finish. New rainwater gutters to be bracketed to same
