Preliminary Damp & Timber Decay Report

Kildare Public Library RPS: B23-41

10th January 2022

Re: Damp & Timber Decay Survey - Kildare County Library, Newbridge, Co. Kildare.

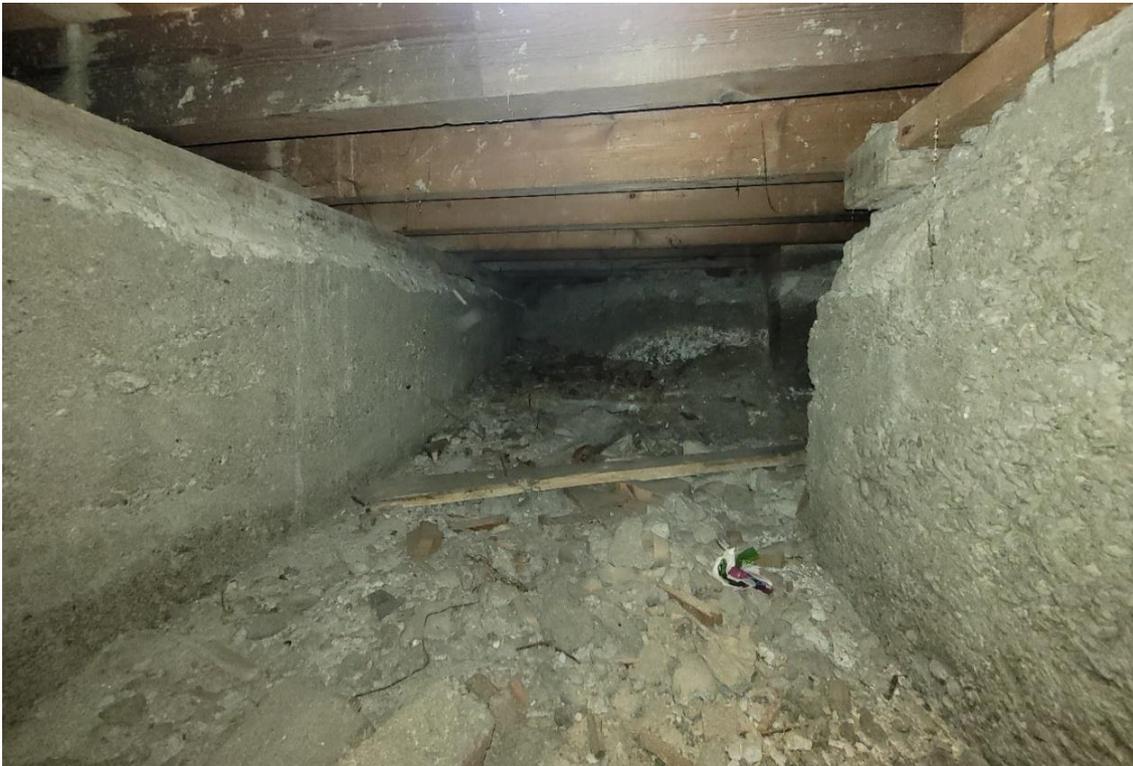
We could not adequately access underneath the timber flooring over the solid floor as the roller racking prevents access. The Library data area was too sensitive to work adjacent to. We are of the view that the flooring is laid on a batten fixed to a concrete subfloor.

Figure 1. Showing the current subfloor detail.

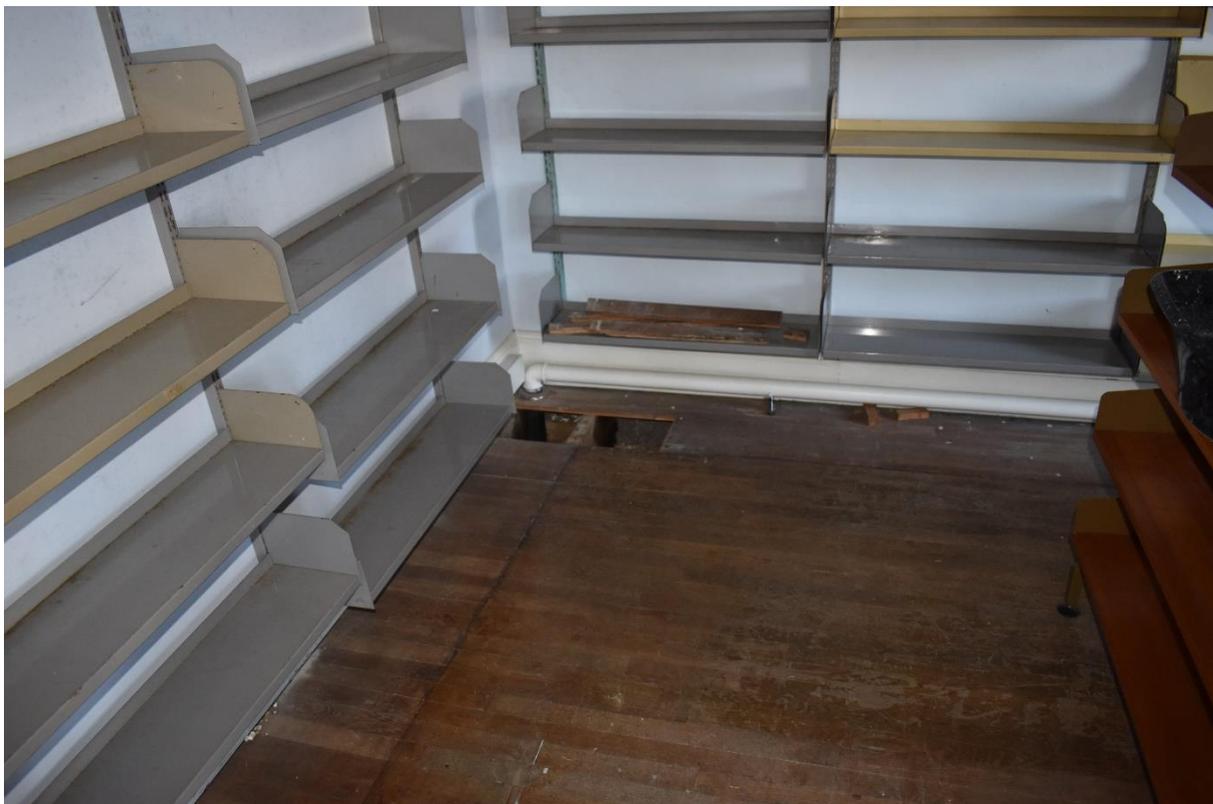
Localised decay was noted on the joists forming and directly adjacent to the bay window at the rear.

Figure 2. Showing a location opened up on the first-floor book repository.

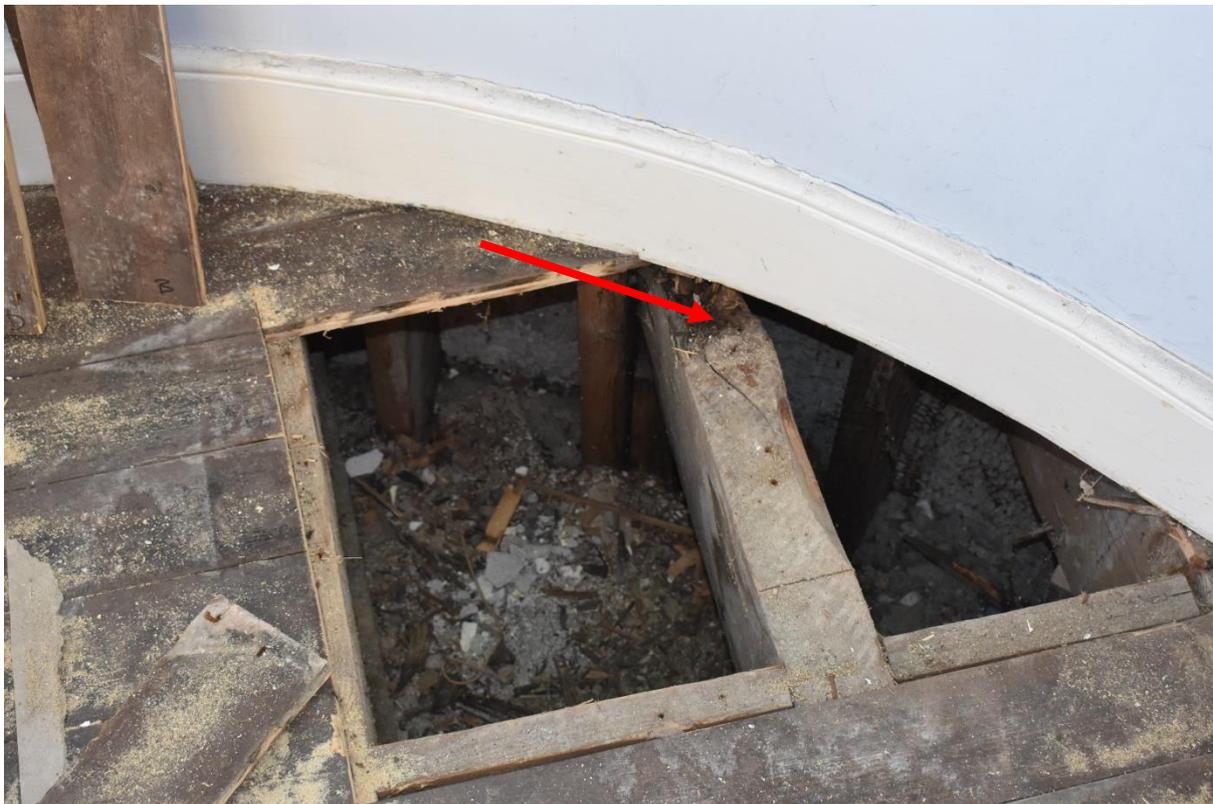
The two bay windows on the southwest elevation formed cantilevered by floor joists, which are supported by steel at the wall junction using a 130x75x8mm steel UB. The bay window floor joists are 250x36mm @ 300mm C/C. The walls are built with timber studs fixed to expanding metal and rendered externally. There is local decay on the floor joists forming the southeast bay, and minor deterioration on the timber studs was noted. The roof of the structure is sloping outwards away from the rainwater outlet, and water is lodging on the flat roof as a result. Additionally, the window sills flashing detail is poor and allows moisture ingress.

Figure 3. Showing the southeast bay window. Note the decayed 225X75 timber.

In our view, the bay windows and particularly the southwest bay will require a significant refurbishment during the planned works, which is likely to include rebuilding it from the ground floor lintel/window upwards. The new construction should take into consideration the vulnerability of slender construction and risk assess the likelihood of condensation in this location.

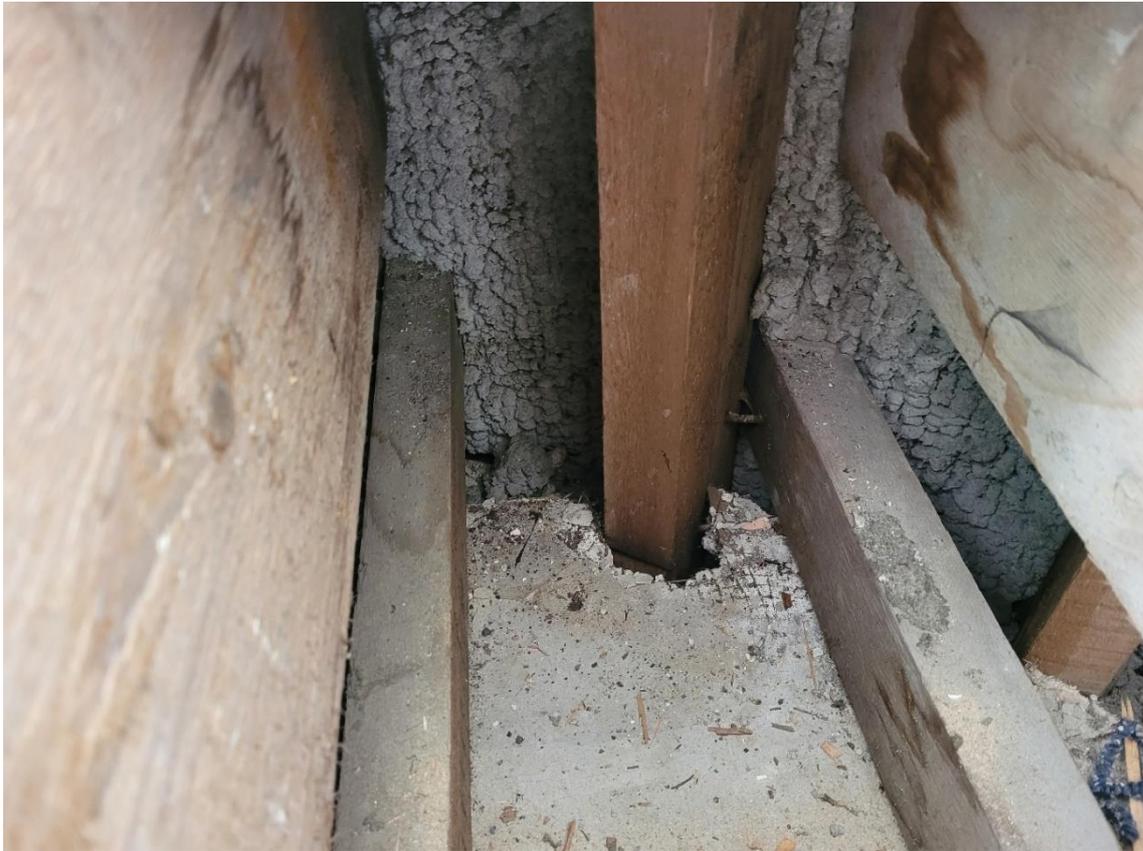
Figure 4. Showing the joist/stud detail forming the external skin of the bay window.

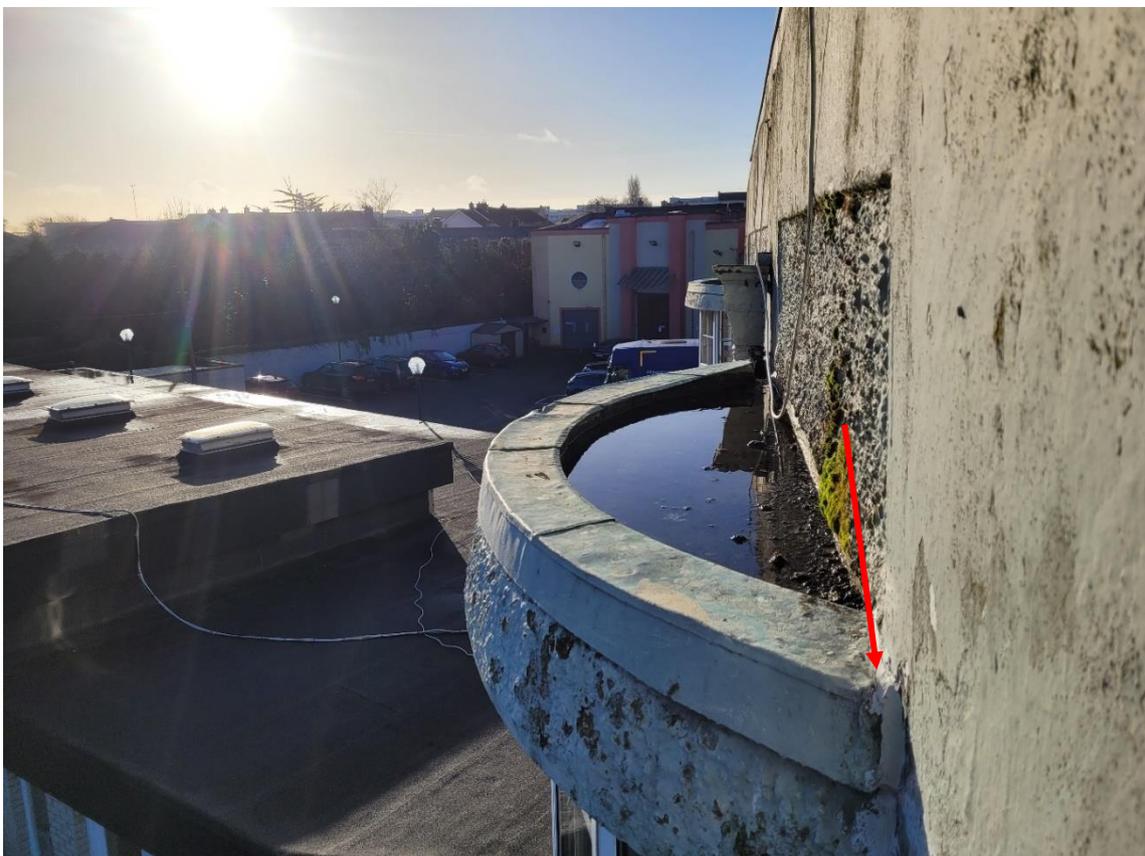
Figure 5. Showing the water lodging at the southeast bay. The roof appears to be leaning out, and there is a crack filled in at the main wall junction.

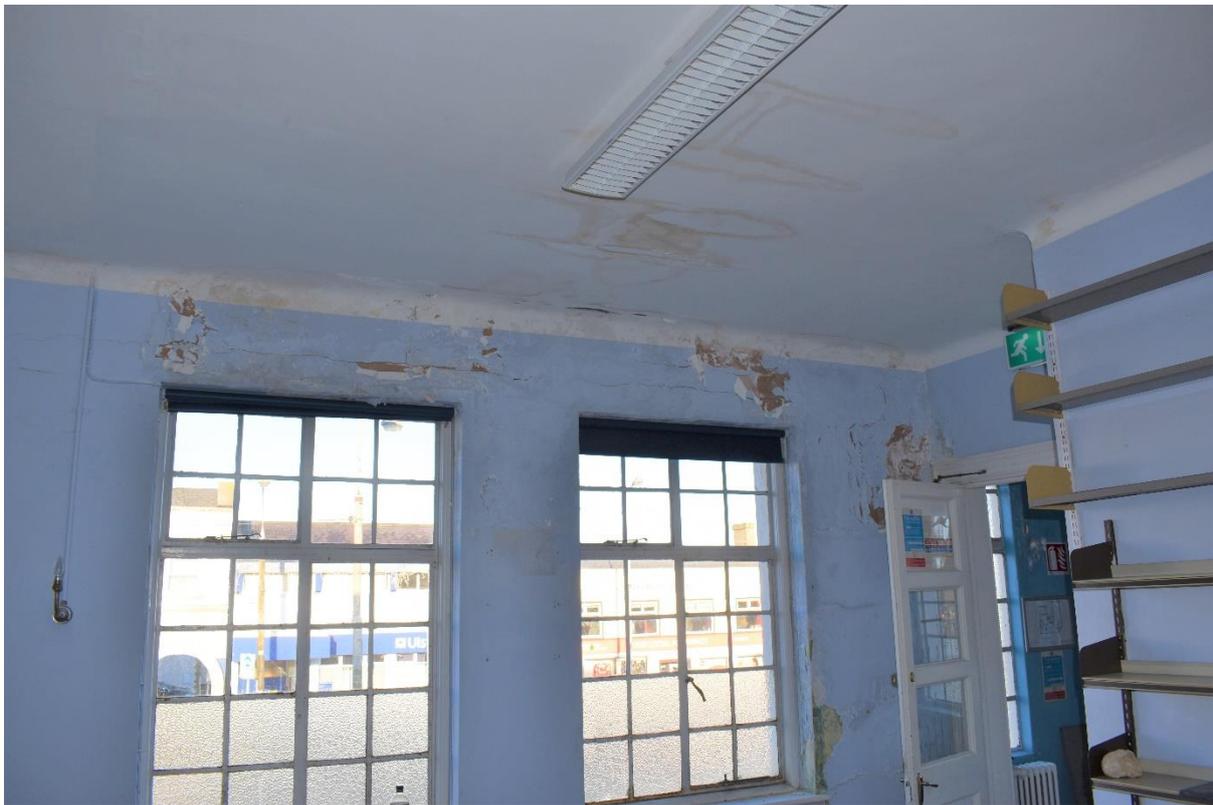
Overall, the internal plaster on the ground floor level is mainly in reasonable condition, but there is local deterioration adjacent to areas of moisture ingress. The plaster at the first-floor level is typically poor due to the ongoing water ingress issues at this level. The gypsum plaster is notably poor on the first floor as it reacts poorly in the presence of moisture.

Figure 6. Showing the northwest facing wall in the first floor Book Repository. Note the gypsum plaster is in poor condition.

We understand that the internal plaster will be stripped back to the concrete to allow a thermal upgrade which will incorporate a new 'breathable' plaster system. We recommend that specific attention be paid when retrofitting the first-floor wall/ceiling junction (parapet), window reveals, between the floor joists and at the ground floor level to prevent thermal bridging, leading to condensation.

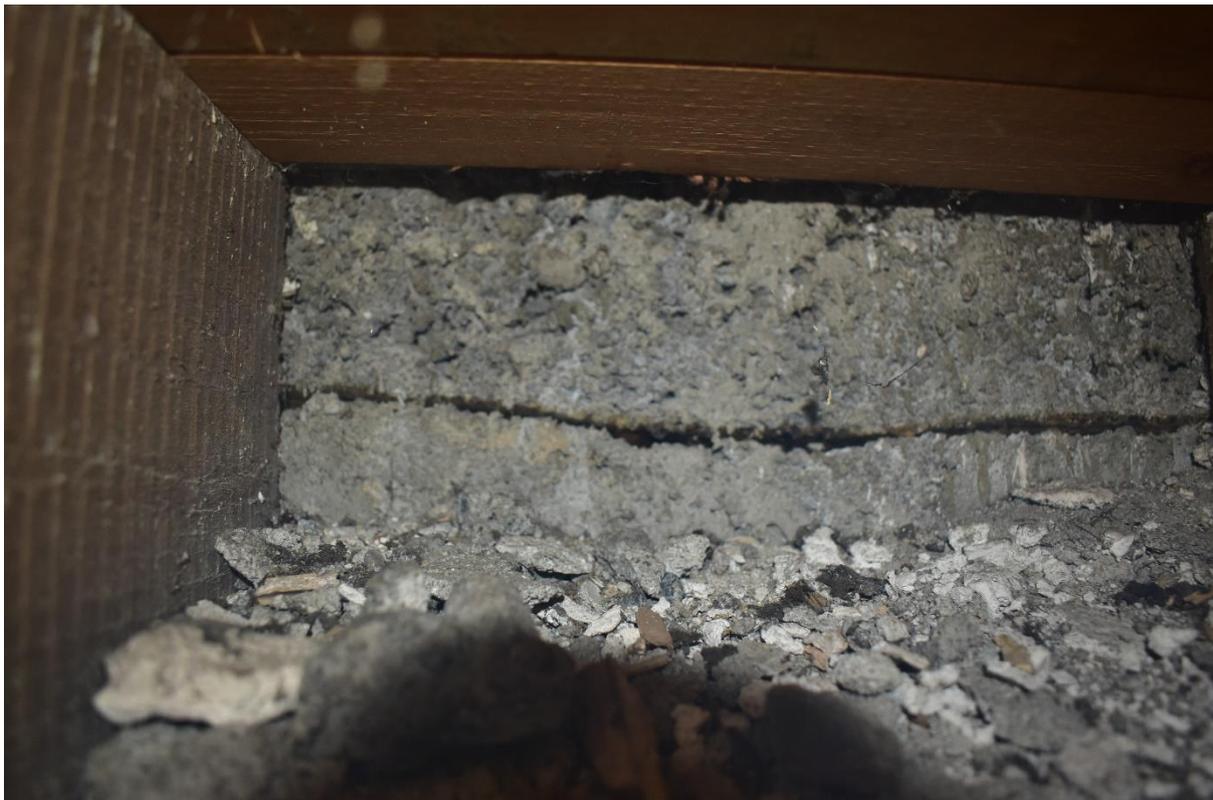
We have located a physical bitumen-based DPC approximately 100mm below the FFL at ground floor level in two locations. We have taken a number of moisture readings at this level using a calcium carbide meter at ground floor level, and all samples were within an acceptable moisture level.

Figure 7. Showing the physical DPC located in the rear sitting room.

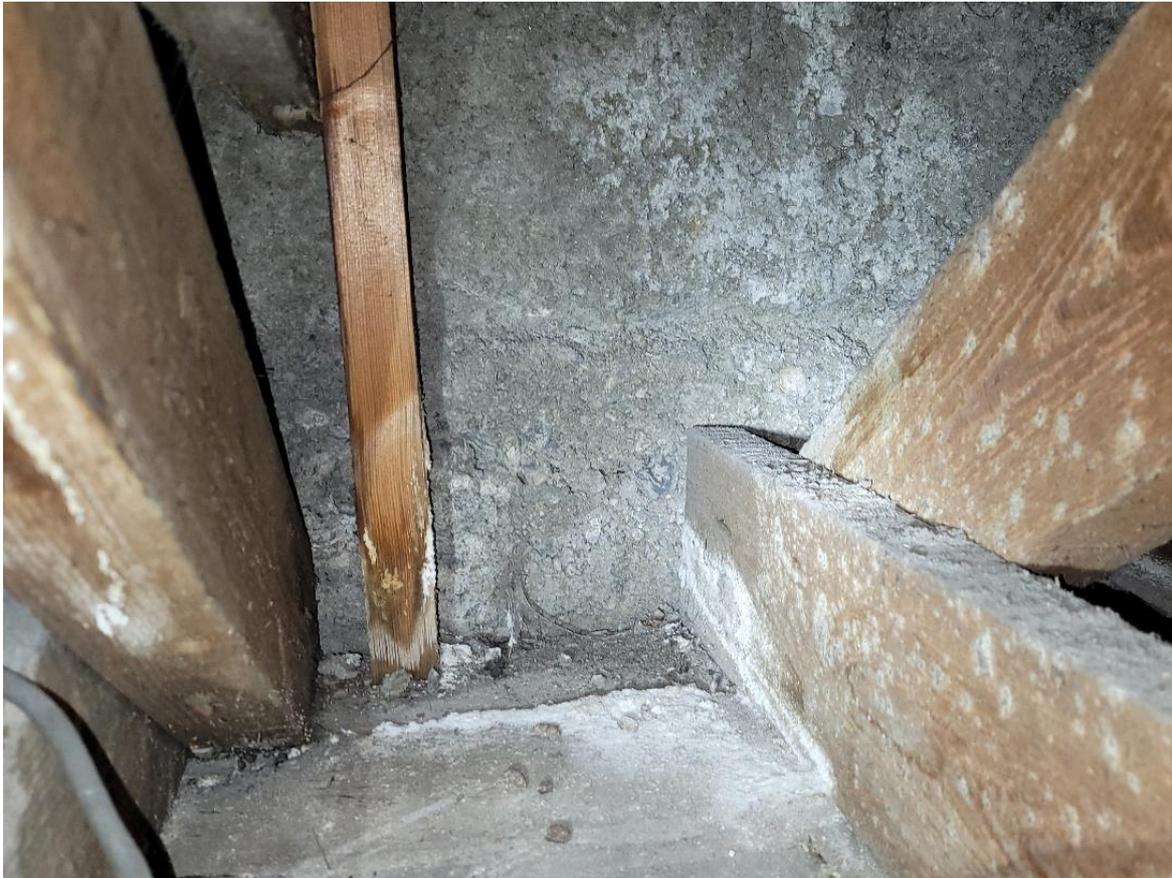
Figure 8. Showing the parapet ceiling joist/wallplate detail.

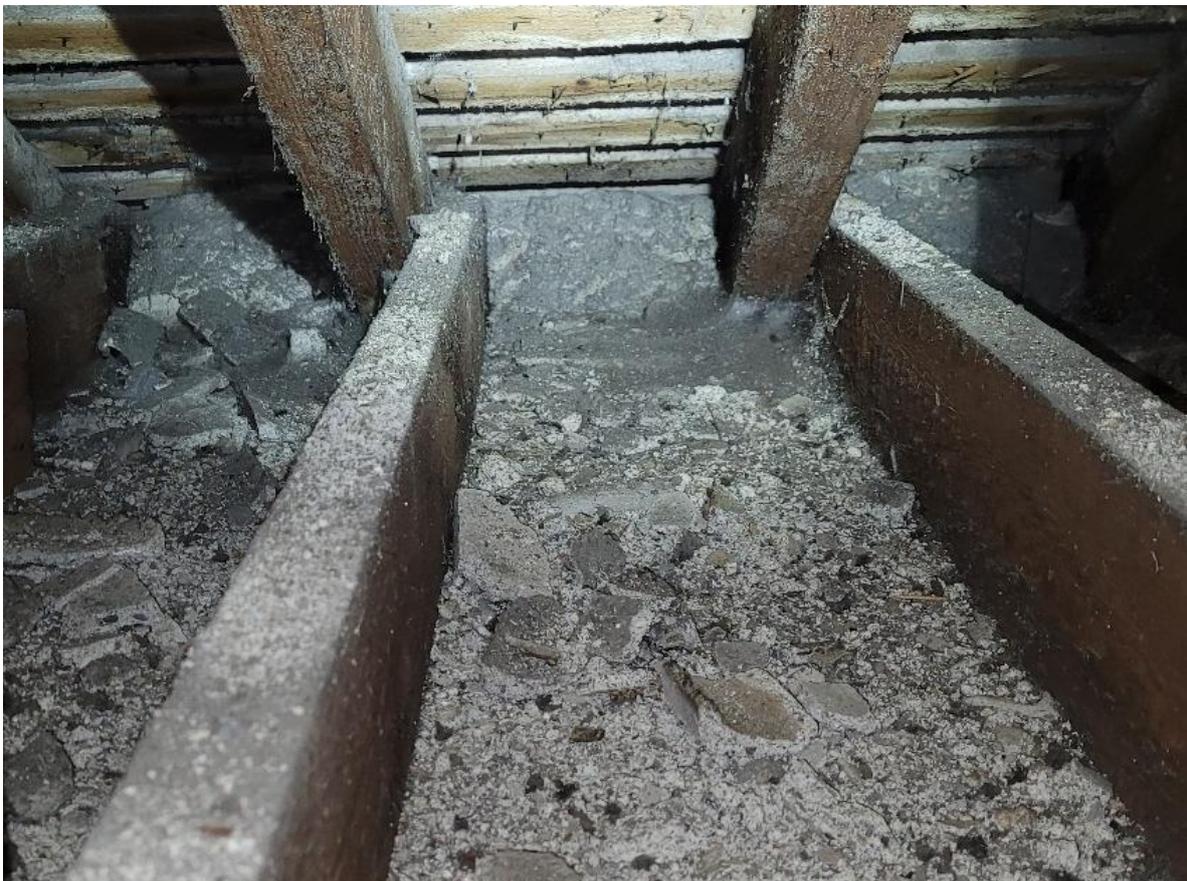
There are two wallplate/rafter details present. The rafters pass into the masonry at the rear to form an overhang that we could not access (see Fig 9 below). The wallplate at the front is supported on a step/shelf at the parapet.

Figure 9. The detail at the rear shows the rafter and ceiling joist penetrating into the concrete.

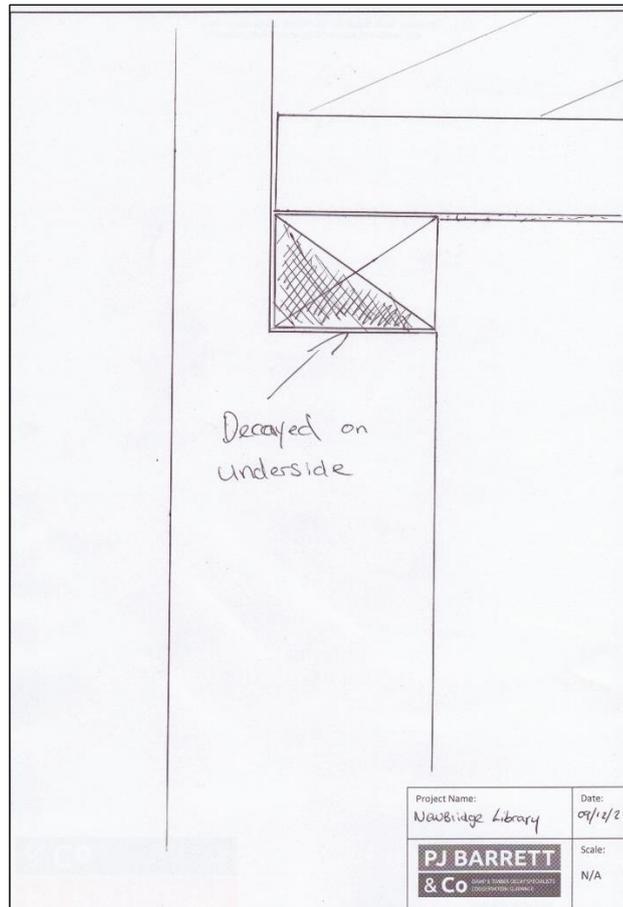
We have locally reviewed the underside of the parapet wallplate in two locations at the front of the building. Both areas had heavy decay present on the underside/rear of the wallplate (see below site sketch Fig 10). Presumably, the density of the concrete structure retained water on the step/shelf, which has resulted in the decay at the underside of the timber.

Figure 10. Site sketch showing the decay at the wallplate where it was opened up.

The underside of the wallplate is not accessible unless the entire ceiling is removed. However, based on the number of areas of water ingress noted, we recommend that the entire parapet wallplate be replaced subject to further investigation during planned works.

The new wallplate should be isolated from the concrete using 10mm structural packers and using certified pressure treated timber. We have noted that there has been a previous repair carried out above the front door section, and approximately 20% of the wallplate was repaired.

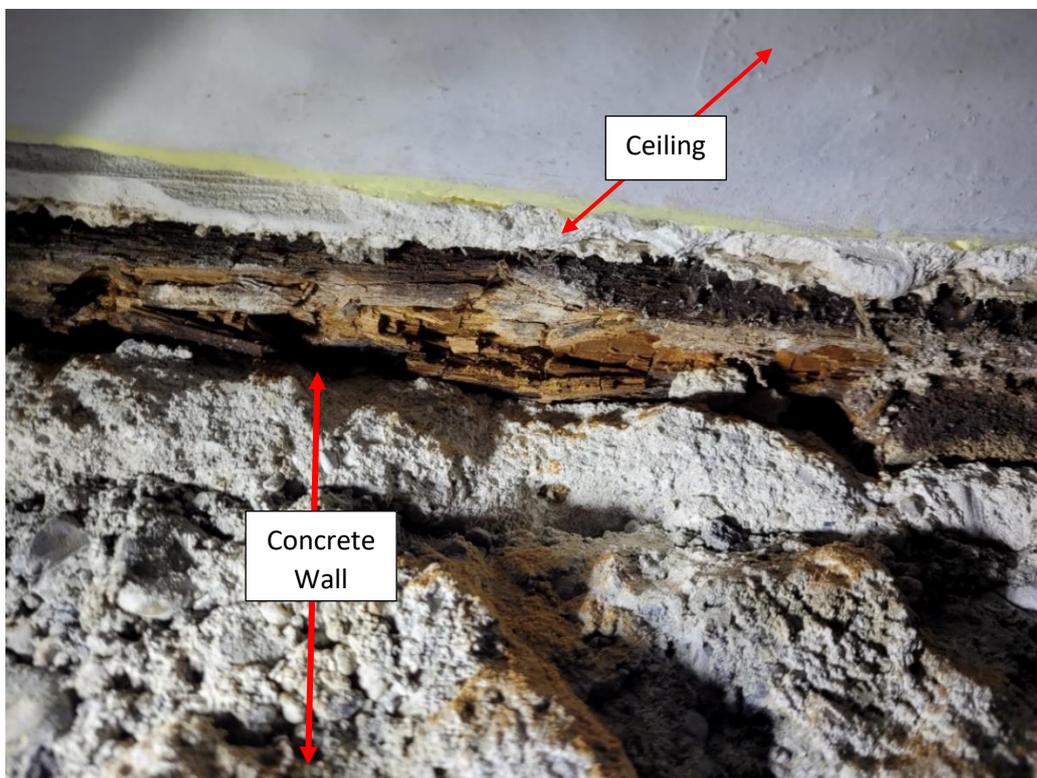
Figure 11. Showing an image of the above sketch where the plaster was removed. Note the concrete below and the plasterboard ceiling abutting the wallplate.

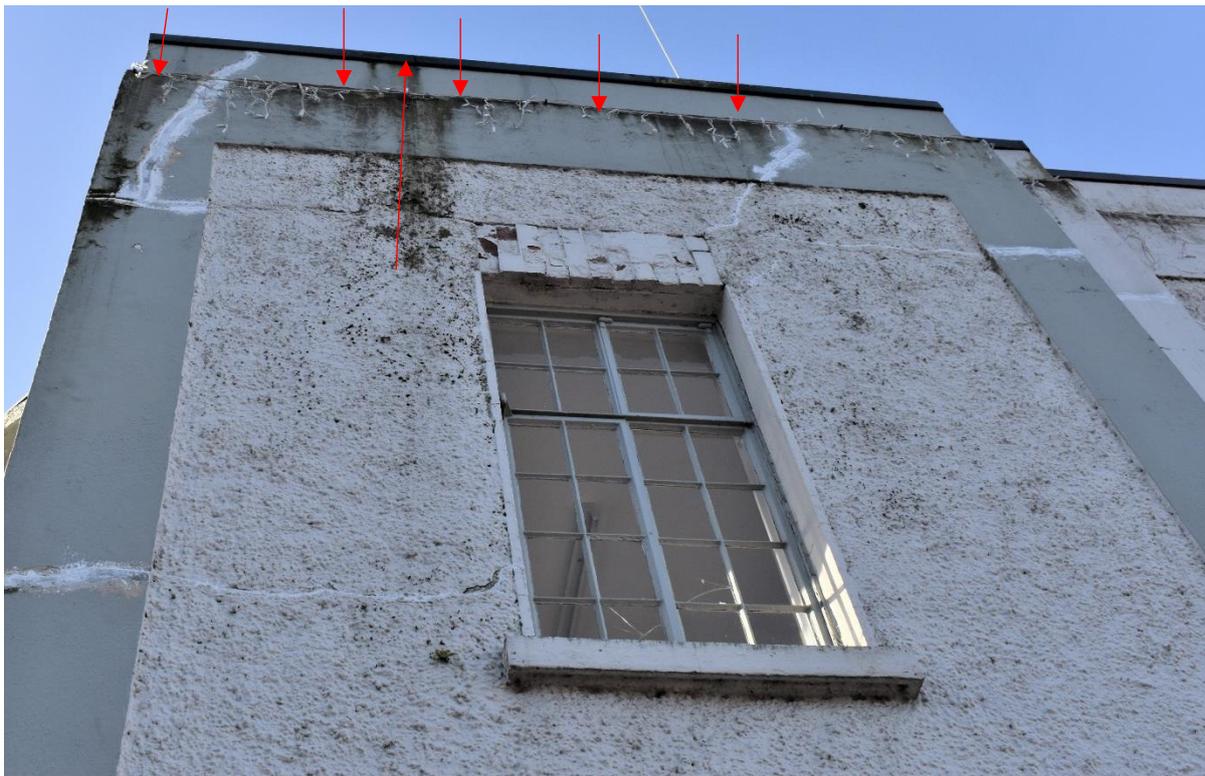
There is a horizontal step in the render across the building at a high level which is encouraging water into the building. This detail is currently being exacerbated by the lack of an overhang on the metal coping flashing. We recommend that consideration is given to installing a Feather Edge wall coping that would shed water inwards into the gutter as mitigation (see Fig 12 below).

Figure 12. Showing the horizontal step and note the staining due to the flashing spilling onto the plaster. The wall is damp inside this location.

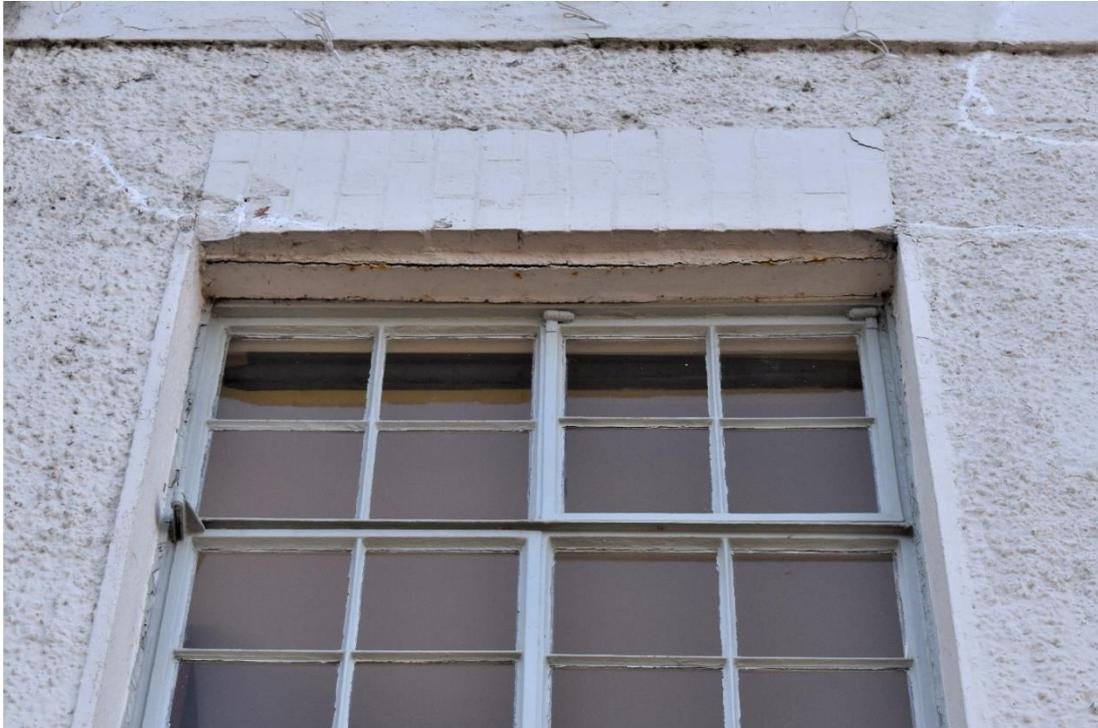
All lintels are concrete, and both northeast and northwest windows have a flat brick arch supported on a steel catnic/lintel. We have noted that the upper lintels are corroded, mostly due to poor weathering at the parapet. The flat brick arch has also deteriorated, which will necessitate repair.

Figure 13. Showing the catnic/lintel at the first-floor level. Note that the lintel is sagging at the centre, and this area corresponds with the internal opening up works.

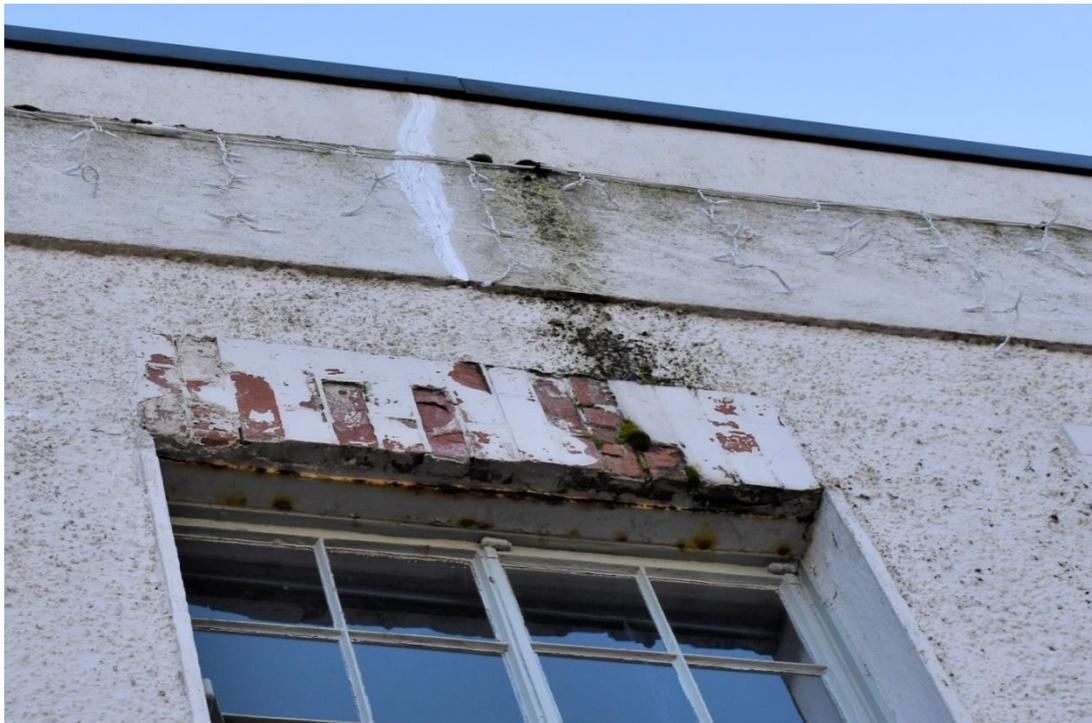
Figure 14. Showing the staining due to water running off the joint of the coping and decaying the brick lintel.

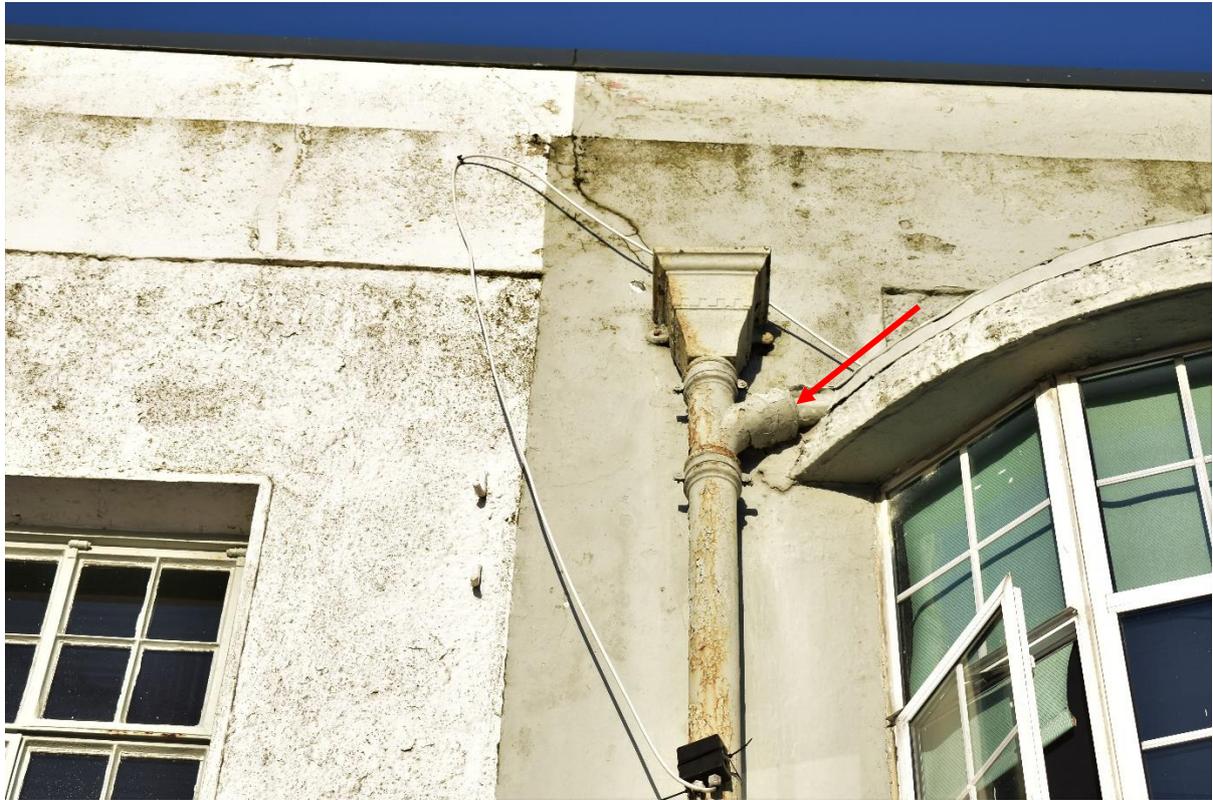
The rainwater goods are generally in poor overall condition, and leaking downpipes are adding to the deterioration of the building fabric. Provide to review all cast iron gutters as per architects detail.

Figure 15. Showing the hopper/downpipe detail at the southeast bay. The bay window outlet is leaking.

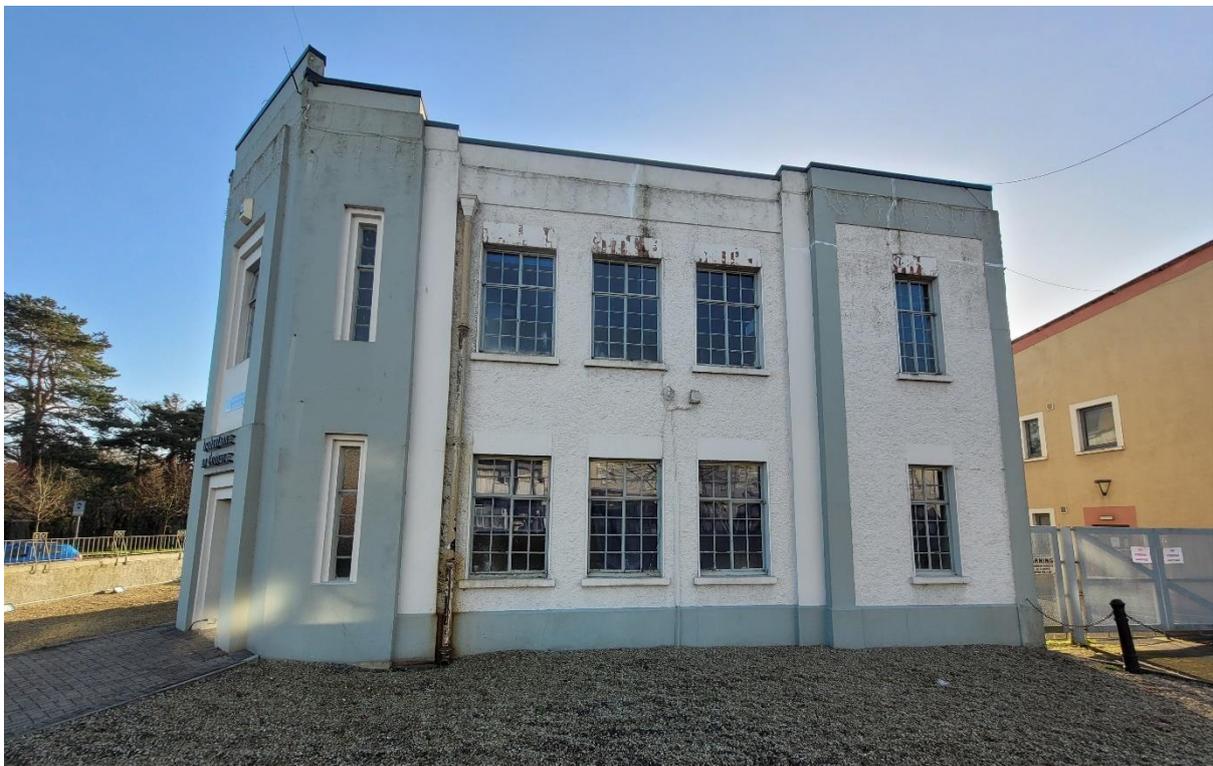
Figure 16. Showing the leaking downpipe at the base. The wall is damp directly adjacent internally.

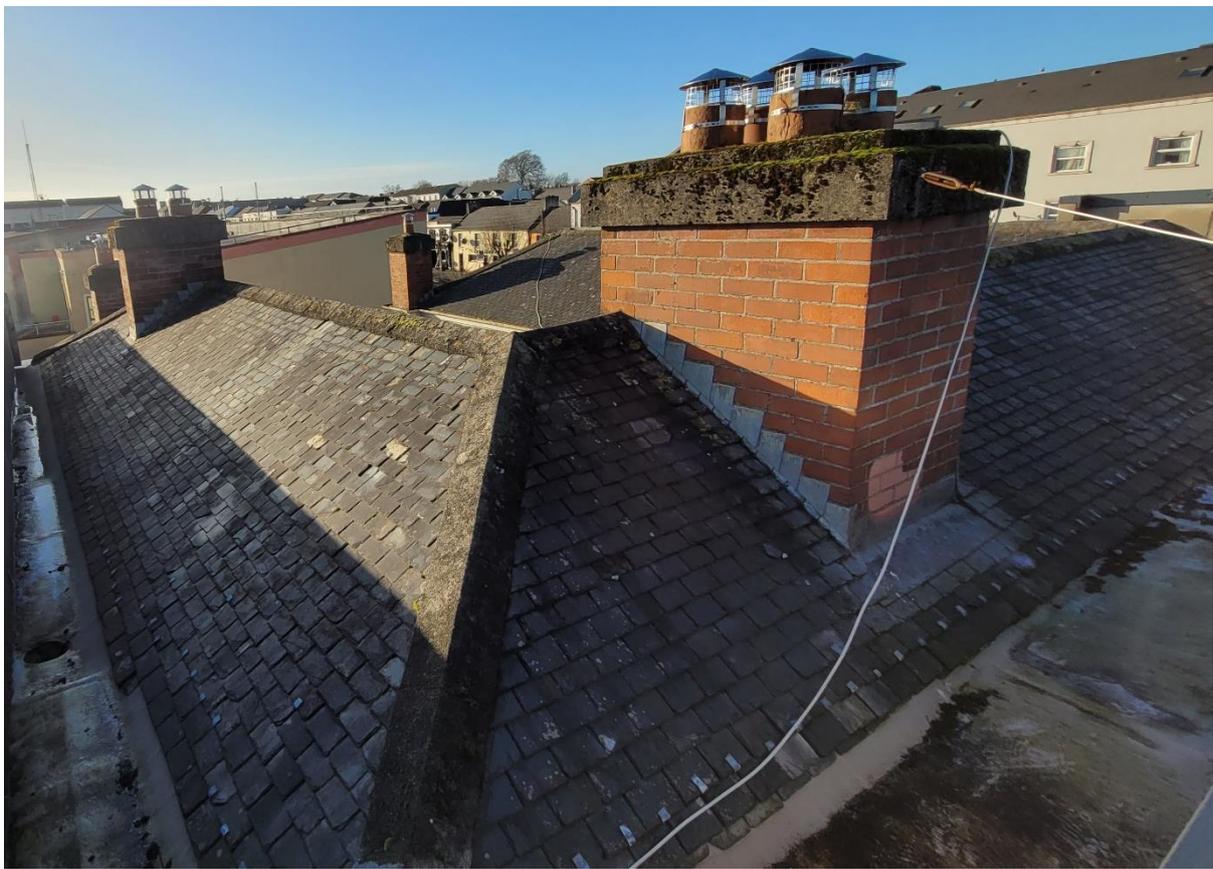
Figure 17. Showing the southeast facing chimney.

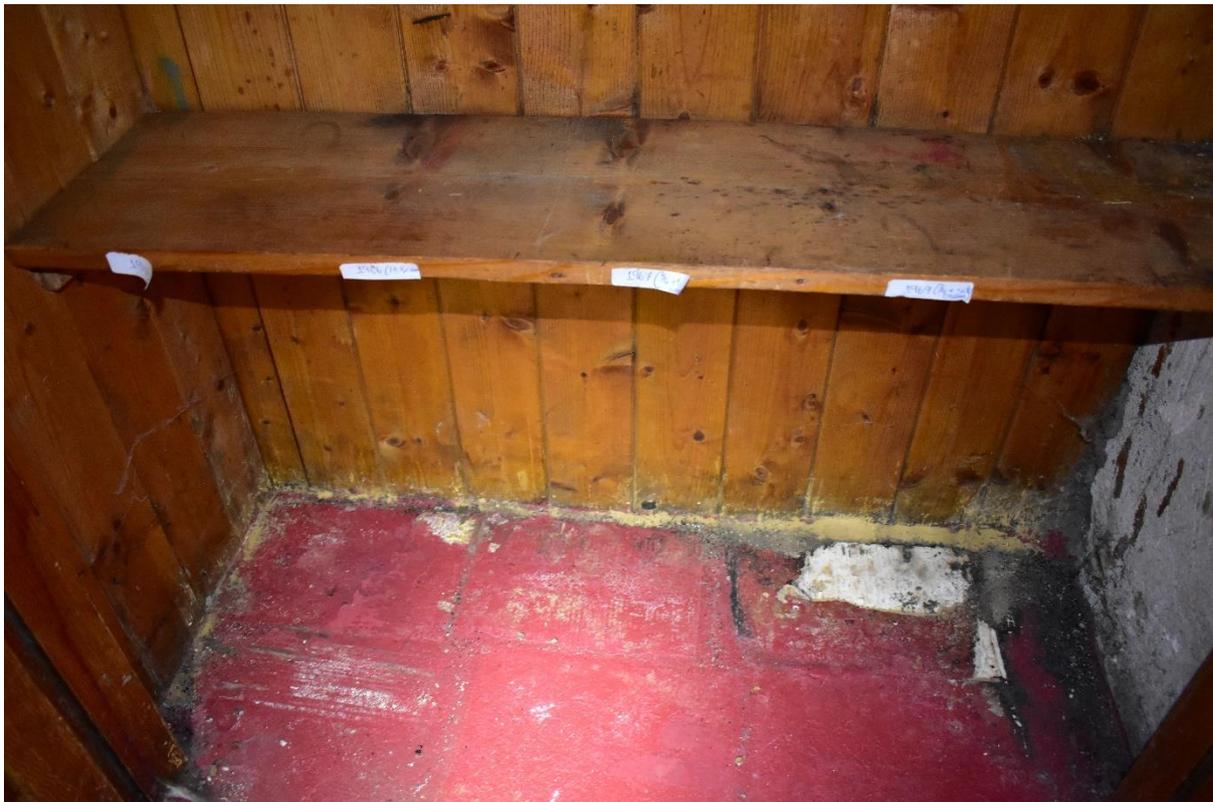
We have recorded that there was an active infestation of wood boring weevil (*Euophryum confine*) at the lower ground floor level underneath the main stairs. The infestation is promoted by an elevated moisture content on the floor. Once the moisture is reduced or timber is isolated from the source of moisture, the infestation should cease as weevil generally will not colonise dry wood.

Figure 18. Showing frass associated with boring wood weevil at the underside of the main stairs, visible at the lower ground floor area.

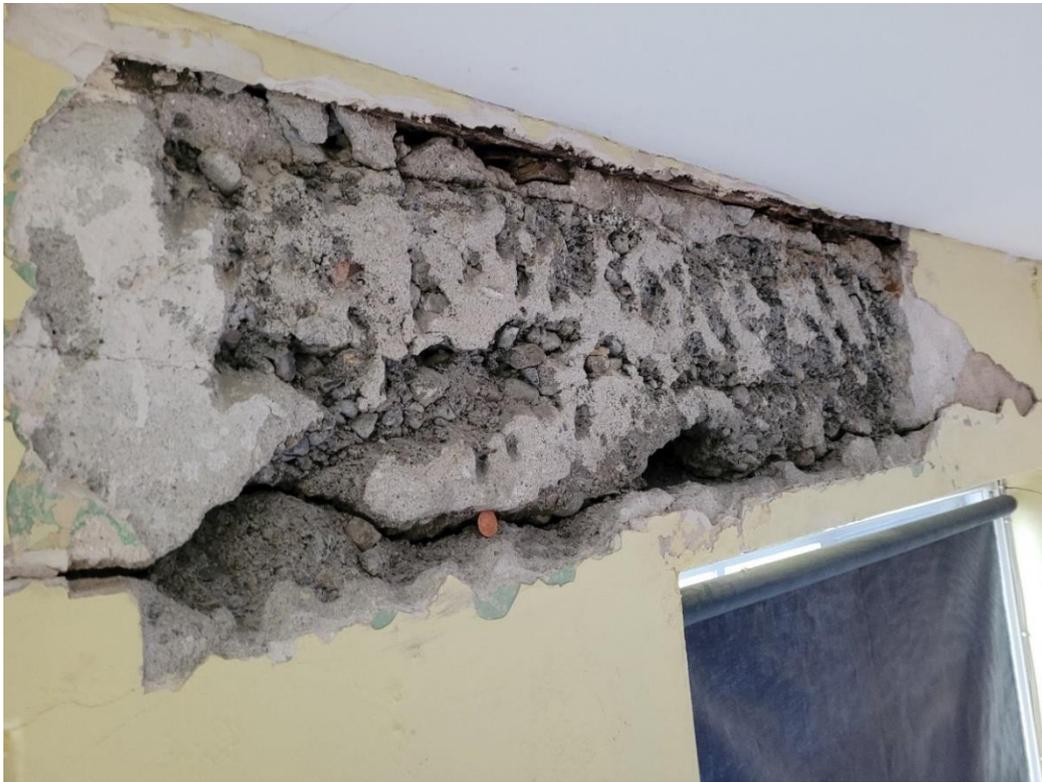
We have exposed the first-floor lintel as per Aecom Detail 4, as requested. The crack is between 8-10mm wide, and the crack is the full width of the wall. We were able to see the rear of the steel lintel through the crack where we opened it up locally.

Figure 19. Showing the crack opened up as per Aecom Detail 04.

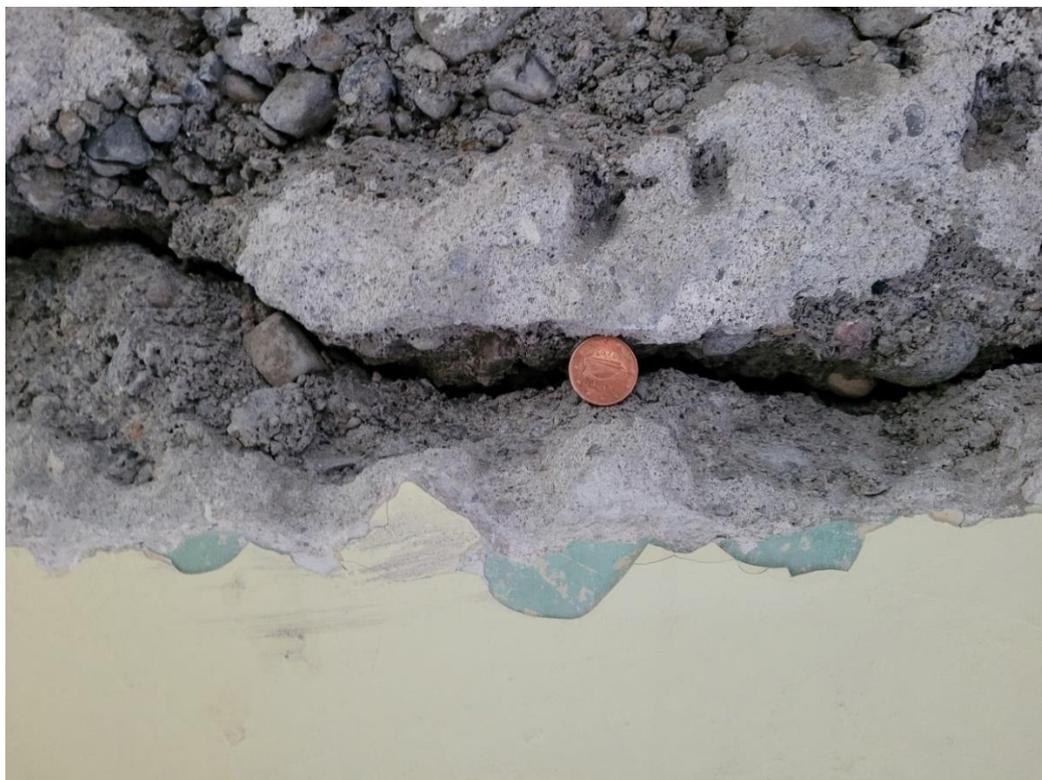
Figure 20. Showing the width of the crack (8-10mm) corresponding with the above image.

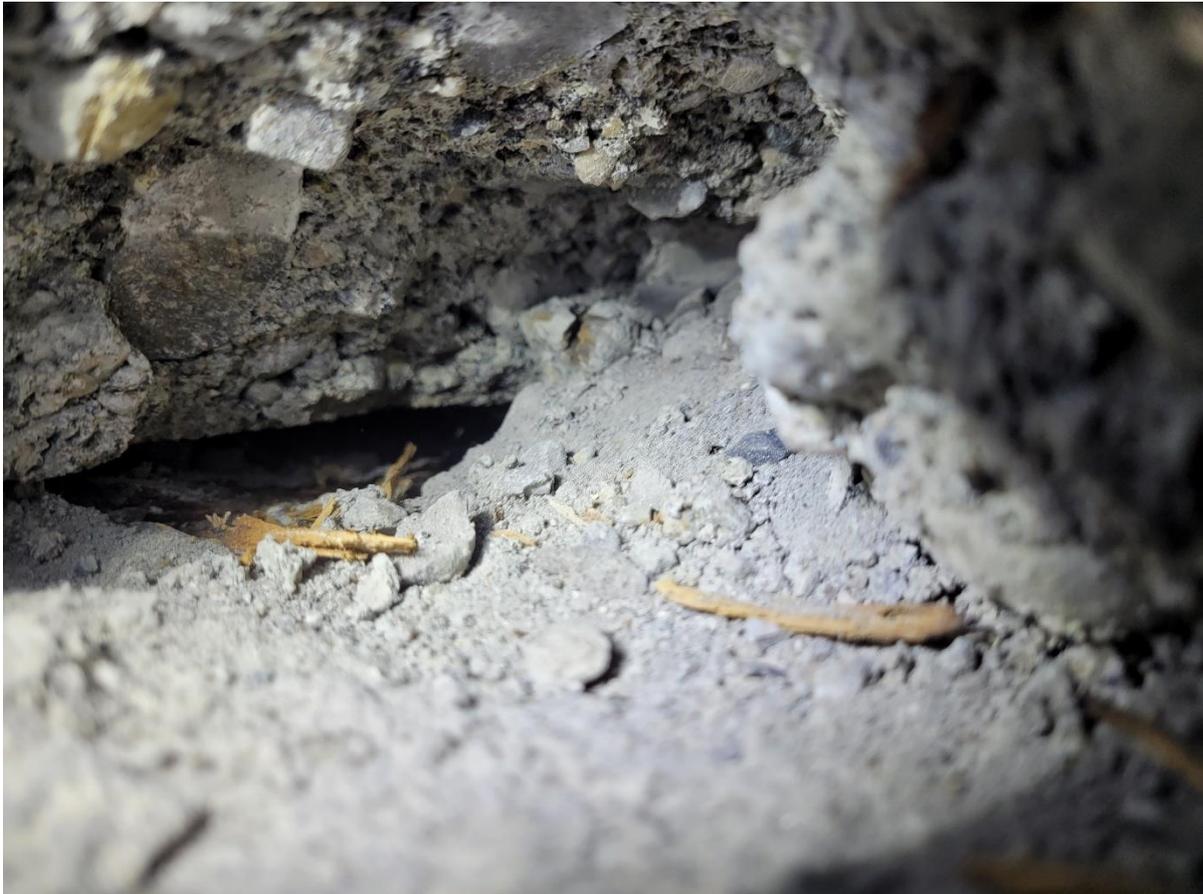
Figure 21. Showing where PJ Barrett widened the crack in a small area showed the crack is full width.

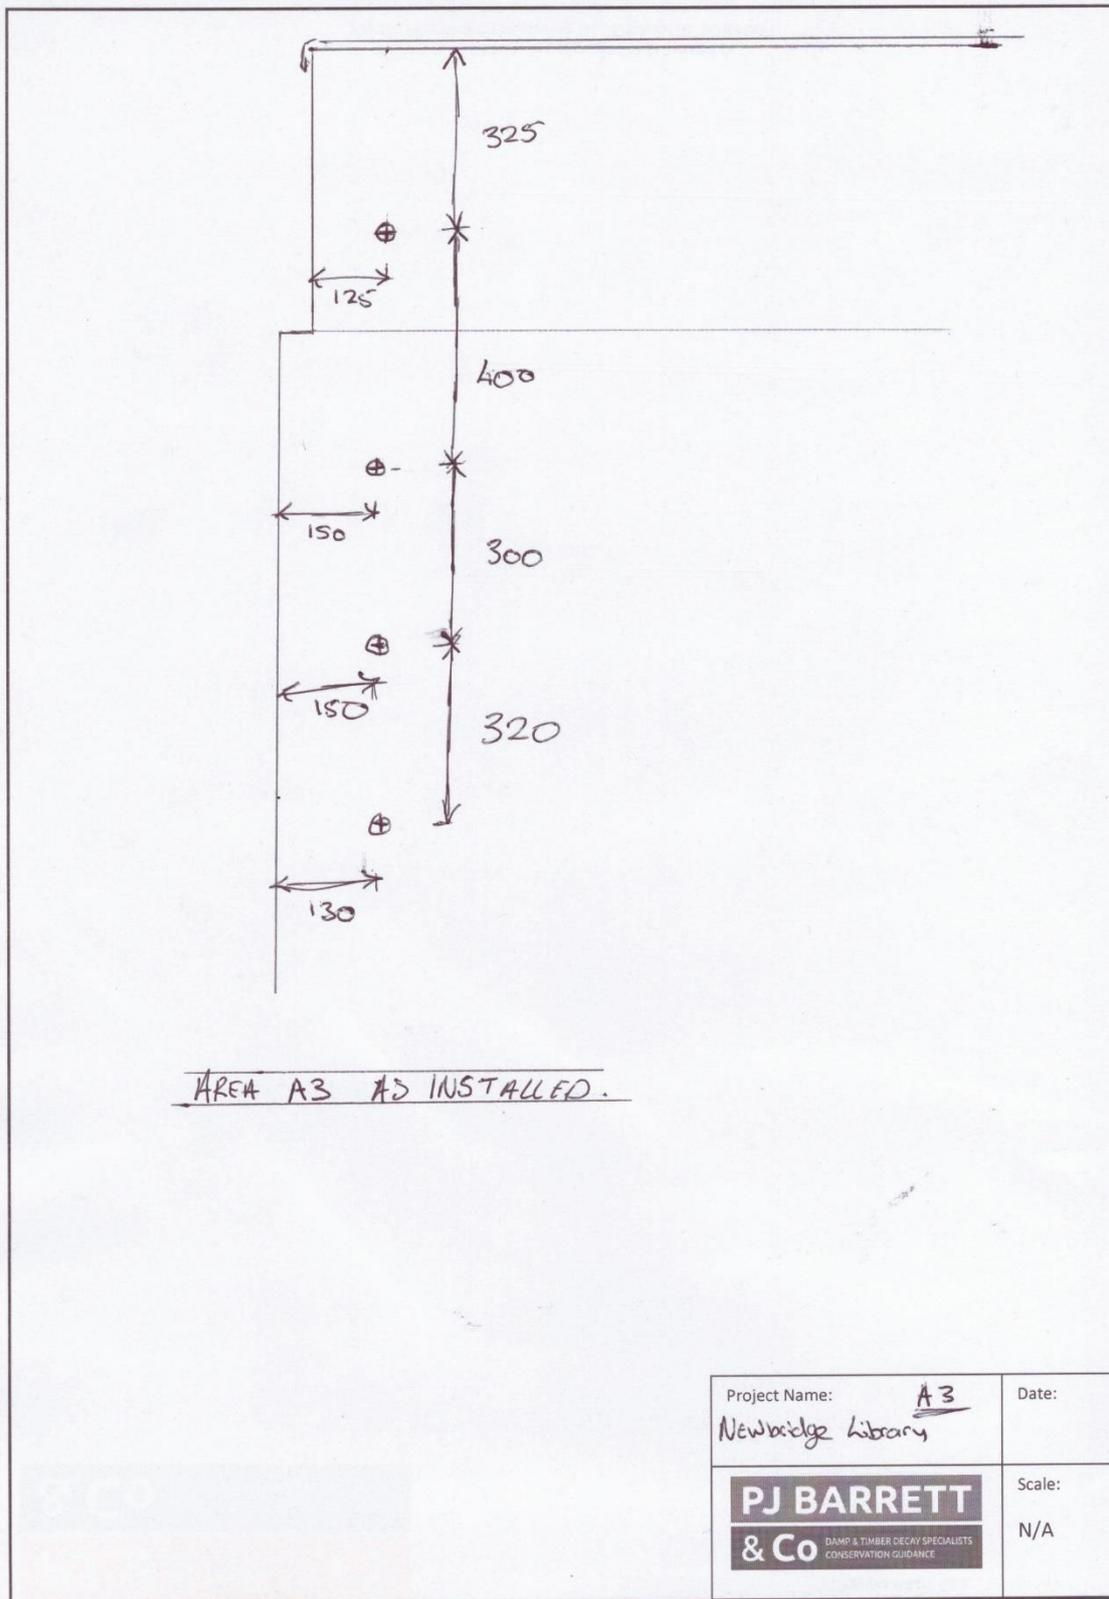
The rods in Area 3 are stitched at approximately 300mm C/C vertically and are embedded approximately 350mm in depth (see site sketch in Fig 22 below).

Figure 22. Showing a site sketch of the stitching works Detail A3 looking West.
