Preliminary Damp & Timber Decay Report

Kildare Public Library RPS: B23-41

10th January 2022

Re: Damp & Timber Decay Survey - Kildare County Library, Newbridge, Co. Kildare.

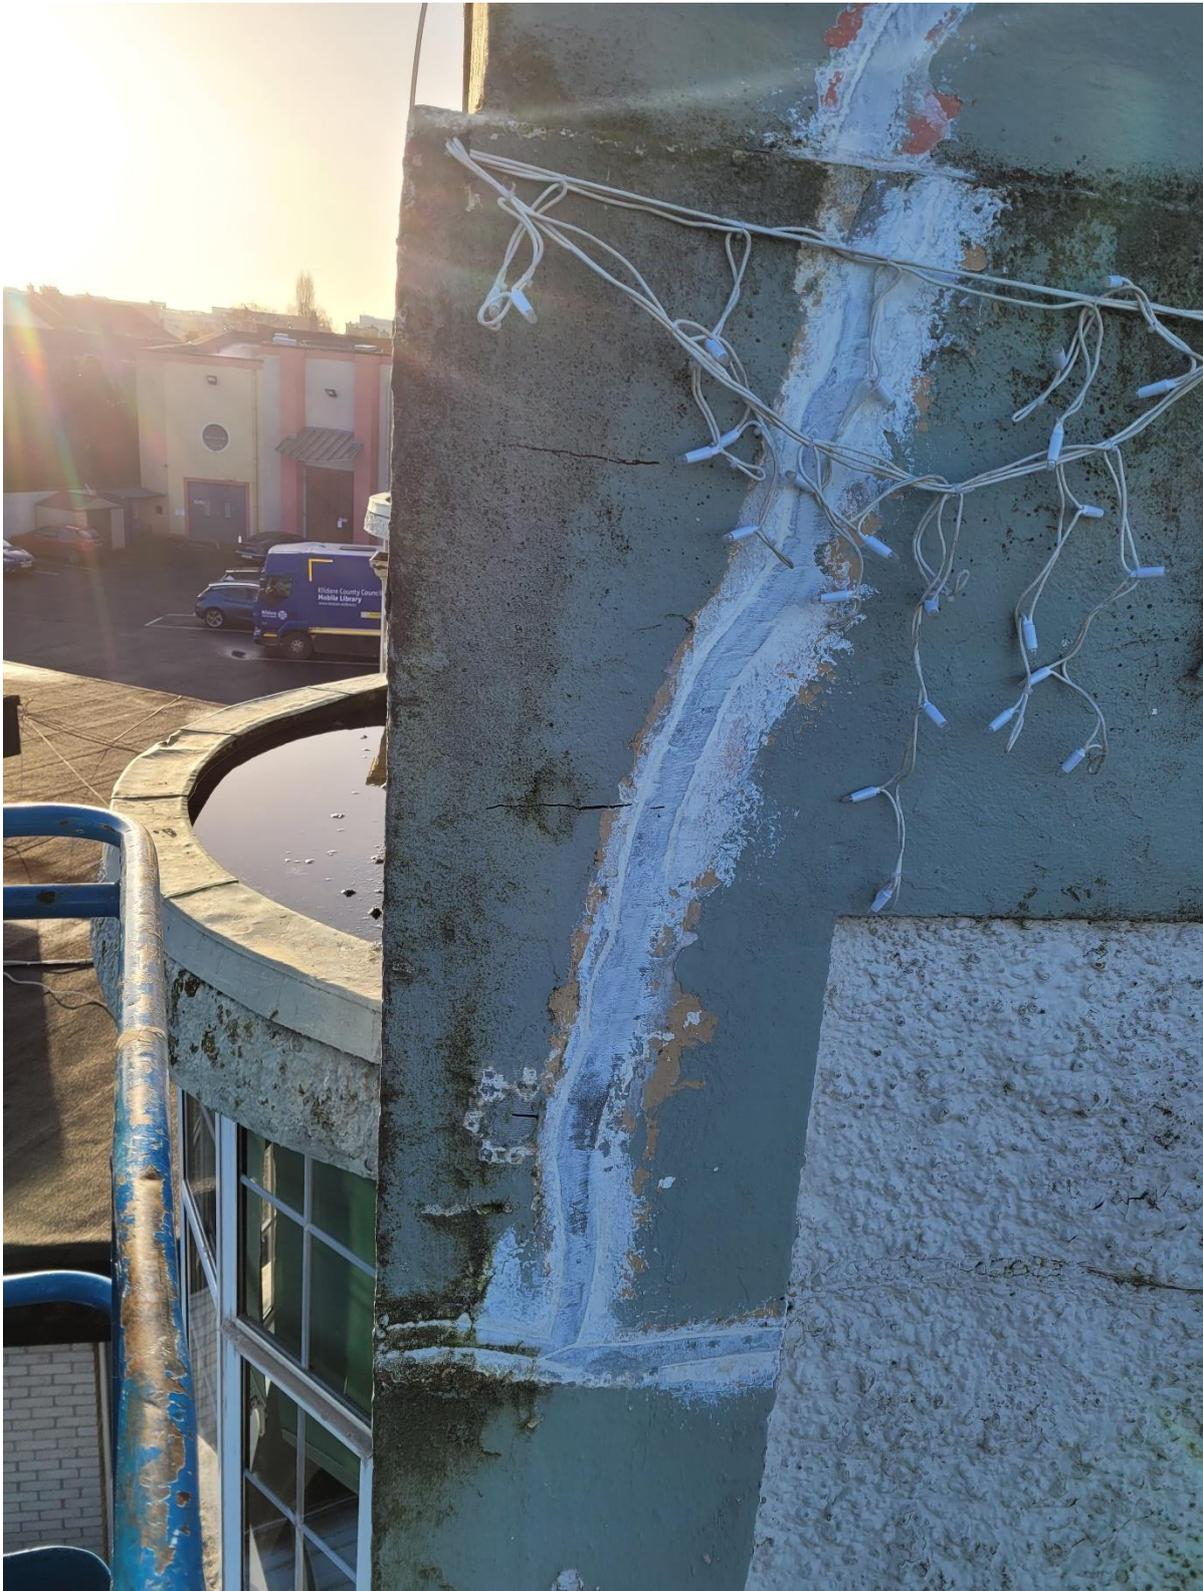
Figure 23. Showing Area 3 looking west. We have marked the holes on site. Note the white filler applied recently.

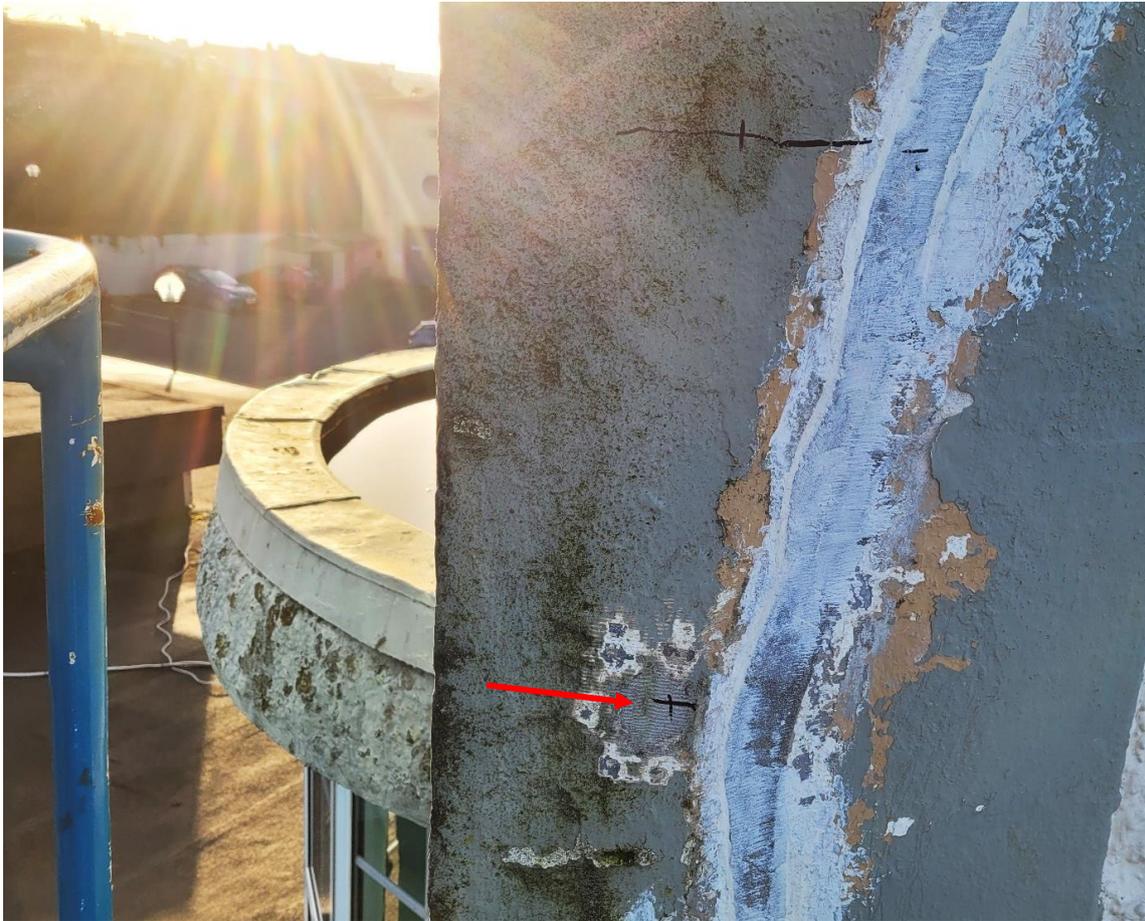
Figure 24. Showing a close-up view of Area 3 looking west. We have exposed the grout at the lower hole.

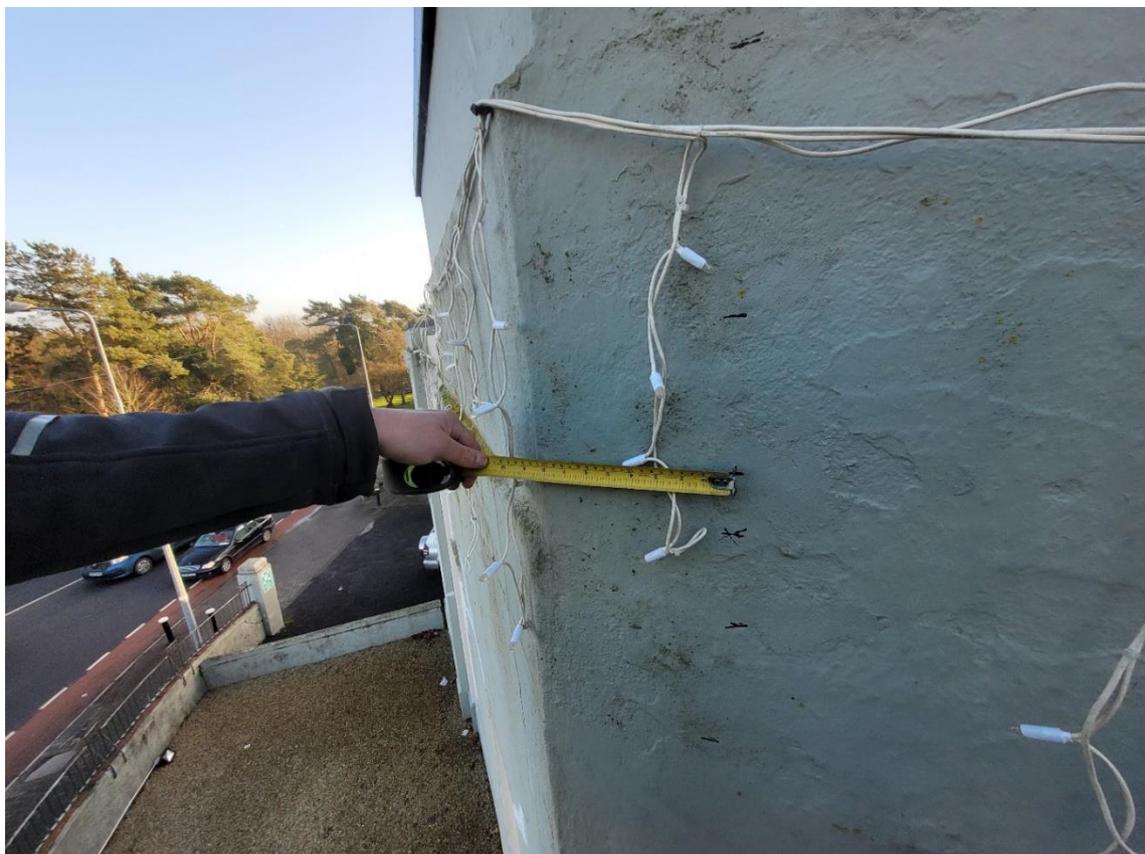
Area 1 & 2 at the front are stitched at 200mm C/C vertically and approximately 450-500mm deep.

Figure 25. Showing Area 1 & 2 where we have marked the spacings on the wall at a high level.

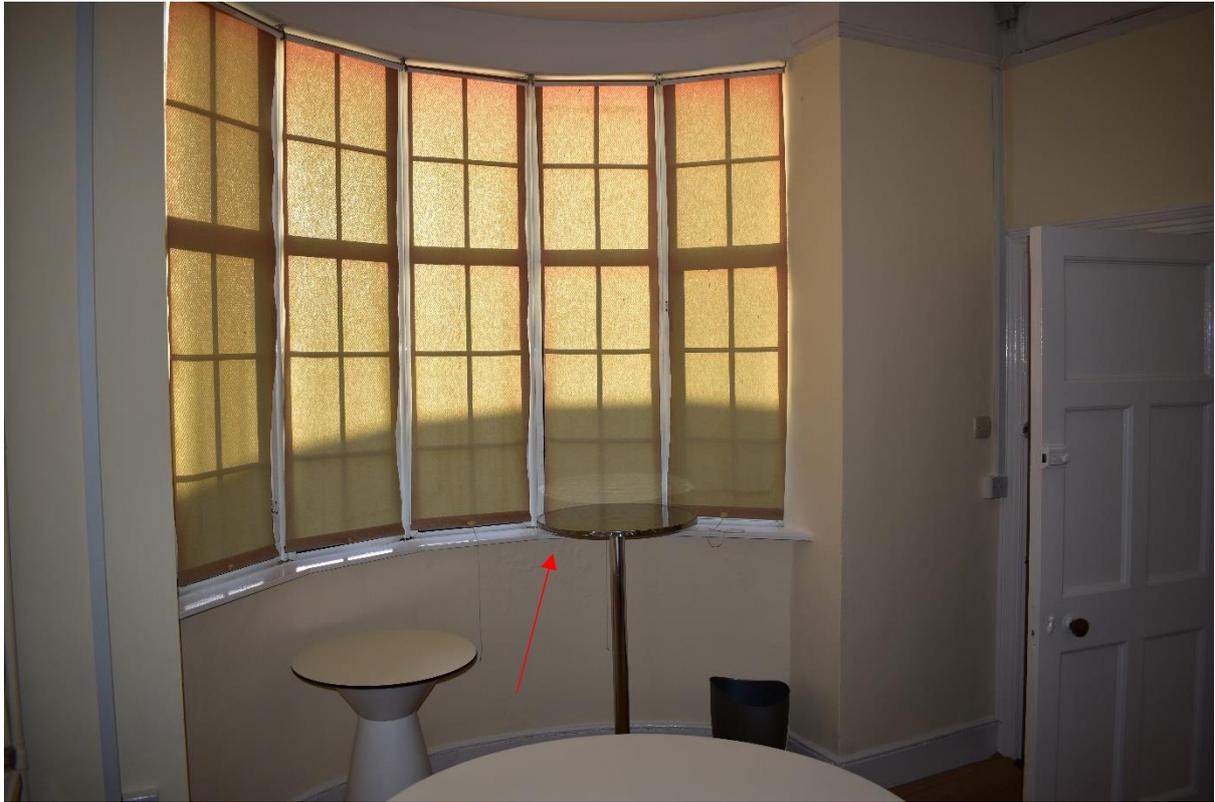
Figure 26. Showing the ground floor dining room. Note the dampness underneath the window sill due to poor detailing.

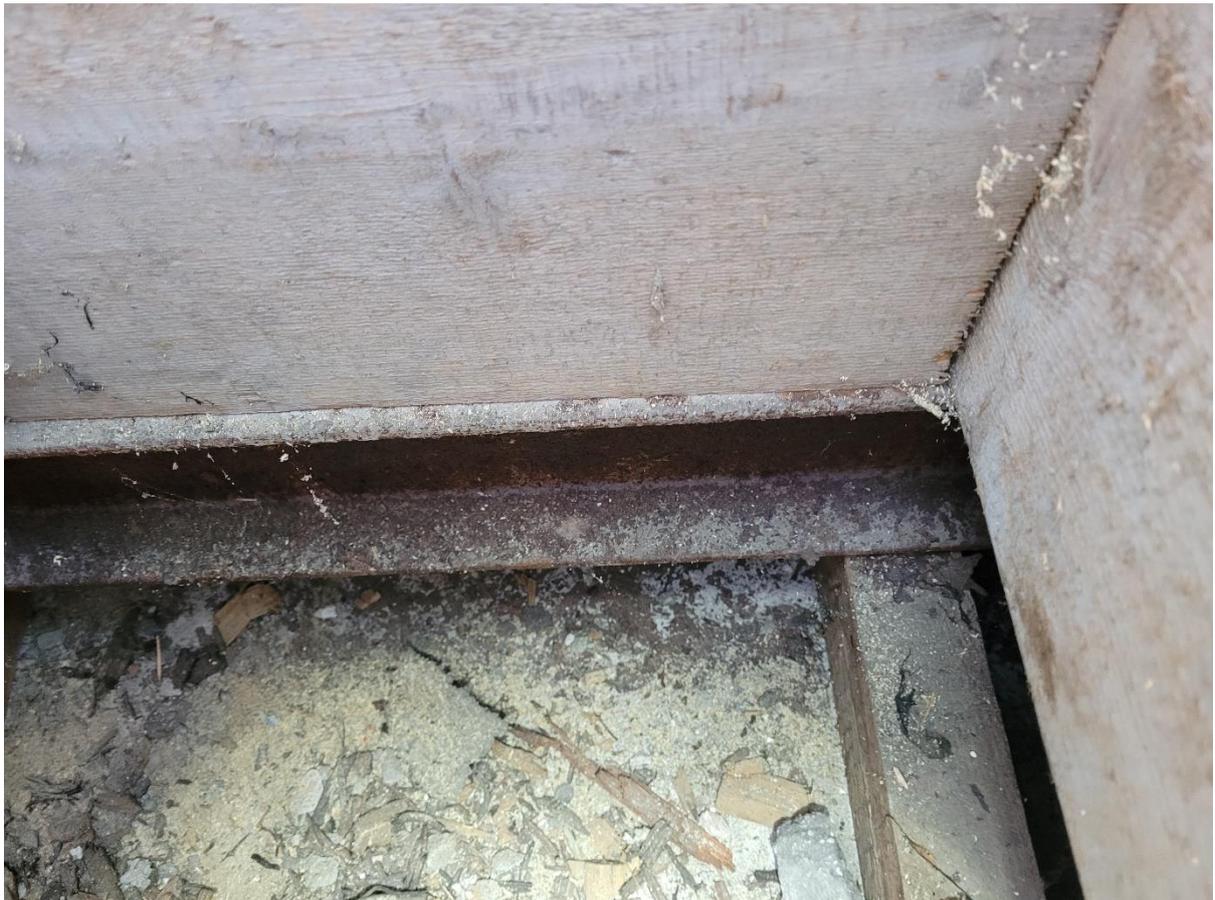
Figure 27. Showing the steel 130X75X 8mm UB underneath the joists cantilevering out to form the bay.

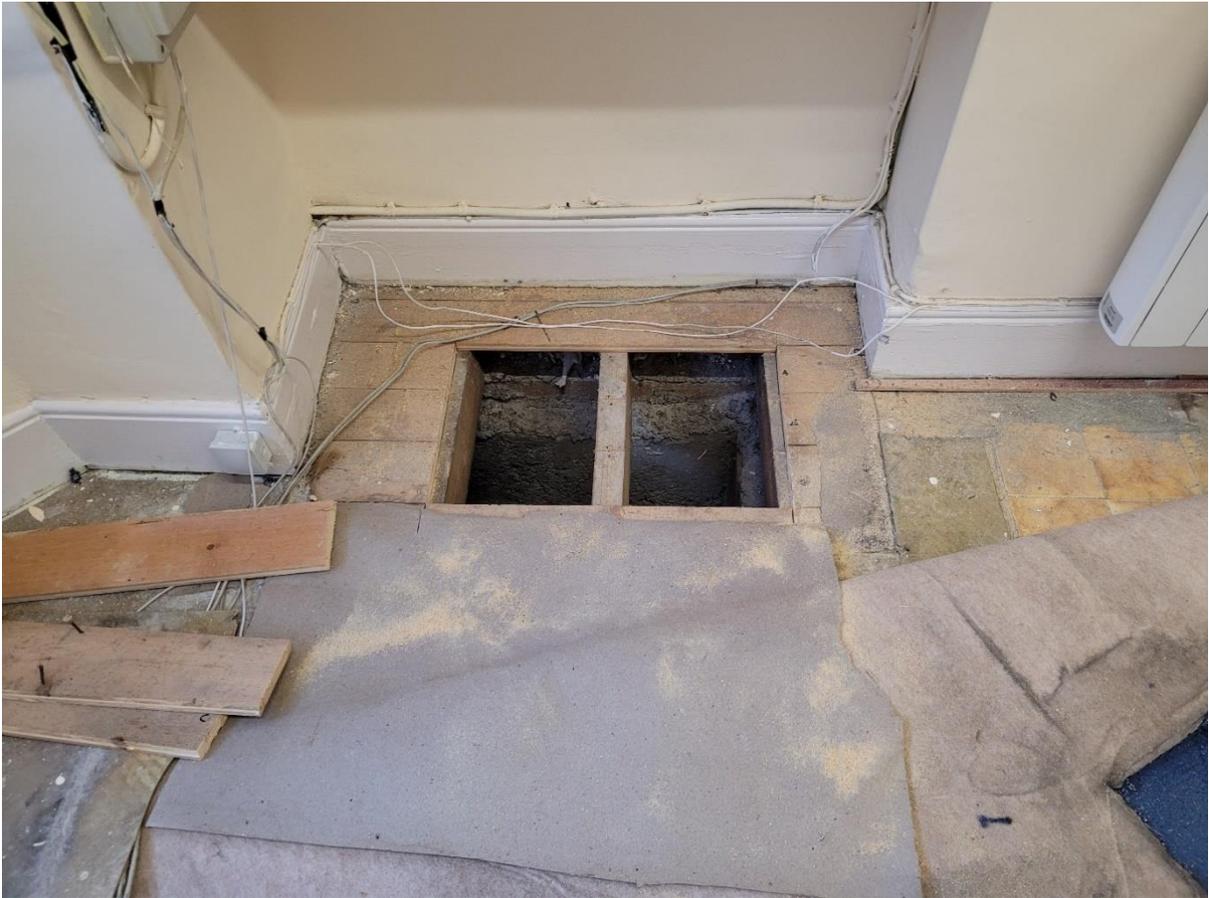
Figure 28. Showing the area opened up in the ground floor sitting room where we exposed the physical DPC.

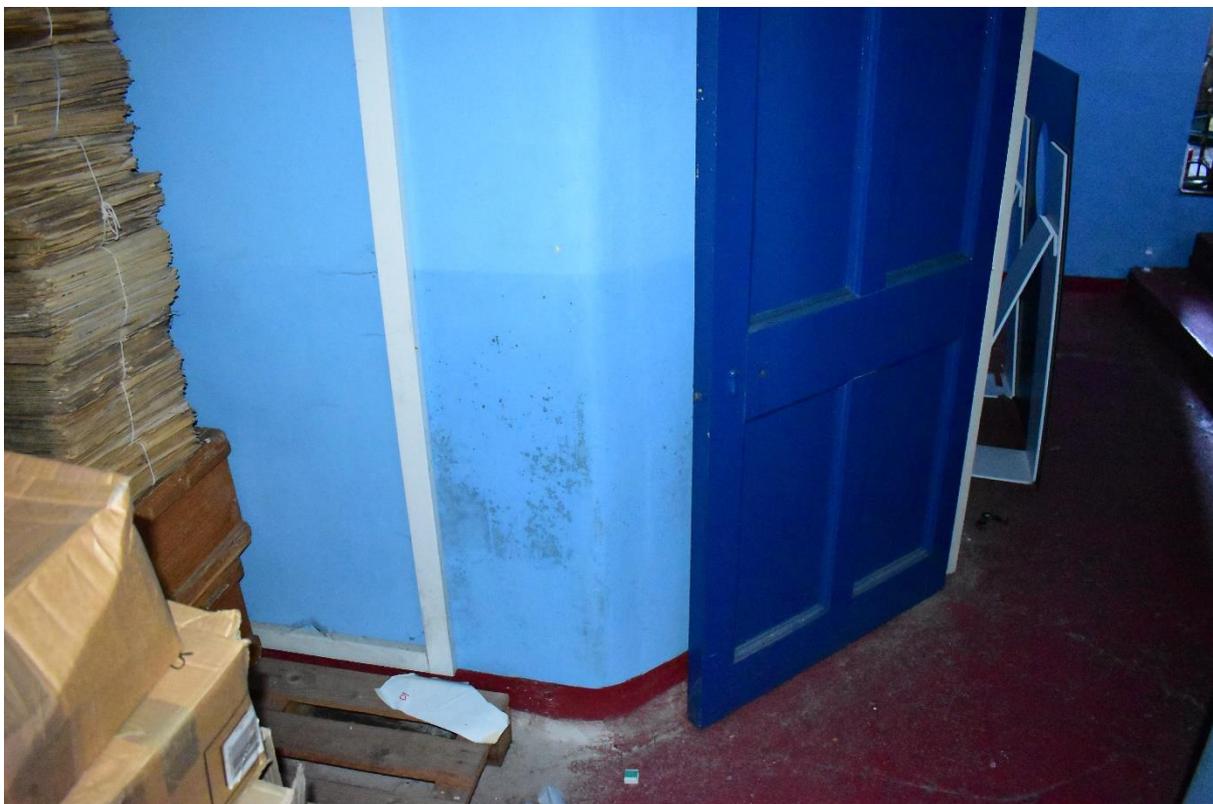
We have recorded extensive mould growth, particularly at the northwest elevation and at the lower ground floor store and W/C. All mould growth noted is due to condensation forming on cold surfaces. The store and W/C at the lower ground floor level should be insulated as per architects detail to prevent further growth.

Figure 29. Showing the mould visible at the lower ground floor level.

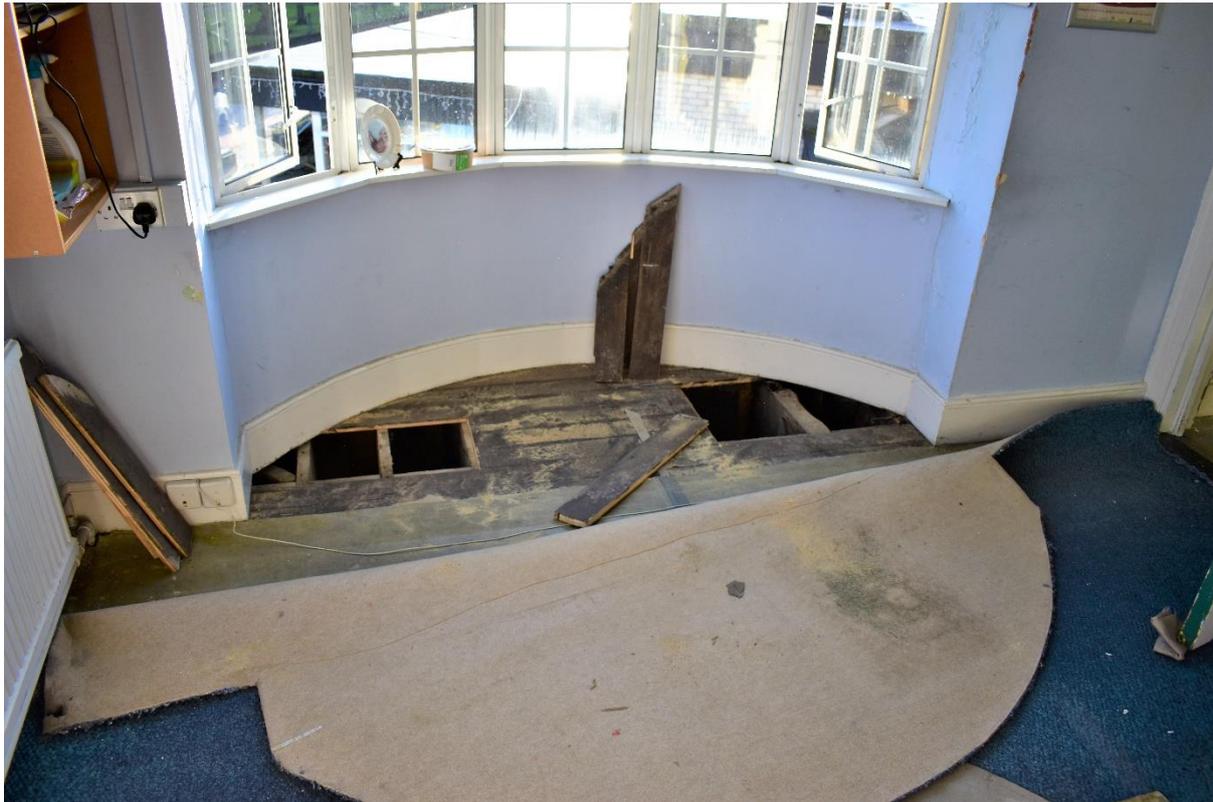
Figure 30. Showing the area opened up at the southwest rear bay.

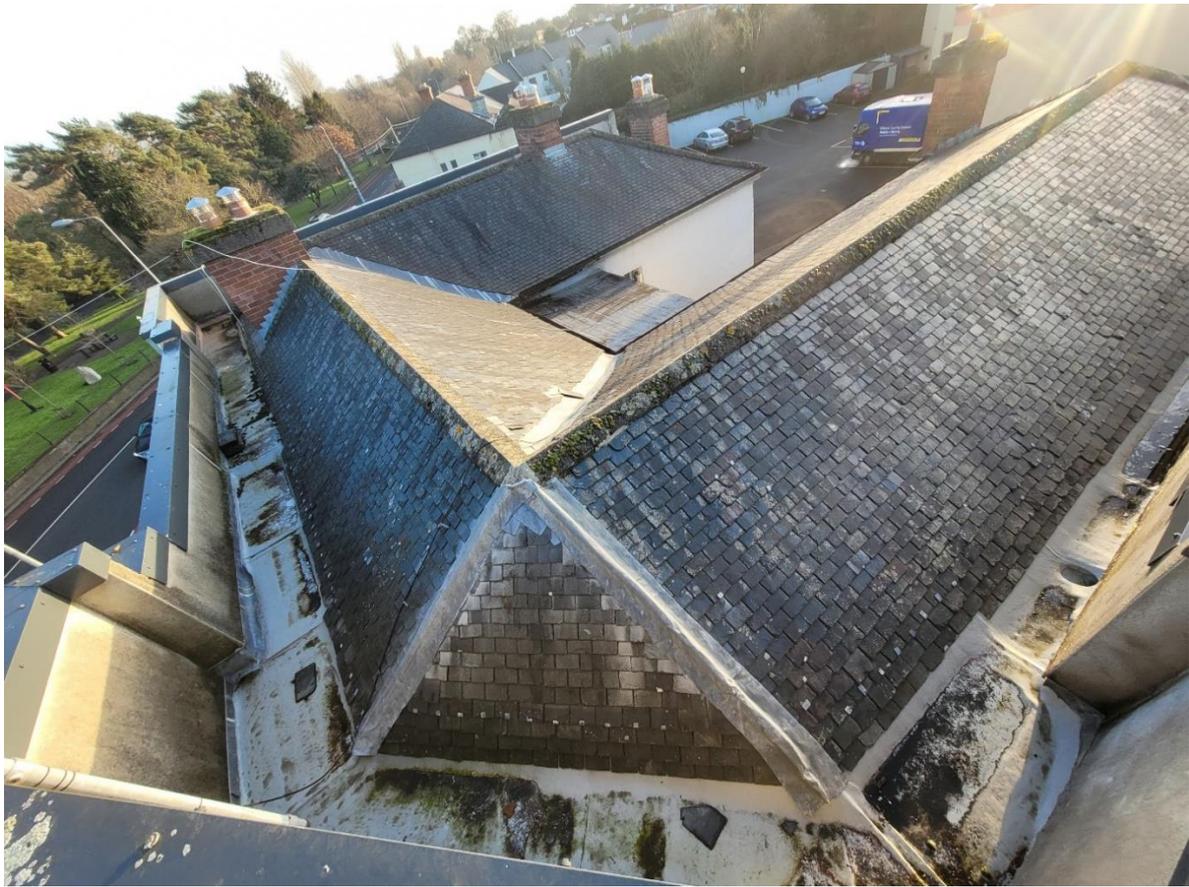
Figure 31. Showing the front section of roof looking south. Note the lead tingles at the fourth row of slates.

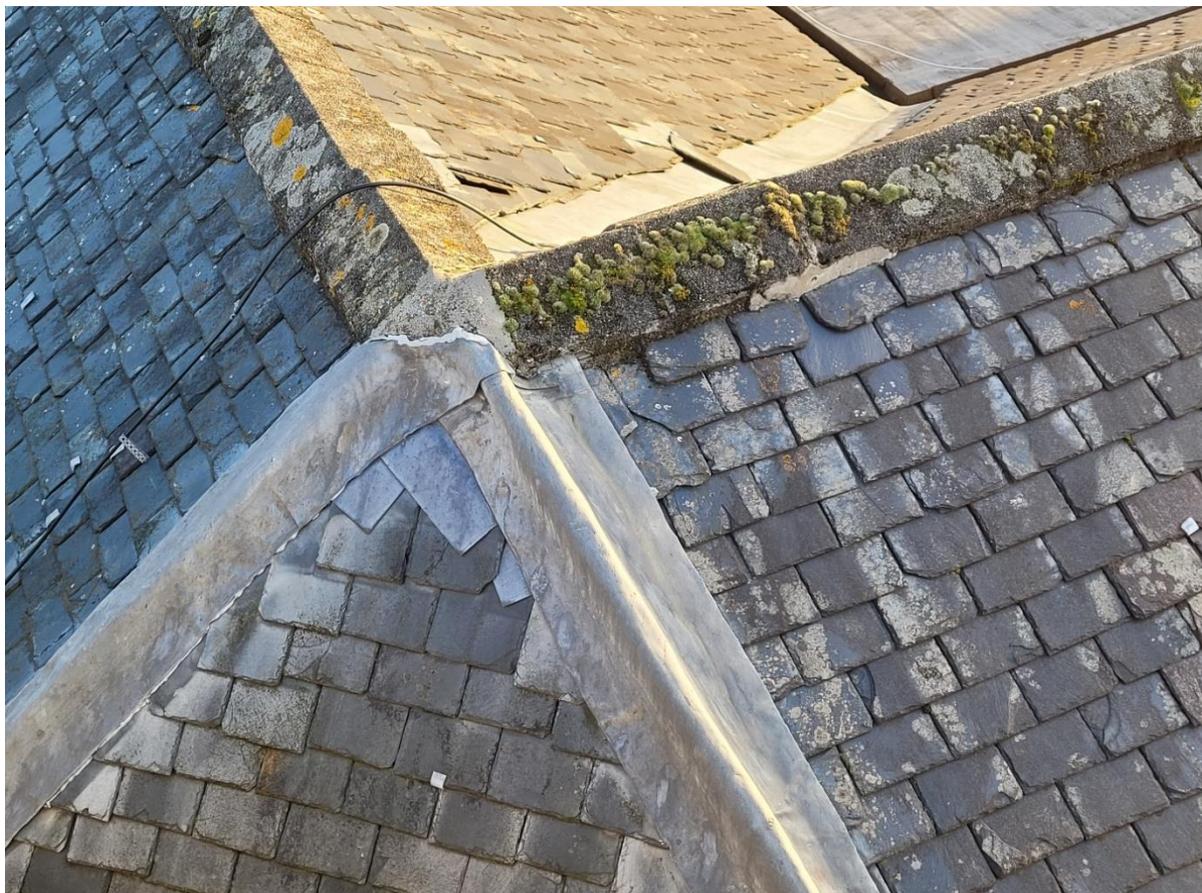
Figure 32. Showing the lead detail at the ridge of the front section.

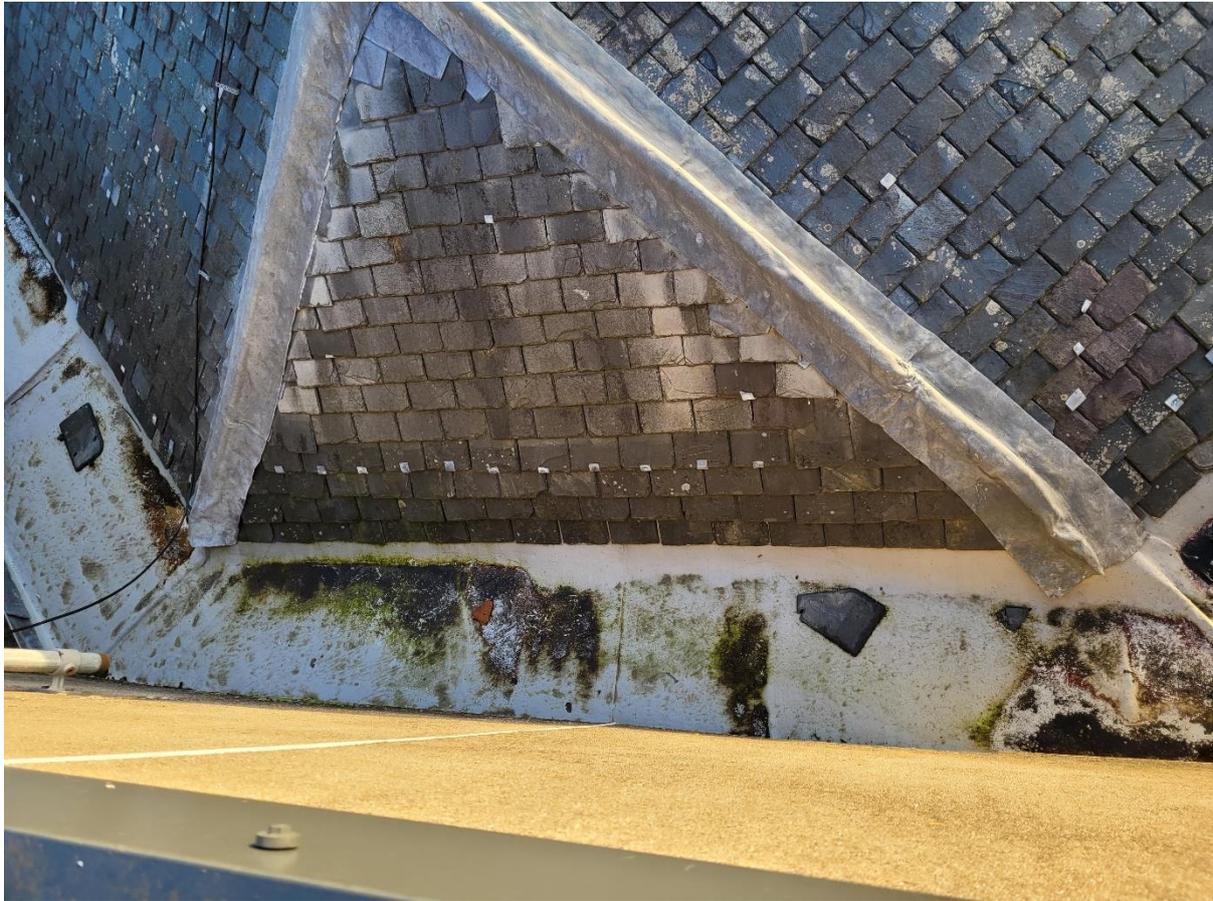
Figure 33. Showing the poor lead detail at the hip ridge

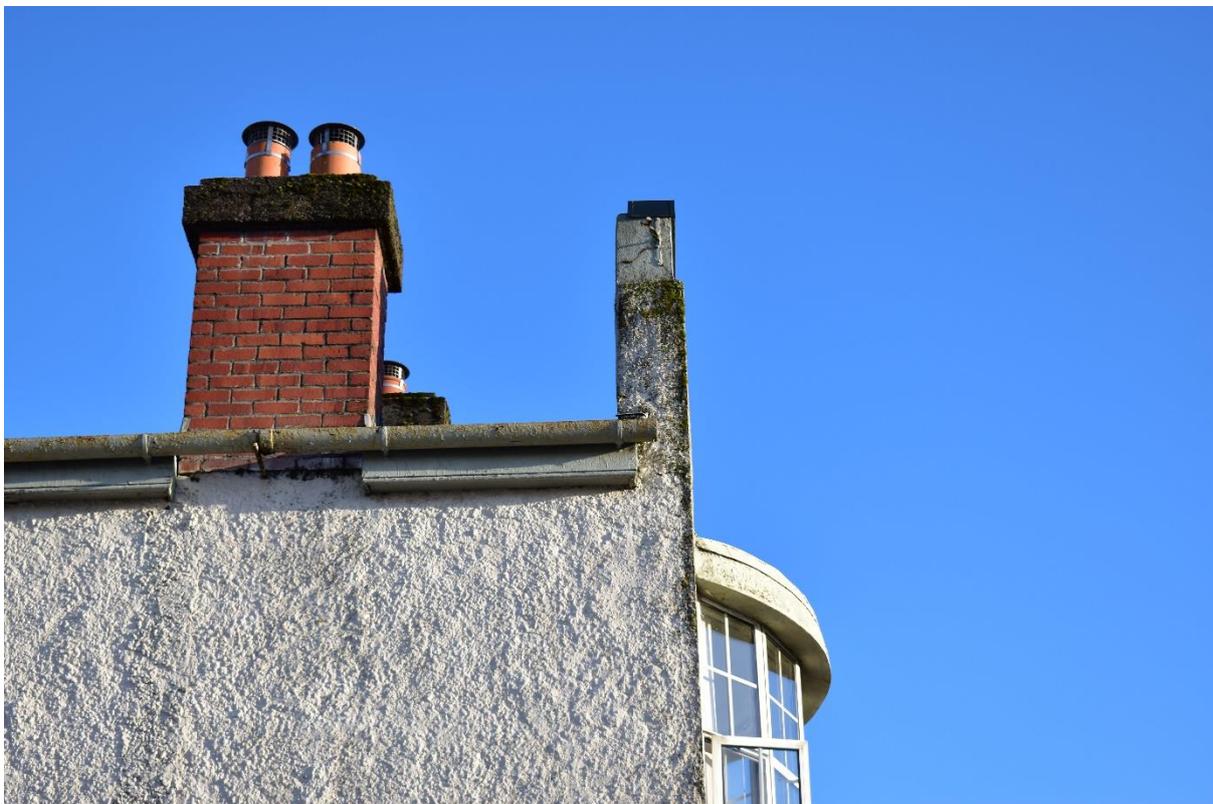
Figure 34. Showing the stained parapet from water running off the coping. This has caused dampness on the ground floor west wall.

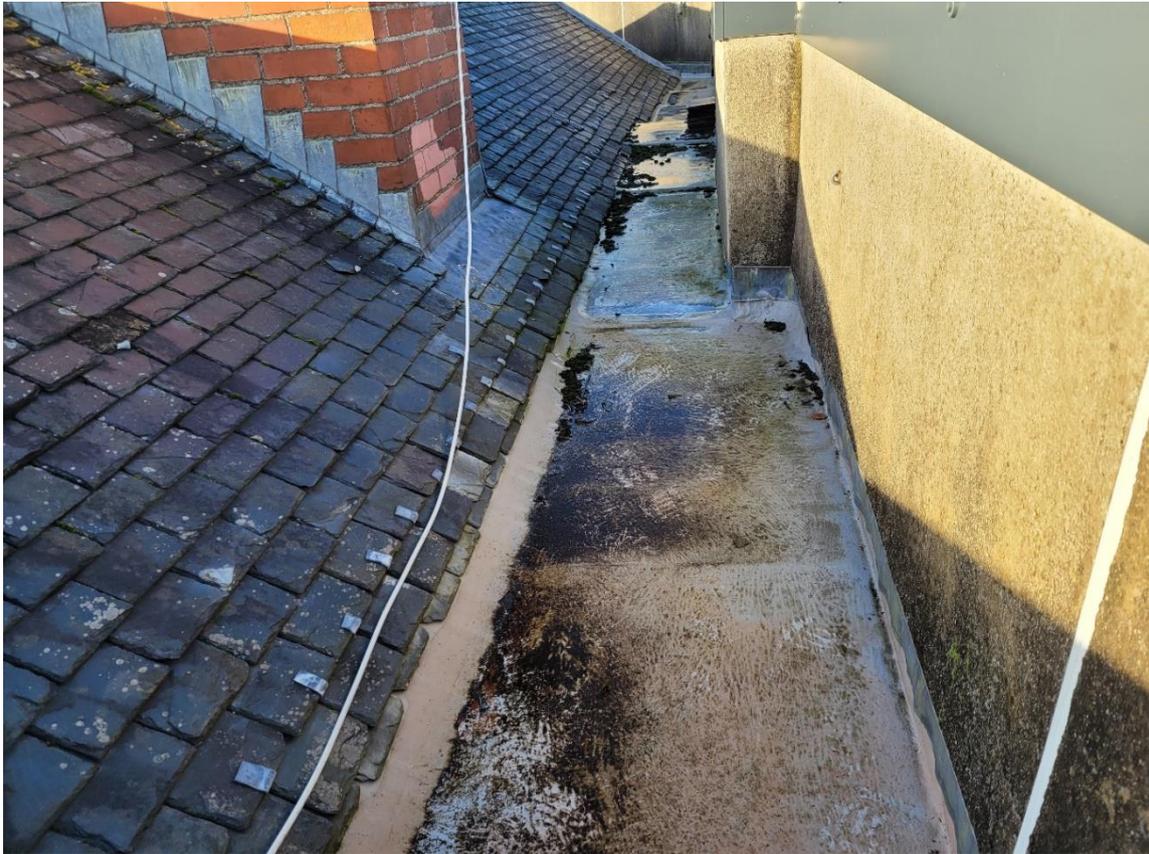
As discussed above, the majority of dampness issues are from the parapet/gutter and from poorly functioning rainwater goods. Although there have been some remedial works carried out at the gutter installing a fibreglass covering, we recommend that a robust flashing detail should be installed to prevent further deterioration bearing in mind the level of decay at this location.

Figure 37. Showing the fibreglass parapet gutter.

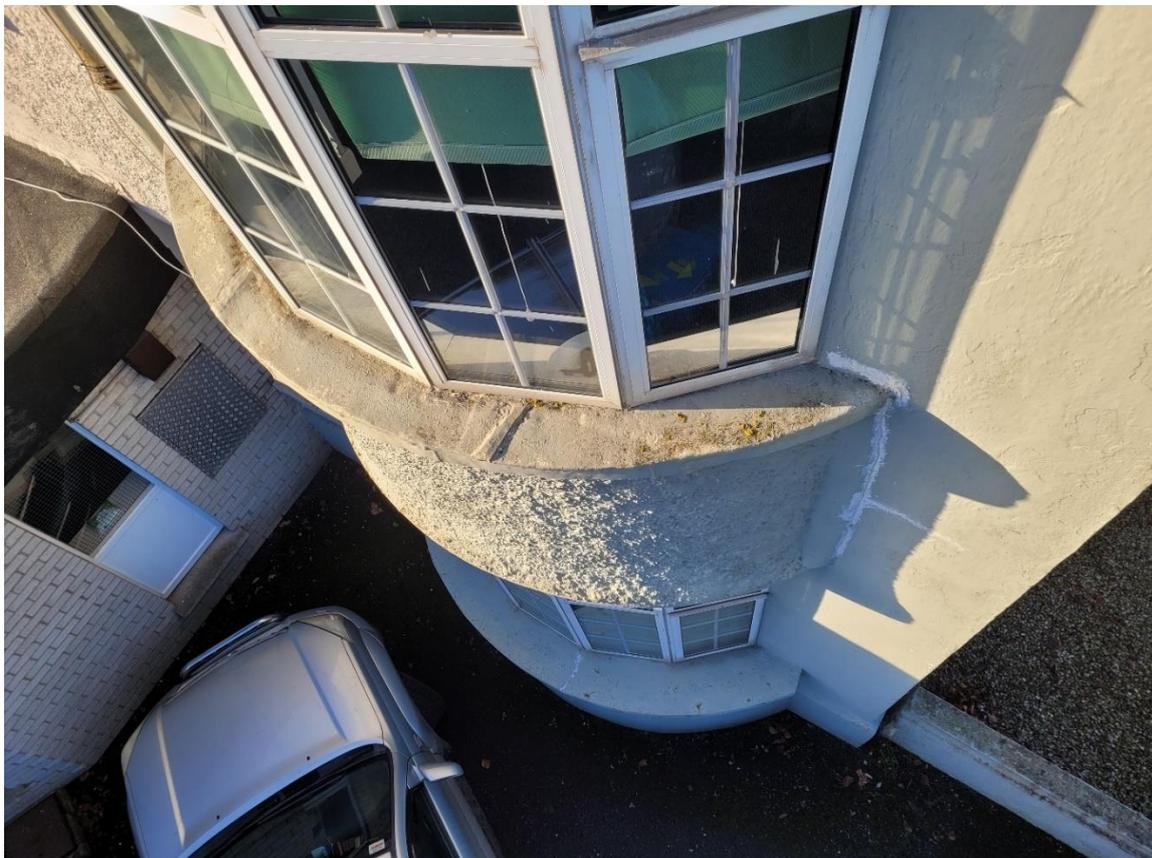
Figure 38. Showing the southeast bay from above. Note the lead flashing over the sill and the crack at the bay/main building junction.

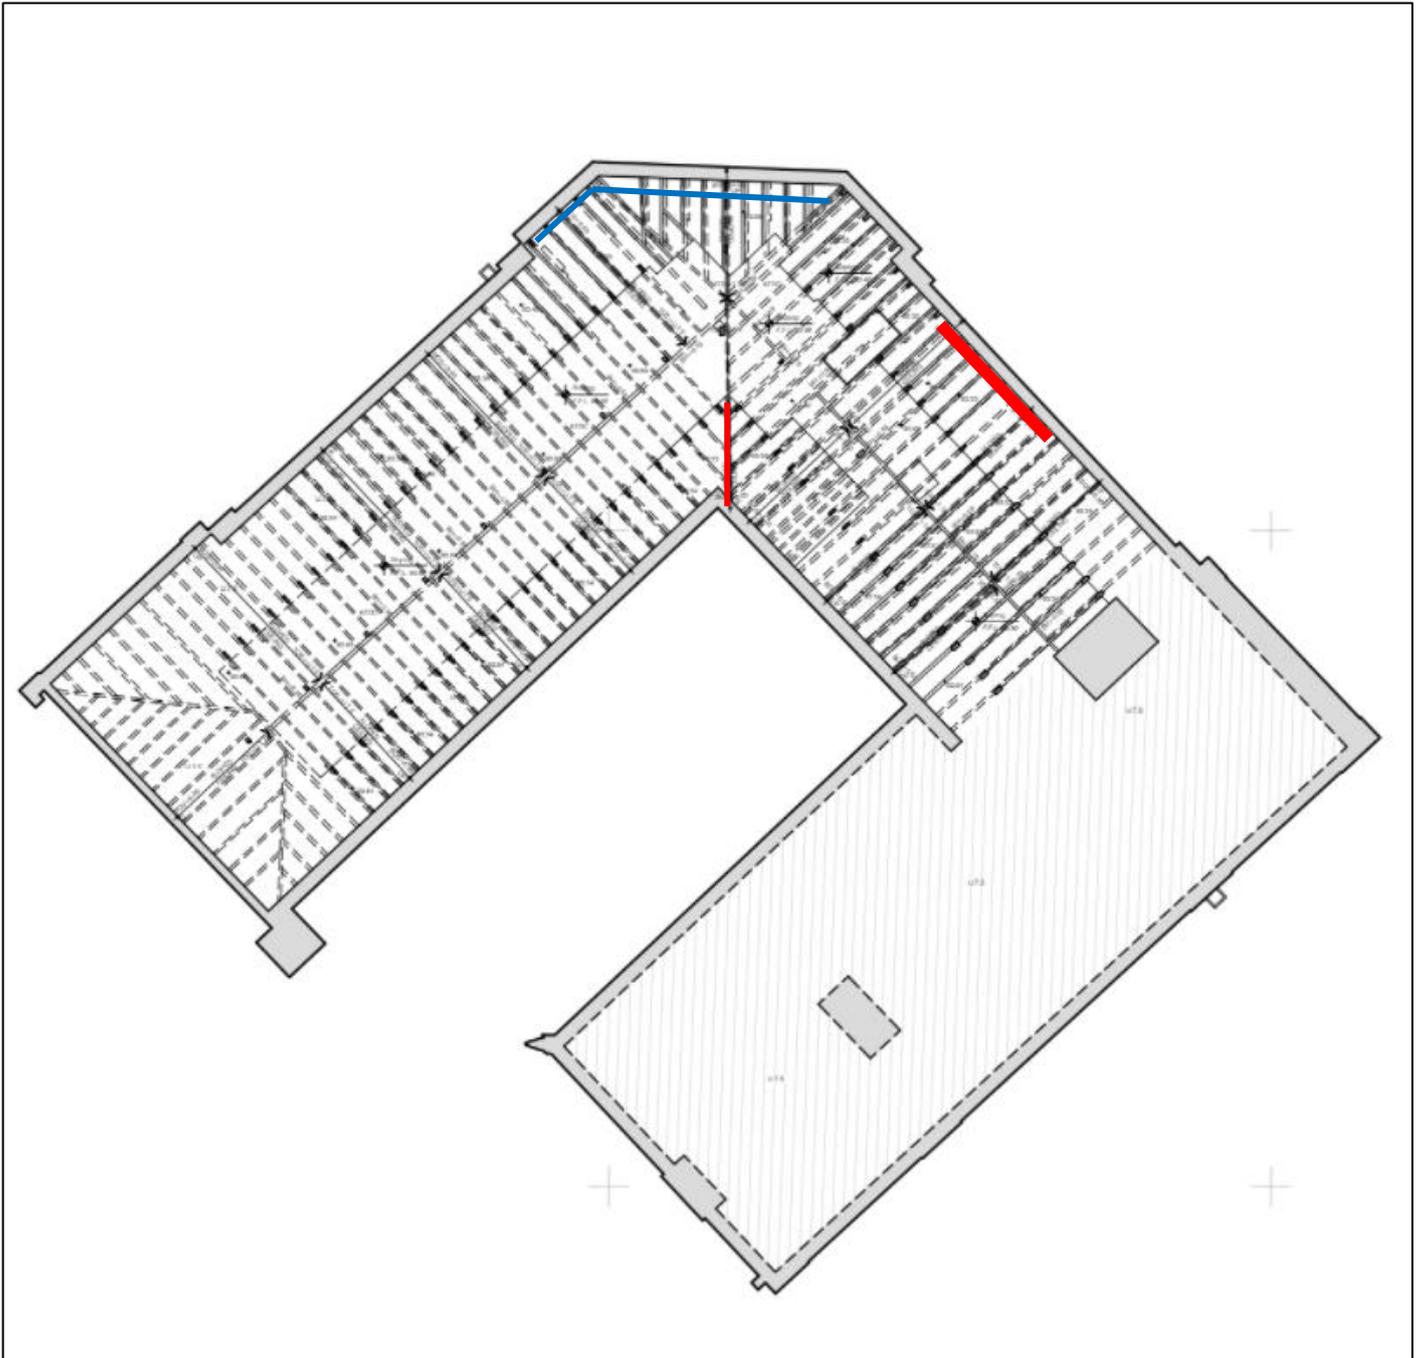
The rear valley rafter has decay present due to water ingress and should be splice repaired as per Aecom detail (see roof plan below).

Figure 41. Showing the roof plan. Areas marked in red show where we exposed the decayed wallplate at the underside and decayed valley rafter. The area marked in blue shows the previously repaired wallplate.
