WINDOWS CONDITION SURVEY AT

Newbridge County Library

Main Street, Athgarvan Rd

2022

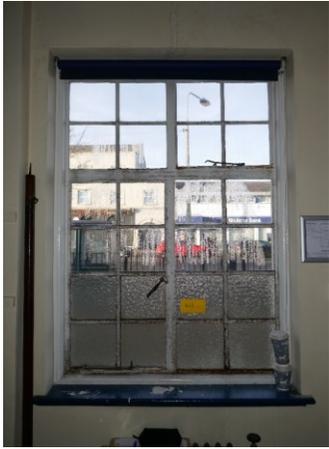
Window Reference	Size (W-H)	Type	General Condition	Timber Cill	Timber Frame	Steel Frame	Casements	Window Board	Ironmongery	Glass	Decoration	Others	PHOTO
GW1	1105 - 1721	A	POOR CONDITION	NO ACCESS EXTERNALLY	FAIR TO THE INSIDE - NEEDS REPAIRS	POOR CONDITION - BOTTOM RAIL IS RUSTED - NEEDS REPLACE AND REPAIRS	NOT OPERABLE - RUSTED AREAS MAINLY AT LOWER SECTION	FAIR CONDITION - NEEDS DECORATION	HOPE & SONS hardware - 1 PEG STAY AT TOP HUNG CASEMENT AND 1 SLIDING STAY AT SIDE HUNG CASEMENT - 1 HANDLE - ALL IN FAIR CONDITION	GOOD CONDITION DRAWN AND 1 FLOAT GLASS - 8 LOWER PANES ARE OBSCURED GLASS	VERY POOR	HEAVY CONDENSATION ISSUES IN ALL THE WINDOWS IN THIS ROOM - BLIND AND RADIATORS

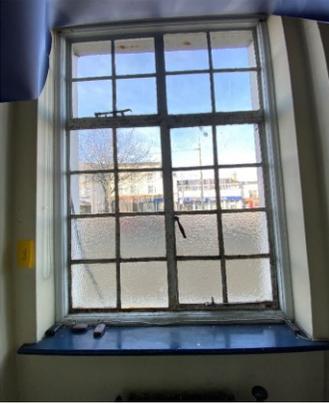
GW2	1103 - 1723	A	POOR CONDITION	NO ACCESS EXTERNALLY	FAIR TO THE INSIDE - NEEDS REPAIRS - WIRES THROUGH AT BOTTOM	POOR CONDITION - BOTTOM RAIL IS RUSTED - NEEDS REPLACE AND REPAIRS	NOT OPERABLE - RUSTED AREAS MAINLY AT LOWER SECTION AND TRANSOM	FAIR CONDITION - NEEDS DECORATION	HOPE & SONS hardware - 1 PEG STAY AT TOP HUNG CASEMENT AND 1 SLIDING STAY AT SIDE HUNG CASEMENT - 1 HANDLE - ALL IN FAIR CONDITION	GOOD CONDITION DRAWN GLASS - 8 LOWER PANES ARE OBSCURED GLASS	VERY POOR	HEAVY CONDENSATION ISSUES IN ALL THE WINDOWS IN THIS ROOM - BLIND AND RADIATORS

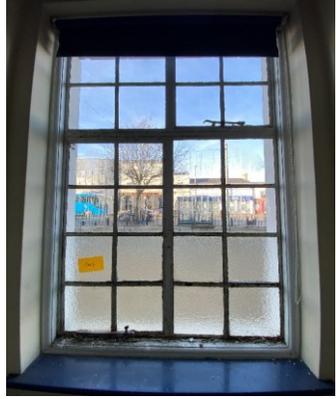
Window Reference	Size (W-H)	Type	General Condition	Timber Cill	Timber Frame	Steel Frame	Casements	Window Board	Ironmongery	Glass	Decoration	Others	PHOTO
GW3	1104 - 1725	A	POOR CONDITION	NO ACCESS EXTERNALLY	POOR TO THE INSIDE - NEEDS REPAIRS	POOR CONDITION - BOTTOM RAIL IS RUSTED - NEEDS REPLACE AND REPAIRS	NOT OPERABLE - RUSTED AREAS MAINLY AT LOWER SECTION AND TRANSOM	FAIR CONDITION - NEEDS DECORATION	HOPE & SONS hardware - 1 PEG STAY AT TOP HUNG CASEMENT AND 1 SLIDING STAY AT SIDE HUNG CASEMENT IN FAIR CONDITION - 1 HANDLE MISSING	POOR CONDITION - 3 PANES BROKEN - ALL DRAWN AND 8 LOWER PANES ARE OBSCURED GLASS	VERY POOR	HEAVY CONDENSATION ISSUES IN ALL THE WINDOWS IN THIS ROOM - BLIND AND RADIATORS

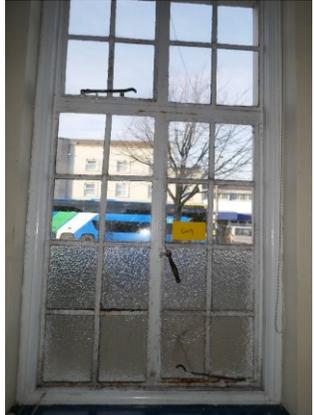
GW4	811 - 1719	A	POOR CONDITION	NO ACCESS EXTERNALLY	POOR TO THE INSIDE - NEEDS REPAIRS - WIRES TO THE LHS AND AT CILL TO LHS	POOR CONDITION - BOTTOM RAIL IS RUSTED - NEEDS REPLACE AND REPAIRS	NOT OPERABLE - RUSTED AREAS MAINLY AT LOWER SECTION	FAIR CONDITION - NEEDS DECORATION	HOPE & SONS hardware - 2 PEG STAYS AT TOP HUNG CASEMENT AND SIDE HUNG CASEMENT - 1 HANDLE ALL IN FAIR CONDITION	POOR CONDITION - 2 PANES BROKEN - 1 FLOAT + 15 DRAWN AND 8 LOWER PANES ARE OBSCURED GLASS	VERY POOR	HEAVY CONDENSATION ISSUES IN ALL THE WINDOWS IN THIS ROOM - BLIND AND RADIATORS

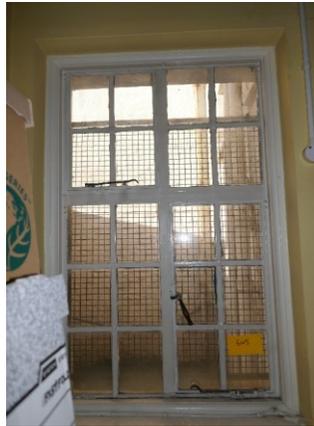
Window Reference	Size (W-H)	Type	General Condition	Timber Cill	Timber Frame	Steel Frame	Casements	Window Board	Ironmongery	Glass	Decoration	Others	PHOTO
GW5	810 - 1419	A	FAIR CONDITION	NO ACCESS EXTERNALLY	FAIR TO THE INSIDE - WIRES THROUGH CILL AT RHS - SIGNS OF DETACHMENT FROM STEEL FRAME	FAIR CONDITION - OVER PAINTED	NOT OPERABLE - PAINTED SHUT - OBSTRUCTION TO THE OUTSIDE	FAIR CONDITION - NEEDS DECORATION	HOPE & SONS hardware - 2 PEG STAYS AT TOP HUNG CASEMENT AND SIDE HUNG CASEMENT - 1 HANDLE -TOP STAY BENT	GOOD CONDITION - HARD TO ASSESS BUT LIKELY TO BE ALL DRAWN GLASS	POOR	SECURITY STEEL MESH TO THE OUTSIDE

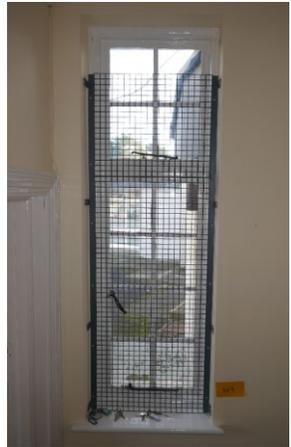
Window Reference	Size (W-H)	Type	General Condition	Timber Cill	Timber Frame	Steel Frame	Casements	Window Board	Ironmongery	Glass	Decoration	Others	PHOTO
GW7	573 - 1940	B	FAIR CONDITION	NO ACCESS EXTERNALLY	GOOD TO THE INSIDE	FAIR CONDITION - OVER PAINTED -	NOT OPERABLE - PAINTED SHUT - OBSTRUCTION TO THE INSIDE	GOOD CONDITION	HOPE & SONS hardware - 1 PEG STAY AT TOP HUNG CASEMENT AND 1 SLIDING STAY AT SIDE HUNG CASEMENT FAIR CONDITION - 1 HANDLE	GOOD CONDITION - HARD TO ASSESS - 2 BOTTOM PANES WITH FILM	FAIR	SECURITY STEEL MESH TO THE INSIDE

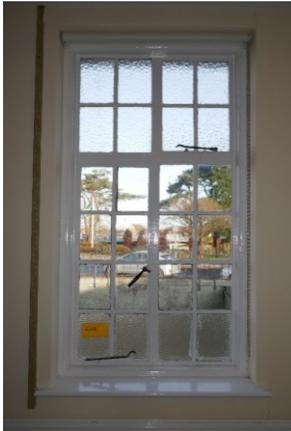
GW8	812 - 1727	A	FAIR CONDITION	NO ACCESS EXTERNALLY	GOOD TO THE INSIDE	GOOD CONDITION - OVER PAINTED	GOOD CONDITION BUT NOT OPERABLE - PAINTED SHUT	GOOD CONDITION	HOPE & SONS hardware - 2 PEG STAYS AT TOP HUNG CASEMENT AND SIDE HUNG CASEMENT - 1 HANDLE	GOOD CONDITION - TOP 8 PANES AND 4 BOTTOM ONES ARE OBSCURED - 4 PANES FLOAT AND 8 DRAWN	FAIR	RADIATORS AND BLIND

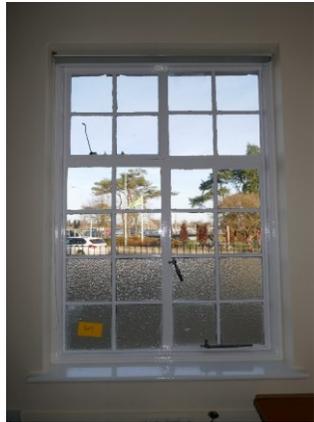
Window Reference	Size (W-H)	Type	General Condition	Timber Cill	Timber Frame	Steel Frame	Casements	Window Board	Ironmongery	Glass	Decoration	Others	PHOTO
GW9	1104 - 1724	A	FAIR CONDITION	NO ACCESS EXTERNALLY	GOOD TO THE INSIDE	GOOD CONDITION - OVER PAINTED	GOOD CONDITION BUT NOT OPERABLE - PAINTED SHUT	GOOD CONDITION	HOPE & SONS hardware - 1 PEG STAY AT TOP HUNG CASEMENT AND 1 SLIDING STAY AT SIDE HUNG CASEMENT - 1 HANDLE - ALL FAIR CONDITION	POOR CONDITION - LOWER 8 PANES ARE OBSCURED THE REST IS DRAWN - SOME PANES SHOW TINY HOLES DAMAGE - 2 BROKEN PANES	FAIR	RADIATORS AND BLIND

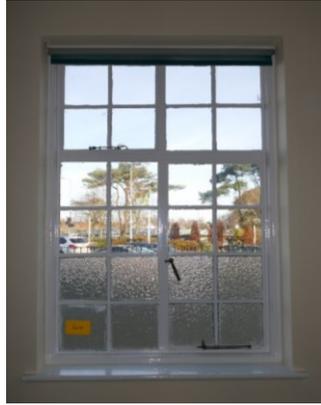
GW10	1103 - 1723	A	FAIR CONDITION	NO ACCESS EXTERNALLY	GOOD TO THE INSIDE	GOOD CONDITION - OVER PAINTED	GOOD CONDITION BUT NOT OPERABLE - PAINTED SHUT	GOOD CONDITION	HOPE & SONS hardware - 1 PEG STAY AT TOP HUNG CASEMENT AND 1 SLIDING STAY AT SIDE HUNG CASEMENT - 1 HANDLE - ALL FAIR CONDITION	FAIR CONDITION - LOWER 8 PANES ARE OBSCURED THE REST IS DRAWN - SOME PANES SHOW TINY HOLES DAMAGE	FAIR	RADIATORS AND BLIND

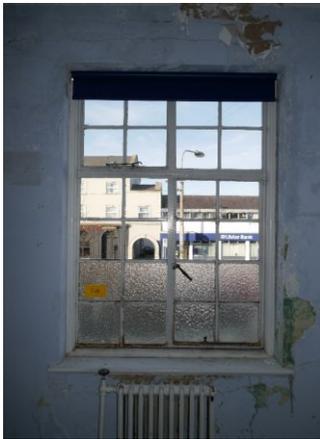
Window Reference	Size (W-H)	Type	General Condition	Timber Cill	Timber Frame	Steel Frame	Casements	Window Board	Ironmongery	Glass	Decoration	Others	PHOTO
FW1	1107 - 1722	A	VERY POOR CONDITION	NO ACCESS EXTERNALLY - STEEL PLATE AT HEAD IS RUSTED TO THE OUTSIDE	FAIR TO THE INSIDE - NEEDS REPAIRS - POOR JOINTS	POOR CONDITION - BOTTOM RAIL IS RUSTED - NEEDS REPLACE AND REPAIRS - EXPANDING FOAM BETWEEN FRAME AND CASEMENTS	NOT OPERABLE - RUSTED AREAS MAINLY AT LOWER SECTION - EXPANDING FOAM BETWEEN GAPS - REALLY POOR INTERVENTION	POOR CONDITION - NEEDS DECORATION	HOPE & SONS hardware - 1 PEG STAY AT TOP HUNG CASEMENT AND 1 SLIDING STAY AT SIDE HUNG CASEMENT - 1 HANDLE - ALL IN FAIR CONDITION	POOR CONDITION DRAWN AND 1 FLOAT GLASS - 8 LOWER PANES ARE OBSCURED GLASS - 4 BOTTOM PANES ARE BROKEN	VERY POOR	HEAVY CONDENSATION ISSUES IN ALL THE WINDOWS IN THIS ROOM - BLIND AND RADIATORS - WATER DAMAGE IN THE MANSORY WALL

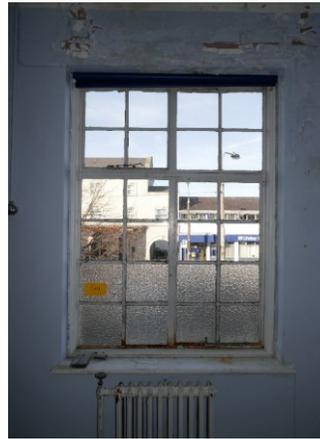
FW2	1102 - 1723	A	POOR CONDITION	NO ACCESS EXTERNALLY - STEEL PLATE AT HEAD IS RUSTED TO THE OUTSIDE	FAIR TO THE INSIDE - NEEDS REPAIRS - POOR JOINTS - WIRES AROUND FRAME	POOR CONDITION - BOTTOM RAIL IS RUSTED - NEEDS REPLACE AND REPAIRS	NOT OPERABLE - RUSTED AREAS MAINLY AT LOWER SECTION - BOTTOM RAIL POOR	POOR CONDITION - NEEDS DECORATION - ELECTRIC WIRES ON TOP	HOPE & SONS hardware - 1 PEG STAY AT TOP HUNG CASEMENT AND 1 SLIDING STAY AT SIDE HUNG CASEMENT - 1 HANDLE - ALL IN FAIR CONDITION	POOR CONDITION DRAWN AND 1 FLOAT GLASS - 8 LOWER PANES ARE OBSCURED GLASS - 3 PANES ARE BROKEN	VERY POOR	HEAVY CONDENSATION ISSUES IN ALL THE WINDOWS IN THIS ROOM - BLIND AND RADIATORS - WATER DAMAGE IN THE MANSORY WALL

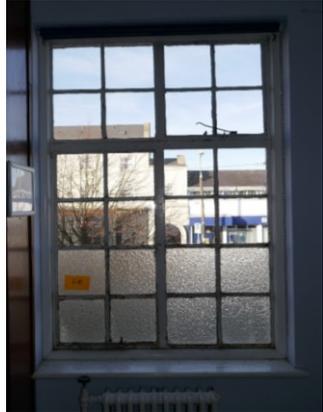
Window Reference	Size (W-H)	Type	General Condition	Timber Cill	Timber Frame	Steel Frame	Casements	Window Board	Ironmongery	Glass	Decoration	Others	PHOTO
FW3	1104 - 1723	A	POOR CONDITION	NO ACCESS EXTERNALLY - STEEL PLATE AT HEAD IS RUSTED TO THE OUTSIDE	FAIR TO THE INSIDE - NEEDS REPAIRS	POOR CONDITION - BOTTOM RAIL IS RUSTED - NEEDS REPLACE AND REPAIRS	NOT OPERABLE - RUSTED AREAS MAINLY AT LOWER SECTION AND GLAZING BARS - BOTTOM RAIL POOR	POOR CONDITION - NEEDS DECORATION	HOPE & SONS hardware - 1 PEG STAY AT TOP HUNG CASEMENT AND 1 SLIDING STAY AT SIDE HUNG CASEMENT - 1 HANDLE MISSING	FAIR CONDITION - DRAWN AND 1 FLOAT GLASS - 8 LOWER PANES ARE OBSCURED GLASS - 1 BROKEN PANE	VERY POOR	HEAVY CONDENSATION ISSUES IN ALL THE WINDOWS IN THIS ROOM - BLIND AND RADIATORS - WATER DAMAGE IN THE MANSORY WALL

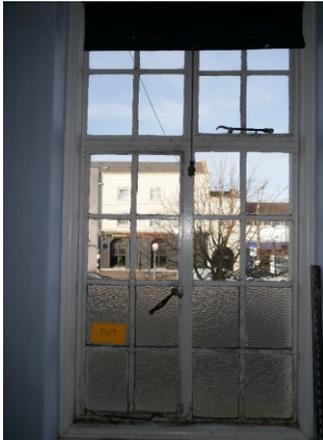
FW4	811 - 1720	A	POOR CONDITION	NO ACCESS EXTERNALLY - STEEL PLATE AT HEAD IS RUSTED TO THE OUTSIDE	FAIR TO THE INSIDE - NEEDS REPAIRS - OPNE JOINTS	POOR CONDITION - BOTTOM RAIL IS RUSTED - NEEDS REPLACE AND REPAIRS	NOT OPERABLE - RUSTED AREAS MAINLY AT LOWER SECTION	POOR CONDITION - NEEDS DECORATION	HOPE & SONS hardware - 2 PEG STAYS AT TOP HUNG CASEMENT AND AT SIDE HUNG CASEMENT - 1 HANDLE - ALL FAIR CONDITION	FAIR CONDITION - DRAWN GLASS - 8 LOWER PANES ARE OBSCURED GLASS AND SOME WITH DIFFERENT PATTERNS	VERY POOR	HEAVY CONDENSATION ISSUES IN ALL THE WINDOWS IN THIS ROOM - BLIND AND RADIATORS - WATER DAMAGE IN THE MANSORY WALL

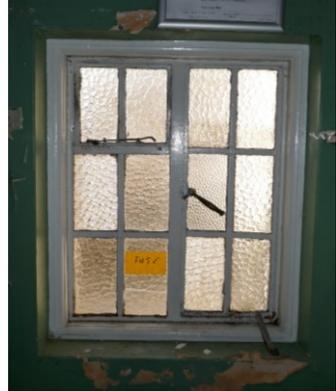
Window Reference	Size (W-H)	Type	General Condition	Timber Cill	Timber Frame	Steel Frame	Casements	Window Board	Ironmongery	Glass	Decoration	Others	PHOTO
FW5	655 - 885	D	FAIR CONDITION	NO ACCESS EXTERNALLY	FAIR TO THE INSIDE	FAIR CONDITION - POOR DECORATION - RUSTED AREAS - BOTTOM RAIL RUST JACKING	TOP HUNG CASEMENT OPEN - BOTTOM SIDE HUNG PAINTED SHUT - SIGNS OF RUST	NO WINDOW BOARD	HOPE & SONS hardware - 2 PEG STAYS AT TOP HUNG CASEMENT AND SIDE HUNG CASEMENT, 1 BENT - 1 HANDLE - FAIR CONDITION	POOR CONDITION - 3 BROKEN PANES - ALL OSBCURED GLASS WITH 3 DIFFERENT PATTERNS	POOR

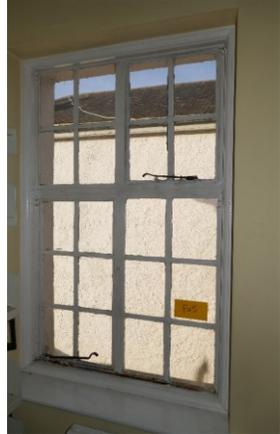
FW6	809 - 1420	A	FAIR CONDITION	NO ACCESS EXTERNALLY	GOOD TO THE INSIDE	FAIR CONDITION - BOTTOM RAIL RUST JACKING	NOT OPERABLE - PAINTED SHUT	GOOD CONDITION	HOPE & SONS hardware - 2 PEG STAYS AT TOP HUNG CASEMENT AND 1 SLIDING STAY AT SIDE HUNG CASEMENT FAIR CONDITION - 1 HANDLE MISSING	FAIR CONDITION BUT POOR DECORATION - ALL PANES ARE SPRAYED PAINTED - ALL DRAWN AND 3 FLOAT PANES - 1 AT BOTTOM LHS BROKEN	POOR

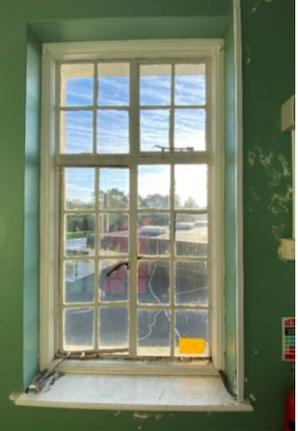
Window Reference	Size (W-H)	Type	General Condition	Timber Cill	Timber Frame	Steel Frame	Casements	Window Board	Ironmongery	Glass	Decoration	Others	PHOTO
FW7	808 - 1716	A	FAIR CONDITION	POOR CONDITION - NEEDS REPLACE	GOOD TO THE INSIDE - WIRES THROUGH TO BOTTOM RHS	FAIR CONDITION - OVER PAINTED - BOTTOM RAIL IS RUSTED	OVER PAINTED - TOP CASEMENT NOT OPERABLE PAINTED SHUT - BOTTOM ONES OPENS AND IN FAIR CONDITION OVERALL	GOOD CONDITION	HOPE & SONS hardware - 2 PEG STAYS AT TOP HUNG CASEMENT AND AT SIDE HUNG CASEMENT- 1 HANDLE ALL IN FAIR CONDITION	FAIR CONDITION - DRAWN GLASS AND 4 FLOAT PANES - 1 BROKEN GLASS	FAIR

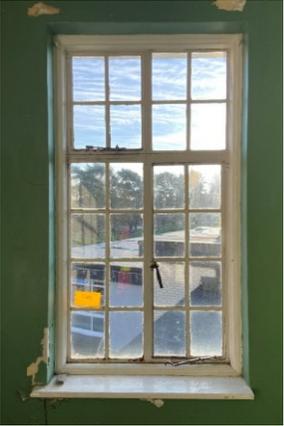
FW8	808 - 1715	A	FAIR CONDITION	POOR CONDITION - NEEDS REPLACE	GOOD TO THE INSIDE - WIRES THROUGH TO BOTTOM RHS	FAIR CONDITION - OVER PAINTED - BOTTOM RAIL IS RUSTED	OVER PAINTED - TOP CASEMENT NOT OPERABLE PAINTED SHUT - BOTTOM ONES OPENS AND IN FAIR CONDITION OVERALL	GOOD CONDITION - ELECTRIC DEVICE ON TOP	HOPE & SONS hardware - 2 PEG STAYS (1 BENT) AT TOP HUNG CASEMENT AND AT SIDE HUNG CASEMENT- 1 HANDLE ALL IN FAIR CONDITION	FAIR CONDITION - DRAWN GLASS AND 3 FLOAT PANES - 1 BROKEN GLASS	FAIR

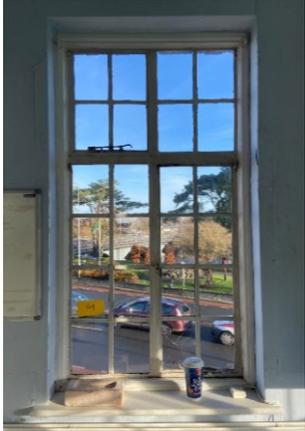
Window Reference	Size (W-H)	Type	General Condition	Timber Cill	Timber Frame	Steel Frame	Casements	Window Board	Ironmongery	Glass	Decoration	Others	PHOTO
FW9	810 - 1714	A	FAIR CONDITION	NO ACCESS EXTERNALLY	GOOD TO THE INSIDE - WIRES THROUGH TO BOTTOM RHS	FAIR CONDITION - OVER PAINTED - BOTTOM RAIL IS RUSTED	FAIR CONDITION BUT NOT OPERABLE - PAINTED SHUT	GOOD CONDITION - ELECTRIC DEVICE ON TOP	HOPE & SONS hardware - 2 PEG STAYS (1 BENT) AT TOP HUNG CASEMENT AND AT SIDE HUNG CASEMENT - 1 HANDLE MISSING	FAIR CONDITION - DRAWN GLASS AND 3 FLOAT PANES	FAIR

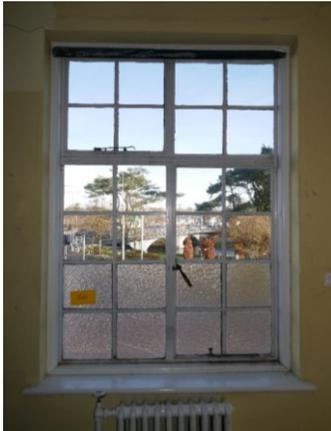
FW10	1112 - 1721	A	FAIR CONDITION	NO ACCESS EXTERNALLY	GOOD TO THE INSIDE	FIAR CONDITION - OVER PAINTED - BOTTOM RUSTED NEEDS REPAIRS	FAIR CONDITION BUT NOT OPERABLE - PAINTED SHUT	GOOD CONDITION	HOPE & SONS hardware - 1 PEG STAY AT TOP HUNG CASEMENT AND 1 SLIDING STAY AT SIDE HUNG CASEMENT - 1 HANDLE - ALL FAIR CONDITION	FAIR CONDITION - LOWER 8 PANES ARE OBSCURED THE REST IS DRAWN - 1 BROKEN PANE	FAIR	RADIATORS AND BLIND

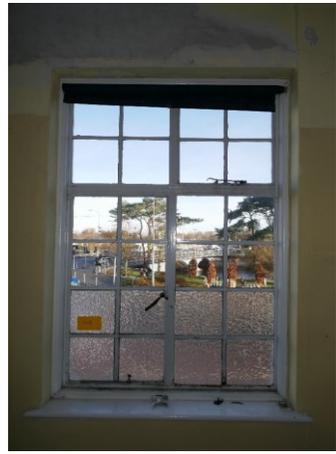
Window Reference	Size (W-H)	Type	General Condition	Timber Cill	Timber Frame	Steel Frame	Casements	Window Board	Ironmongery	Glass	Decoration	Others	PHOTO
FW11	1105 - 1730	A	FAIR CONDITION	NO ACCESS EXTERNALLY	GOOD TO THE INSIDE - SIGNS OF DETACHMENT FROM STEEL FRAME	FIAR CONDITION - OVER PAINTED - BOTTOM RUSTED NEEDS REPAIRS	FAIR CONDITION BUT NOT OPERABLE - PAINTED SHUT	GOOD CONDITION - ELECTRIC DEVICE ON TOP	HOPE & SONS hardware - 1 PEG STAY AT TOP HUNG CASEMENT AND 1 SLIDING STAY AT SIDE HUNG CASEMENT - 1 HANDLE - ALL FAIR CONDITION	FAIR CONDITION - LOWER 8 PANES ARE OBSCURED THE REST IS DRAWN - 1 BROKEN PANE	FAIR	BLIND

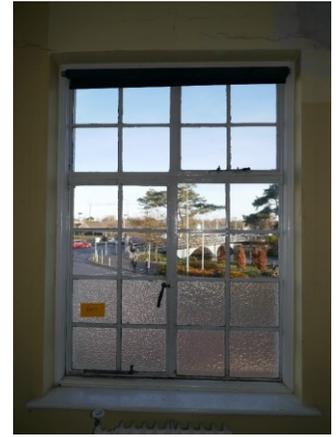
FW12	1103 - 1721	A	FAIR CONDITION	NO ACCESS EXTERNALLY	GOOD TO THE INSIDE	FIAR CONDITION - OVER PAINTED - BOTTOM RUSTED NEEDS REPAIRS	FAIR CONDITION BUT NOT OPERABLE - PAINTED SHUT	GOOD CONDITION	HOPE & SONS hardware - 1 PEG STAY AT TOP HUNG CASEMENT AND 1 SLIDING STAY AT SIDE HUNG CASEMENT - 1 HANDLE - ALL FAIR CONDITION	FAIR CONDITION - LOWER 8 PANES ARE OBSCURED - 5 PANES ARE FLOAT AND THE REST IS DRAWN	FAIR	RADIATORS AND BLIND

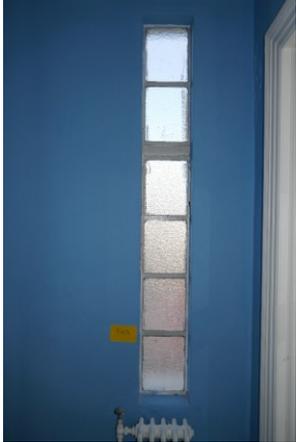
Window Reference	Size (W-H)	Type	General Condition	Timber Cill	Timber Frame	Steel Frame	Casements	Window Board	Ironmongery	Glass	Decoration	Others	PHOTO
FW13	245 - 1857	C	GOOD CONDITION	NO ACCESS EXTERNALLY	GOOD TO THE INSIDE	GOOD CONDITION - OVER PAINTED	GOOD CONDITION	N/A	N/A	ALL OSBCURED GLASS IN GOOD CONDITION	FAIR - OVER PAINTED	NO OPENING CASEMENTS - RADIATORS AT BOTTOM

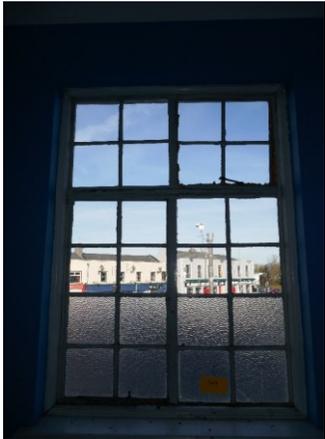
FW14	1112 - 1727	A	VERY POOR CONDITION	NO ACCESS EXTERNALLY	POOR TO THE INSIDE - NEEDS REPAIRS - POOR JOINTS - DETACHED FROM STEEL FRAME	VERY POOR CONDITION - BOTTOM RAIL IS RUSTED - NEEDS REPLACE - EXPANDING FOAM BETWEEN FRAME AND CASEMENTS - ALL FRAME IS BENT	NOT OPERABLE - VERY POOR CONDITION - RUSTED AT SEVERAL SECTIONS - EXPANDING FOAM BETWEEN GAPS - REALLY POOR INTERVENTIO N	POOR CONDITION - NEEDS DECORATION	HOPE & SONS hardware - 1 PEG STAY AT TOP HUNG CASEMENT AND 1 SLIDING STAY AT SIDE HUNG CASEMENT - 1 HANDLE - ALL IN FAIR CONDITION	POOR CONDITION DRAWN AND 1 FLOAT GLASS - 8 LOWER PANES ARE OBSCURED GLASS - 4 BOTTOM PANES ARE BROKEN	VERY POOR	HEAVY CONDENSATI ON ISSUES IN ALL THE WINDOWS IN THIS ROOM - BLIND AND RADIATORS - WATER DAMAGE IN THE MANSORY WALL

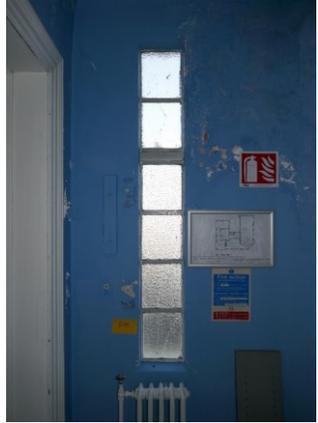
Window Reference	Size (W-H)	Type	General Condition	Timber Cill	Timber Frame	Steel Frame	Casements	Window Board	Ironmongery	Glass	Decoration	Others	PHOTO
FW15	235 - 1854	C	FAIR CONDITION	NO ACCESS EXTERNALLY	FAIR TO THE INSIDE - OPEN JOINTS	GOOD CONDITION - OVER PAINTED	GOOD CONDITION	N/A	N/A	ALL OSBCURED GLASS - 2 DIFFERENT PATTERNS - 1 BROKEN PANE FIXED WITH SILICONE, POOR INTERVENTION - 4 PANES BROKEN IN TOTAL	FAIR - OVER PAINTED	WATER DAMAGE IN THE MANSORY WALL

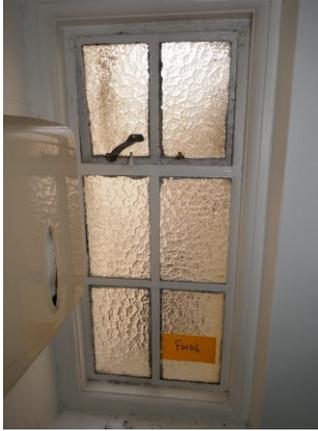
FW16	352 - 886	E	FAIR CONDITION	NO ACCESS EXTERNALLY	GOOD TO THE INSIDE	FAIR CONDITION - DECORATION IS POOR	FIAR CONDITION - TOP HUNG CASEMENT OPERABLE	N/A	1 PEG STAY IN FAIR CONDITION	ALL OSBCURED GLASS - ALL FAIR CONDITION	FAIR
