# Wonderful Barn

## Leixlip, Co. Kildare

**Architectural Heritage Impact Assessment (AHIA) Report**

May 2024

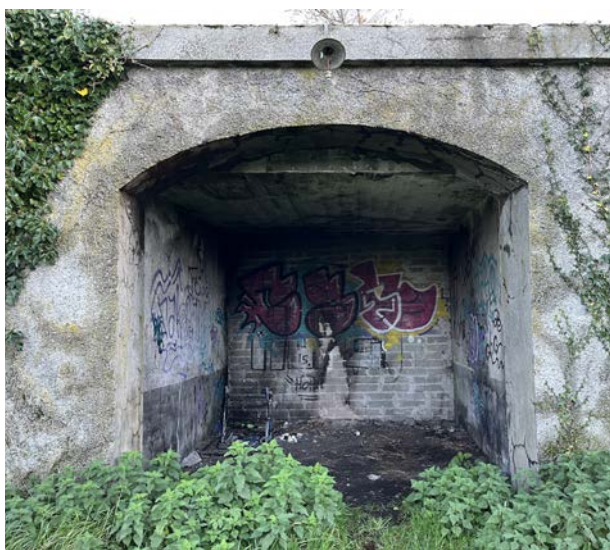
Figure 27 - Archway in the north-south running stable range, infilled with blockwork

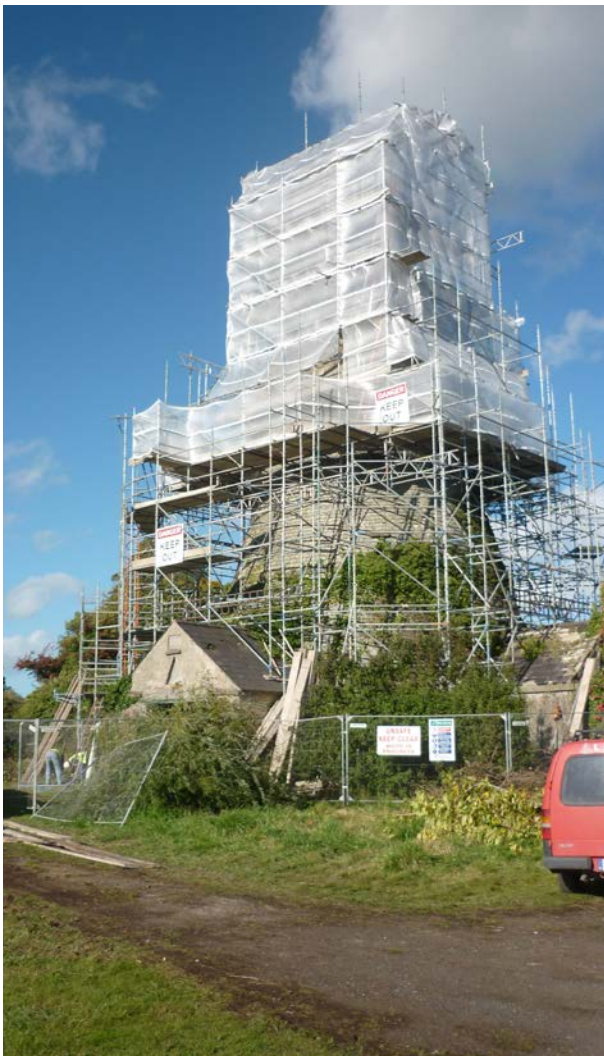
Following completion of a conservation report on the site in 2005, Howley Hayes Cooney Architecture was commissioned to carry out a sequence of emergency repairs and anti-vandalism measures to the barn and the house. The first was a programme of complex masonry repairs to the brick staircase that spiralled around the external wall of the barn. This was in a very poor condition and on the verge of collapse, as was the castellated crow's nest feather at the top of the stairs, which was designed as a viewing platform. Many of the coping stones of this feature had been pushed over and had fallen onto the slate roofs to the four-projecting single-storey wings below. A successful programme of masonry repairs, re-plastering and slate repairs was duly completed to a high standard (fig 35).

Figure 35 - Repair works carried out to the Barn in 2005

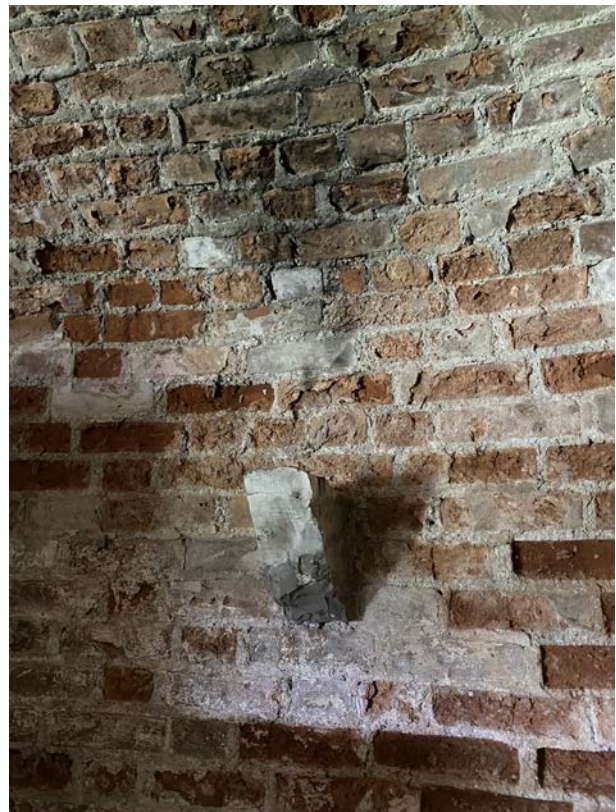
Figure 36 - Internal brickwork in the ground floor of the barn

As the main structural repairs to the barn have been completed, there is no longer a structural risk, although further conservation works are necessary throughout. The internal brickwork, within the ground floor in particular is starting to degrade (fig 36), and the removal of cement pointing should be undertaken. A minor leak is evident in the entry way which should be investigated. Repairs are required to many of the small window openings. Externally the vertical slating, added to the southeast portion of the structure has started to come loose and detach.

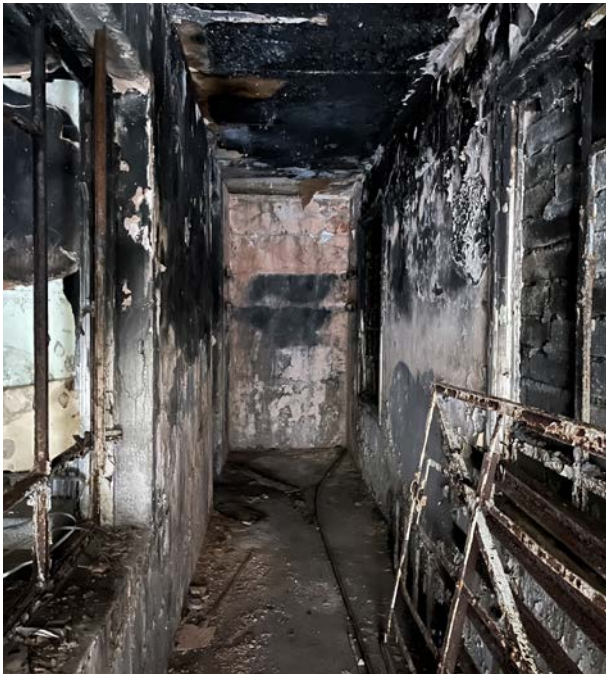
Having been subjected to an arson attack, was badly damaged, particularly to the roof structure, while much of the interior was scorched with some timber floors also suffering structural damage (fig 37). A major programme of works was completed in 2005 to re-roof the house and to undertake an initial “clean and sweep” operation for a preliminary clear out of the house. Since the completion of these works, nothing further has been done other than to add services to the ground floor of the house to make useful as a store to serve occasional community use of the complex. The house now has an effective roof, which has prevented ongoing deterioration due to weather, but it remains blocked up with a semi-derelict interior (fig 38).

Figure 37 - Fire damage in Barnhall House

Internally the intention is to remove sand and cement plaster from walls and ceilings, if this is possible, and to demolish all modern partitions. Existing timber rafters, floor joints and joinery will need to be carefully assessed to determine the extent of historic fabric which can be retained. Reinstatement of missing fireplaces and diagonal chimney breasts with suitable historic replicas or salvaged fireplaces will be explored.

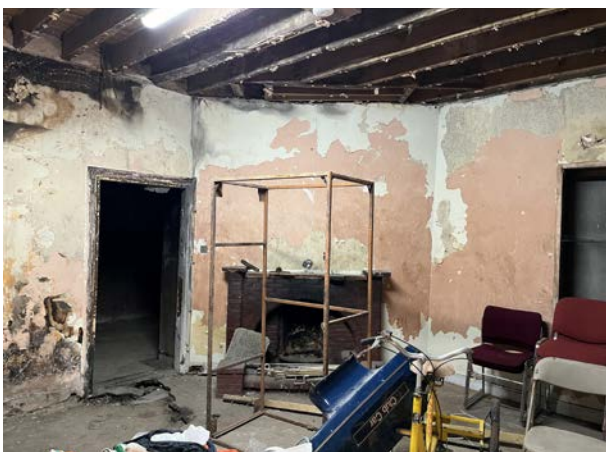
Figure 38 - Derelict interior of the house

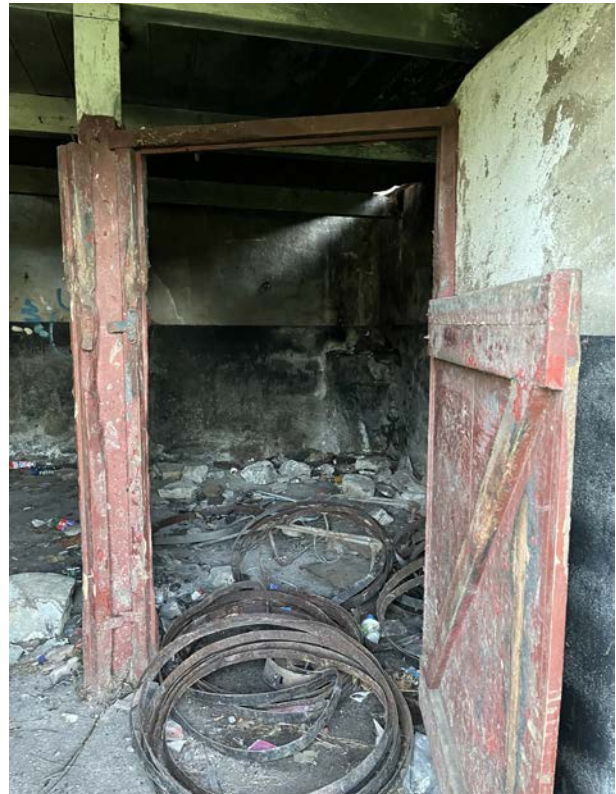
Figure 39 - Historic stables in the north-south range

These historic structures have changed little since the three phases of works to the barn and the house, apart from the two ranges of out-buildings in the western courtyard, the roofs of which had deteriorated badly. These roofs are now beyond repair and at risk of complete collapse. It is not possible to access much of the interior though some parts are still accessible. The east range (running north-south) contains historic stalls for horses, (fig 39) which are in poor repair, with a small hay loft above. The interiors are in poor condition, with ongoing water ingress.

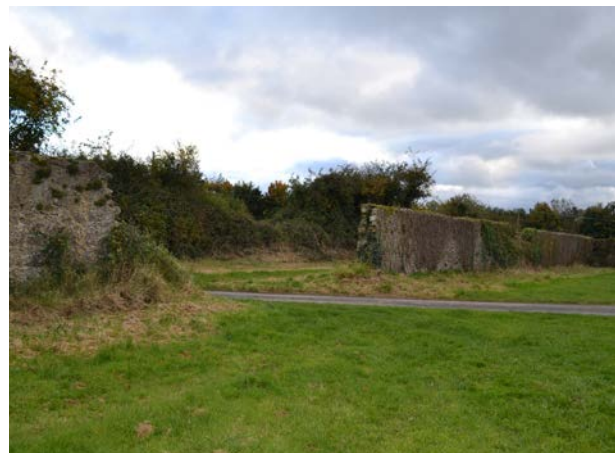
Figure 40 - Opening the walled garden to accommodate a vehicular route

The walled garden remains largely intact apart from the two openings made within the wall to accommodate the driveway, an unfortunate intervention which has resulted in the loss of historic masonry (fig 40), over the two smaller historic openings in the west wall (running north-south) are still relatively intact and only require minor repair (figs 41 and 42).

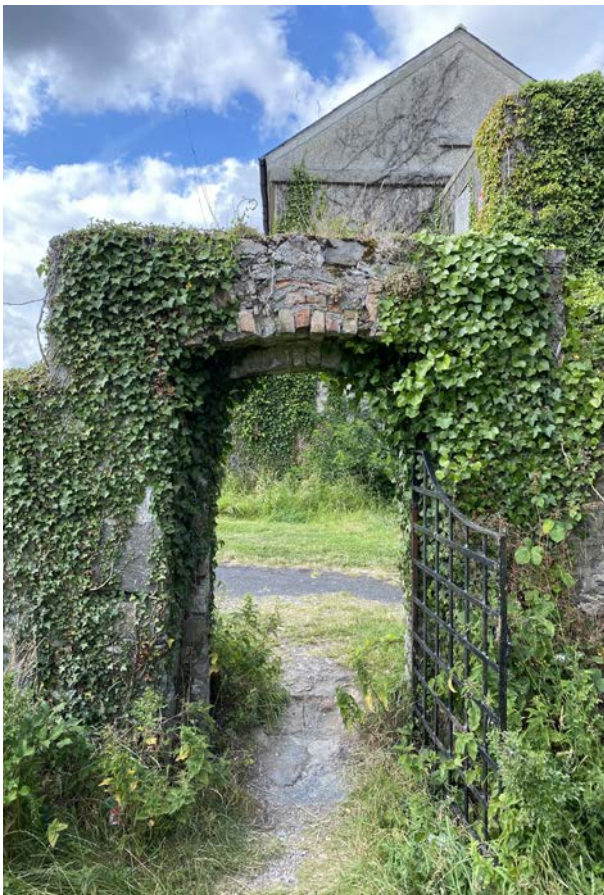
Figure 41 - Arched entrance to the walled garden, from the house

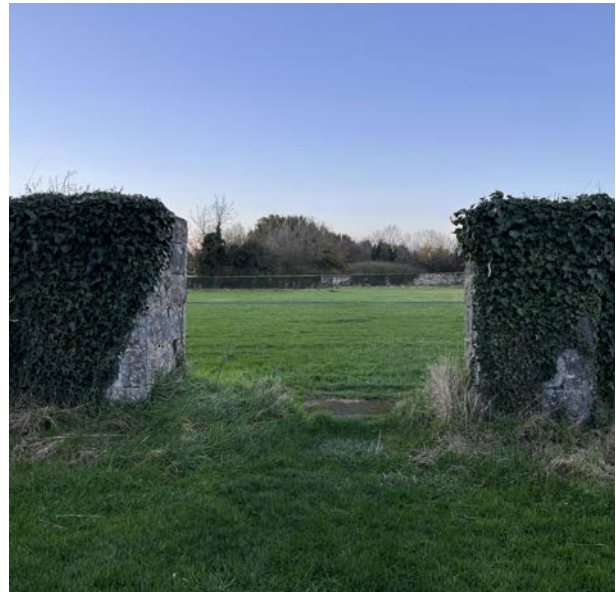
Figure 42 - Stone piers remain either side of this previously gated entrance to the wall garden

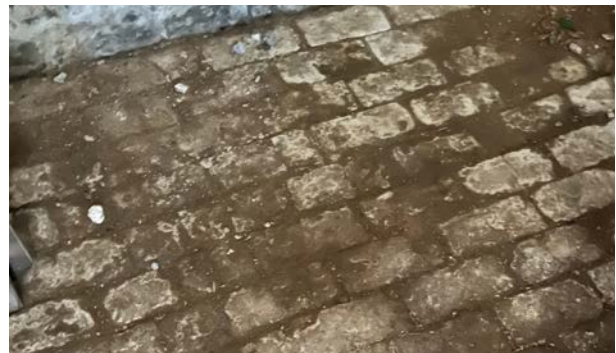
Previously completed conservation works to the barn have ensured that it is generally in stable condition, with minimal evidence of weather ingress. Repairs are required to the internal brickwork on all levels, along with minor repairs to the wall openings and floors. The removal of the cement floor at ground floor level will be undertaken to determine if the original floor could be revealed throughout (fig 47). The application of a lime coat, to consolidate the remaining slate on the southeast facades, will preserve what remains of this interesting weathering feature. Re-opening of the northeast doors will also be undertaken, which will reinstate the link between the park to the front of the barn and the yard to the rear.

Figure 47 - A small portion of the original brick floor is visible in the ground floor of the barn

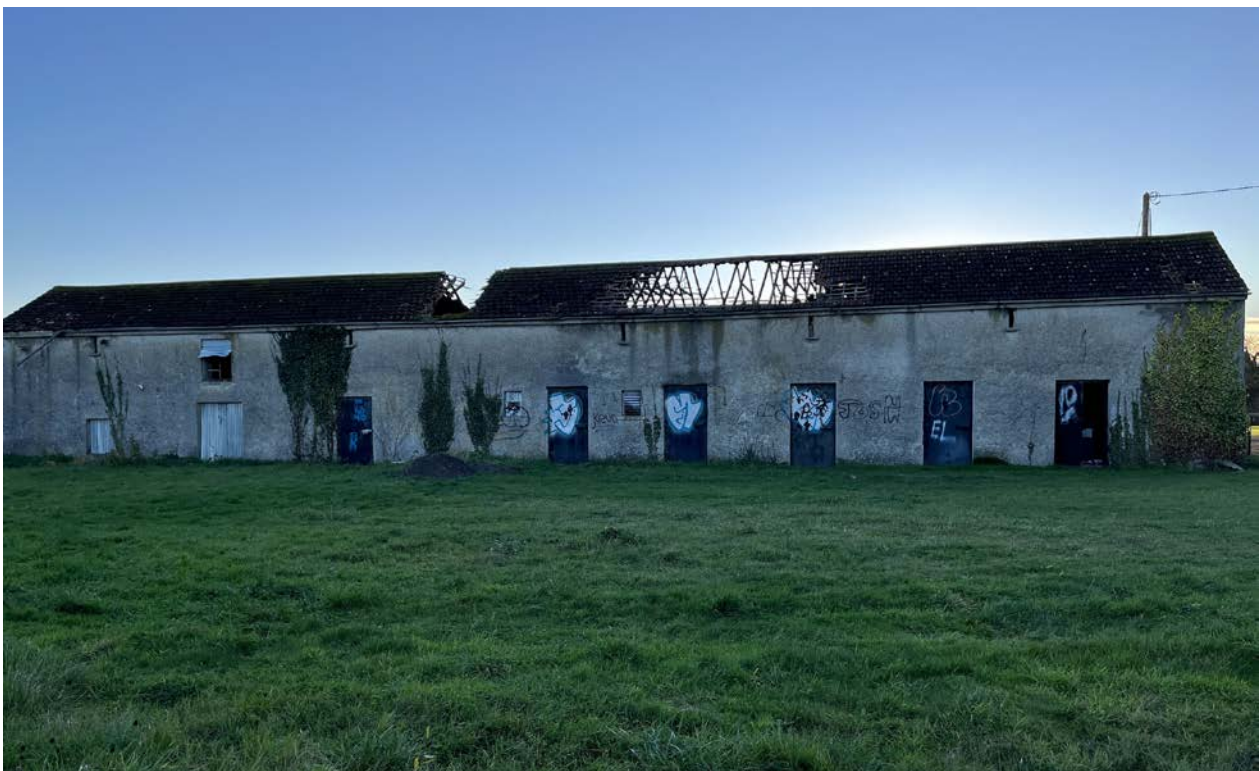
Figure 46 - The east-west stable building in advanced state of dereliction

The removal of all roofing slates and concrete tiles will be undertaken – many of which have already fallen from the collapsed roofs. Careful grading should be undertaken of any historic slates if found and they should be stored for reuse.

Internally the existing concrete slabs will be removed, to allow for the insertion of insulated floors, and any historic timbers, if found in the roof or loft levels should be retained and reused if in acceptable condition.
