BALLITORE TANYARD

Conservation Architect's Report

Date: 24th March 2023

Ref.: 23-308

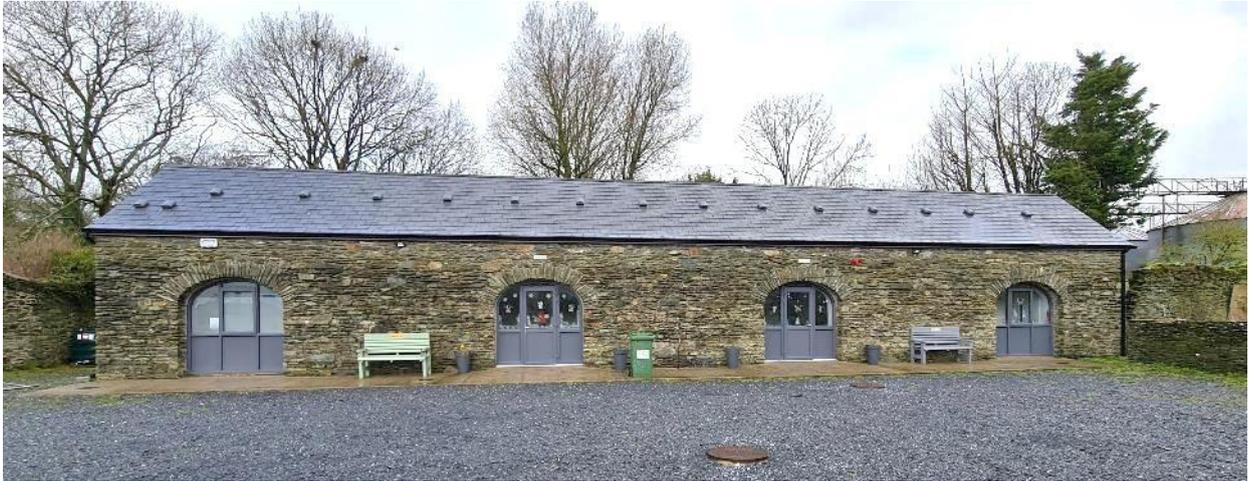
Fig. 4 South façade of Building No. 1 (formerly part of tannery, now artist’s studio/workshop) to north of Tanyard

Building No. 1 was reviewed for the outside only and appears to be in relatively good condition. The stone rubble of the external walls has been re-pointed in a cement-based mortar. This will have impacted on the vapour permeability of the wall construction and may give rise to saturation of the masonry over time. This building has timber frame glazed windows and doors, associated with its conversion to artist's studios approximately ten years ago.

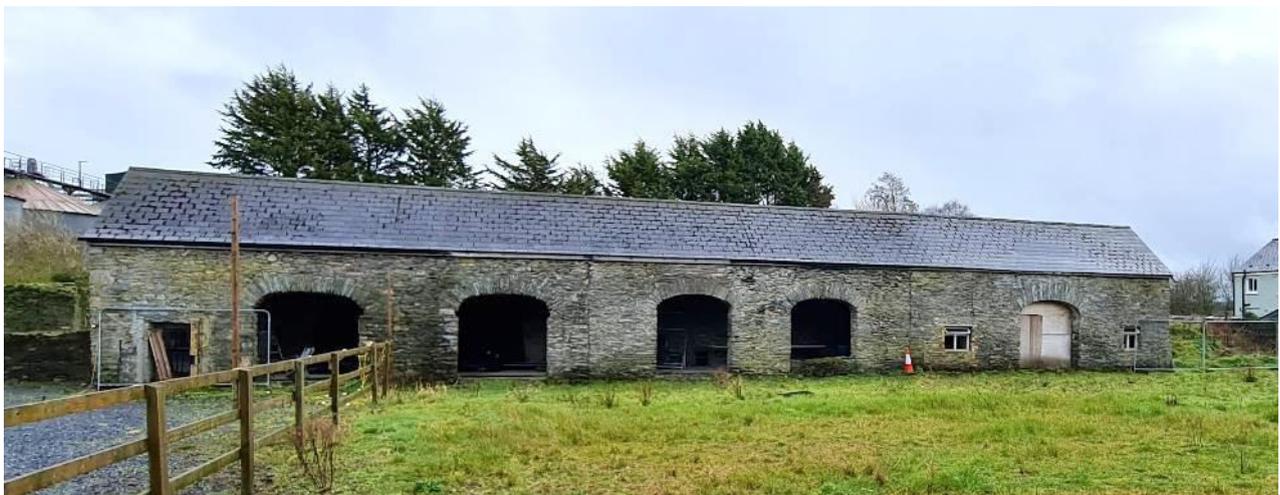
Fig. 5 West façade of Building No. 2 (formerly part of tannery) on east side of Tanyard

Building No. 2 is in relatively good condition. The external stone rubble walls retain much of their historic lime mortar and have not been subject to inappropriate cement-based re-pointing. The re-roofing of the building in c.1995 has helped to protect the fabric of the interior and the stone rubble walls. The introduction of an in-situ concrete ring beam, which would not accord with present-day conservation practice. While there was no visual evidence of cracking at the interface between this ring-beam and the stone rubble walls, it is recommended that this component is assessed by a structural engineer with conservation experience. The building has a concrete floor slab, which appears to date from the 1990's. It is unclear if this incorporated a damp proof membrane (DPM). The building was constructed in three phases, with the southern section retaining its timber loft floor structure. The large arched openings on the west façade (facing the central yard area) are unglazed and open to the elements. This has not caused any evident damage to the interior.

- Repointing and lime mortar repairs to stone rubble external walls; remove cement-based internal plaster.
- Existing roof (with fibre cement slates) to be retained for the medium term. Introduce ventilation to the roof space.

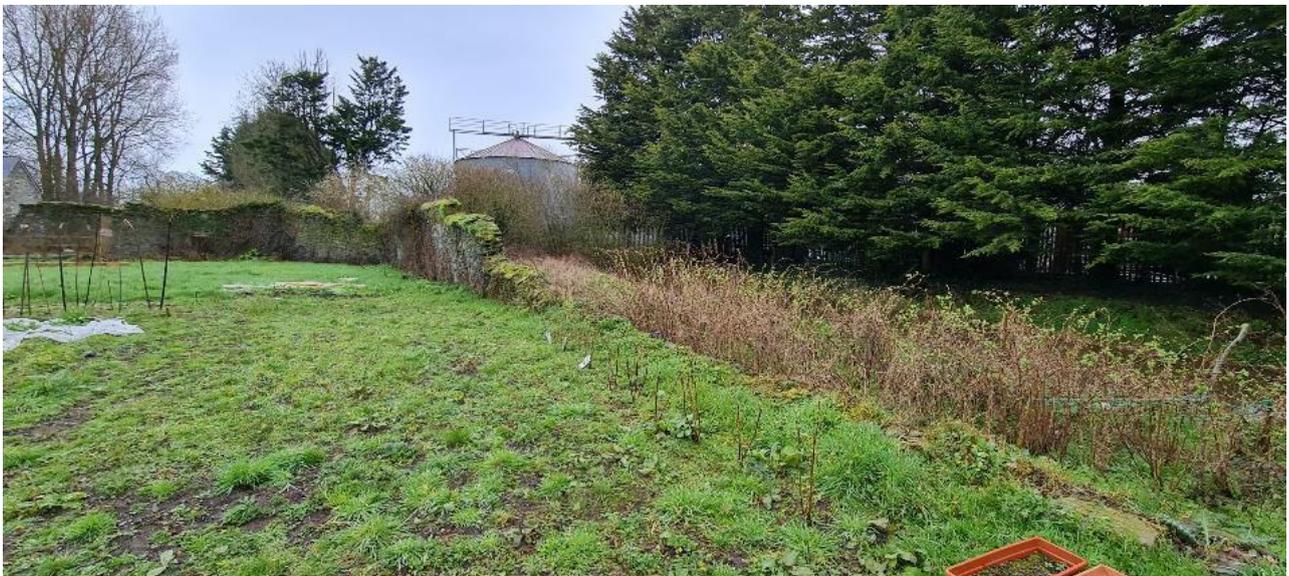
Fig. 7 The stone rubble east boundary wall to the River Griese has partially collapsed.

The stone rubble boundary walls are largely intact to the south, east and west of the site. A section of the east boundary wall, adjacent to the River Griese, has collapsed.

- Undertake localised repointing of the open joints along the east (riverside) boundary. The missing section of wall along the middle of this boundary is to be reconstructed using salvaged stone rubble. Include for arched pedestrian access to the riverbank. All new pointing to be carried out using lime mortar, with wider joints packed out using stone gallets and pins.

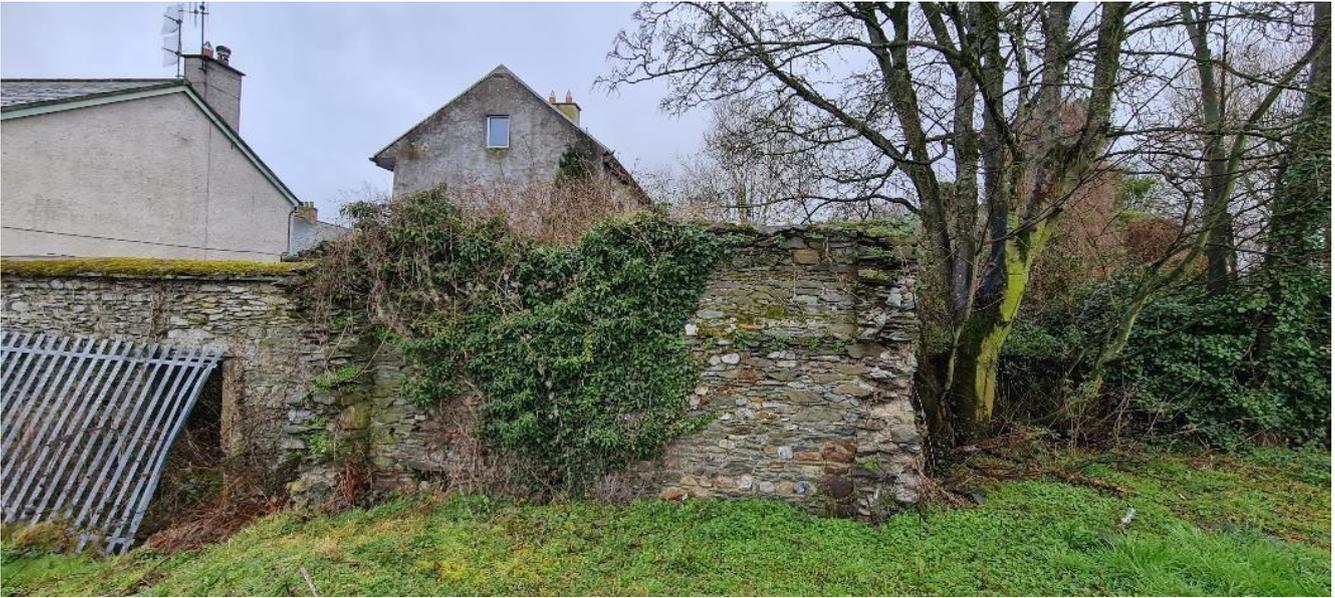
The west boundary wall to the Tanyard site incorporates stone rubble fabric from earlier (now demolished) buildings. The wall is partially overgrown with creeper and semi-mature woody vegetation. The stepped boundary line reflects the historic plot divisions of the demolished smaller buildings to the west of the former tannery. There is a group of mature self-seeded sycamores in a recess at the southern end of the boundary. The ground level in front (to the immediate east) of the boundary wall is elevated, comprising a levelled mound of stone rubble (possibly associated with the earlier demolished buildings).

Fig. 8 Detail of the west boundary wall incorporating the west wall of an earlier (now demolished) building.

- Undertake localised repointing of the open joints along the west boundary. Include for reinstatement of missing stone rubble at holes and gaps in the wall. All new pointing to be carried out using lime mortar, with wider joints packed out using stone gallets and pins.

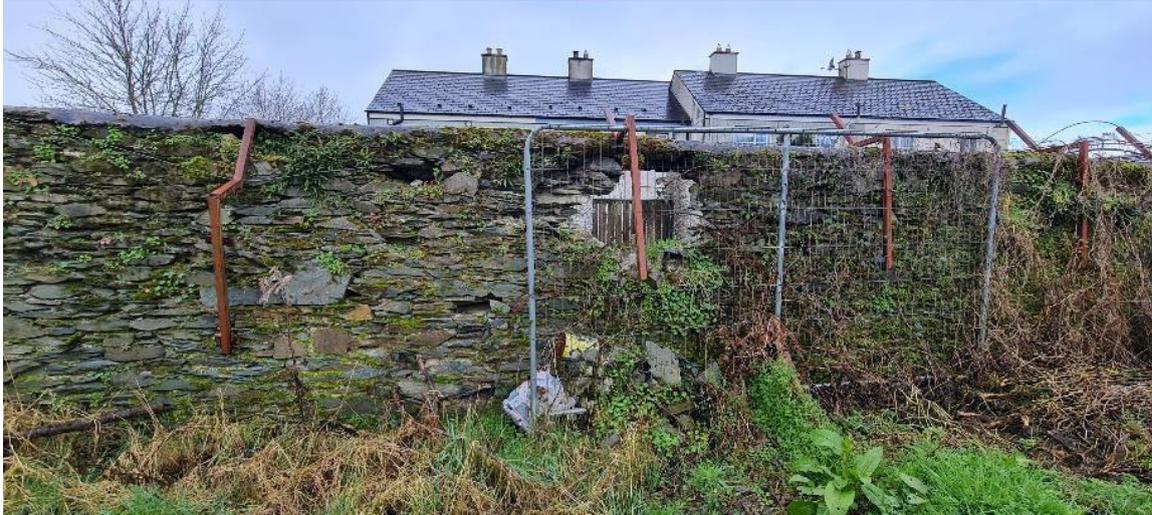
The south boundary wall has less vegetation growth and presents visually as being relatively intact. Sections of this wall have been repaired with cementitious mortar. This type of modern mortar is not suitable for use of traditional stone rubble and may cause cracking or instability over time. There are areas of missing and collapsed masonry, which require repair.

Fig. 15 Collapsed area of masonry on the south boundary wall of Tanyard

- Undertake localised repointing of the open joints along the south boundary. Include for reinstatement of missing stone rubble at holes and gaps in the wall. All new pointing to be carried out using lime mortar, with wider joints packed out using stone gallets and pins.

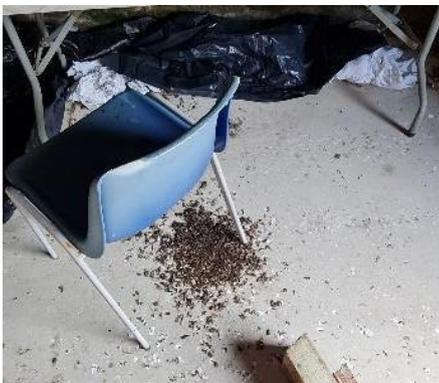
The proximity to the river and the surrounding areas of mature trees makes this an attractive location for bats and other wildlife. There are large birds’ nests visible in the trees to the north of Building No. 1. I noted clusters of droppings on the floor of Building No. 2, which indicate the bat activity within this building. The droppings were located close to the internal wall opening into the loft area, suggesting that the southern part of the building is used by bats.

Fig. 16 Probable bat droppings within Building No. 2

A bat survey should be carried out, encompassing Building No. 2 and the surrounding site, before carrying out significant construction work. This survey should ideally be carried out between May and early September.

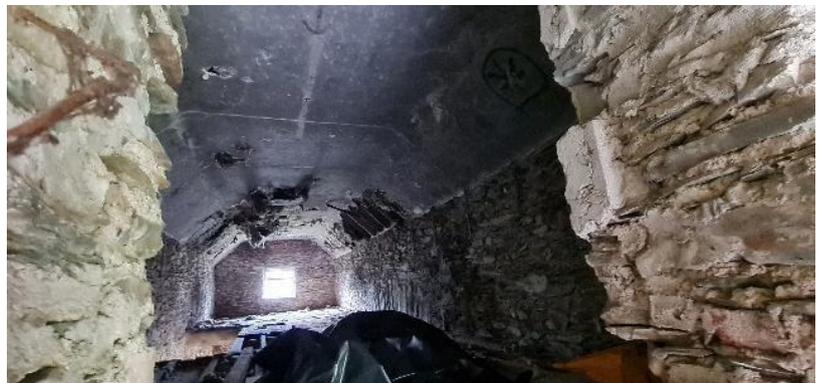
Fig. 17 Interior of loft above southern part of Building No. 2

- Install hygroscopic wall insulation (calcium silicate board or similar) to external walls, with cork lime plaster to loadbearing cross walls.
- Remove decayed loft floor and partially collapsed loft ceiling within southern part of building; fit out interior to include toilets, kitchenette, and ancillary accommodation.
