# Conservation Management Plan

Clane Abbey Community Centre

Final Nov 2023

For Kildare County Council

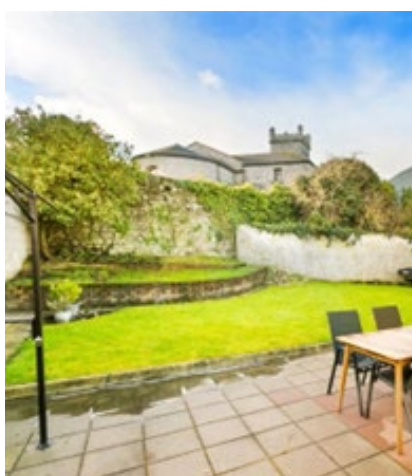
**Figure 6.3 (Left)** Graveyard retaining wall to a private garden, and in the distance the adjoining garden retaining wall to Behan's overgrown with considerable vegetation.

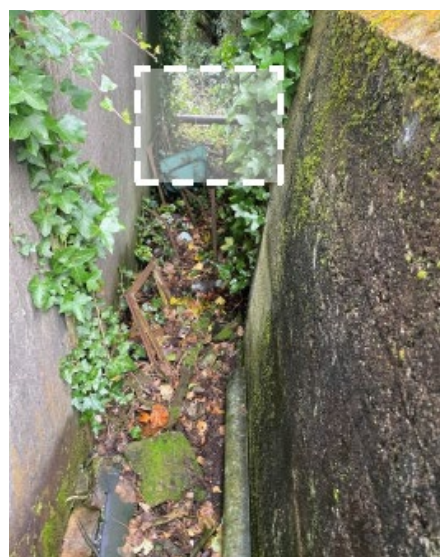
**Figure 6.4 (Right)** Later Foul Pipe servicing the community hall above ground and is vulnerable to damage

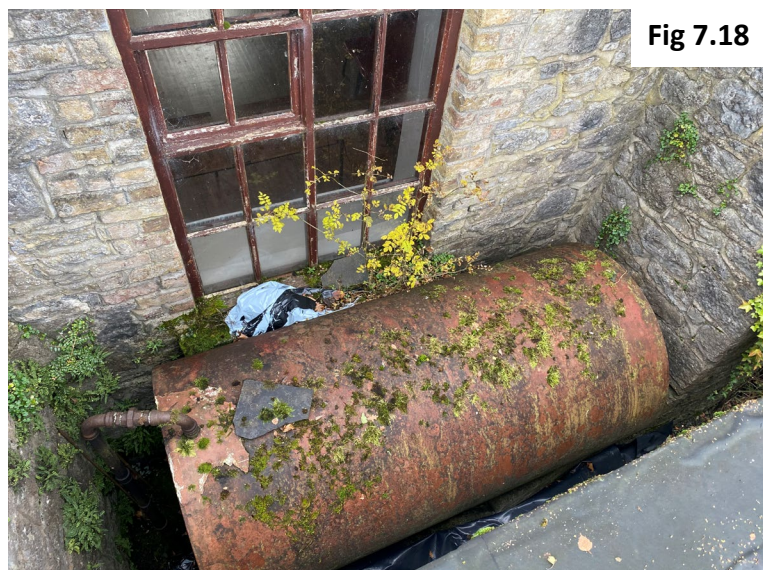
**Fig 7.18**

*Window above oil tank in need of repair and removal of plant growth at base. Location of the tank is problematic to service or even to replace.*

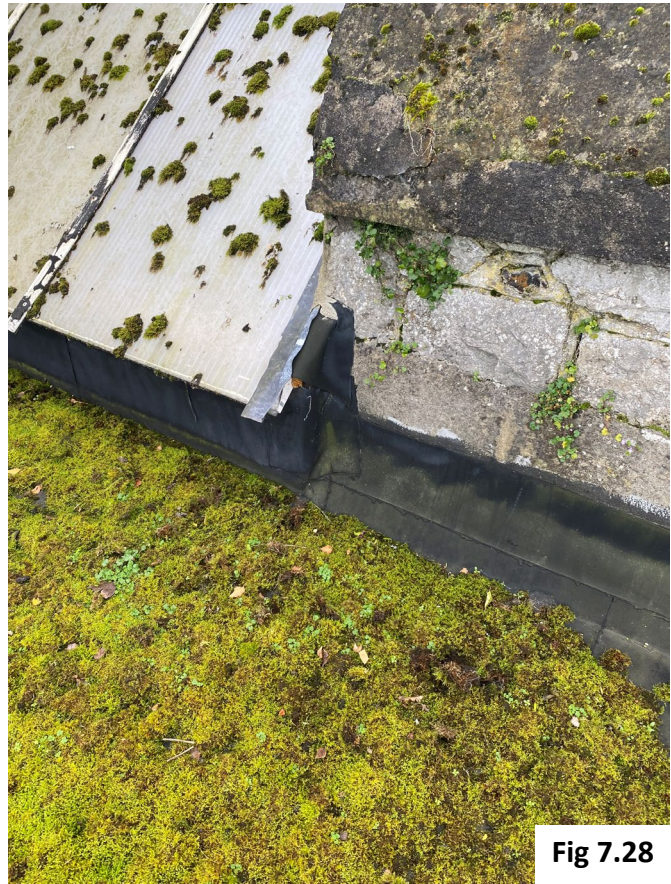
**Fig 7.28**

Extent of moss indicates issue with the fall on the roof.

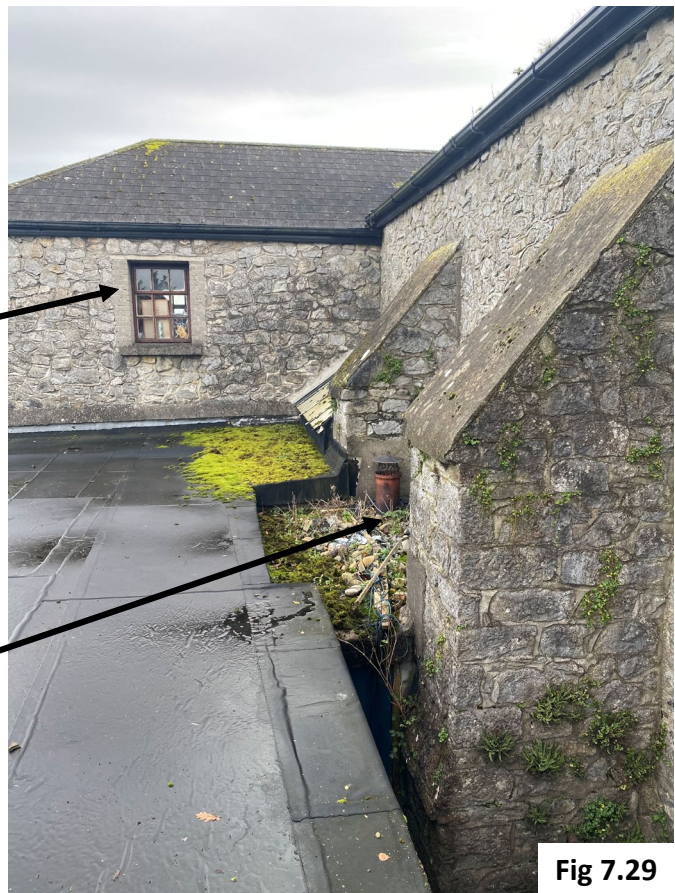
**Fig 7.29**

**Fig. 7.29** *Condition of flat roof adjoining Roof 2*

Roof above boiler house has a lot of debris and is at a lower level than the rest of the roof. Overlap from higher roof may not be sealed.

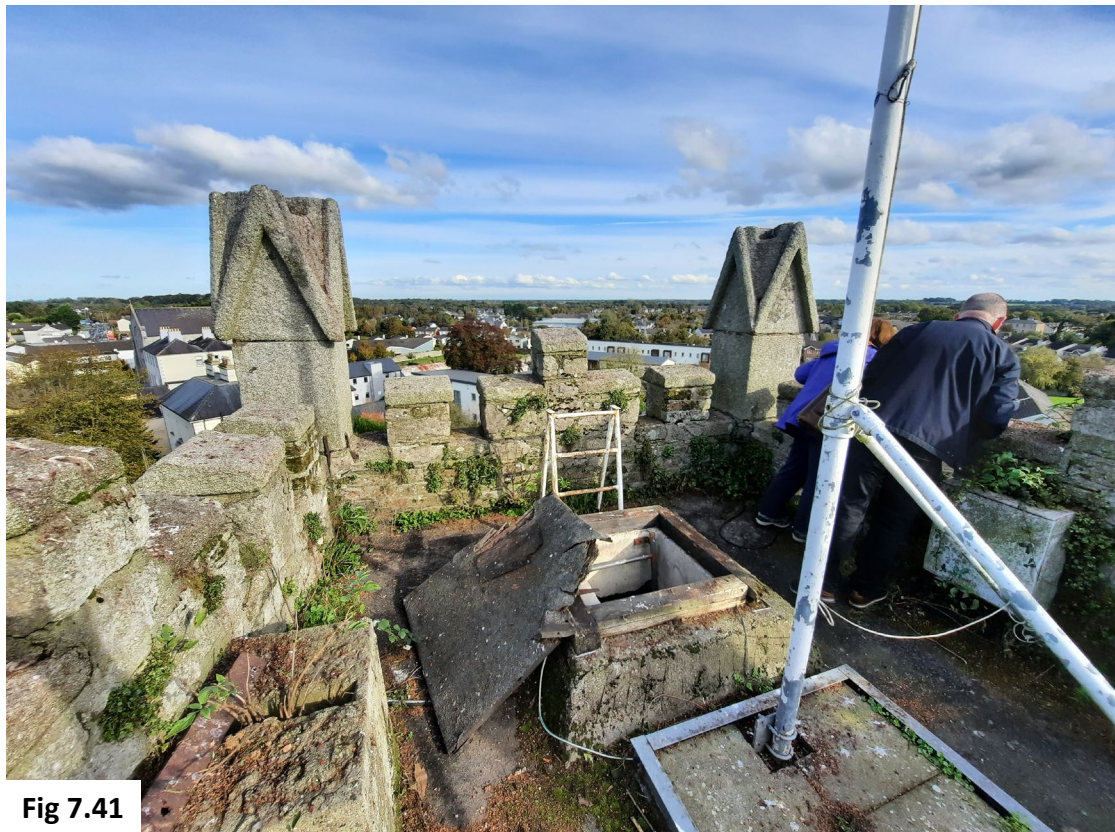
Fig 7.41

The top of the tower was rebuilt to include a concrete slab. This appears to be covered in bitumen and dressed horizontally through the walls to a ledge. The existing pinnacles have had earlier spikes/pinnacles removed, which may have even occurred in the 1798 disturbance. The joints to the parapet wall are holding water as is evidence from the biological growth. The coping stones are very worn and possibly holding water. The access to the tower hatch is by a timber ladder which may need to be changed to something with a restrainer cage. The plywood access hatch itself is presently disintegrating. It needs immediate attention to prevent further damage due to water ingress. e.g. to be fitted with some form of cover. The external parapet to the top of the tower has a linear flood lighting system and conduit which may be trapping water and debris sufficient to encourage Buddleia and other plant growth. This stone string course and all the water outlets from the roof need to be relined to ensure water is discharged in a safe manner. To the top of the tower there appears to be the remains of lightning protection, and a flag pole with occasional use.

An assessment report is needed by a conservation structural engineer to look at cramps on the pinnacles, and supports to the floors further down the tower. Sectional drawings provided with this Conservation Management Plan should enable an accurate scope of works for this.

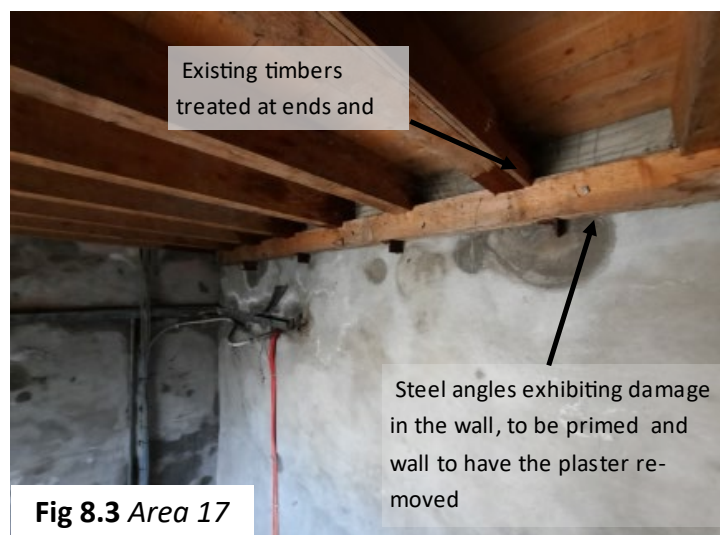
Fig 8.3 Area 17

Existing timbers treated at ends and

Steel angles exhibiting damage in the wall, to be primed and wall to have the plaster removed

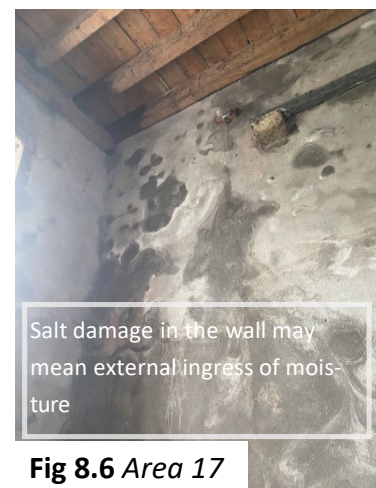
Fig 8.6 Area 17

Salt damage in the wall may mean external ingress of moisture
