REPORT ON THE ARCHITECTURAL/HISTORIC SIGNIFICANCE  
OF DERELICT COTTAGES ON STATION ROAD, KILDARE,  
COUNTY KILDARE AND ASSOCIATED LANDS TO THE REAR

OBSERVATIONS ON THE IMPACT OF CURRENT DEVELOPMENT  
PROPOSALS

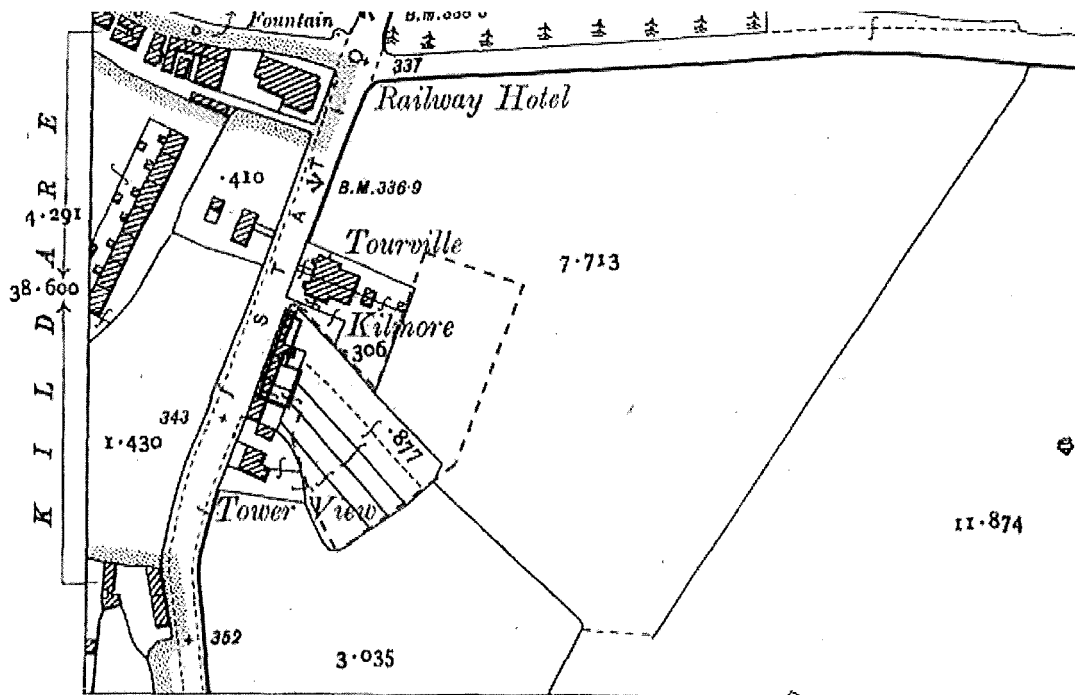
Figure 6: 1908 3<sup>rd</sup> Edition Survey Map. The Blue dashed line outline indicates the approximate subject site. The red line indicates the approximate subject cottages.

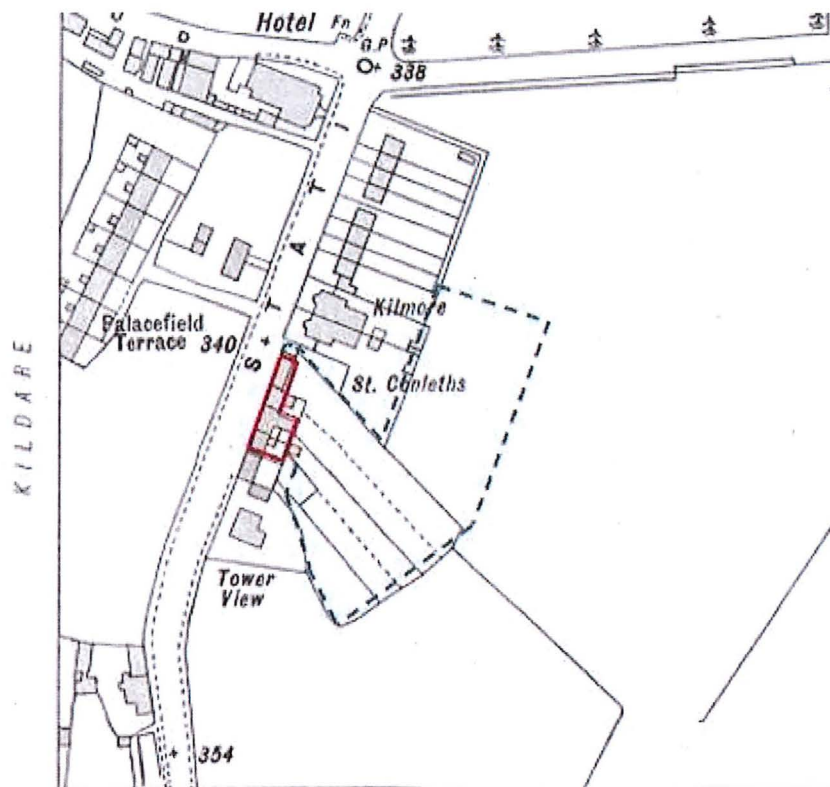
Figure 7: 1939 Last edition Survey Map. The Blue dashed line outline indicates the approximate subject site. The red line indicates the approximate subject cottages.

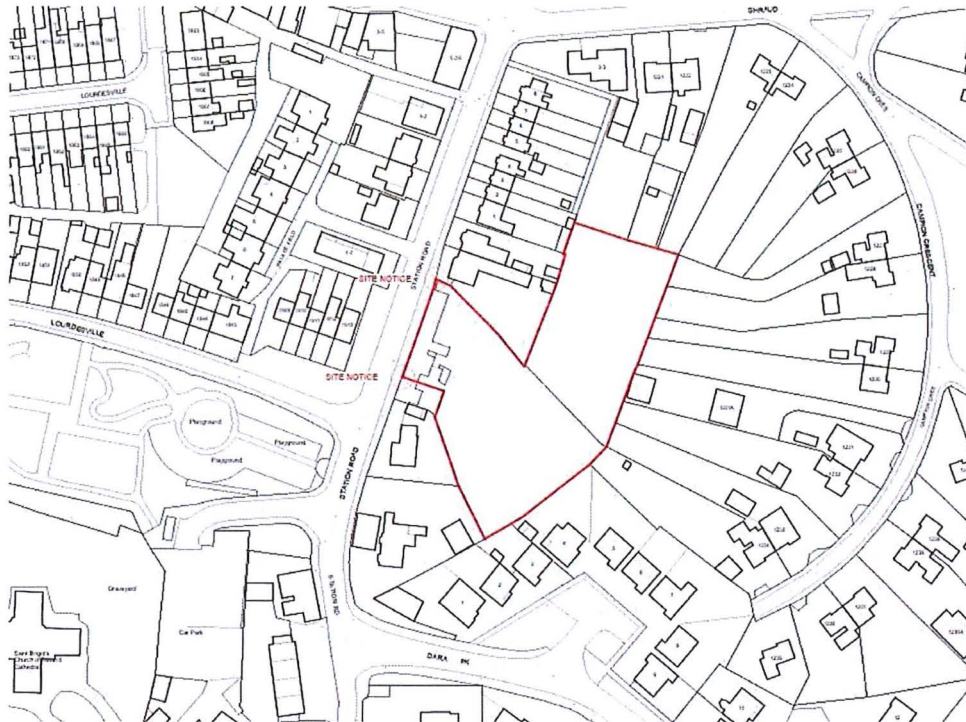
Figure 9: Current OS Map. Red outline indicates the subject site. Source: Shay Cleary Architects.

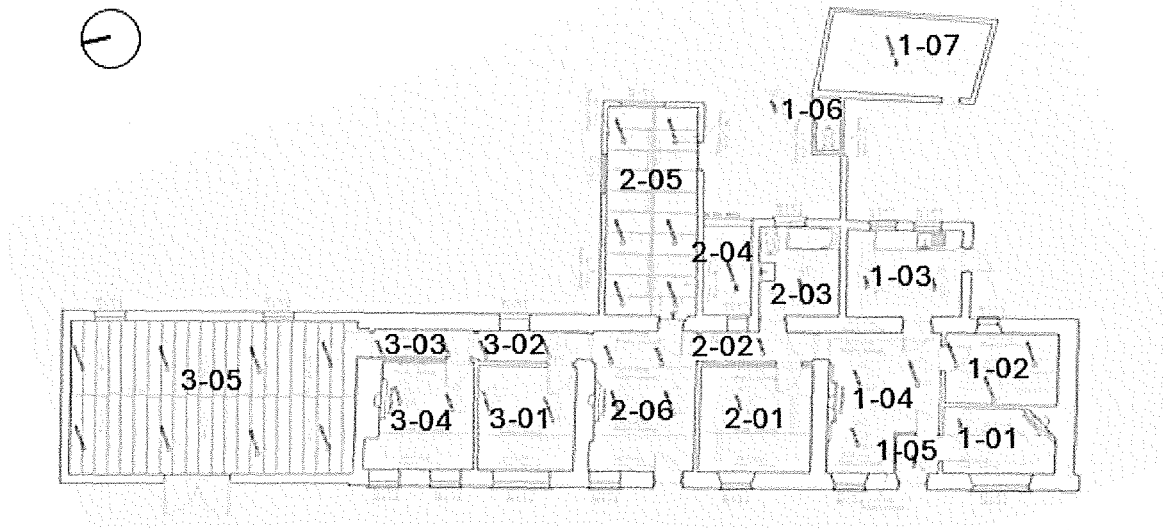
Figure 10: The cottages. Ground Floor key plan with added room numbers. Source: Shay Cleary Architects & Apex surveys.

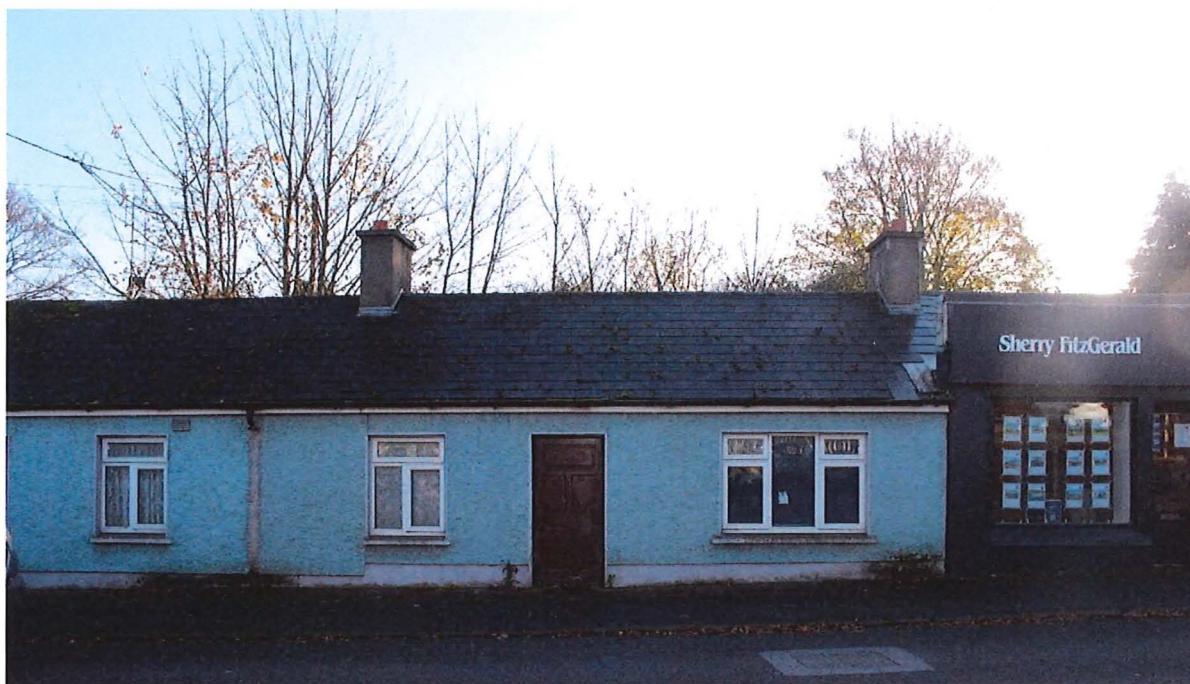
*Figure 13: The cottages viewed from Station Road. West elevation, south section.*

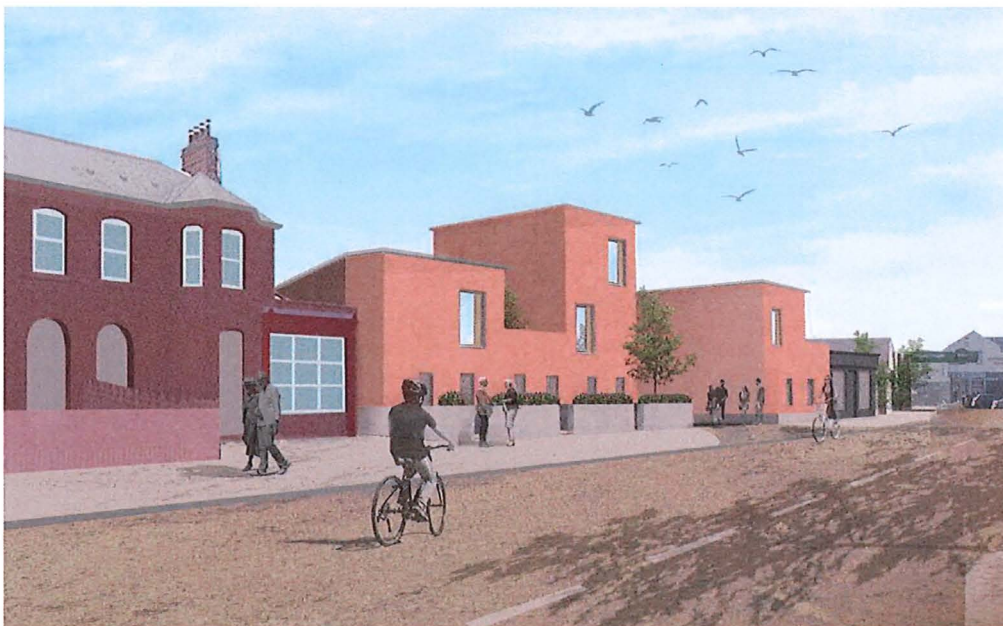
Figure 21: Proposed view on Station Road. Looking south with the significant Edwardian houses in foreground. Source: Shay Cleary Architects.

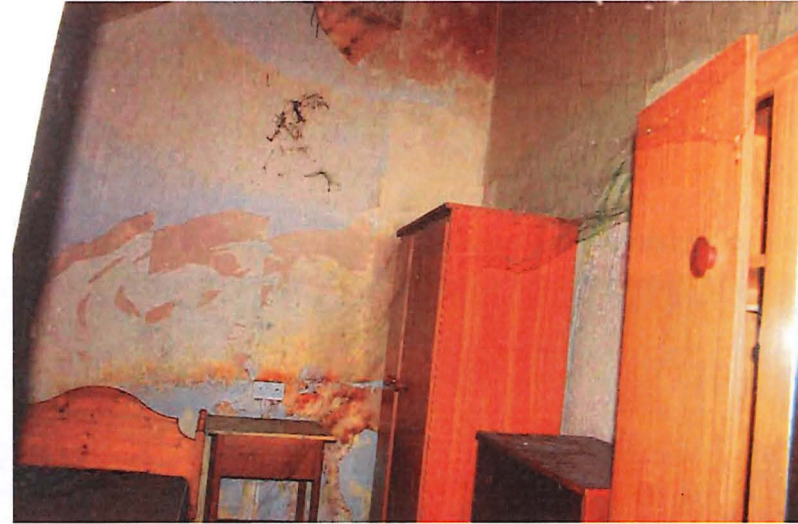
Fig. 5 – Room 1-02, looking south. Wall paper is detached from the wall and the plaster is crumbling (to the right) due to moisture.

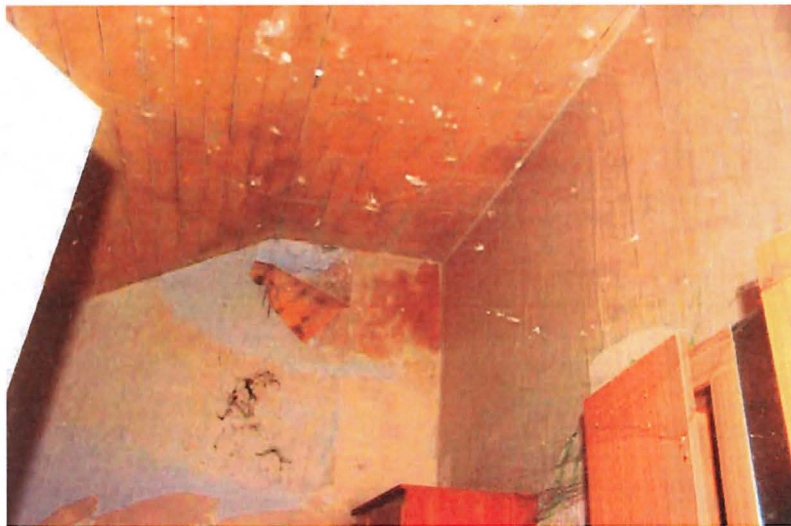
Fig. 6 – Room 1-02, looking south. The ceiling is sloped and has a timber board finish.

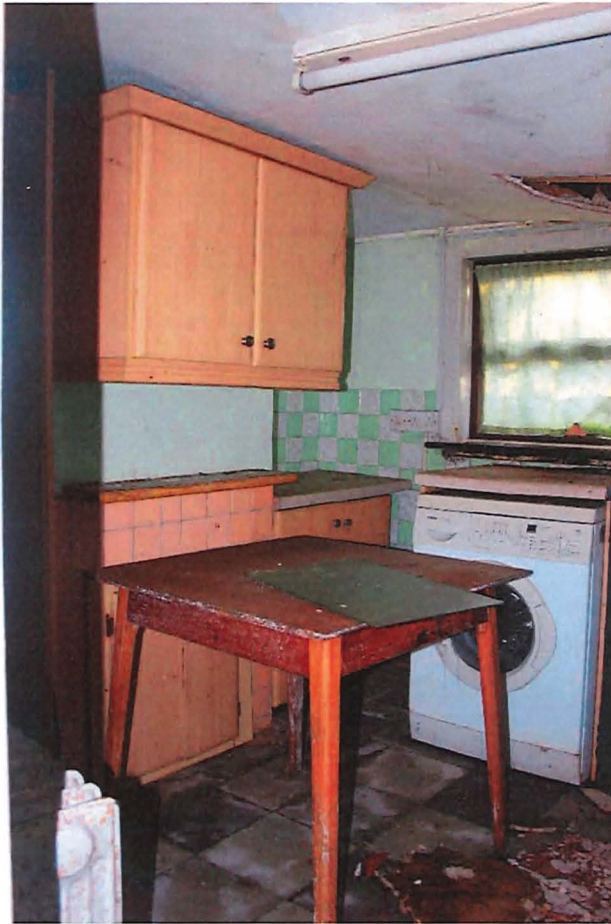
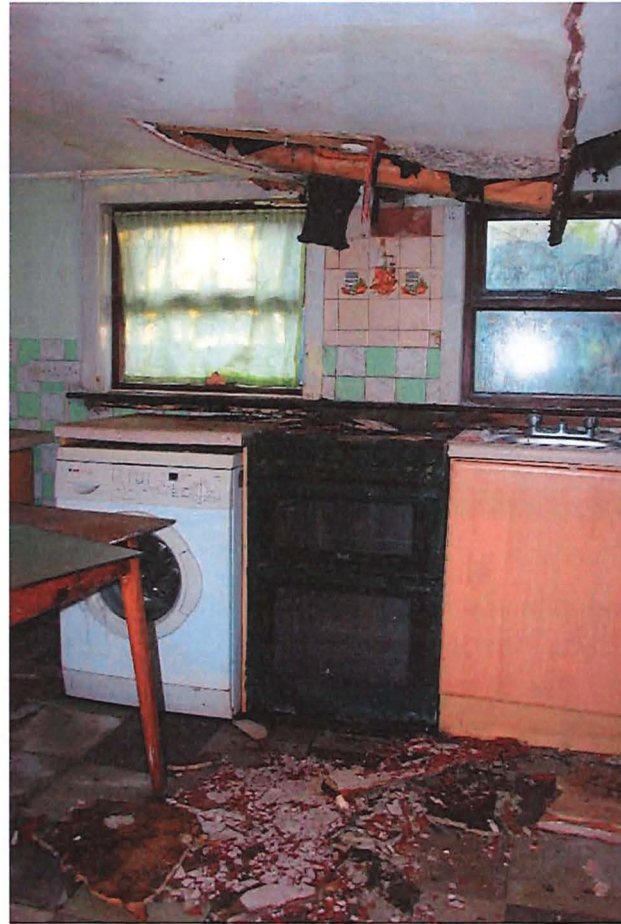
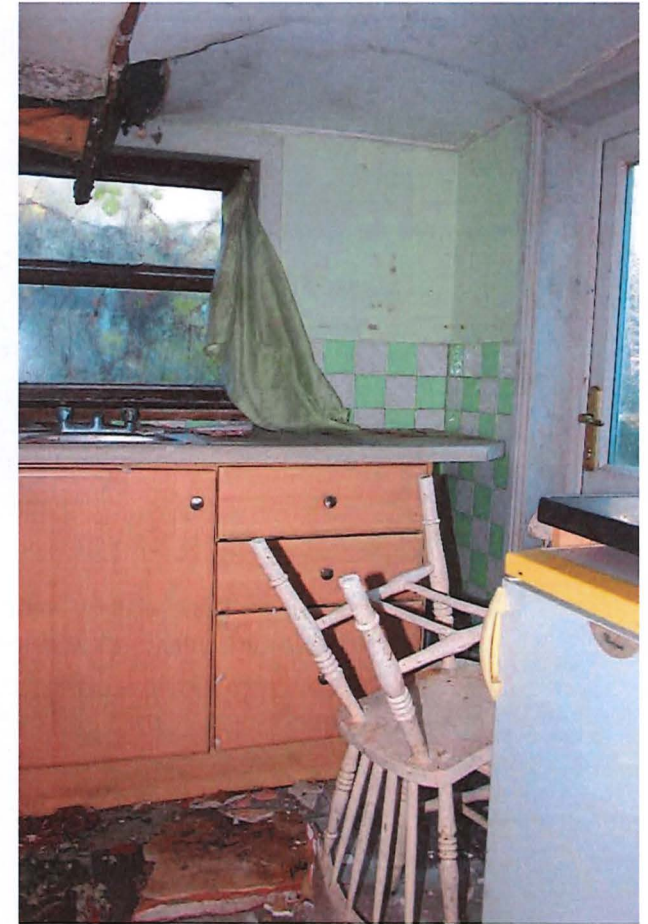
Fig. 6 & 7 & 8 – Room 1-03, looking east. Mid-20<sup>th</sup> century extension. The ceiling timber joist is disassembled and the ceiling plaster collapsed due to moisture.

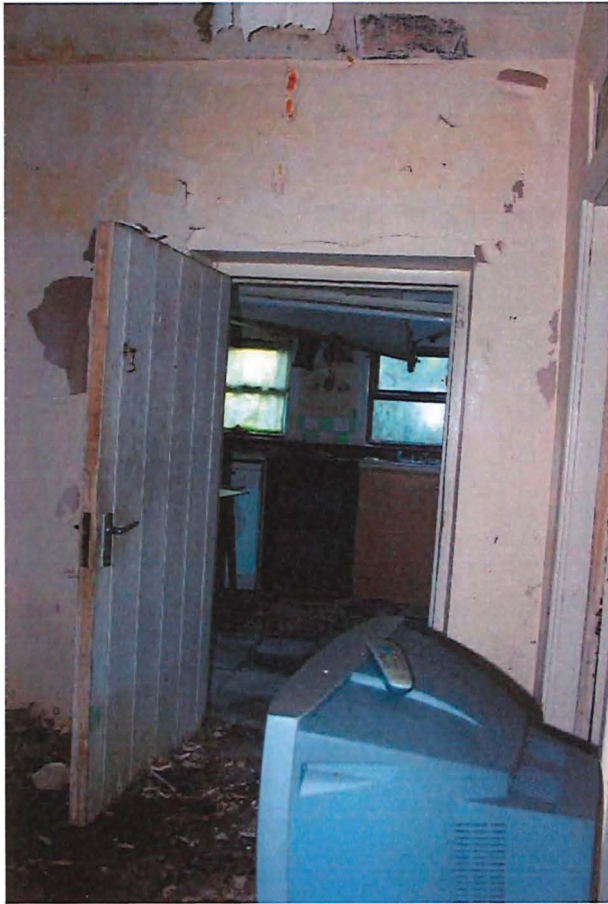
Fig. 9 – Room 1-04, looking east. Non-original timber door.

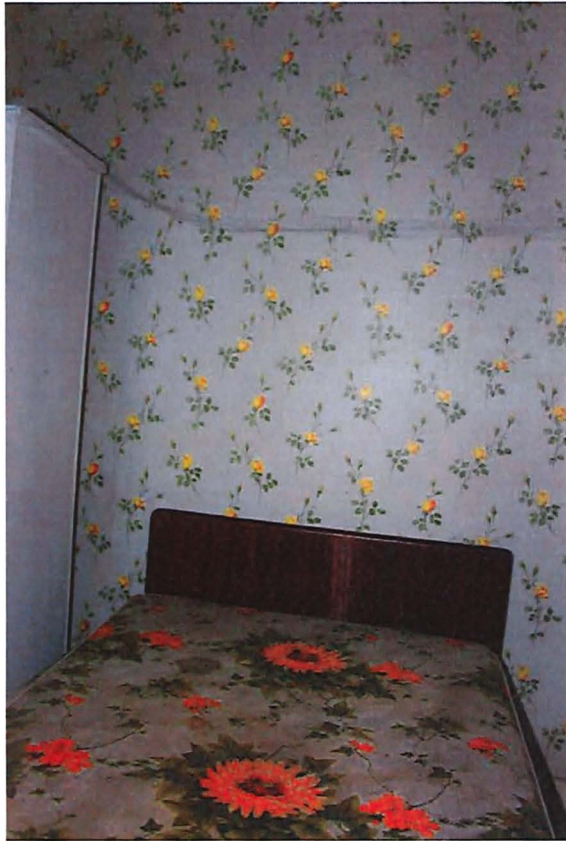
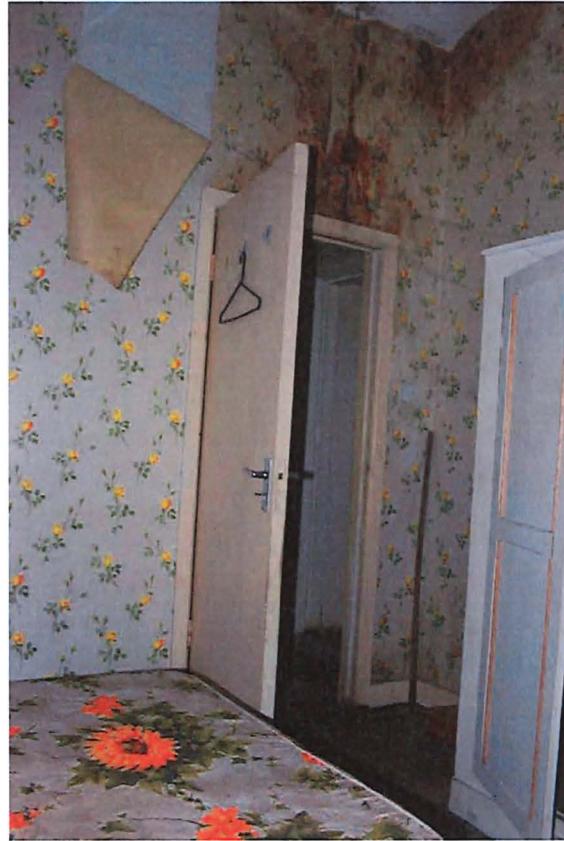
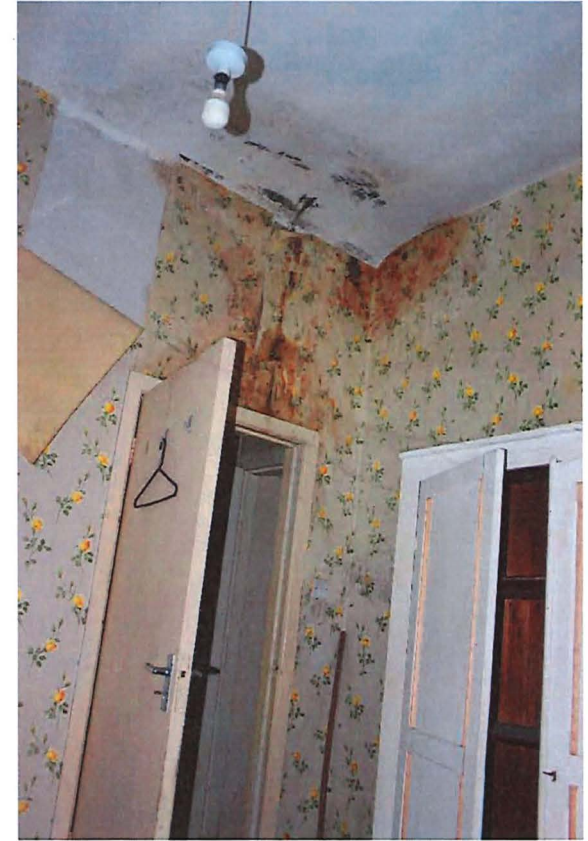
Fig. 23 & 24 & 25 – Room 2-01, looking north and northeast. Wall paper finish is detached from the walls and there are black staining due to moisture.

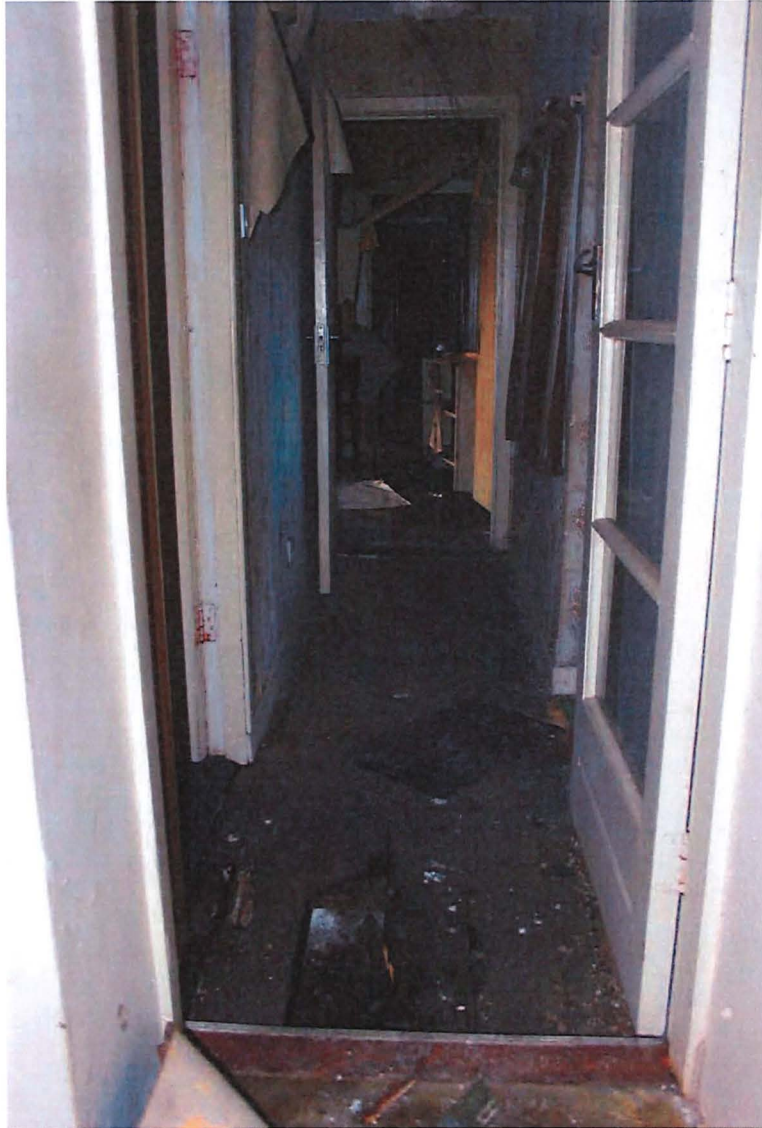
Fig. 26– Room 2-02, looking north. Section of timber floorboards is missing, wall paper finish is detached from the walls due to moisture.

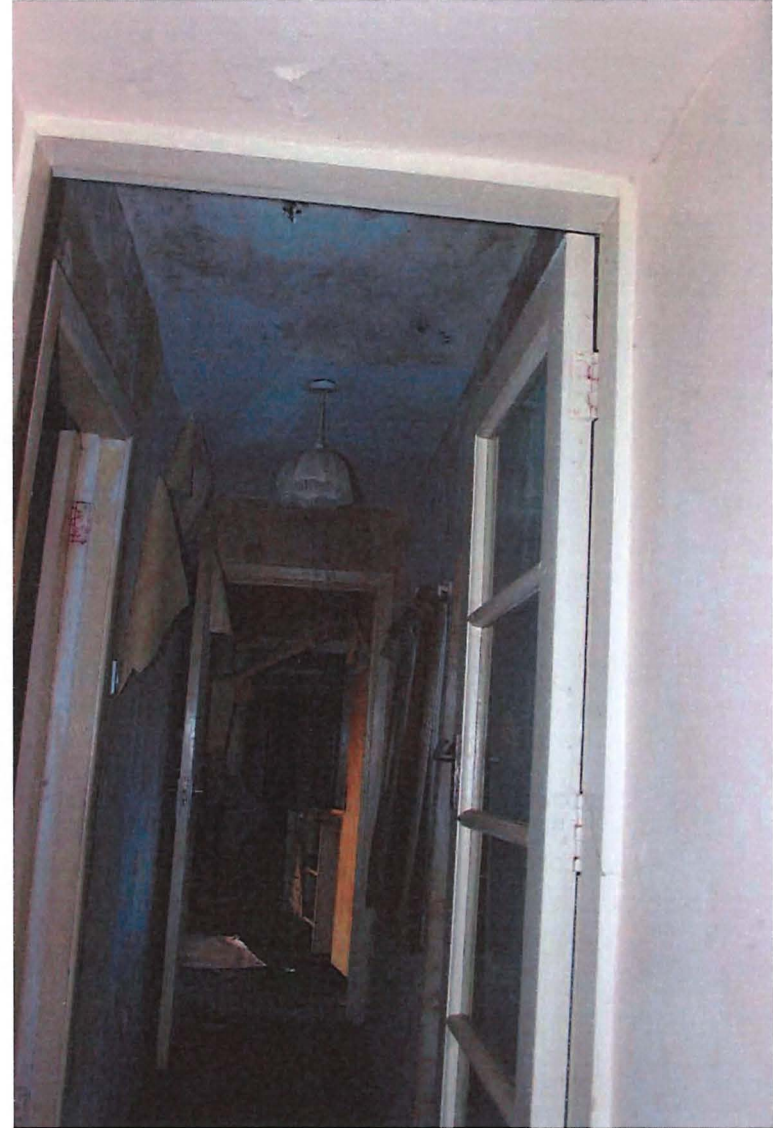
Fig. 27– Room 2-02, looking north. Plasterboard ceiling finish shows signs of moisture.

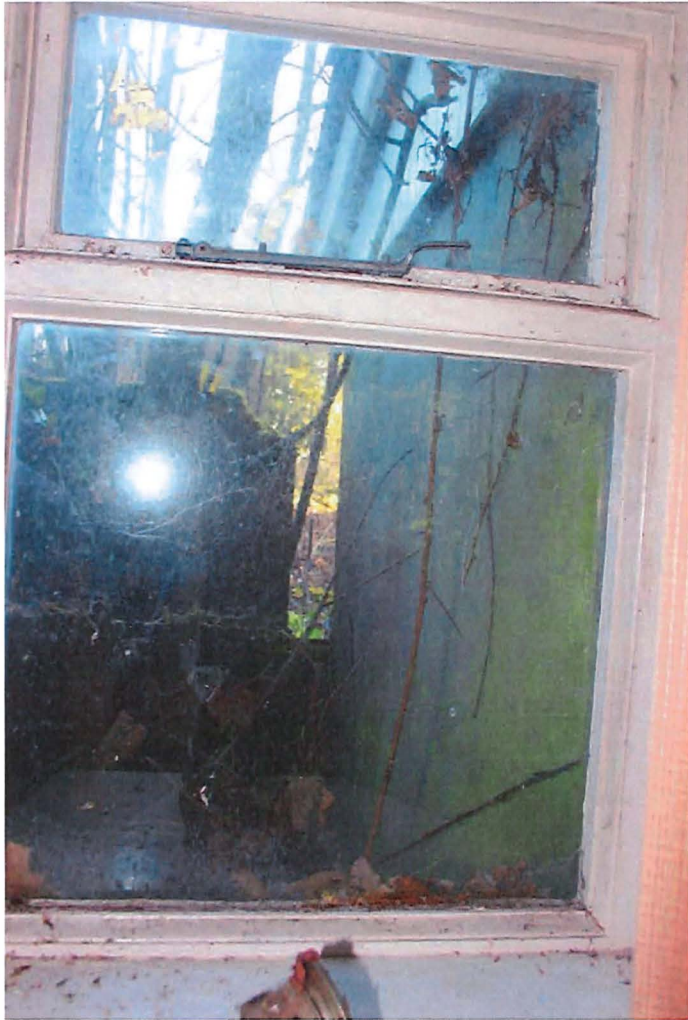
Fig. 28— Room 2-02, looking east. Non-original timber window.

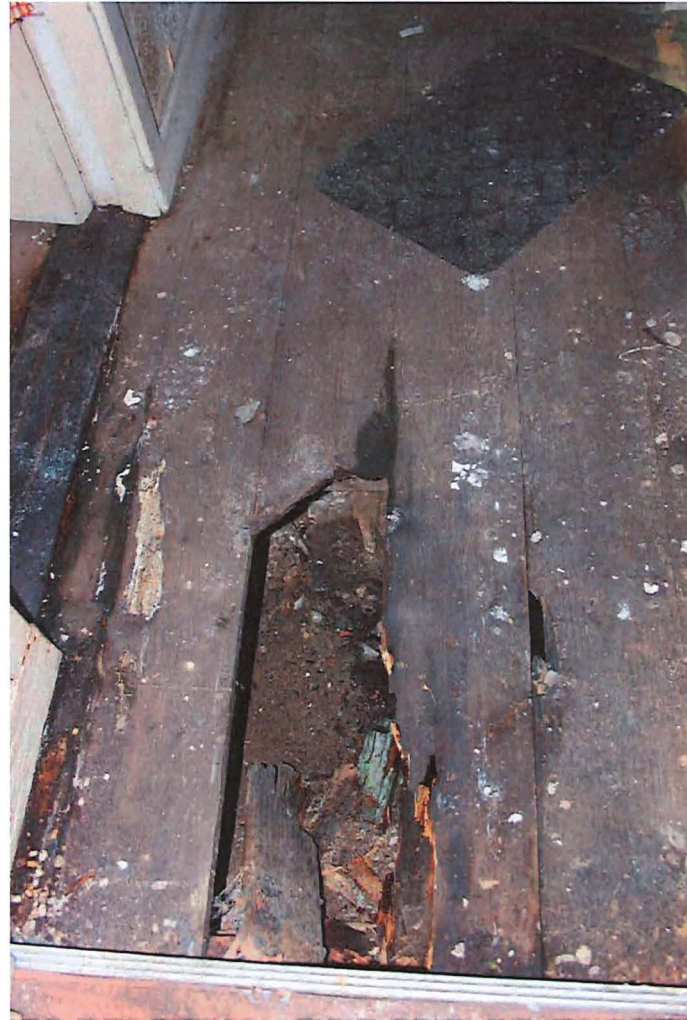
Fig. 29— Room 2-02, section of timber floorboards is missing.

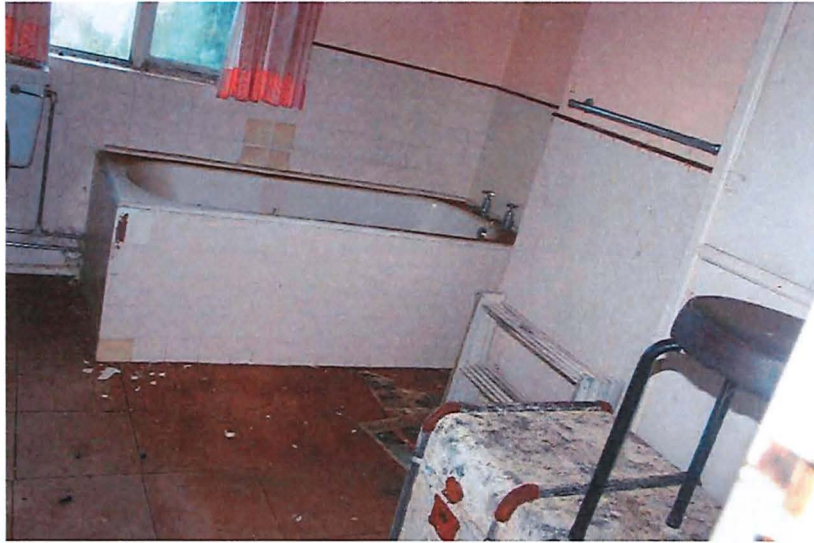
Fig. 30– Room 2-03, looking east, mid-20<sup>th</sup> century extension bathroom, tiles on the floor and the bottom section of the walls.

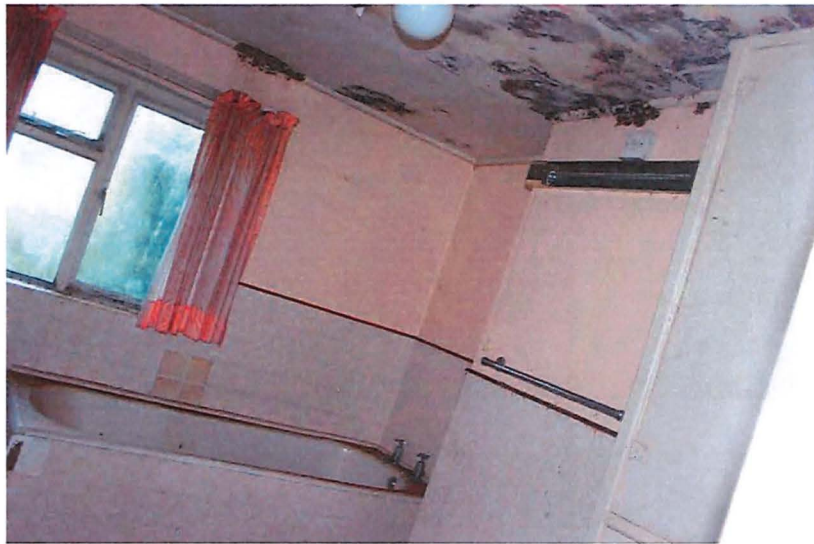
Fig. 30– Room 2-03, looking east, mid-20<sup>th</sup> century extension bathroom, black stains on the plasterboard ceiling due to moisture.

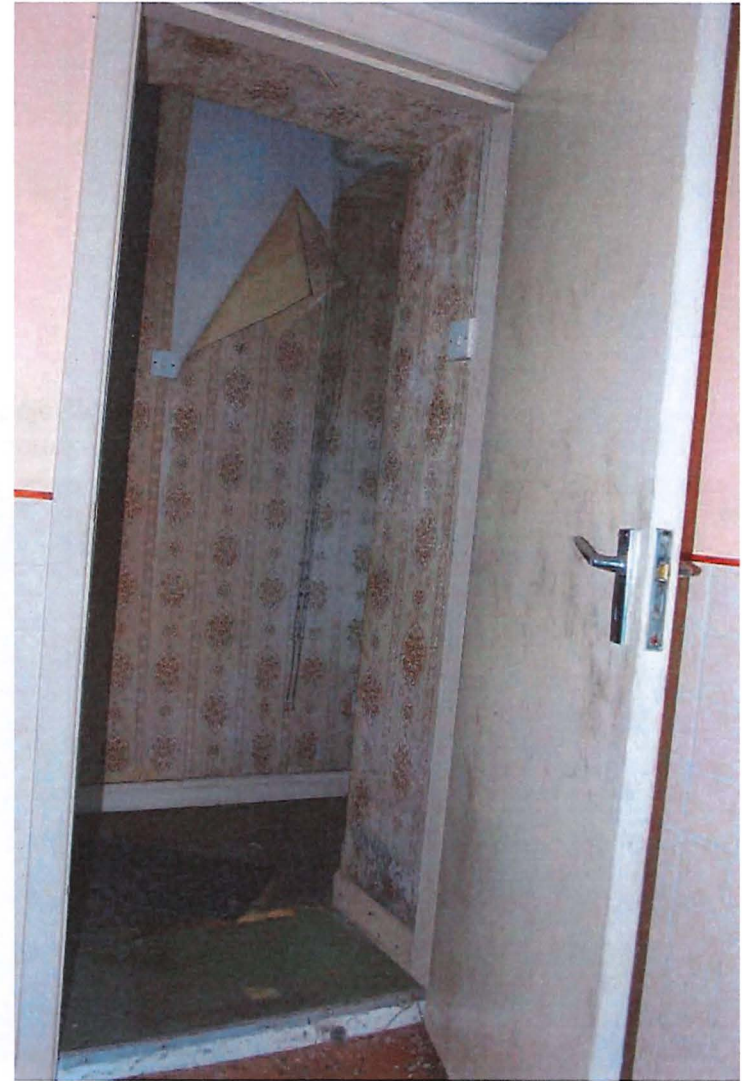
Fig. 31– Room 2-03, looking west to room 2-02, non-original timber door.

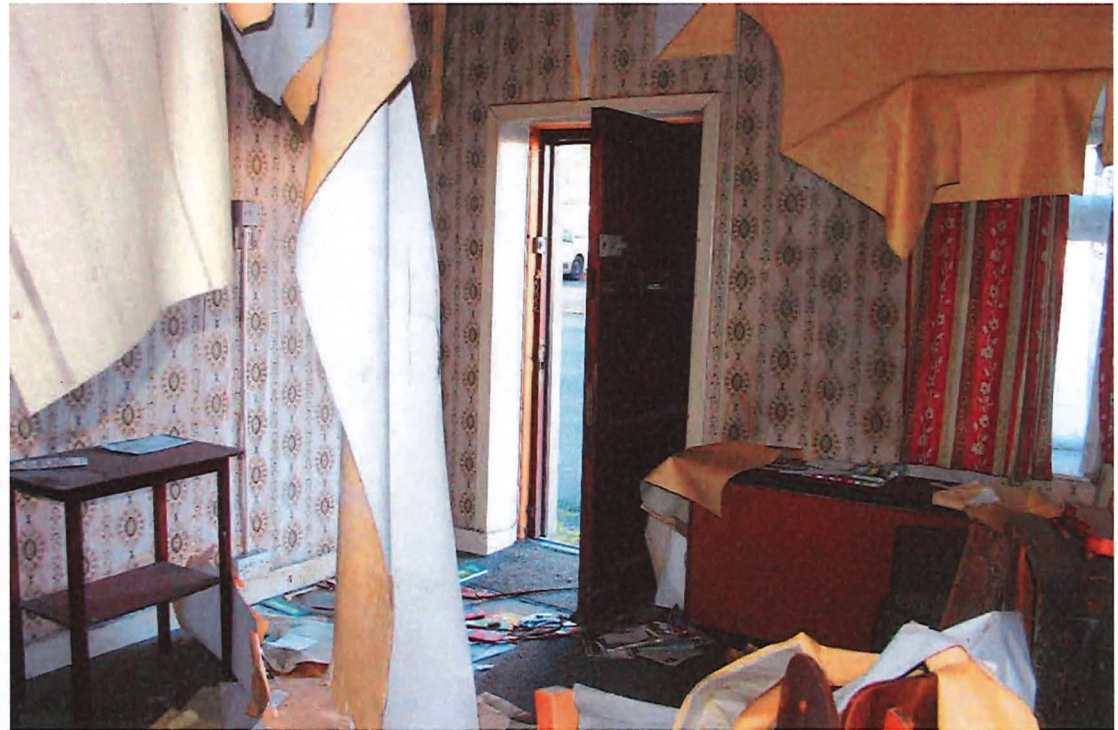
Fig. 37– Room 2-06, looking west, wall paper is detached from walls due to moisture.

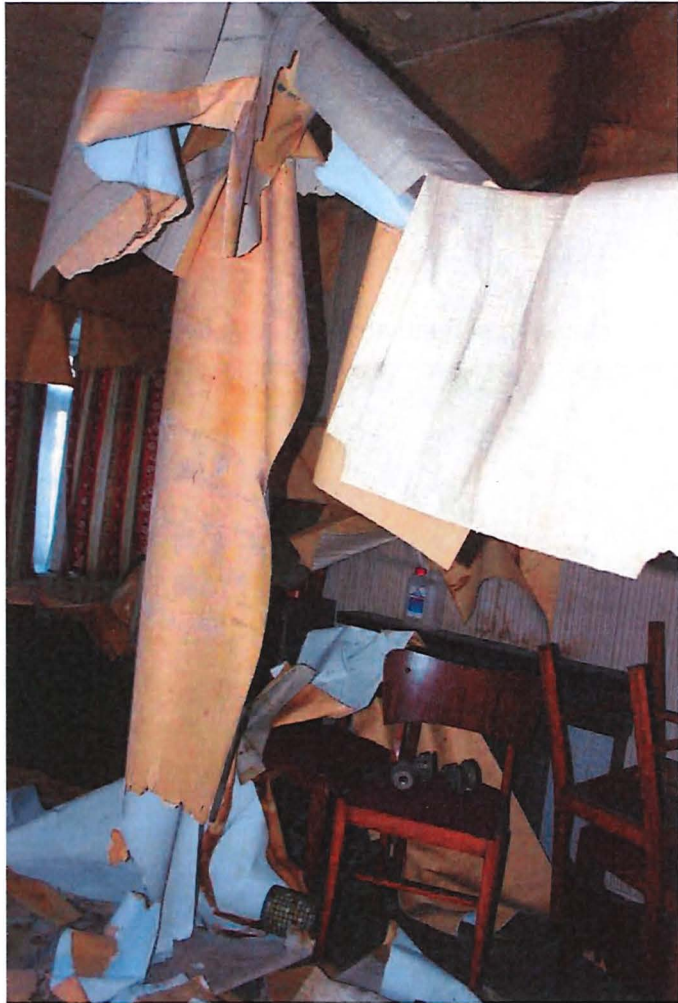
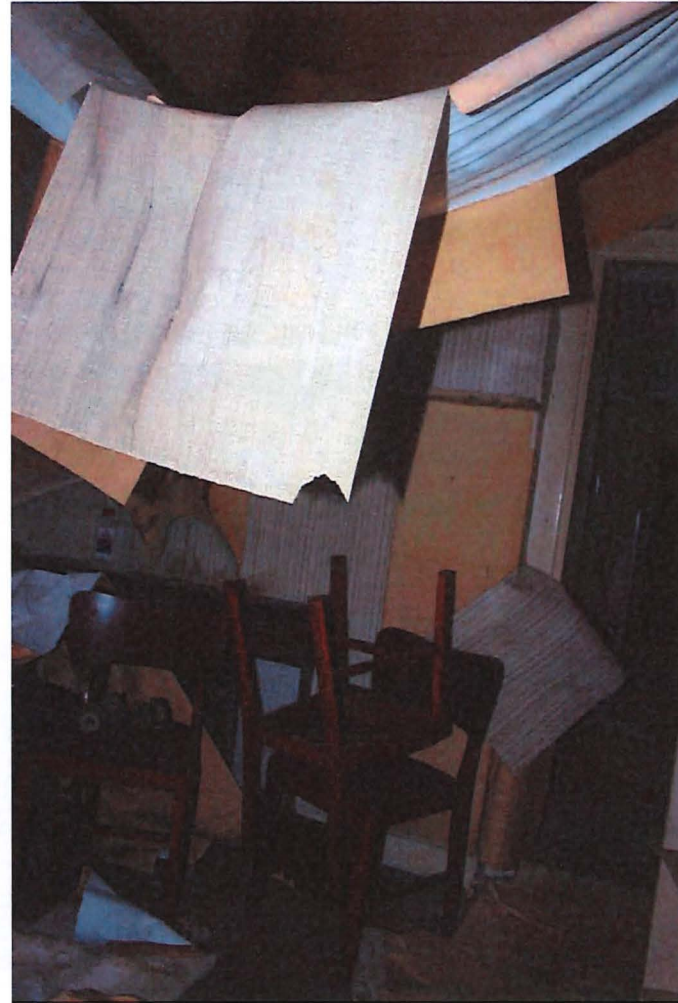
Fig. 38 & 39– Room 2-06, looking north, wall paper is detached from ceiling due to moisture.

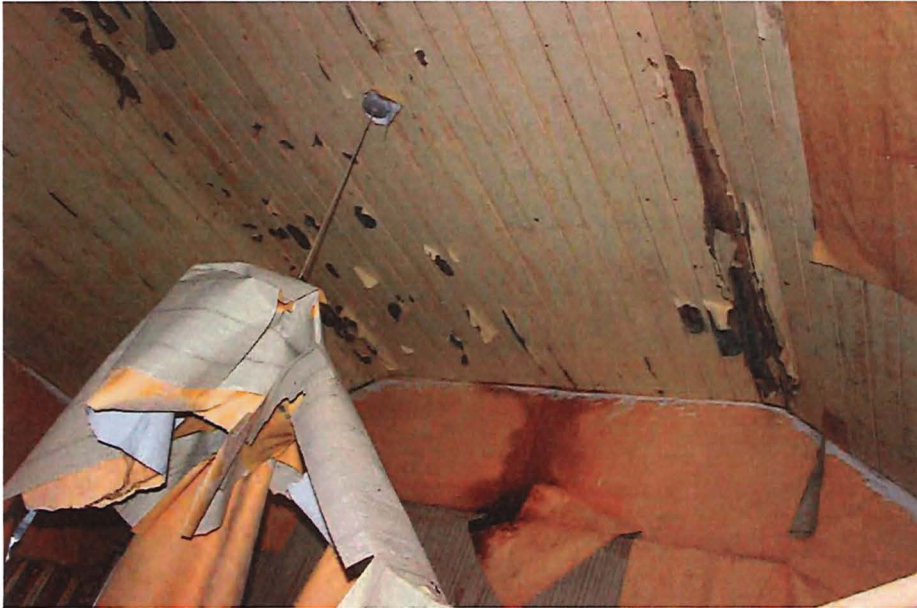
Fig. 40– Room 2-06, looking north, painting is detached from ceiling timber boards.

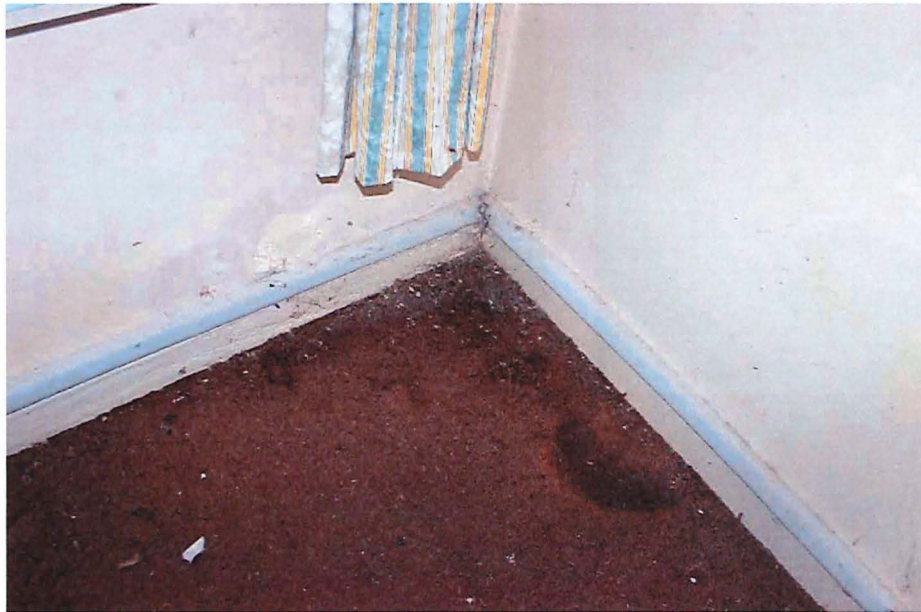
Fig. 51– Room 3-04, looking northwest. The carpet finish floor shows signs of moisture

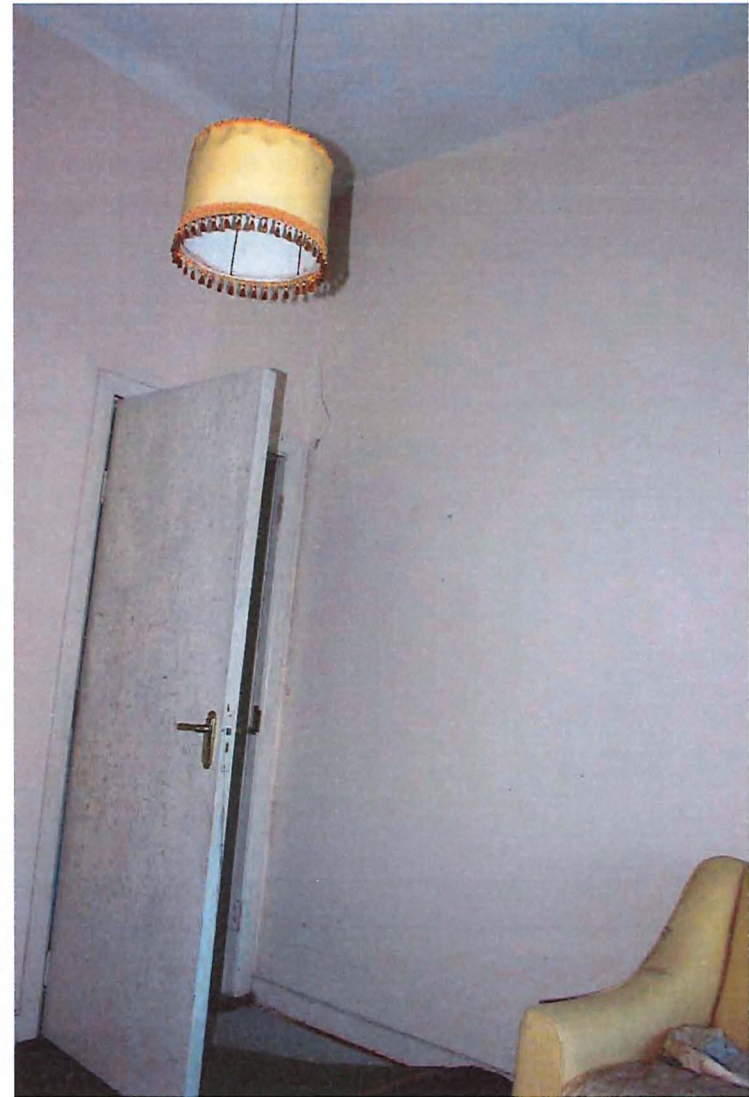
Fig. 52– Room 3-04, looking southeast. Non-original timber door.
