Re-using Farm Buildings

A Kildare Perspective
Authors Laura Bowen and Nicki Matthews

Authors: Laura Bowen and Nicki Matthews

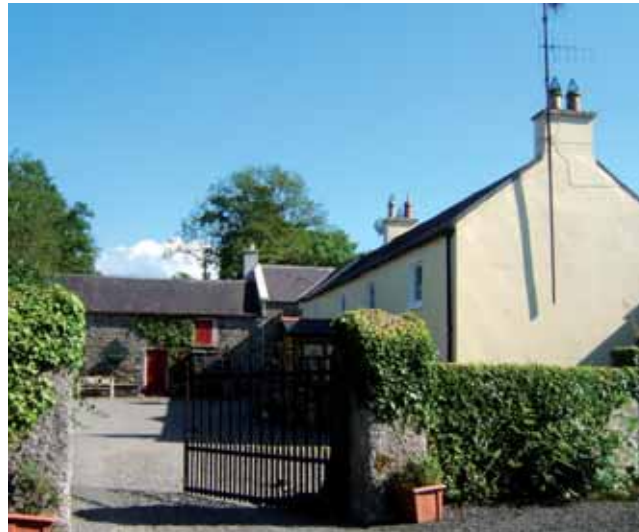
Farmyard enclosure near Eadestown with a fine example of a farmyard wrought iron 'button' gate entrance.

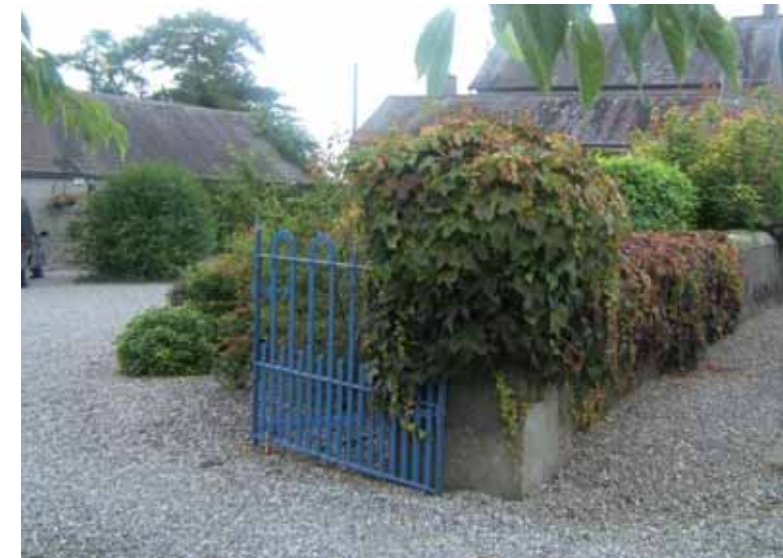
Below: Entrance to the earlier, 18th-century farmyard and house at Mylerstown.

Mylerstown House (case study no. 8) is a wonderful example of a very early modest two-storey farmhouse that was subsequently reconfigured into a more substantial edifice, while retaining a cobbled sett yard with a small box garden next to the 18th century entrance of the earlier house.

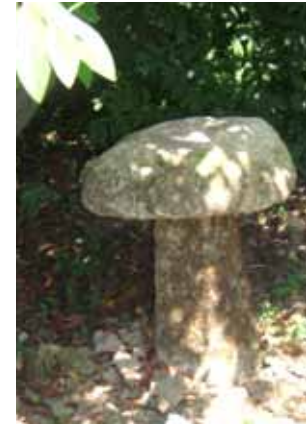
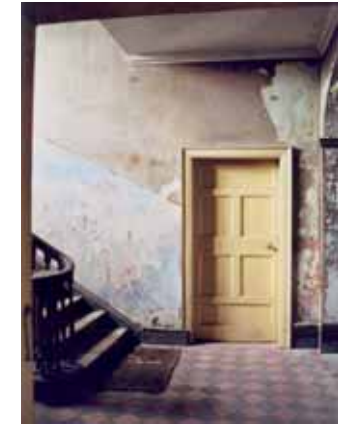
*Top left: Cow-and-calf wall. This refers to stone detail at the top of the wall where smaller stones are interspersed with larger ones.
Above (left): Stone toadstool for supporting hay rick.
Above (right): Interior shot of Belin House with red and black terracotta floor to entrance hall stairwell.*

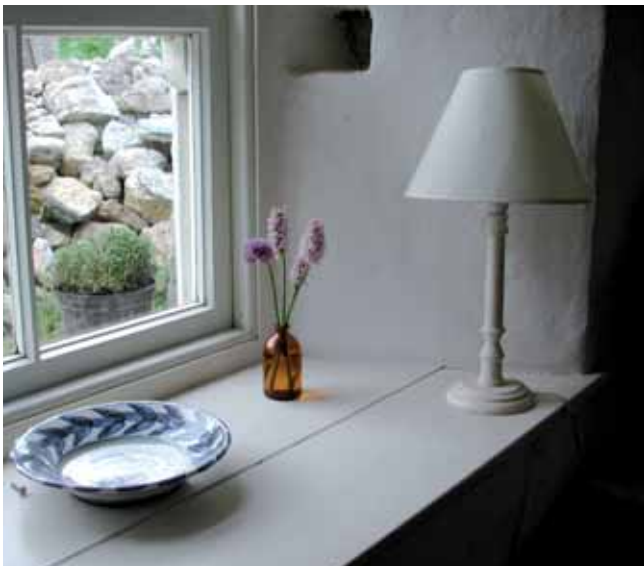
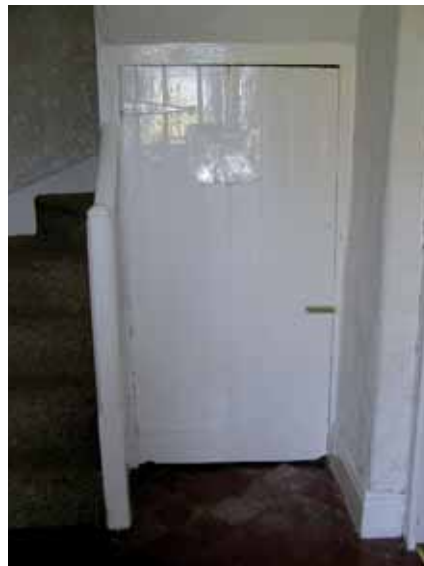
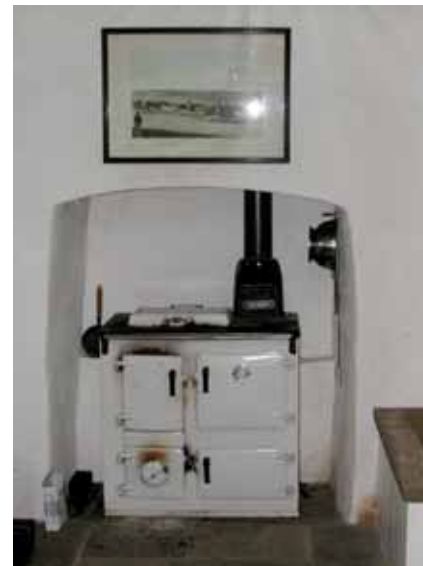
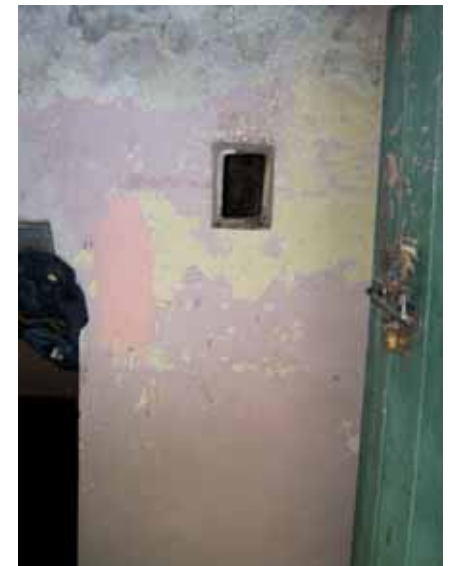
Interior character referenced by position, scale and detail of openings.

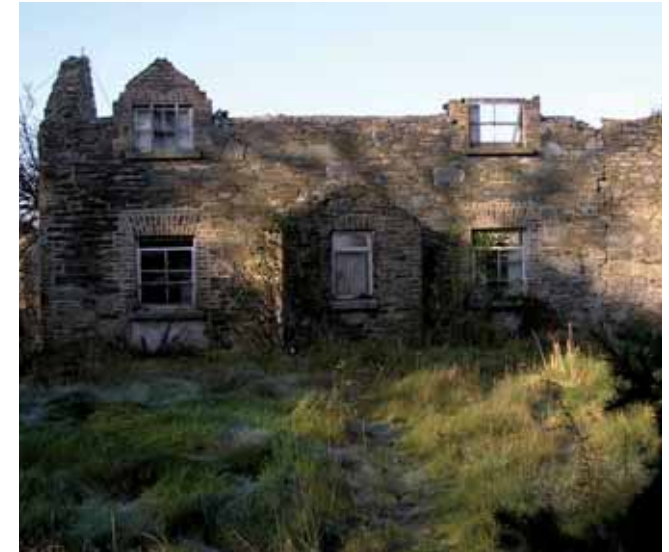
Above left: Outbuildings to farmhouse at Calverstown, circa 1838. Above: Calverstown farmhouse immediately adjacent to Calverstown Demesne.

This concept is well demonstrated by considering a disused farm complex in Calverstown, County Kildare. This appears to have been built contemporaneously with the Calverstown Estate (now a ruin) in a Gothic Revival style, circa 1838, using locally available stone. It is a particularly fine example of a stone farm complex retaining its formal relationship to the main road and possibly acknowledging the importance of the entrance to Calverstown House. The images indicate the richness of the materials and details in the construction of the principal house and the outbuildings, using brick reveals to all openings in random-rubble masonry walls, which were apparently rendered.

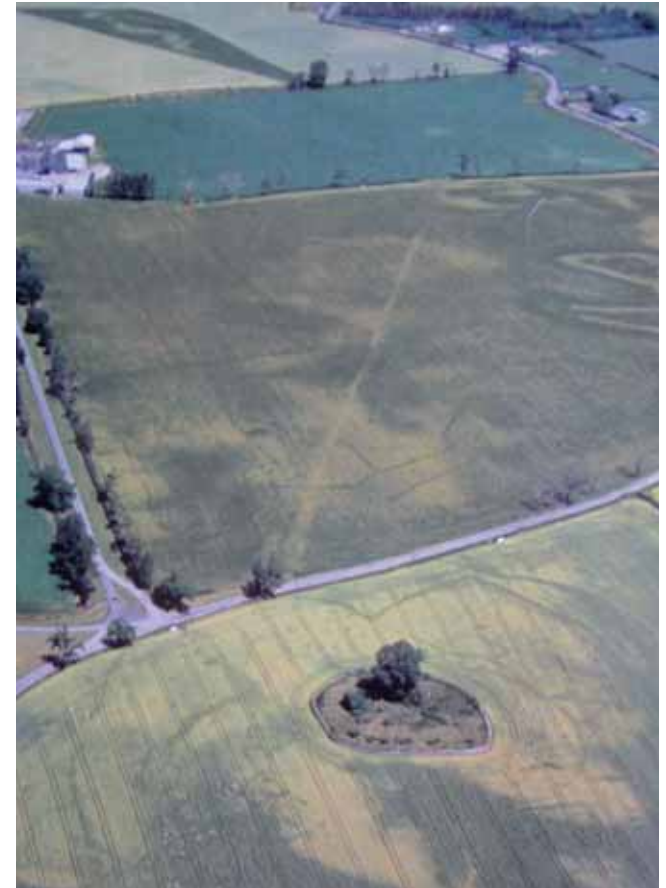
Dunmanoge, County Kildare. Aerial photograph indicating cropmarks evident in the field patterns, with several types and scale of settlement adjacent. (Courtesy of the Atlas of the Irish Rural Landscape, Early Landscapes.)

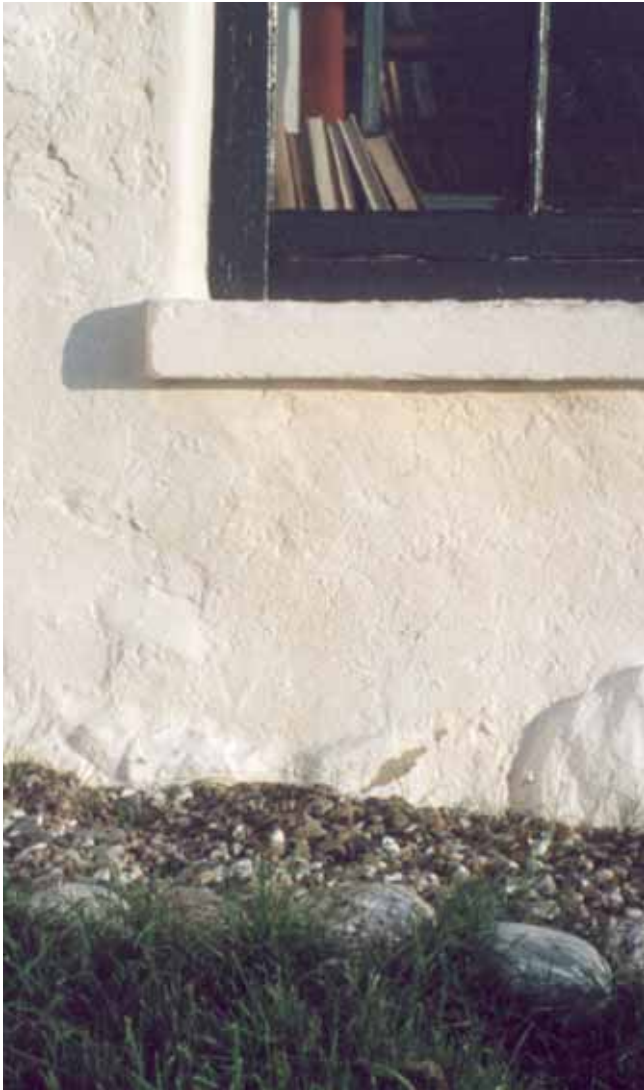
Lime washed wall with French drain to the base of the wall at Termon House, Donegal, conserved by the Irish Landmark Trust.

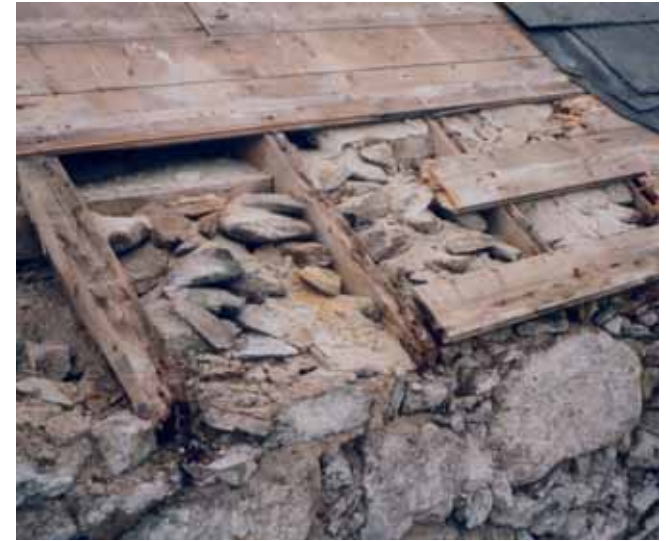
Above: Timber rafters built into top of wall showing degeneration over time due to failure of slate covering at Termon House, prior to conservation.

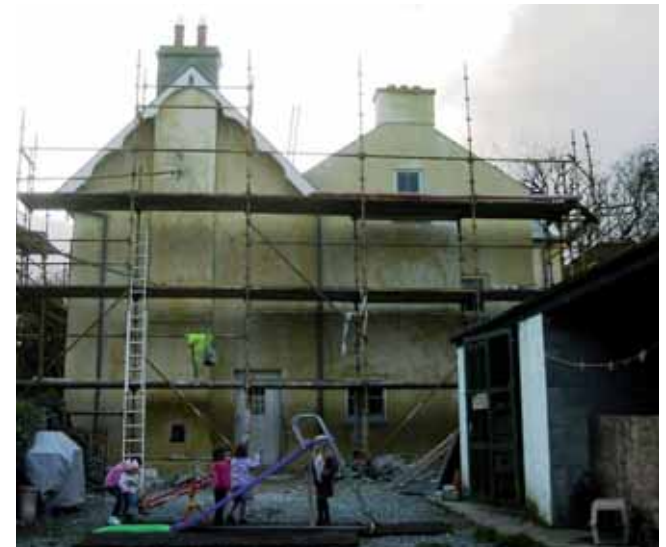
Below: Grant-assisted project showing new lime wash over recently applied lime render to the house exterior at Gower, County Clare.

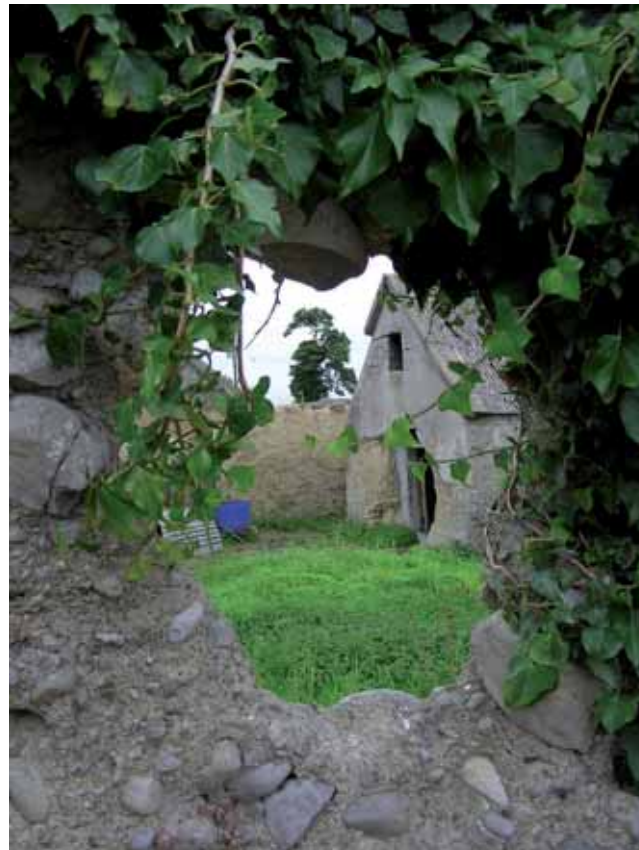
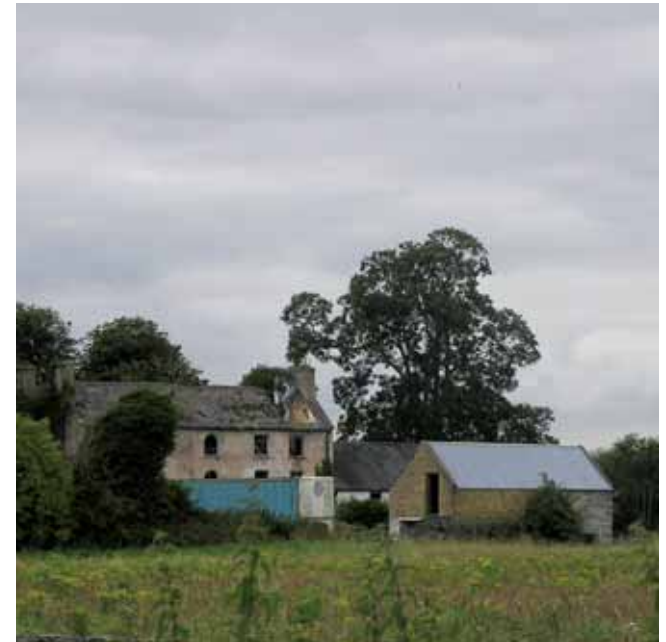
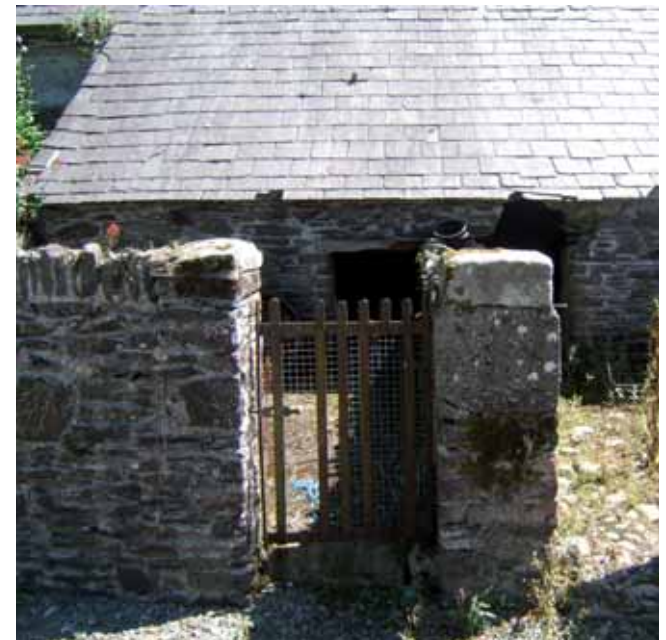
Above: Dissolving mud-walled house with adjoining barn, near Nurney. Top right: Farmhouse and farmyard near Athy in ruinous state. Bottom right: Stone pigsty as part of farmyard arrangement in Athgarrett.

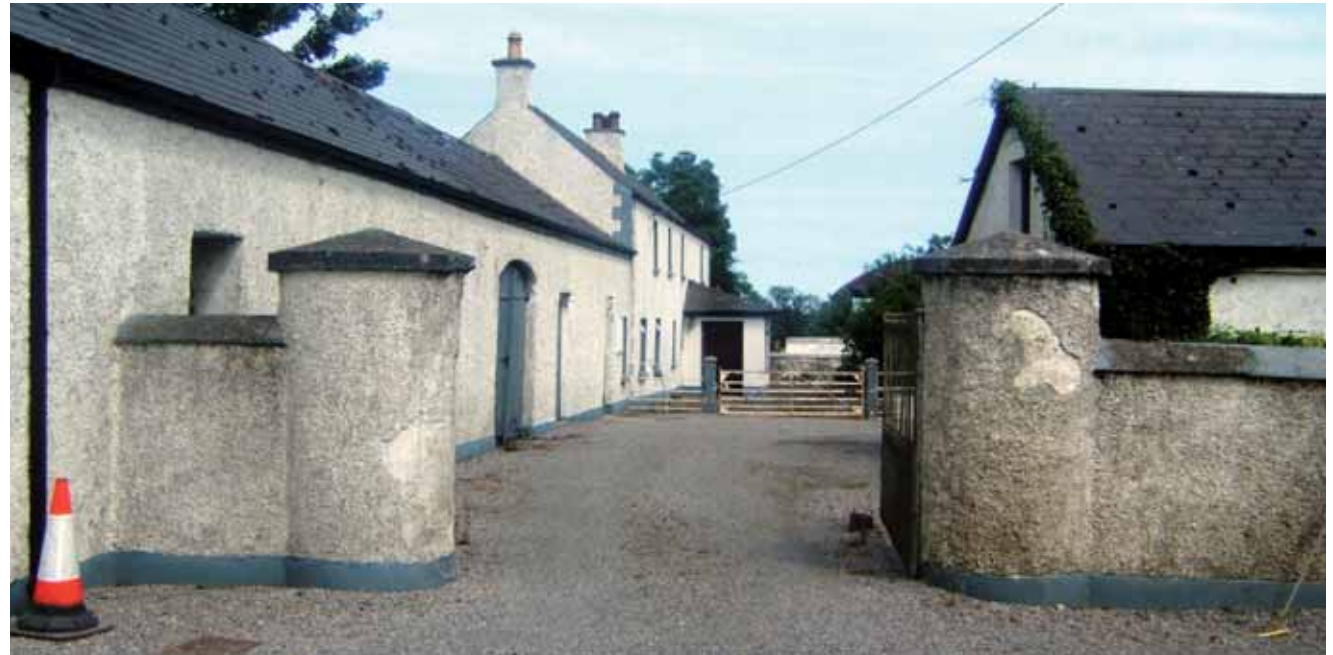
*Above left: Illustration of this typology.
Above: Linear farm complex situated off Caragh Main Street.
Right: Linear farmhouse in between Timolin and Moone.*

These structures typically possess classically ordered façades. They include smaller window openings at the upper floor, frequently set gable-ends perpendicular to the main road, with small formal gardens, manicured hedgerows and a range of outbuildings to a yard. The linear plan form also adapted to create a formal space or to create an impact to the culmination of a road or junction. These structures were sometimes built with arched entrances or defined gated entrances leading to more substantial adjoining yards.

Typical and subsequent modifications evident to this building type include the addition of entrance porches, single-storey wings and the enlargement of footprint length. The extension of the accommodation footprint is limited, and is usually along

its linear axis retaining the continuous roofline and gable-end characteristics of the structure. The more typical adaptations include the addition of returns to the rear elevation or the doubling in depth of the footprint. Both solutions provide a double-pile plan with single aspect windows to the rear and front elevation.

Windows are well ordered in the mainly classical façade and are diminutive in scale to the upper floor with the main vertical circulation separate and centrally placed within the cellular linear plan form. Rooms are interconnected using the classical mechanism of 'en filade' design arranged along the front façade of the house. This feature comprises all the accommodation doors being positioned in line with one another for ease of access and progression through the sequence of rooms. Modest entrance porches were also added providing additional circulation space to the central staircase and hall.

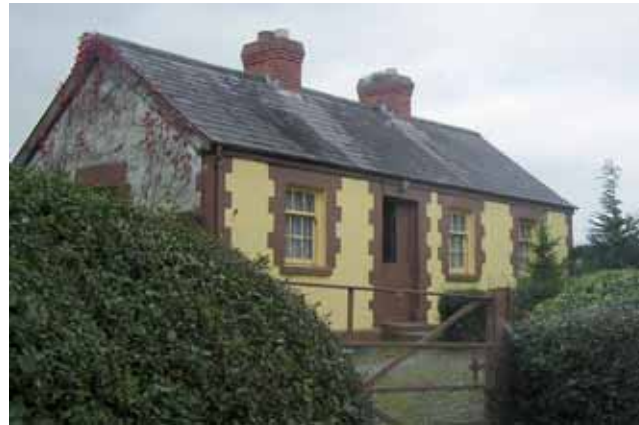
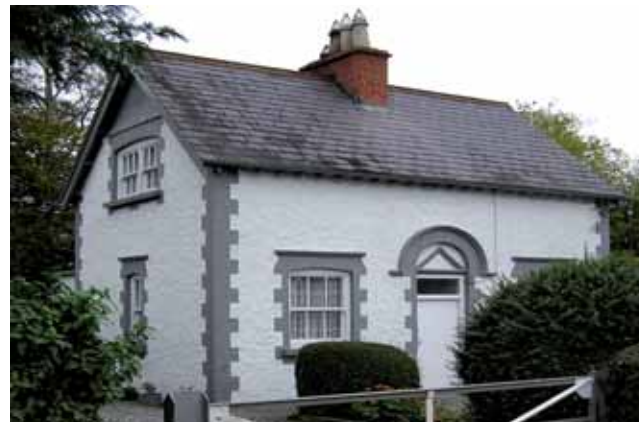
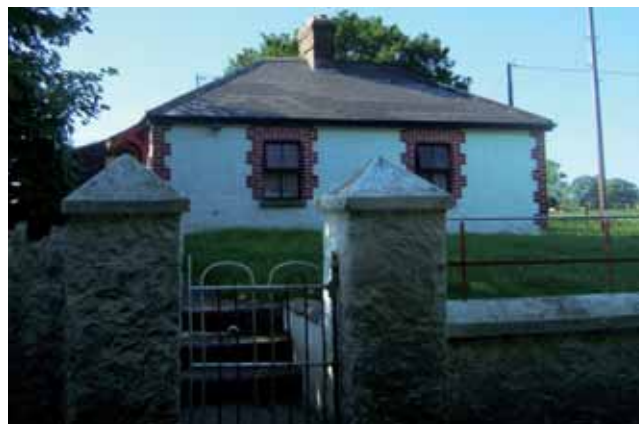
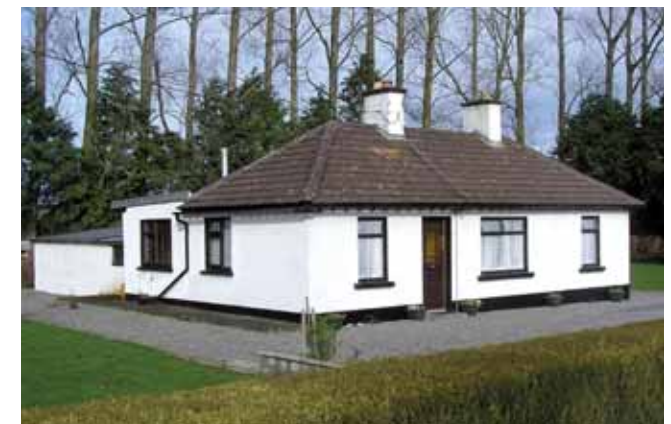
Bottom left: Cottage at Ballymore Eustace associated with the waterworks.

Below: 1950s isolated County Council cottage, near to Kilcullen.

The farmhouses were constructed of a variety of materials, with a simple plan form comprising of one or two storeys, with pitched roofs and well-ordered exteriors. Small yards to the rear were enclosed by a modest range of outbuildings constructed of lime-washed random-rubble stone with corrugated roofs, used for storage or animals.

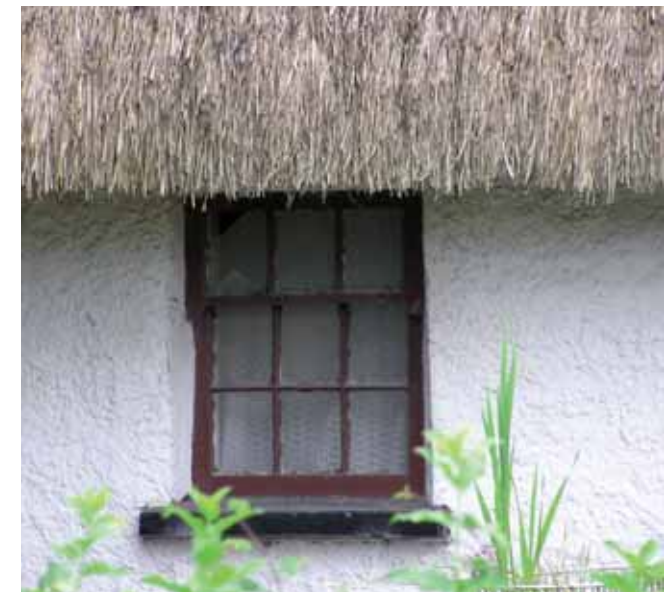
Authentic details including historic sash window, lime rendered walls and overhanging thatched roof.

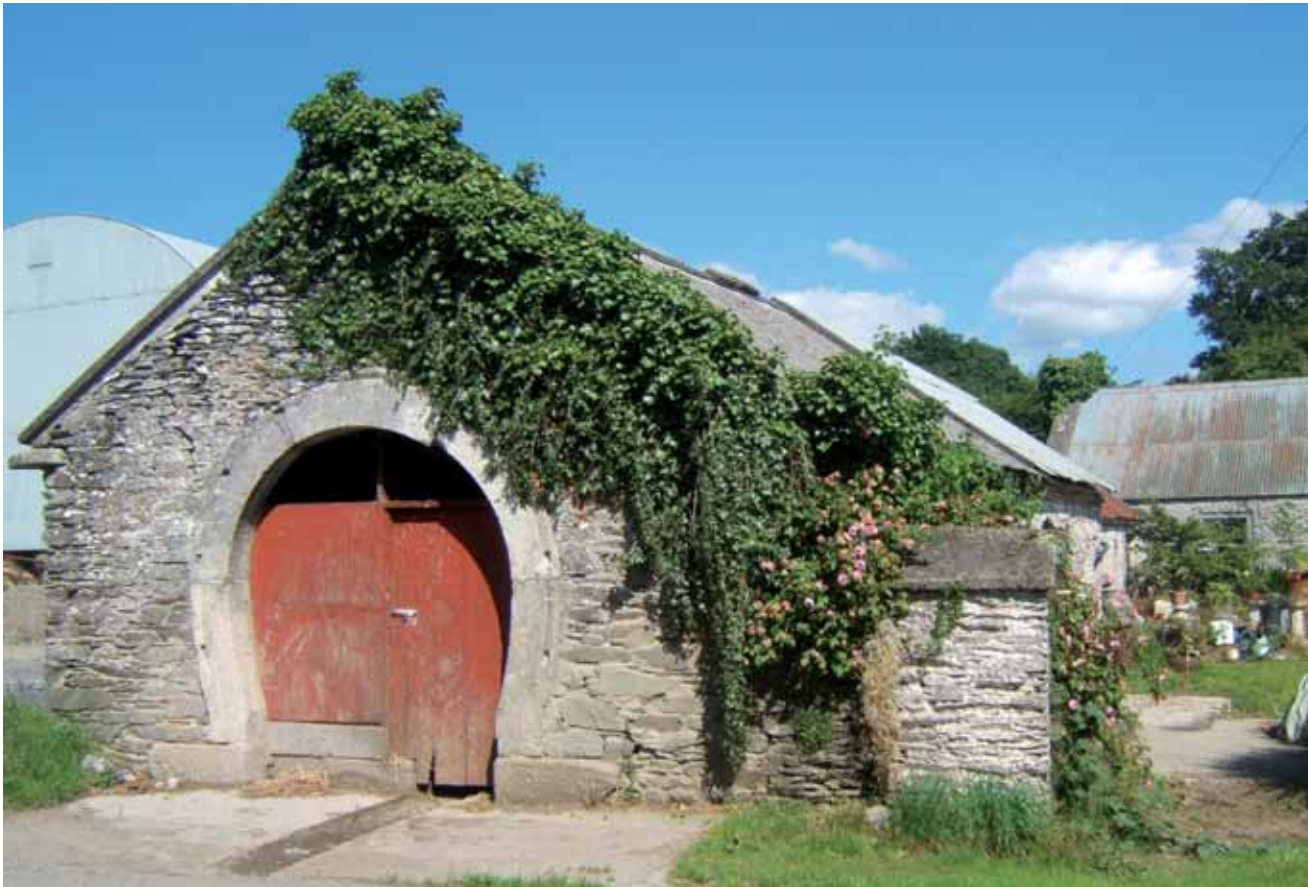
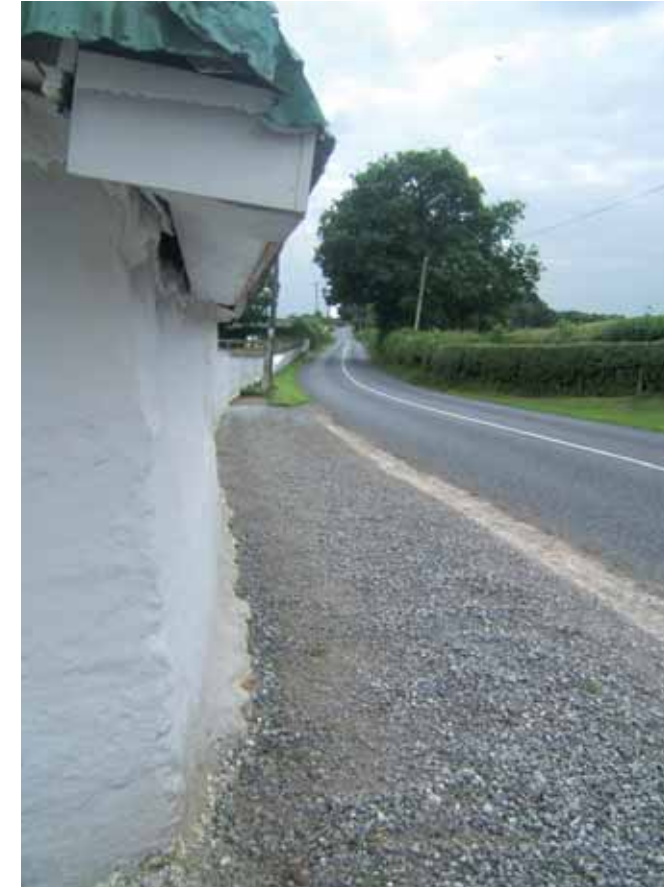
Right: Old stone forge near Glebe West.

Below: The earthen outbuildings at Meddenstown North mirror the route of the main road.

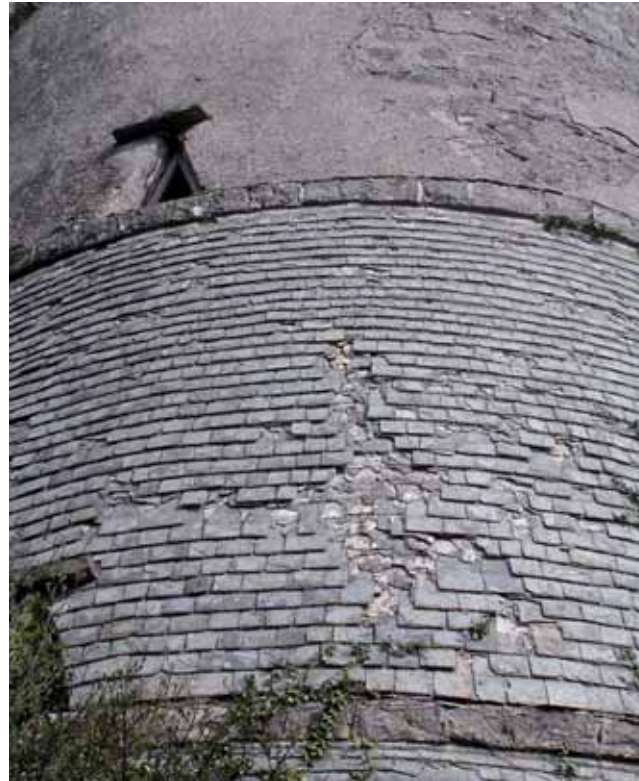
Vertical slate detail set into lime at the Wonderful Barn, near Leixlip.

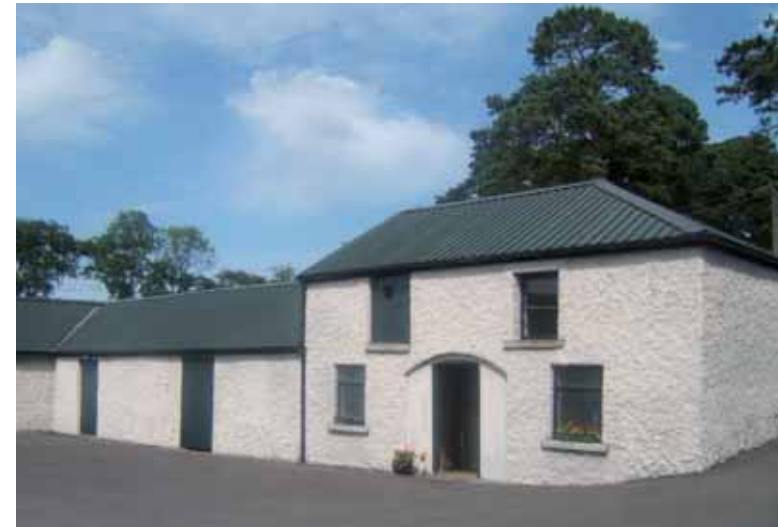
*Bottom left: Preservation of thatched structure near Nurney, temporarily protected with plastic-wrapped roof.
Above: Significant road-fronting farm complex at Halverstown cross-roads preserved with corrugated metal roofs.*

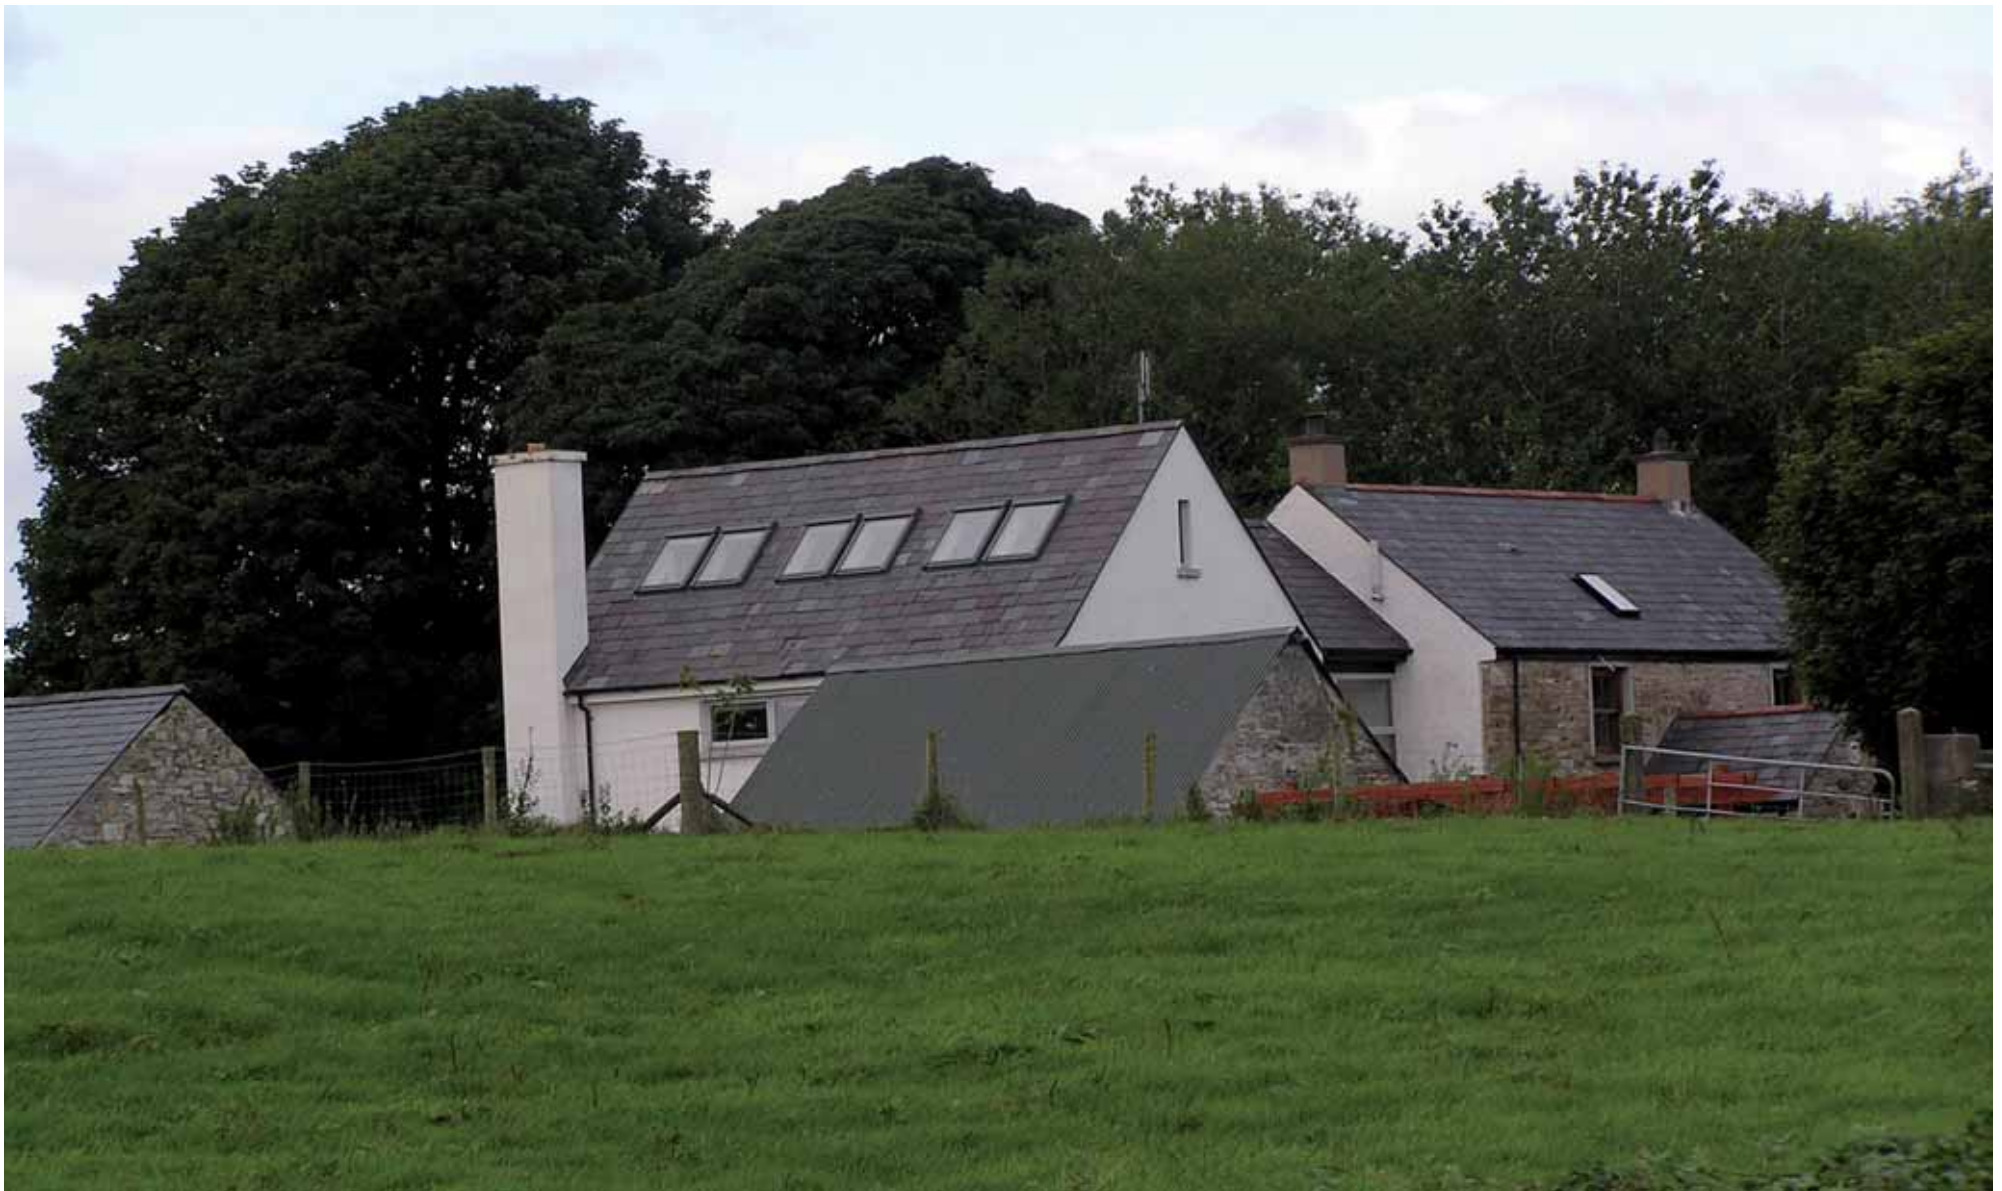
Contemporary addition to farmhouse in County Fermanagh referencing the scale and mass of original house.

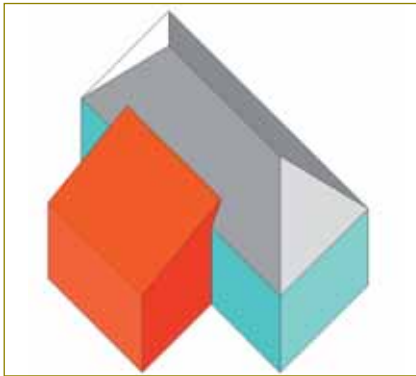
1. Rear extension at differing pitch to accommodate longer extension. This is hard to detail and can cause weathering difficulties in the long run.

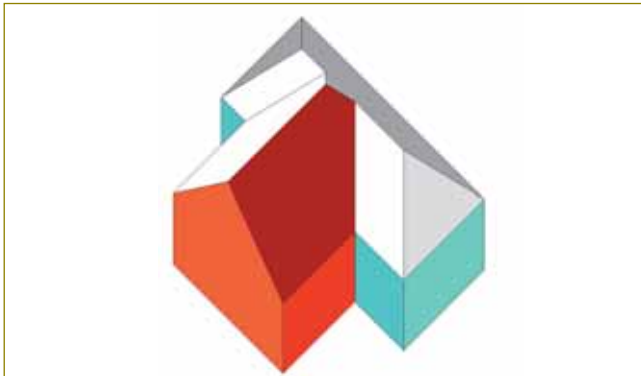
3. Wider extension causes unsightly ridge to main elevation, shown in no. 4.

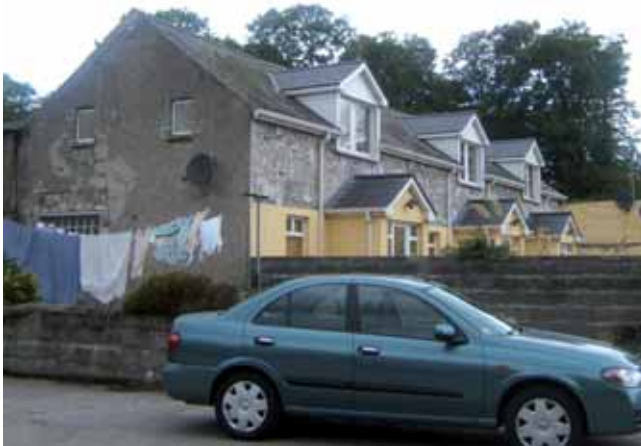
Bottom: The use of dormer projections to the roof in the conversion of outbuildings to residential houses is not a common roof detail in County Kildare.

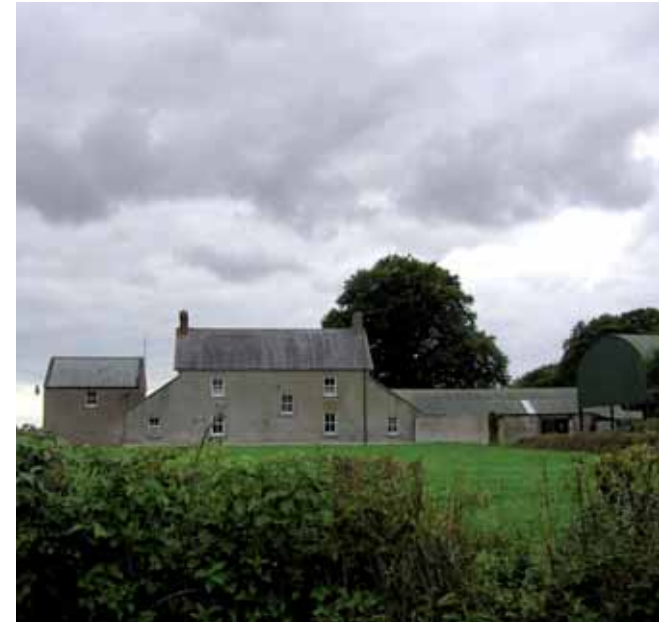
Right: Example of the typical development of a linear farmhouse range through three stages, with the top showing the earliest form.

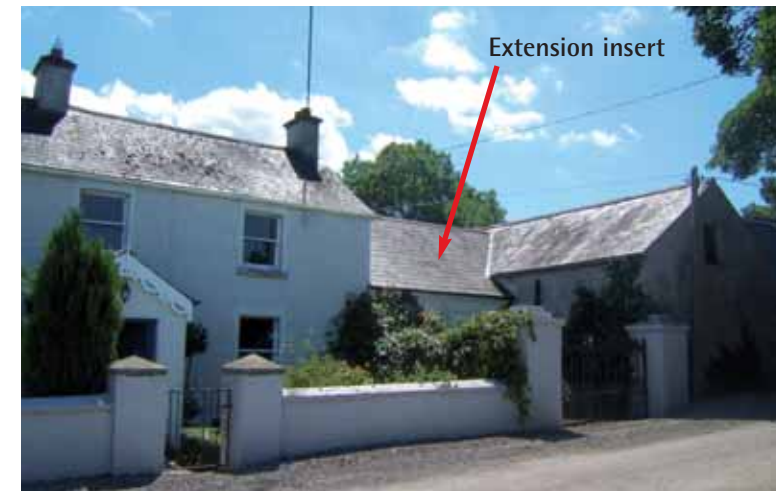
The model to the left demonstrates the manner in which a contemporary extension wraps around a modest mud-walled farm dwelling with partially surviving outbuilding. The mud outbuilding is used as the link between the new and the old, containing the key uses such as the kitchen and utility with extra bedroom accommodation.

Note how the roof height necessitates the use of a mono-pitch roof with high-level lighting to the bedrooms, thus the prominence of the height of the main building is kept.

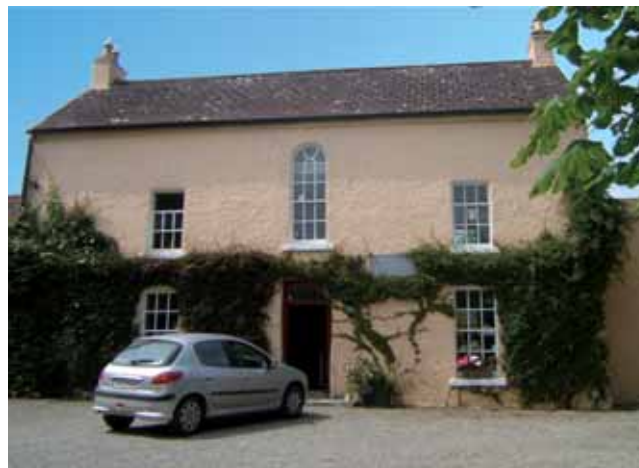
Below left: Front elevation of an 18th century farmhouse, road-fronted, with classical fenestration pattern, retaining many original features and materials.

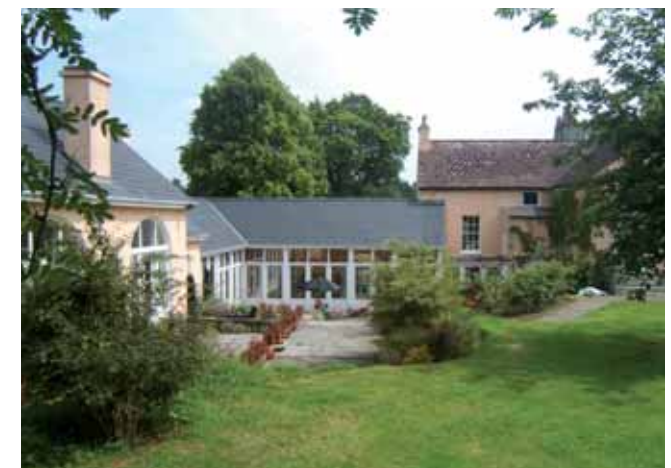
Below right: Rear view of structure indicating the sympathetic addition of a contemporary wing that avoids any adverse impact on the principal façade, yet provides wonderful naturally lit living space.

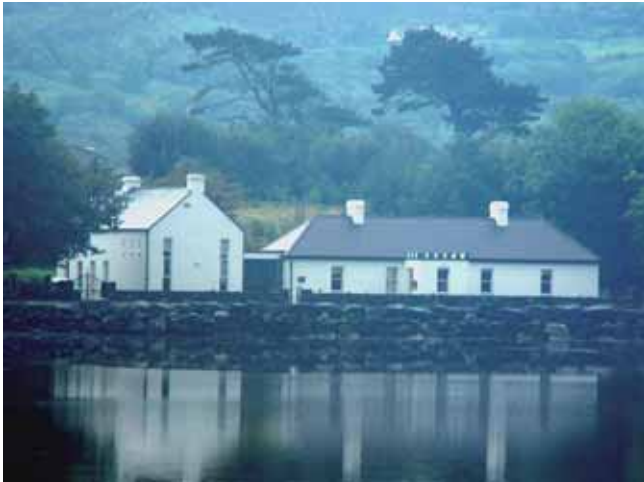
Left: Single storey original farmhouse with additional accommodation provided by adding new two-storey section set perpendicular to the original structure and integrated with glazed link.

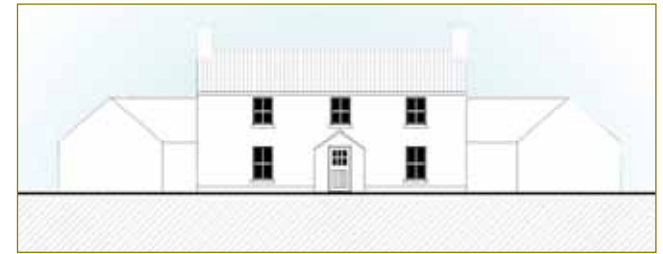
Above: Extension to principal structure by introducing additional volumes symmetrically to either side of two-storey farmhouses.

The sketch (top right) indicates a proposal for symmetrical additions on either side of the main farmhouse, which is only possible on a site much wider than the house. This maintains the prominence of the original farmhouse. The above photograph shows an older farmhouse in Mayo that connects to a new two-storey extension by a glazed link. The extension, though taller because it has been separated, is distinct and has not impacted on the main range.

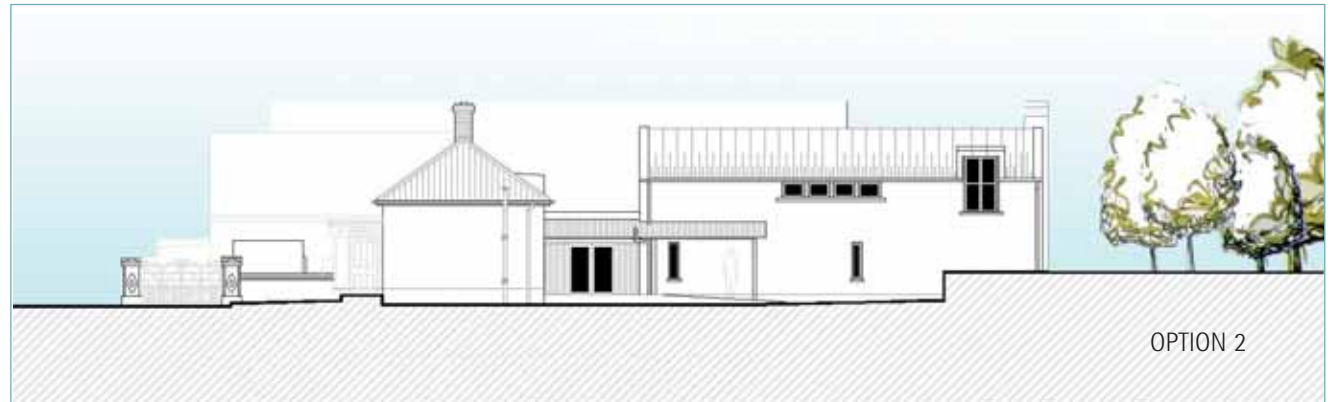
An alternative rear two storey solution is shown on this overall site plan. Entending to the rear gives a better orientation for all the new rooms and a more compact form. Care was taken to ensure its height did not impact on the front view of the original section

In this solution, the extension is two-storey and placed to the rear of the existing buildings, with the height reduced as much as is physically possible by using a barrel-shaped roof. This confines the windows to a low eye height upstairs, a feature of the existing farm building. The new extension contains 53 sq. m. upstairs and 99 sq. m. on the ground floor, giving a total of 158 sq. m. This is additional accommodation consisting of a living room, two bedrooms, a main bathroom, kitchen and utility with guest bathroom on the ground floor. There is a screened secondary entrance to the rear, at the junction of old and new, with a covered walkway that ties the larger extension back to the original. This is to have a roof of corrugated sheeting.

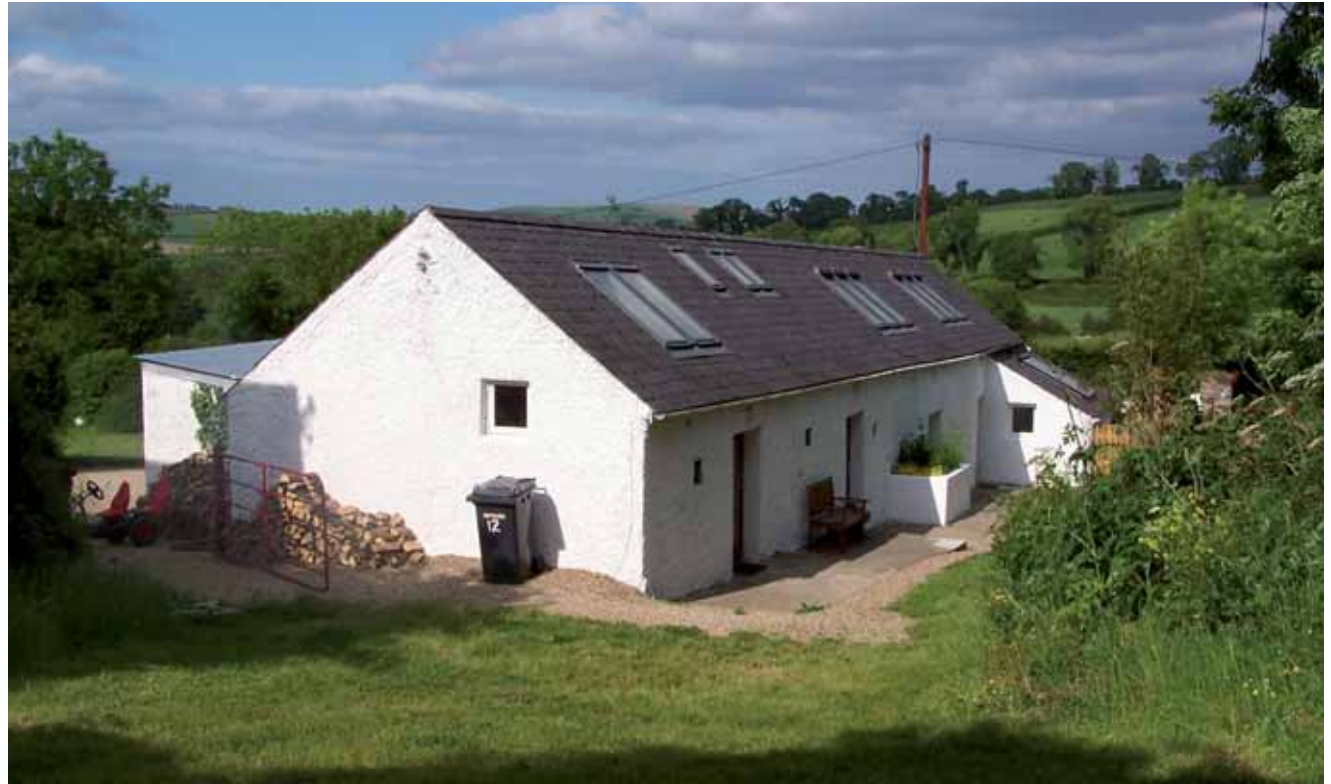
*Top: Rear elevation of old milking parlour.
Above: Ballymurrin, Co. Wicklow before restoration.
Left: Ballymurrin, Co. Wicklow after restoration.*

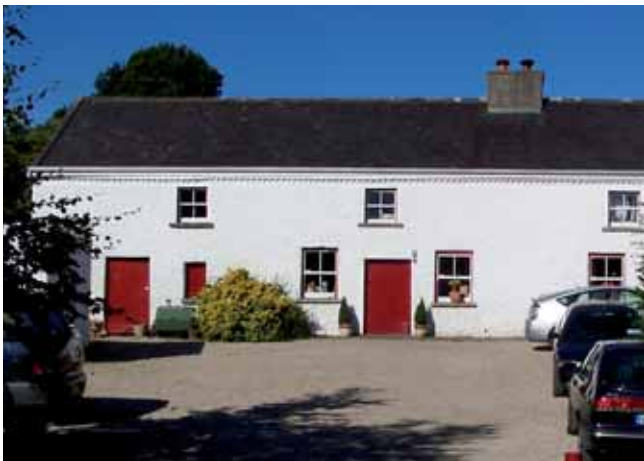
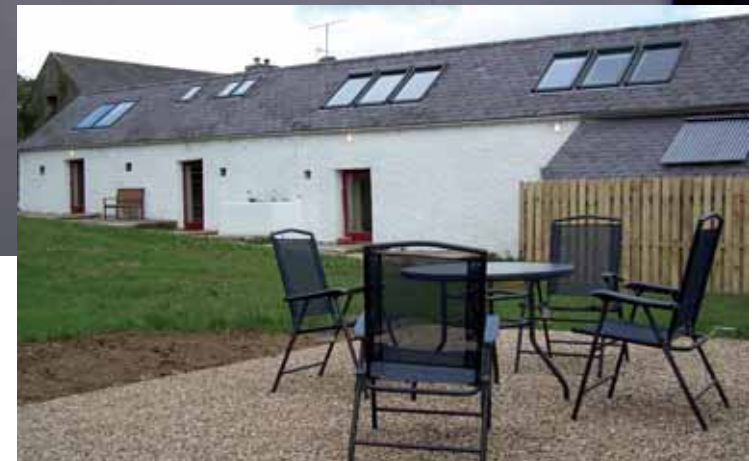
*Left: The studio showing simple proportions of door and window openings.
Above: Old milking parlour with the internal animal stalls retained as a division between kitchen and living room.
Right: Patio to rear of old milking parlour.*

The old milking parlour, measuring 28 metres in length by 4 metres in width, was the next structure to be restored as an exemplary model for sustainable energy as well as for building conservation of structures at risk of being lost. The development of a sustainability brief meant that grant-aid towards restoration and use as tourism development was availed of. The proposed use was a self-catering cottage even though the space available for conversion would have facilitated the development of two units. This, however, would have been at the expense of the original internal layout and the historic form of the structure. The stepped form and rhythm of the structure was retained and fully utilised to provide different accommodation zones and architectural character. The accommodation to the old milking parlour includes two bedrooms with en-suite accommodation, a dining and kitchen area and a large lofty living room. Rooflights were used to enhance the natural light levels of the internal spaces. A state-of-the-art heating system, combined with solar energy and a default boiler for cold snaps as well as a turf/wood-burning stove, were used to create optimum comfort conditions.

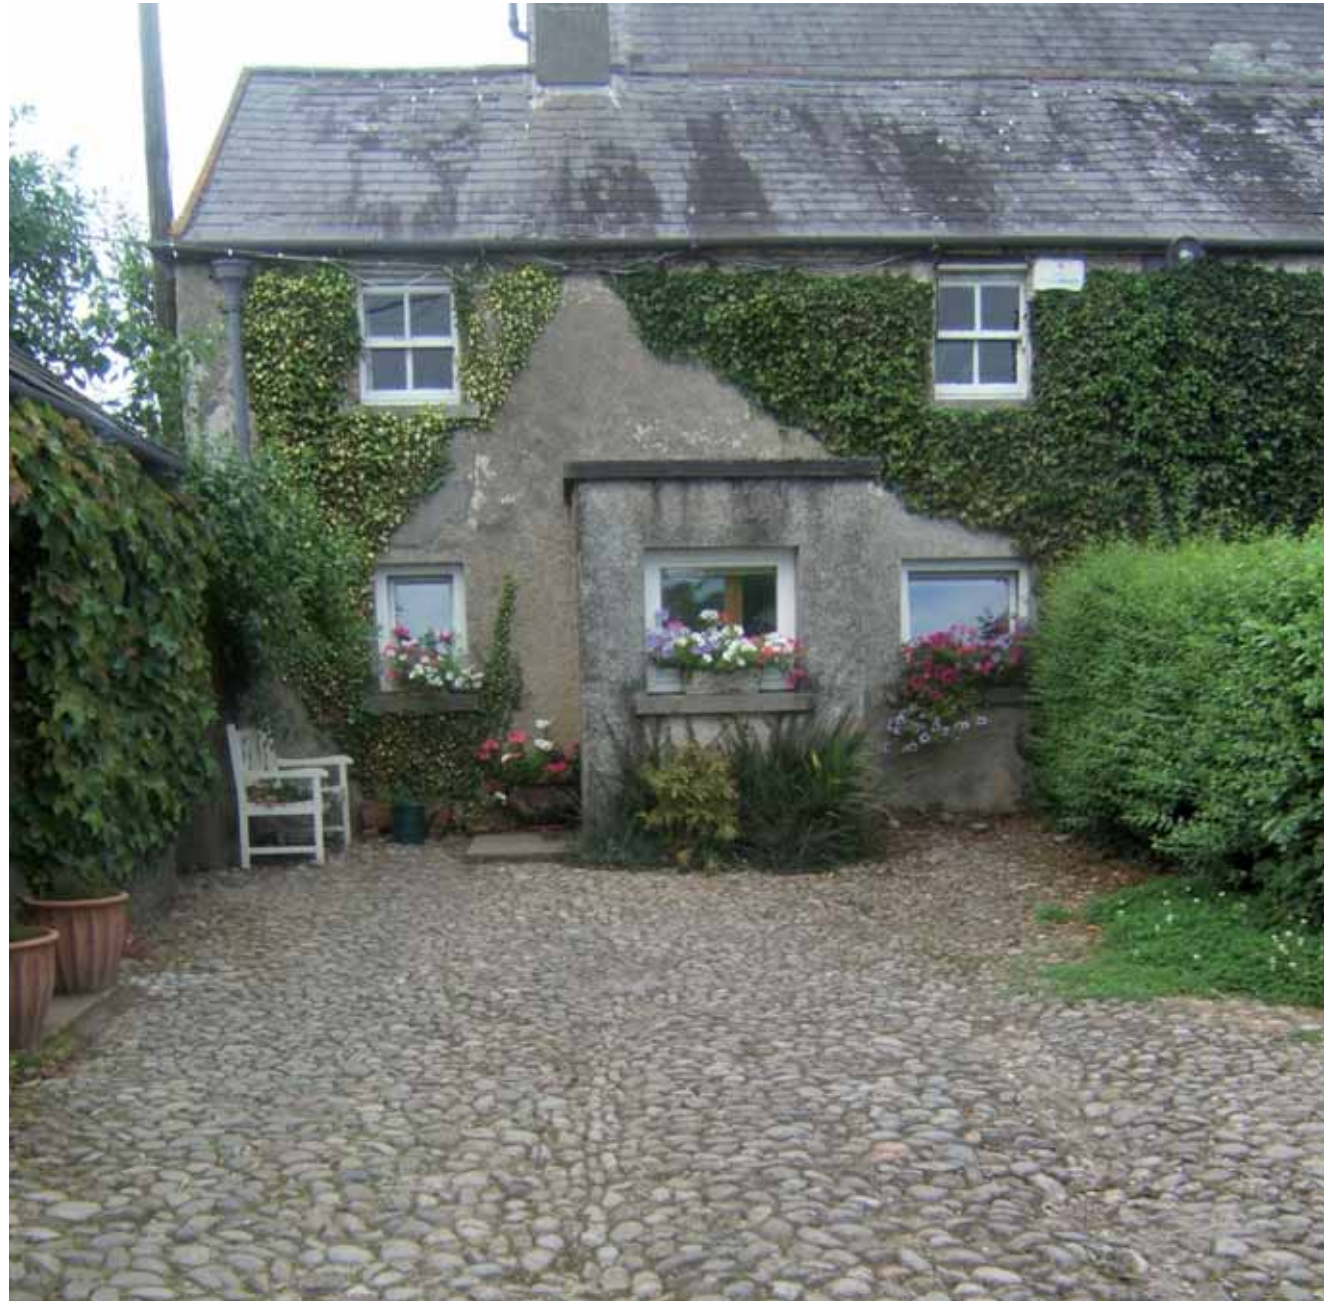
Main image: Original 18th-century farmhouse range, now to rear of the property with cobble setts to cobble yard.
