Re-using Farm Buildings

A Kildare Perspective
Authors Laura Bowen and Nicki Matthews

Authors: Laura Bowen and Nicki Matthews

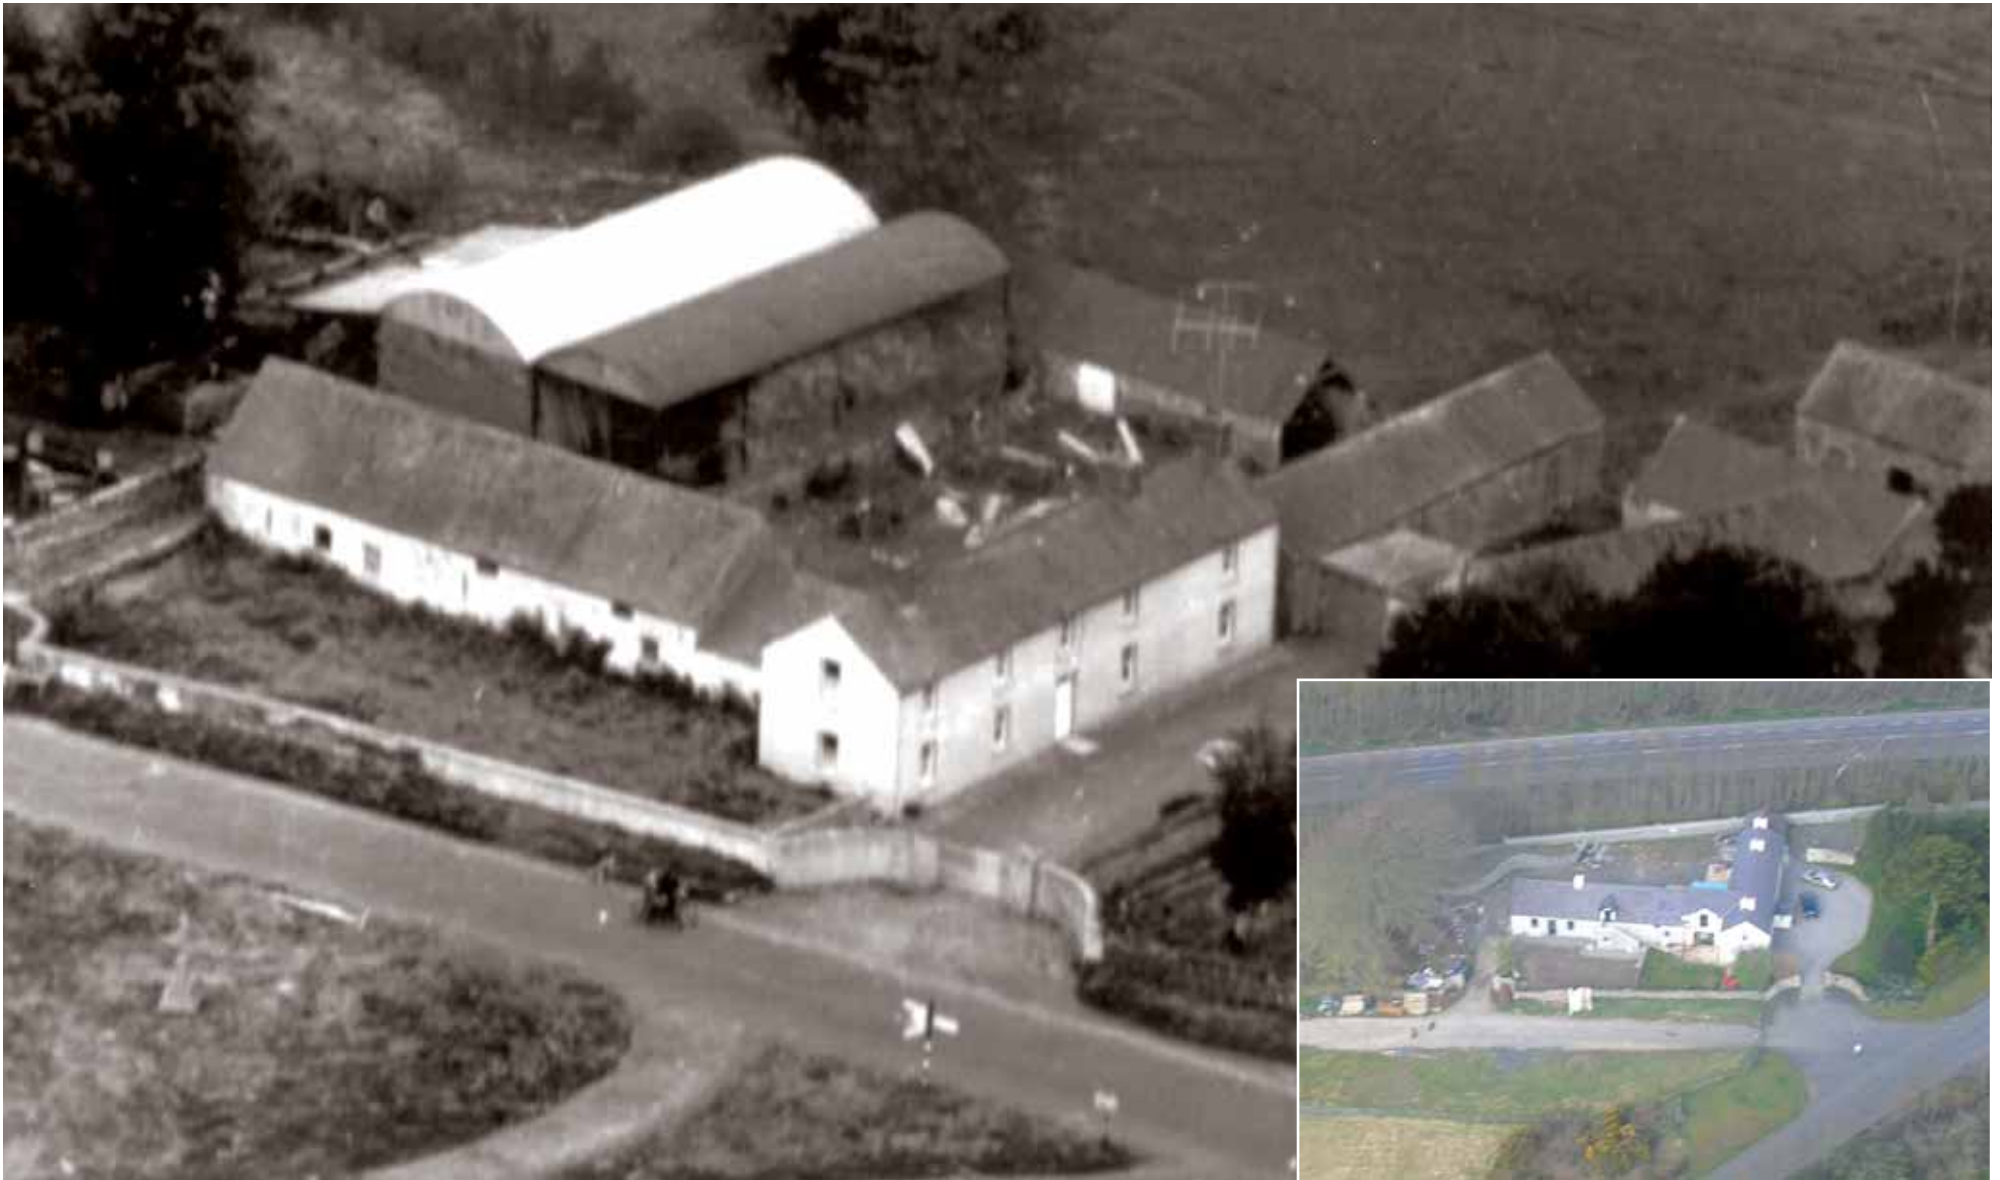
Aerial view of Knockaulin farm complex circa mid 1950s (showing the main Dublin/Athy road running to the side of the complex) and inset of Knockaulin today showing the N78 behind the house.

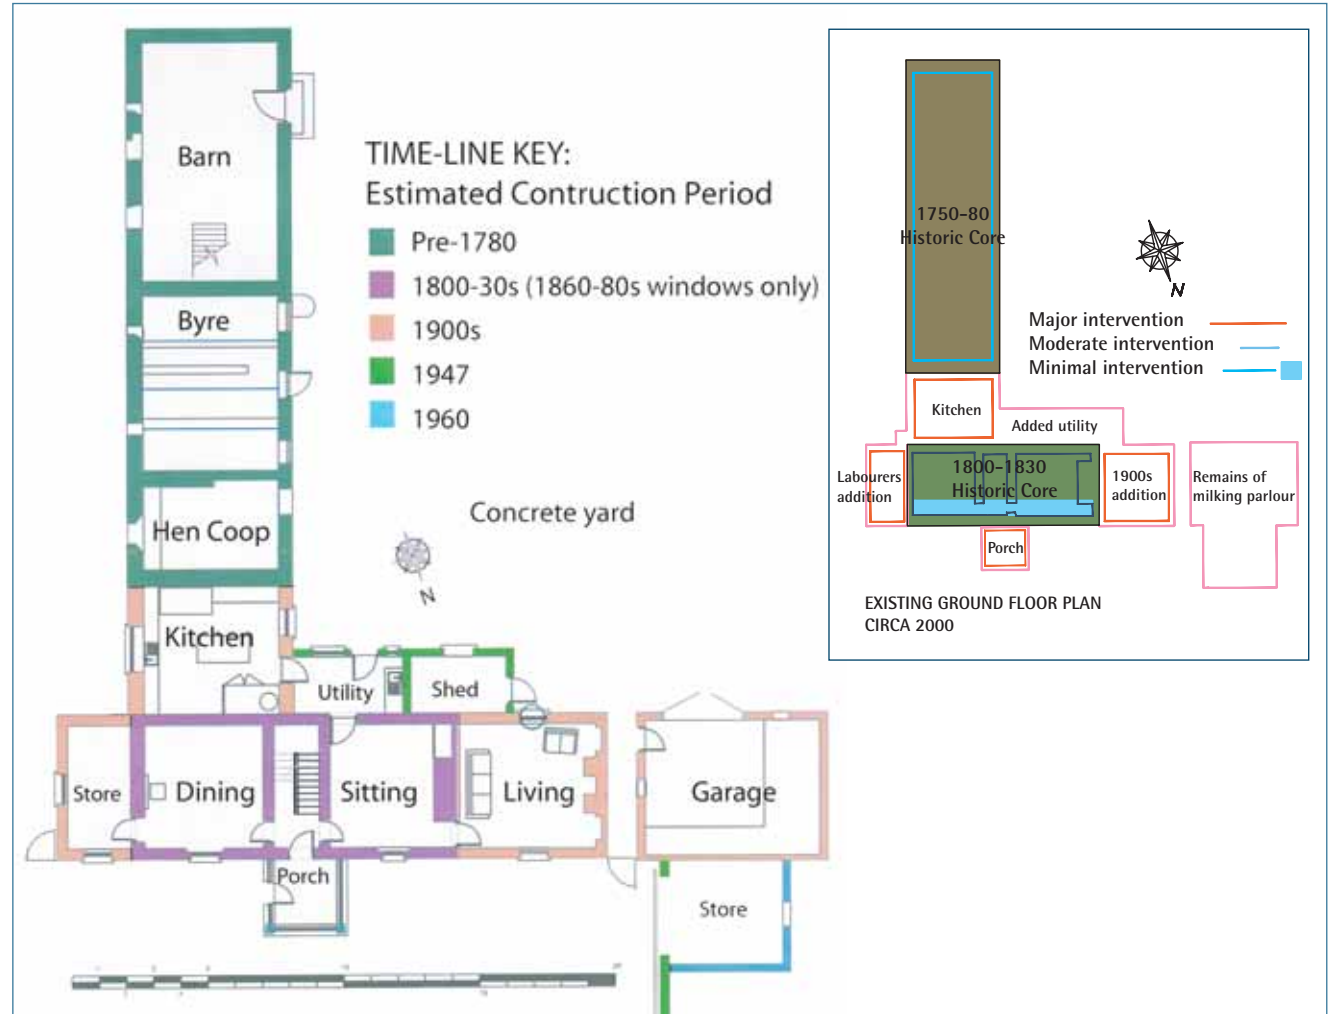
Above: Diagram/plan demonstrating the chronological development of the site.

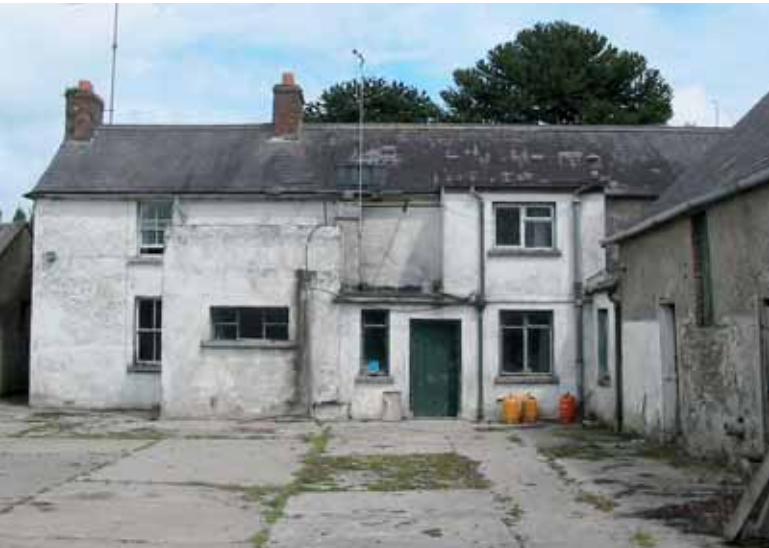
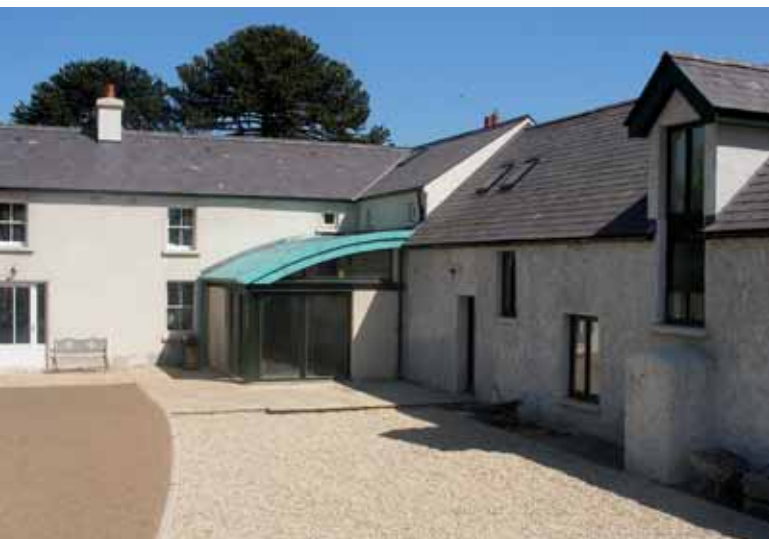
Above: Rear view of Knockaulin farmyard in 2003.

Below: A similar view in 2006, with the curved copper extension and two storey infill as a link between the front and barn sections.

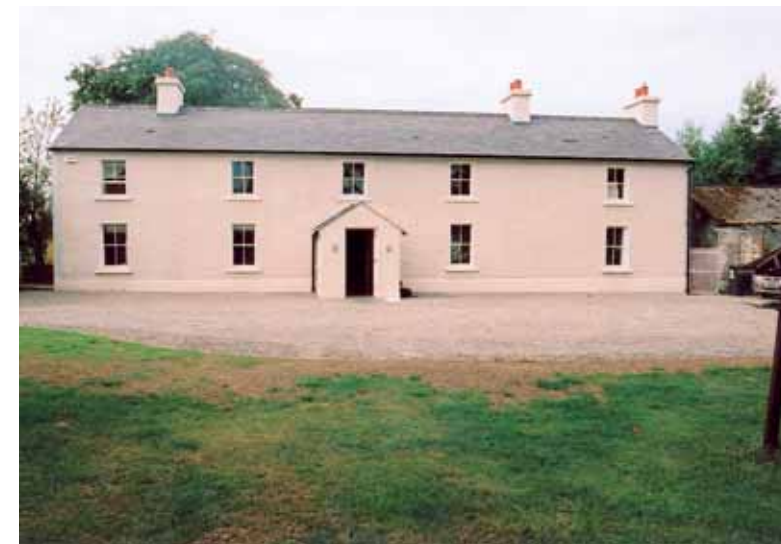
Below: Front elevation showing the importance of maintaining the chimney stacks as they indicate the development of the house and provide proportion to what is a very long elevation.

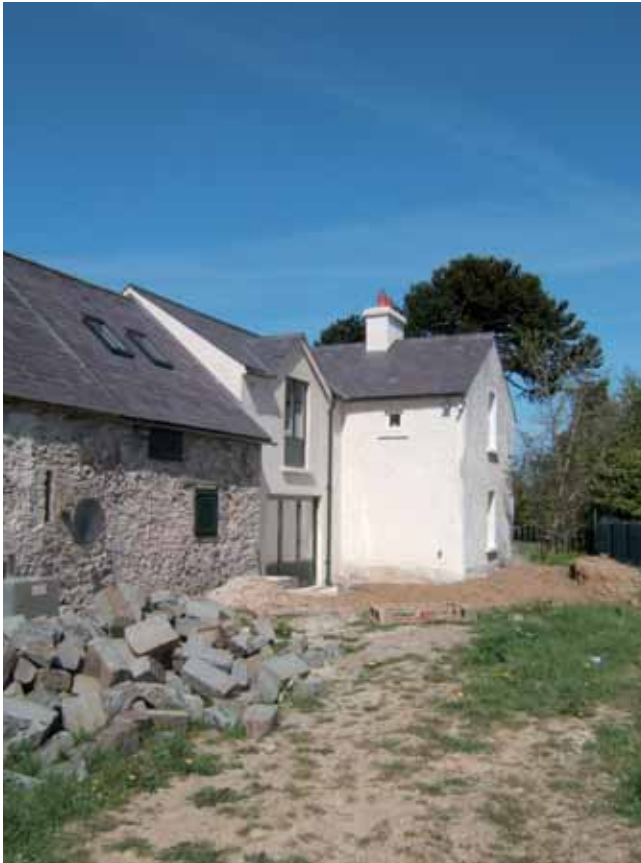
Above: Side view taken from the kitchen garden, showing the infill addition recessed to differentiate it from the original structure.
 Right: The kitchen, the heart of the house.

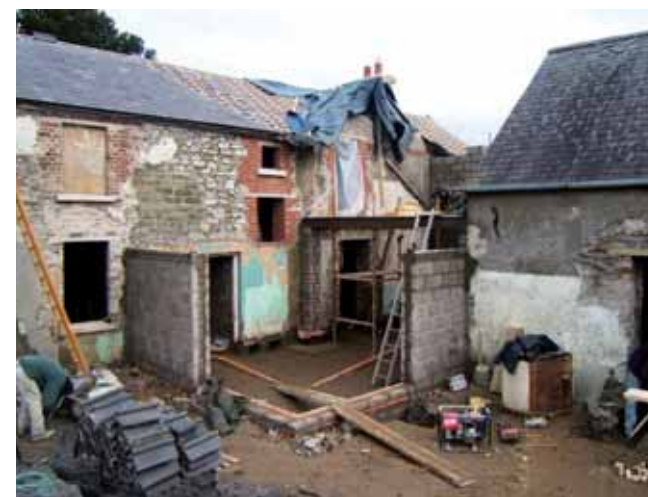
Knockaulin farmhouse project, Kilcullen

The above image indicates the progress of site work indicating the myriad constructions confronted.

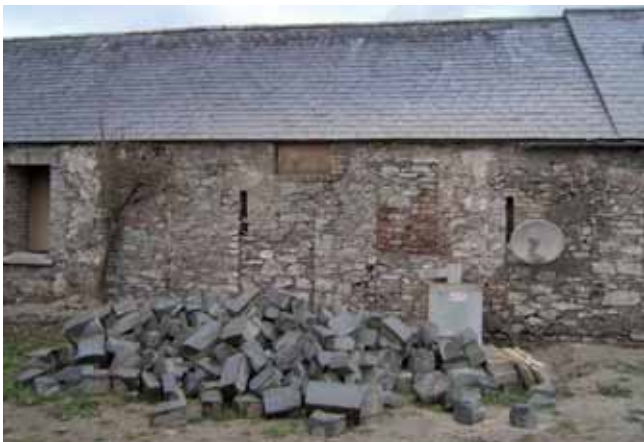
1. Venting the dry lining (top). Ships vent used as an ancillary vent to an independent stud wall.

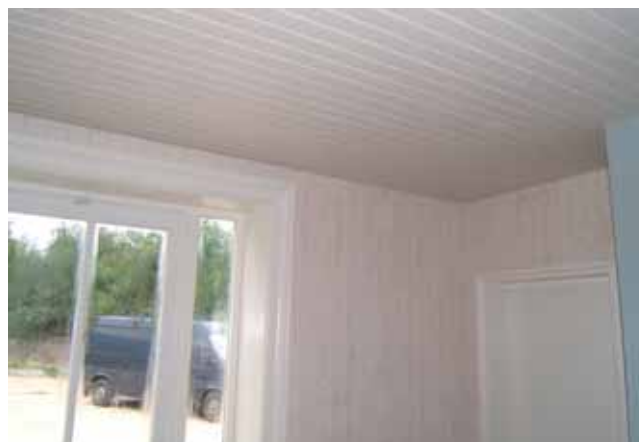
2. Existing timbered ceiling with tongued, grooved and 'Vee'd sheeting (below). A common feature in farmhouses. Existing walls to this end room were originally lined with timber but this needed to be replaced due to dry rot and insect infestation. It has been replaced with a beaded sheeting to differentiate new from old.

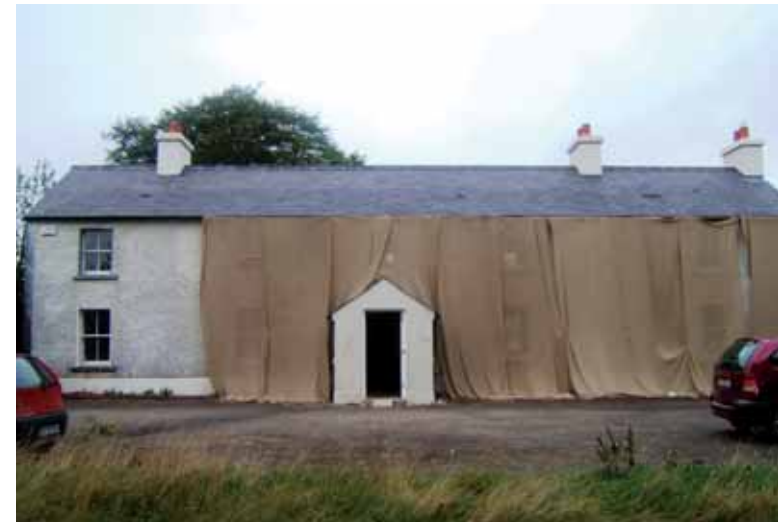
Protection during lime work

Shown above is a sack cloth hung from a batten in the gutter to protect a lime mortar coating, applied over the sand cement dashing, from direct rain wash. This same sacking was used to protect the lime render during the hotter periods when the it was exposed to strong sunshine. The sacking creates a zone in front of the wall that allows moisture to evaporate slowly without too much drying from the wind.

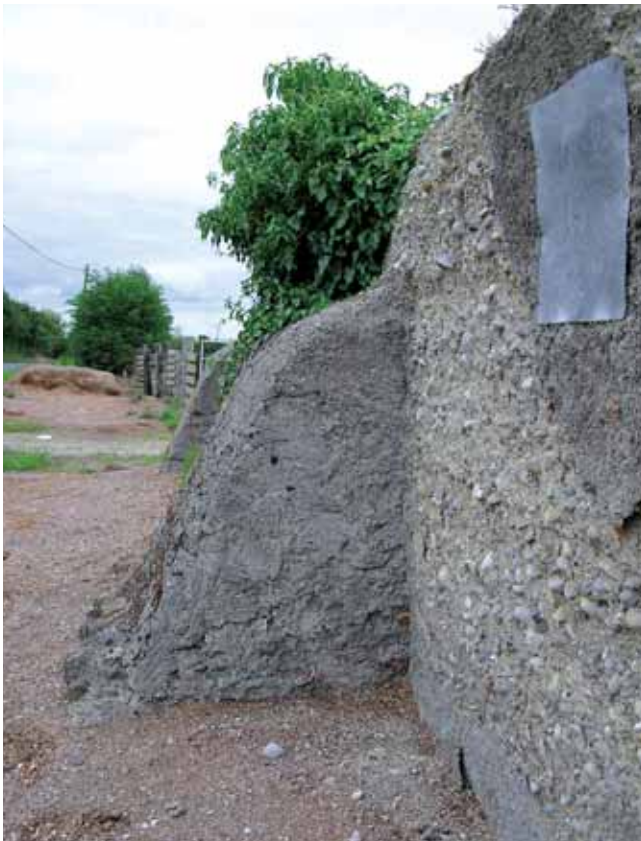
Mud boundary wall with buttress near Nurney.

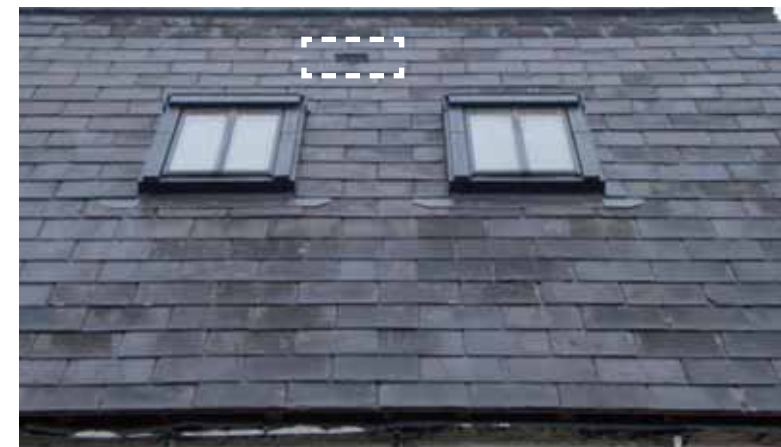
Flush slate between two conservation rooflights

The vent does not protrude above the roof. Flush slates were also used for venting the internal soilpipes.

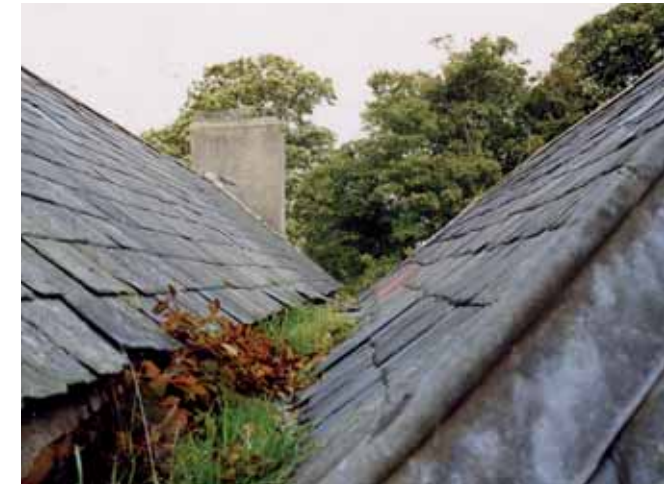
A build up of vegetation and debris in the valley gutter of this house has caused water to leak over the top of the gutter and down into the interior of the house, emphasising the need for maintenance and easy access to the roof, i.e., rooflights for roof profiles of this type.

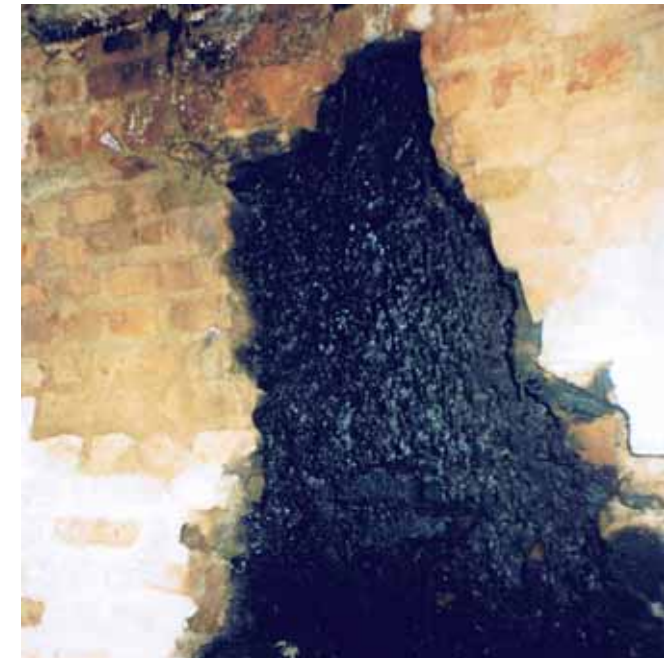
Disintegrating chimney flue due to damp ingress and lack of use.

The external stack on the brick gable had only one flue serving two fireplaces, with the rear of the upper fireplace opening directly into the flue below. This can be very dangerous for ingress of carbon monoxide fumes, so this fireplace was removed and the flue sealed off, cleaned and reinstalled to the other stack that had two flues. The stack was lined with clay liner and vermiculite pumice installed around the flue. The vermiculite has insulation properties, which can keep the flue at an

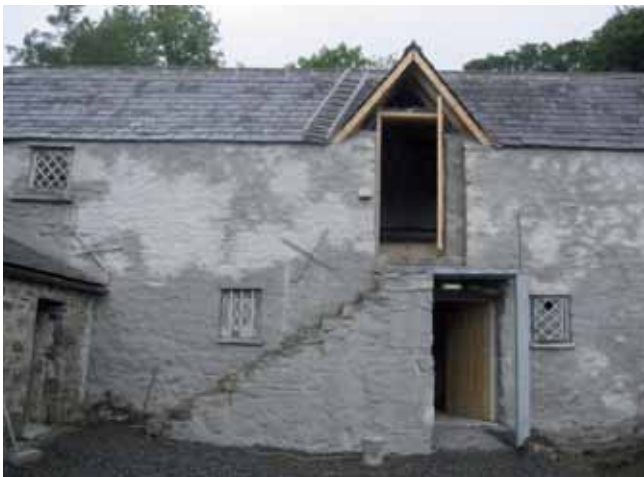
An example of an external stone stairs (generally used for access to hay loft or labourers' accommodation). The walls of this outbuilding in County Meath have been given a new coat of lime render. The structural steel ties, a later addition bracing the stone walls, can be seen as crosses. These ties can be painted to highlight them in a decorative manner.

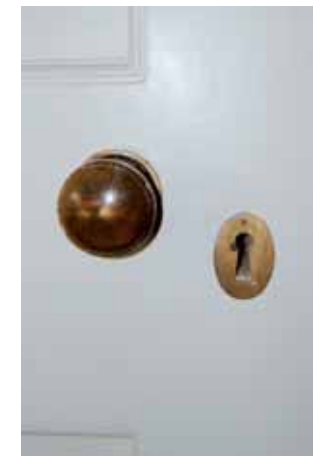
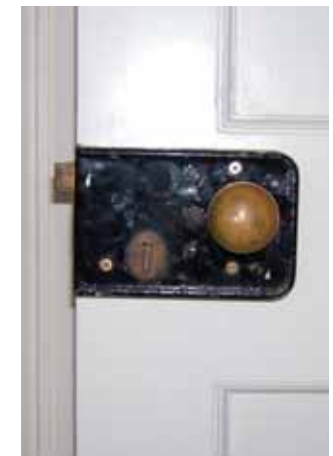
Examples of door ironmongery (5 and 6) that are particular to different phases of refurbishment should be retained as a feature of the historic interior. Different types of ironmongery can also be discovered on shutter boxes and to timber sashes and can assist in the dating of the window fabric.

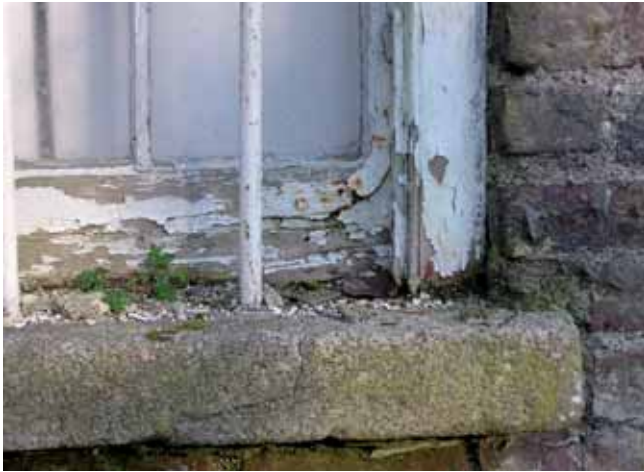
each window and door should be recorded. Each opening should, as a minimum, be identified with a designated number and coordinated with some photographic information.

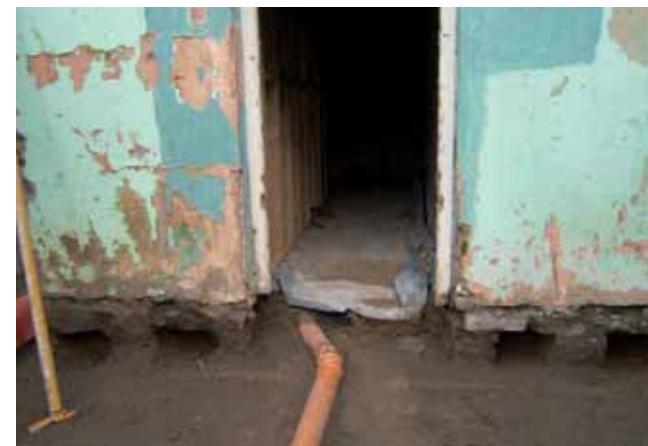
Description of floor solutions

(Above): The floor was laid with the sub-floor pocketed beneath shallow foundations as indicated above. A conventional screed on top of the slab was only possible where there was no problem laying the structural slab at a lower level. In areas where excavation was a problem, no screed was used and the under-floor pipes were laid within the thickness of the structural slab. Where this was done, edge insulation was used to all edges of the new floor slab – not just external walls – to allow for expansion of the slab when heated.

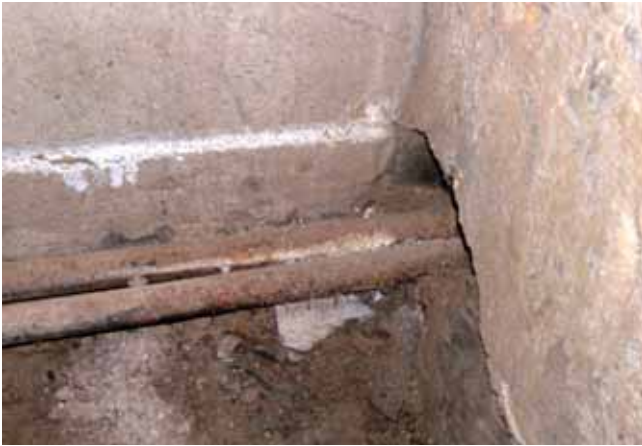
(Opposite page, left): These pipes were all surface runs and had removed considerable amounts of skirting for their installation. The over-large holes occurring in the corner location had stressed the wall, causing cracking elsewhere. Any new services were reintroduced into these holes and the openings reduced.

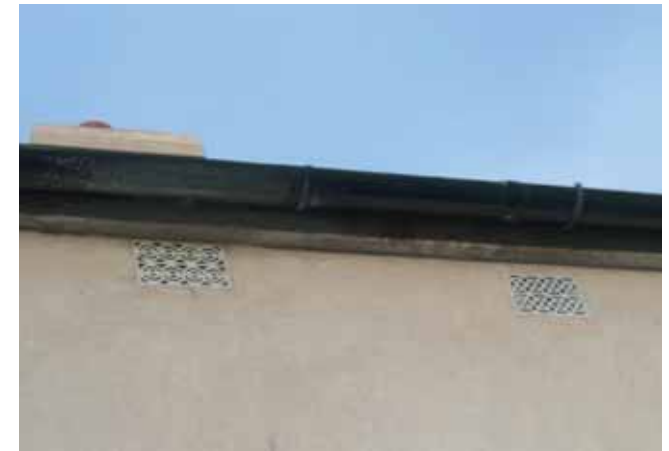
Description of venting solutions

The cast iron reproduction vents installed as room ventilators into two different wall structures. To the left, installing into a brick wall it was possible to control the vent's position. To the right, in a stone wall, which meant that the vent could not be precisely positioned to match due to the presence of a large stone.

natural ventilation from these features can supplement the existing air changes for a room without new openings being made in the external wall. Adding ventilation slots into an existing window is detrimental to its fabric, as it will weaken the timber member. In a brick wall, a vent opening can be cut quite easily in a carefully selected position and covered with a cast iron reproduction or salvaged vent cover, matching where possible the style or pattern of existing vents. In the Knockaulin Farmhouse, a modern reproduction cast iron vent was sourced through The Traditional Lime Company. A number of fireplaces on the upper floor were not going to be used and it was decided to use their flues to ventilate rooms. An additional benefit of this approach is that it prevented a damp penetration through the flue. A flexible flue liner was used and connected to a discreet in-line slate vent at roof level. Traditionally, the installation of decorative vents or airbricks to the side of the chimney-stacks was a means of permanently ventilating an unused flue.

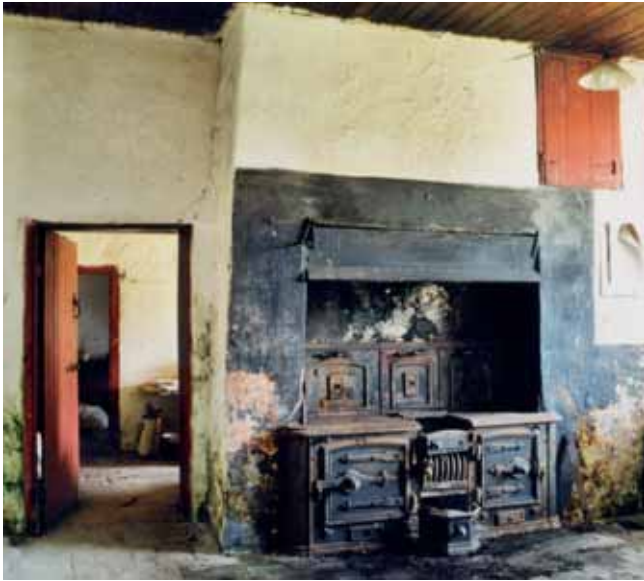
Distinctive range from the kitchen of Belin House, Co. Laois.

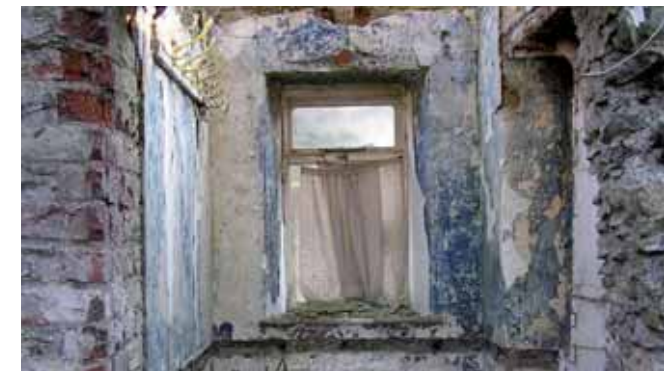
Below: Interior of a derelict house, indicating the remains of lime-rendered walls with 'blue lias' pigment still evident to the entrance porch walls. Very little research has been carried out on the interior schemes of these small farmhouses.

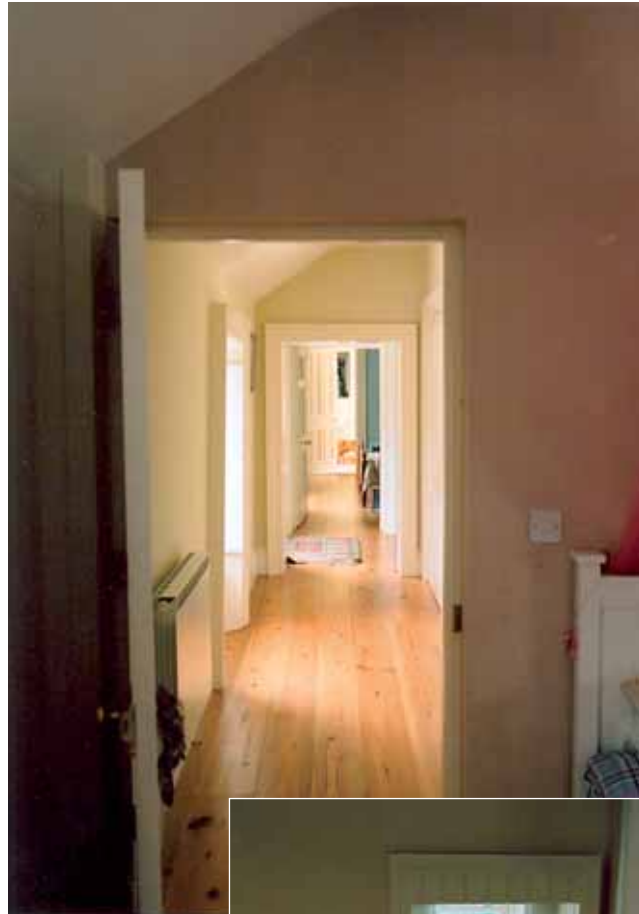
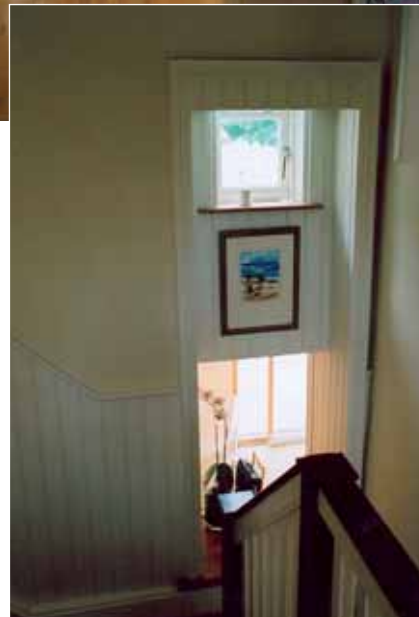
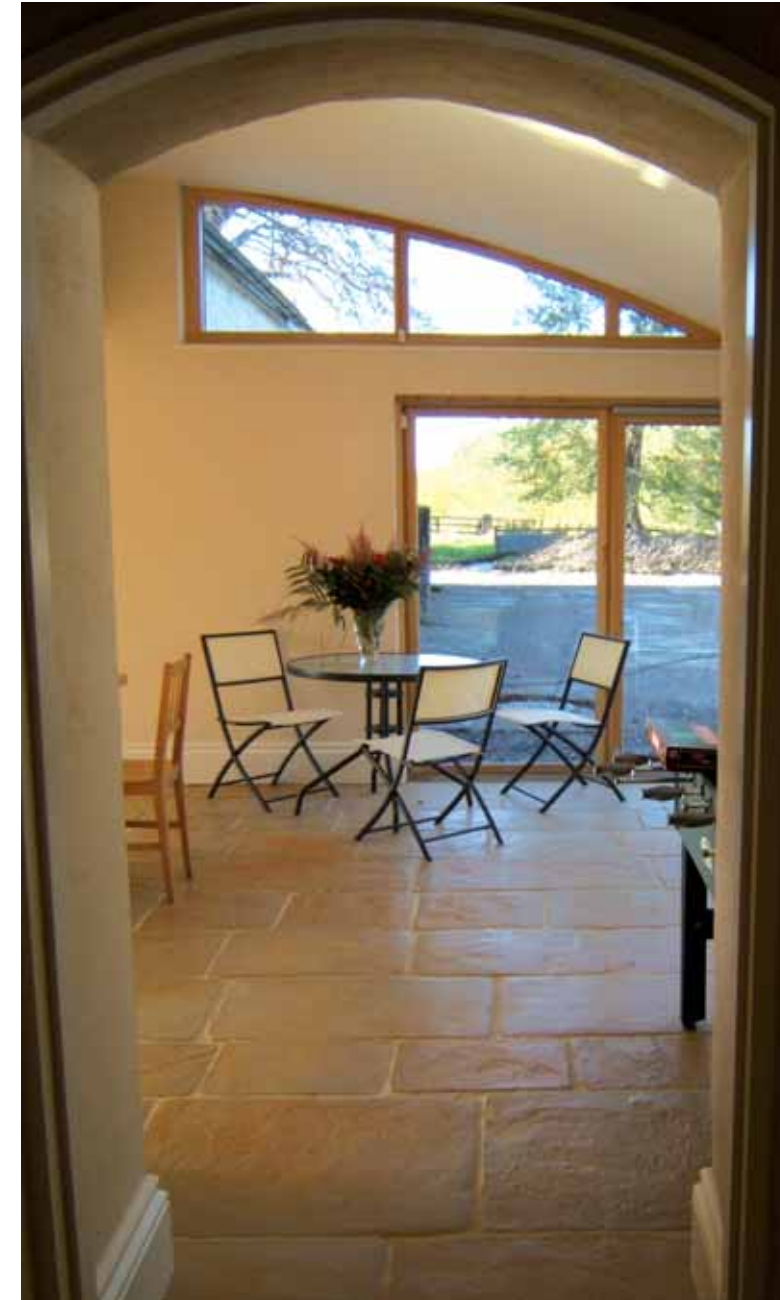
Below: The previous doorway to the removed bathroom extension has been converted into two windows. The lower window is internal into the kitchen area under the curved roof while the upper is above the curved roof and provides natural light directly into the original stairway.

Far right: High windows on curved roof allow a view up towards the foliage of the trees above the barn, and the corner patio doors allow a view towards the rear field.
