## PREFACE

This report and inventory survey of thatched houses in County Kildare, was commissioned by Kildare County Council fulfilling an objective of the Heritage Plan. It was funded by the Heritage Council. Thatched houses are becoming an increasingly rare site in the county. Most surviving thatched houses are of great significance to the cultural, historical and architectural identity of the area, where features unique to the county still survive intact.

Kildare County Council commissioned Charles Duggan, Architectural Heritage Advisor with Stephen Farrell, to revise a thatch survey compiled during 1986-1987 by Michael Higginbotham of the Office of Public Works (OPW). The Higginbotham Survey identified 91 thatched buildings in Kildare, of which 53 survive with varying degrees of intactness. Two additional thatched cottages, previously unidentified were also found. The revised survey aimed to assess the rate of attrition and loss and to identify the attitudes and perceptions to thatch as a means of determining the future of the existing stock of thatched buildings and to the thatch industry in the county. The revised survey took place between April and September 2005.

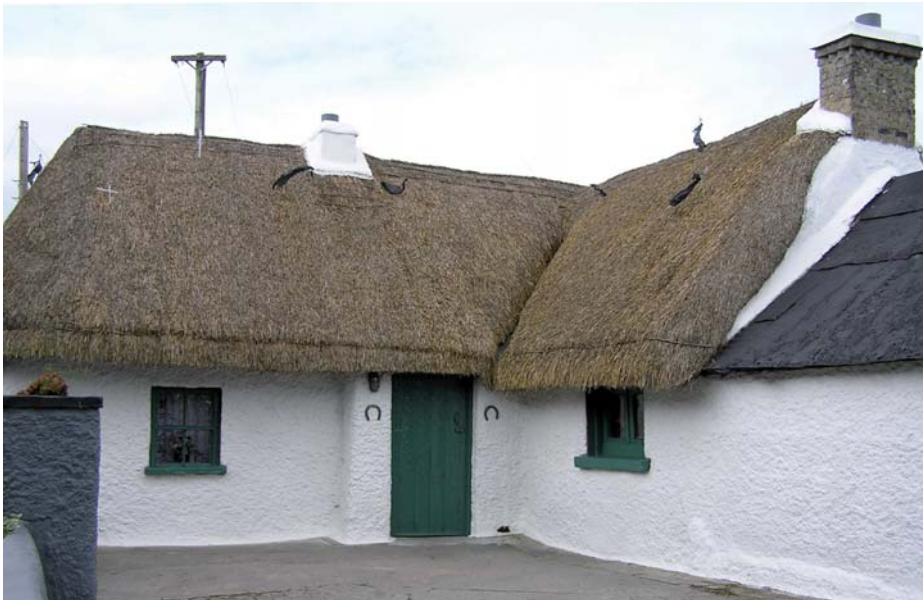
*Fig. 1 This house in Killeen West represents both the simplicity and grace that a well maintained thatched house embodies. (Site number 63)*

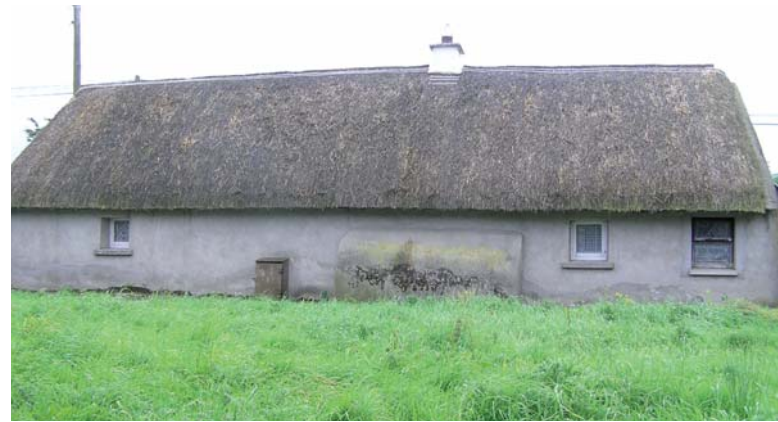
*Fig.2: A single-storey thatched farm house at Allenwood, Co. Kildare, which is nestled against the gentle slope of a field behind.*

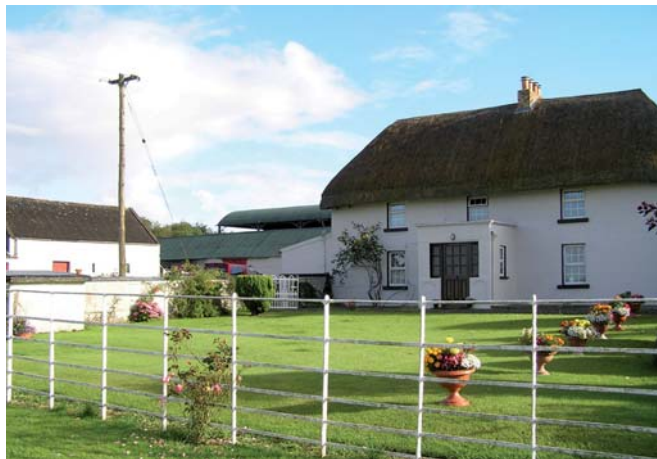
*Fig. 4: Greatrath, Co. Kildare, an exceptionally fine example of the thatched mansion in the county.*

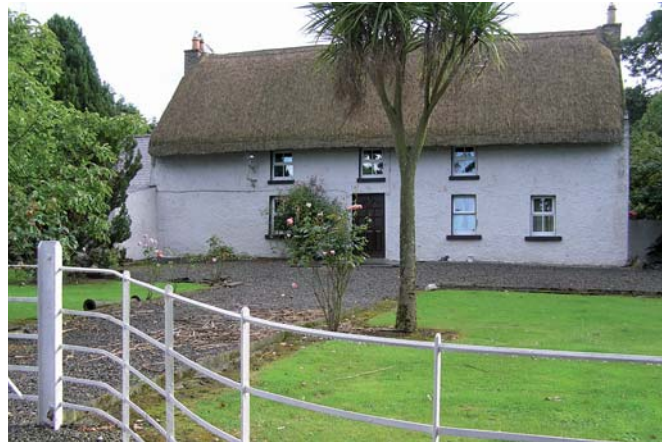
*Fig. 5: The second thatched mansion in Greatrath, Co. Kildare*

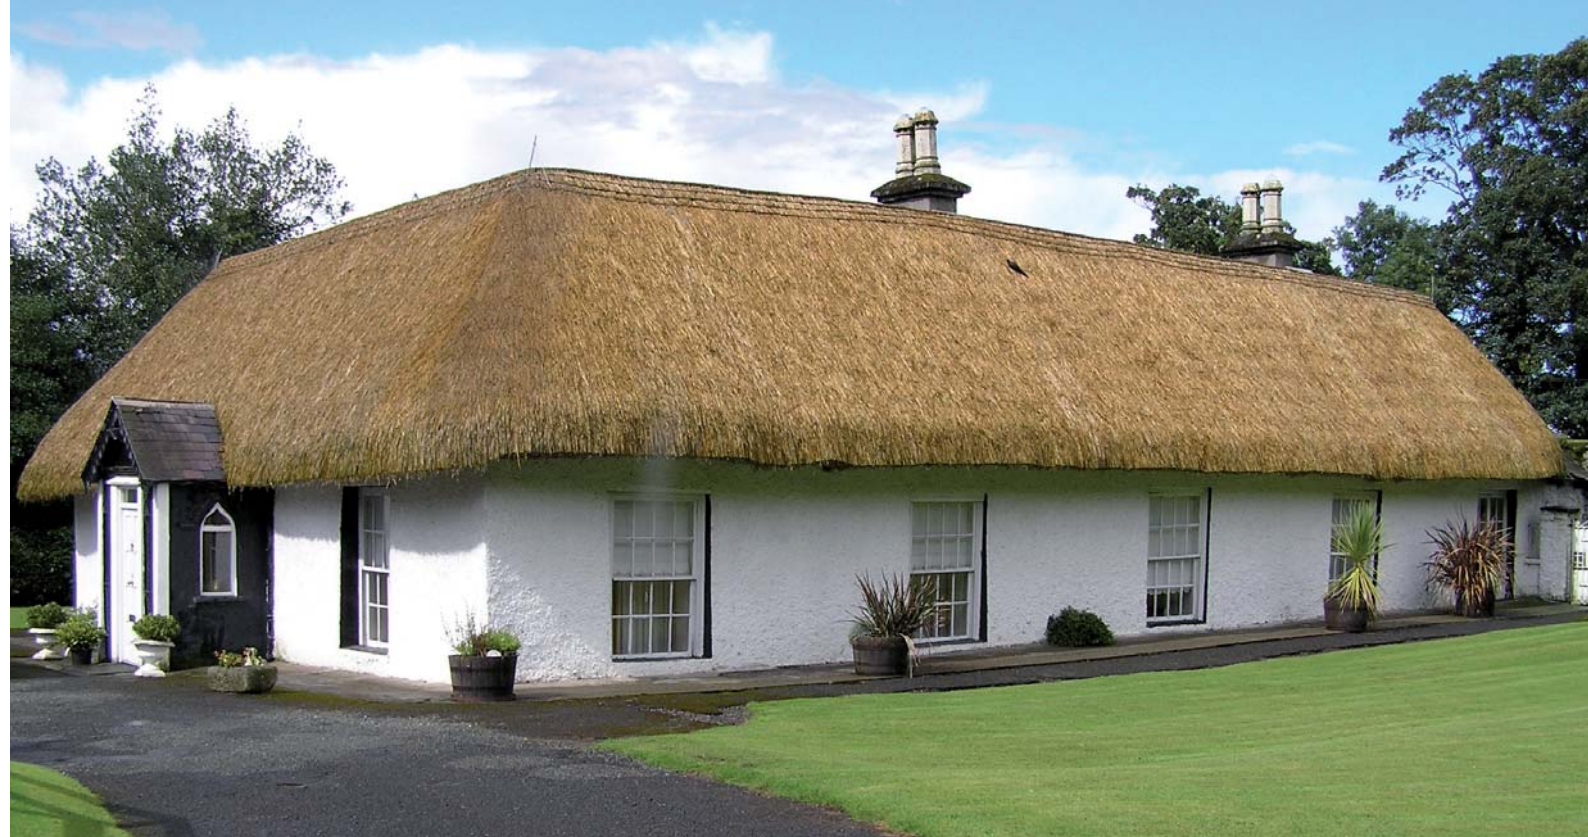
*Fig.6: (Top) The Hermitage, in the townland of Boley Great, Co. Kildare, appears to have been built between 1750-1800.*

*Fig.7: (Above) Located at Thomastown Crossroads. Note the irregular placement of the windows, and the smaller chimneystack over the gable. (Site no. 28).*

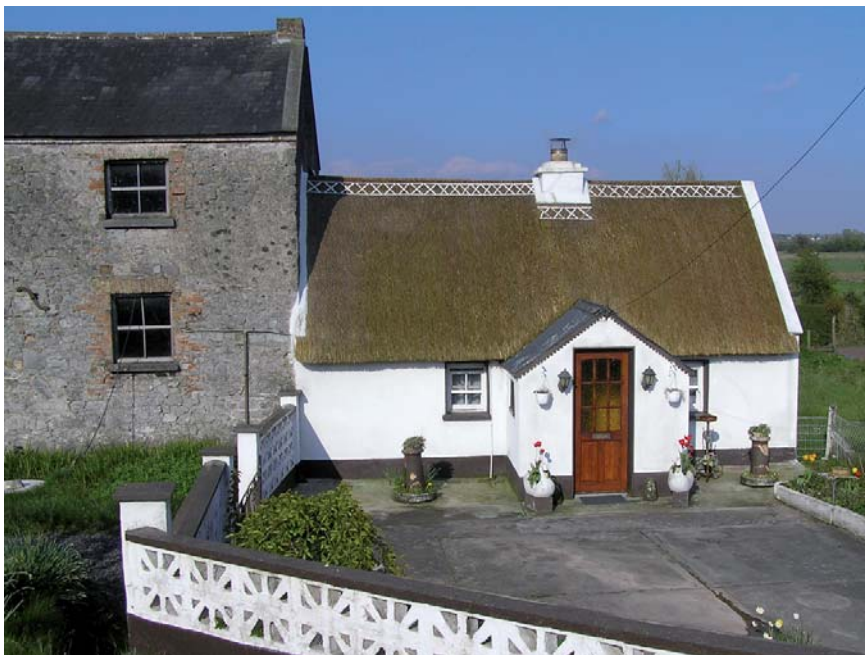
*Fig.8: (Left) This is the home of the thatcher Jack Donohue in Robertstown, which is attached to a building, possibly a local school at one point. This cottage, which retains much of its original character faces onto the canal towpath.*

This house type is generally quite rare. Most houses originally of this type have been altered and extended over time. (Fig. 8) In each case the cottage forms a three-bay single-storey house, with a centrally placed door opening and a simple two-roomed internal layout divided by the chimneybreast and jamb wall of the lobby entry. Extensions are generally located to the rear. Historically, these houses tend not to have outbuildings.

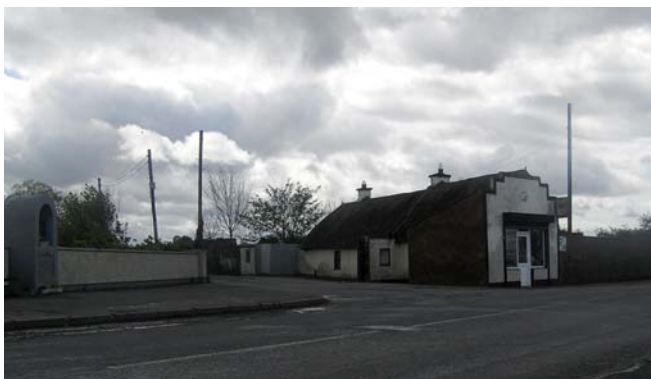
*Fig.9: O(Below) 'Loughlin's shop at the end of a thatched house at Mountrice Crossroads, shares the junction with a wall mounted post box and Marian shrine. (Site no. 28)*

dynamic of country life (see Fig. 9). Other examples include the tin-roofed public house at Ballagh Crossroads, O'Loughlin's shop at Mountrice Crossroads, where a wall-mounted post box and Grotto dedicated to the Virgin Mary attribute importance to the junction. Close-by at another junction there is a forge, though it is no longer operational.

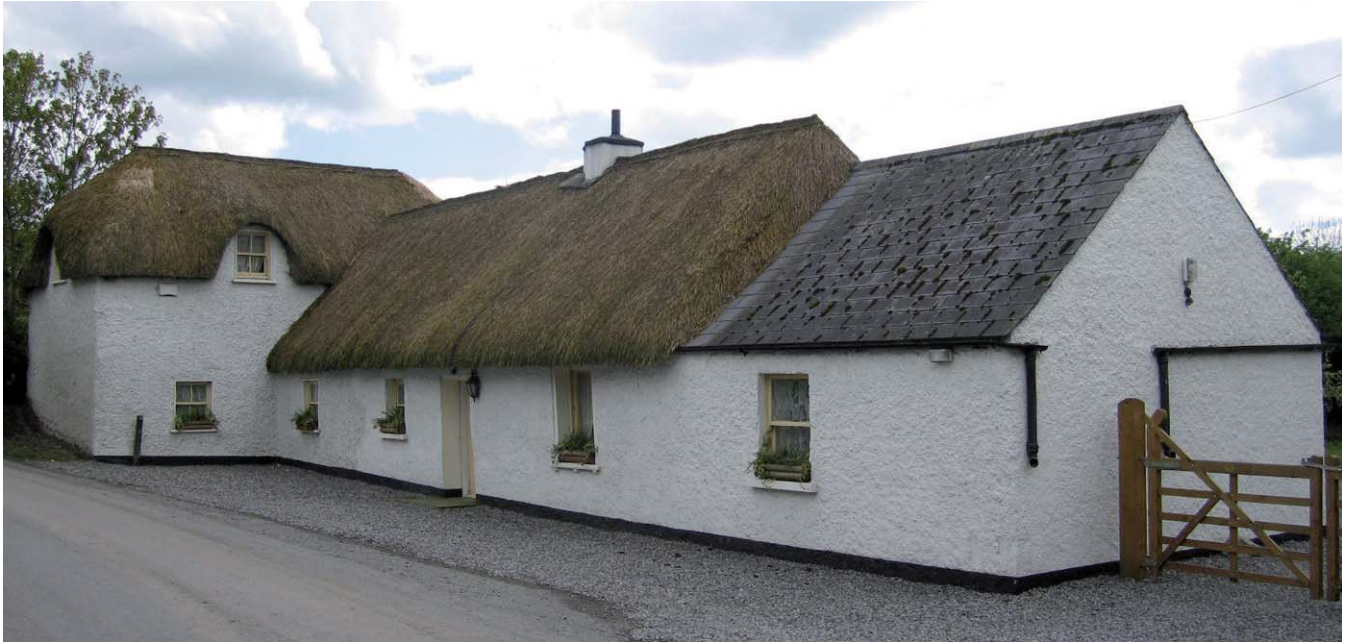
*Fig. 10: The house was dramatically enlarged when compared with the original. (Site number 06)*

A number of new structures which interpret the vernacular style complete with thatched roofs have been built in recent years in Kildare. There are some instances where a thatched house has been dramatically enlarged, such as that represented in Figs. 10/ 11, located at Painestown Crossroads. Originally a three-bay house with a single-storey addition to one side, this house formerly known as O'Neill's pub, was prolonged by a single-storey single-bay addition linked to a dormer two-storey block breaking forward from the building line and set perpendicular to the original. Two thatched houses have been rebuilt using thatch.

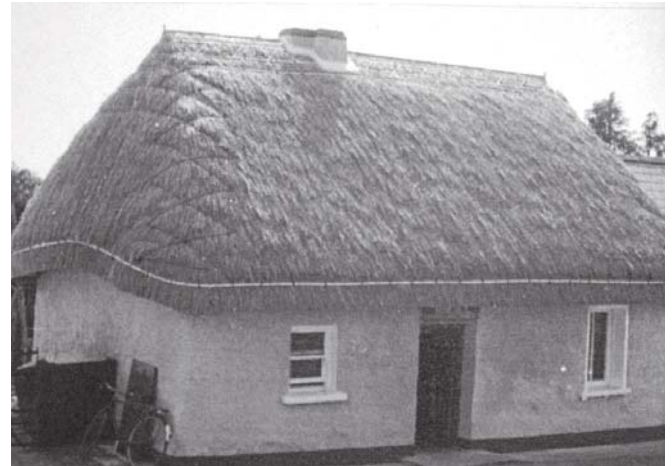
*Fig. 11: Formerly O'Neill's pub, located close to Painestown Crossroads, in its original form comprising a three bays single-storey house with a slate roofed single-bay addition. (Site number 06)*

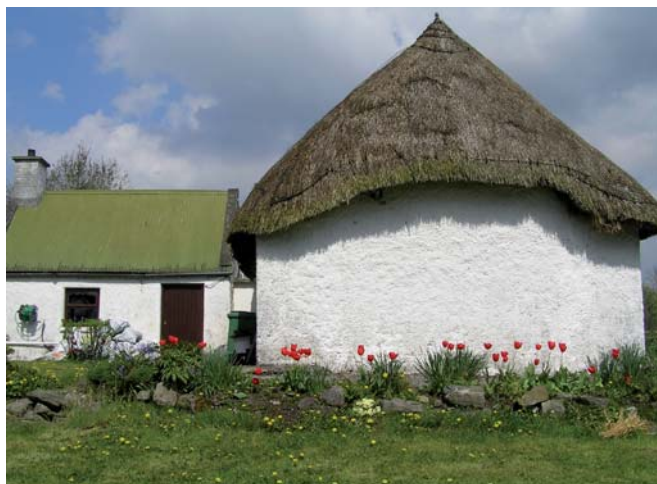
*Fig.12: The hipped side elevation of a thatched house in Thomastown has a slight bow resulting in an arc at the eaves . (Site no. 28)*

The prevailing historic roof type of the thatched houses in County Kildare is the single-span, hipped roof, which is normally pitched at a 40°-45° angle. The roof structure generally comprises quite a simple structure of A-framed principal rafter trusses with collar beams, set at regular intervals standing just beneath the top of the wall. This contrasts with more formal architecture where timber wall plates are generally employed to support the roof structure. This survey has identified at least one example where the roof truss has settled outside of the wall itself, an irregularity which adds to the interest of such a building.

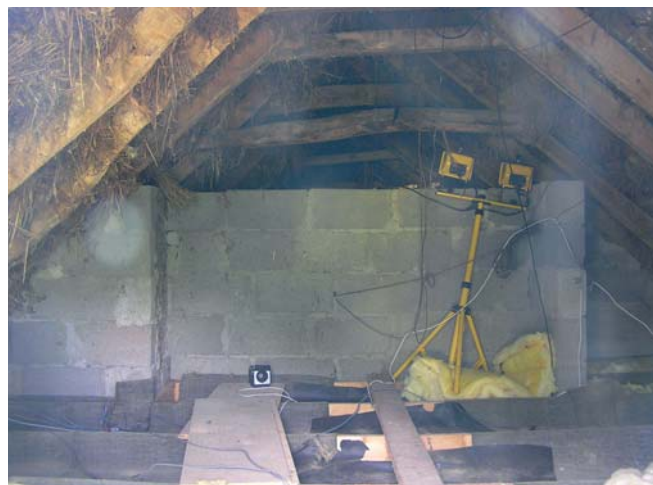
*Fig.13: The rough hewn A-framed timber roof structure of example one. (Site no. 24)*

This roof structure belongs to a rather handsome thatched house, ennobled by formally proportioned windows and a segmental-arched doorcase on the facade. The proximity of this house to the canal tow path would suggest that it was constructed after the opening of the canal, and so may well date to the beginning of the nineteenth century. The roof space is accessible from the gabled side elevation where a replacement timber ladder rises to meet at attic opening. It is believed by the current owners that the attic space was historically used to accommodate farm hands. The roof structure forms the standard A-frame of principal rafter trusses, composed of roughly hewn timber, and strengthened by half round collar beams. One collar beam has scarring to suggest laths were once attached, which may have been reused from elsewhere, or may indeed have been used to partition the roof space. There is no underlying basal layer of

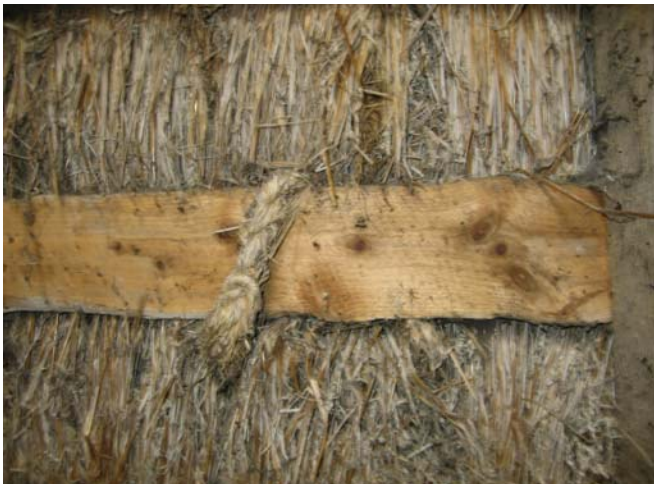
*Fig.14: Note the rope used to tie the thatch to the planked purlins. Note also the absence of a scraw. (Site no. 17).*

scraw, and the thrust thatching technique appears to have been applied (note the jabs of knotted straw sticking out from the thatch).

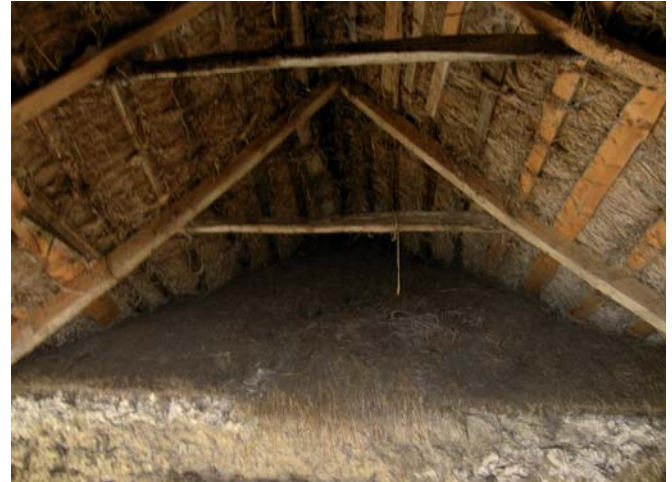
*Fig. 15: The byre extension of this clay walled house has a sawn timber roof structure with the thatch placed directly onto purlins, to which it is attached with hemp rope. (Site no. 17)*

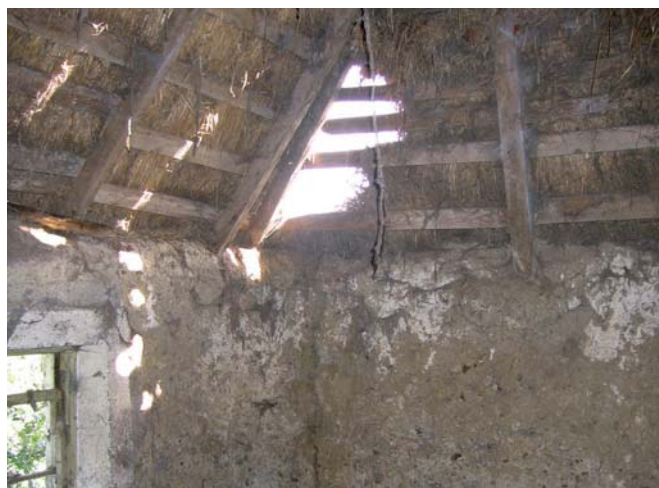
*Fig. 16: The roof of this structure of this byre extension incorporates the original hip roof. Note the A-frame structure formed of roughly sawn timber, collar beams and purlins. Again there is no scraw and the thatched is bound to the roof by rope.*

byre, where the roof structure is entirely exposed. The A-frame roof structure is formed of sawn lengths of tree branch, the rough barked edges of which are evident on the purlins which are placed outside the A-frame. Again there is no scraw and the thatch has been fixed to the purlins by means of rope and scollops. The rope may be an example of the hemp rope that was often used, though a bituminous coating, which the hemp rope was historically dipped in, was not noted.

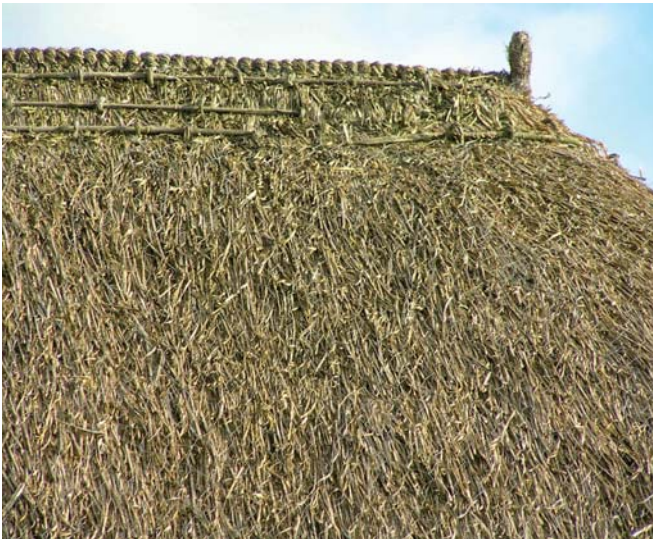
*Fig. 17: (Above): The sloping eaves of a thatched roof.*

The eaves is generally angled at 45° with a 300 mm - 500 mm overhang, which terminates with a drip course formed by lowering the outermost layer of thatch. The eaves is a crucial detail of the roof structure which is designed to throw rainwater of the roof well away from the wall surface, keeping it dry. If the eaves is not deep enough and conversely too heavy, it will be at risk of decay. A failing eaves will sag with the weight of rain, and begin to decay according to Jack Donohue, a well known local thatcher. Once the eaves begins to decay the clay wall constructed houses are at imminent risk.

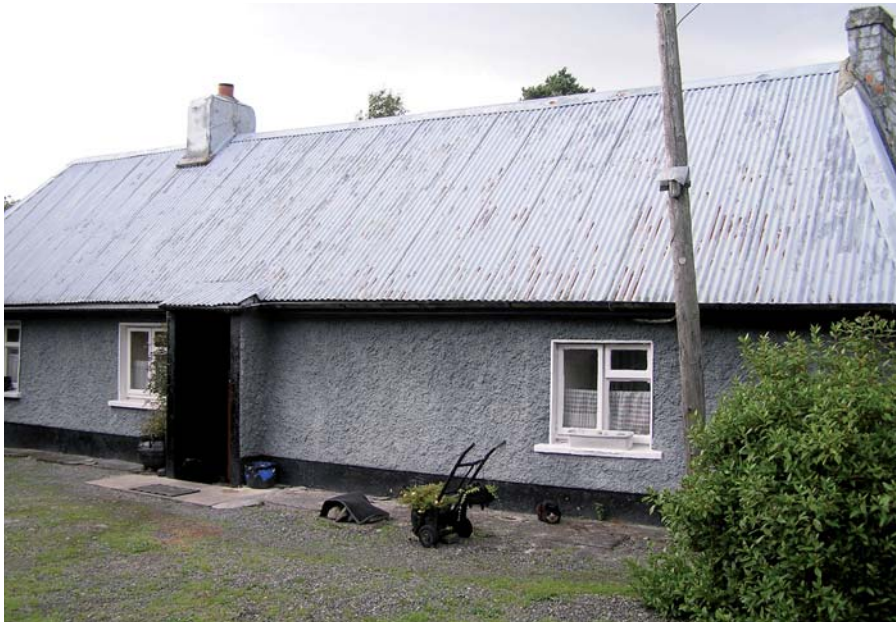
*Fig. 19: This tin-roofed structure in Kildoon was put over the existing thatched roof since 1988.*

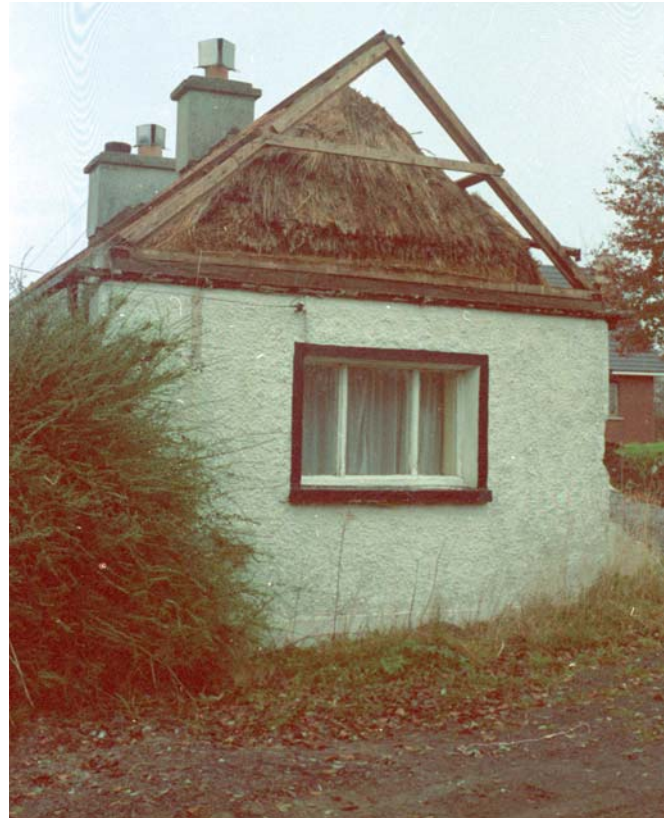
*Fig. 20: The tin has been removed from the roof of Silliot Lodge (demolished in 1987), which was located on the road from Kildare to Kildangan. The simple A-frame roof structure was placed over the existing thatched roof. In many cases the chimneystacks have to be built up to take the additional ridge height. (image courtesy of Irish Folklore Department, UCD, A024.09.00049)*

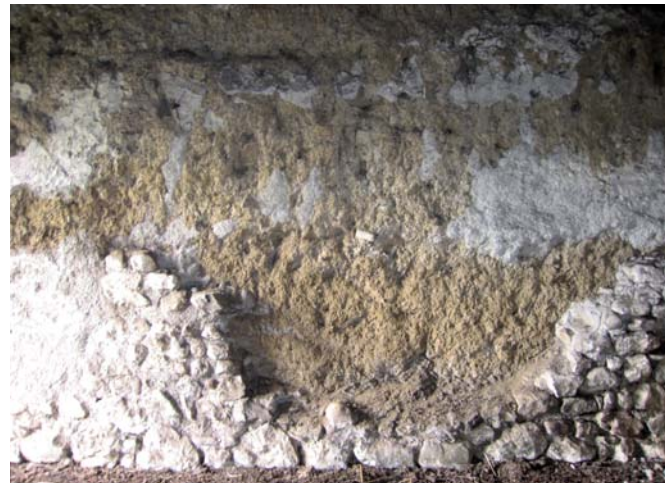
*Fig. 21: This clay-walled side elevation has been incorporated within a byre extension. The base of the wall has been built up with a protective layer of rubble stones to prevent damage to the clay wall from animals. The stone facing has partly fallen away taking with it the lime render coating, exposing the clay of the wall.(Site no. 16)*

every other type of construction, require water tight conditions to function properly. This is why there is an outer coating of render applied, and also why the eaves is so deep throwing water off away from the walls. When thatch fatigues or is not replaced the threat of decay sets in. Once water ingress becomes constant, the clay walled house will virtually disintegrate in a short period of time.

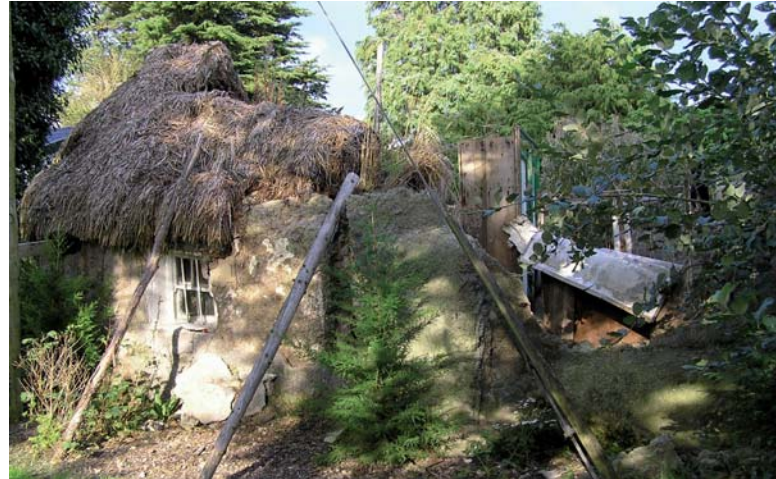
*Fig.22: (Above) This clay walled house in Turnakill, is now a ruin and will be, in a short space of time, virtually untraceable. Note the country style dresser which still stands inside though the thatched roof and clay walls around it have disintegrated. (Site no. 78).*

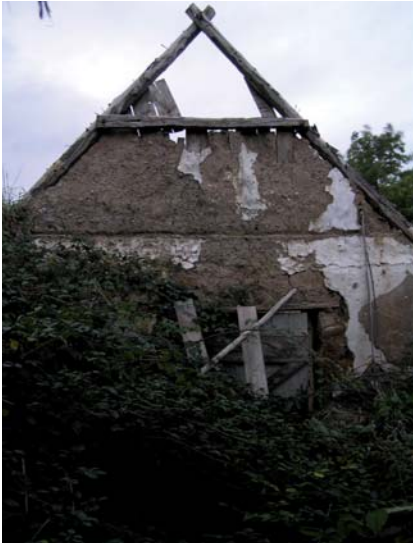
*Fig. 26: An internal partition wall, in this case, not a hearth wall, but nonetheless illustrating the incorporation of the A-frame of the roof structure in the wall.)*

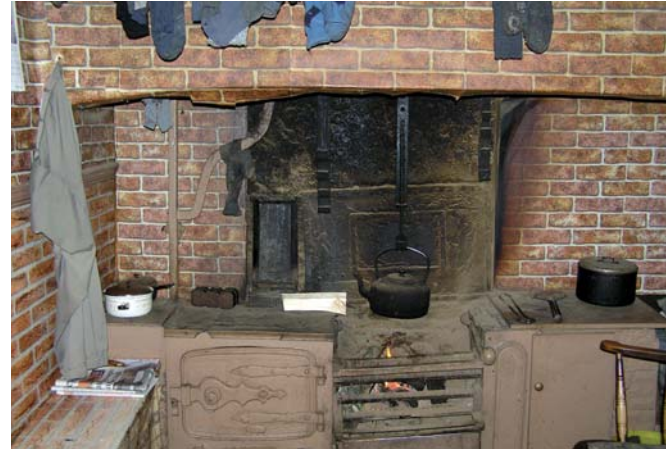
*Fig. 27 A traditional hearth with a 19th century range built into the open hearth and incorporating a wrought-iron crane.*

Generally speaking the hearths which have been inspected remain largely intact. Some, however, have been blocked up to form normal sized openings to accommodate a range, or they have been blocked up altogether. Where they do survive many retain the wrought-iron crane and associated hardware. Generally, the hardware is not operational and has been retained for nostalgic and decorative reasons.

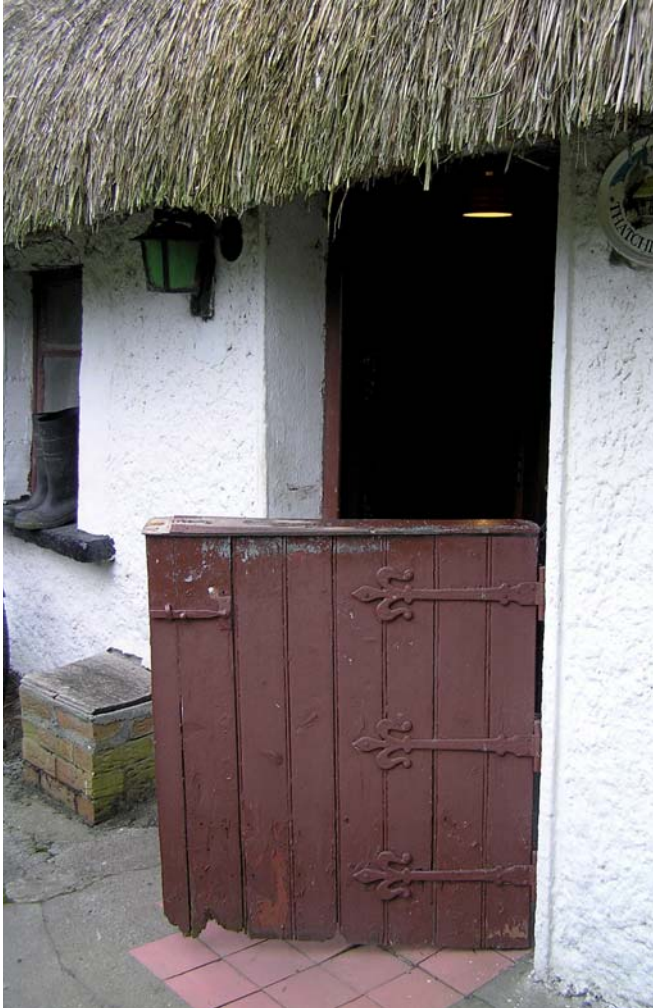
*Fig. 28: A half door which is separate from this handsome raised and field-panel led timber front door which leads into a lobby entry house. (Site no. 67)*

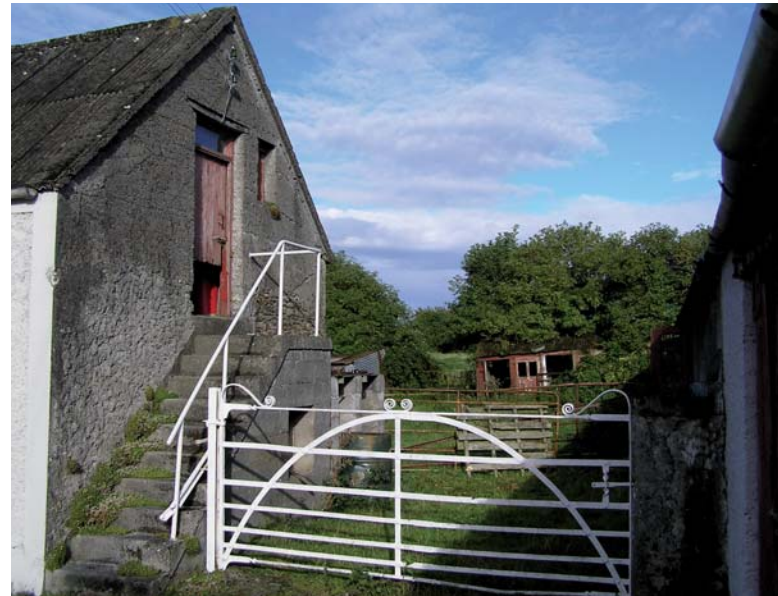
Fig. 30: The relationship between the dairy and the single-storey range of outbuildings proves important in the movement of animals into and out of the farm yard. The wrought-iron gate with characteristic arched brace bar and decorative c-scrolls are typical of these farm gates. (Site no. 75)
