Addendum to Archaeological Testing Report, Kerdiffstown, Co. Kildare

Prepared for Kildare County Council/RPS
By Ger Dowling PhD MIAI

10 August 2019

Licence Ref.: 18E0665
Planning Ref.: PL09.JA0041

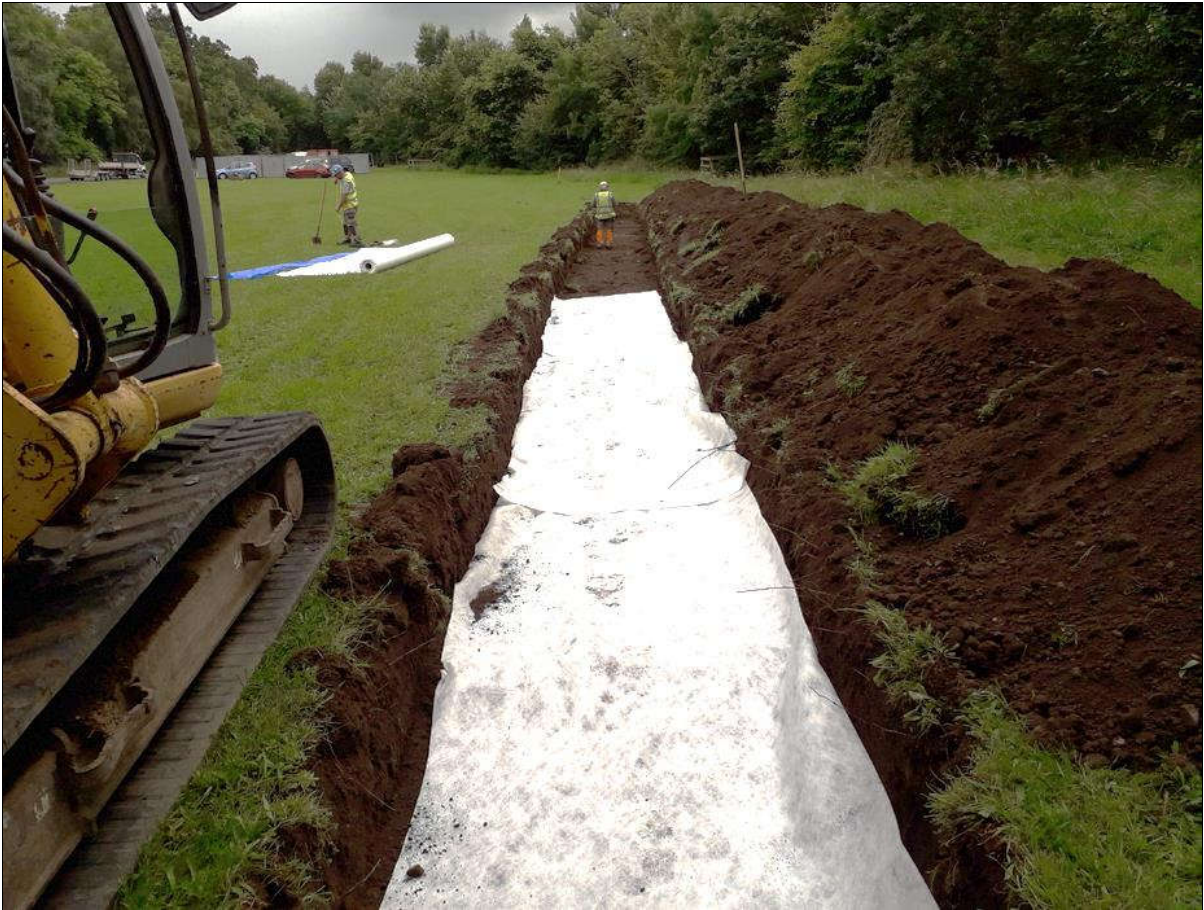
Due to health and safety concerns, moreover, it was not possible to leave the excavated trenches open as originally intended. Therefore, the base of Trs 2.16 and 2.17, as well as each of the foundation pads, were lined with terram before being lightly backfilled (Plate 1).

Plate 1: Terram lining base of Trench 2.16, Field Location 2, looking southeast

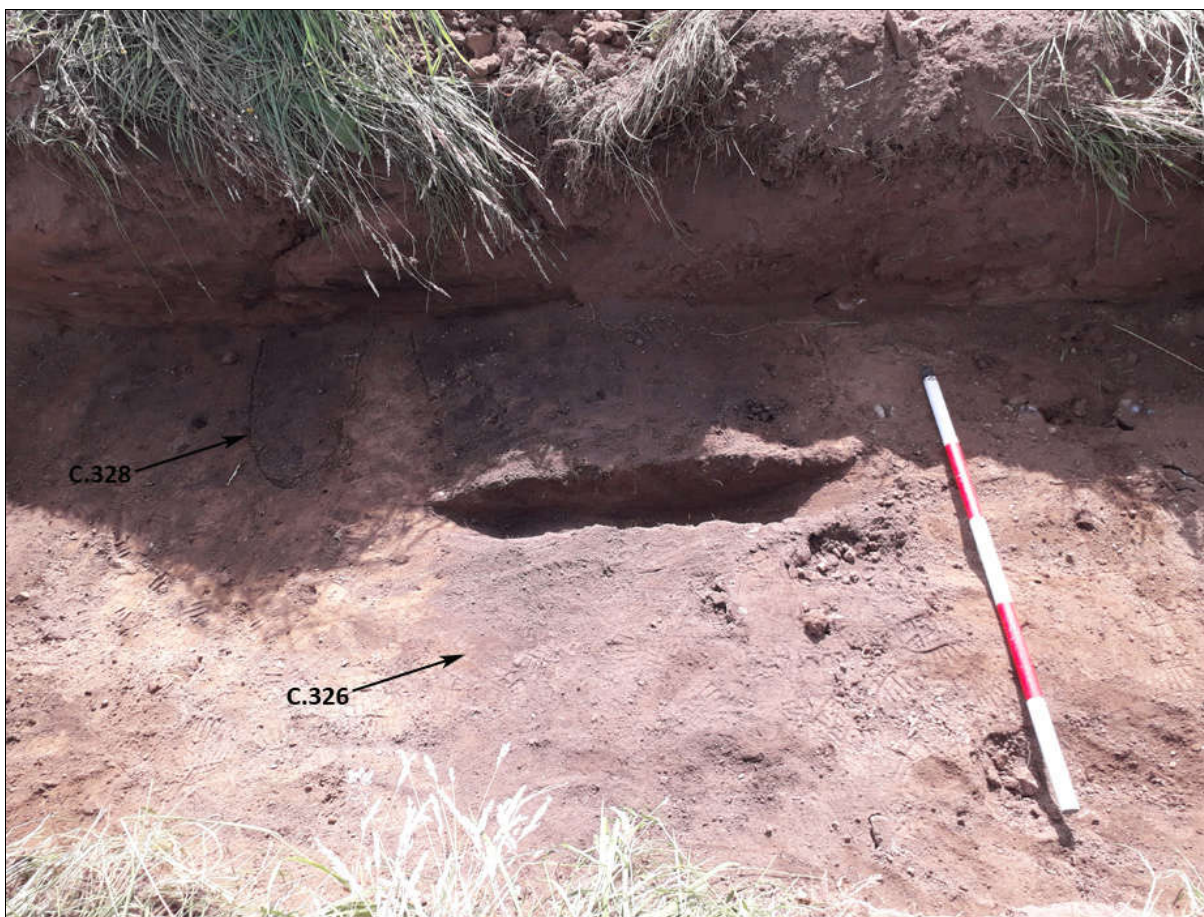
A shallow linear feature (C.327) was identified in the approximate centre of the trench. Oriented roughly east–west, C.327 is about 0.9m wide and reaches a maximum depth of some 0.2m (see Figure 12 & Figure 13; Plate 3). It has moderately sloping sides that give way to a broad, U-shaped, slightly uneven base. It is filled by a friable dark-brown humic clay (C.326) that contains occasional animal bone and flecks of charcoal. Its shallow nature may indicate past disturbance to this feature, further traces of which were identified in Trench 1.11 some 5m to the east. A second possible feature (C.328) was revealed directly north of C.327 in Trench 1.9 (see Plate 3). The former is defined by a band of dark brown silty clay, measuring some 0.3m in length by 0.5m in width. It was not tested and extends under the eastern bank of the trench. C.328 was not recorded in Trench 2.11.

Plate 3: Looking east over linear feature (C.326), possible ditch, in Trench 1.9, with C.328 to left

1. It is recommended that if preservation *in situ* is not possible that the archaeological remains within the footprint of the proposed development in the subject area be archaeologically excavated and recorded in advance of development at the site.

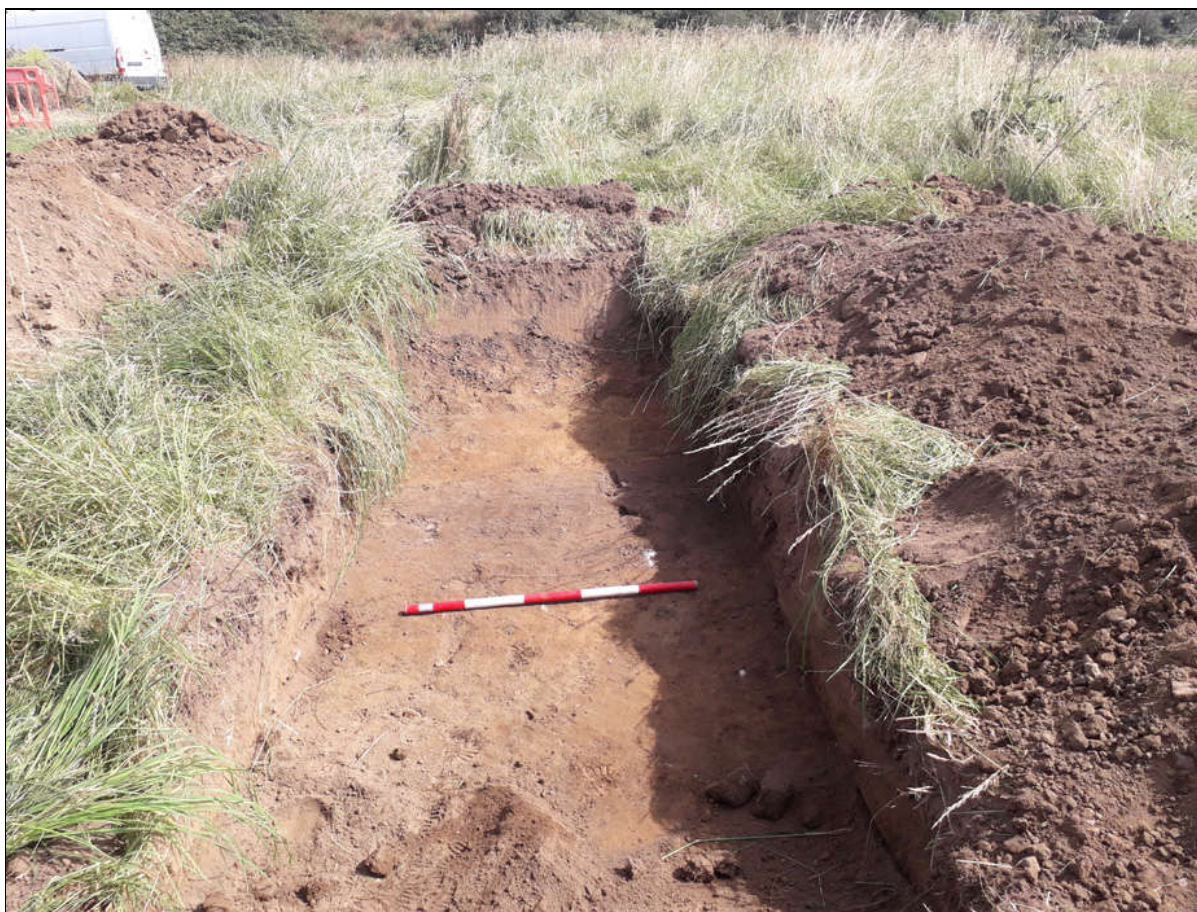
A probable continuation of ditch-type feature C.327 was identified in this trench (Plate 4). It is defined by the same dark-brown humic clay (C.236) as noted in C.327 in Trench 1.9 and measures about 0.9m in width.

Plate 4: C.328 in Tr. 1.11, looking northeast

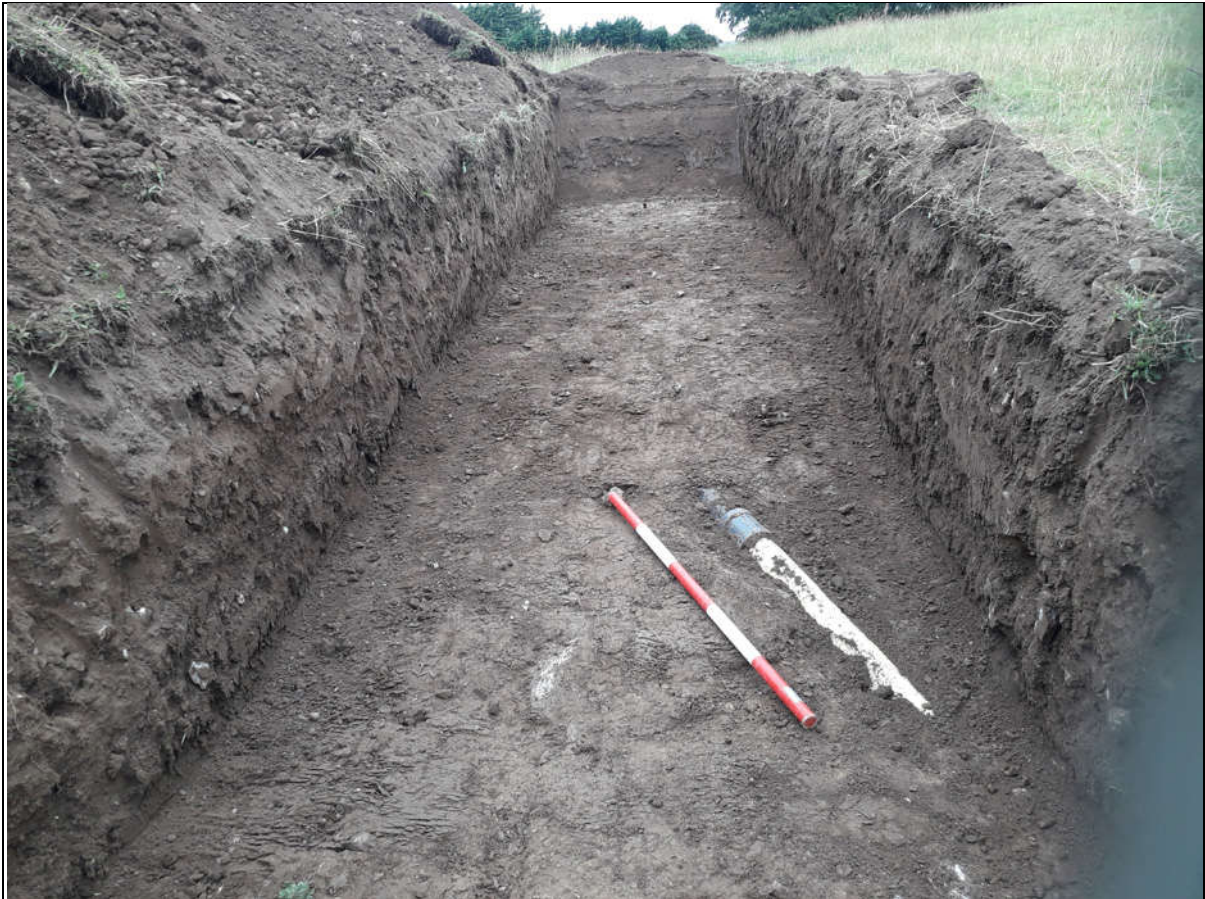
Trench 4.4 was located on a relatively steep slope. It was positioned to investigate a potential ditch-type feature identified during earlier testing in this location. The trench measured 18m in length and reached a maximum depth of 0.90m (Plate 12). The topsoil here is about 0.20m in depth and covers a mid-brown silty clay up to 0.80m deep that likely comprises colluvium (hill wash) material. No trace of the putative ditch or any other features of archaeological potential were identified; a modern plastic pipe was encountered in the approximate centre of the trench (Plate 13).

Plate 13: Modern plastic pipe in Trench 4.4, looking northwest

1. No archaeological remains were uncovered and no further work is recommended in this area.

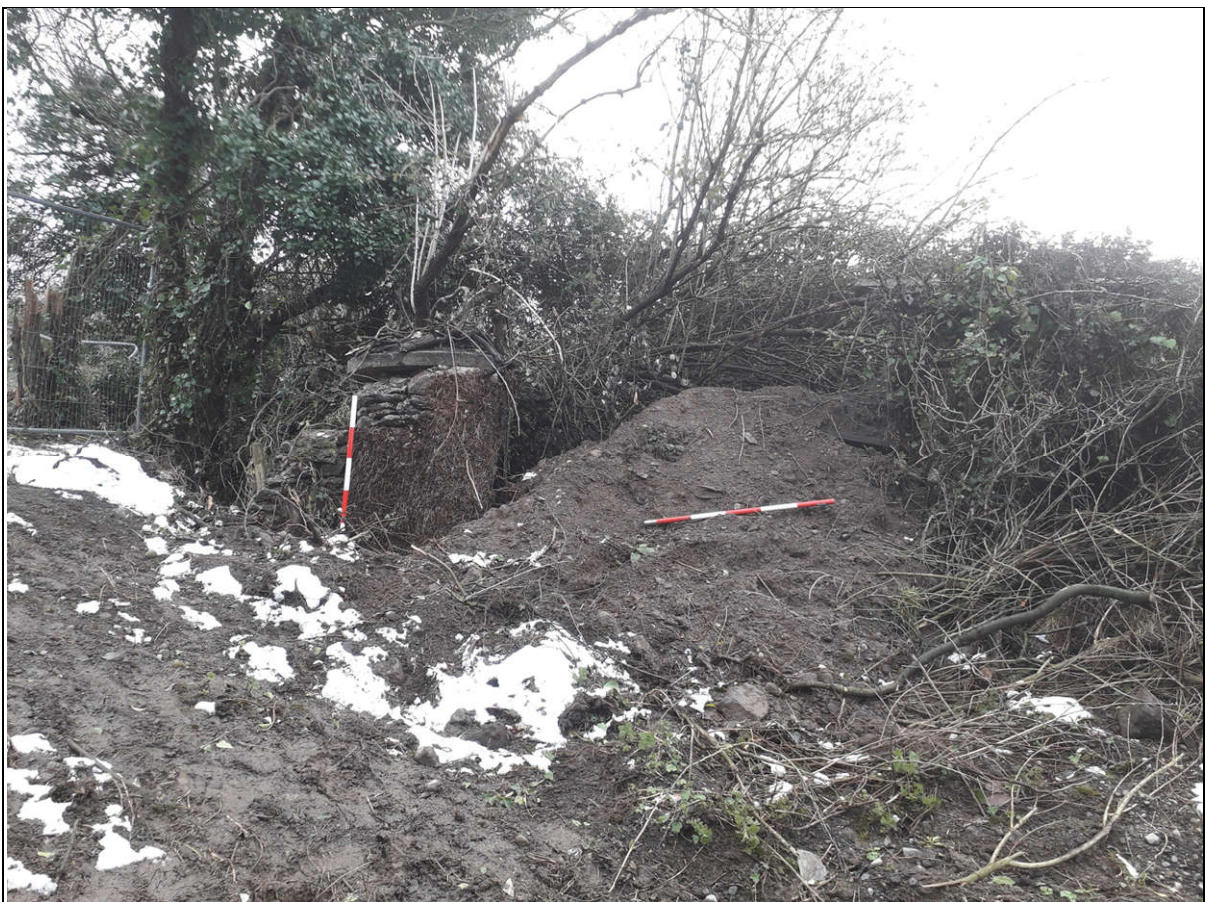
The pillars (set some 3.60m apart) appear to be relatively sound and stable, though both are heavily overgrown with vegetation and surrounded by extensive dumps of soil (Plate 14). The eastern pillar stands approximately 1.5m high but it is likely to be somewhat taller (Plate 15). A small iron gate hanger is affixed to the inside of the pillar, perpendicular to the former gate, and it is abutted by the dilapidated remains a low external wall. The western pillar still retains a horizontal steel plate with notch that likely functioned as a gate latch (Plate 16). Careful clearance of the surrounding soil heaps and vegetation will allow for a better understanding of the fabric of the gate pillars.

Plate 14: Gate pillars, looking south

1. Careful clearance of the surrounding soil heaps and vegetation will allow for a better understanding of the fabric of the gate pillars.
2. Any excavations in this area should be undertaken under archaeological supervision to ensure preservation of any subsurface remains potentially associated with the path marked on early cartographic sources.

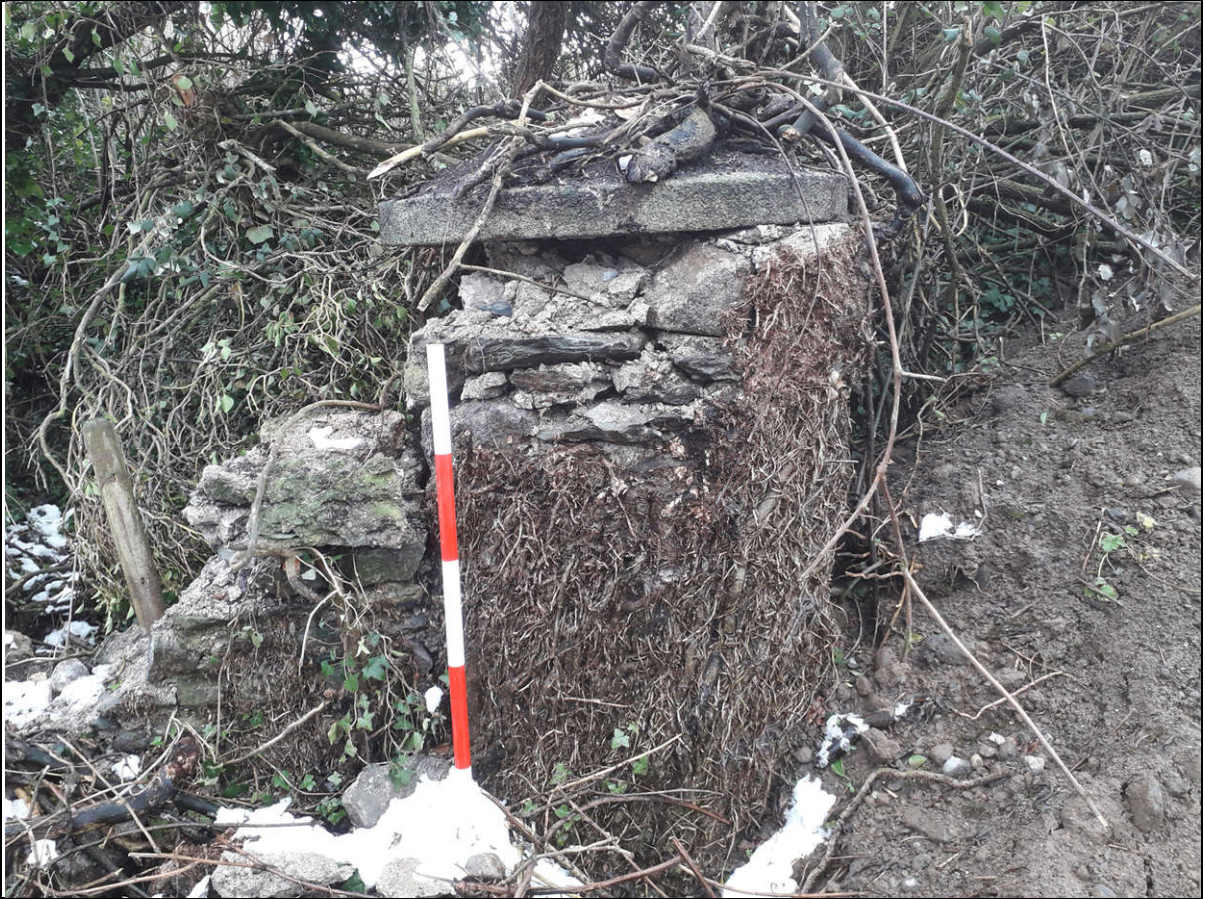
Plate 15: The eastern gate pillars, looking west

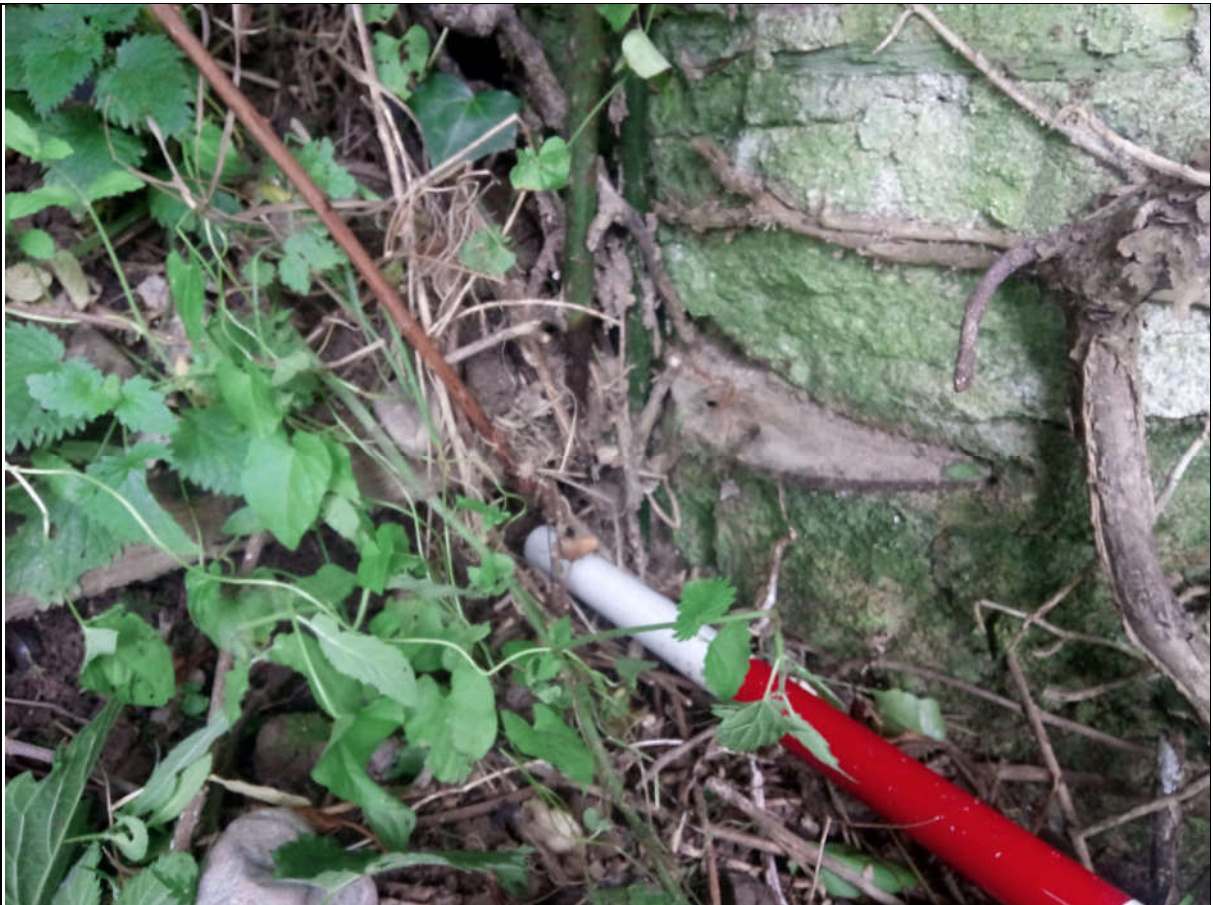
Plate 16: Gate latch on the western pillar
