Draft Archaeological Wade and Metal Detection Survey on the Morell River, Kerdiffstown, Co. Kildare

Prepared for Kildare County Council/RPS
By Colum Hardy & Pawel Rudzinski
January 2019

Licence Ref. 18D0126 & 18R0238
Planning Ref. PL 09.JA0041

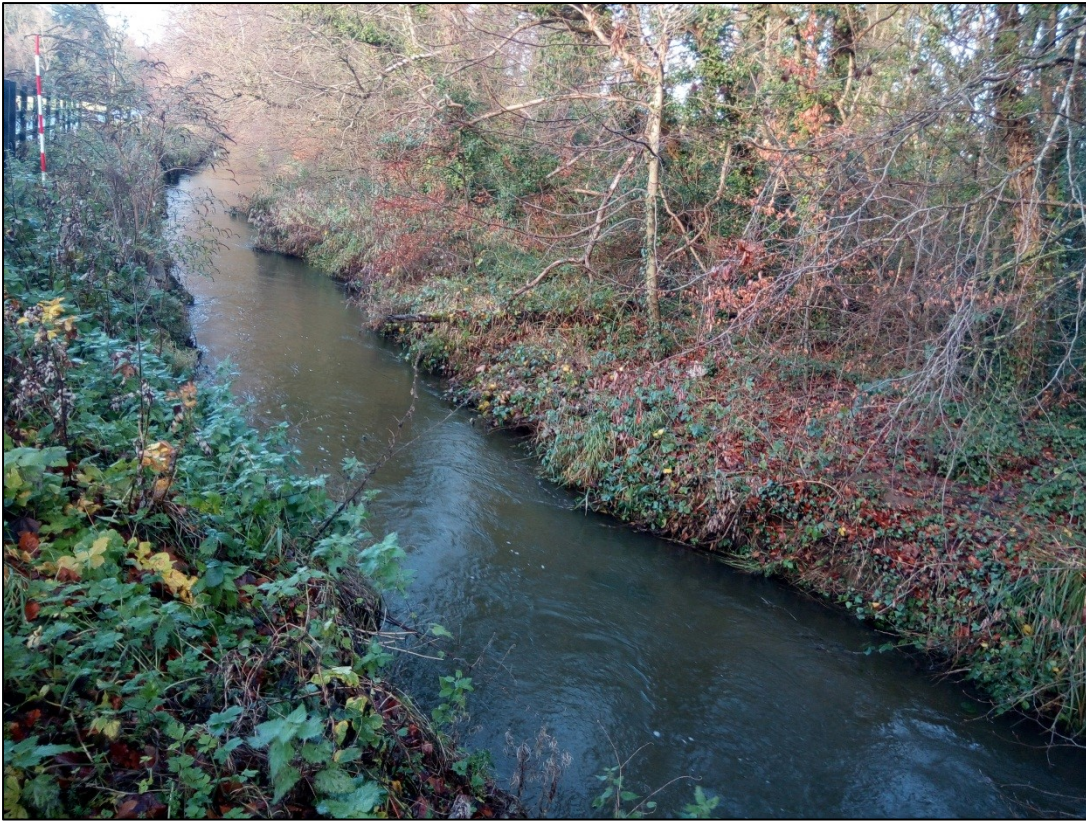
The 30m length of the southwestern bank of the river was comprised of 3–4 layers of modern, large limestone and concrete boulders. This composition was a result of the foundation for the adjacent road during its construction and thus heavily influenced the shape of the riverbank. After such an intrusive amount of activity so close to the river, it is almost impossible for any in-water structures to survive *in situ*. The northeastern edge of the riverbank was much less structured and had an uneven natural shape, most likely the result of naturally undercutting riverine water activity (due to periodical changes of water level and possible floods) with a variety of trees and bushes overgrowing. This side also showed no evidence of any structures of archaeological or historical importance.

Plate 2: General view of the Morell River and survey area, facing northwest

It is recommended that archaeological monitoring and metal detection of any removed riverine material is undertaken at this location during the construction stage of the project.

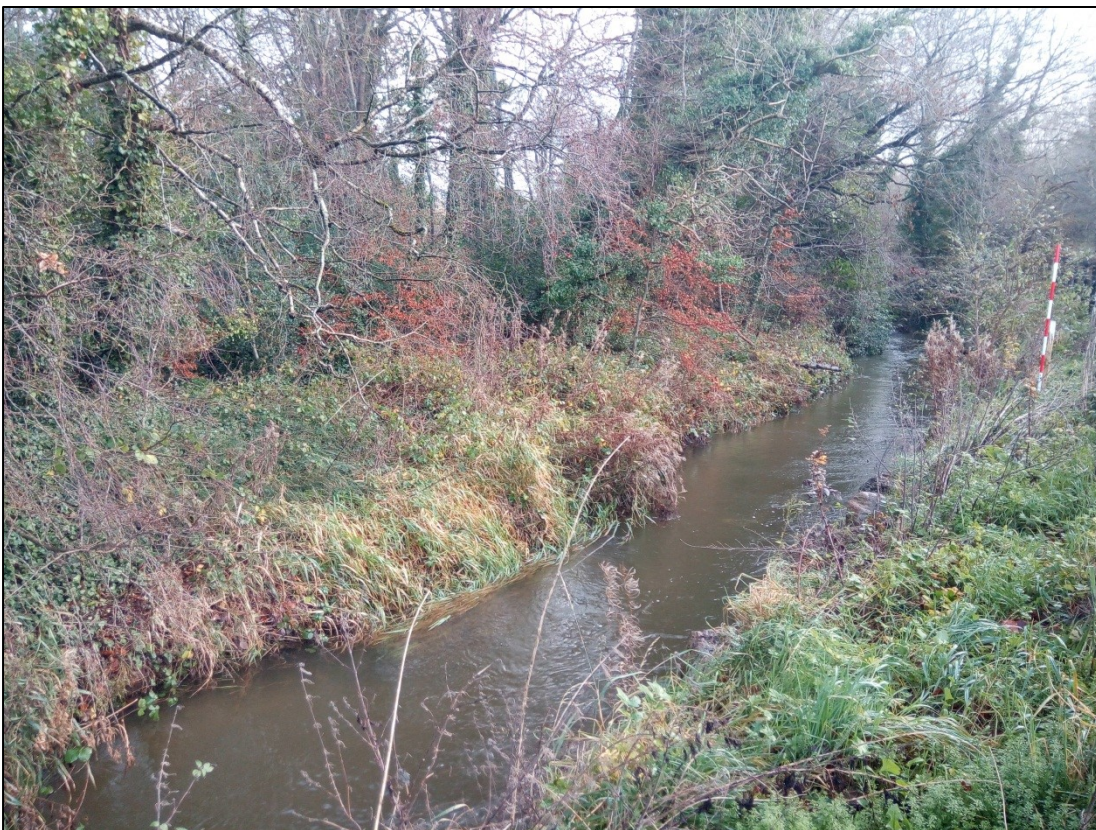
Plate 3: General view of the Morell River and survey area, facing southeast

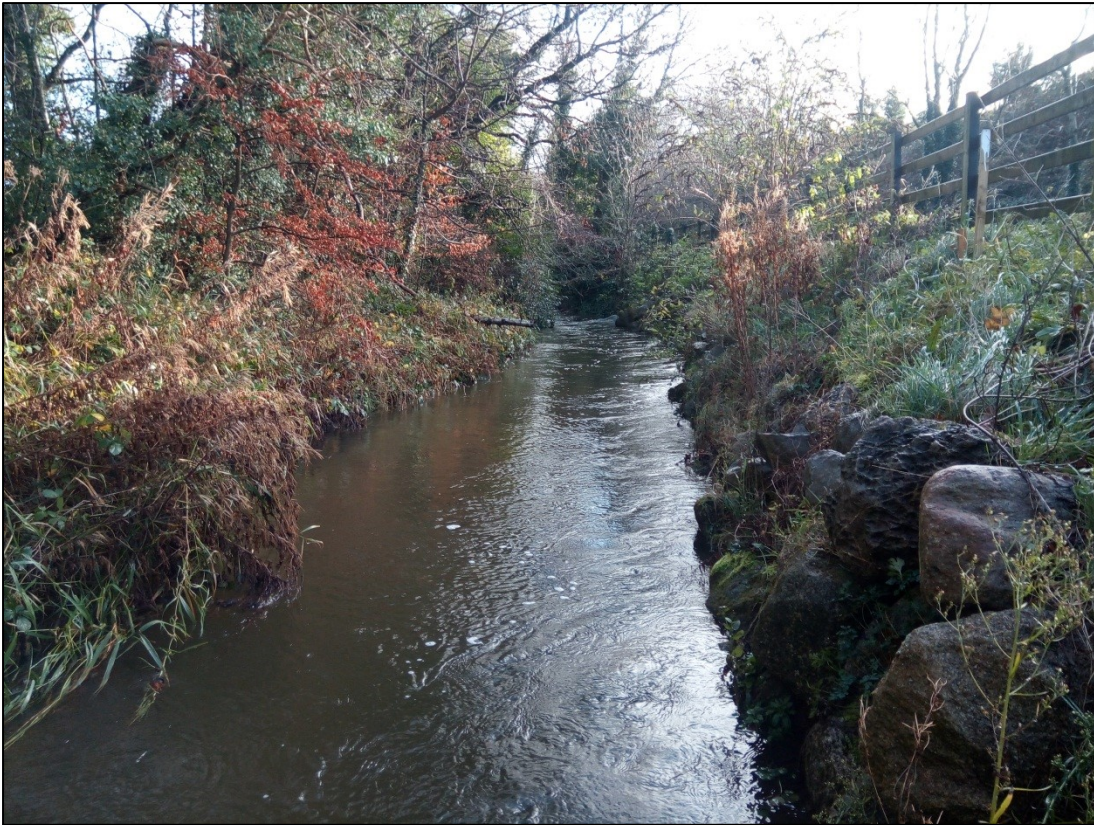
The wade and metal detection survey examined a targeted 30m stretch of the Morell River (Plates 2–14). The survey was carried out on 7 December 2018 and on the day of survey there was a moderate high water level depth of 0.7m and a slow stream current. This allowed for a safe access into and out of the river. The river had a depth that varied from 0.4–0.7m along the 30m stretch of survey. Though the water levels were deep enough to undertake a snorkel survey, a wade survey was carried out in reasonably good visibility, thus allowing the surveyor to determine if any possible structures or features of archaeological potential were present.

Plate 4: View from within the Morell River, facing southeast

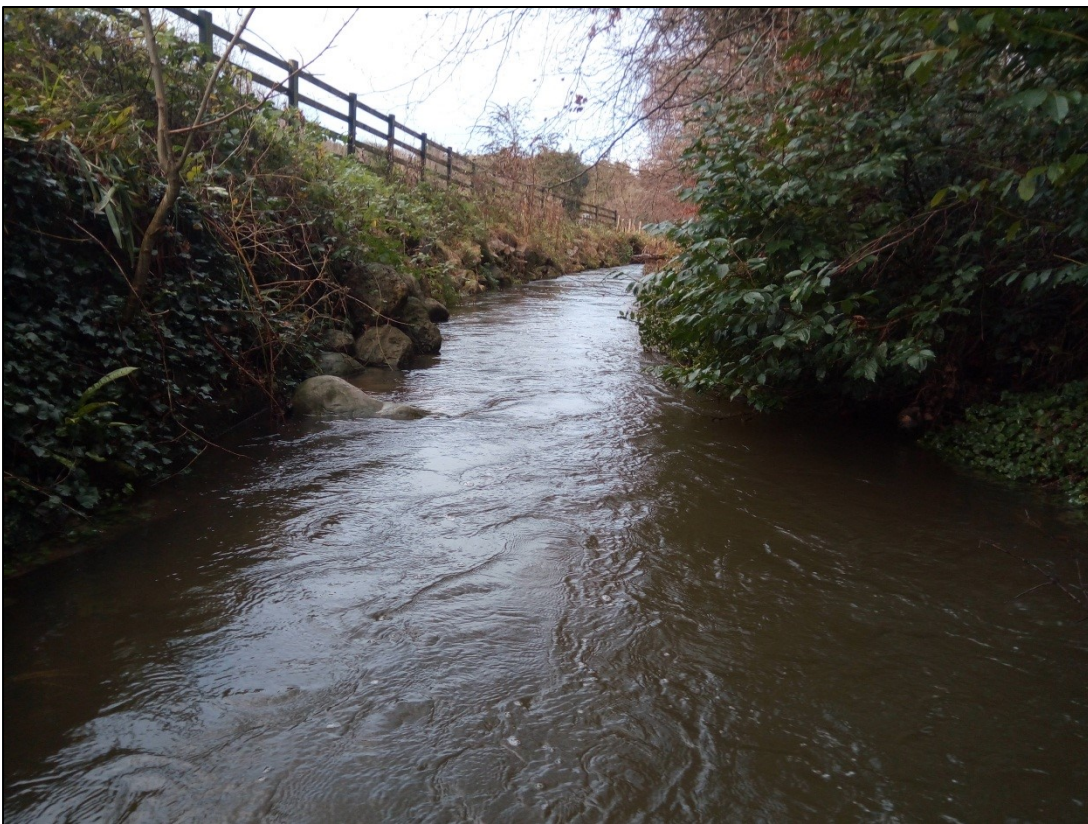
Plate 5: View from within the Morell River, facing northwest

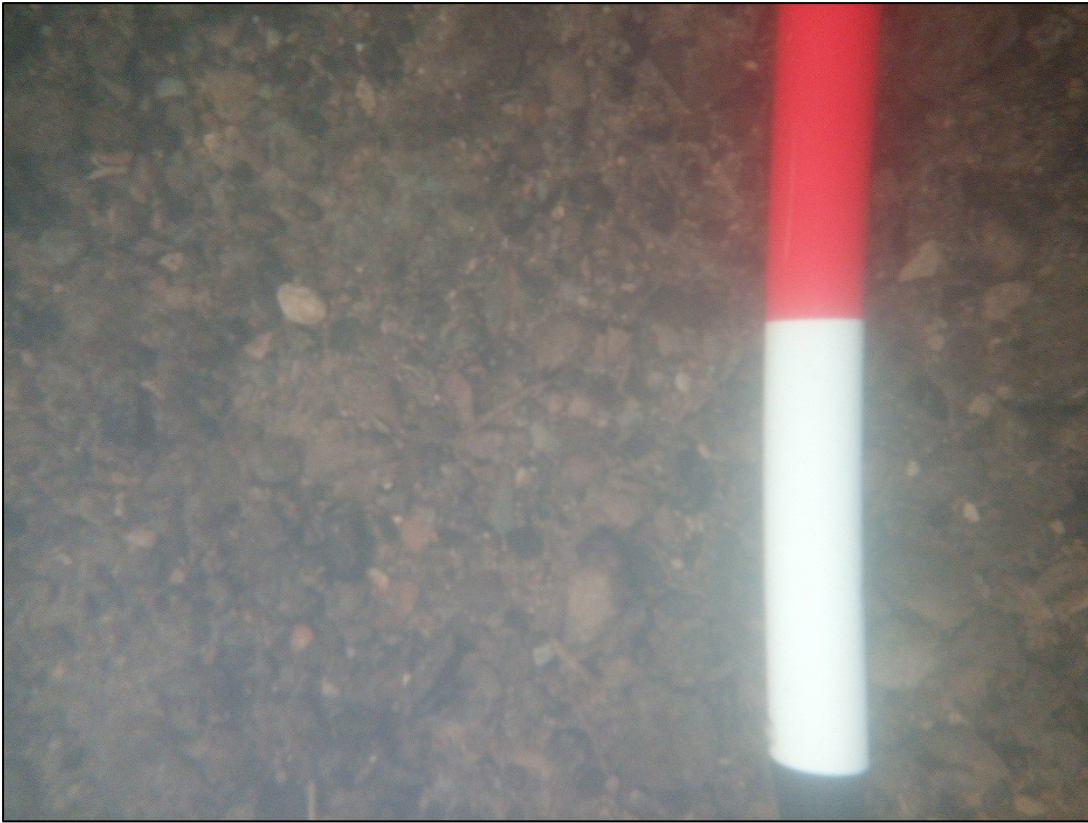
Plate 6: View of the Morell river bed (scale 0.2m)

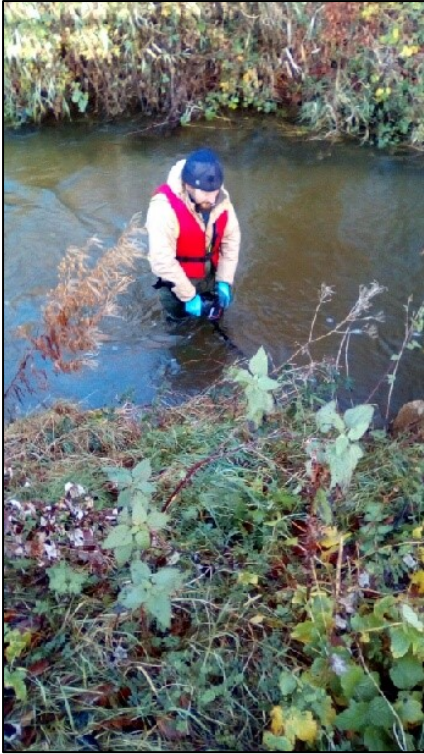
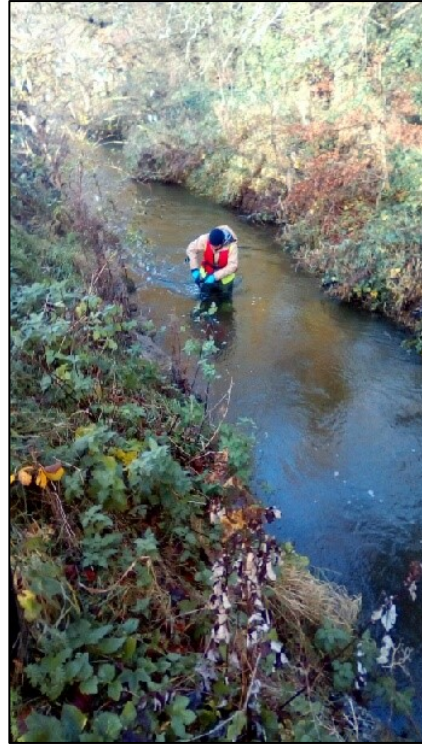
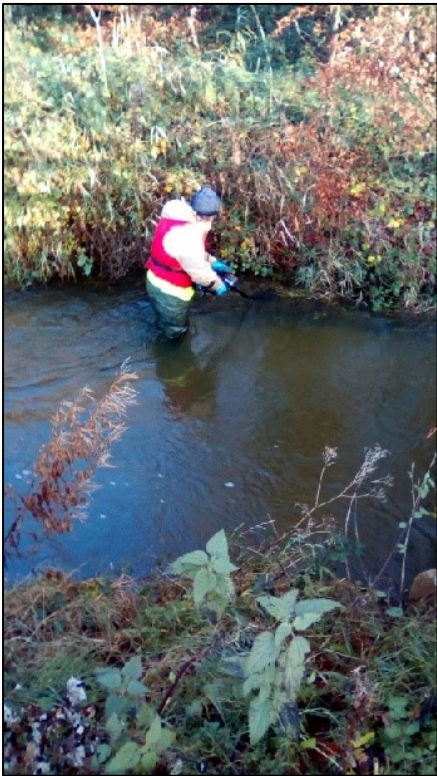
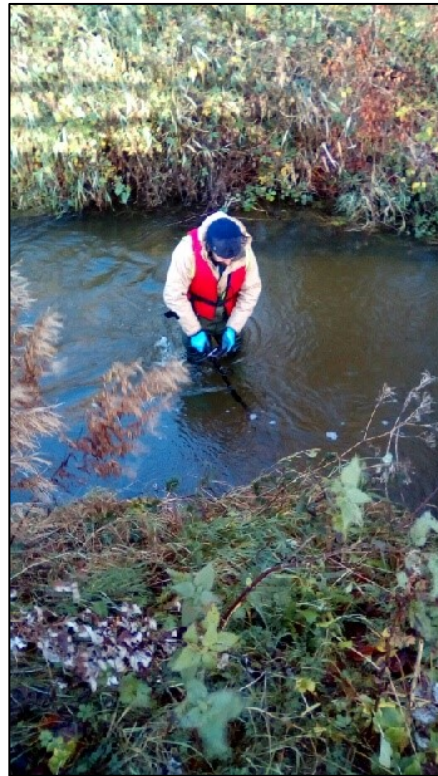
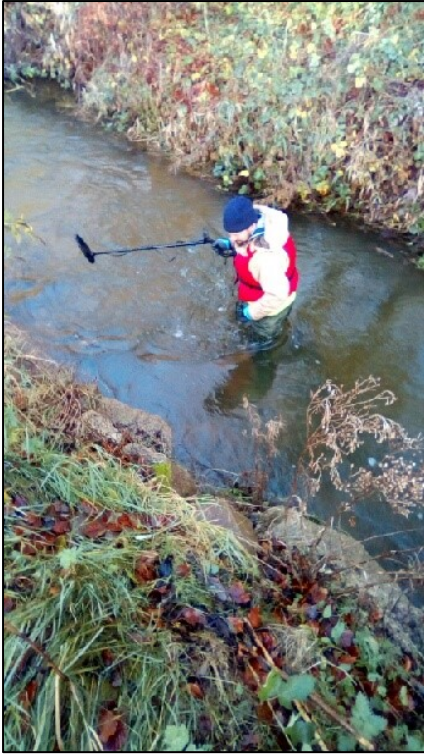
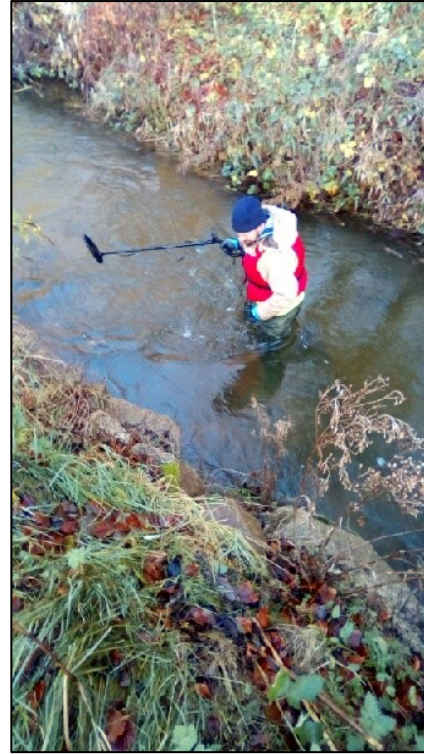
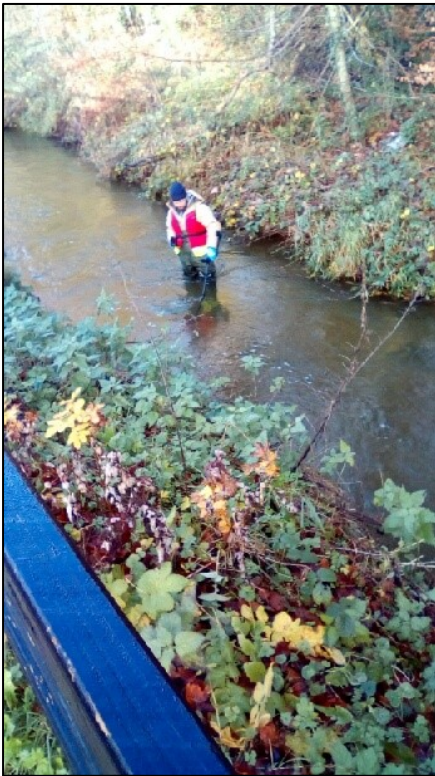
Metal detecting was confined to the entire river channel, the riverbanks, underwater and in the stream bed (Plates 7–13). There were two positive signals detected but later investigation showed modern garbage waste finds (Aluminium beer cans). Within the 30m targeted area of the river there were no other finds of historical or archaeological significance recorded.

Plate 7: Metal Detection Survey in progress
