Kerdiffstown Landfill Remediation Project

Annual Environmental Report 2018

Report Title: Annual Environmental Report 2018
Licence No. P1063-01
Report Ref: 2018_AER
Status: Final

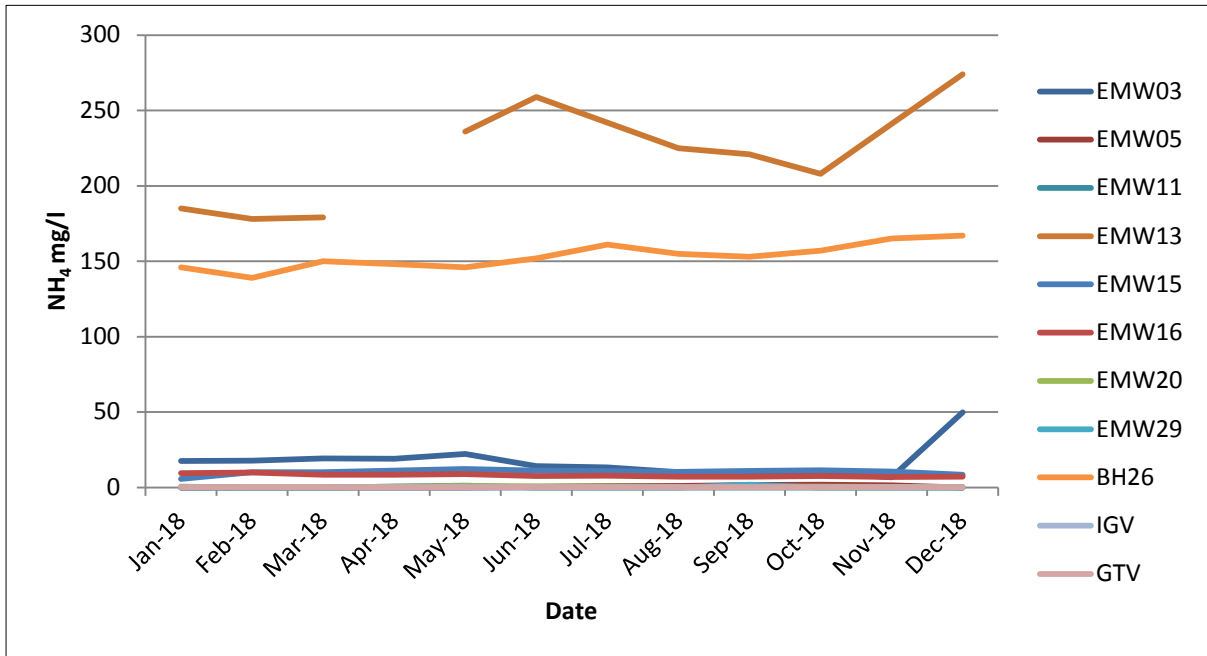
Graph 7.1 Ammoniacal Nitrogen in Selected Overburden Monitoring Wells 2018

Throughout 2018 ammoniacal nitrogen concentrations were generally found to be elevated at monitoring boreholes along the northern and north-eastern boundary area in Zone 1 at DB02, EMW03 and EMW19. Ammoniacal nitrogen (depicted in graph 7.1) coupled with the presence of other determinands such as chloride (discussed below) is indicative of the presence of landfill leachate in groundwater beneath this area. This is consistent with the results obtained during monitoring over previous years.

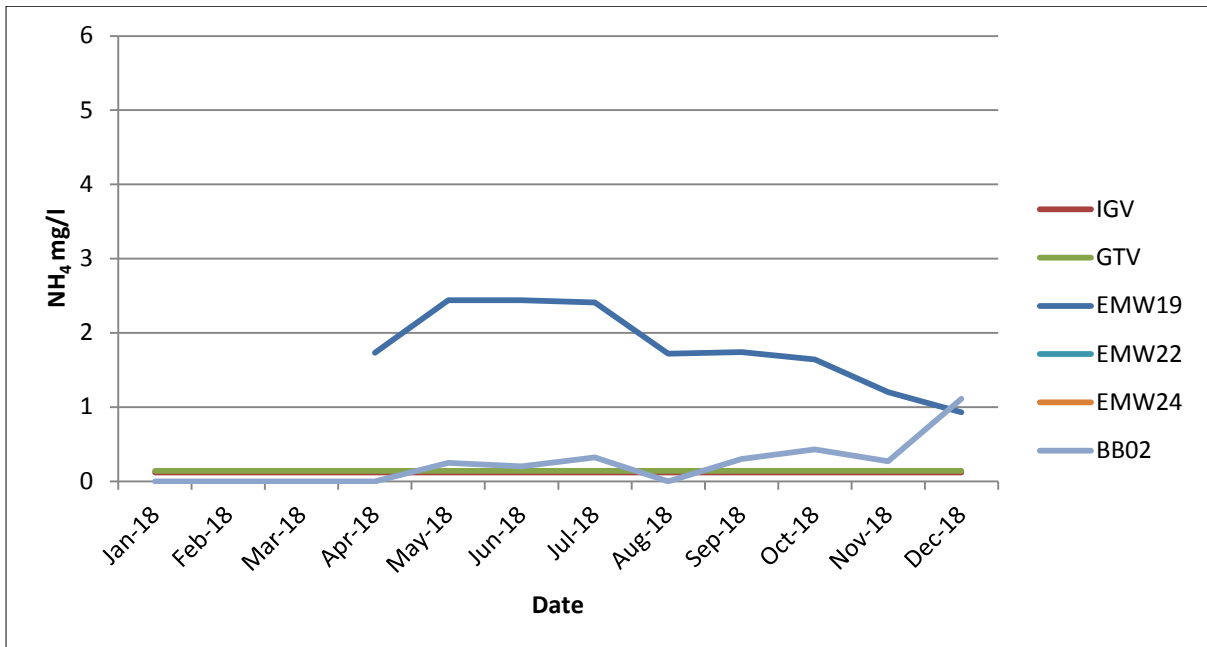
Graph 7.2 Ammoniacal Nitrogen in Bedrock Monitoring Wells 2018

At the bedrock monitoring well EMW19 concentrations of ammoniacal nitrogen were elevated but remained stable through the year. Ammoniacal nitrogen ranged from 0.93 mg/l (Dec) to 2.44 mg/l (May). Since monitoring began in October 2012 seasonal peaks greater than 3.5 mg/l have been observed. This pattern can be seen in Graph 7.2.

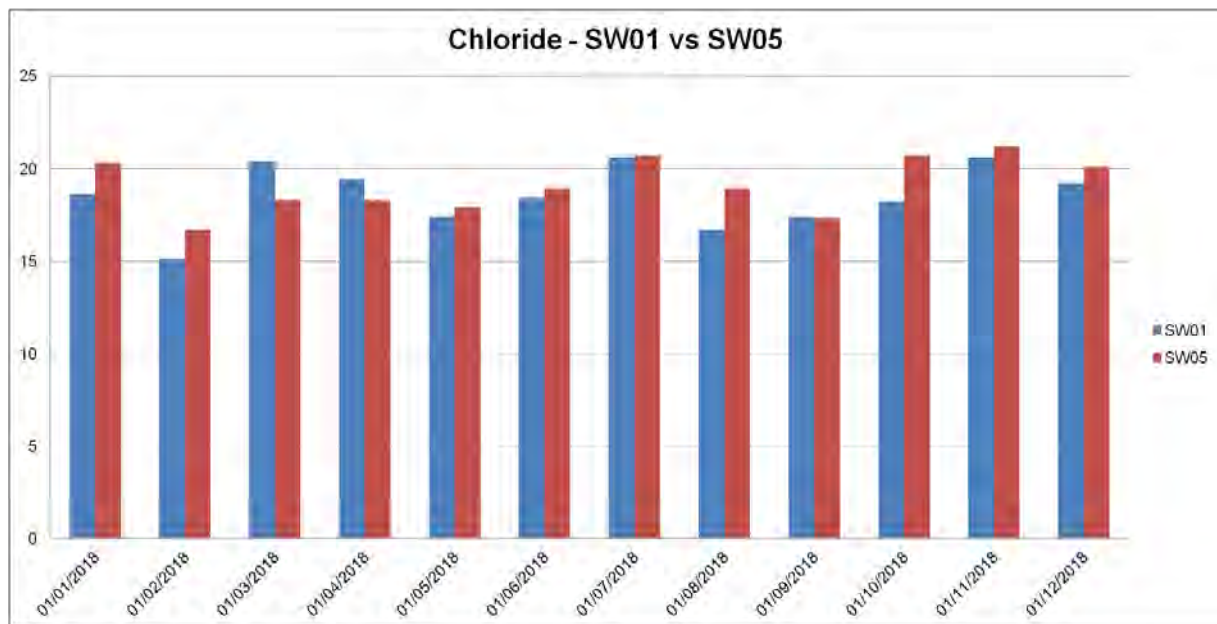
Graph 7.6 Chloride in Morell River – Upstream (SW01) vs downstream (SW05) 2018

Given the small magnitude of the changes in concentration, it is uncertain if this could be attributable to landfill leachate discharging to the river or other sources or laboratory uncertainty. In all surface water samples taken from the Morell River the concentrations of chloride detected were below the Drinking Water and Surface Water Regulations limit of 250 mg/l for 2018.

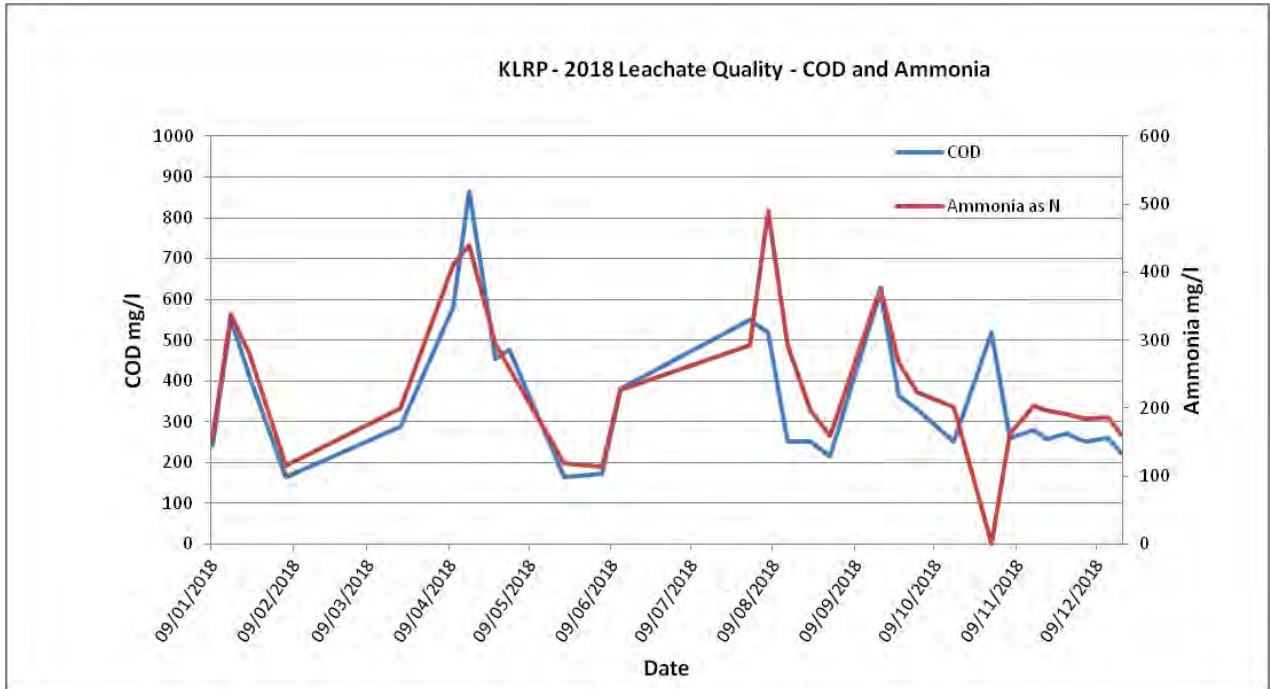
Graph 7.7 Leachate Composition - COD and Ammoniacal Nitrogen

parameters peaked during the summer months when the leachate was most concentrated due to a lack of rainfall to cause dilution. During the winter and spring months there was a reduction in these concentrations attributed to dilution from rainfall both directly onto the open cell area and also through the waste body itself. The averages and peaks have been reducing since 2011, with 2015's average being the lowest recorded at 224 mg/l for ammoniacal nitrogen and now 2018's average the lowest recorded at 360 mg/l for COD. The graphs in **Appendix F7** present leachate results from July 2011 to December 2018. The graphs clearly show this prevailing downward trend in those leachate pollutants since 2011.

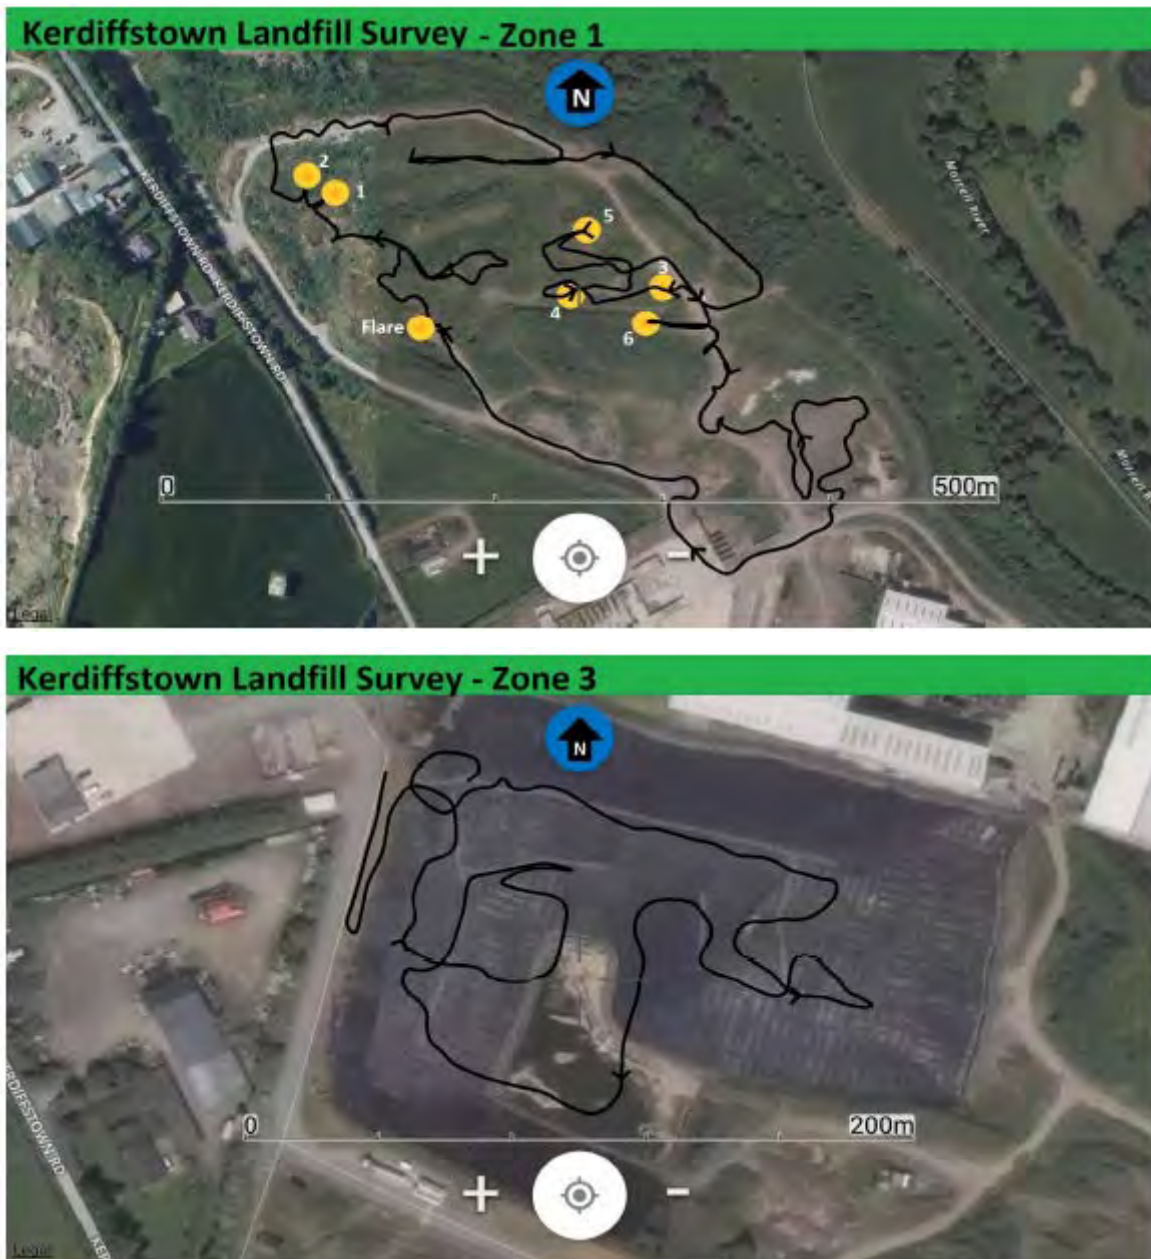
Plate 7.4 2018 Leakage Survey Monitoring Map

Location	VOC average (ppm)	VOC maximum (ppm)	Map No.	Reference	Recommended Trigger Levels (ppm)
Zone 1	0 (Strong Smell)	0 (Strong Smell)	1	LG8	< 100
Zone 1	0 (Strong Smell)	0 (Strong Smell)	2	LG9	< 100
Zone 1	0 (Strong Smell)	0 (Strong Smell)	3	Security Hut	< 100
Zone 1	4.55	5.3	4	LG35	< 100
Zone 1	0.3	0.4	5	BH63	< 100
Zone 1	1.0	1.0	6	BH36B/LG 37	< 100

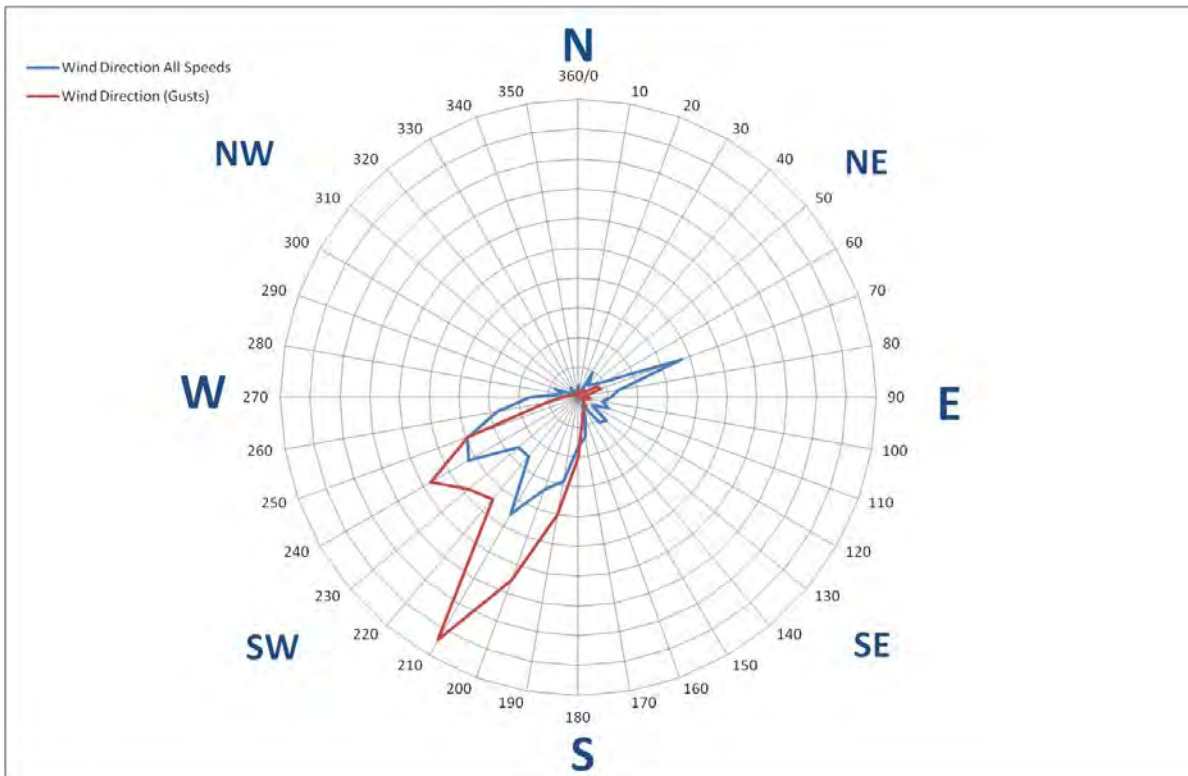
A wind rose showing wind direction for 2018 is provided below and shows that the prevailing wind direction was from a westerly or south westerly direction.

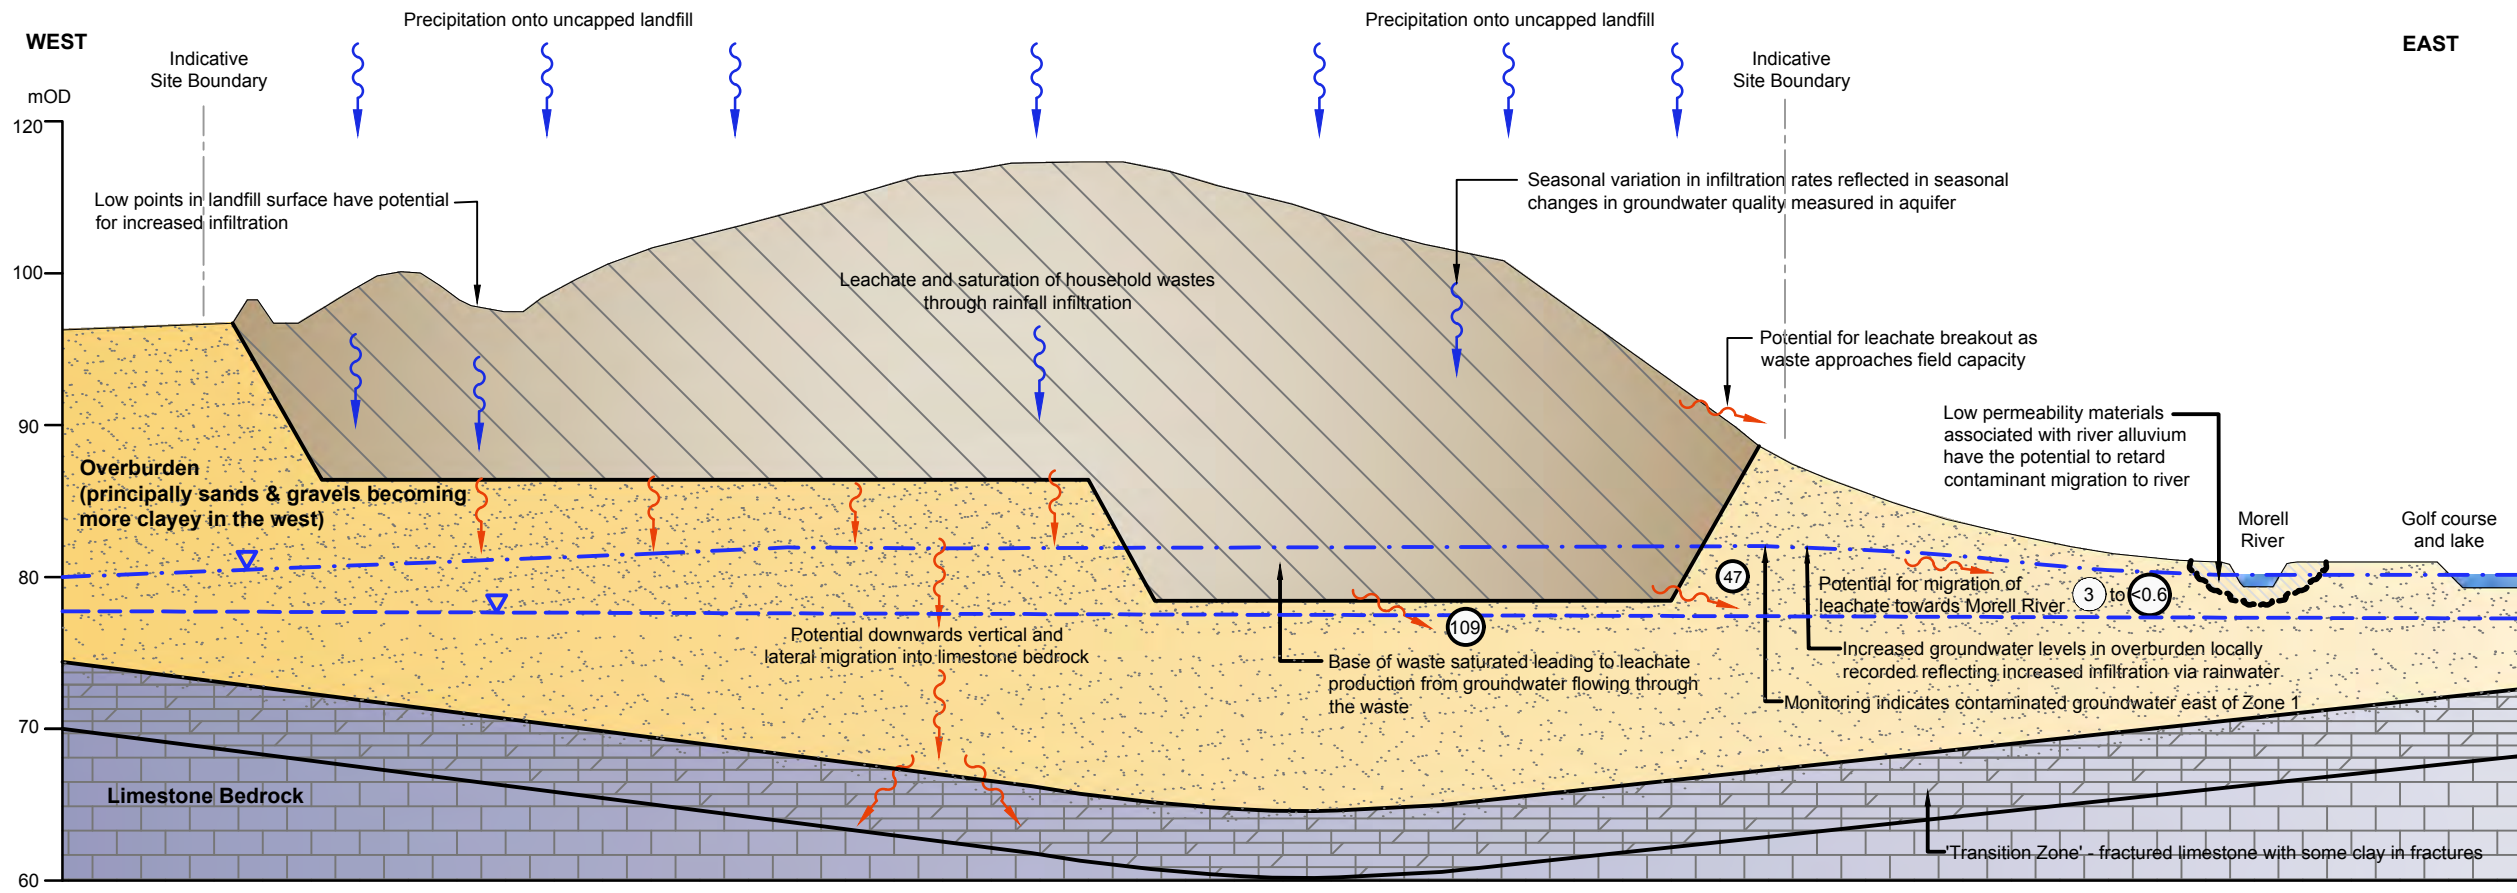
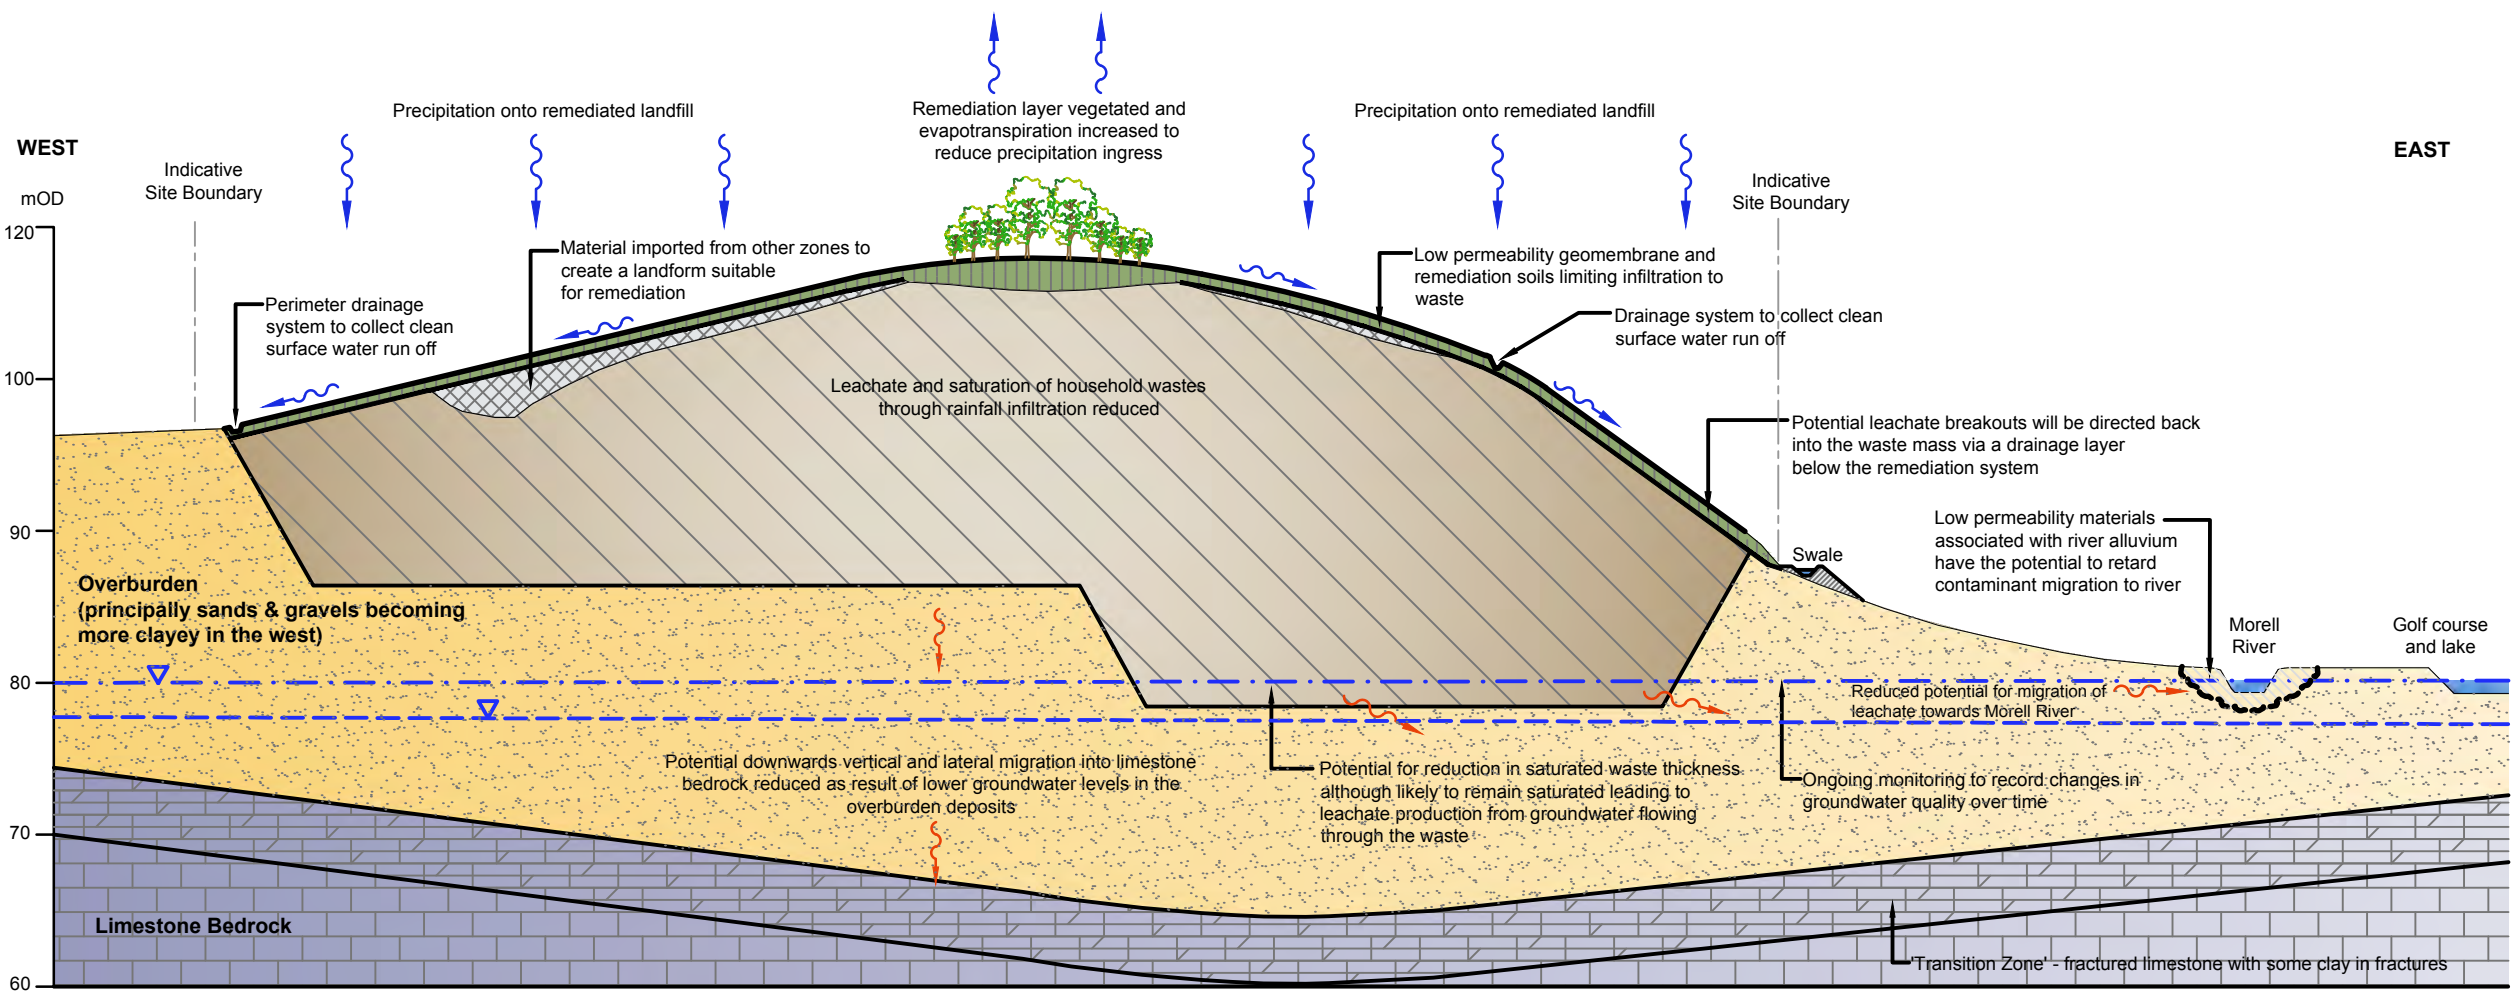
Landfill Gas Management Conceptual Site Model (Zone 1)

Groundwater Conceptual Site Model for Zone 1: Current Scenario

The conceptual model for the site shown in Figure 4 includes dilution of leachate from winter rainfall. The model also shows a general increase in groundwater levels within the overburden and bedrock aquifers in response to (likely) increased rates of infiltration. Water levels recorded in both aquifer units during 2018 show an annual trend of decreasing levels through the late spring and early summer months.

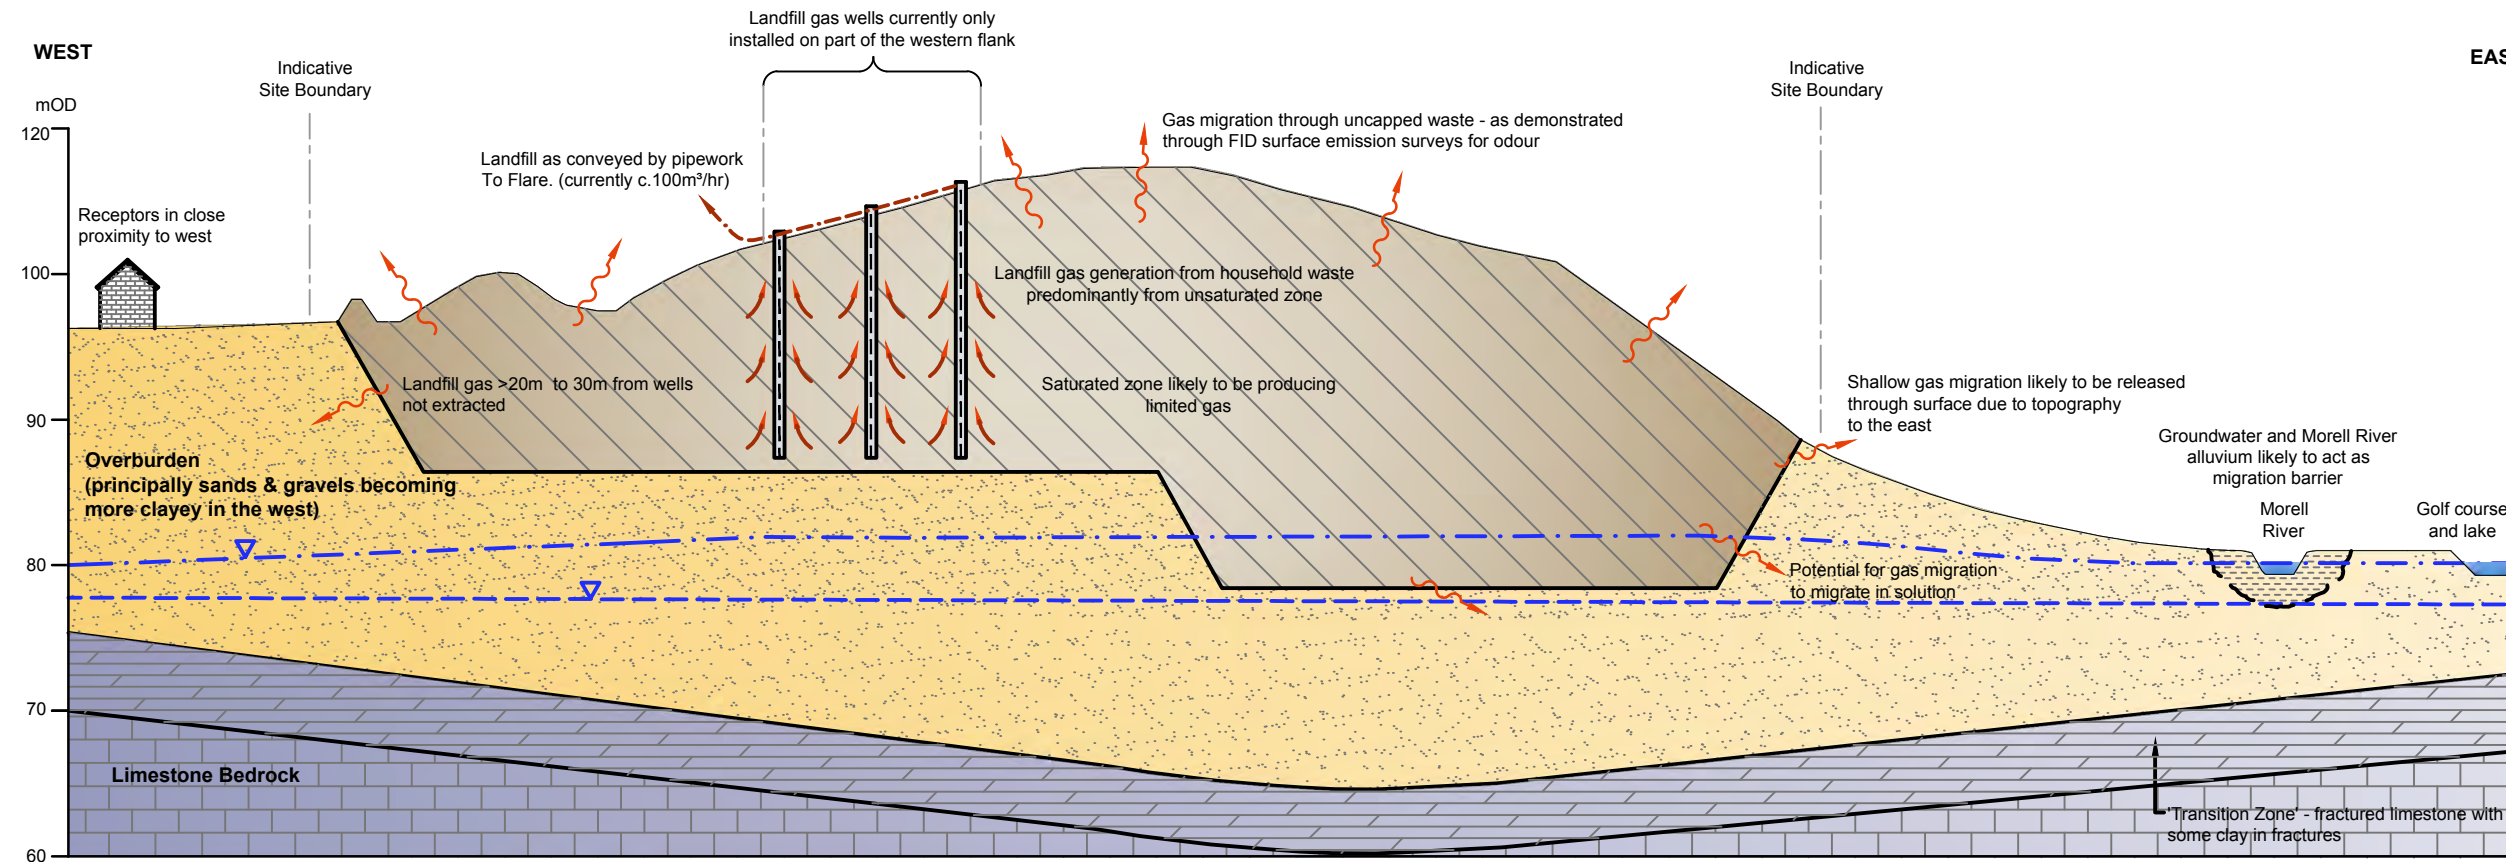
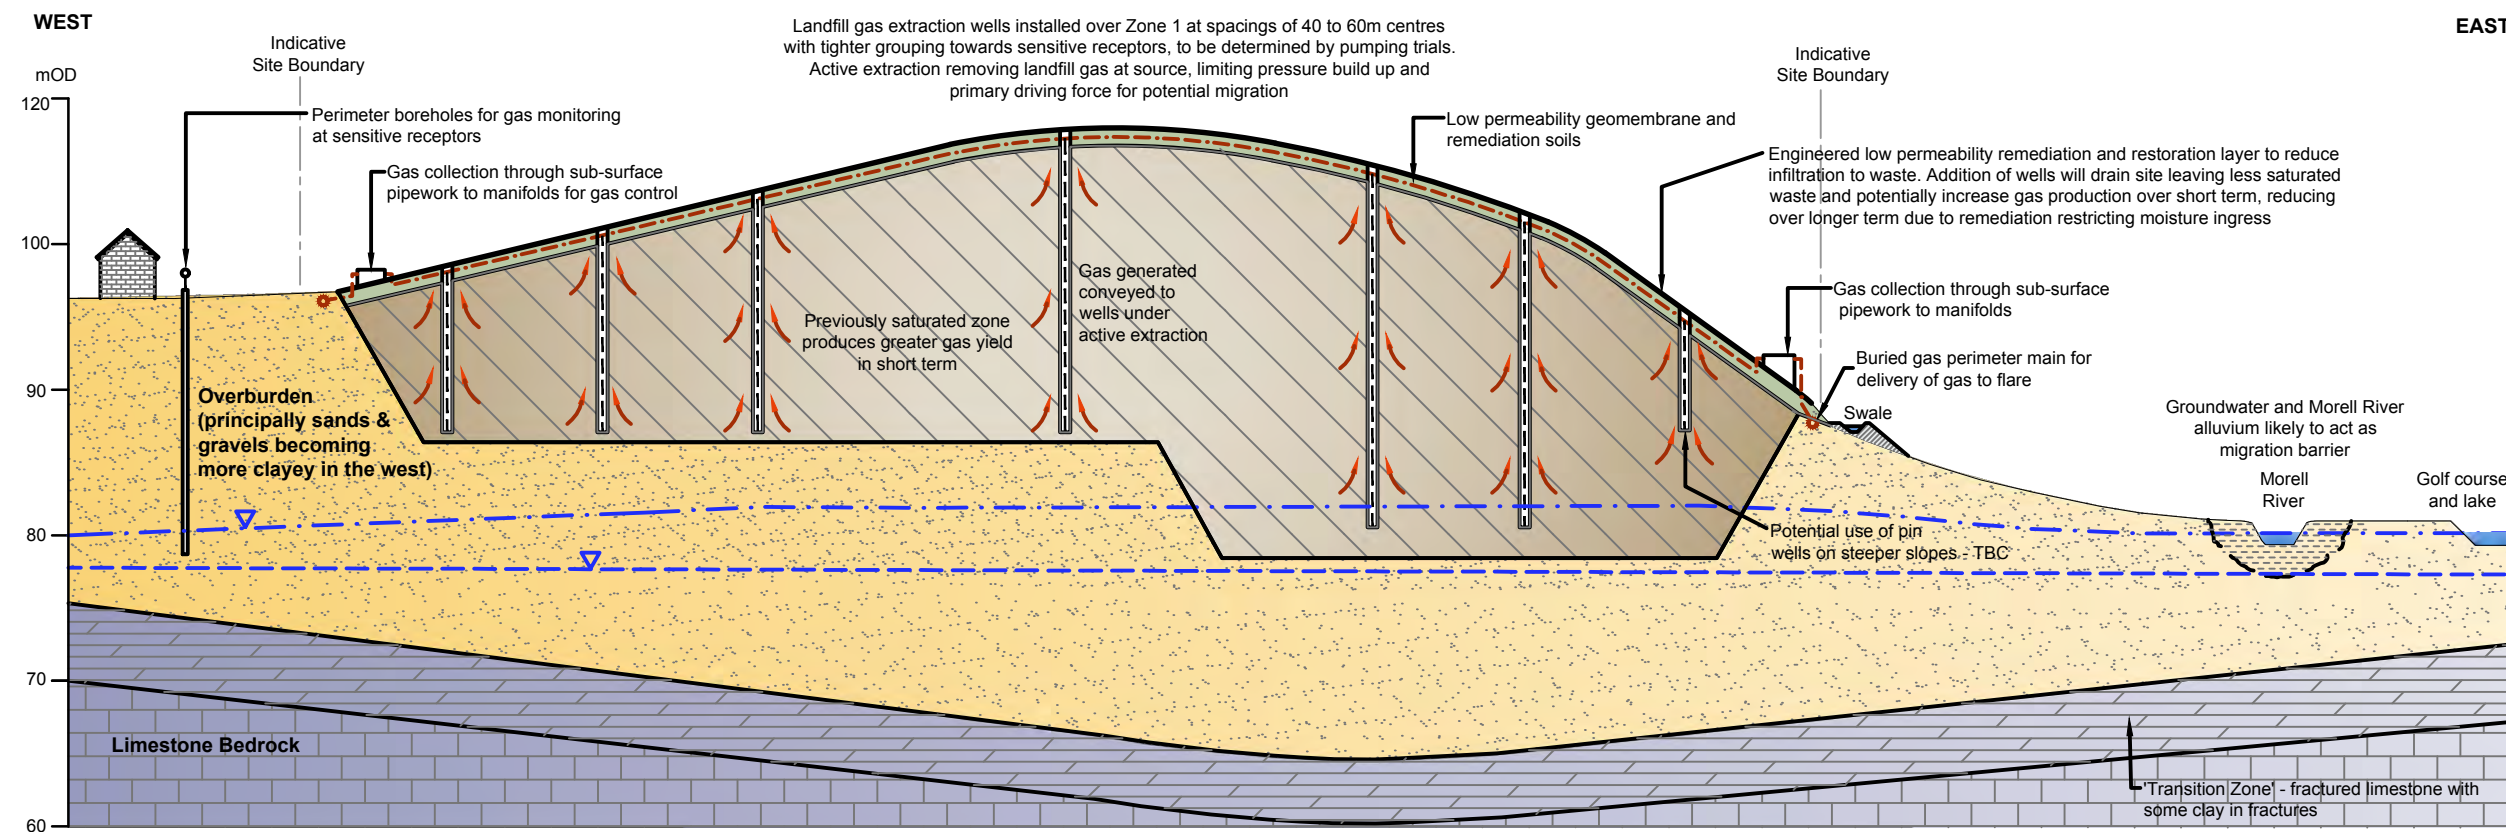
Gas Conceptual Site Model for Zone 1: Current Scenario

Gas Conceptual Site Model for Zone 1: Post Remediation
