## **Appendix A7.7 SKM Enviros 2013 Odour Control Plan**

## Kerdiffstown Landfill

### TASK 7: KERDIFFSTOWN ODOUR CONTROL PLAN

- Final
- August 2013

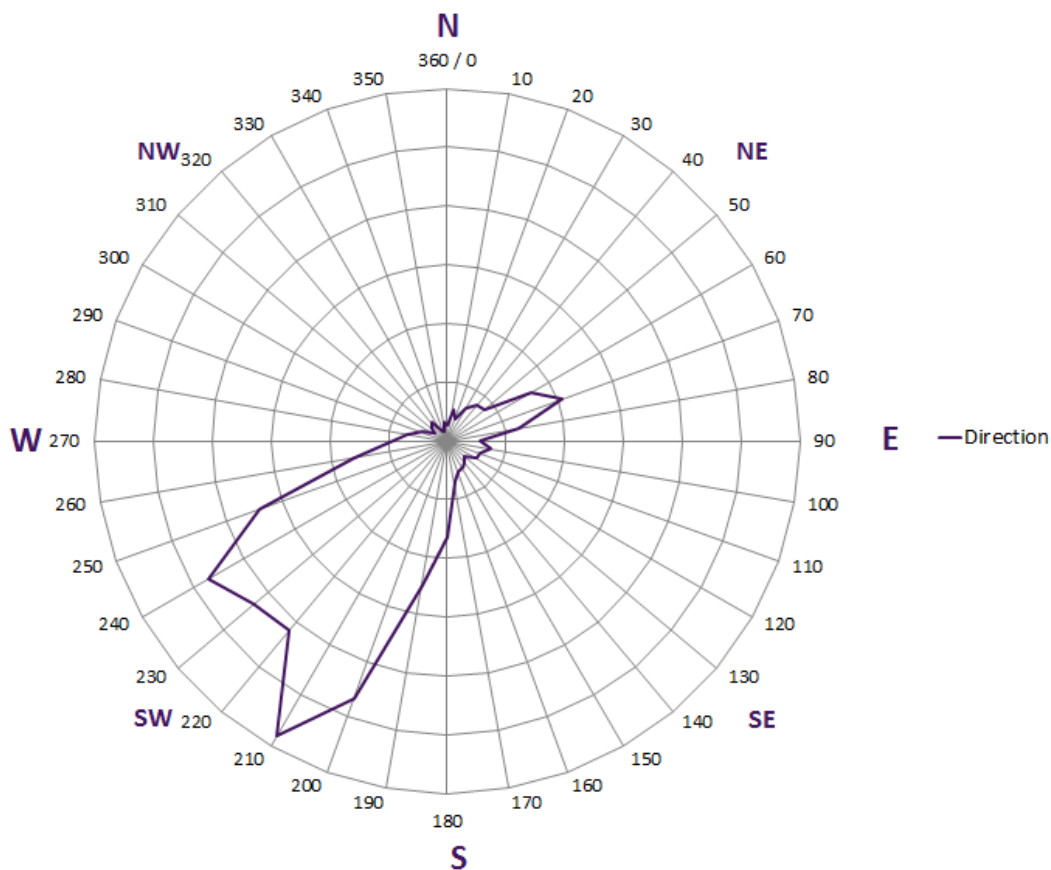
**Figure 3.2. Windrose from Casement Metrological Station Casement (2006-2013) (Source EPA)**

The prevalence of odours can change with weather conditions, in that the strongest odours are experienced on site during low wind conditions, when there is little dilution of air. In addition, at landfills a sudden drop in barometric pressure tends to result in an increase in gas diffusing from the waste body, until the pressure differential between the soil and air has balanced out again. High atmospheric temperatures also stimulate gas particle movement, and lead to increased gas diffusion, resulting in more odours being released in warm weather.

The prevailing wind at the site is south-westerly. The sensitive receptors to the north and north-east of the site are therefore at higher risk of receiving odour impacts. However, no complaints from these locations have been received over the past 2 years.

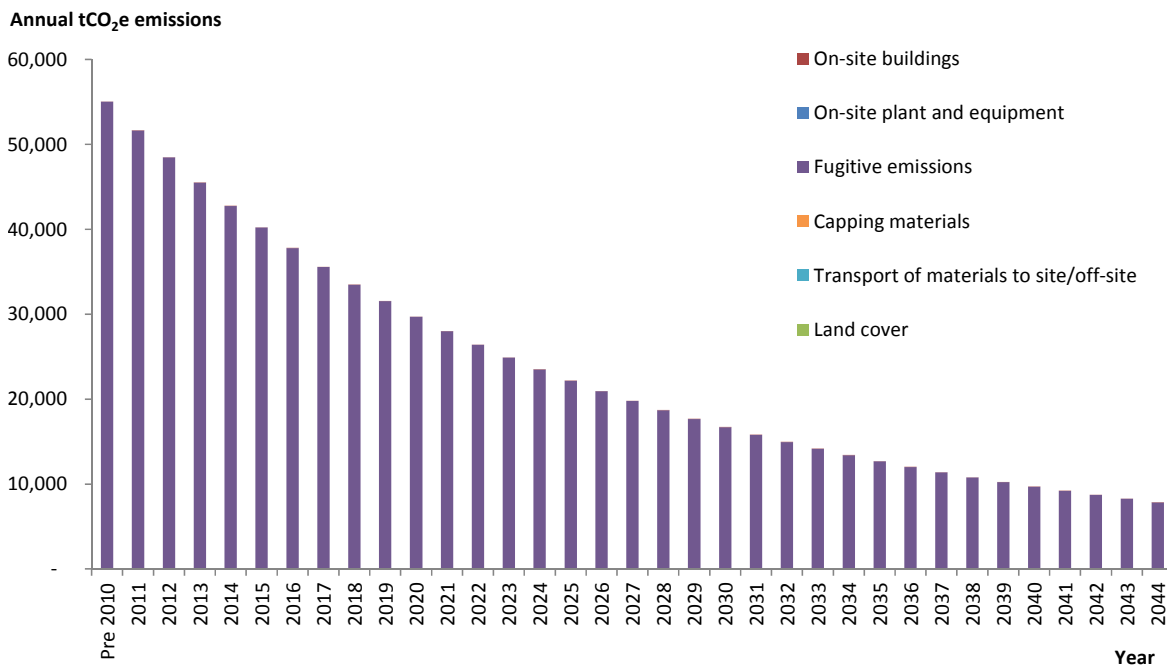
**Figure 3.: Annual estimated lifecycle carbon emissions for Scenario 1 – ‘No remediation’ (tCO<sub>2</sub>e/annum)**

The following three figures (3, 4 and 5) show the distribution of emissions over the assessed timescale (2010 to 2044) for the three scenarios. For all three scenarios, the highest emissions are in the early years (pre-2010 to 2020) when the production of landfill gas is highest and, for scenarios where remedial works are implemented there is maximum activity.

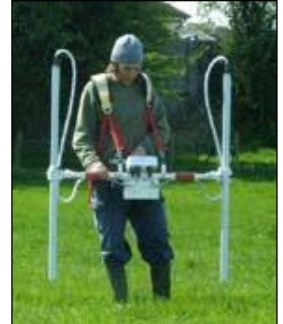
#### ***Bartington GRAD 601-2***

The Bartington Grad 601-2 instrument is a specifically designed gradiometer for use in archaeological prospection. The gradiometer operates with a dual sensor capacity making survey very fast and effective. The sensors have a separation of 1m allowing greater sensitivity.

This is conducted to clearly define any responses detected during scanning, or can be applied as a stand-alone methodology. Detailed survey is often applied with a sample interval of 0.25m and a traverse interval of 1m. This allows detection of potential archaeological responses. Data is collected in grids 40m x 40m, and data is displayed accordingly. A more detailed survey methodology may be applied where archaeological remains are thought likely. A survey with a grid size of 10m x 10m and a traverse interval of 0.5m will provide a data set with high resolution.

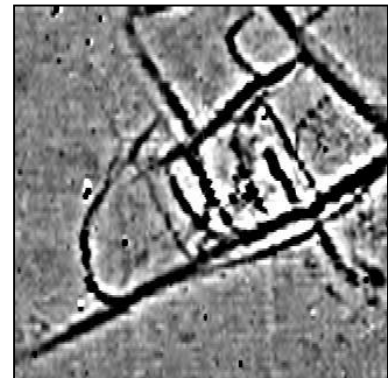
### **Greyscale\***

As with dot density plots, the greyscale format assigns a cell to each datum according to its location on the grid. The display of each data point is conducted at very fine increments, allowing the full range of values to be displayed within the given data set. This display method also enables the identification of discrete responses that may be at the limits of instrument detection. In the summary diagrams processed, interpolated data is presented. Raw un-interpolated data is presented in the archive drawings along with the xy-trace plots.

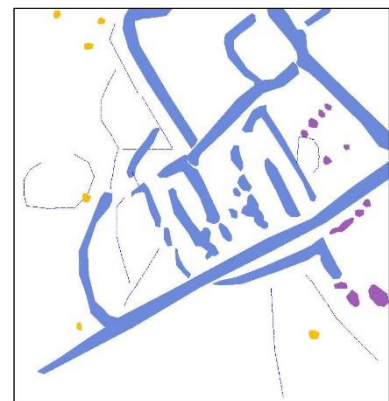
### **Interpretation**

An interpretation of the data is made using many of the plots presented in the final report, in addition to examination of the raw and processed data. The project managers' knowledge and experience allows a detailed interpretation of the survey results with respect to archaeological potential.
