Archaeological Impact Assessment at

Proposed development of 74 no. residential units at Craddockstown
Road, Craddockstown Demesne, Naas, Co. Kildare

December 2016

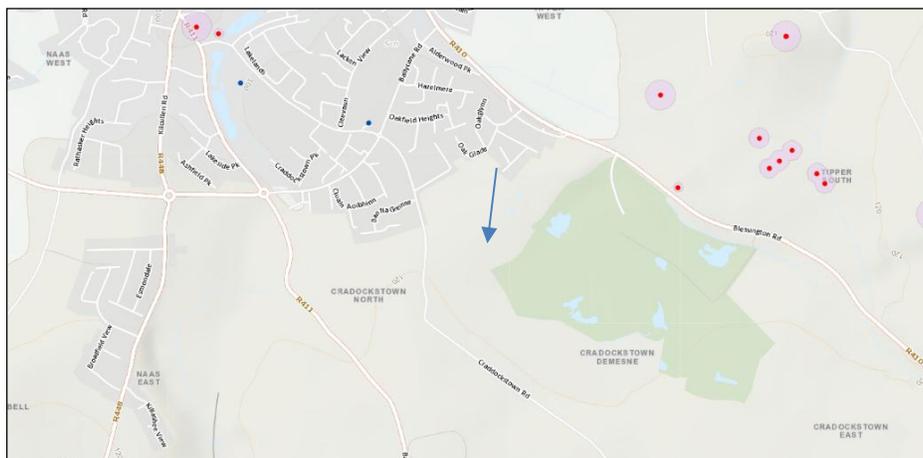
Figure 2: Extract from the RMP for the development with the proposed development marked

located in the wider environs of the site. A cluster of fulacht fiadh are recorded over 100m to the northeast. These monuments are commonly found throughout the country and can be uncovered during excavation works.

The site does not include any archaeological remains however, a cluster of fulachta fiadh are recorded 100m to the northeast. They are most common in low lying areas adjacent to water sources such as streams. These are often not visible at ground level and can only be identified as a result of excavation.

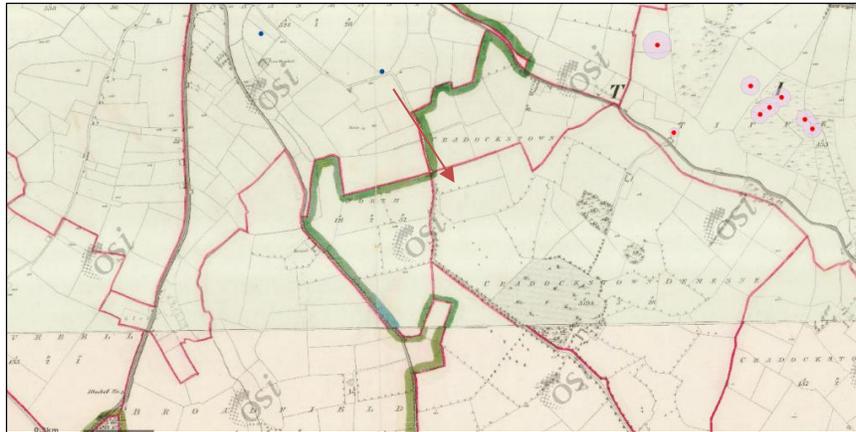
Figure 4: First edition OS map with the development marked

The first edition OS map and the 25" maps do not include any archaeological finds features anomalies that could be interpreted as a features in the study area. Aerial photographs did not uncover any features. The current OS map includes a circular feature at the north of the site. This was visible at ground level as a sub-oval pond with mature trees at the south. There was nothing archaeologically suggestive of this feature.

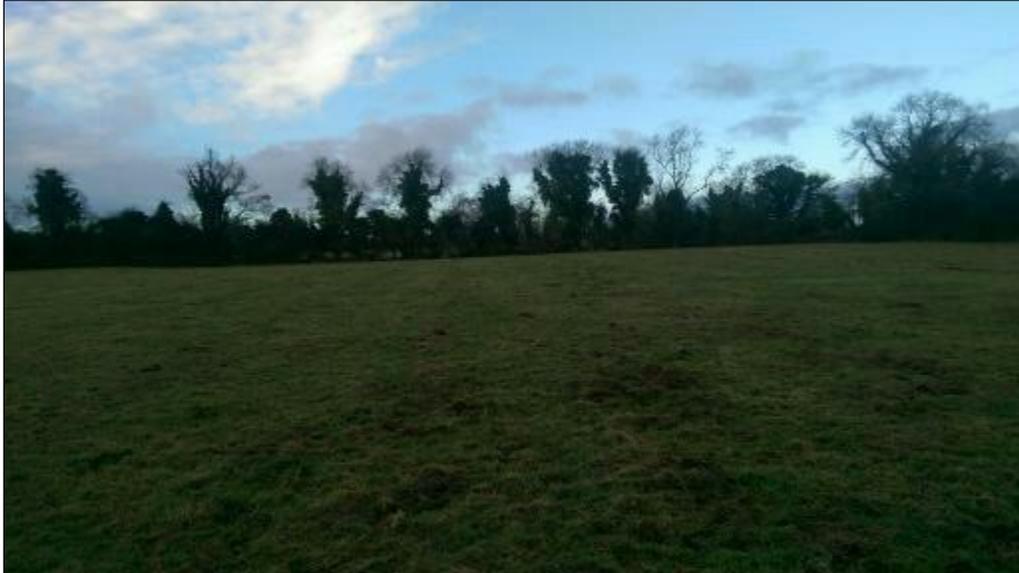
Plate 1: Looking north over the proposed development

Field walking was undertaken in December 2016. The site is divided into five interconnecting fields by mature hedgerows. Visibility in the fields was very good as the grass was tightly cropped. The dividing hedgerows included drains and mature trees. The field at the north included a sub oval pond surrounded by trees at the south. No archaeological remains were visible during field walking.

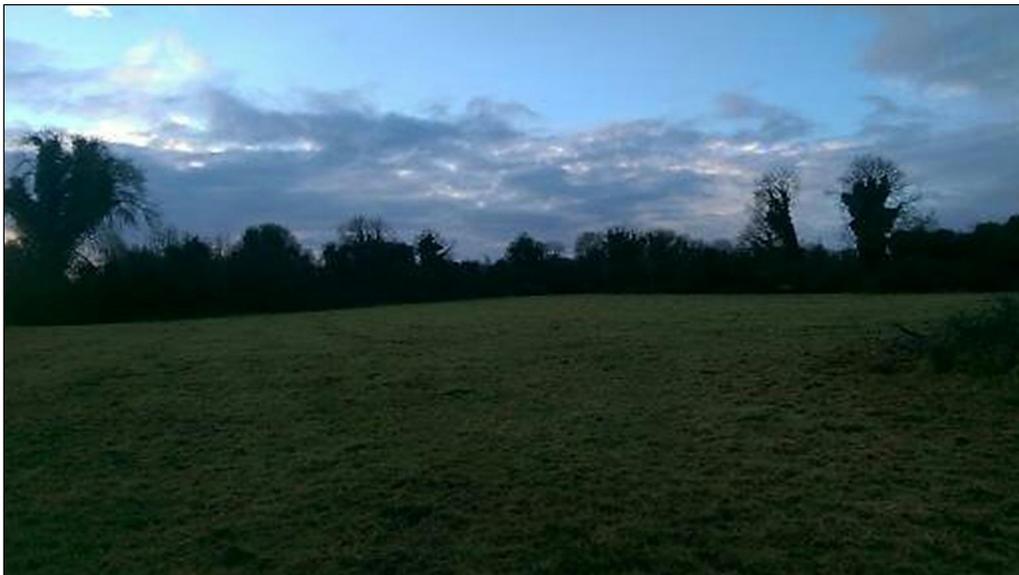
Plate 2: Looking northwest over the proposed development

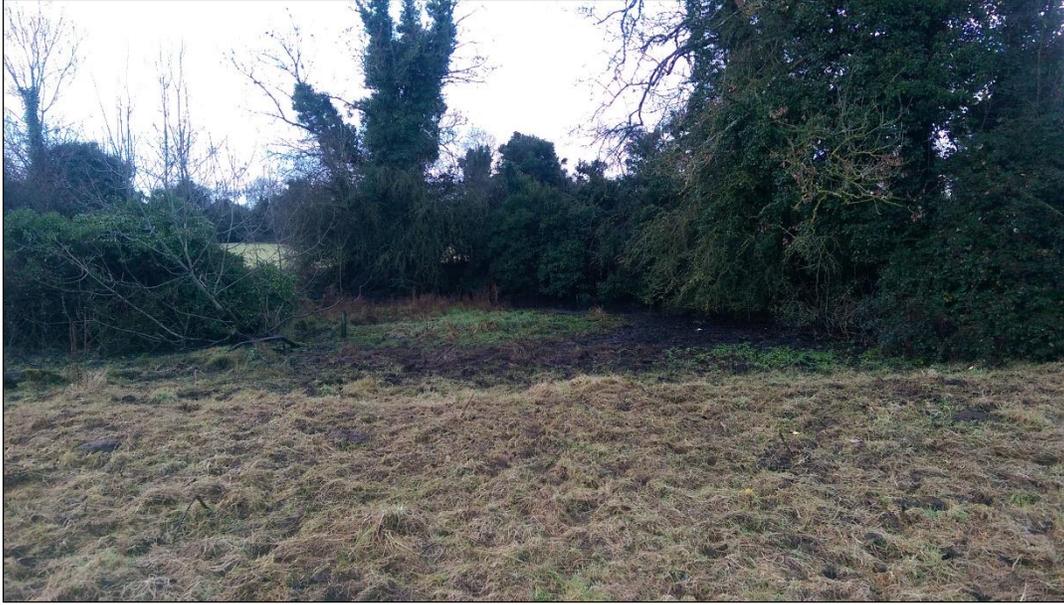
Plate 3: Looking south at the pond at the north of the site

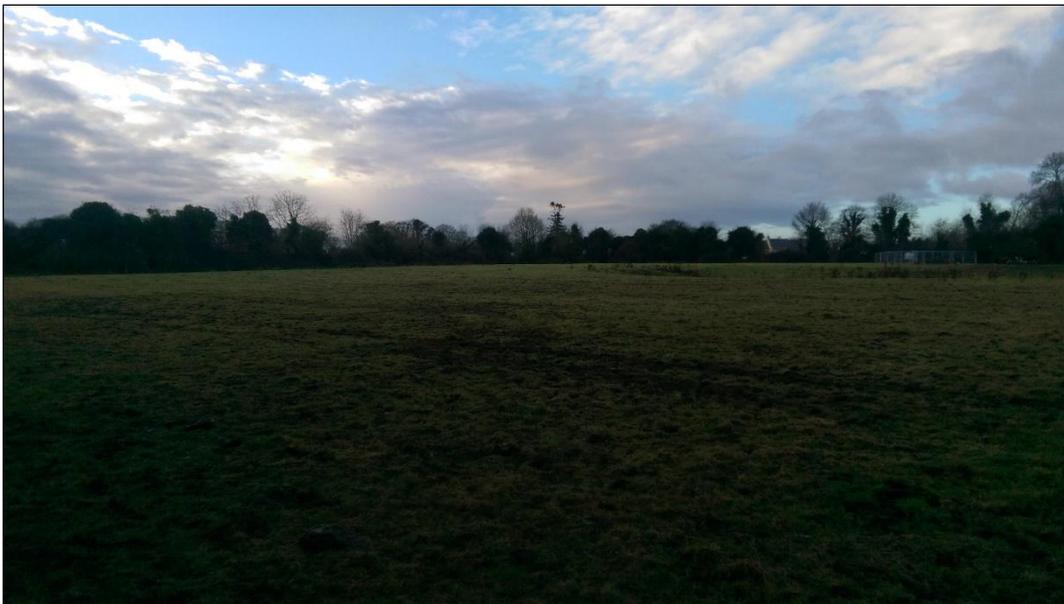
Plate 4: Looking southeast at the south of the proposed development
