PPP Social Housing Bundle 3:
Development at Athy, Co. Kildare
Stage 1&2 Road Safety Audit

PPP Social Housing Bundle 3: Development at Athy, Co. Kildare

Stage 1&2 Road Safety Audit

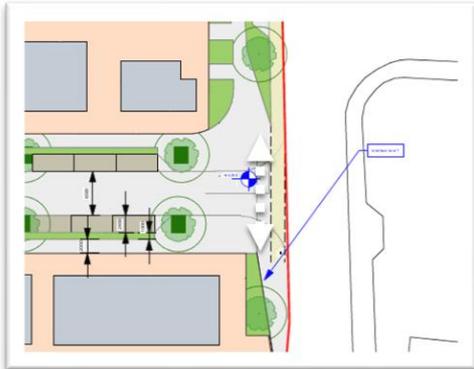
Figure 2.1 – Pedestrian Crossing at Main Access Junction

Location: Main Direct Access Junction onto Fortbarrington Road

Measures to afford priority and safe crossing for pedestrians do not appear to have been proposed at the new access junction. This could lead to conflicts between pedestrians and vehicles.

Measures to afford both priority and safe crossing for pedestrians should be provided at the location described.

| Problem Reference (Section 2) | Designer Response Section | | | Audit Team Response Section |
|---|---|---|---|--|
| 2.1 | Yes | Yes | | |

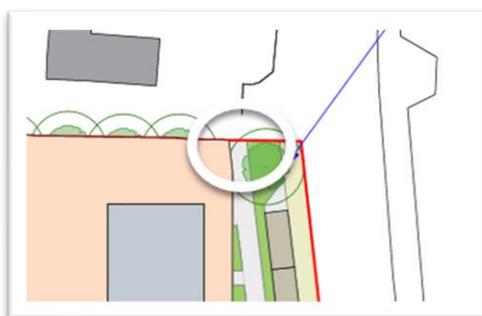
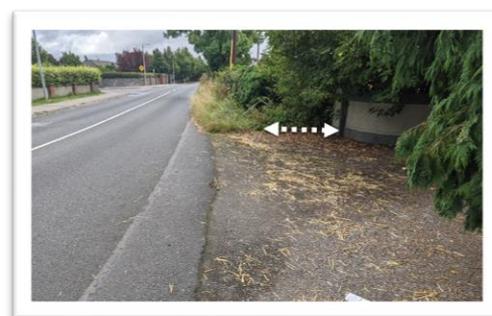
Figure 2.2 – Northern Termination of Proposed Footpath

Location: Site Frontage onto Fortbarrington Road, Northern Boundary Termination

The proposed footpath both directs pedestrians towards and terminates at an existing dwelling access. This could lead to pedestrians (in particular the mobility impaired) coming into conflict with traffic as they attempt to cross the road to re-join the safety of a footpath which continues on the opposite side of the road.

The footpath termination should be moved away from the dwelling access and a formal crossing connection should be provided to the footpaths on the opposite side of the road.

| Problem Reference (Section 2) | Designer Response Section | | | Audit Team Response Section |
|---|---|---|---|--|
| 2.2 | Yes | Yes | A pedestrian crossing is proposed at this location for review and approval by Kildare County Council. | <i>Noted with thanks</i> |

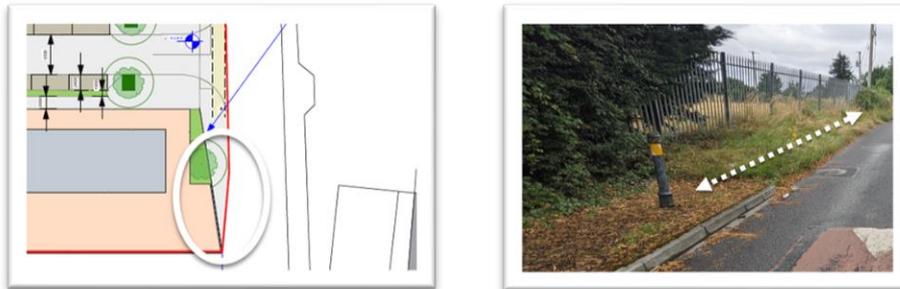
Figure 2.3 – Southern Connection of Proposed Footpath

Location: Site Frontage onto Fortbarrington Road, Southern Boundary Termination

A tapered footpath termination has been proposed without safe connection for pedestrians to existing footpaths further to the south in front of the Halting Site. This could lead to pedestrians (in particular the mobility impaired) being forced to walk in the carriageway with general traffic.

The tapered termination should be replaced with a footpath of continuous (and appropriate) width which connects to the existing footpath facilities in front of the Halting Site.

| Problem Reference (Section 2) | Designer Response Section | | | Audit Team Response Section |
|---|---|---|---|--|
| 2.3 | Yes | Yes | | |

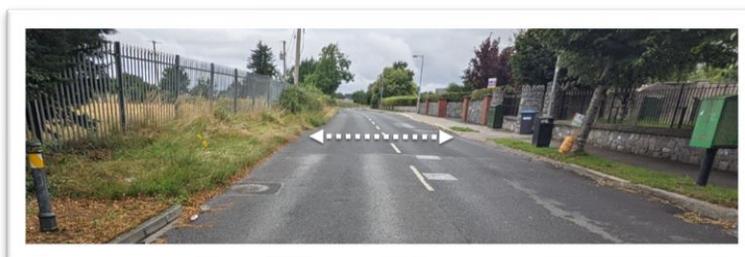
Figure 2.4 – Pedestrian Desire Line across Fortbarrington Road

Location: Amenities on Opposite Side of Fortbarrington Road

Residents and visitors will be attracted to the various amenities on the opposite side of Fortbarrington Road. Failure to provide a formal crossing here (to meet the increase in footfall) could result in conflicts between pedestrians and general traffic.

A formal pedestrian crossing facility should be provided to link the housing development with the various amenities.

| Problem Reference (Section 2) | Designer Response Section | | | Audit Team Response Section |
|---|---|---|---|--|
| 2.4 | Yes | Yes | This will be discussed with Kildare County Council. | <i>Noted with thanks</i> |

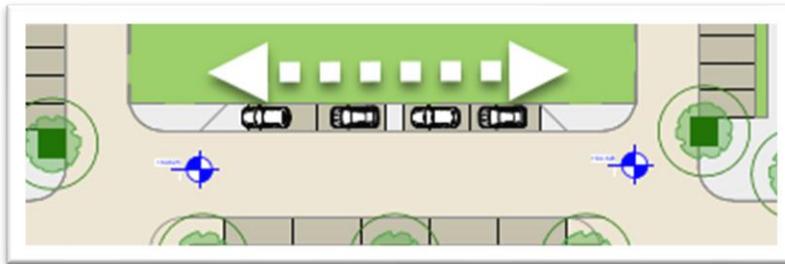
Figure 2.5 – Footpath Terminating Each Side of Parking

Location: Main Internal Street

The footpath terminates each side of a short section of parallel parking. This is inconsistent with the rest of the development and could result in conflicts between pedestrians and general traffic.

The footpath should be continued behind the parallel parking.

| Problem Reference (Section 2) | Designer Response Section | | | Audit Team Response Section |
|---|---|---|---|--|
| 2.5 | Yes | Yes | | |

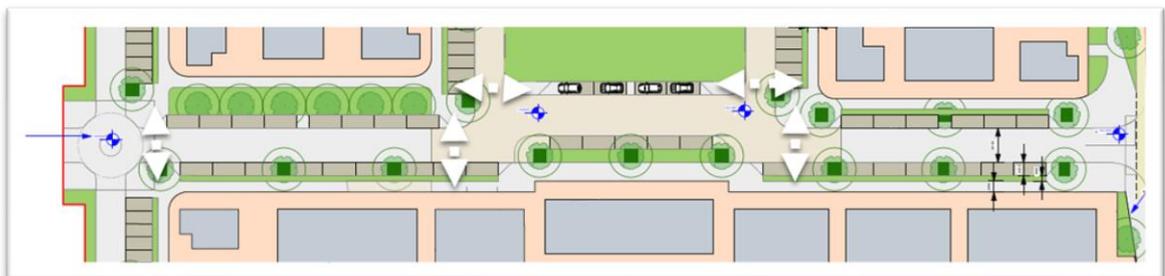
Location: Internal Streets at Key Junctions

Direct crossing points on many of the key pedestrian desire lines have been obstructed by parking or planting. This could result in conflicts between pedestrians and general traffic.

Figure 2.6 – Some Examples of Where Crossing Points Have Been Obstructed at Key Junctions

Formal, direct courtesy crossings should be aligned with pedestrian desire lines where they are likely to occur on the internal road network.

| Problem Reference (Section 2) | Designer Response Section | | | Audit Team Response Section |
|---|---|---|---|--|
| 2.6 | Yes | Yes | | |
