**Andrew, Athy,
Co. Kildare**

Final Archaeological Assessment Report

Kildare County Council

21E0268

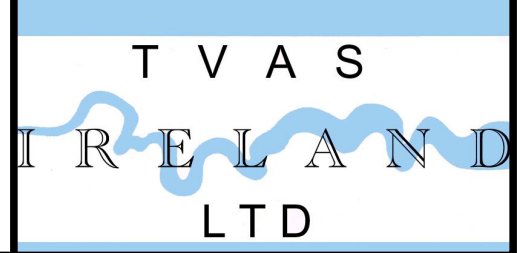
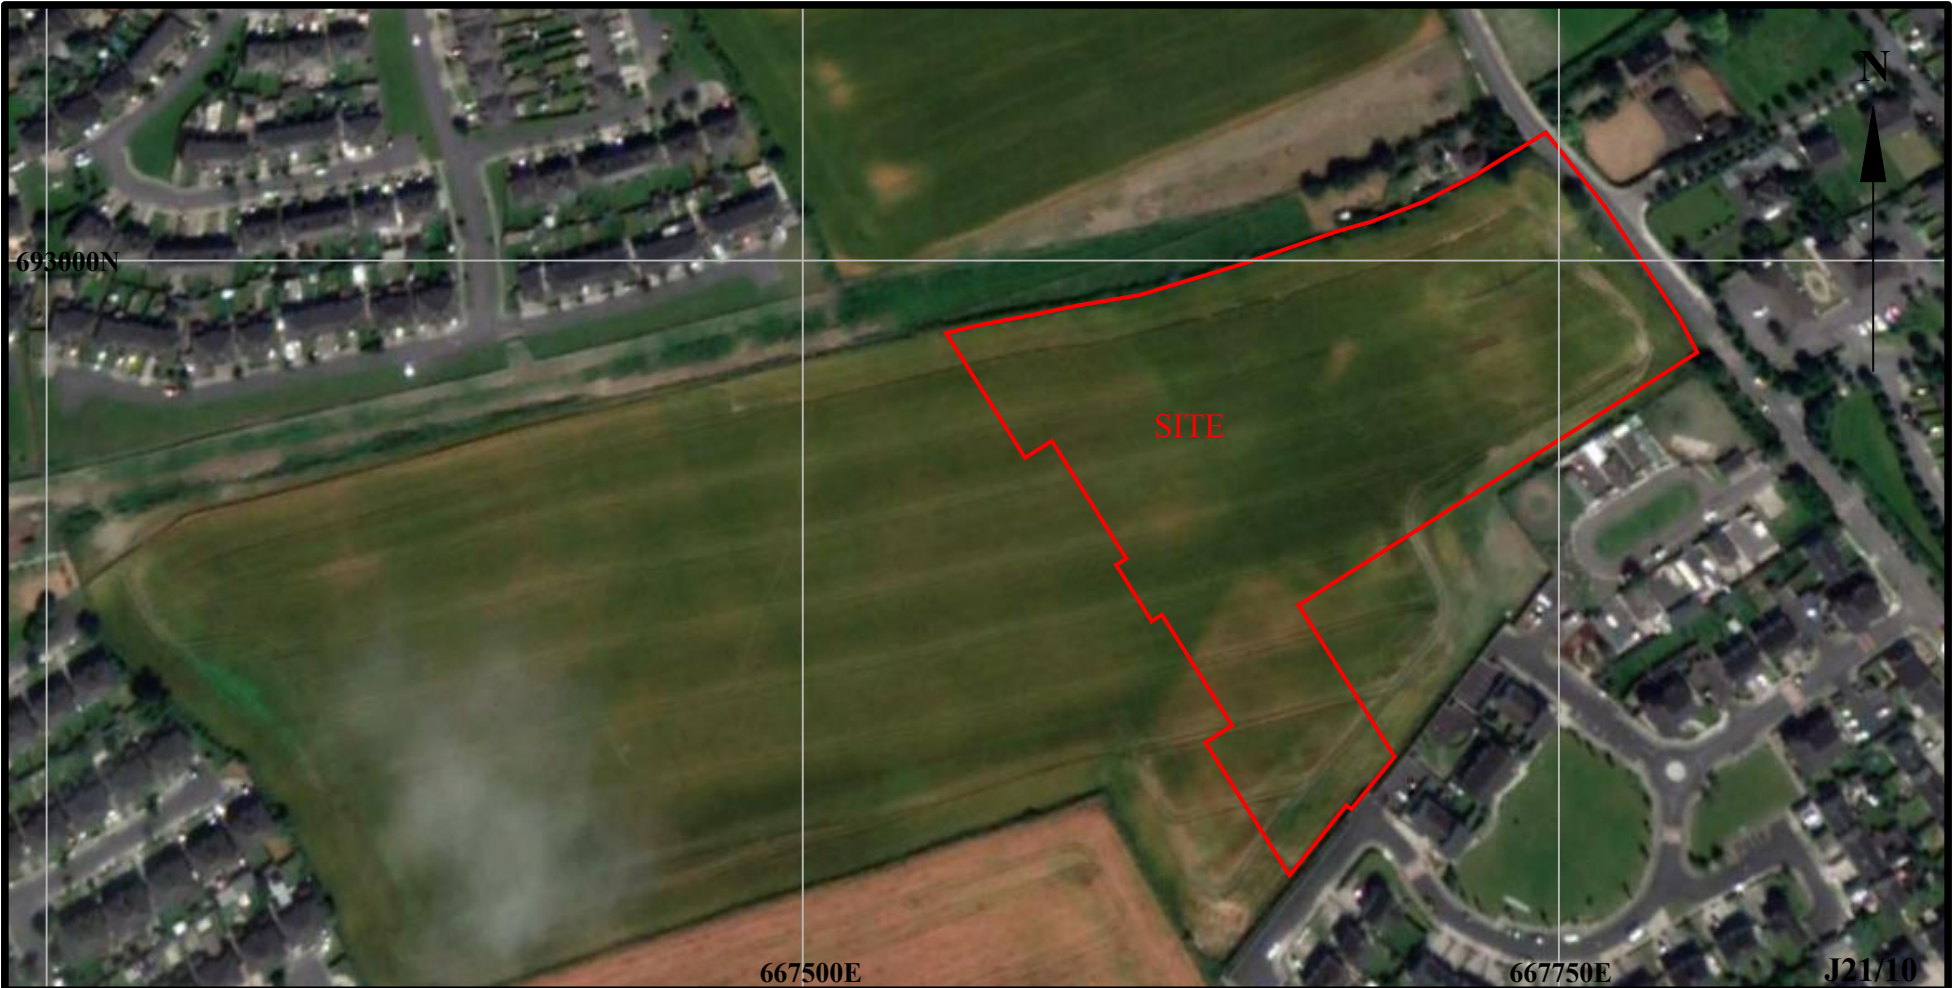
Figure 6: Site on aerial photograph April 2009

Aerial photographs from the later 20th century onwards are available on sources such as Google Maps Pro and demonstrate the changing land use of the eastern part of the development site. In particular, a halting site was constructed on the east part of the site in the first decade of the 21st century (Fig. 6) and demolished and the field returned to agriculture in the second decade (Fig. 7).

The north-eastern corner of the site contained evidence of recent development in the form of construction gravels, broken brick, disused water pipes and modern refuse. This development can be seen in aerial photography from 2009 (Fig. 6) which shows a site immediately north-west of Ardrew Halting Site. A local resident explained during fieldwork that the area had been used as a temporary halting site while the current halting site was under construction, it was then returned to agricultural use. The area was also identified in the geophysical survey (Fig. 8) but with no distinct shape due to magnetic disturbance likely from the refuse associated with the development.

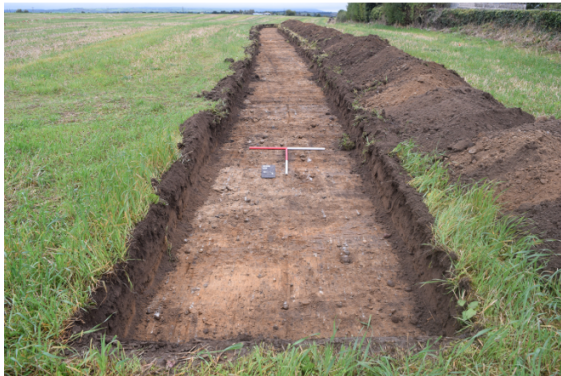
Trench 1, with a length of 52.50m and a depth of 0.25m, revealed agricultural furrows. The topsoil contained modern refuse.

**Plate 1: Trench 1. Looking south-west.
Scales 1m & 1m**

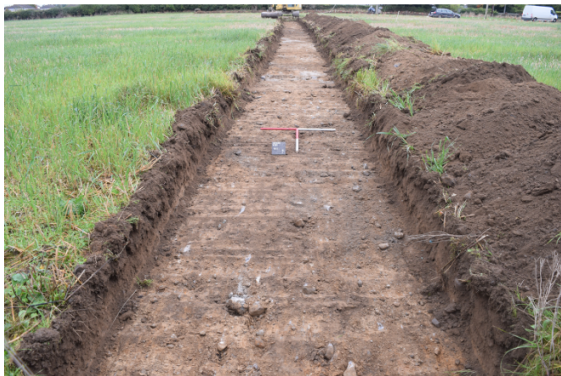
Trench 2 was 50.50m long and 0.30m deep; evidence of previous development was visible, including construction gravel, brick and a waterpipe.

**Plate 3: Trench 2, with gravel from
previous development. Looking
north-west. Scales 1m & 1m**

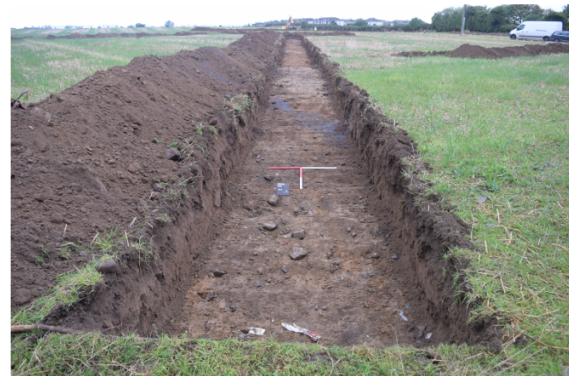
Trench 3 had a length of 50.75m and a depth of between 0.40m and 0.70m and contained evidence of previous recent development similar to that seen in Trench 2.

**Plate 4: Trench 3, with gravel from
previous development.
Looking west. Scales 1m & 1m**

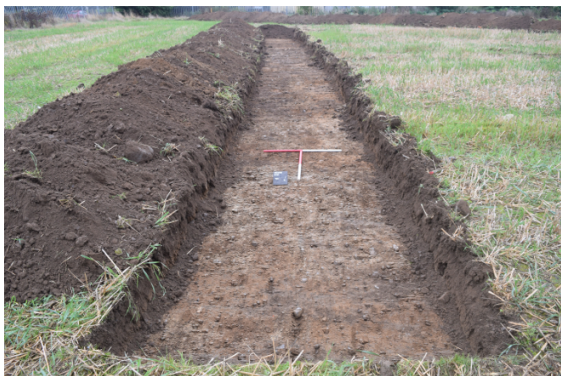
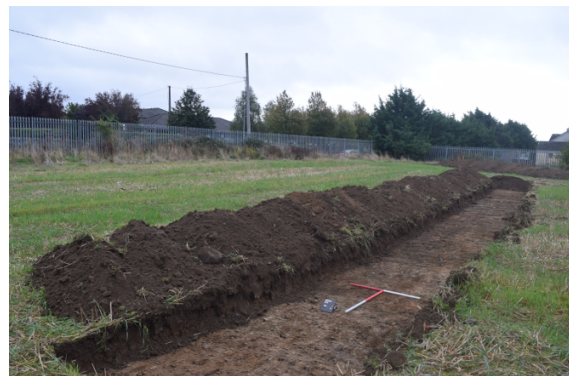
Trench 4, with a length of 24.50m and a depth of 0.20-0.45m contained the skeletal remains of an animal at the same depth as the previous development disturbance seen in Trenches 2 and 3.

**Plate 5: Trench 4. Looking south-east.
Scales 1m & 1m**

**Plate 6: Trench 4, view towards road.
Looking south-east.
Scales 1m & 1m**

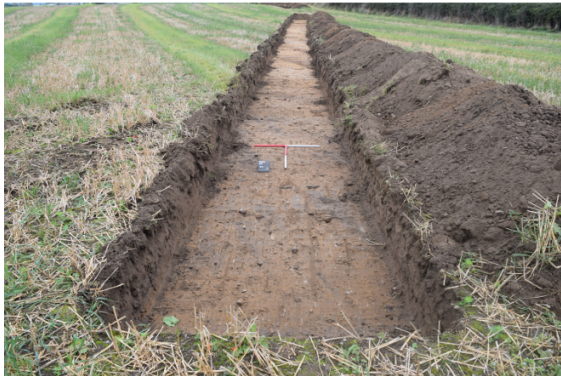
Trench 6 was 51m long and 0.50m deep with agricultural furrows visible cut into the natural deposits on a east-north-east to west-south-west alignment.

Plate 7: Trench 6, agricultural furrows visible. Looking west. Scales 1m & 1m

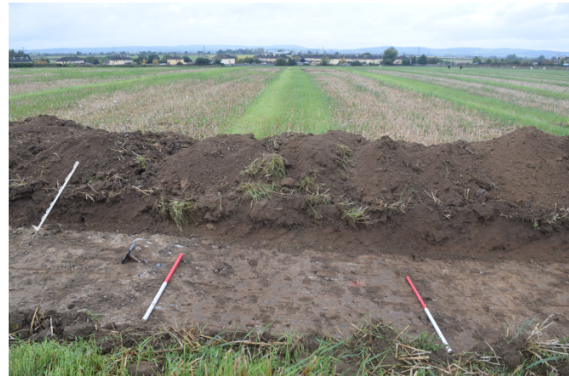
Trench 9 had a length of 5.50m and a depth 0.35m and showed evidence of east-north-east to west-south-west aligned agricultural furrows, typically 2.5m wide and 5m apart.

Plate 8: Trench 9, agricultural furrow visible. Looking south-west. Scales 1m & 1m

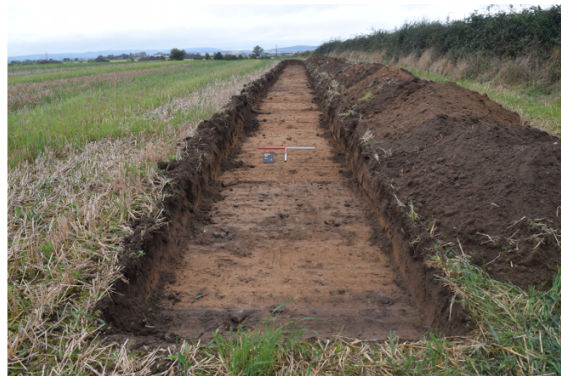
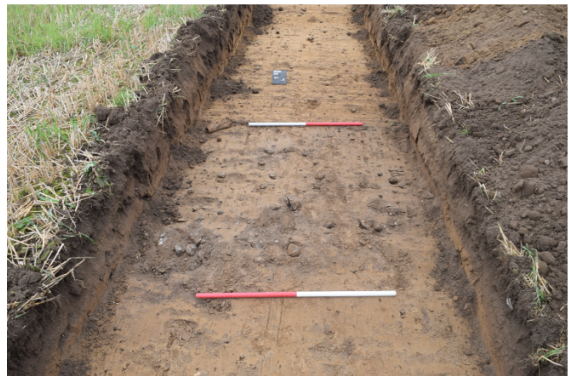
Trench 7, with a length of 48m and a depth of 0.35m, contained a former north-west to south-east aligned field boundary, 1.70m wide.

Plate 9: Trench 7, former field boundary. Looking west. Scales 1m & 1m

Plate 10: Trench 7, former field boundary. Looking west. Scales 1m & 1m

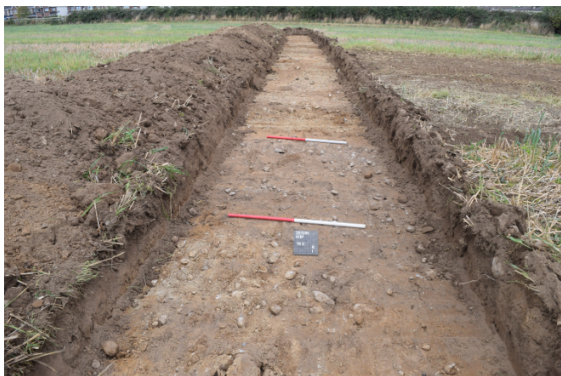
Trench 11, 49.50m long and 0.32m deep, contained a former field boundary ditch located 19.40m from the southern end of the trench. The 2.30m wide ditch was aligned east-north-east to west-south-west and contained mid brown silty sand with abundant stone and brick. The trench also contained modern agricultural furrows similar to those seen in Trenches 8-10.

Plate 11: Trench 11, former field boundary. Looking north-west. Scales 1m & 1m

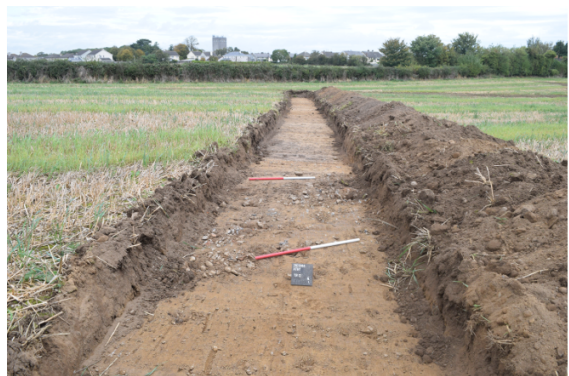
Trench 12, with a length of 43m and a depth of 0.40m, revealed the same former field boundary as was seen in Trench 11. This ditch was located 9.30m from the southern end of the trench and was 2.5m wide, with a fill of mid brown silty sand with abundant stone and brick. The trench also contained similar agricultural furrows.

Plate 12: Trench 12, former field boundary. Looking south-west. Scales 1m & 1m
