# An Triantán, Station Road Housing Kildare

Part 8 – Civils Basis of Design Report

# **Kildare County Council**

Job No:	1040805
Doc ref:	ATR CDL XX XX T C 10230
Revision:	P03
Revision date:	20 December 2024

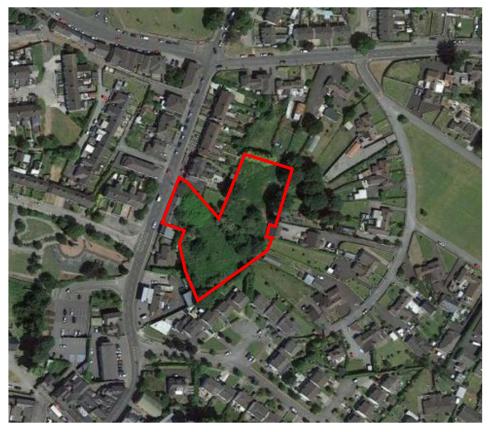
Figure 1-1: Site Location (Google Earth)

The existing site is currently a brownfield site with two existing cottages and a shed. A Virgin Media telecommunications mast with associated infrastructure is also on the site. The majority of the site is covered in vegetation and trees including Japanese Knotweed which has been undergoing treatment prior to removal. The site is bounded by existing residential developments along each of the boundaries with the site location and red line boundary indicated in Figure 1-1 below.

The site gradient falls from the eastern boundary at a level of approx. +102mAOD in each direction with the lowest point of the site noted at the western boundary, +100.83mAOD, giving a gradient of approx. 1 in 47. Please refer to Appendix A for the topographical survey carried out by Apex Surveys in December 2023.

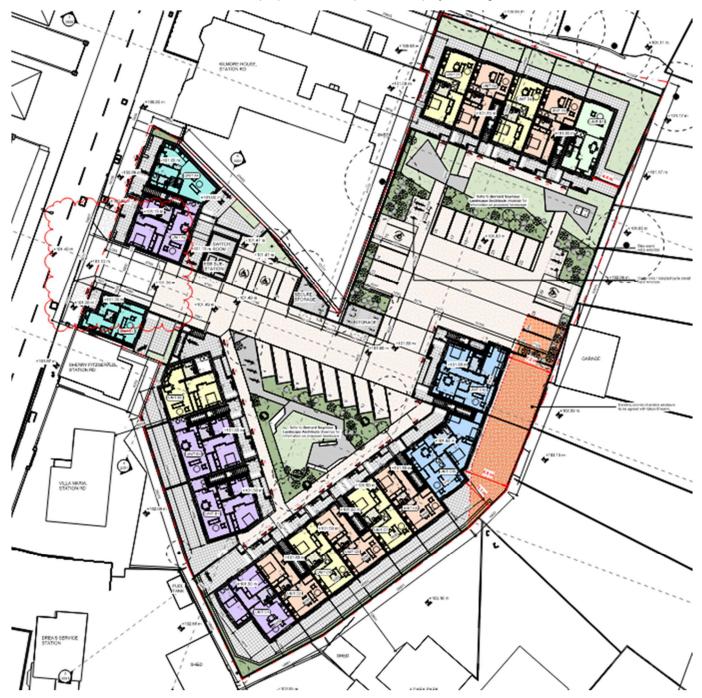
Figure 1-2: Proposed Site Layout (Architect Drawing No. 2308-Z-DR-SCA-AR-2000-07)

Full details for the proposed development are included in the site description and within the architect's information and reference should be made to this area. The proposed development is displayed in Figure 1-2 below.

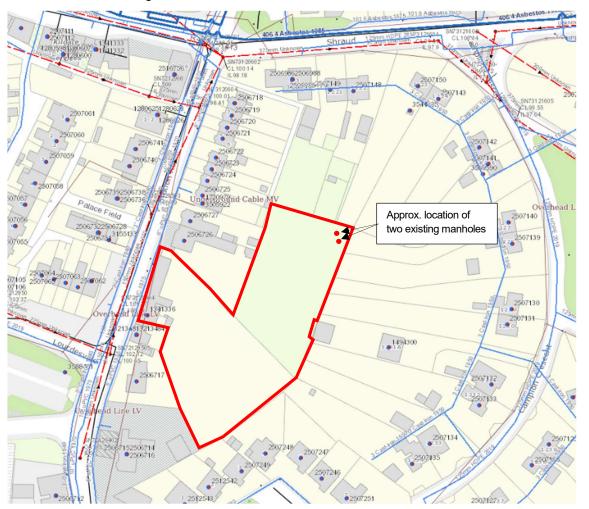
Figure 2-1: UÉ record maps (KCC)

Uisce Éireann (UÉ) record maps received from KCC, refer Figure 2-1 below, do not indicate any existing surface water sewers within or in close proximity to the site. However, there is a network assumed to be within the footway of Station Road with locations of gullies noted in the footway outside the existing cottage.

It was noted from site walks conducted that two existing manholes are within the site boundary, approximate locations of manholes indicated in Figure 2-1 below.

From the GPR survey information received it was noted that there is a surface water network present within the footway immediately outside the existing cottage garage. Two gullies, one located in the footway and the other within the road, discharge into a manhole located here which was traced futher down the pathway, but from this point onwards the pipe could not be traced due to excessive silt build up within the pipe. Additionally, it was noted that the manholes are approximately 450mm below ground level.

A CCTV survey was conducted on site to verify what the two existing manholes located to the north-east corner are serving and if they are in operation. Their initial findings indicate that one of these relates to an existing surface water network that serves the Dara Park residential estate to the south-east of the site. It was noted that there was a defect within this line which occurs at the bend on the pipeline as it changes direction towards Dara Park. The defect does not appear to be preventing the surface water flow through the pipe.

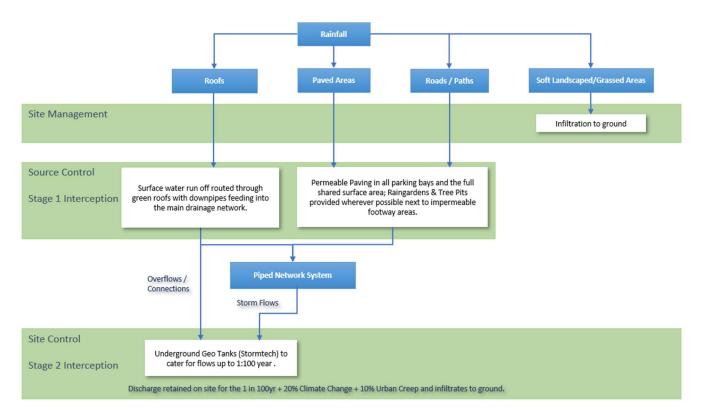
### Figure 2-2: Surface Water Management Design Strategy

Surface water runoff from the site's road network will be captured at source through the proposed porous paving surfacing on the carriageway with impermeable footways discharging to adjacent bio-retention zones, overflows to the main drainage network will also be provided. Porous pavements will collect surface water runoff from parking spaces also. Surface water runoff will also be collected in tree catch pits, which will overflow into the main piped network. Surface water runoff from rooftops will be collected from green roofs and be directed to the proposed surface water pipe network via connections from downpipe locations. Rain gardens will be provided wherver possible in the green areas as a form of attenuation and biodiversity. Refer to Figure 2-2 below for the proposed surface water design strategy.

The proposed surface water drainage network will collect surface water runoff and convey it to the main attenuation feature before discharging it via infiltration. As the site has very good infiltration rates and given the limited options to connect to an existing surface water sewer within Station Road an infiltration design is deemed appropriate for the development.

The proposed design intention for the surface water network is provided on drawing ATR-CDL-ZZ-XX-D-C-14001. As the existing sewer within the site is noted to be live, this will be diverted to ensure there is no reduction in the number of units to be provided. This diversion will be kept as tight to the boundaries as possible. Slit trenching is to be carried out to verify the depths where the existing networks enter the site.

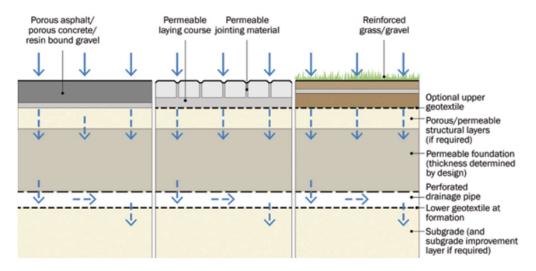
Figure 2-3: Typical Porous Paving Systems - Type B Partial Infiltration (CIRIA SuDS Manual C753)

Porous paving is suitable for pedestrian and/or vehicle traffic, while allowing rainfall to pass through the surface and into the underlying structural layers. Stormwater that infiltrates through the permeable paving, is stored before being discharged into the existing drainage network. Temporarily storing the stormwater in the structural layers slows the rainfall reaching the drainage network and reduces the risk of overloading the system.

Permeable paving is currently proposed to the parking bays and shared surface carriageway which will provide sufficient attenuation and treatment. Refer to Figure 2-3 for a typical example of porous paving systems with partial infiltration considered possible.

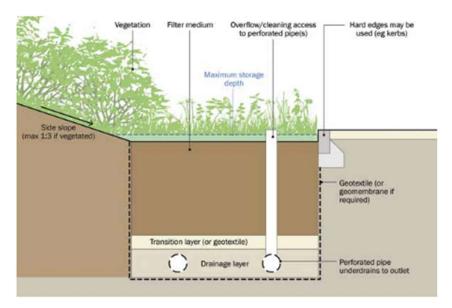
Figure 2-4: Components of a Bio-Retention System (CIRIA SuDS Manual C753)

It is currently proposed to provide bio-retention areas wherever possible within the soft landscaped areas of the site to drain adjacent impermeable areas. A typical section detail of the components of a bio-retention system is provided below in Figure 2-4.

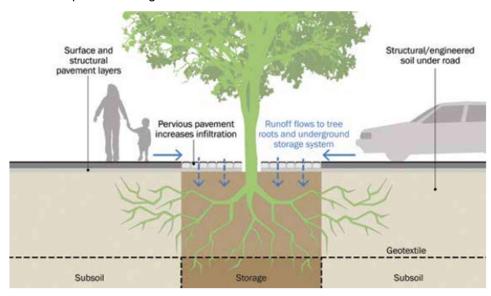
Figure 2-5: Typical Tree Pit Detail (CIRIA SuDS Manual C753)

Tree pits can be designed to collect and attenuate runoff by providing storage within an underlying structure. The soils around the trees can also provide treatment of runoff by filtering out the pollutants from runoff directed towards the features. Tree pits are proposed wherever possible on the site and will be surrounded with a root protection barrier to ensure sufficient protection is provided to the roots and other services. A typical section detailing the surface water runoff for trees is provided in Figure 2-5 below.

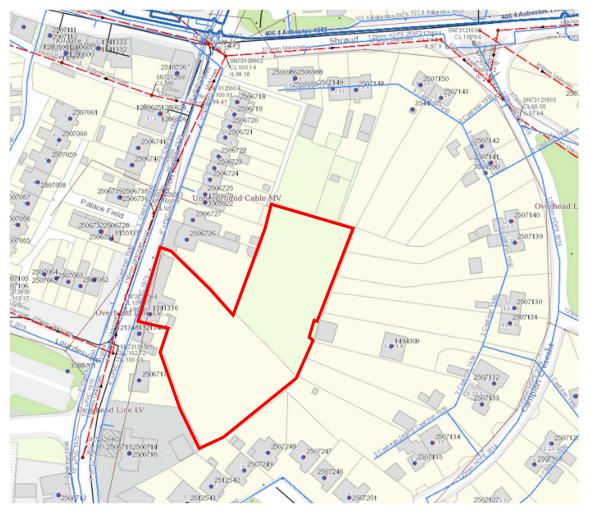
Figure 3-1: UÉ Record Map (KCC)

UÉ record maps received from KCC, refer Figure 3-1 below, indicates an existing 150mm dia. wastewater sewer of unknown material within Station Road.

From the GPR survey information received to date it is noted that there is an existing wastewater sewer within Station Road with manhole depths ranging from 0.8m to 1.4m along the 150mm dia. vitirified clay pipe run.

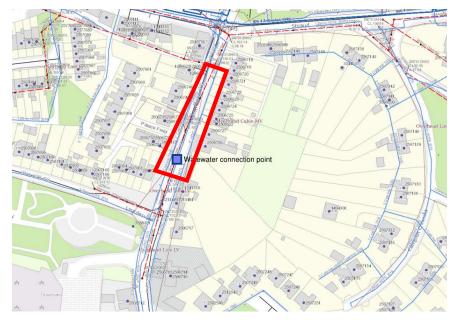
Figure 3-2: Proposed Connection Point and Upgrade Works

The proposed connection point for the site is shown in Figure 3-2 below with the approximate section of sewer to be upgraded outlined in red. The level of this wastewater connection may impact on the proposed levels design as to ensure the connection discharges via gravity levels with the development may have to increase.

A Confirmation of Feasibility, CoF, (CDS23008235, refer to Appendix J) was received, and it was noted that the foul sewer connection is feasible once approximately 90m of the existing 150mm gravity sewer in Station Road is upgraded to a 225mm pipe.

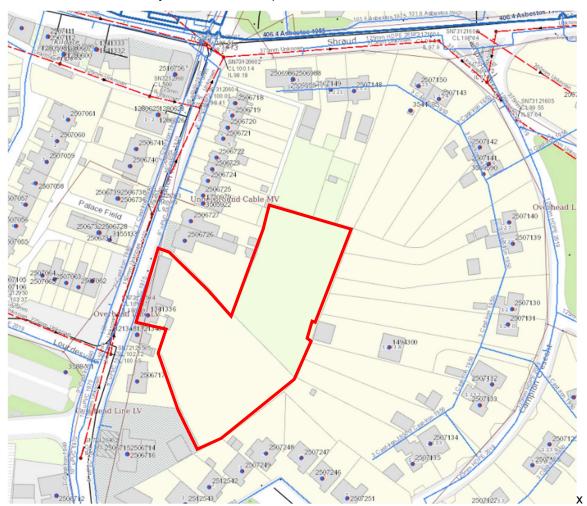
Figure 4-1: UÉ Record Map (KCC)

This was verified via the GPR survey with three existing pipe networks picked up, however it is noted on the preliminary survey that one pipe is 10" (250mm) dia. uPVC located within the main Station Road and the other is a possible 10" dia. uPVC located in the footway outside the development site.

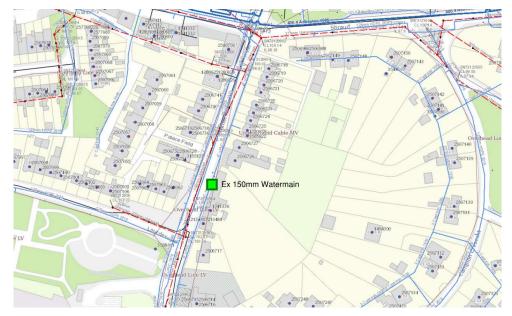
Figure 4-2: Proposed Connection Point Watermain

As per the CoF (CDS23008235, refer to Appendix J) it was determined that the water connection is feasible without any infrastructure upgrade work. It is proposed to provide the connection for the site off the existing 6" (150mm) water main running along Station Road outside the proposed housing development, refer to Figure 4-2 below.

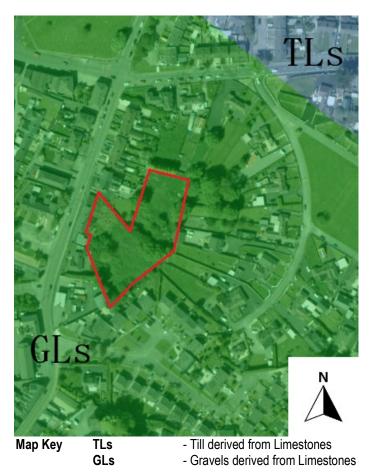
# Figure 4 – Quaternary Soils Map for the Kildare Town Site

The Quaternary Soils map for the area (Figure 4 - retrieved from GSI website) indicates the presence of Gravels derived from Carboniferous-aged limestone.

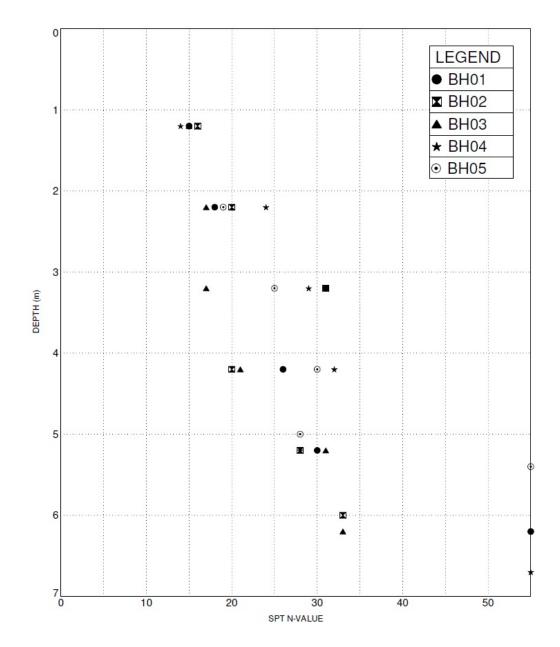
Figure 6 – SPT Plot versus Depth for Cable Percussion boreholes

- In-situ testing was undertaken during the construction of all five cable percussion bores. The standard penetration test [SPT] allows for an appraisal of the ground stiffness. A plot showing the blowcounts generated from testing is presented in Figure 6. SPT testing undertaken in the natural overburden soils generally proved the presence of initially firm becoming stiff to eventually very stiff CLAY passing to a dense GRAVEL deposit with depth. From 5m bgl, many of the test drives were reported as refusals once in the deeperseated soils and therefore appear along the right-hand side of the plot.

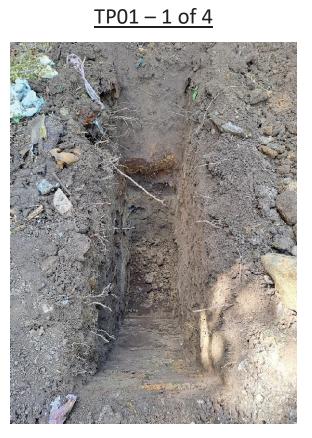
<u>TP01 – 2 of 4</u>

Obstru End of	ction Trial Pit at 2.70m		2.70 759 759 6-50 758 759 759 759 759 759 759 759 759 759 759	98.09		AA229994	В	2.40-2.60			
Groundwate Dry	Conditions										
Stability Good											
General Rem Pit excavated	arks I into embankment. Pit ended due to	slow progress in de	ense around	PBT04 ar	nd SA02	carried ou	ut at TP	04.

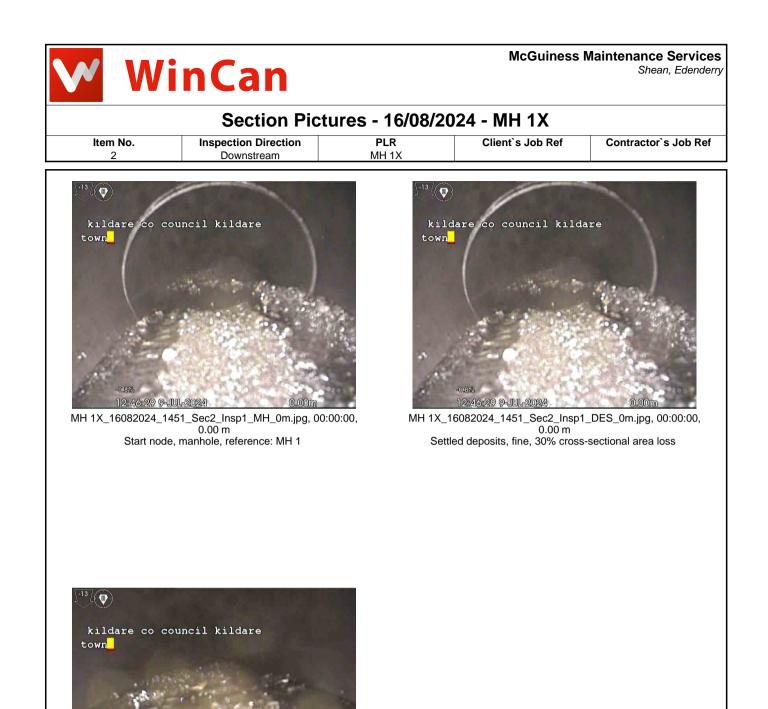
MH 1X\_16082024\_1451\_Sec2\_Insp1\_SA\_0m.jpg, 00:00:13, 0.00 m Survey abandoned, Unable to complete survey due to silt in line

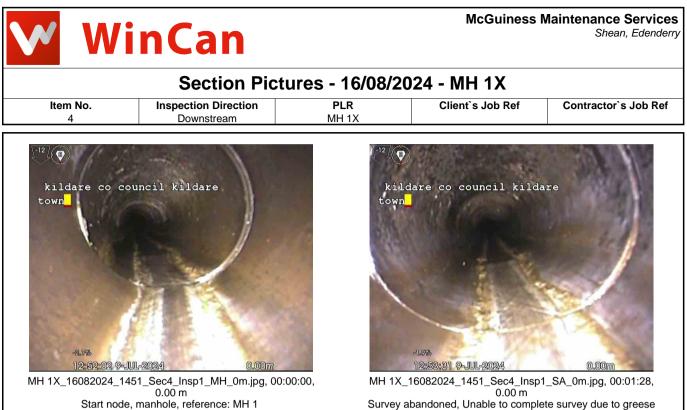
Survey abandoned, Unable to complete survey due to greese on pipe. Unable to determind length due to no meterage chang

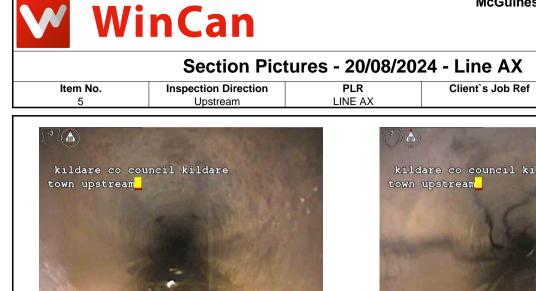
0.00	SA		abandoned: L ind distance	Inable to comple	ete survey	v. Unable to	00:05:30	Line AX_200 024_16	82
			ction Featur					Miscellaneous	Features		
			ural Defects			CED No. Def		e & Operation			
<b>STR No. E</b> 5	Def STR		<b>FR Mean</b> 0.0	STR Total 140.0	STR Grade 4.0	SER No. Def 5	<b>SER Pe</b> 17.0	ak SER Me		<b>R Total</b> 7.0	SER Grade 5.0

There was also an additional feeder line that appears to come from the back of the properties 1-8 on Station Road into the existing manhole. This line was noted to be partially blocked with the camera unable to pass. The defect does not appear to be preventing the surface water flow through the pipe.
