S.I. Ltd Contract No: 5994

Client: Kildare County Council
Engineer: Tobin Consulting Engineers
Contractor: Site Investigations Ltd

Maynooth Fire Station,
Maynooth, Co. Kildare
Site Investigation Report

Issue Date:	24/06/2022
Status	Final
Revision	1

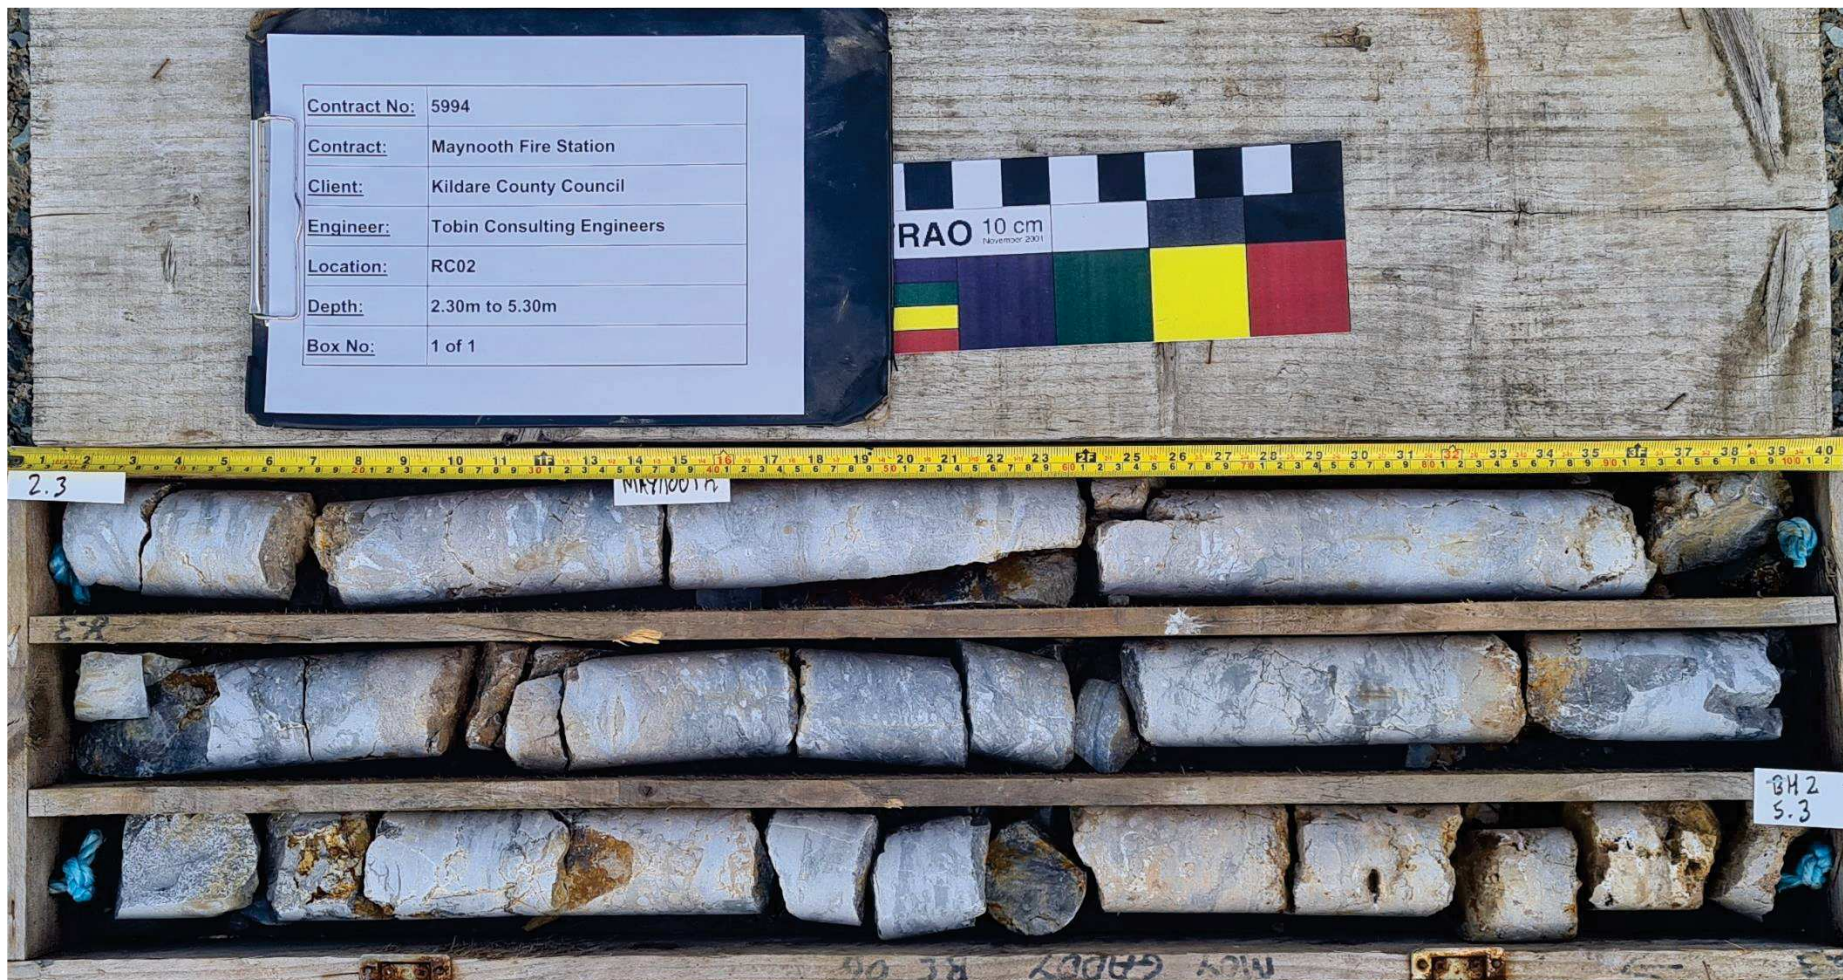
RC02 Box 1 of 1

The bedrock was recorded at 2.30mbgl at RC02 and 3m of core was recovered. This is a moderately strong, light grey, massive LIMESTONE with occasional calcite veins and a fresh to slightly weathered state. The discontinuities are rough, undulating, tight to open, sub-horizontal, occasionally sub-vertical dip and the surfaces are clean with occasional brown staining.

62.03	62.0						
1.5				62.5							
2.0				61.5							
2.30		Moderately strong light grey massive LIMESTONE with occasional calcite veins. Fresh to slightly weathered. <i>Discontinuities - rough, undulating, tight to open, sub-horizontal, occasionally sub-vertical dip, clean with occasional brown staining.</i>

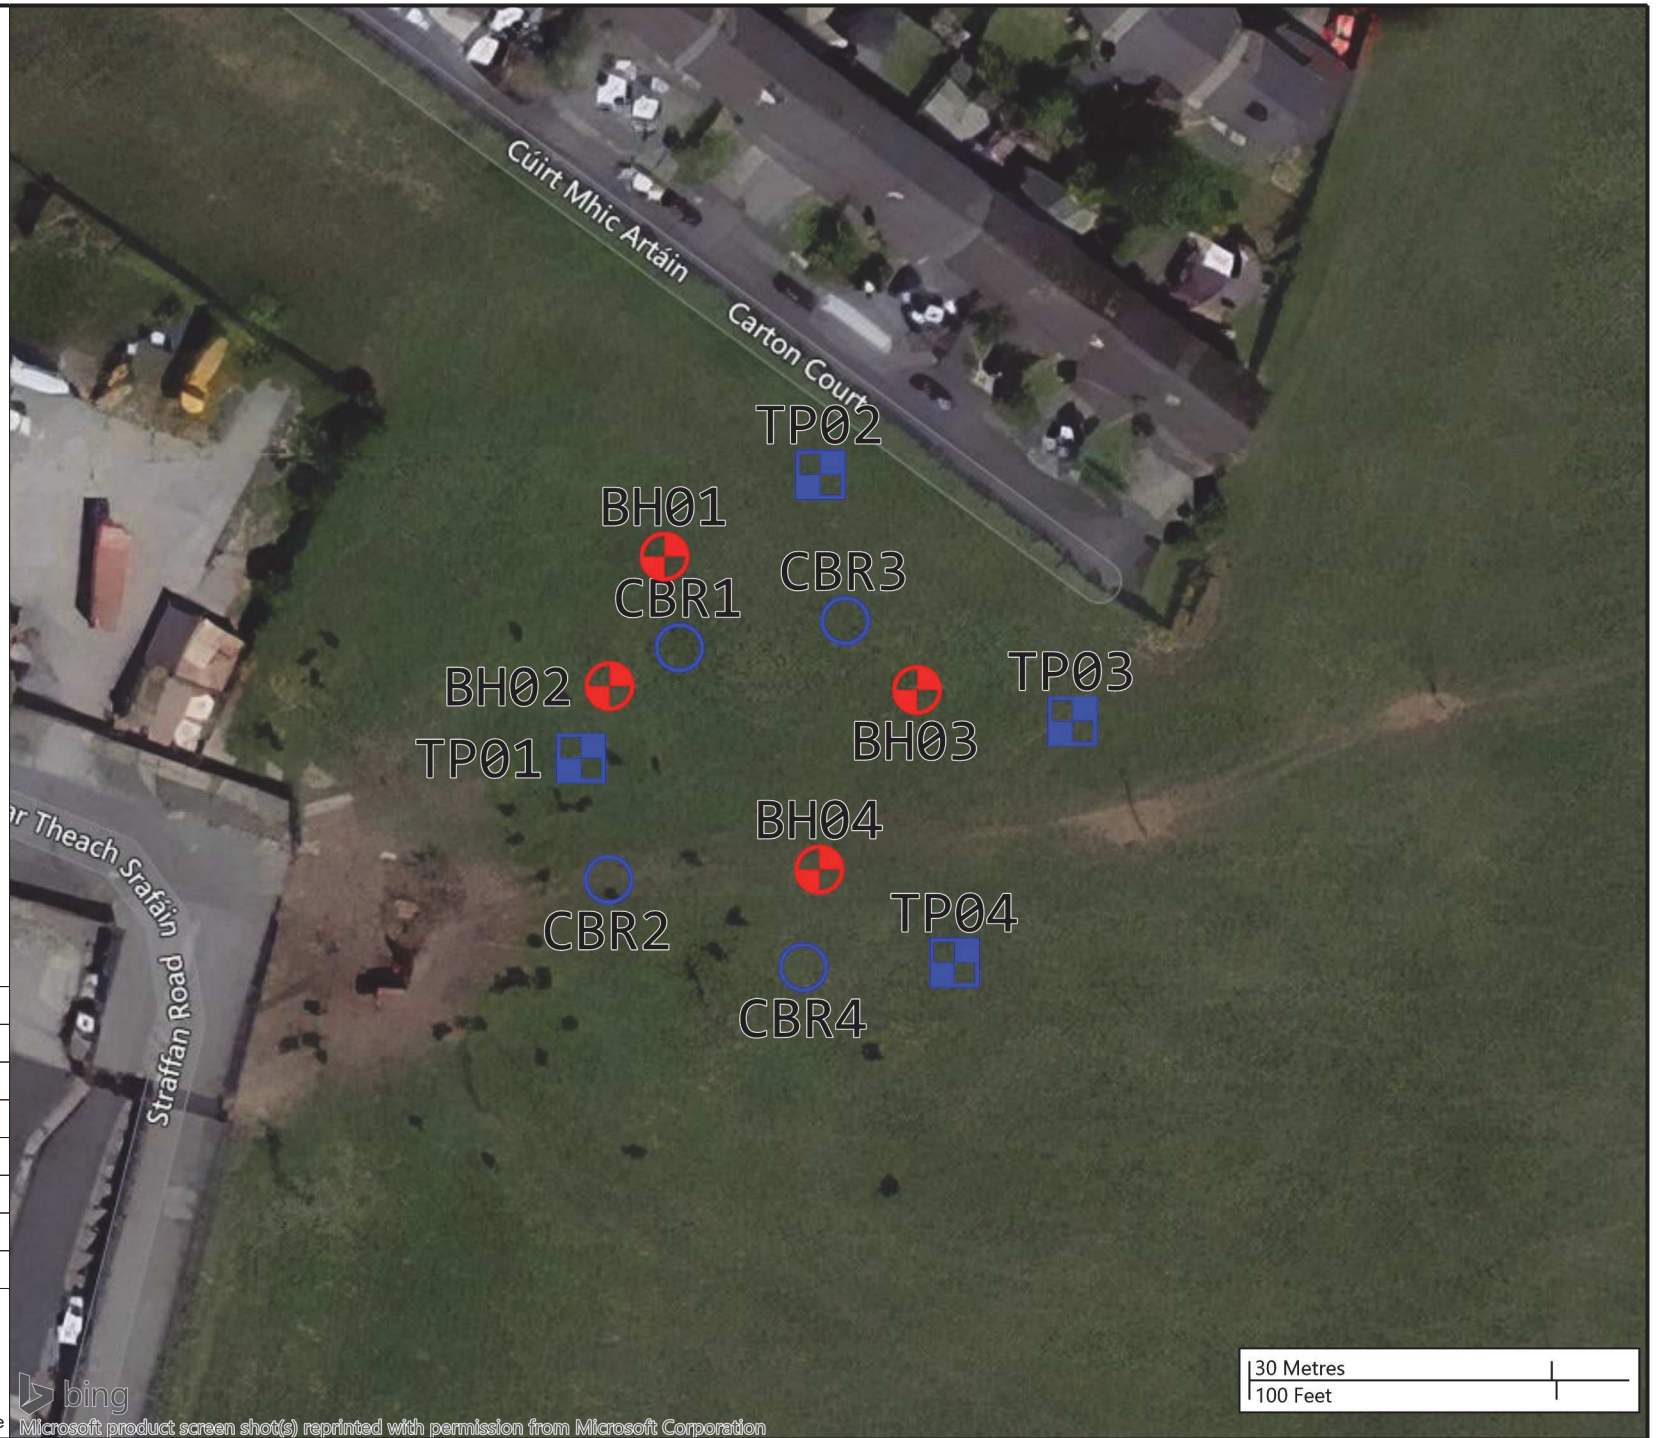
Locations By Type - TP

Contract No:	5994
Contract Name:	Maynooth Fire Station
Location:	Maynooth, Co. Kildare
Client:	Kildare County Council
Engineer:	Tobin Consulting Engineers
Title:	Site Plan
Scale:	1:750
Drawn By:	SL
