### SCREENING FOR EIAR

Screening for Environmental Impact Assessment Report Naas to Kill Cycle Scheme

#### **Kildare County Council**

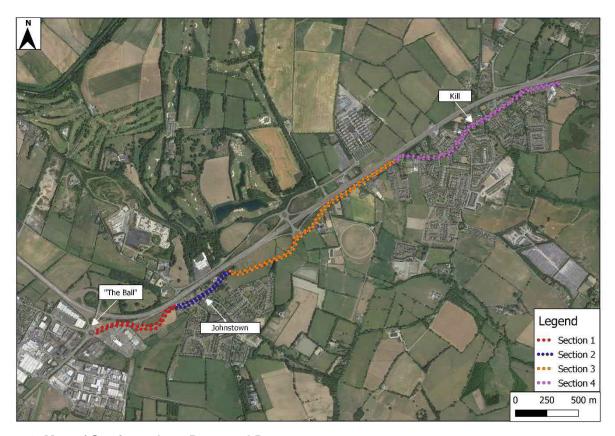
Figure 2: Map of Sections along Proposed Route

The project comprises of the following sections: (as seen in Figure 2):

#### Section 1: "The Ball" to Johnstown

'The Ball' Naas to Johnstown Village. It consists of c.850m in length, with a 4.0m wide shared use pedestrian-cycle path and grassy verge. The 1m grassy verge will be reduced/removed to widen cycle path.

#### Section 2: Johnstown Village

It consists of c.530m in length, with modifications to car parking spaces, bus stops and bus lay-bys.

#### Section 3: Johnstown Village to Kill Village

Exiting Johnstown to Kill. It consists of c.1.6km in length, with a 4.0m wide shared use pedestrian-cycle path and grassy verge. The 1m grassy verge will be removed to widen cycle path.

#### Section 4: Kill Village

It consists of c.1.53km in length, with modifications to car parking spaces, roundabout and bus stops.

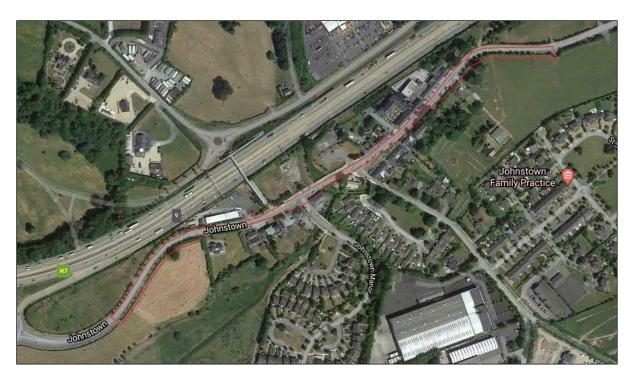
**Figure 1:** Aerial image of Johnstown village with the approximate boundary of the tree survey area outlined in red. The survey for this section began at the edge of the red line in the far left of the image. The tree numbering begins at this point on T615 and finishes in the east of the village on T681.

- 2.2.1. The tree survey targeted the trees within the red line area defined on the Tree Survey Boundary drawing (drawing ref: 40000089-WSP-DG-HW-0001). Where trees were established on adjacent lands outside the red line boundary but had the potential to be impacted upon, these trees were included in the survey.
- 2.2.2. The areas that were assessed are divided into two sections in Johnstown village and Kill village. The Johnstown section begins in the west of the village close to the roundabout on the R445. The section continues for approximately 800m to the east of the village where the land use changes to agricultural grazing.

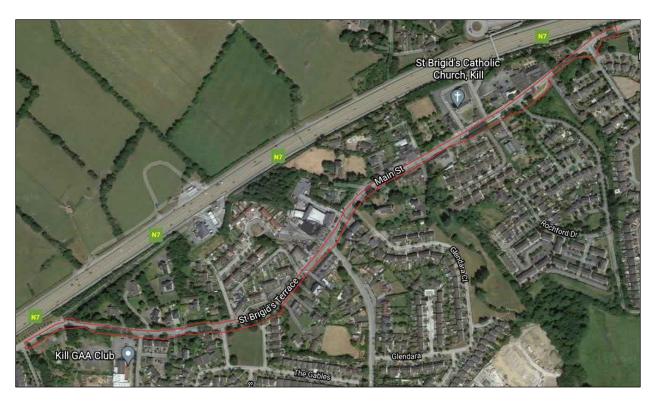
**Figure 2:** Aerial image of Kill village with the approximate boundary of the tree survey area outlined in red. The tree survey for this section began at the edge of the redline in the far left of the image. The tree numbering begins on TG682 at this point and finishes in the east of the village on T803.

2.2.3. The Kill section of the survey begins west of the village at the entrance to Embassy Manor. The survey area continues to the east through the Main Street in Kill for approximately 1200m. The survey area finishes in the eastern end of the village close to the entrance to Earls Court.

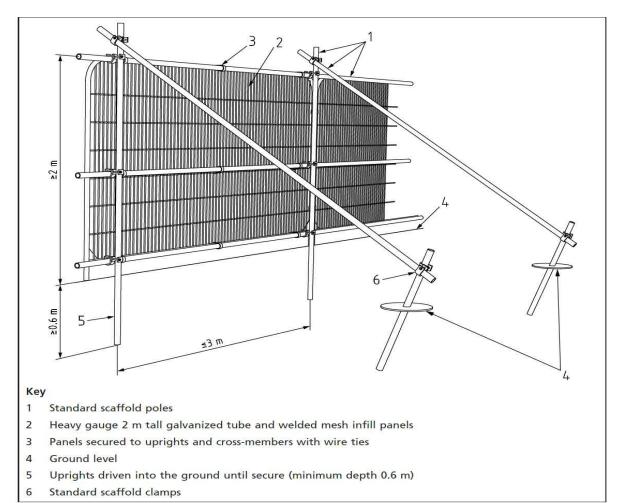
## **BS 5837 British Standard Tree Protection Fencing:**

The main contractor will inform the client that the tree protection fencing, and signage is in place before construction activities commence.
