REPORT

Proposed New Naas to Kill Cycle Route and Associated Works

Screening for Appropriate Assessment

Kildare County Council

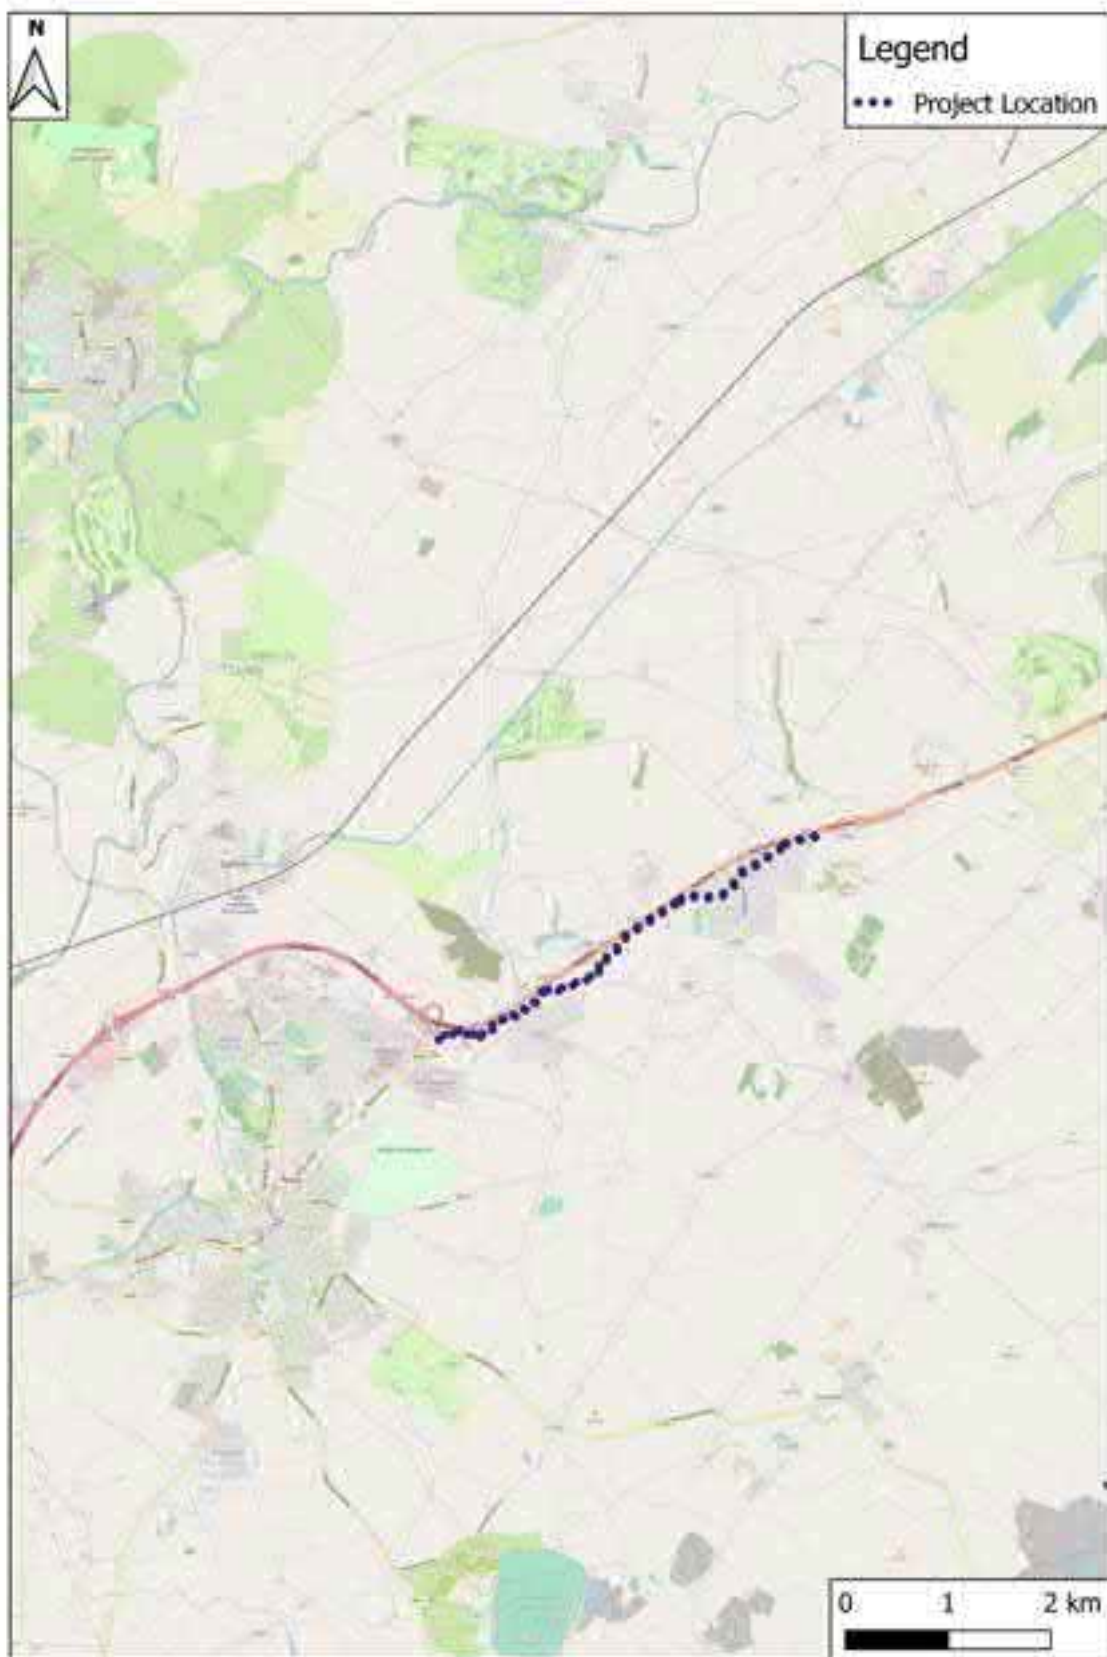
Figure 1: Site Location Plan

The Project is located in County Kildare, approximately 2.1 km north-east of Naas town centre, running generally parallel to the N7 from Junction 9, Naas North/Sallins exit to Kill (Figure 1).

Specifically, the Project is along the R445 heading northeast from Naas, to Johnstown village and the L2014 finishing at the Slí na Naomh Junction, Kill. The Project consists of roadway, pedestrian kerbs and grassy verges. As the surrounding environs encompasses two lengths of roadway and Johnstown and Kill villages, for ease of reference, the project has been grouped under the following four sections (Figure 2):

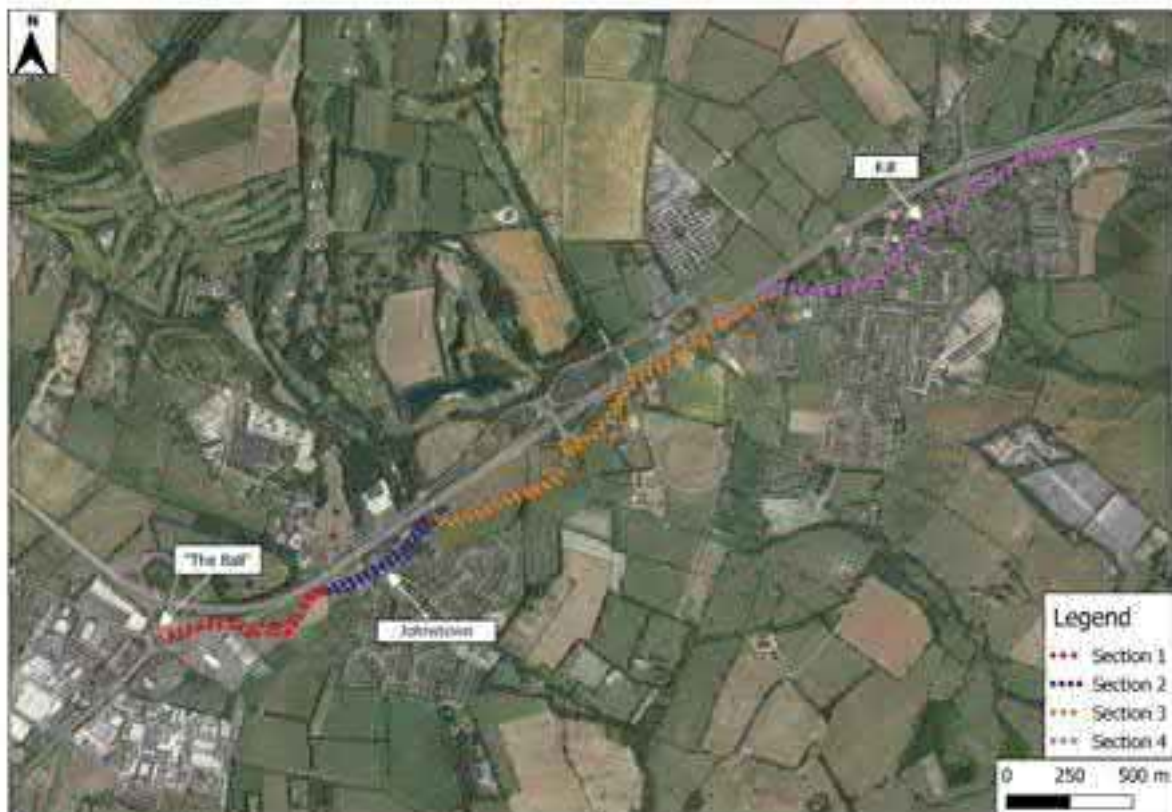
Figure 2: Section Map of Project Description

- Section 1: 'The Ball' Naas to Johnstown Village. It consists of c.850m in length, with a 4.0m wide shared use pedestrian-cycle path and grassy verge. The 1m grassy verge will be removed to widen cycle path.
- Section 2: Johnstown Village. It consists of c.530m in length, with modifications to car parking spaces, bus stops and bus lay-bys.
- Section 3: Exiting Johnstown to Kill. It consists of c.1.6km in length, with a 4.0m wide shared use pedestrian-cycle path and grassy verge. The 1m grassy verge will be removed to widen cycle path.
- Section 4: Kill Village. It consists of c.1.53km in length, with modifications to car parking spaces, roundabout and bus stops. Project design has been carefully considered to ensure retention of Class A trees.

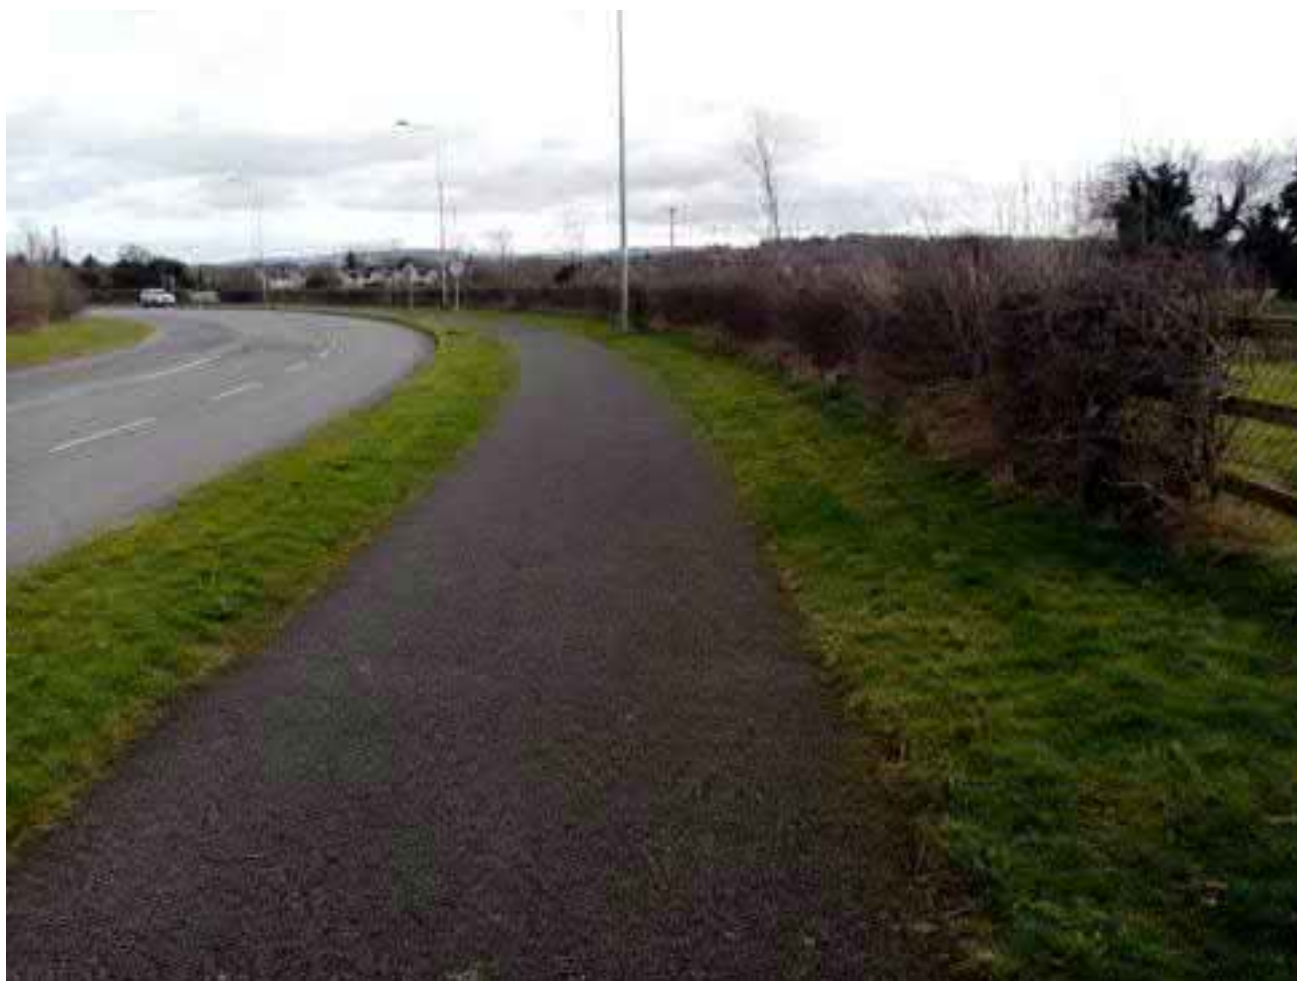
Figure 3: Pedestrian Pathway in Project Design

Main use of land has been for pedestrians, walking and cycling – **Fossitt Code BL3** (Figure 3).

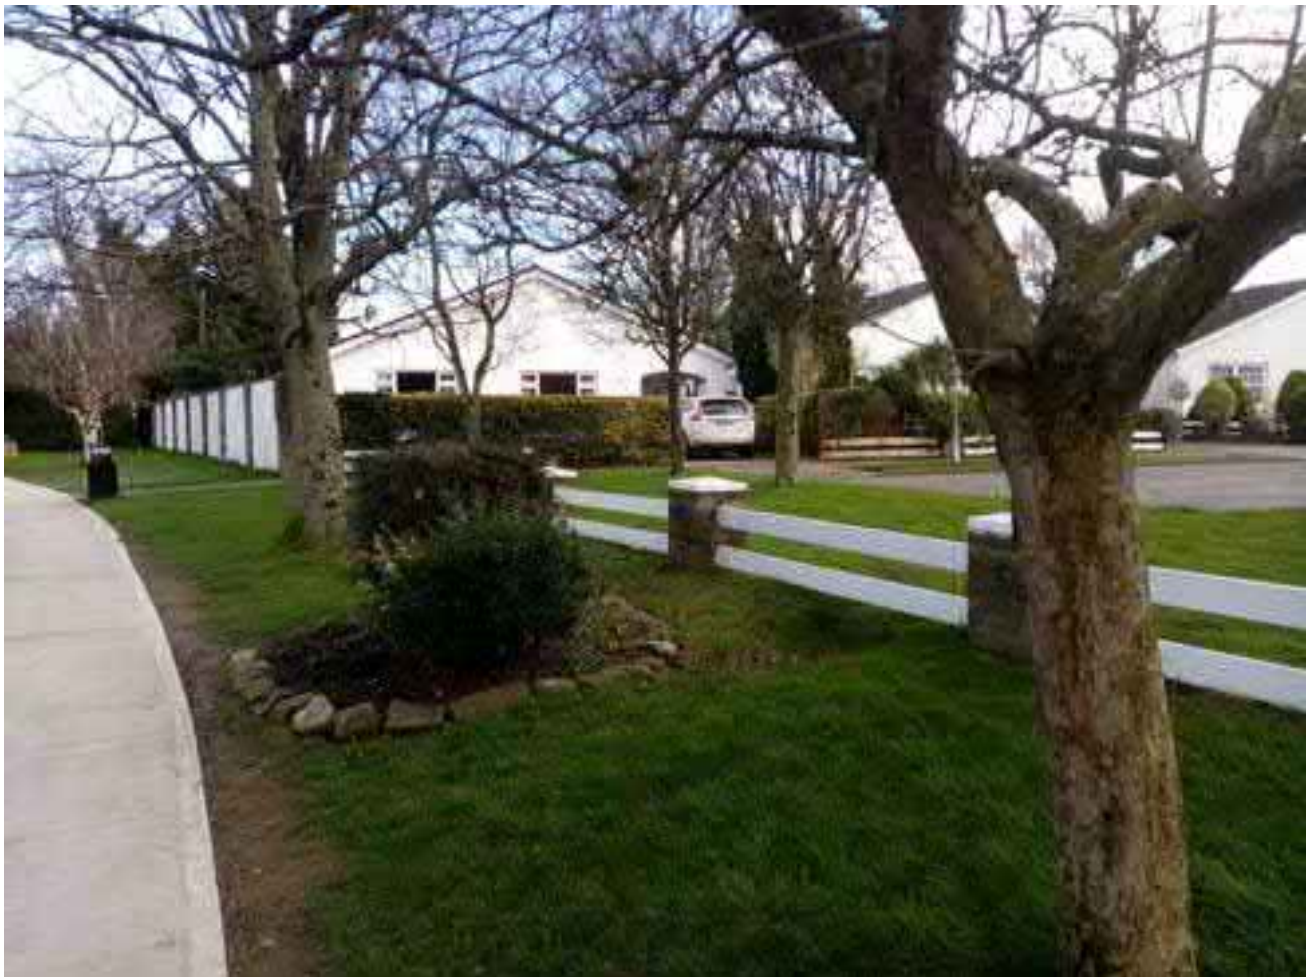
Figure 4: Semi-Natural Treeline, Kill Village

The Project will not modify the bordering hedgerows and trees within Section 1 and 3 (please see Figure 3). In the villages of Johnstown and Kill, trees have been established along the roadside in the grassy verges (Figure 4) – **Fossit Code WL2** and an Arboricultural Assessment Report (Appendix B) was undertaken to evaluate and survey trees. This report (Tree-space, 2022) indicates that: *17 trees or 7% of the total surveyed population will be lost to facilitate the construction of the cycle scheme. 12 category A trees (10% of total CAT A) will be removed, 3 category B (3% of total CAT B) and 1 category C tree (3% of total CAT C).* Additional ash tree loss is recommended to allow for lime trees to develop more freely at the eastern region of Johnstown (Tree-space, 2022). Protective fencing has been recommended to protect neighbouring trees during construction works, especially for two mature beech trees at Johnstown graveyard and Kill churchyard. In summary; *the tree loss to facilitate the construction of the proposed scheme was not considered significant. Ninety three percent of the surveyed population will be retained* (Tree-space, 2022).

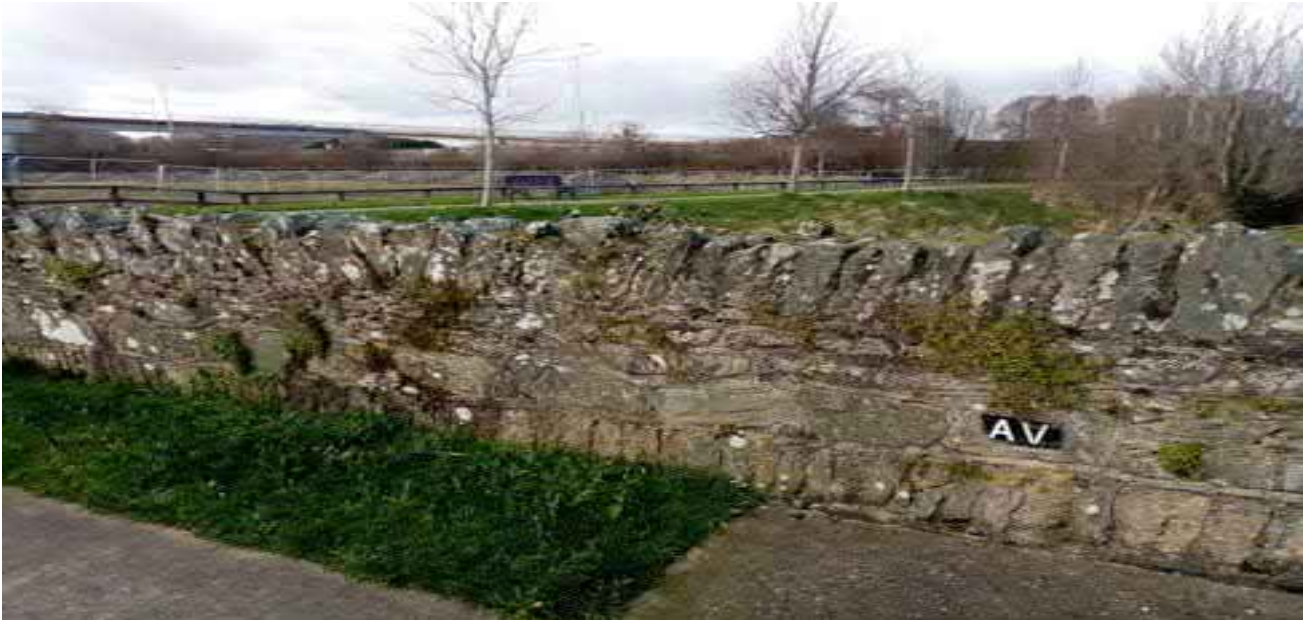
Figure 5: Bridge infrastructure in place at Johnstown

The Proposed Project is located in proximity to the Morrell and Rathmore stream in Johnstown and the Painestown stream in Kill. All are referenced as poor in the Water Framework Directive status (2013-2018). However, there is no aquatic connectivity from the Project to the streams, which underpass the roads (Figure 5 & 6) or danger of groundwater infiltration due to hardstanding environment.

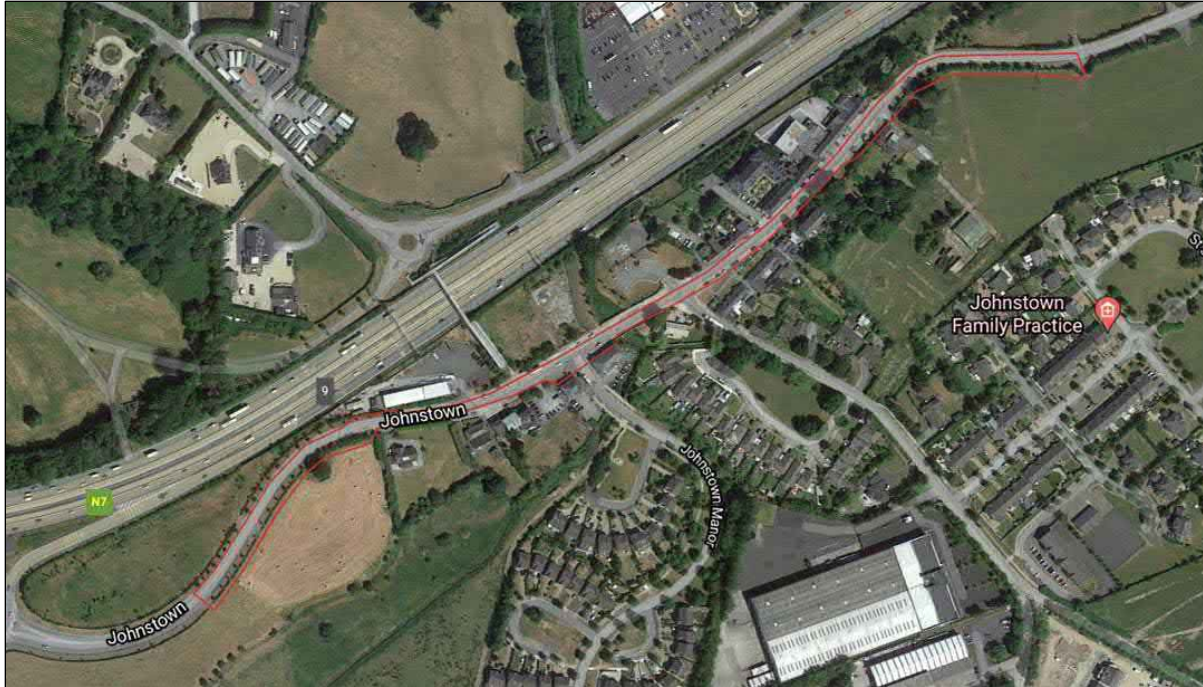
Figure 1: Aerial image of Johnstown village with the approximate boundary of the tree survey area outlined in red. The survey for this section began at the edge of the red line in the far left of the image. The tree numbering begins at this point on T615 and finishes in the east of the village on T681.
