# Arboricultural Assessment Report

Naas to Kill Cycle Scheme  
Co. Kildare

February 2022

**PROJECT NAME:** Arboricultural Assessment – *an assessment of trees in relation to development.*

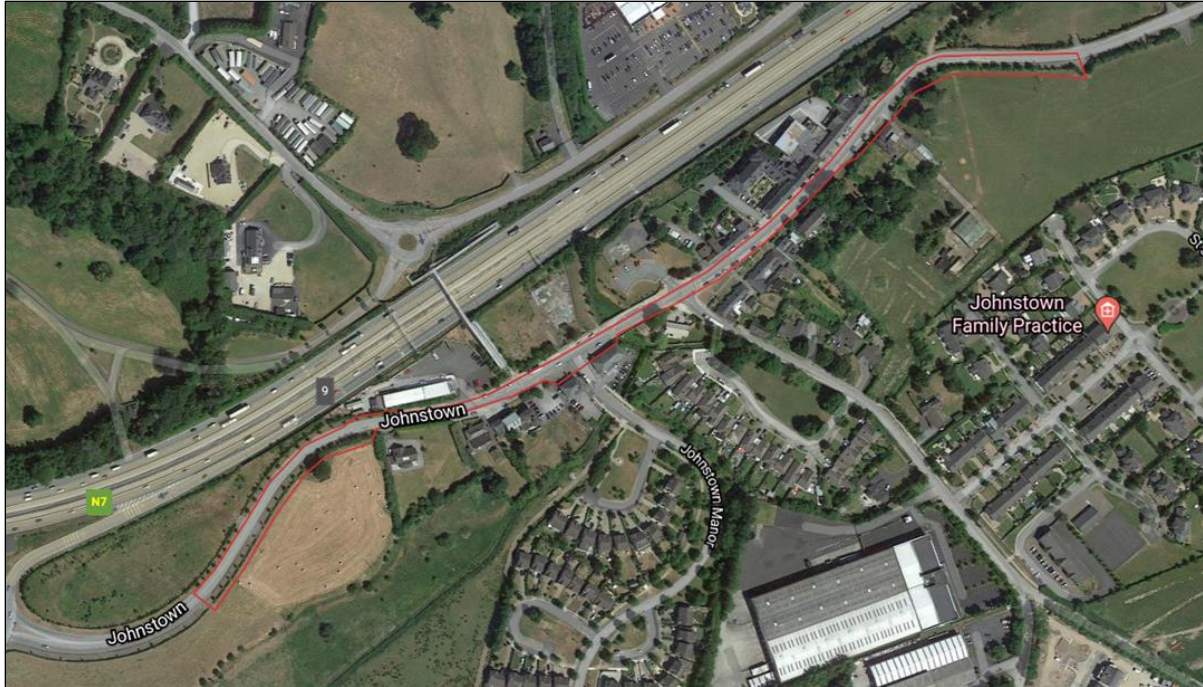
**Figure 1:** Aerial image of Johnstown village with the approximate boundary of the tree survey area outlined in red. The survey for this section began at the edge of the red line in the far left of the image. The tree numbering begins at this point on T615 and finishes in the east of the village on T681.
