# **Bat Suitability Assessment**

Kildare County Library,  
Newbridge, Co. Kildare

30 March 2023

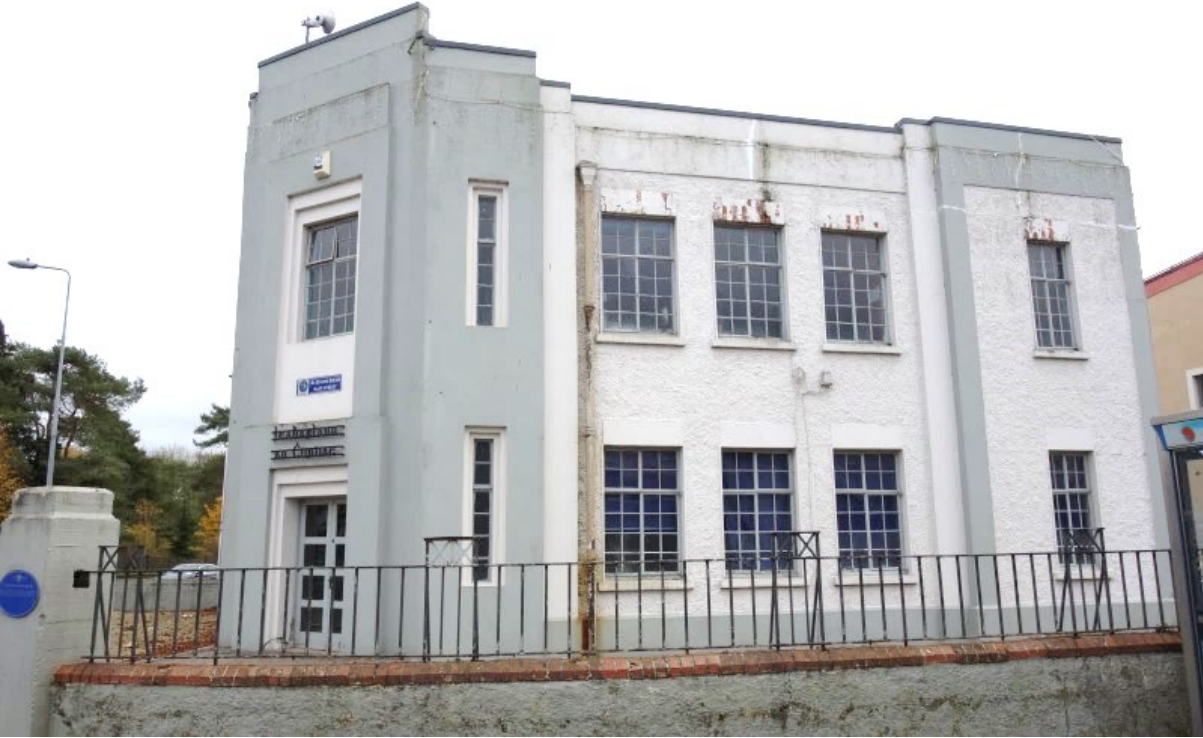
It is understood that the original building (Figure 1) was constructed in the 1930s. It has a pitched slate roof, obscured by parapet walls on the northern, eastern and southern sides. It has wooden soffit / fascia panels on the western side, and lead flashing around gutters and chimneys (Figure 2).

Figure 1: Exterior of original library building

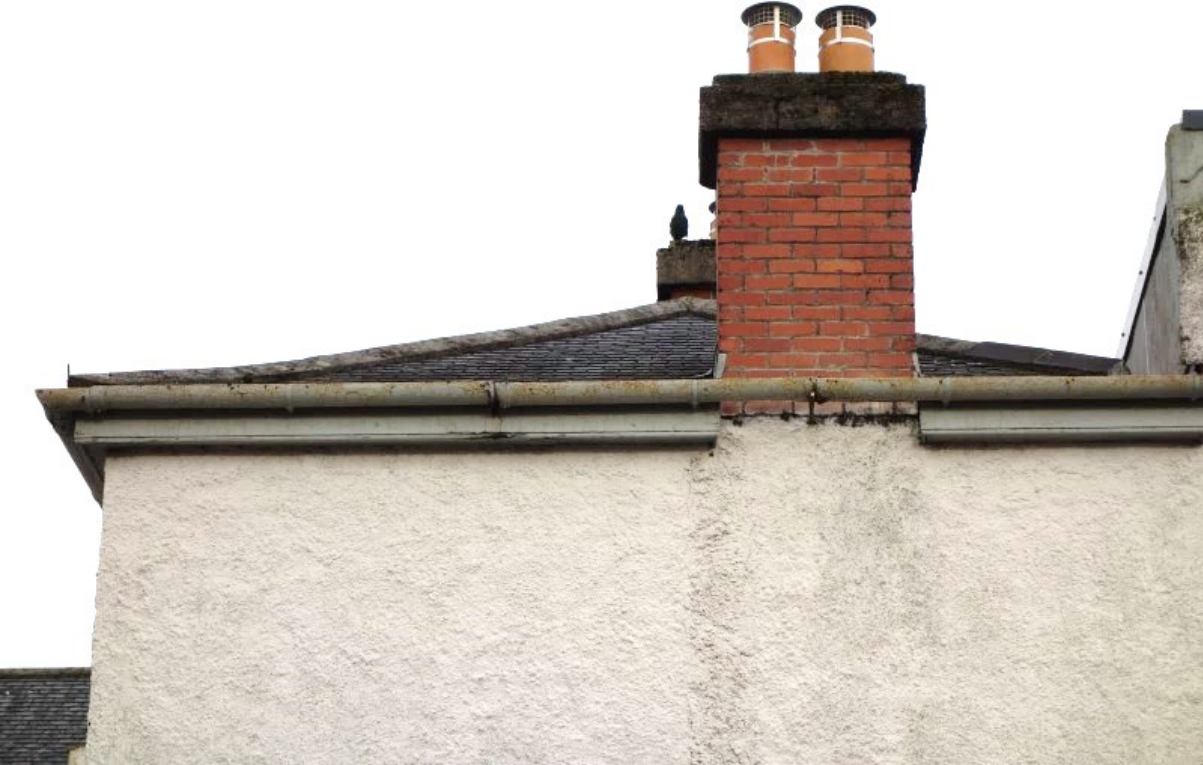
Some of the roof tiles have slipped, and gaps were observed around the edges of the soffit / fascia panels. These features could potentially provide access points for bats.

Figure 2: Western side of original building, showing slate tiles and wooden soffit / fascia panels

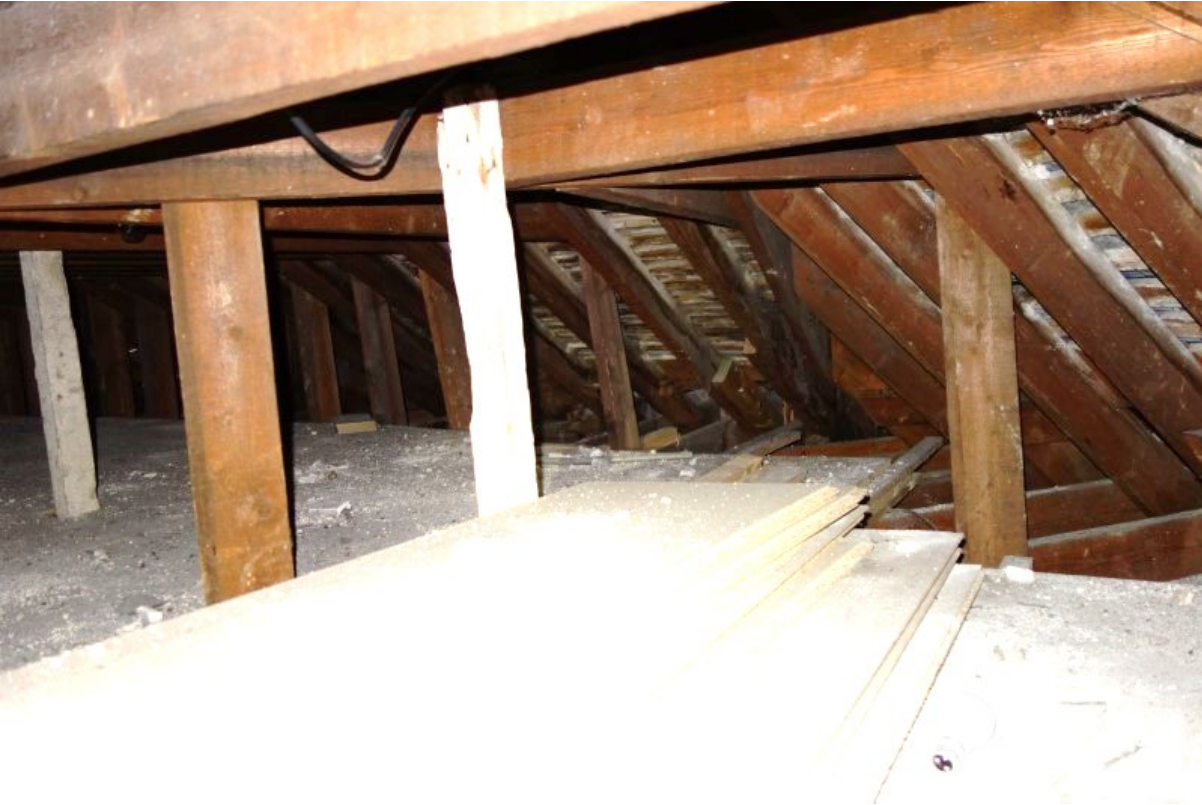
A section of the attic of the original structure was accessible (Figure 3). It was partially floored and had a crawl space of approx. 40 cm height. No bat droppings or any other field signs were observed within the attic. Rat droppings and urine staining were present throughout.

Figure 3: Interior of attic in original building

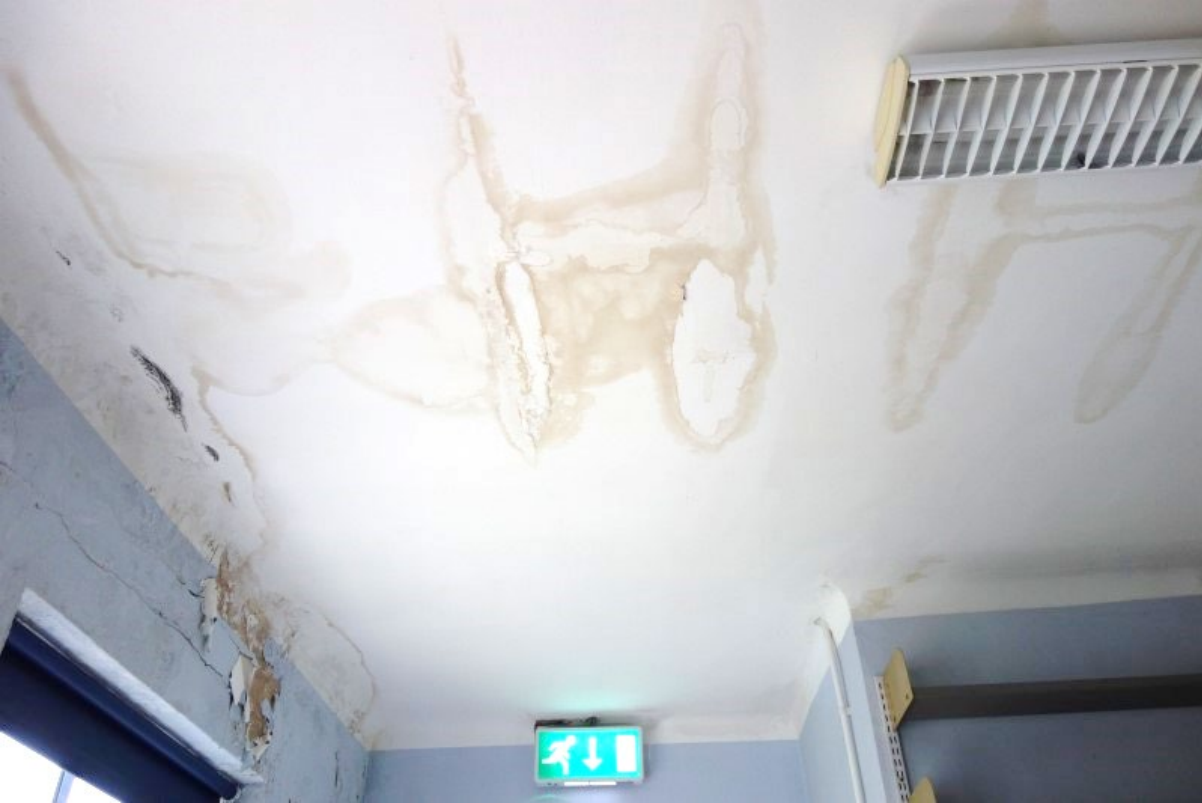
The upper storey of the original building had water damage in several places on the ceilings and walls (Figure 4), likely due to missing roof slates. All rooms in the upper storey were searched, but no signs of bats were found.

Figure 4: Ceiling damage in upper storey of original building

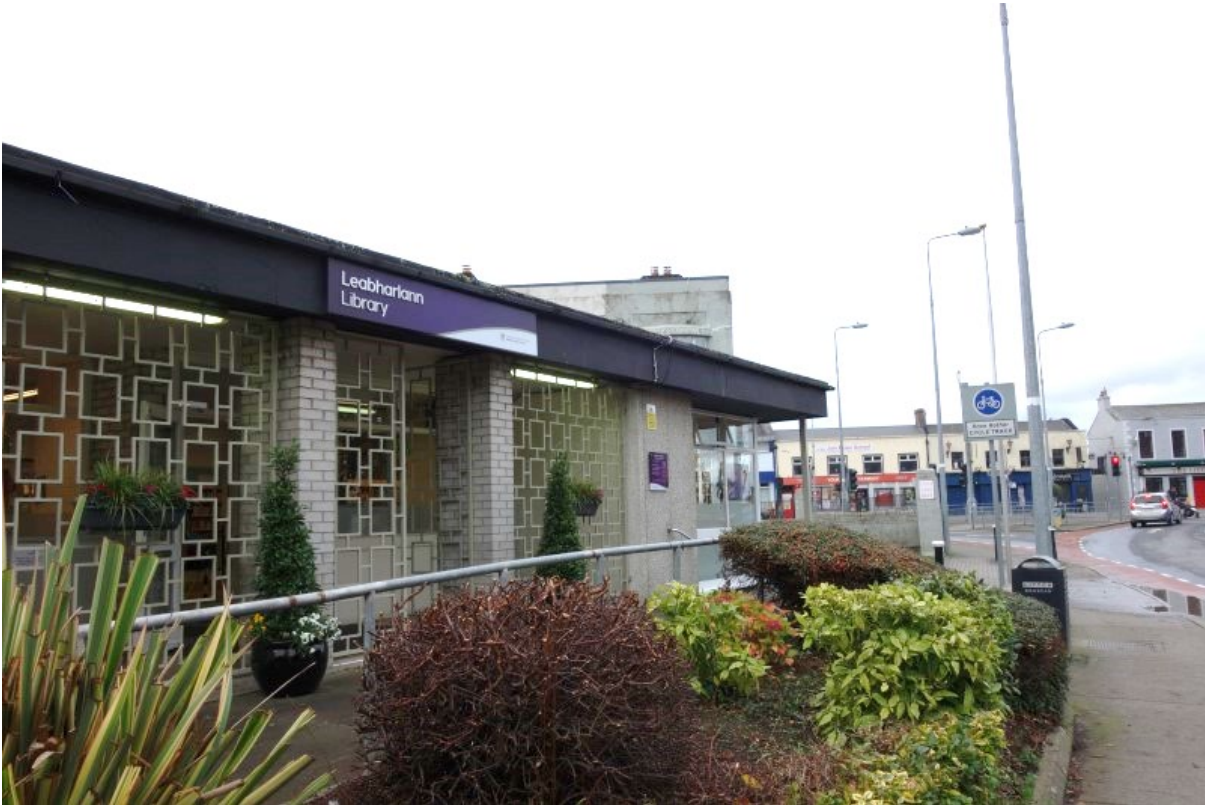
The building has a flat roof that appears to be torch-on felt (Figures 5 and 6). It has wooden soffit / fascia panels that appeared to have been painted in the previous year. No potential roost features were noted in this structure.

A high level of external lighting was noted in the surrounding area. There are multiple streetlights in close proximity to both buildings along Main Street to the north of the Site and Athgarvan Road to the east of the Site. There are also lights in the car park to the west of the modern building, and on the exterior of the Riverbank Arts Centre. One of these lights faces the western side of the original structure.

Figure 5: Front of single storey building. Note the streetlights on the right side of the image

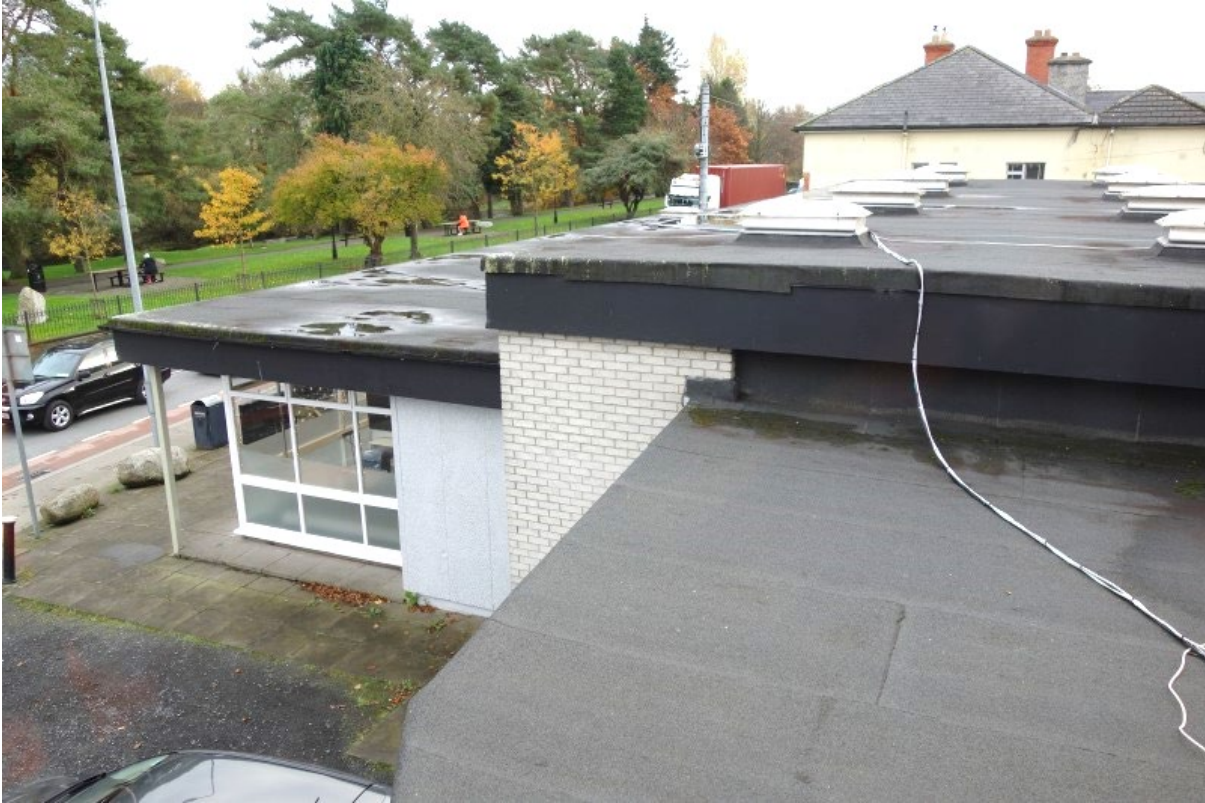
Figure 6: Flat roof of the single-storey building
