# Cassidy's Complex Monasterevin, Co. Kildare.

## Conservation Management Plan

for Kildare County Council  
March 2024

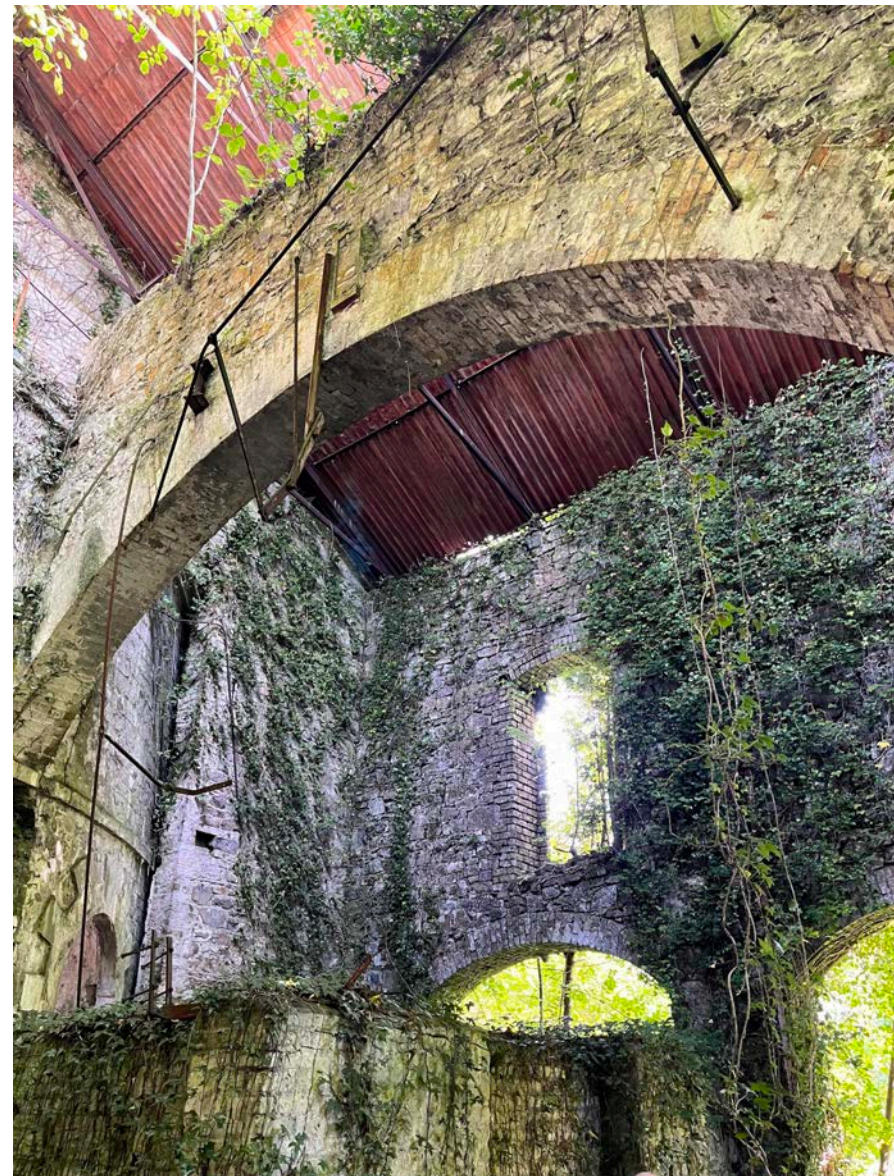
Figure 7 - Still house interior lookin East.

condition with significant cracks in the external walls and will require temporary stabilization prior to clearing out. Where the north end of the still house engages with the circular masonry of the mash house there is a significant gap in the original construction, with no attempt to create any bonding. As a result, there is a major crack in the masonry of the still house. There are also cracks in the mash house at this junction where one of the flying buttresses of the still house, bears onto the masonry of the mash house.

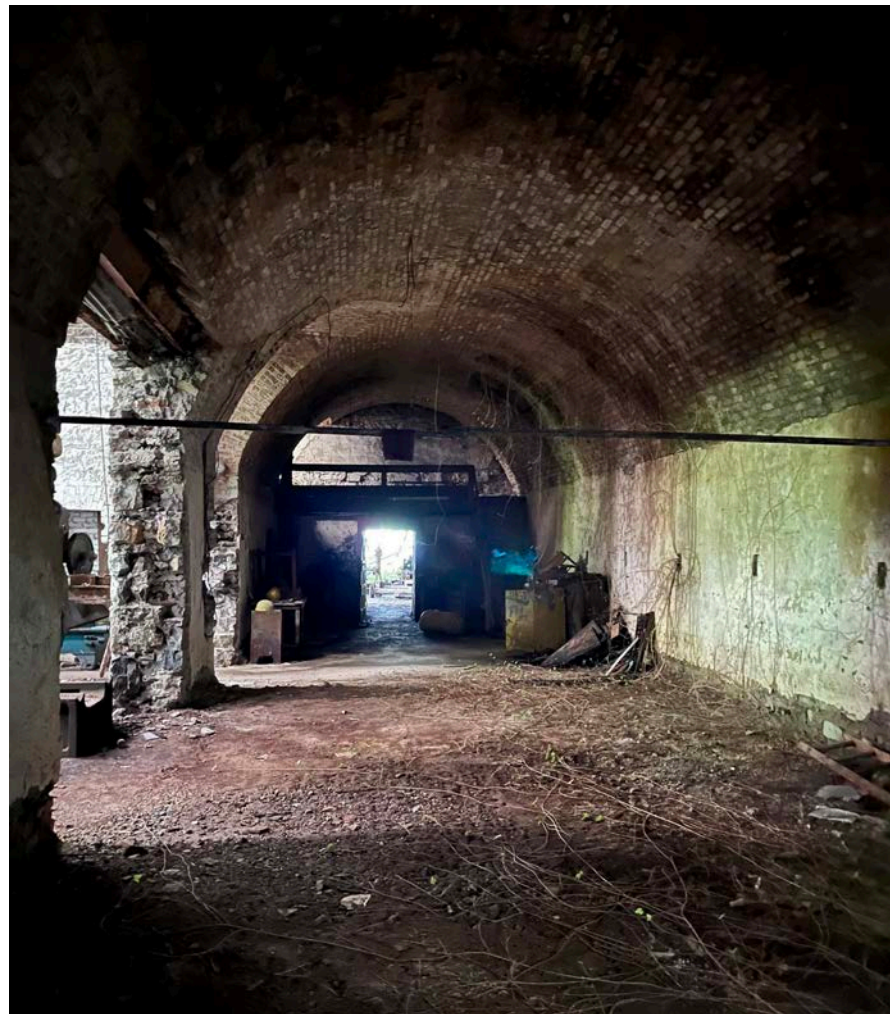
Figure 28 - Bonded warehouse looking east with removed lower floor.

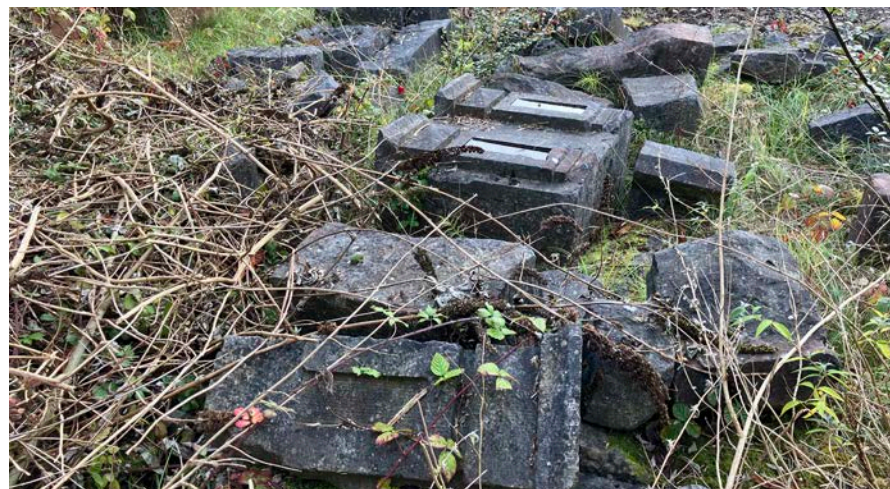
Figure 31 - Entrance gateway salvaged masonry.

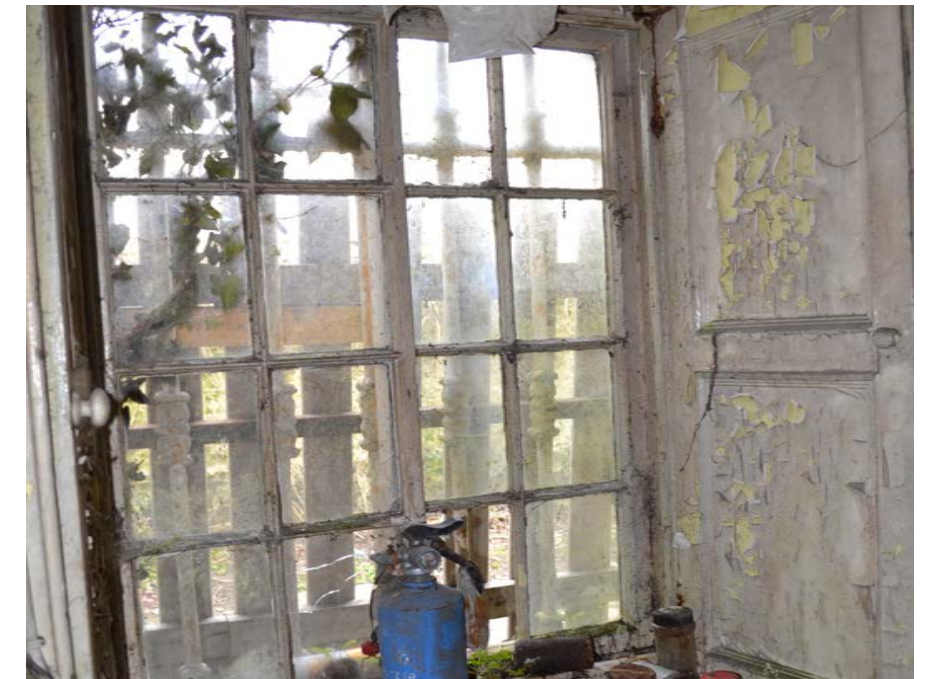
Figure 34 - Offices detail of original Yorkshire sash window

Constructed in rubble stone the external walls retain much of their original soft lime coatings, which have survived remarkably well. Almost all of the original windows survive and can and should be repaired as they are of an unusual design. They consist of small paned, horizontally sliding sashes, known as Yorkshire Sashes, which are rarely found in Ireland. Internally the building is semi-derelict, however, some original office furniture and cupboards, including one with cast iron panel doors, survive. There is also, what appears to be asbestos lagging on the early central heating distribution pipes, which should be removed as a matter of urgency for health and safety reasons. Trees and shrubs had invaded the yards to the rear and have since extended into the now roofless portions of the building. These have been partially removed to prevent further damage, however, further clearance will be necessary. Probably dating from the mid nineteenth century, this important building should be fully restored and could serve a number of future uses.

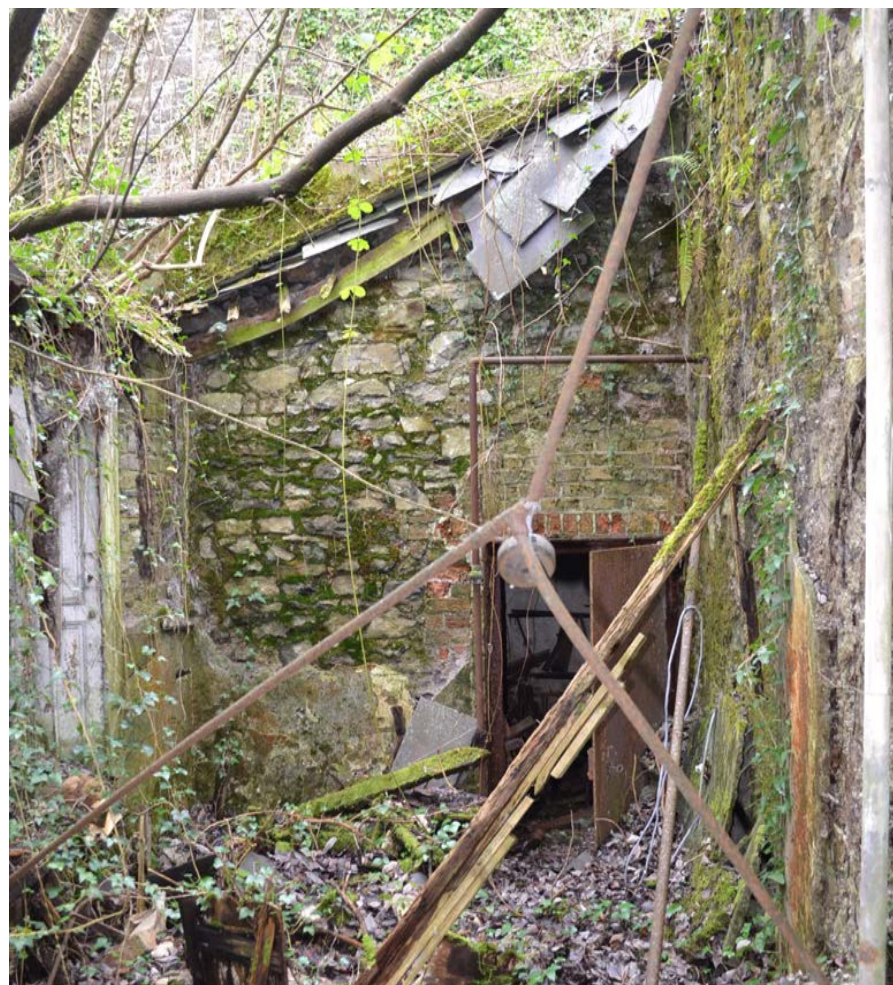
Figure 35 - Offices - roofless rear extension.

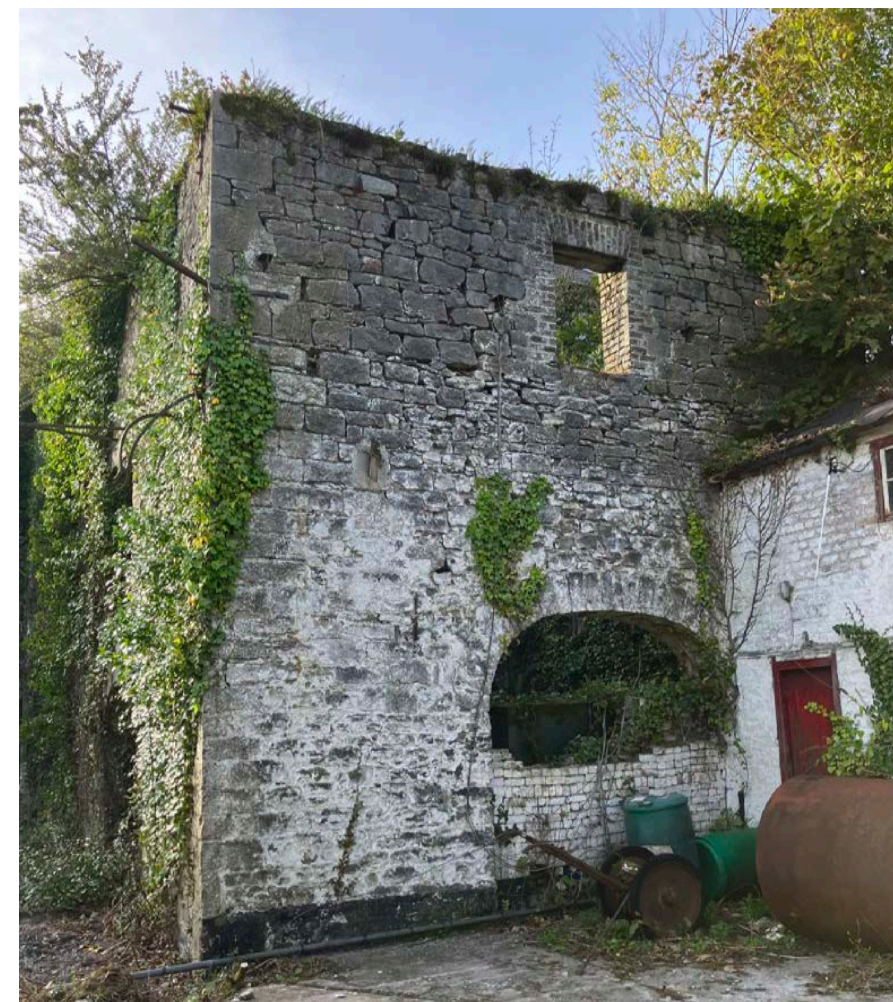
This former engine house, which on plan measures 7m x 16m, is in a very poor state of repair, with the roof now missing. The slender, square chimney was originally the highest chimney in the complex, however, only the lower section of this elegant structure survives, and this too is also in a poor condition. Invaded by trees and shrubs the structure is currently hard to interpret, but is highly attractive and constructed of rubble limestone, with wide, arched openings on the ground floor. One of these, on the south side, has an opening directly above, formed with a flat stone lintols, that was most likely a first-floor loading bay. However, despite the poor structural condition and invasive vegetation, it is likely that the chimney and external walls could be repaired and the structure given a new roof to allow it to serve another useful purpose.

Figure 37 - Former engine house connection with near of offices building.

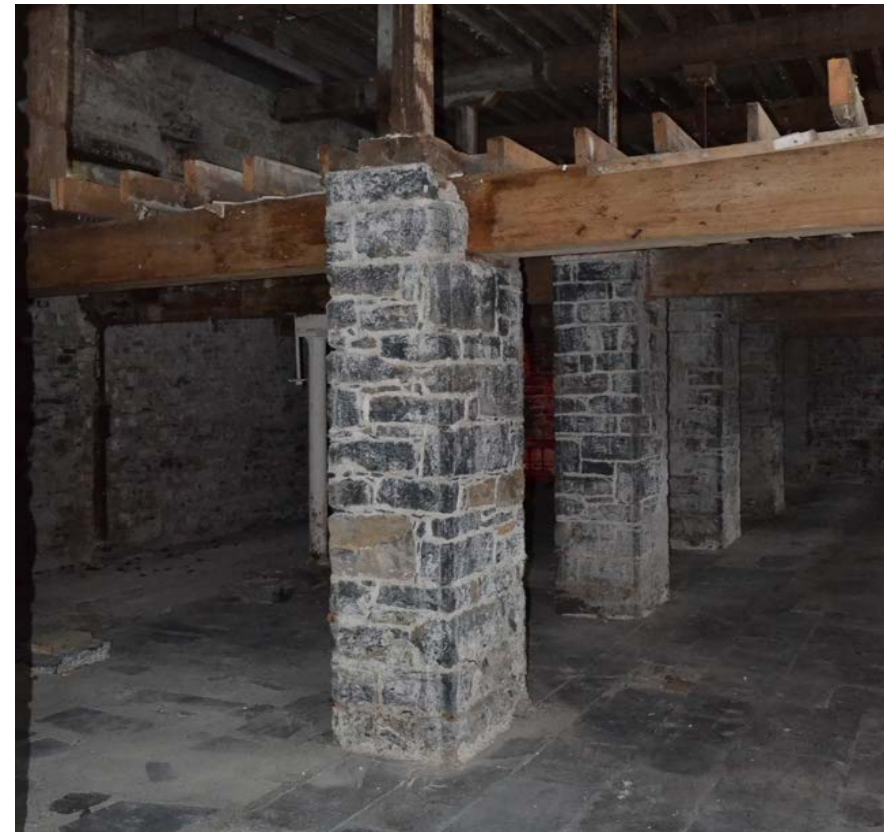
Figure 39 - Mill/grainstore ground floor structure & stone flagged floor.

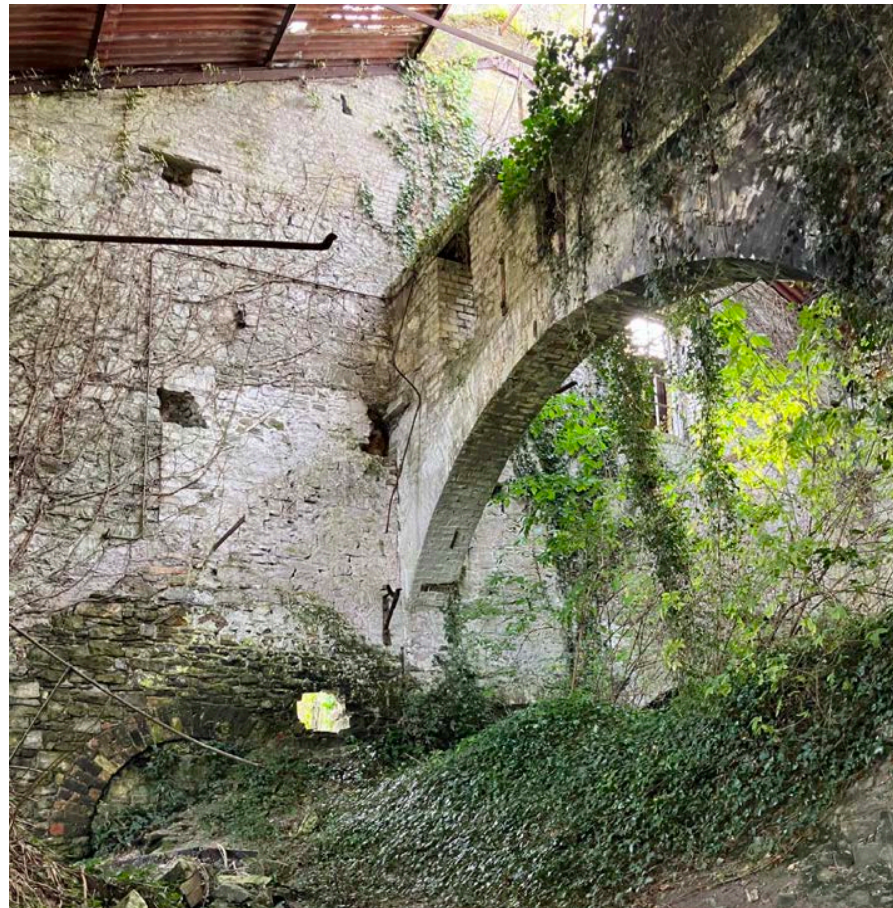
Figure 52 - Still house interior detail of flying butress.

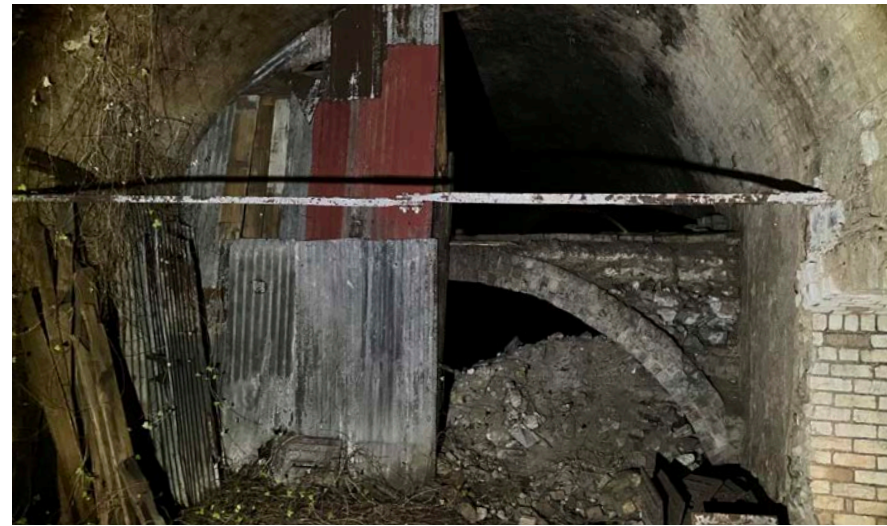
Figure 56 - Bonded warehouse interior showing ground and first floor vaults.

that is now contained within the workshop there are two cut stone door surrounds leading into the structure. One of these is at ground level, the second, now altered, was originally at first floor level, which confirms that the structure originally had a first floor level, part of which was later removed. Unfortunately, another larger opening has been formed, somewhat crudely with a series of steel beams inserted, which are now rusting. Steel ties have also been inserted across the vault to counteract the instability caused by this insertion into the vaulted masonry. Given the robust masonry construction of this tripartite vaulted construction, the superstructure appears to be reasonably sound, with the exception of the opening formed within the workshop. However, the exposed crowns of the first-floor vaults will have become saturated due to their exposure to the elements, which has led to a small plantation of self-seeded trees and shrubs.

All vegetation should be removed as a matter of urgency and the vaults protected with a limecrete slab to prevent any serious damage occurring to this singular structure. The western end of the structure is currently filled with water, the cause of which is not clear and may be caused by either a high water table or a build-up of rainwater. Some of the ground floor vaults are filled with soil and others with accumulated rubbish. All should be cleared out as soon as possible to allow for a closer inspection of the interior of the vaults. A hoist or long ladder would also allow access for a similar close inspection of the first and second floor levels. This bonded warehouse is one of the most interesting, and architecturally sophisticated structures in the former Cassidy's Complex. It is hard to imagine a future use for it, other than for the purpose originally intended, to store barrels of whiskey in a cool, environmentally stable and secure place.

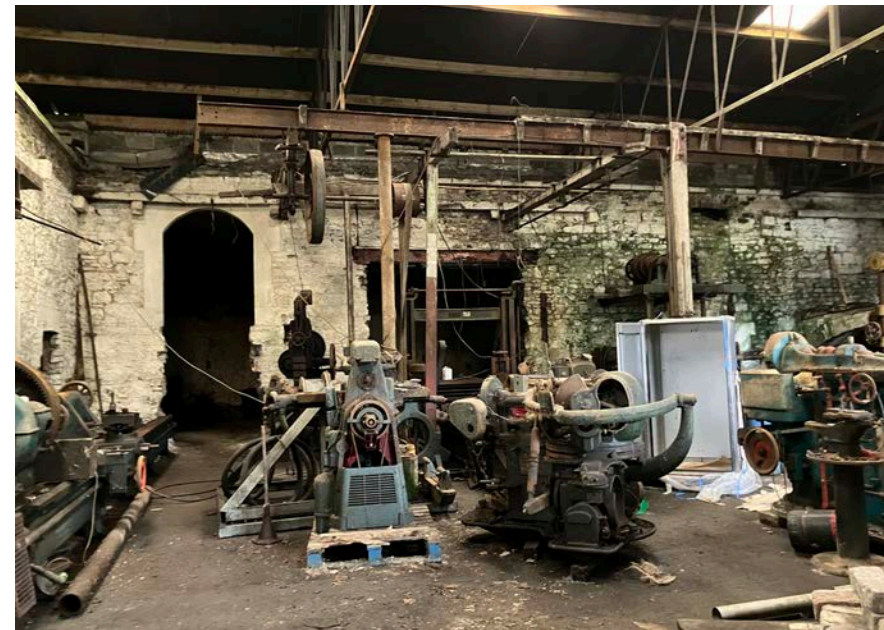
both historically and technically, it should certainly be restored. While the current roof is keeping most of the water out it will need to be replaced and the existing shallow trusses strengthened or replaced with a more substantial roof structure. There is a lot of old machinery and other debris, now stored within this structure and a clearer picture will no doubt emerge for the future use of this space after these have been removed.

Figure 60 - Workshop looking towards bonded warehouse.

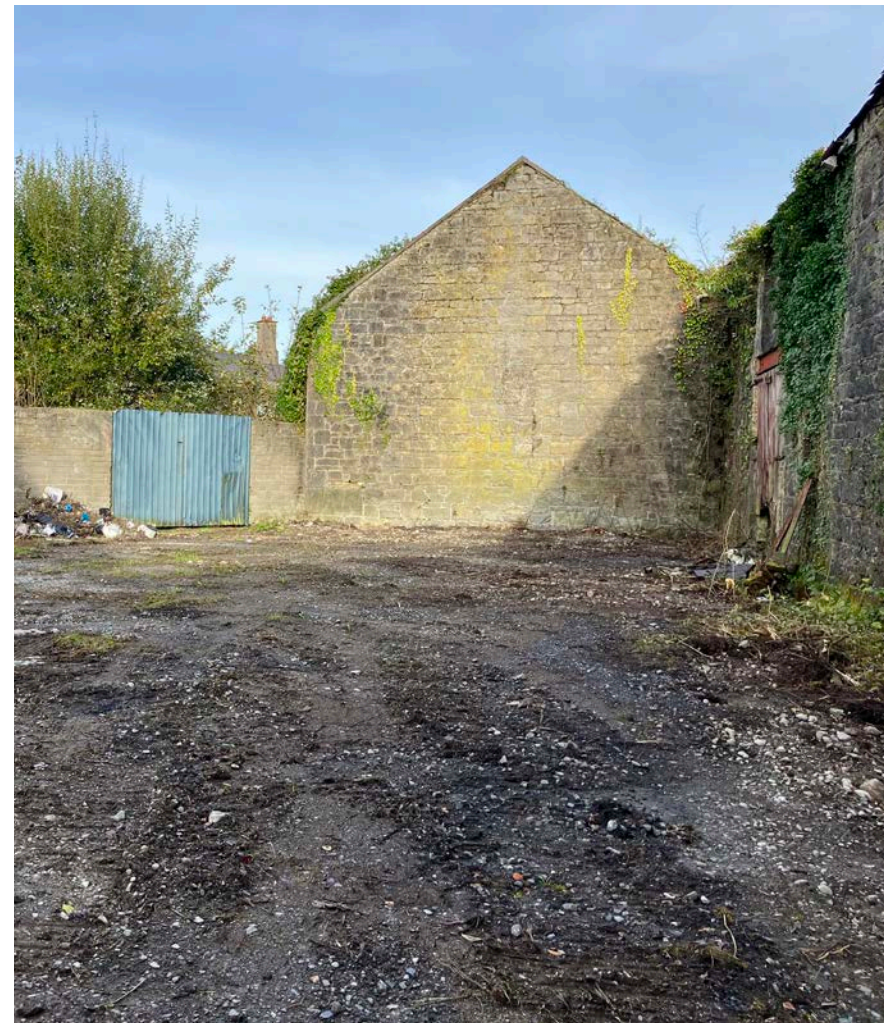
This rectangular, two-storey building measures 9m x 20m but with a splayed eastern gable, the reason for which is unclear. It was used to store steel components and known as the 'steel store' when the complex was used as an engineering works. Constructed of roughly squared rubble limestone, the structure presents blank gables at eastern and western ends. The roof has now collapsed into the walls, which appear to be in a reasonable state of repair. On the NIAH website photographs from 2002 show boarded doors at both levels, the upper level probably being a loading bay, together with small upper windows, which may be ventilators for the storage of grain. Most likely constructed as a workshop or a store, the exact purpose will probably only be revealed with closer inspection as to date, the building has only been viewed from the western end. From the NIAH entry it would appear that the building continued eastwards beyond the cranked gable, however, this portion of the site has either collapsed or been demolished.

Figure 64 - View of the splayed eastern gable of the store/ workshop.

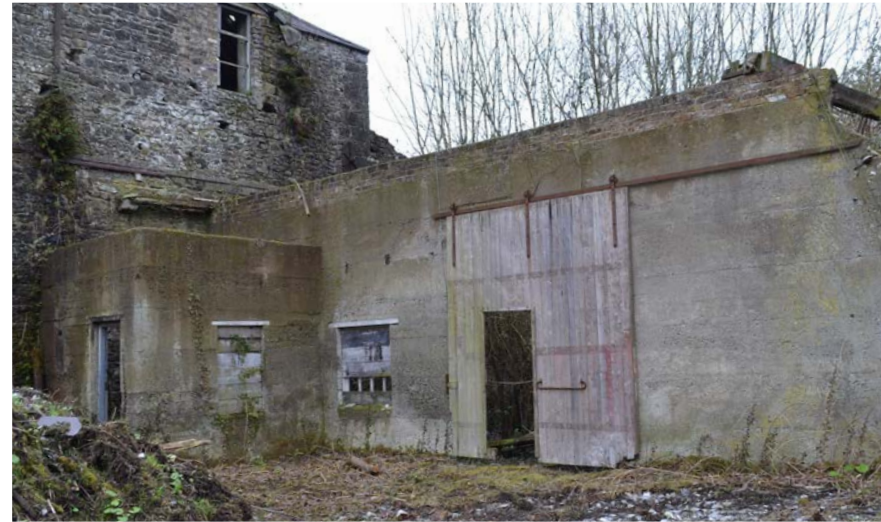
This ruined and now roofless, single-storey structure, measuring 10.5m x 11.5m stands against the rubble stone boundary wall of Brennan's public house. Constructed in mass concrete, the structure has a large sliding door opening together with a standard single door opening on the south side, from which a small concrete wing extends. On the east-facing façade there is a large timber window, now badly damaged and another wide, vehicular opening. This building was known as the 'joinery shop' and originally extended much further to the south in the form of an open canopy, and probably dates from the early decades of the twentieth century. What survives today is of little architectural, or technical merit and the now, largely demolished structure detracts from the older buildings to which it is connected. However, photographs from 2002 contained in the National Inventory of Architectural Heritage, show the building in a derelict state, but still intact, which present quite a different story. When complete the building extended to four wide bays, with a deep plan, covered by a shallow barrel-vaulted roof finished in corrugated iron.

Figure 69 - Carpenter's shop remaining concrete walls.

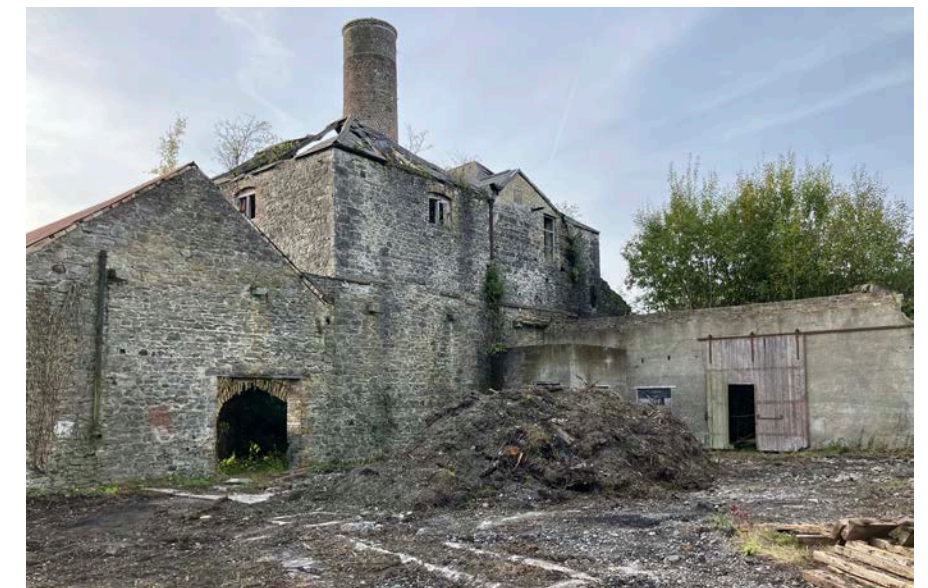
Figure 70 - Carpenters shop site behind engine house.

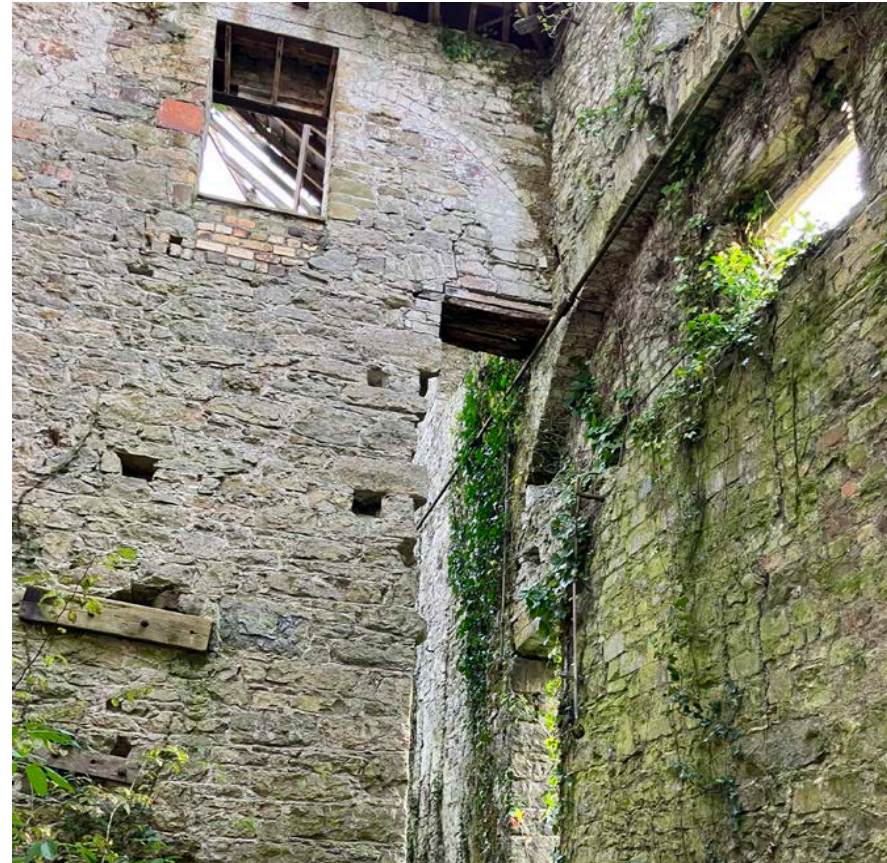
Figure 72 - Kiln/engine house interior view of chimney.

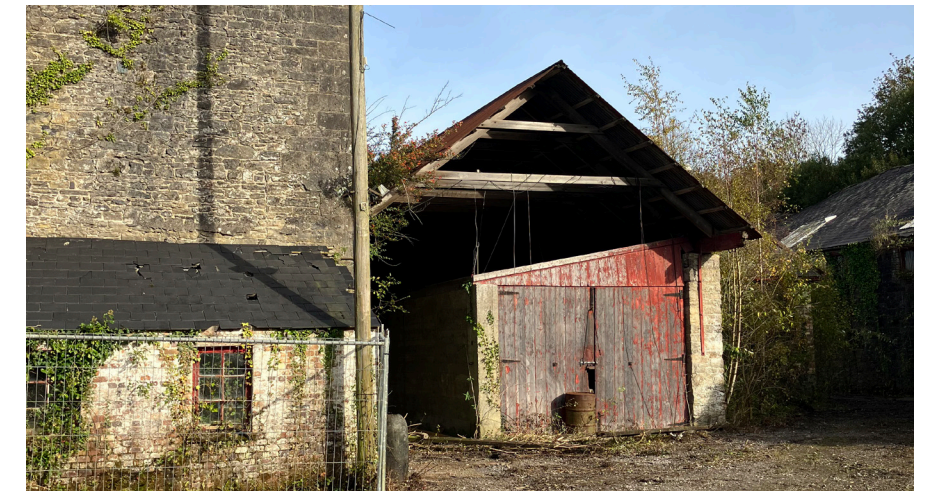
Constructed up against the south façade of the former engine house, and measuring approximately 14m x 9m, is a large single-storey shed. This open structure consists of a rubble stone east gable and a solid south wall of similar construction. The west end is open under a pitched corrugated iron roof, supported on coupled timber rafters. Originally a simple open structure, a mass concrete wall has been constructed running west to east approximately 2m from the south wall of the engine house. This wall links to an opening in the east gable creating a passage through the building, while the adjoining space has been enclosed with a lower roof spanning from the concrete wall to the south façade. The result is a rather strange building within a building, secured by timber doors at the west end. There is no architectural merit, nor interesting historic fabric within this later intervention, and we recommend it be removed and the structure opened up to reflect the original arrangement.

Figure 74 - Shed west end, showing pitched corrugated iron roof.

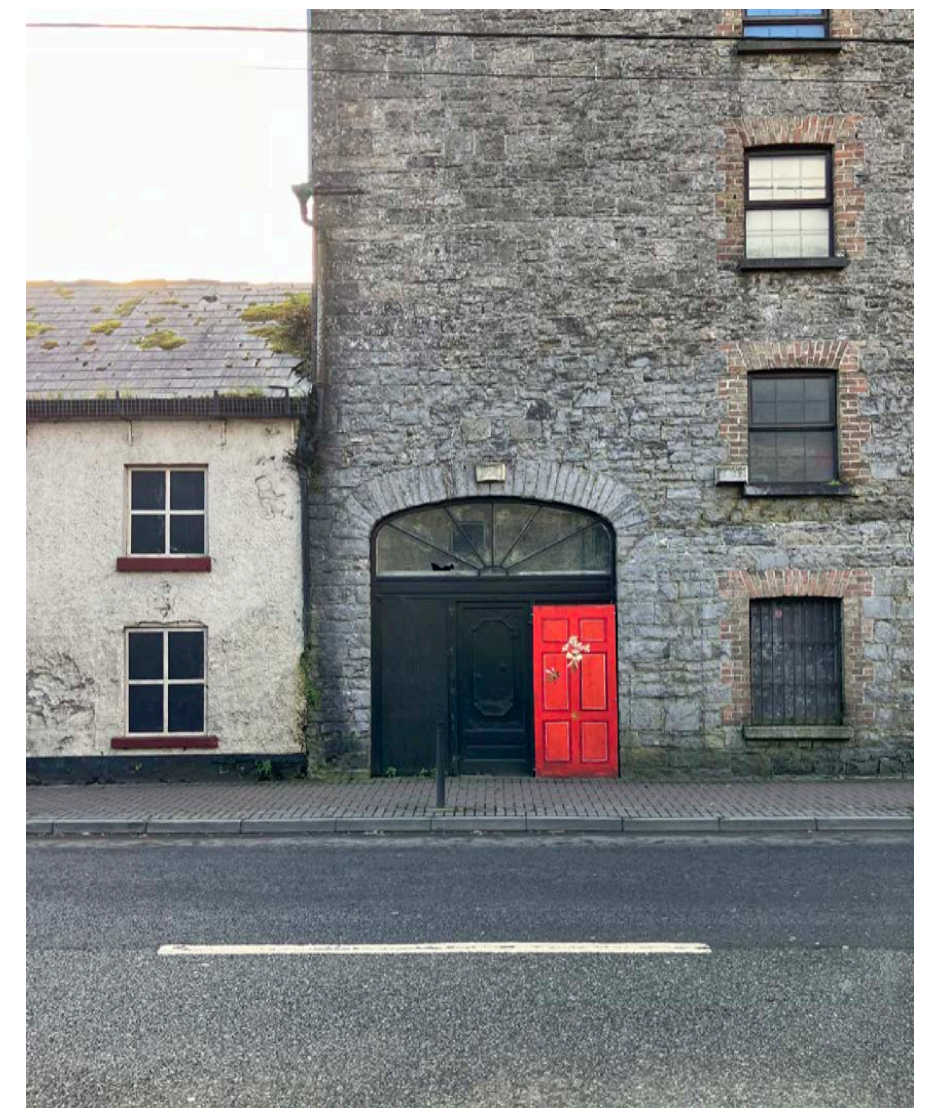
Figure 93 - Mill & grain store - infilled carriage arch.

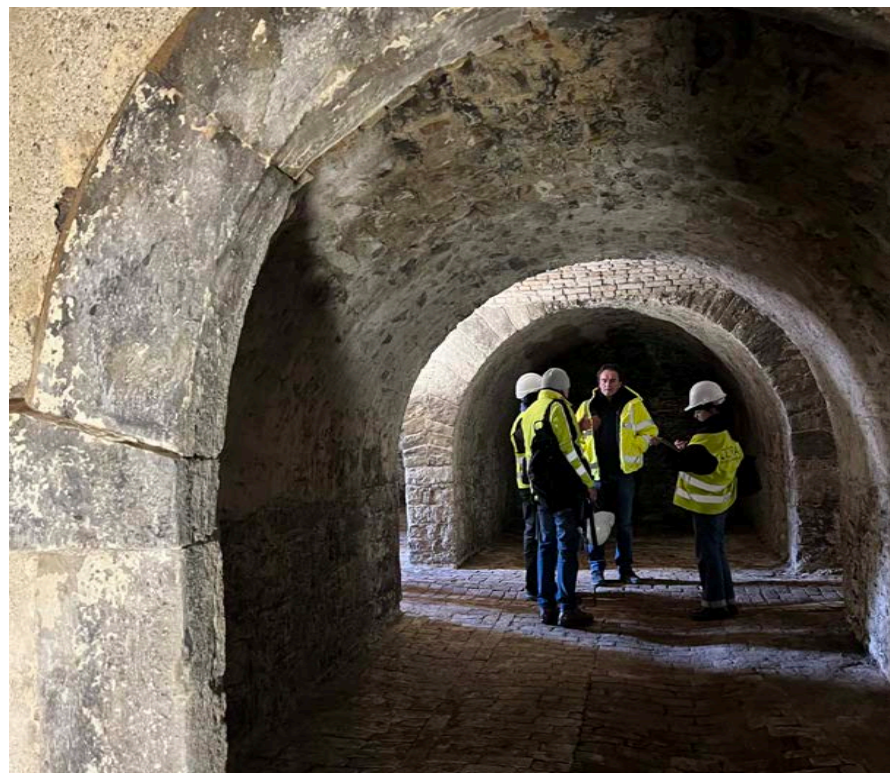
Figure 94 - Mill & grain store - infilled carriage arch.

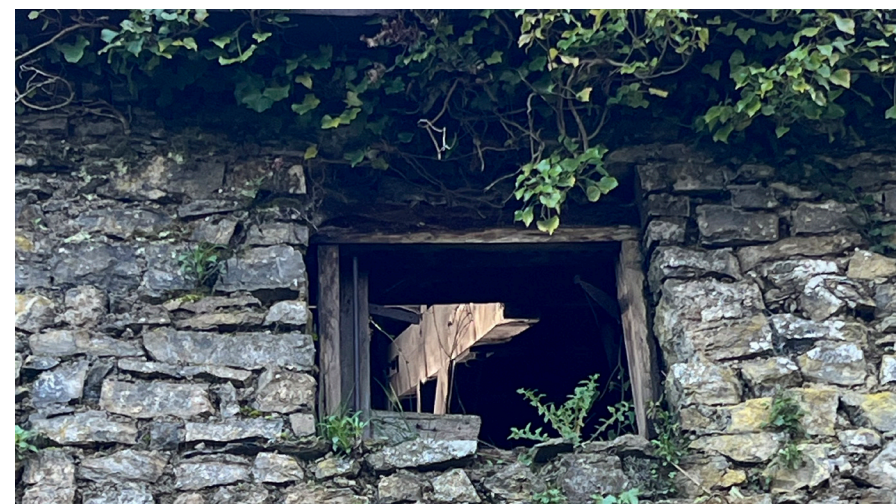
Figure 99 - Malt house eaves detail.

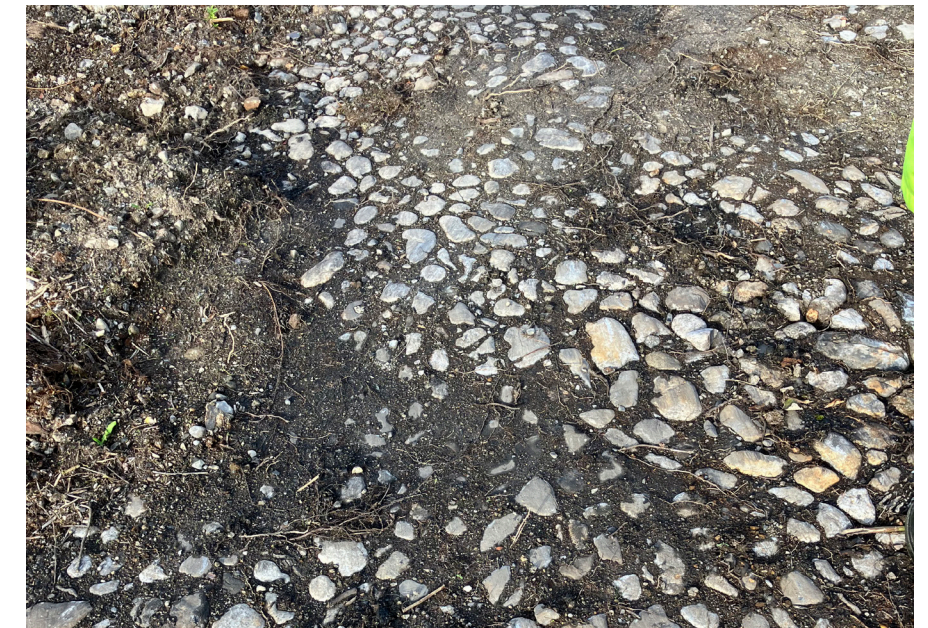
Figure 103 - Distillery yard detail of original cobbled paving.

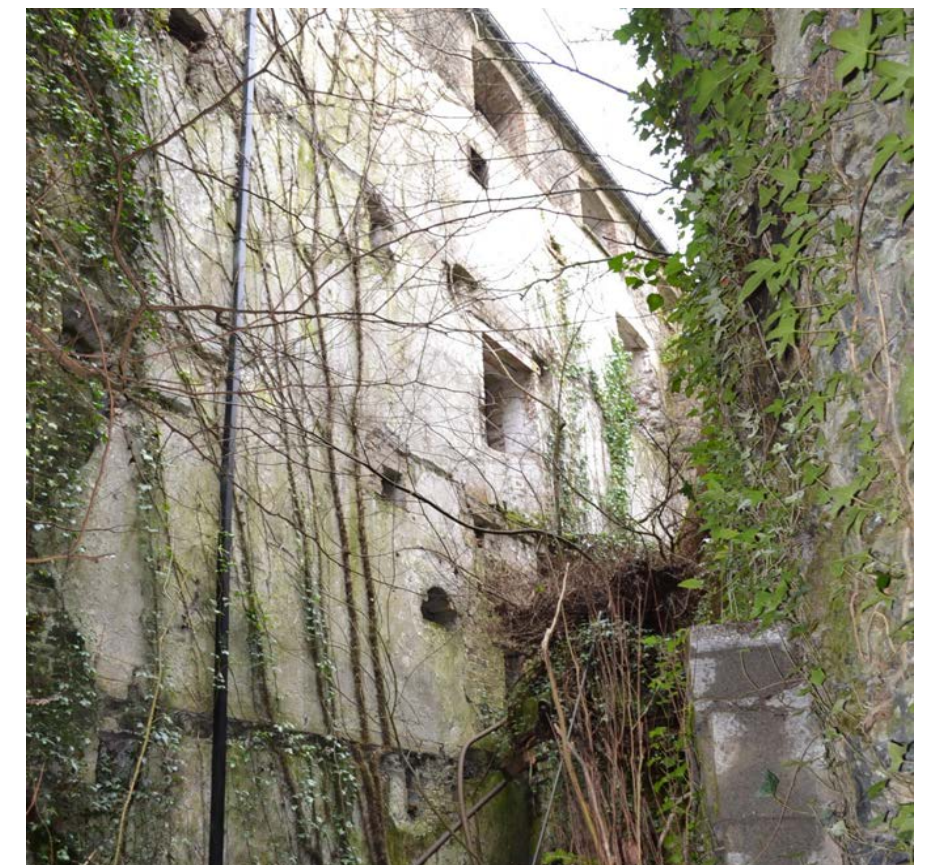
Figure 114 - Mill & grain store detail of south facade.

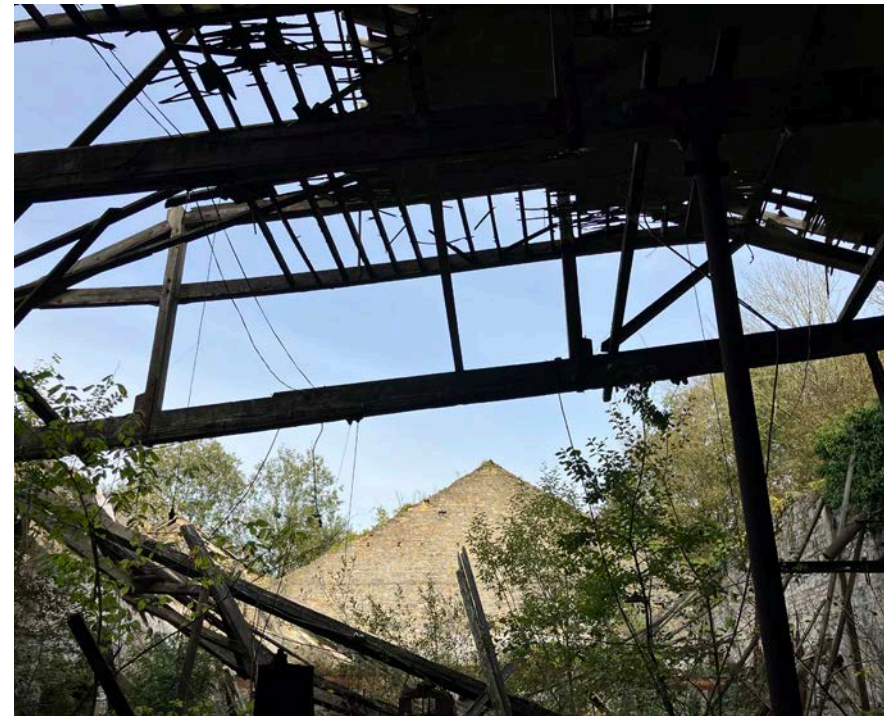
Figure 116 - Long shop - collapsed roof at east end.

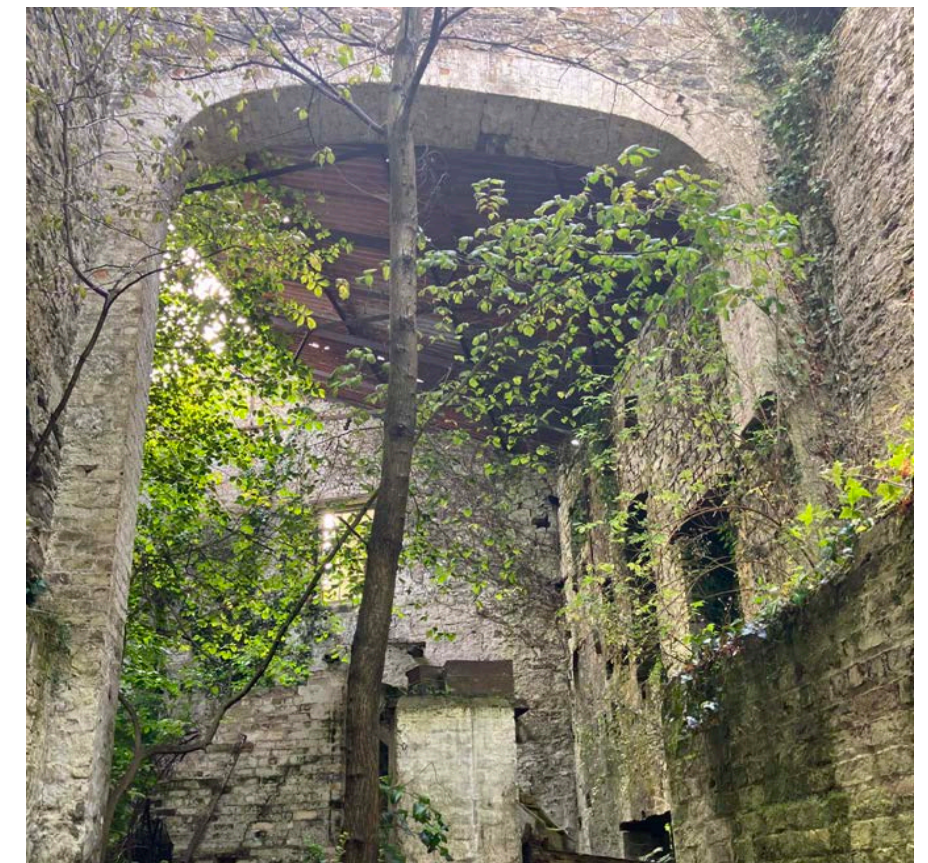
Figure 117 - Still house interior looking south.

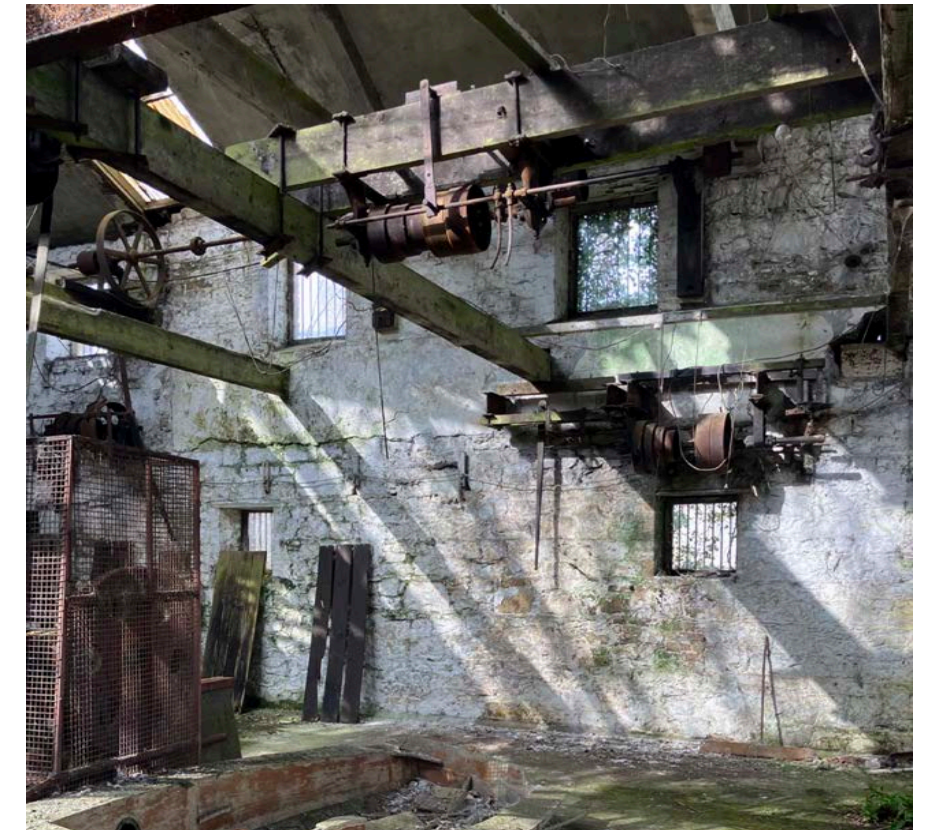
Figure 122 - Long shop - south facing opening.

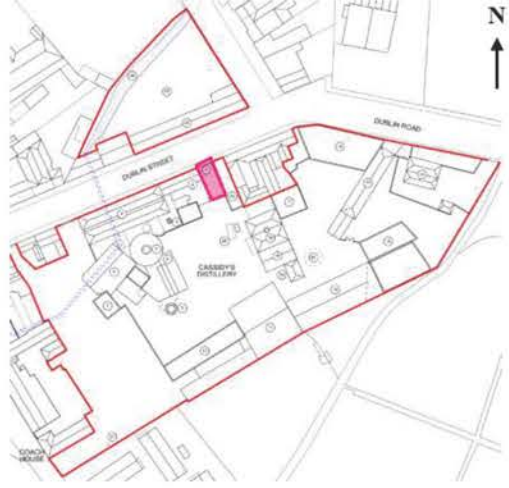
<p><b>Building No.1 Gateway</b></p>

<p>The stone entrance arch has been removed. There is some evidence of the arch on the corner of building 2. There is missing stone at eaves and ground level where the piers from the arch may have tied into the building.</p> <p><b>Proposed Repairs:</b> Repair the missing stone at the corner of building number 2.</p> <p><b>Rebuilding:</b> Long term it is proposed to reconstruct the arch after at least phase II works are completed to allow for access into the site.</p>

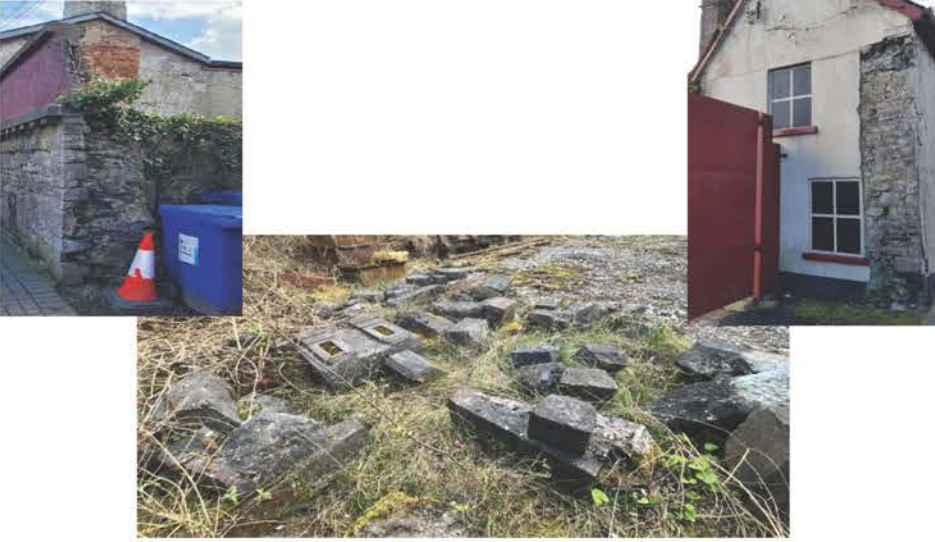
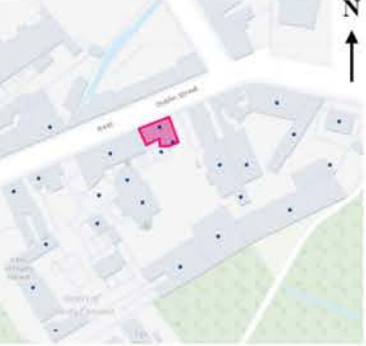
<p><b>Building No. 2 Office</b></p> <p>Pair of semi-detached three-bay two-storey houses. The building has been reroofed previously and retains its original fenestration. Roughcast chimney stack over red brick construction.</p>

<p><b>NIAH Reg. No.</b> 11816035</p> <p><b>NIAH Rating</b> Regional.</p> <p><b>NIAH Category of special interest</b> Architectural, Historical, Social.</p>	<p>The rear and chimney of the office is in poor condition.</p> <p>The internal part of this building is not accessed because of potential of loose Asbestos There is cracking in the rear side of the chimney. The timber lintels are in poor condition with decay in several locations.</p> <p><b>Proposed Repairs:</b> Repair the cracks in the chimney. Replace the timber lintels that are in poor condition. Reinstate the lintel and relieving arch over door on the south side.</p>

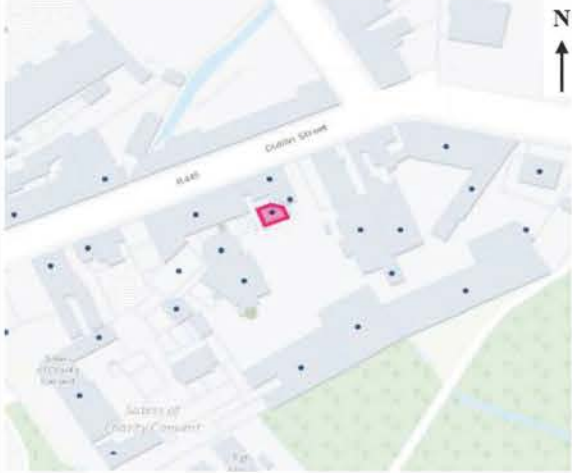
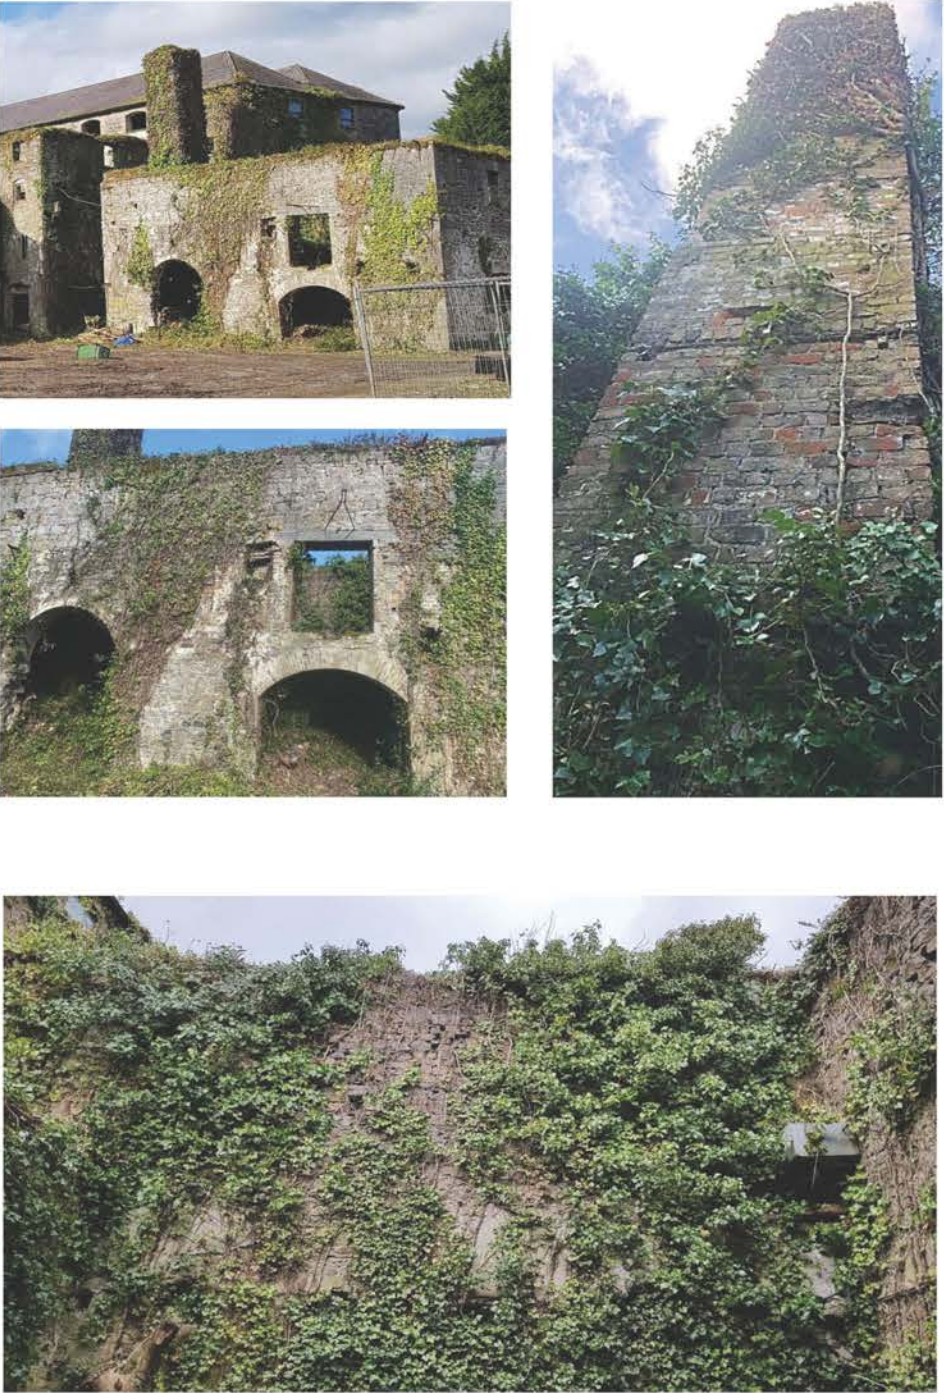
<p><b>Building No.3 Engine House</b></p> <p>Attached two-bay three-storey random rubble masonry building, constructed in 1830.</p> <p>The square internal chimney constructed from yellow brick tapers from the base to the top.</p> <p>There are a number of round and elliptical headed arches over the carriageways at ground floor level.</p> <p>The kiln is approximately 7m x 16m on plan.</p>

<p><b>NIAH Reg. No.</b> 11816067</p> <p><b>NIAH Rating</b> Regional.</p> <p><b>NIAH Category of special interest</b> Architectural, Historical, Social, Technical.</p>	<p>The Engine House is in poor condition and roofless.</p> <p><b>Roof:</b> The building is roofless.</p> <p><b>East Elevation:</b> There is significant amount of mortar missing from the first floor section of this wall and some of the smaller stones have likely fallen. Vegetation is growing from the wall tops.</p> <p><b>South Elevation:</b> There is missing stone work to the right hand side of the first arch. Corroding metal in arch. One of steel members has cracks raditating out from it and a section of the brick arch may come loose in time. The stone lintel over opening above arch right hand side arch is cracked. There is a slight bulge in the middle section of the south wall. The lower section of left hand side of arch is missing some stonework.</p> <p><b>West Elevation:</b> There are decaying embedded timber sections in the west wall. The masonry walls about the brick chimney on either side. There are damaged and missing bricks in the chimney. Vegetation covers more than half wall + tree roots growing along base.</p> <p><b>North Elevation:</b> Opening building 2 &amp; 3 in poor condition, timber lintel + arch missing. The arch over the eastern opening is in poor condition.</p> <p><b>Internal Walls:</b> The internal brick arch is missing brick on the lower left hand side. There is extensive vegetation covering the internal walls. There is missing bricks, stone and mortar.</p> <p><b>Proposed Repairs:</b> Install temporary props to support the ground floor right hand side arch. Removal of the vegetation from all the walls and excavation out the build up at ground floor level. Install temporary props to support the first floor right hand side opening. Repair the wall tops. Repair any loose masonry.</p>
