# Cassidy's Complex Monasterevin, Co. Kildare.

## Conservation Management Plan

for Kildare County Council  
March 2024

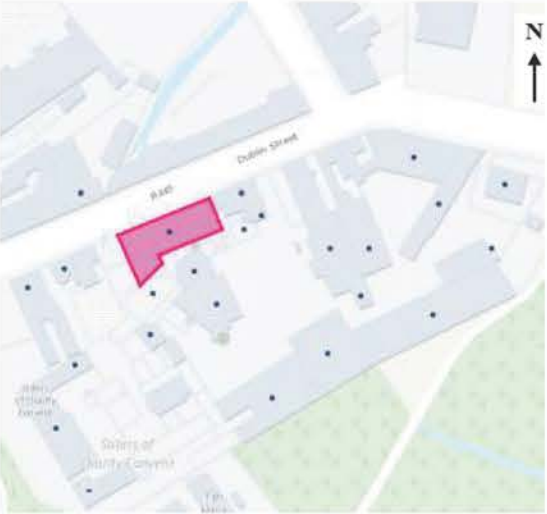
<p><b>Building No. 4 Mill and Grain House</b></p> <p>8-bay plus carriage entrance 5-storey warehouse with a footprint of approximately 420 sq metres Two-bay three-storey return to rear to south-east. Rubble stone walled with brick surrounds to openings Masonry arched Coach entrance and front door Flat brick arches to windows Masonry piers &amp; cast iron columns internal supports Timber beams and joisted floors and remains of stairs Double A frame timber roof detail not seen</p>

<p><b>NIAH Reg. No.</b> 11816066</p> <p><b>NIAH Rating</b> Regional.</p> <p><b>NIAH Category of special interest</b> Architectural, Historical, Social, Technical.</p>	<p><b>Drying out process well underway.</b> <b>Building dry and ready for structural repairs</b> Recently bought along with Back house and associated yard All debris and rotten sections removed. Drying out has been promoted Roof weathered but yet to be repaired</p> <p>Storey heights are low Sections of timber floors missing but many of the beams and joists intact</p> <p>Brick + stone masonry piers @ ground level, CI columns disconnected Historic water ingress through roof valley along line of masonry piers</p> <p>Mill race culvert passes through building at location of front door, 6th bay Wheel pit existent in base of return building</p> <p>Brick missing or damaged in some of arches over the window openings. Subsidence of front pier to left of front door + cross wall internally Likely as a result of undermining associated with head race culvert</p> <p><b>Proposed Repairs:</b></p> <p><b>Main Building</b> Drying out process should be continued. Full roof repair in traditional materials and to original details required Further assessment of in built timbers required This will allow programme of structural repairs to be established Monitoring of front pier and cross wall should be established</p> <p><b>Mill race and wheel pit</b> Full assessment of this subterranean structure required This may need to be carried out during dry spell and water diverted Condition of culvert may determine solution for front pier / cross wall</p>

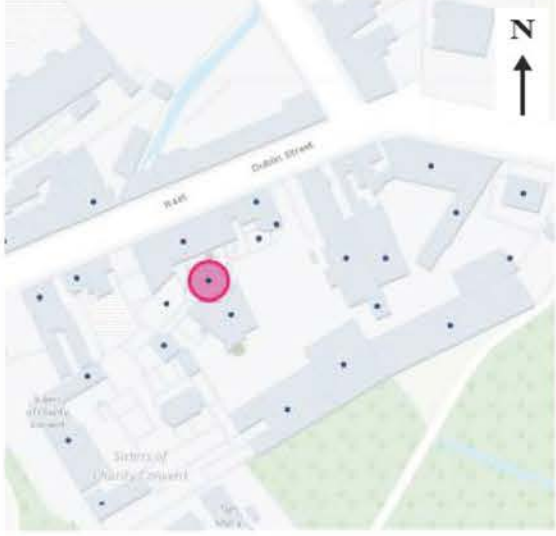
<p><b>NIAH Reg. No.</b> 11816033</p> <p><b>NIAH Rating</b> National</p> <p><b>NIAH Category of special interest</b> Architectural, Historical, Social, Technical.</p>	<p><b>Walls and dome roof are in fair condition.</b> The timber roof lantern has since fallen away.</p> <p>The underside of the brick domed roof with an oculus is in good condition. There are some embedded steel at high level to support a timber roof that covered the oculus.</p> <p>There are a number of tree roots that had been recently cut before the site visit that were growing from the roof.</p> <p>There is some decaying timber built into the wall in various locations.</p> <p>There is some corroded steel work embedded into the wall.</p> <p>One of the opening has been previous infilled with blockwork. This blockwork is leaning out.</p> <p>The brick arch over the block infill is missing some of its bricks.</p> <p>There is missing stone to the bottom right hand side of the entrance door on the East elevation.</p> <p>There is missing stone over the top of the entrance door.</p> <p><b>Proposed Repairs:</b></p> <p>Removal of all vegetation growing from the roof and walls Repairs to the brick walls and roof masonry Replacment slate over roof and parapet gutter linings New roof lantern to prevent water ingress. Repair to the internal brick arches. Excavation of the ground floor debris to establish origianl floor details</p>

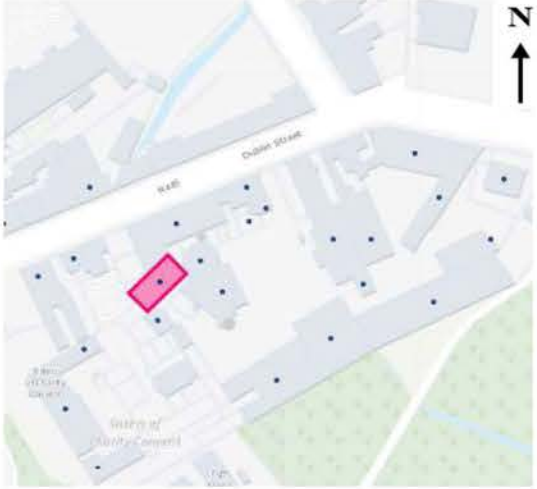
<p><b>NIAH Reg. No.</b> 11816040.</p> <p><b>NIAH Rating</b> Regional</p> <p><b>NIAH Category of special interest</b> Architectural, Historical, Social, Technical.</p>	<p><b>Fair Condition but roof requires weathering</b></p> <p>Recently bought along with Mill and Grain House and associated yard All debris removed. Drying out has been promoted Trussed rafter roof 1980/90s. 600c/c. not properly weathered. Large steel beams at first floor level from 1980/90's 9.7m clear span. Channels at ground floor possibly to cool vaults under. Extensive vaulting under possibly from an earlier phase of building Tail race passes under north side of this building beside vaults.</p> <p><b>Proposed Repairs:</b></p> <p>Main Building Repairs to the roof weathering membrane. Repair to the window and door lintels. Tail race culvert Full assessment of this subterranean structure required This may need to be carried out during dry spell and water diverted Condition of culvert may determine works to north face of undercroft</p>

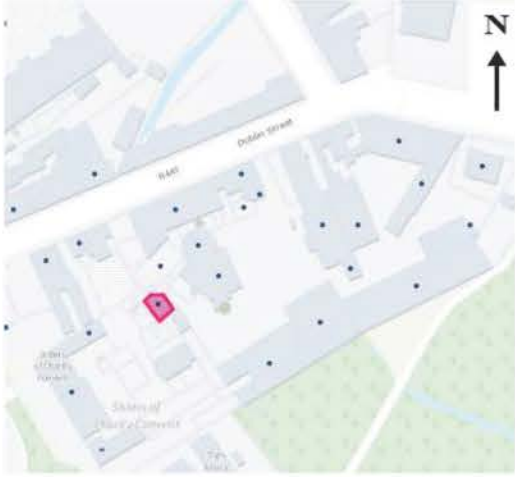
<p><b>Building No.7 Water tower</b></p> <p>Attached single-bay three-storey water tower, c.1800 on a square plan with cast-iron water tank to roof. Segmental-headed integral carriageway to right of the ground floor.</p>

<p><b>NIAH Reg. No.</b> 11816109.</p> <p><b>NIAH Rating</b> Regional.</p> <p><b>NIAH Category of special interest</b> Architectural, Historical, Social, Technical.</p>	<p><b>External facades of the water tower are in good condition.</b></p> <p><b>West Elevation:</b> There are several holes in the west elevation where timber purlins and floor beams from an adjoining building would have connected into. On the north west corner there is the remains of the wall that formed part of the adjoining building.</p> <p><b>East Elevation:</b> The timber lintel over the opening has sagged. Separation joint between the stone infill and the relieving arch over</p> <p><b>Water Tank:</b> There is some surface corrosion to the sides of the water tank when viewed from the ground. The water tank is supported on timber beams that cantilever over the east and west elevations. There is no signs of decay in the timber beams when viewed from the ground but these beams haven't been seen internally</p> <p><b>Proposed Repairs:</b> Inspect the water tank and cantilever timber beams from a hoist. Replace the timber lintel over the opening to east elevation. Control all remaining vegetation and repoint the walls</p>

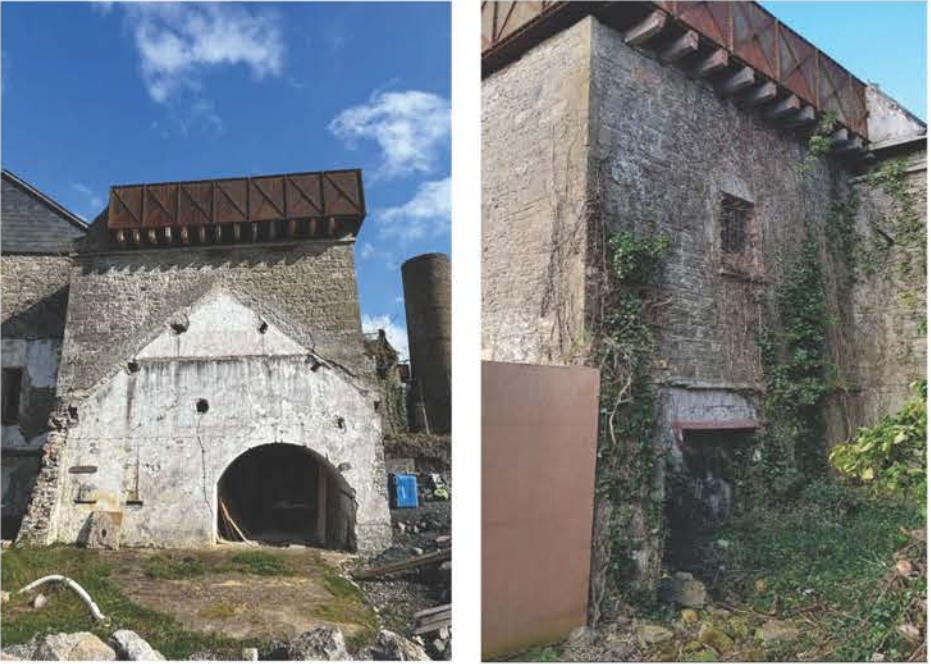
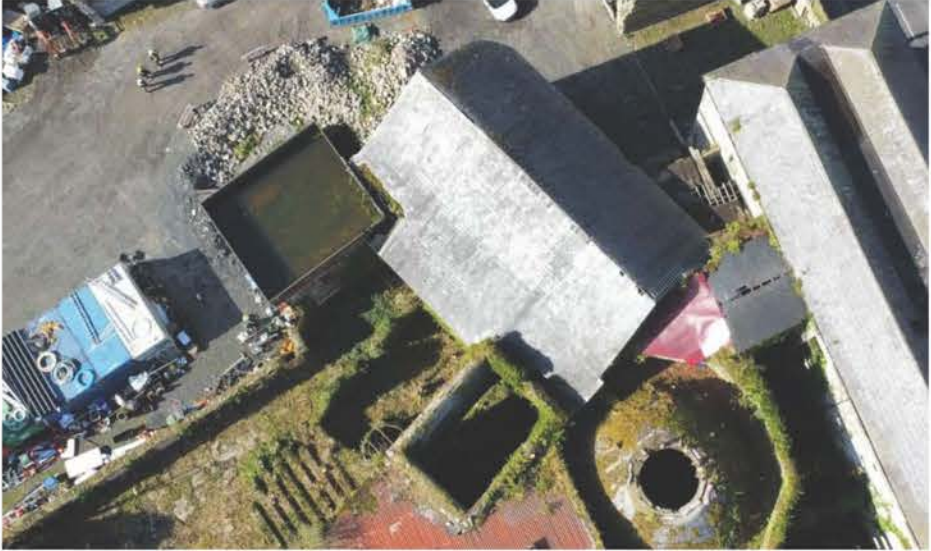
<p>Drone Photos March 2024 showing water tank from above</p>

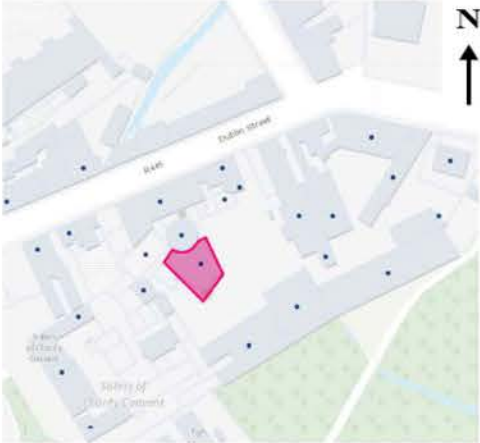
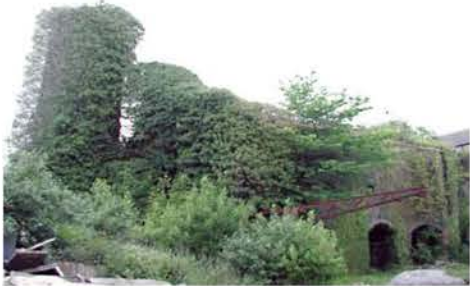
<p>Image from NIAH 2002</p> <p><b>NIAH Reg. No.</b> 11816065</p> <p><b>NIAH Rating</b> Regional.</p> <p><b>NIAH Category of special interest</b> Architectural, Historical, Social, Technical.</p>	<p><b>The Still house is roofless and in poor condition.</b></p> <p><b>Roof:</b>                      The metal sheeting is supported on metal purlins on metal trusses.                      The metal sheeting has corroded in places and is allowing water ingress.                      There is a large roof light at the ridge that has no sheeting.</p> <p><b>North Elevation:</b>                      The north wall abuts the curved walls of the mash house.                      On the right hand side of the north wall there is a diagonal crack from the top of mash house wall to the roof level.                      One of the internal brick arches is supported on the curved section of the mash house and there is missing stone work directly under the arch.                      There is missing stonework in several location.                      The arches over the window and door openings on the left hand side of north wall are in poor condition with mortar lose and poor support to the side of the arch.                      There is missing stonework at eaves level and movement in the stone.</p> <p><b>West Elevation:</b>                      There are several areas of missing stone in this elevation.                      There are a number of steel members embedded into the wall.                      However there is no sign of jacking from corroding metal                      The brick arches over the window openings are in poor condition with no support in some locations.                      The timber lintels have decayed and have left voids under the arches.                      There is vegetation growing from the wall tops.</p> <p><b>South Elevation:</b>                      Vertical crack at the corner between the west &amp; south elevations.                      A water tank is supported off the wall at high level.                      The timber lintels over the door openings are in poor condition.                      Gound floor brick arch has been altered previous and there is a vertical crack from the top of the arch.                      There are a number of pockets / missing stonework in this elevation.</p>

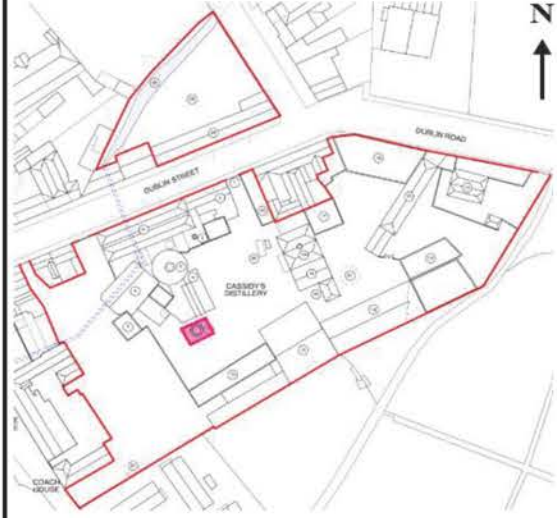
<p data-bbox="305 489 572 516">Building No. 9 Chimney</p>

<p data-bbox="305 1255 468 1318"><b>NIAH Reg. No.</b> 11816065.</p> <p data-bbox="305 1360 448 1423"><b>NIAH Rating</b> Regional.</p> <p data-bbox="305 1465 736 1528"><b>NIAH Category of special interest</b> Architectural, Historical, Social, Technical.</p>	<p data-bbox="872 489 1228 516">The chimney is in fair condition.</p> <p data-bbox="872 558 1611 821">The chimney stack is constructed from yellow brick with a number of metal straps around the chimney at various heights. Over the entrance door on the south elevation there is mortar washout and a vertical crack. On the west elevation that is a second vertical crack from ground level to approximately mid height. There is debris buildup internally within the chimney. Ivy growing around the lower section of the chimney.</p> <p data-bbox="872 1094 1463 1283"><b>Proposed Repairs:</b> Remove the vegetation and repoint were required. Stitch across the vertical cracks in the chimney. Inspect and consolidate the top of the chimney if required. Remove the debris from the inside the chimney Inspect the internal faces.</p>

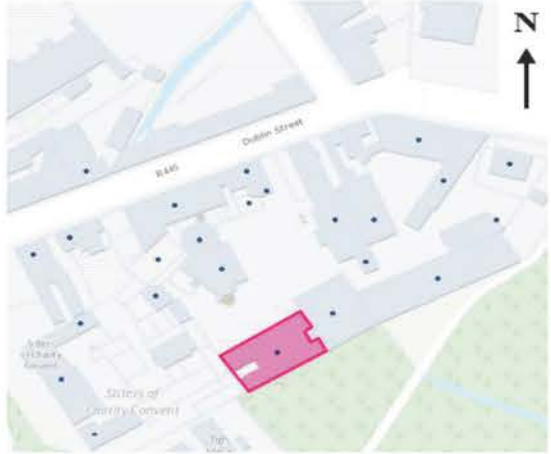
<p>N ↑</p> <p>NIAH Reg. No. 11816037</p> <p>NIAH Rating Regional.</p> <p>NIAH Category of special interest Architectural, Historical, Social, Technical.</p>	<p><b>Roofless and in fair condition.</b> Only part of this building was accessed during the inspection. Building is split into 3 sections, north, middle and south sections.</p> <p><b>Section 1 Northern section:</b> This section is constructed with a stone facade with a brick vault at ground and first floor level. The second floor had a timber roof over that has since collapsed. Ground floor brick vault is in good condition with some water penetration. There is standing water in the south part of this building. The 1st flr brick vault was not accessible on the day of inspection it is assumed that there is ongoing water penetration. There is a crack in the brick vault over eastern entrance door. The timber lintels on the north elevation have decayed, There is some vegetation growth on the north elevation and the wall top. There are steel members embedded into the north elevation. There is no evidence that this steel members have caused jacking of the stone work. Some of the stone work is loose along the north elevation.</p> <p><b>Section 2 Middle section:</b> The middle section is not accessible on the day of the inspection.</p> <p><b>Section 3 Southern Section:</b> This section of the building is constructed with a stone facade with a brick vault at ground and first floor levels The second floor had a timber roof over that has since collapsed. The entrance to the ground floor vault of blocked with debris. No access to the first floor vault on the day of the inspection.</p> <p><b>Proposed Repairs:</b> Reinstate the roof or temporary weather first floor vault Repair the cracks in the vaults. Remove the standing water and debris from the vaults. Remove the vegetation and the walls and over the first floor vault. Repair the lintels and wall tops.</p>

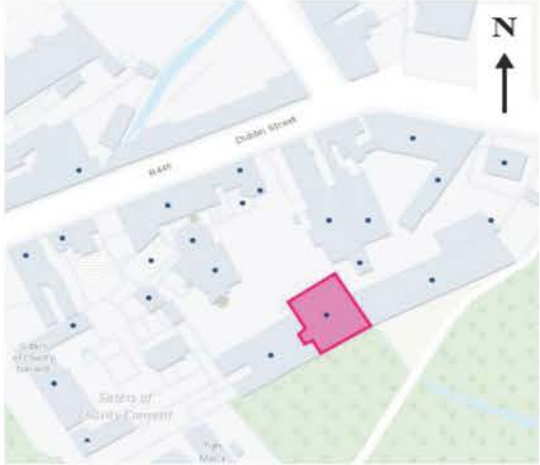
<p><b>NIAH Reg. No.</b> 11816038.</p> <p><b>NIAH Rating</b> Regional.</p> <p><b>NIAH Category of special interest</b> Architectural, Historical, Social, Technical.</p>	<p><b>The heavy shop is on fair condition.</b></p> <p><b>Roof:</b> Metal roof sheeting supported on timber purlins on steel trusses. The timber purlins have a slight sag to them.</p> <p><b>North Wall:</b> There is mortar wash out at the location of the rainwater outlet. There is cast concrete along the top of the north wall. Timber lintel over door has decayed on right side of north wall. Arches missing brick and cracked in places</p> <p><b>West Wall:</b> Wall only visible internally with a number of steels embedded into wall. Holes / openings at junction between stone wall and metal sheeting.</p> <p><b>South Wall:</b> Lower section of wall only visible internally, forms part of brick vault The visible section of the brick wall was in good condition.</p> <p><b>East wall:</b> The stonework at the top corner of the east and north walls has moved. The timber lintel over the window opening has sagged.</p> <p><b>Internal brick arch to the south side:</b> Good condition with some water penetrating through the brick arch. A number of openings formed in northern wall to access main space Some of these openings have no supporting lintels. Steel lintels over some of the openings in arches has started to corrode. Metal tie rods at the springing point of the arch, one snapped</p> <p><b>Internal Wall:</b> Crack to internal wall supporting first floor. The opening in this wall is missing its timber lintel.</p> <p><b>1st Floor (not accessed for safety reasons):</b> The timber joists that support the first floor have rotten in places. Section of floor between access stairs and main floor area is missing.</p> <p><b>Proposed Repairs:</b> Replace the timber purlins that have sagged. Repair the brick arch in the north wall. Replace the timber lintels over the openings. Repoint and repair the stone works at the rainwater outlets. Infill the openings between the wall top and the roof. Repair the internal arches and install lintels to support the brick over. Replace the corroded steel lintels supporting the arch. Replace the rotten timber floor joists supporting the first floor.</p>

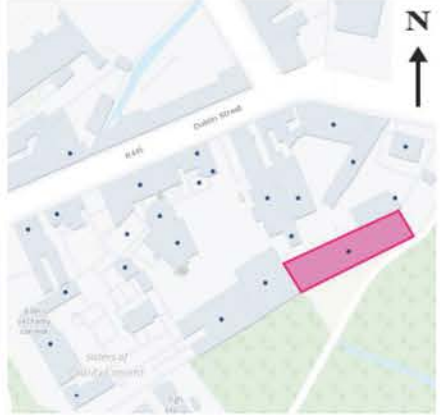
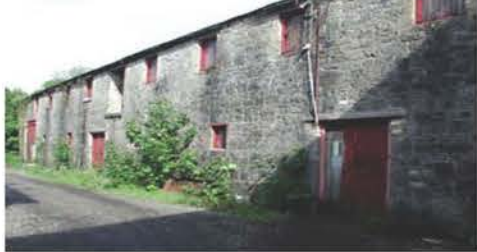
<p>Image from NIAH</p> <p><b>NIAH Reg. No.</b> 11816039.</p> <p><b>NIAH Rating</b> Regional.</p> <p><b>NIAH Category of special interest</b> Architectural, Historical, Social, Technical.</p>	<p><b>Partial roof collapse.</b></p> <p><b>Roof:</b> Queen post trusses with a lath and plaster ceiling. Queen post trusses to the eastern side of the building have collapsed. One truss has decayed and is pulling part of north wall with it. Ends of one queen post truss has decayed on western side of building. The roof has collapsed on the eastern side of the building. There are a number of holes in the roof throughout the building.</p> <p><b>North elevation:</b> Timber lintels over high level windows are in poor condition in places. A section of the wall has been pulled out from the queen post truss. The wall top where the roof has collapsed is in poor condition with several of the arches missing over the windows. There are a number of machinery steel supports embedded into walls</p> <p><b>West Elevation:</b> Crack in the lintel over the door opening between building 11 and 12. There is a pattress plate installed beside this door opening. There are a number of machinery steel supports embedded into walls</p> <p><b>South Elevation:</b> The wall top on the collapsed roof section is in poor condition. There are a number of machinery steel supports embedded into walls. There are a number of infills of original windows and doors that are in poor condition and becoming detached.</p> <p><b>East Elevation:</b> There is a vertical crack at the corner between the east &amp; south walls. The gable wall tops are exposed and in poor condition.</p> <p><b>Proposed Repairs:</b> Remove the vegetation . Weather the roof to prevent water ingress. Repair the damaged queen post trusses. Stabilise the wall tops where the roof has collapsed. Repair / replace the decayed timber lintels. Stitch across the cracks in the wall. Stabilise the previous infills.</p>

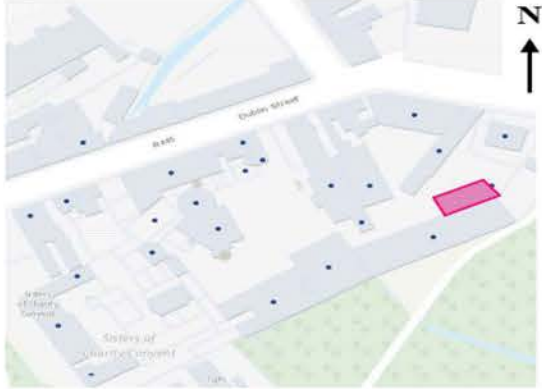
<p><b>Building No. 13 Store / Workshop</b></p> <p>Attached eight-bay two-storey rubble stone warehouse. Four-bay section to north-east now collapsed South west section roofless</p>

<p><b>NIAH Reg. No.</b> 11816063</p> <p><b>NIAH Rating</b> Regional.</p> <p><b>NIAH Category of special interest</b> Architectural, Historical, Social, Technical.</p>	<p><b>Roofless and part fallen</b> <b>This building is at serious risk of further collapse</b></p> <p>No access to this building. Four-bay section to north-east now collapsed South west section roofless and in danger of further collapse South west gable shows fine masonry work</p>

<p>Picture from NIAH 2002 - the furthest 4 bay structure is now fallen</p> <p><b>Proposed Repairs:</b> Clear out all debris Assess remaining upstanding walls Repair walls to southwest end and re-roof</p>

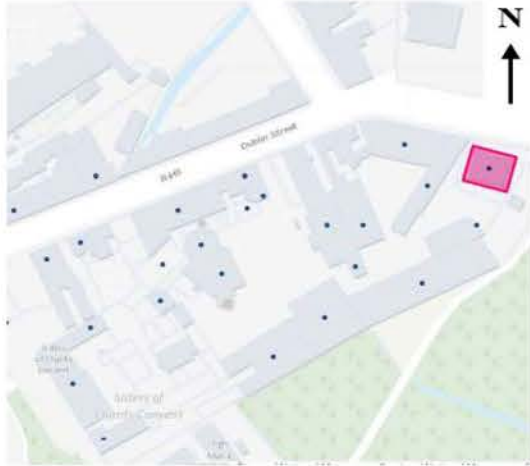
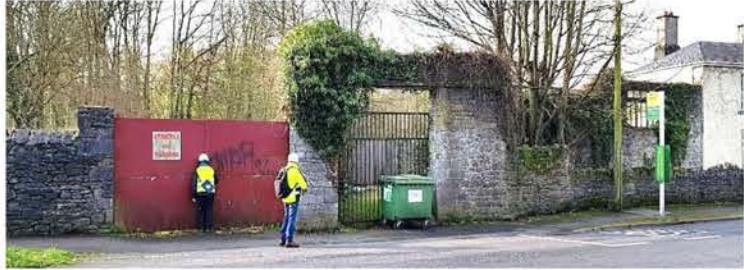
<p><b>NIAH Reg. No.</b> 11816064</p> <p><b>NIAH Rating</b> Regional.</p> <p><b>NIAH Category of special interest</b> Architectural, Historical, Social.</p>	<p><b>Assumed to be in good condition as inhabited</b></p> <p>No access to this building but understood to be inhabited</p> <p>The windows have been replaced since the 2002 NIAH listing</p> <p>Gable to east side is much covered with vegetation</p> <p>Entrance to east has potential to provide access to east part of complex</p> <p>The timber beam over the entrance however has rotted away and the brickwork over is in a precarious state</p>

<p><b>Proposed Repairs:</b></p> <p><b>Main House:</b> Control all vegetation Clear all Rubbish from rear yard Full condition survey</p> <p><b>Gable and gateway to east:</b> Repair and reinstate lintels repair wall tops</p>

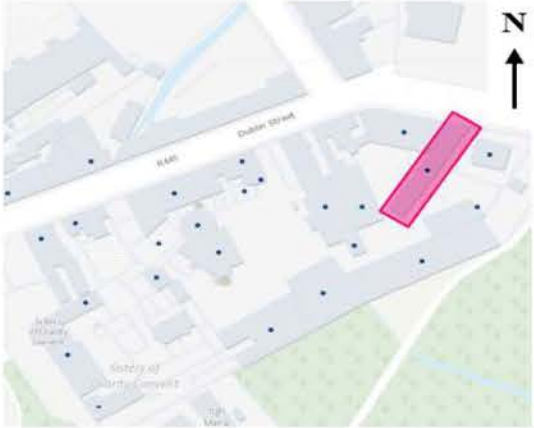
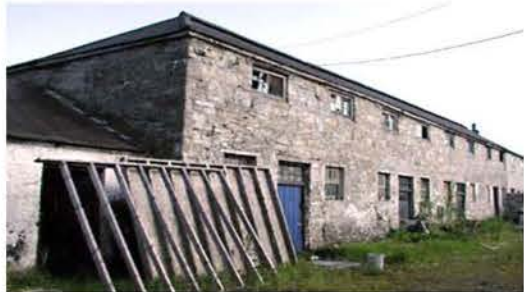
<p><b>Building No.15 Stables and Dublin Road Entrance</b></p> <p>Attached ten-bay two-storey rubble stone warehouse</p> <p>Two-bay section to north-east residential use Random rubble stone walls. 2 bay single-storey rubble stone outbuilding to sw</p>

<p>Above image from NIAH 2002</p> <p><b>NIAH Reg. No.</b> 11816062</p> <p><b>NIAH Rating</b> Regional.</p> <p><b>NIAH Category of special interest</b> Architectural, Historical, Social.</p>	<p><b>Poor condition</b></p> <p>No access to this building</p> <p><b>Roof:</b> Missing slates and exposed timbers in places. Ridge vents missing in places.</p> <p><b>North West Elevation:</b> Loose stone in places. Mortar wash out at eaves level. Timber lintel decayed at eaves level and dislodged stone over the lintel. Extensive vegetation growth along this revelation, lower part of external</p> <p><b>South West Elevation:</b> The south west elevation is leaning towards the yard with cracking visible  This movement has caused a large dislocation at roof level.</p> <p><b>South East Elevation:</b> Crack in the wall due to the movement of the south west elevation. Loose bricks at the elevations level. No access to the rest of this elevation.</p> <p><b>North East Elevation:</b> Frontage onto Dublin Road Possible future access to the site immediately to SE end of this range</p> <p><b>Proposed Repairs:</b> Install temporary props to support the first floor and roof to allow salvage Removal of the vegetation from all walls Excavation out the build up at ground floor level. Careful dismantling of first floors and roof Repair any loose masonry. New first floor and roof structures likely required</p>

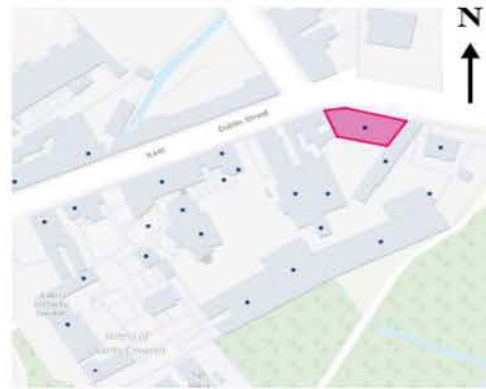
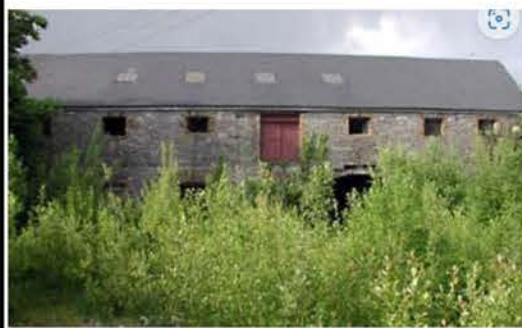
**Building No.16 Warehouse / Cooperage**

1st flr timber beams temporarily weathered with plywood and felt  
Temporary weather has deteriorated and has failed in some locations.  
Timber beams supported on ci columns timber spreader plates in walls  
A number of the timber spreader beams have decayed.  
The ends of a couple of the timber beams have started to decay.  
Timber packer between ci column & timber beams are missing in places.

North elevation supported with steel raking shores internally  
fixed to the wall with pattress plates on the street side of the wall.  
Timber window lintels in poor condition and showing signs of decay  
The window openings are braced out with timber temporary props.  
One of the timber lintel over the door has decayed.

The south elevation is supported with steel raking shores  
fixed to the wall with pattress plates on the yard side of the wall.  
Timber lintels over windows are in poor condition with several decaying.  
The windows are braced out with timber temporary props.  
One of the timber temporary props has fallen out.  
The arch over the door opening is temporarily propped with timber.  
The wall tops are exposed and are starting to unravel.

- Vegetatio control required
- Repair the lintels and arches over the windows and doors.
- Repair the wall tops.
- Repair the weathering membrane on top of the timber beams.
- Replace missing packers between the timber beam and CI columns
- Replace the timber spreader plates with durable hardwood
- Consider re-roofing whole building

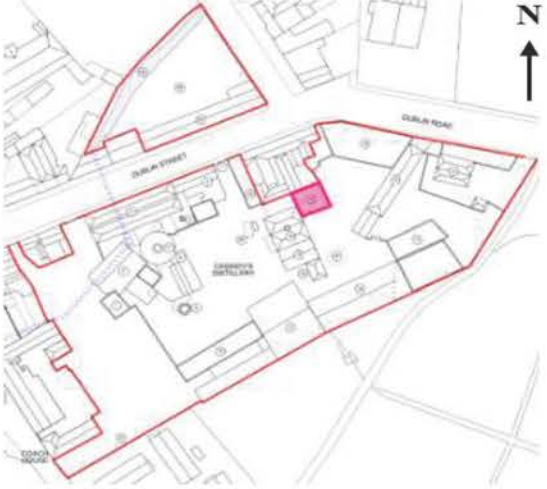
<p><b>NIAH Reg. No.</b> 11816059</p> <p><b>NIAH Rating</b> Regional.</p> <p><b>NIAH Category of special interest</b> Architectural, Historical, Social, Technical</p>	<p>The carpentry workshop is in poor condition.</p> <p>Less than half of building 17 remains. The building is constructed from mass concrete on the south and east elevations and stone on the north and west elevation.</p> <p><b>Roof:</b> The barrel roof has since collapsed. Stone corbels to western side that likely supported timber wallplate beam that the roof was supported off.</p> <p><b>North Elevation:</b> The stone capping missing in places.</p> <p><b>West Elevation:</b> Brick arch in poor condition with missing brick. There is loose stone along the top of this elevation. Mortar loss at the rainwater outlet.</p> <p><b>South Elevation:</b> The mass concrete walls are in fair condition.</p> <p><b>East Elevation:</b> There is a crack in the concrete lintel over the window openings. The concrete lintel over the window opening has sagged. The embedded timbers at the end of the concrete lintel on right hand side of the window opening has decayed. The lintel over the left hand side window missing.</p> <p><b>Proposed Repairs:</b> Remove the concrete lintel over the window opening in east elevation. Remove the timber beam over the windows on the east elevation. Repair the wall top along the northern elevation. Repair the rainwater outlets and direct the water away from the building. Repair the stone work around the rainwater outlet. Repair the brick arch in the western elevation.</p>

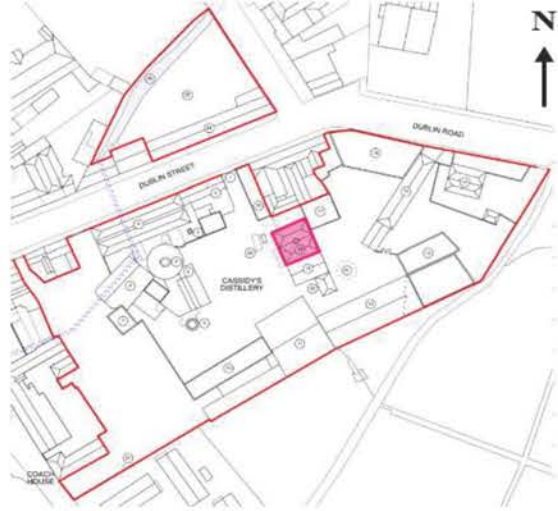
<p><b>NIAH Reg. No.</b> 11816036</p> <p><b>NIAH Rating</b> Regional.</p> <p><b>NIAH Category of special interest</b> Architectural, Historical, Social.</p>	<p>The Engine house is in poor condition.</p> <p><b>Roof:</b> Roof in very poor condition. Sections of the roof has collapsed. The remaining sections of the roof is in a precarious condition, with loose slates.</p> <p><b>North Elevation:</b> On the north elevation there is two windows at high level and two stone and brick arches are ground level. There is missing stone from the cills of both windows. One number pattress plate at high level on western side of this elevation. Loose and missing stone above the pattress plate. Vertical crack to the RHS of the western arch from ground to roof level. Diagonal crack from RHS of western arch to middle of high level window. Diagonal crack from LHS side of eastern arch to the high level window. There is a slight bulge in the north wall. Vertical crack to the right hand side of the eastern arch. Western arch, horizontal crack through the top of the arch. Eastern arch, key stone missing the bottom section. Eastern arch, brick missing from the top of the internal part of the arch.</p> <p><b>West Elevation:</b> Infill panel under the arch on the western elevation is leaning outwards. Brick missing from the top of the arch internally. Section of stone work missing in several location internally. Pattress plate at high level on the northern side of this elevation. Stone at the belfry appears to be loose. Vegetation covers half of the wall. Timber lintel over the high level window in poor condition. Brick arch over window in poor condition &amp; missing bricks from reveals.</p> <p><b>Western Elevation Lean-to:</b> No access to this section of the building. Timber rafters with slate roof. The walls are constructed from brick. The timber lintels over the windows in poor condition. Steel lintel over the door has surface corrosion.</p>

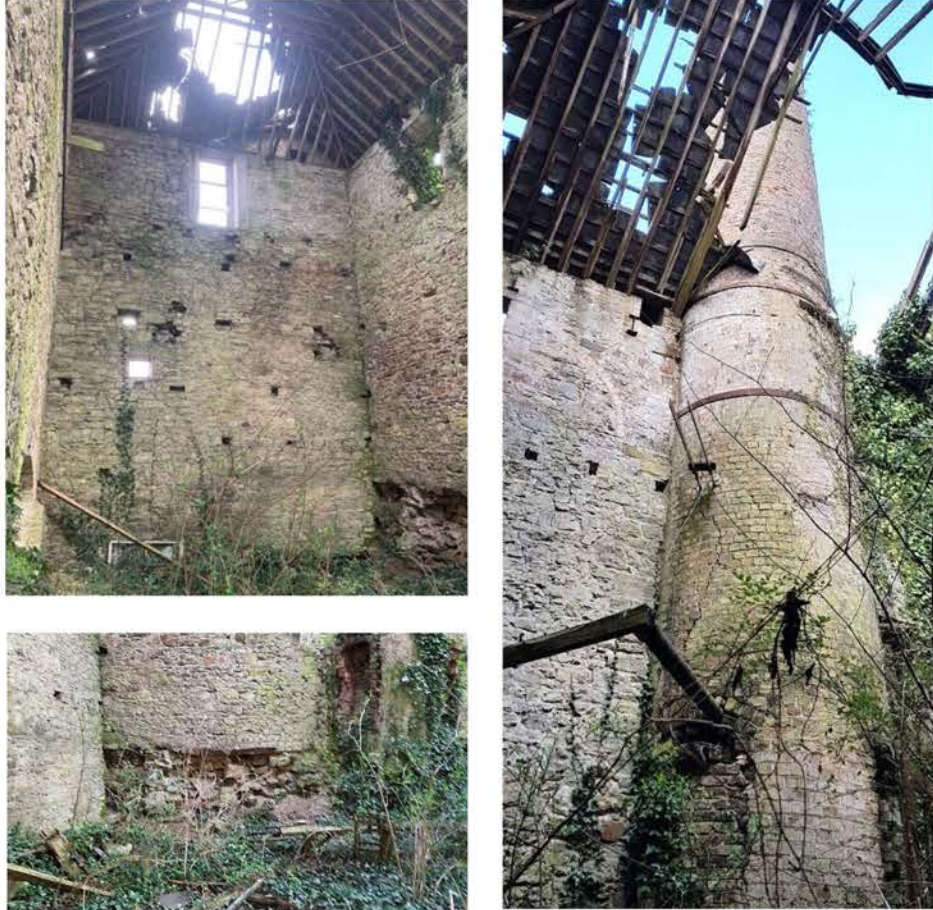
<p>Building No.18 Engine House with Chimney</p> <p>Sheet 2 of 2</p>	<p><b>South Elevation:</b> 2 number arches at ground level with two number windows at high level. There is mortar wash out at the location of the rainwater outlet. Western arch is missing bricks at the top. Eastern arch is missing brick at the top and at the side of the arch. Stone corbels support the roof of building 19, refer to building 19.</p> <p><b>Eastern Elevation:</b> Stone corbels at high level. Brick infill is in poor condition. There is mortar wash out at the rainwater outlets.</p> <p><b>Internal wall:</b> The internal wall is in poor condition. The eastern side of this wall is undermined on one side. Timber lintels are in very poor condition and rotten in places. There are several holes in the wall possible to support a previous floor. There are number of embedded steel in the wall. There is a vertical crack between the internal wall and the chimney.</p> <p><b>Chimney:</b> Brickwork construction with metal bands at several locations. There is mortar wash out in several locations. North side 2 openings with brick arches over These openings infilled with brick in poor condition that is unsecured Several vertical cracks in the brick chimney on the north side. South side of the chimney 2 openings with brick arches over These openings infilled with brick now cracked at junction with chimney One of the brick arches has a metal pipe through the arch head. There are several vertical cracks in southern side of the chimney.</p> <p><b>Proposed Repairs:</b> Secure the roof and remove any unsafe slates. Stitch across the cracks. Repair the arches. Repair openings at high level. Repair / replace the timber lintels over the openings. Repair the undermined section of the internal wall. Secure the infill section on the western elevation. Repair the cracks in chimney. Repair the wall tops and the belfry.</p>

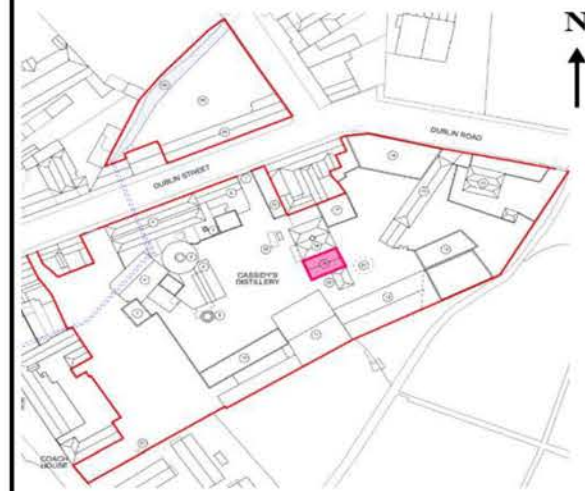
**Building No.19 Shed**

**The original shell only remains and is in poor condition**  
A single storey lean to has been constructed under the pitched roof.  
There was no access inside the lean to.

The original western elevation is missing.

There is mortar wash out at the rainwater outlet.  
There is missing stone in some locations.  
Tree roots along the base of the wall.

There are stone corbels at high level.  
The timber lintel over the opening is in poor condition with a sag and rotten at the ends and at mid span.

Building repairs  
Renewal of roof finishes and valley gutter linings recommend  
Extensive repairs to the roof timbers will be required  
Repointing of the walls required

Better circulation around this site would be promoted by making a vehicular route through this building  
The more recent lean-to structure would have to be removed  
A large opening would need to be made through the east gable wall a portalised steel or concrete frame is recommended for this insertion

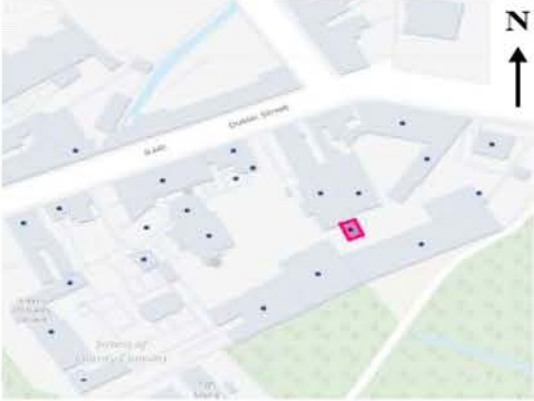
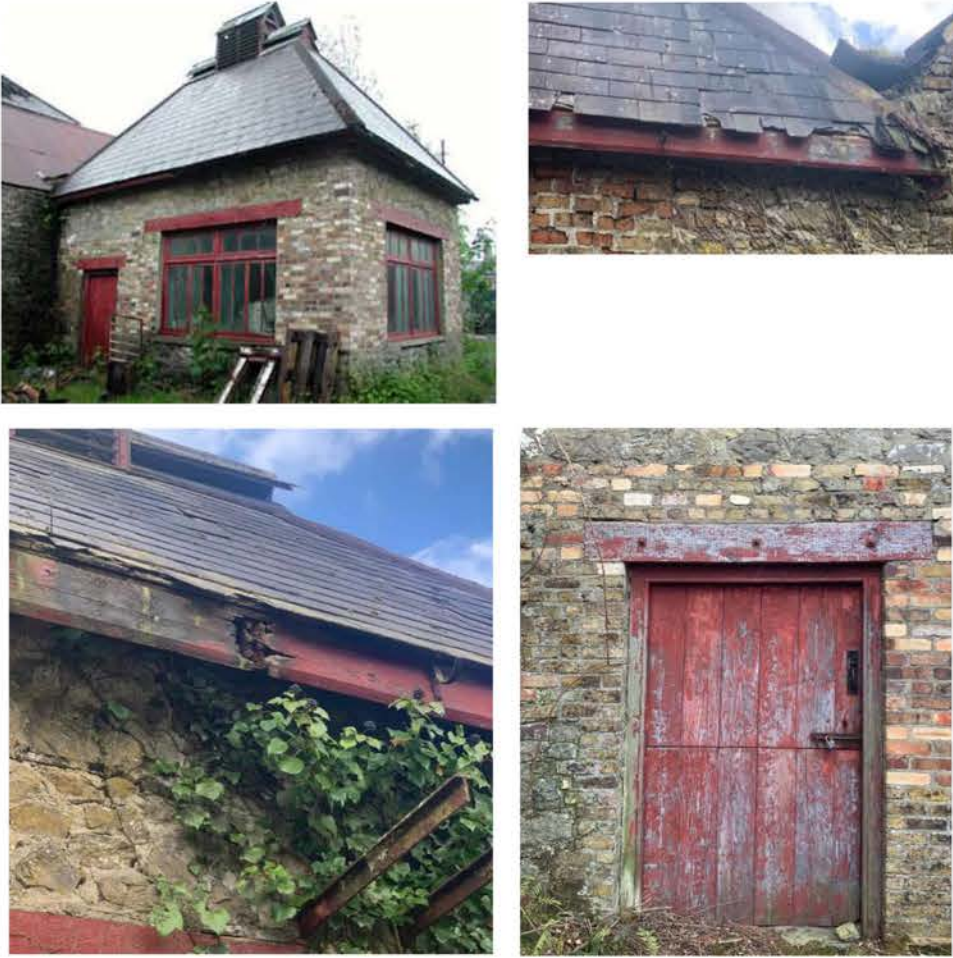
<p><b>Building No.20 Gas works house</b> Attached two-bay single-storey yellow brick building. Early aspect with lantern to roof. sheeted</p> <p>Yellow brick irregular bond walls with rubble stone course to eaves,</p>

<p><b>NIAH Reg. No.</b> 11816060.</p> <p><b>NIAH Rating</b> Regional.</p> <p><b>NIAH Category of special interest</b> Architectural, Historical, Social, Technical.</p>	<p><b>The exterior is in fair condition</b> There was no access into the building but it is assumed that there will be existent joinery etc</p> <p><b>Roof:</b> Timber hipped roof with a timber roof vent part of roof vent has collapsed. Several of the timber rafter ends are rotten. There are a number of slipped slates.</p> <p><b>North Elevation:</b> The north elevation adjoins with building number 19 and was not visible.</p> <p><b>West Elevation:</b> Sag in timber lintel over door but external face of lintel in good condition. Rainwater outlet in the north west corner is causing mortar wash out.</p> <p><b>South Elevation:</b> External face of the timber lintel in good condition.</p> <p><b>East Elevation:</b> Exposed ends of the timber rafter are rotten. The brick infill is in poor condition. Loose brick and missing mortar in the north east corner.</p> <p><b>Proposed Repairs:</b> Repair the roof vent and all rotten rafter ends Repair / replace all rainwater goods Repoint areas of mortar washout</p>

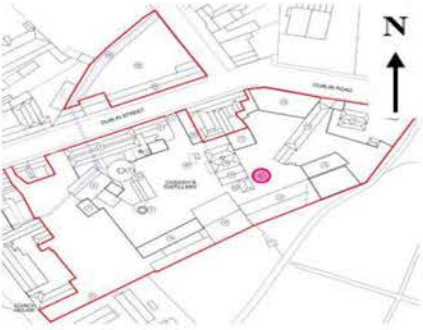
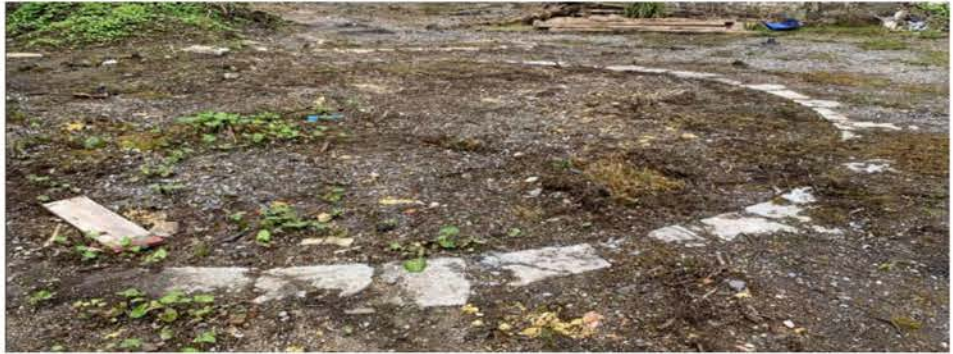
<p><b>Building No.21 Gasometer remains</b></p>

<p><b>Foundations only remain</b></p> <p>Some of the stones remains of the gasometer are visible. Stones on the northwest side of the circle buried.</p> <p><b>Proposed Repairs:</b> the site. Foundations to be retained and incorporated into the future use of the site.</p>

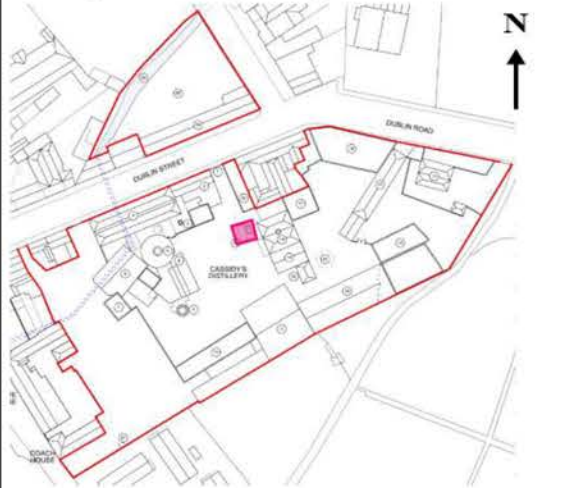
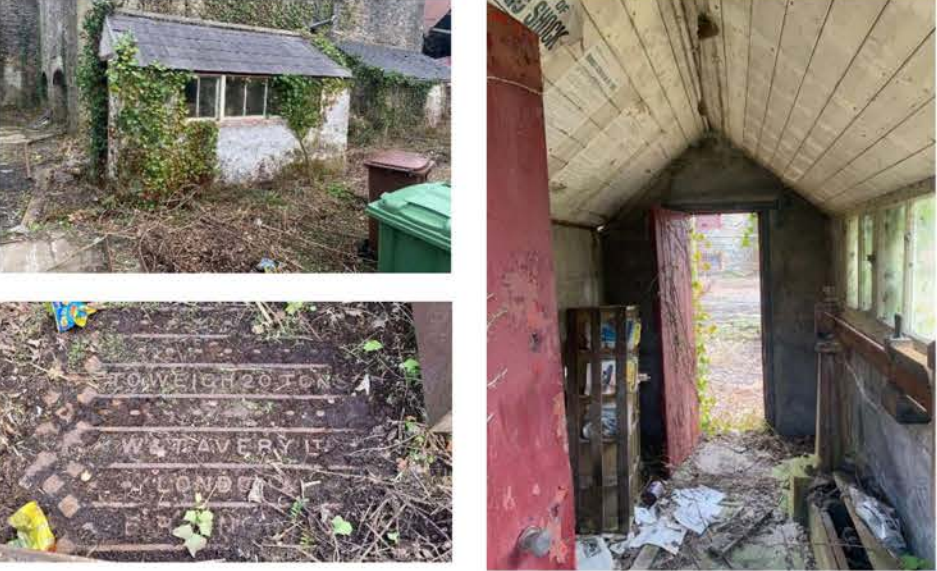
<p><b>Building No.22 Weighbridge and Attendants hut</b></p>

<p><b>Weighbridge overrun with debris and vegetation</b> The condition of the weighbridge is hard to determine.</p> <p><b>Proposed Repairs:</b> Clear all debris &amp; vegetation. Arrange to lift top plate off and clear under. Reinstall in fixed position with additional support</p> <p><b>Attendants Hut on point of failure</b> Timber pitched roof with timber sheeting to the underside. The walls are constructed from reinforced concrete. The exposed reinforcement has corroded in several locations. The corroded reinforcement has caused cracking and parts of the concrete to dislodge.</p> <p><b>Proposed Repairs:</b> Sections of the Attendants Hut will have to be rebuilt due to the damage caused from the corroding reinforcement.</p>

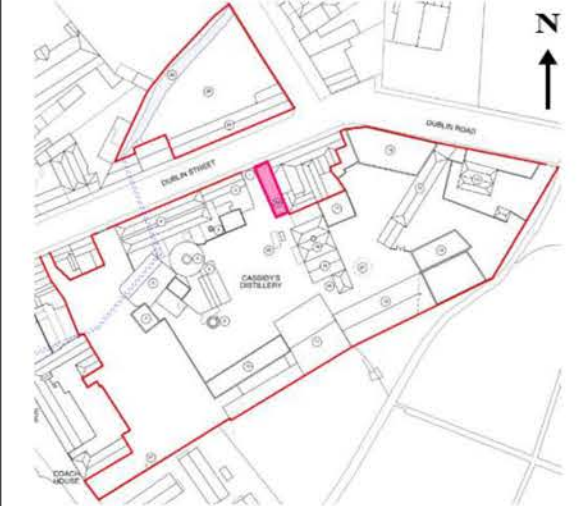
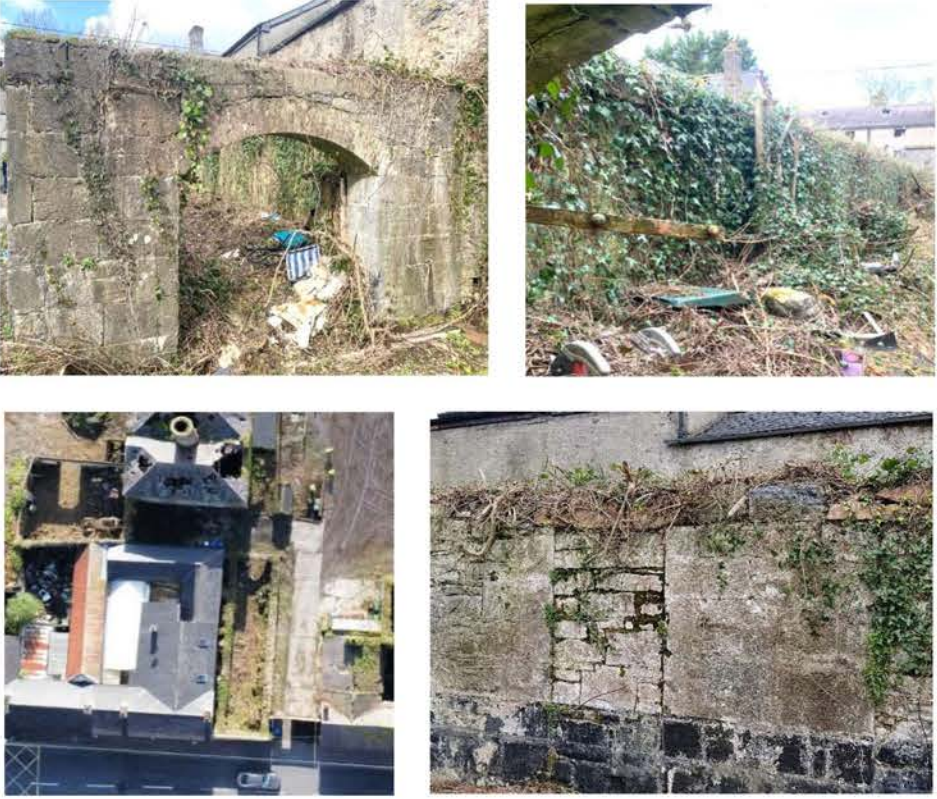
<p><b>Building no. 23 - Water Tank / Store</b></p>

<p><b>Roofless with extensive vegetation</b> The water tank / store building constructed from ashlar stonework. The roof has since collapsed. There are a number of tree roots growing along the wall which have been previously cut down. There is vegetation growing from the wall tops.</p> <p><b>South elevation:</b> There is a crack in the left hand side of the arch. Rainwater down pipe in the south east corner causing mortar wash out.</p> <p><b>West elevation:</b> The two number previous openings infilled with stone. The timber lintels over these openings is in poor condition.</p> <p><b>North Elevation:</b> Stone corbels at the top of the wall, possible support for a water tank.</p> <p><b>Proposed Repairs:</b> Remove the vegetation. Replace the rotten timber lintels. Repair the rainwater outlets.</p>

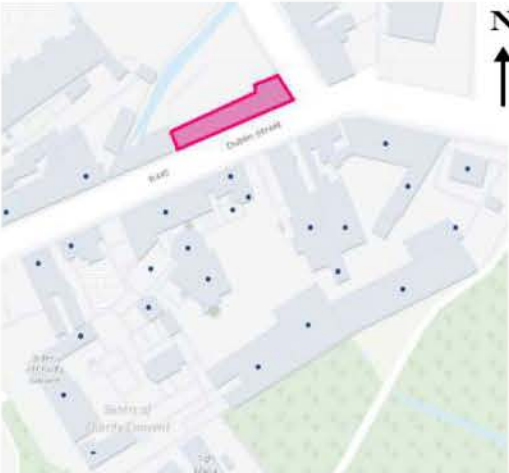
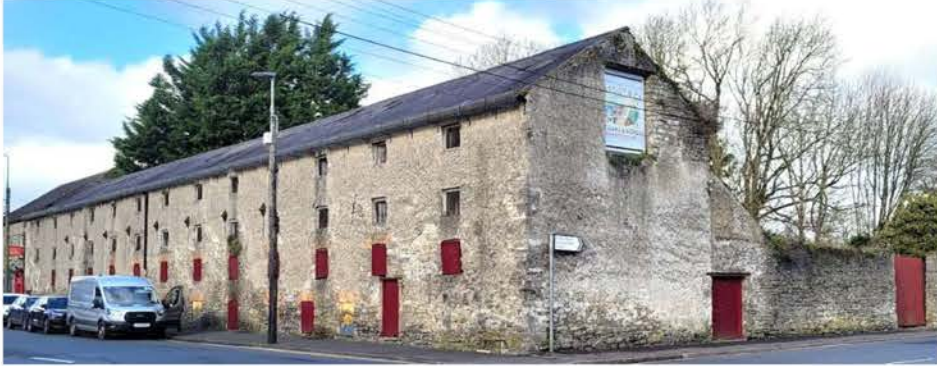
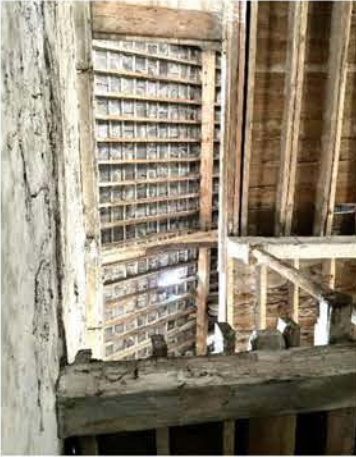
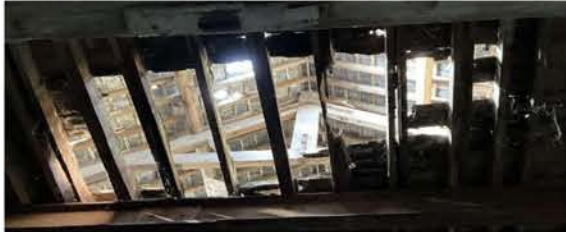
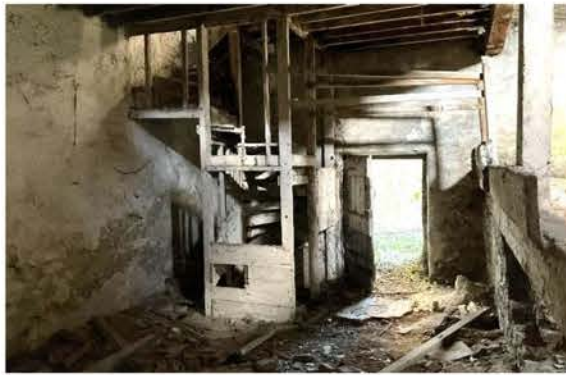
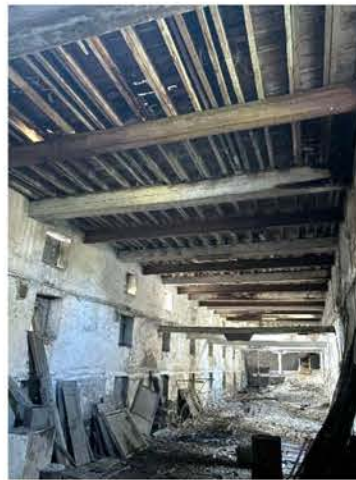
<p><b>Building no.24 Malt house</b></p> <p>13 bayed four storey Malting house. A pitched roof of raised collar tie timber king post trusses. Random limestone rubble walls</p> <p>Floor to ceiling heights very low Ground floor level lower than street level</p>

<p><b>Poor Condition but most of roof still functioning</b></p> <p>Raised collar tie king post roof trusses between every window bay Potentially rotten timber ends.</p> <p>13 bays 6.38m span clear internal span Stairs at north side west end. Gin hoist south side west end</p> <p>First and second floors fallen, top third floor still in place in the main Some timber beams remaining at 2nd floor level. Large timber beams spanning across 3rd floor (approx 14" square). Steel beams spanning across 3rd floor between timber beams 3rd floor timber joists spanning between beams. some are doubled up. Water staining on timber.</p> <p>Likely large timber sections are rotted where embedded into walls. Ground floor full of debris from collapsed upper floors Other artifacts and general household rubbish in building</p> <p>Masonry walls generally appear robust and plumb Likely most timber lintels rotten</p> <p>Rear lean-to return collapsing</p> <p><b>Proposed Repairs:</b> Internal scaffold to support 3rd floor &amp; provide crash deck for roof works Record and dismantle rear return Repair roof retaining as much of original form of roof as practicable Repair as much as third floor and west end stair core as practicable Remove debris build up from ground floor</p> <p>Hold whilst re-use established - potentially only height for 2 full floors Particularly as it will be necessary to raise grd floor to street level Possible to insert high retail ground floor storey and reinstate second floor level with mezz areas at original 3rd level</p>

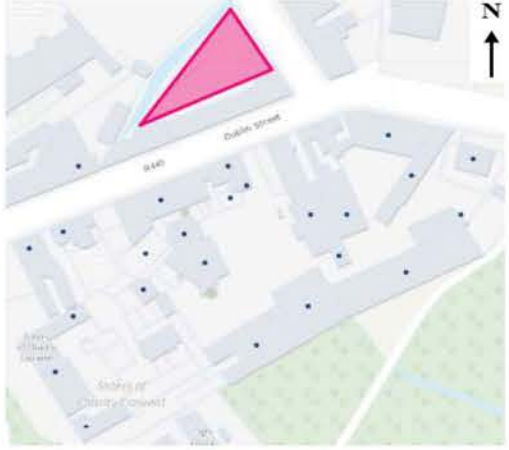
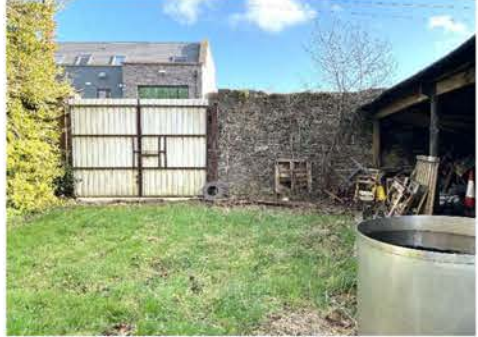
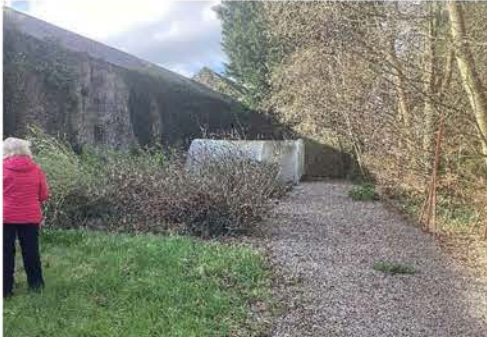
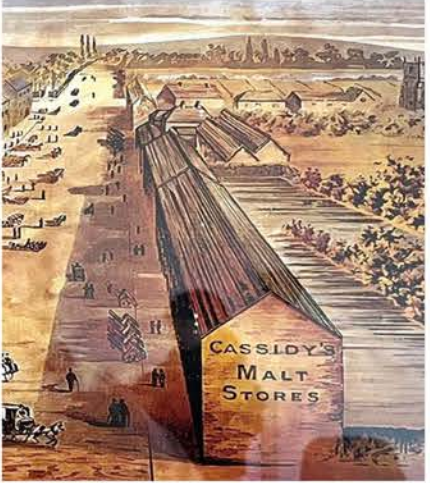
<p>No.25 Mill pond</p>

<p><b>Mill pond now infilled and allotment type planting</b> The mill pond is clearly depicted on historical maps and prints It is now infilled and a tranquil garden</p>

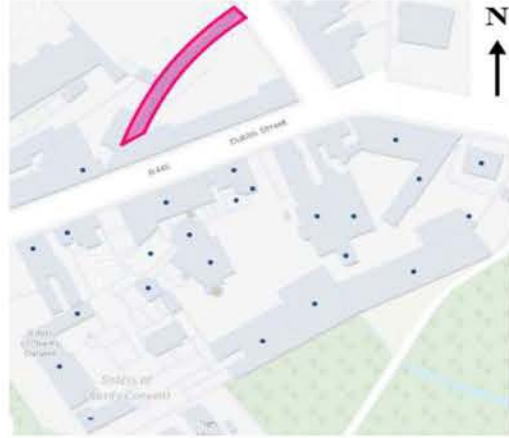
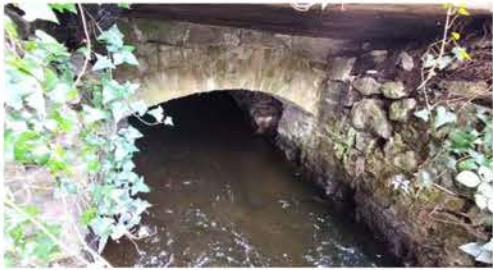
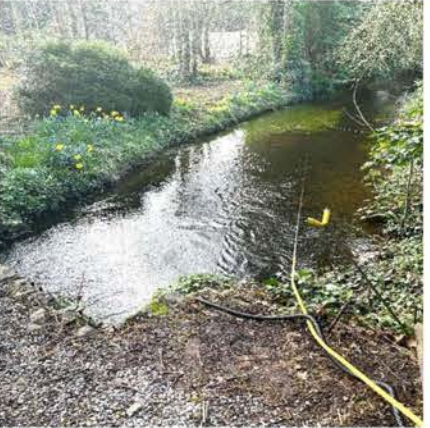
<p>No. 26 Mill race</p>

<p><b>Fully Existent some repairs required to side walls</b> <b>Part culverted under Dublin Street - Condition unknown</b></p> <p>The Pinkeen Stream thought to be a natural river course runs adjacent to Drogheda Row and flows under Drogheda Street into the walled garden area to the north of the Malt stores The race is contained between stone walls through the walled garden Mill race splits at west rear end of malt house into a culvert under road</p> <p><b>Proposed repairs</b> The side walls to the race through the garden should be repaired The culvert under the road should be surveyed Any required repairs can then be scheduled</p>
