# Cassidy's Complex Monasterevin, Co. Kildare.

## Conservation Management Plan

for Kildare County Council  
March 2024

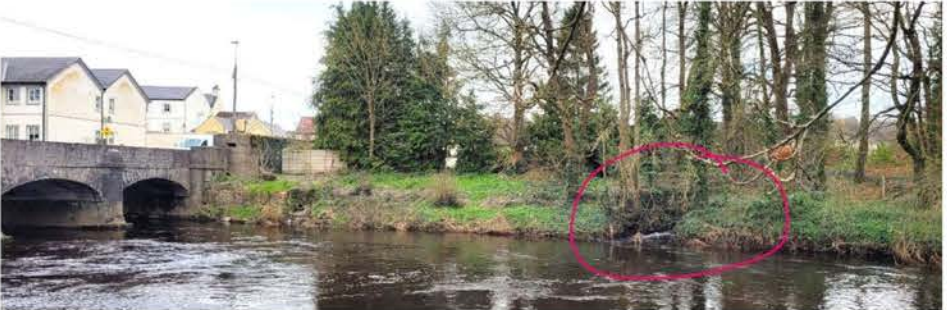
<p>No.29 Tail Race</p>	<p><b>Fully Existent but culverted and condition unknown</b></p> <p>The tail race can be seen at start at Wheel pit in Building 4 From there on until it emerges above ground in the Abbey Demesne its condition is unknown but known to be flowing</p> <p><b>Proposed repairs</b> The culvert should be surveyed during a dry spell Any required repairs can then be scheduled</p>

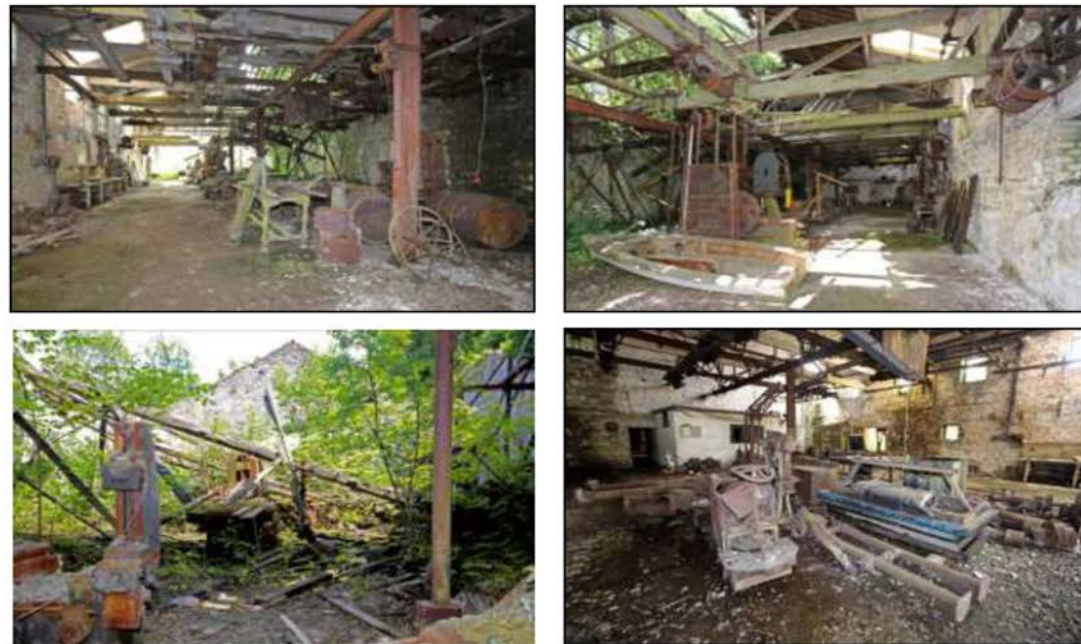
This long single-storey building was known as the "Light Shop" and contains various machine tools, many of which were driven by flat belts from overhead line shafts fixed to the undersides of the roof trusses (fig.4). Unfortunately the east end of the roof has collapsed and the surviving machinery has long been exposed to the elements and is also obscured by the ensuing vegetation overgrowth.

Fig.4 General views of items in Building 2: *Top left:* Looking E along N side of room. *Top right:* Looking E along S side of room. *Bottom left:* Collapsed roof at E end of building. *Bottom right:* Looking W along N side of room.

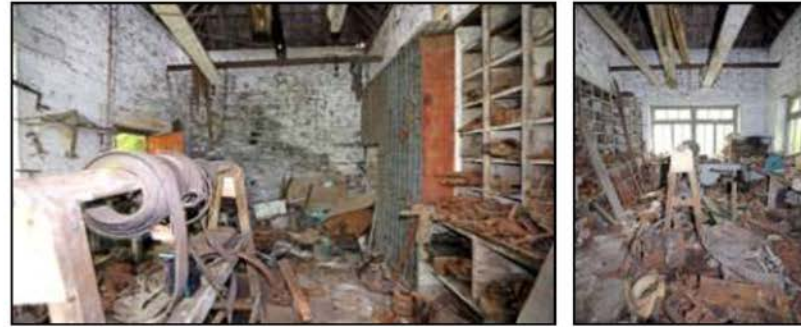
This building is believed to have originally been a gasworks for the distillery but it was gutted and converted into a store by Messrs Holmes (fig.6).

Fig.6 General views of interior of Building 3:  
Far left: Looking N.  
Left: Looking S.

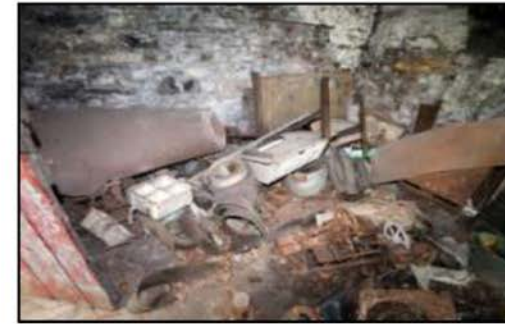
1. Items at N end of room.

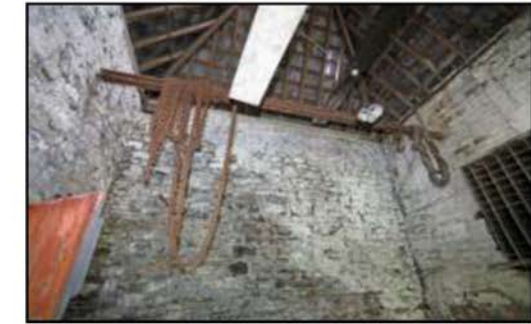
2. Hanging chains at N end of room.

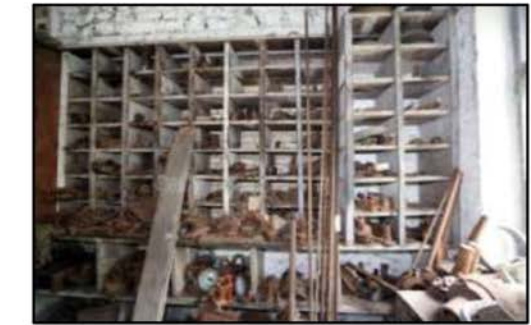
4. Pigeonhole racks along E side (2).

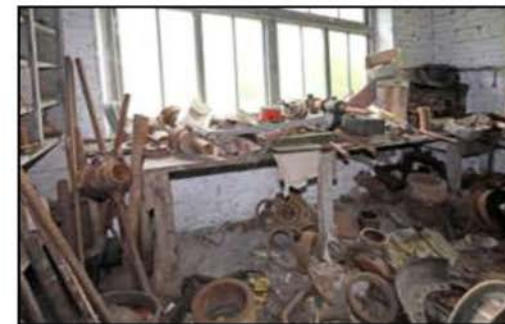
5. Workbench along S side.

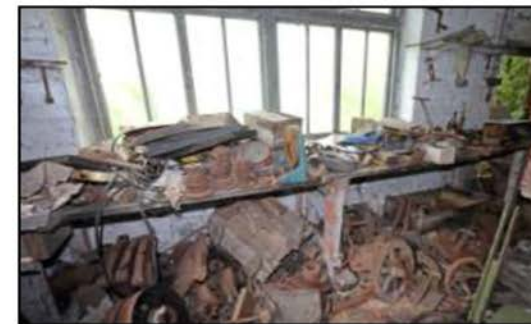
6. Workbench along W side.

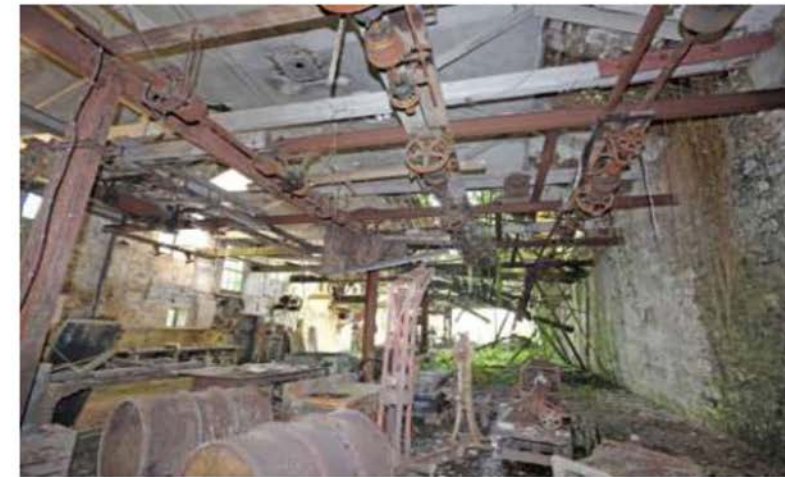
Fig.9 Overhead lineshafts in Building 2.

Some of the shafts and pulleys have been dismantled and now lie loose on the floor, particularly in Building 2. Whilst of little intrinsic interest, these items may nevertheless be of value to anyone undertaking the restoration of an industrial site elsewhere. Resources permitting, each pulley should be recorded as follows:

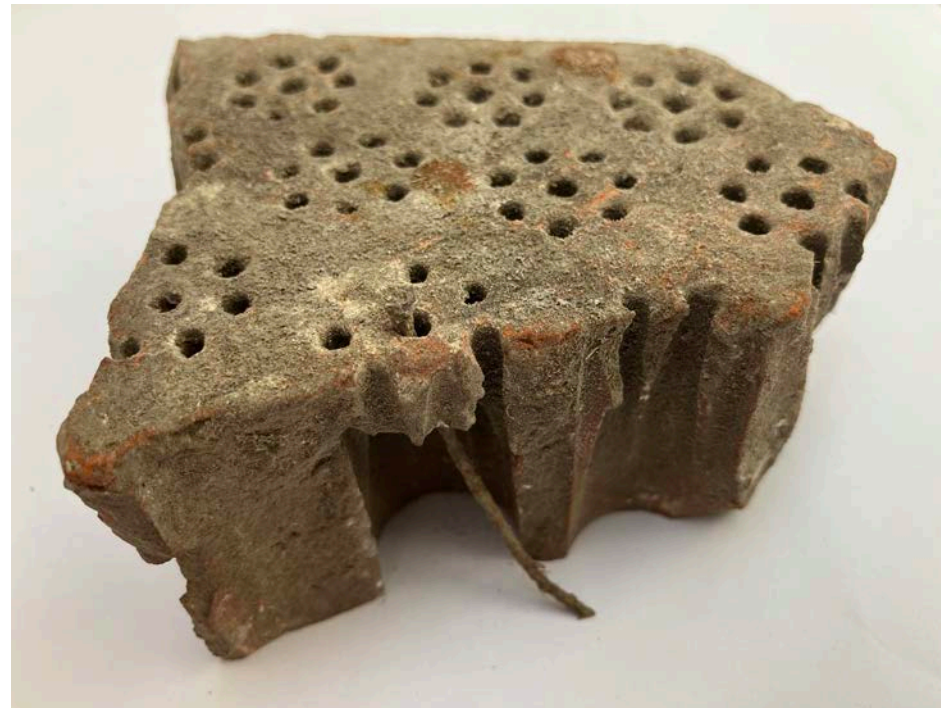
Fragment of a damaged Worcester, perforated brick, found in the former kiln of the Dublin Street malt house, with a fragment of fossilised straw as would have been used by the shoeless young boys, who were observed by Alfred Barnard - *'pricking out the holes of the tiles to unstop them, which has to be repeated three times a year to ensure perfect ventilation.'*
