# TO 268 Leinster Bridges Rehabilitation Contract No. 2 Part 2 Carlow and Wexford Bridges - Change Order No. 1

## Inspection and Rehabilitation Report

**Inspection and Rehabilitation Report**

**Document No:** ..... 15.135.10 Pt2 CO1- IR

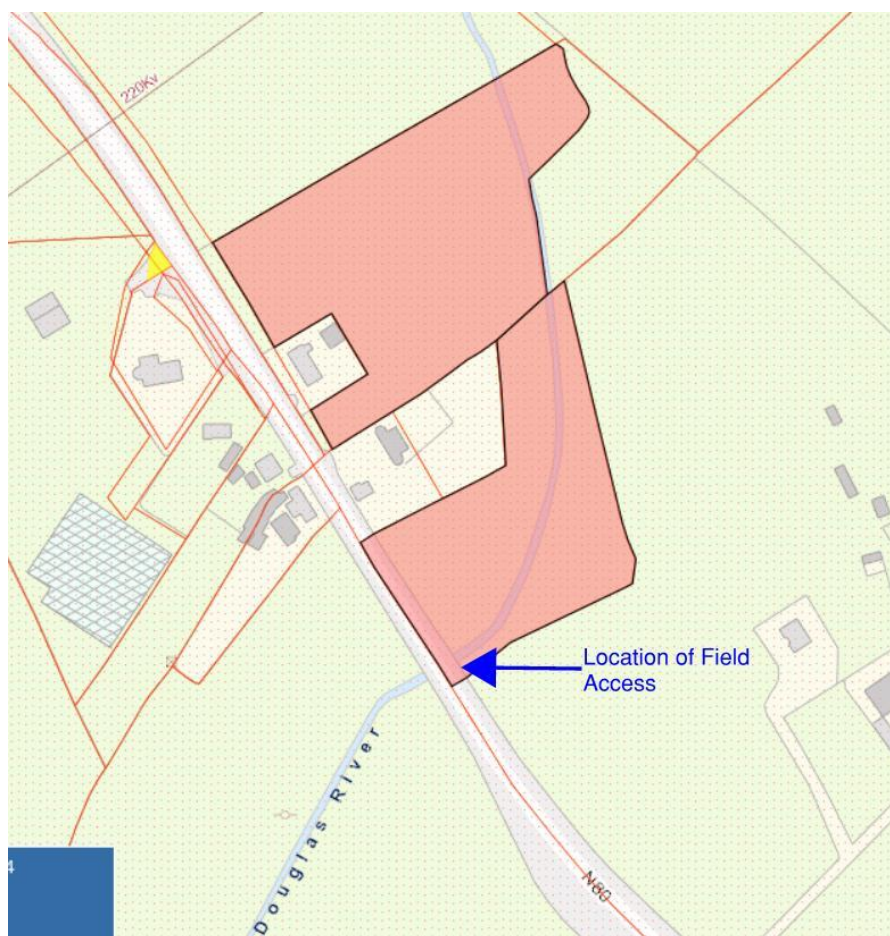
**Figure 3.3: Landownership at East Side of Boggan Bridge**

Initially, the possibility of relocating the field accesses on the northeast approach and southeast departure will be investigated. The location of the gate and the arrangement of boundary fencing on the southeast departure would tend to indicate that relocation of this access will not be feasible (see Photograph 16). A review of the relevant landownership folio (see Figure 3.3 below) further supports this assumption.

Where relocation of either of the field accesses is not possible a Departure from Standard will be required to allow for an opening in the barrier or the omission of barriers at that location.

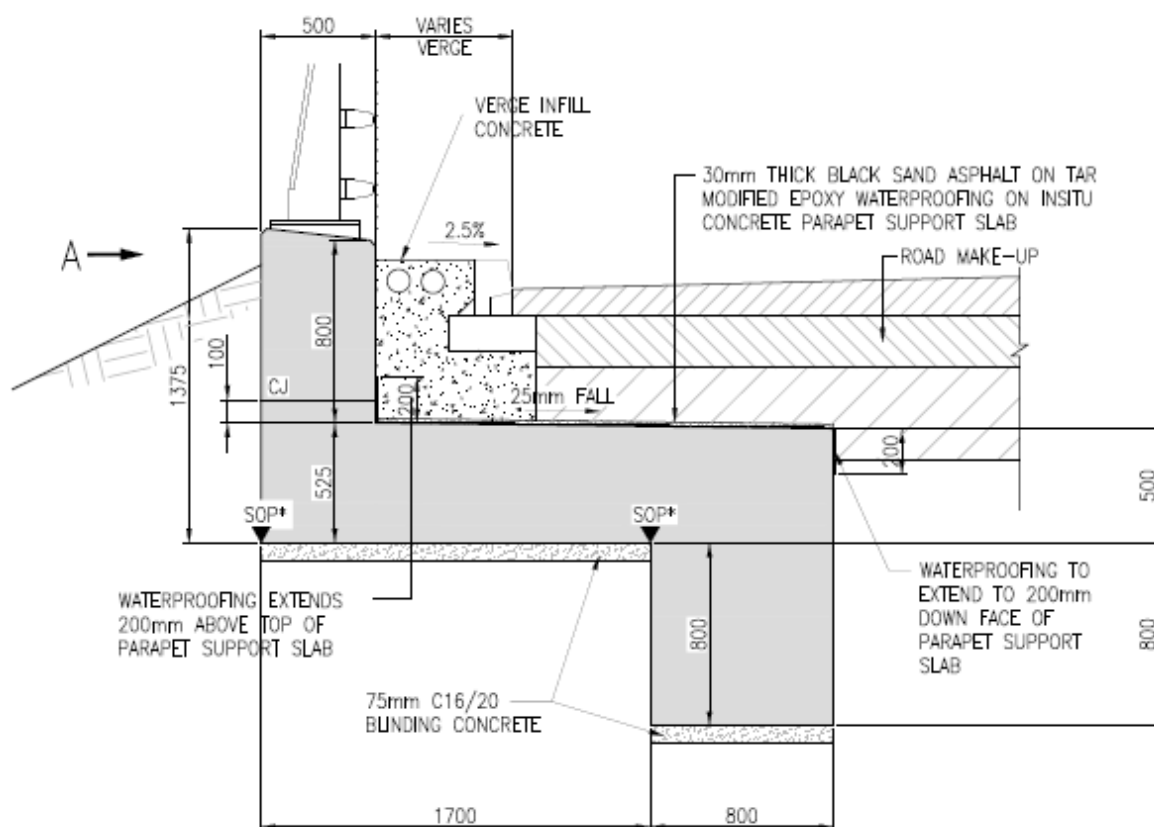
**Figure 4.3(a) – Typical Restraining Slab Detail off Bridge Deck**

At the south side of the structure, the masonry sections of the parapet do not bear on the wingwalls which run alongside the river parallel to the abutments (see Photograph 31). Details of the masonry parapet foundations on this side of the bridge are unknown but will be ascertained via the forthcoming structural investigation. However, it is highly unlikely that the existing foundations will provide sufficient stability or structural capacity for either an N2 or H2 parapet system and a new reinforced concrete restraining slab will be required. An H2 replacement foundation is likely to take the form of a restraining slab similar to that shown in Figure 4.3(a) below. The restraining slab required to achieve N2 Containment would be somewhat lighter.

Steel parapets shall be protected by galvanising only and the galvanising **coverage** rate shall be in accordance with EN ISO 1461. Stainless steel bolts shall be used for holding down the parapet and for all other system fixings.

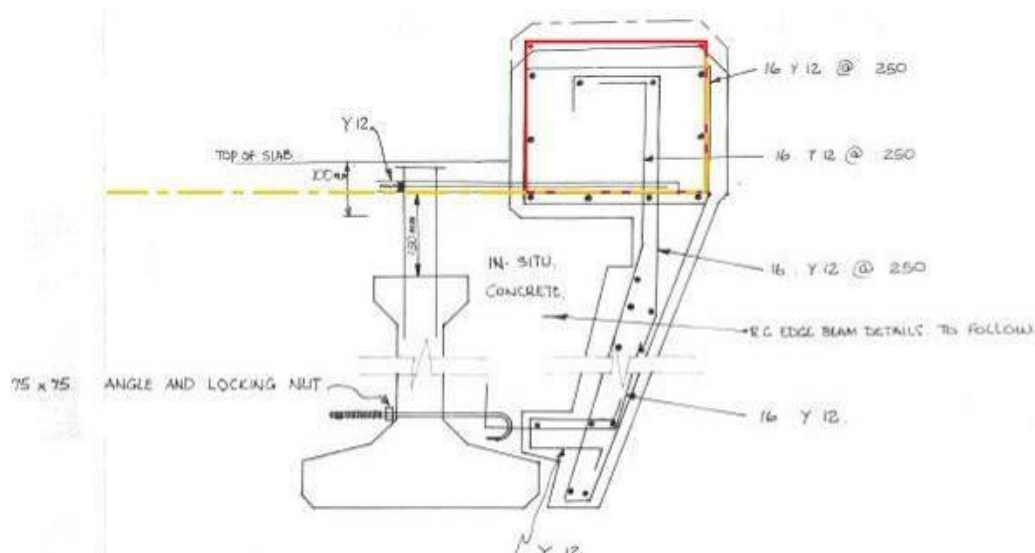
**Figure 4.3(b): Indicative Edge Panel Strengthening Measures**

The forthcoming structural investigation will include a concrete breakout to verify the size, spacing and condition of the existing edge panel reinforcement. Following on from this, a structural check will be carried out to determine whether the existing edge panel reinforcement has sufficient structural capacity or whether strengthening is required. Where it is decided to proceed with parapet upgrade works, it is highly likely that strengthening will be required given the magnitude of the increase in containment required from an existing P2 (N1) system to either an N2 or H2 level of containment. These works will not only require a breakout of the edge panel but also localised breakouts (approx 1.2mx1.2m) to the top of the bridge deck at the base of all proposed parapet post locations. Figure 4.3 (b) below illustrates indicative edge panel strengthening measures. In addition, in order to comply with modern standards, the existing edge panels will be raised to provide a minimum upstand of 50mm above the adjoining paved surface.

It should be noted that the hydrodemolition required for these breakouts is inherently dangerous due to the uncontrollable nature of the process i.e. ejection of high velocity particles /aggregate. Extensive containment measures will be required to ensure the works can be carried out safely.

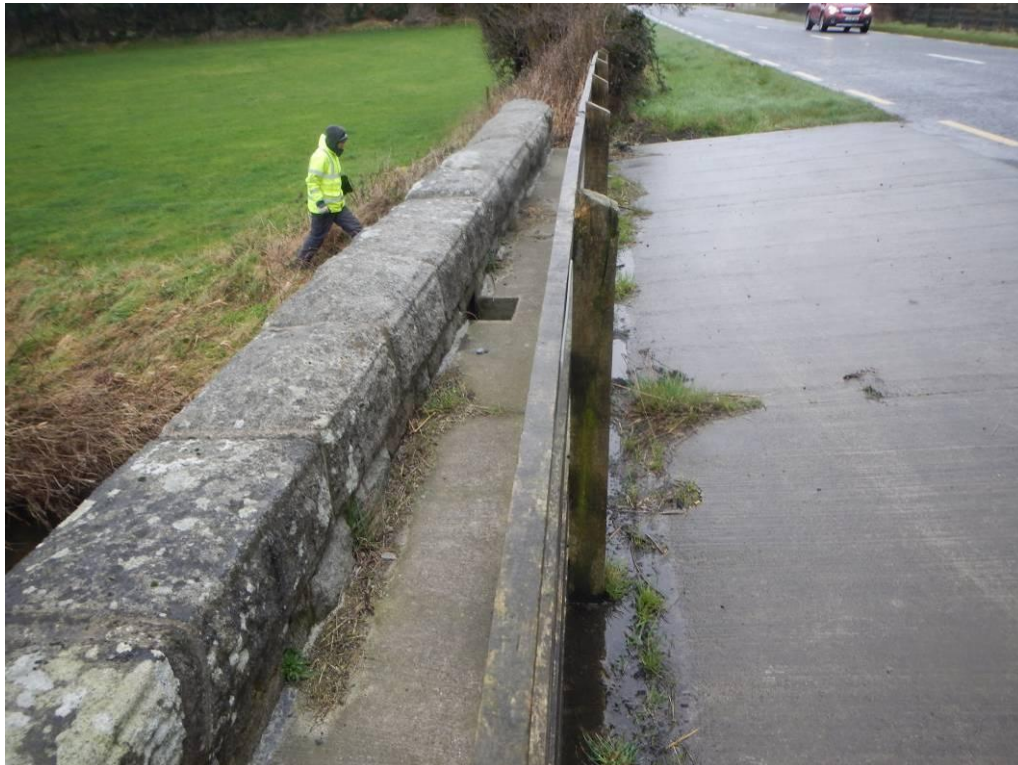
At 0.27m high (measured above the adjoining paved surface), the west parapet does not meet the height requirements specified in Clause 3.10 of NRA BD 52/16 – ‘The Design of Vehicle and Pedestrian Parapets’ (see Photograph 2). In addition, the parapet does not meet the containment requirements outlined in Table 3/1 of the standard. There is no effective vehicle parapet provided along the east side of the bridge, however, the timber post and rail fencing acts as pedestrian guardrail (see Photograph 3).

**Photo 2 – Structure 1: View of West Parapet**

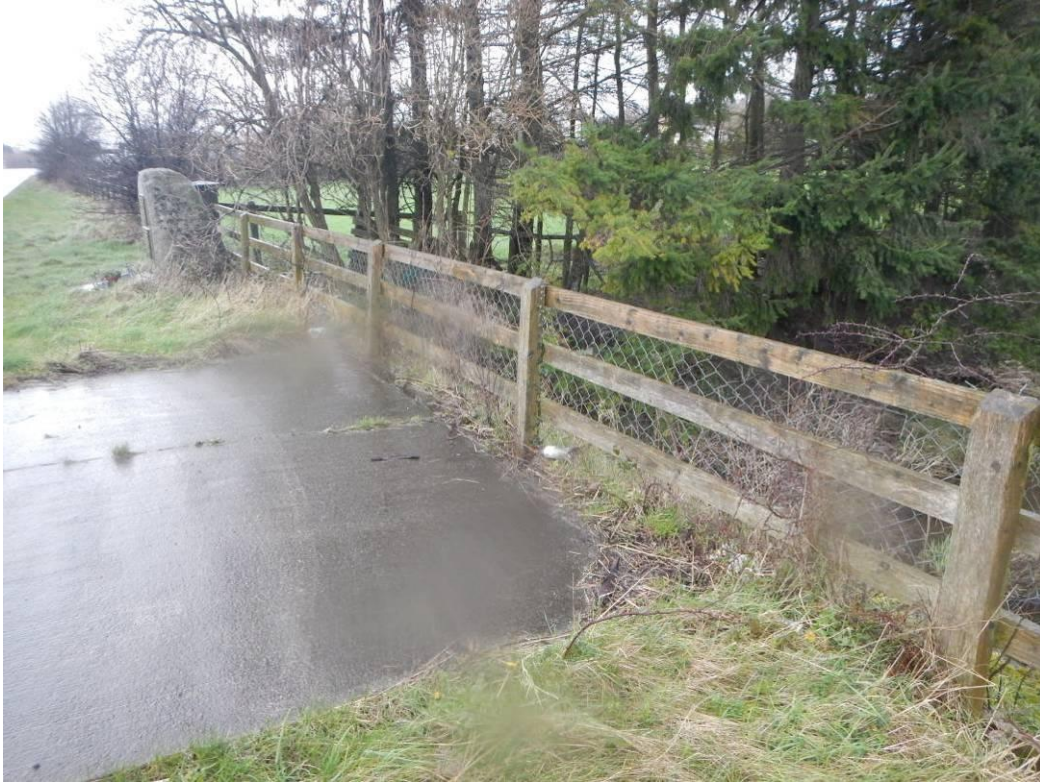
**Photo 3 – Structure 1: View of East Parapet**

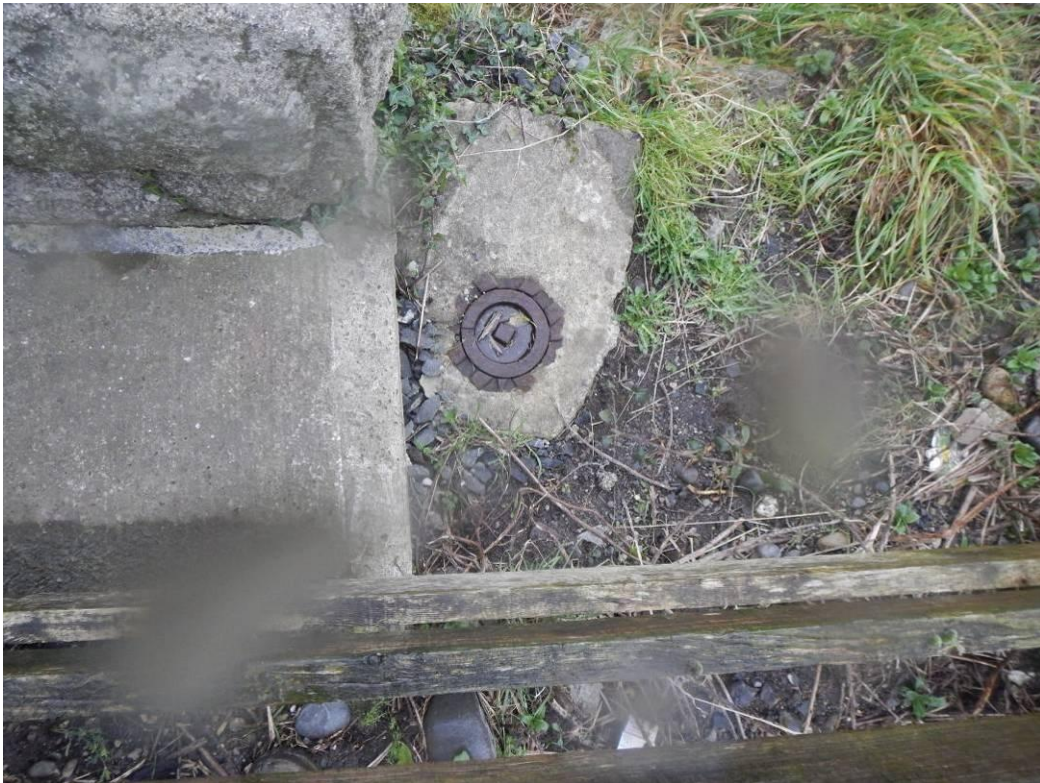
Service enquiries are ongoing at the time of completion of this report. However, responses received to date confirm the presence of underground Eir services in the east verge (1x100mm diameter polypropylene duct) and Irish Water underground services in the west verge (1x100mm diameter UPVC watermain). There are a number of associated air/scour valves visible in the west verge (see Photograph 4). Slit trenches will be carried out as part of the proposed investigation works to identify all services crossing the structure.

**Photo 4 – Structure 1: View of Scour Valve in West Verge**

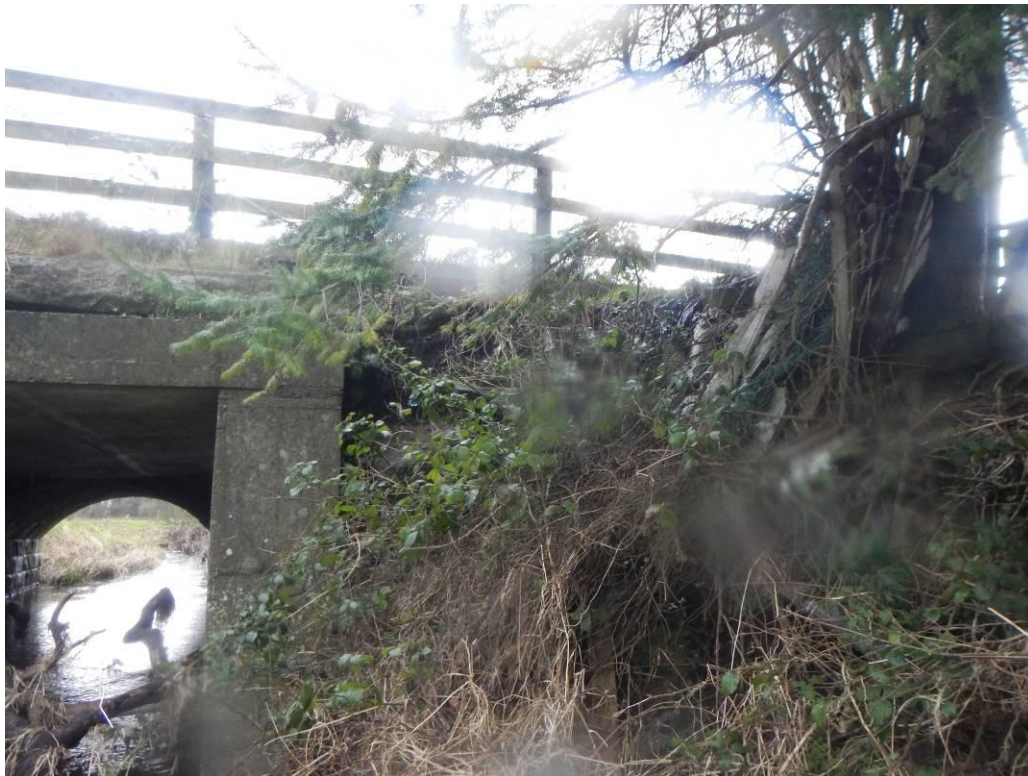
The west embankments are generally well vegetated and stable. However, there is evidence of scour and slippage of the northeast and southeast embankments. This issue is exacerbated by the lack of proper wingwalls on the east side of the structure to prevent loss of material from behind the abutments. The boulder/drystone wingwall provided on the southeast embankment has been undermined by scour and appears to be unstable (see Photographs 6 and 7). The northeast embankment also shows evidence of erosion and loss of material from behind the north abutment (see Photograph 8). Both of the east embankments require regarding and the installation of a suitable embankment protection system to prevent further erosion.

**Photo 8 – Structure 1: Erosion of Southwest Embankment**

As outlined above, there is evidence of scour and slippage of the northeast and southeast embankments. The boulder/drystone wingwall provided on the southeast embankment has been undermined by scour and appears to be unstable (see Photographs 6 and 7) and the northeast embankment also shows evidence of erosion and loss of material from behind the north abutment (see Photograph 8). It is proposed that both of the east embankments are regarded and a suitable embankment protection system is installed to prevent further erosion. This is likely to comprise the installation of gabion walls backfilled with a suitable imported fill.

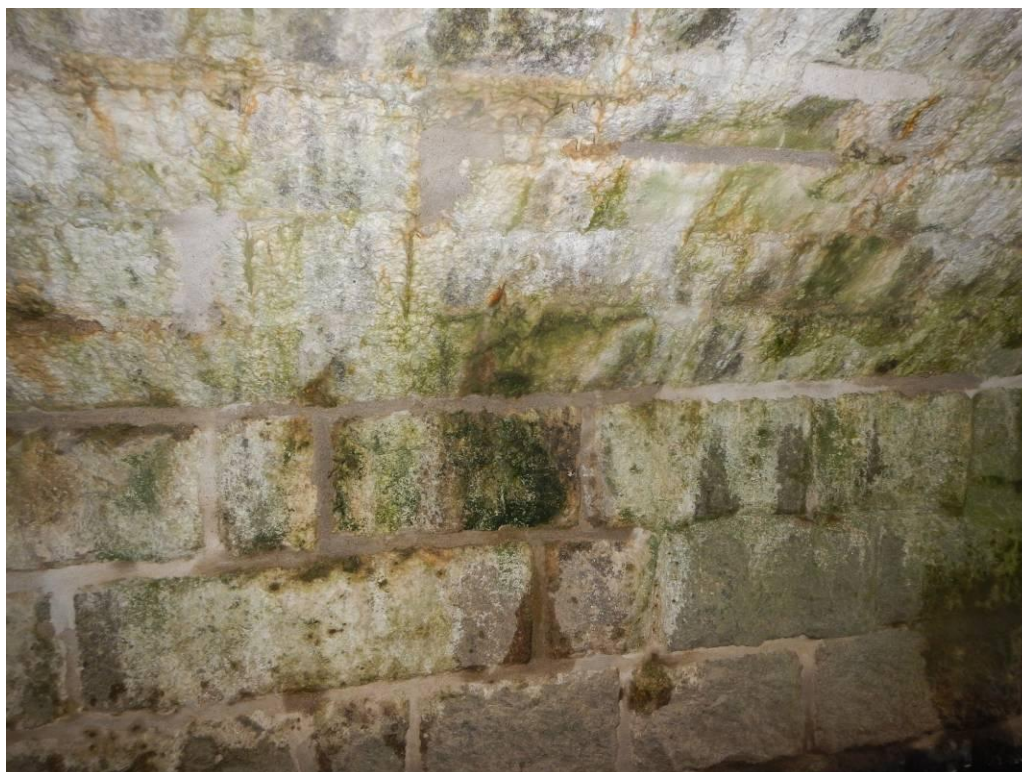
The expressed arch and arch barrel are also constructed from finely dressed quarry faced ashlar masonry and were found to be in very good condition with only minor seepage and resultant staining and calcite deposits noted at the west end of the barrel. The arch shape is very good and there is no evidence of structural distress in the form of cracking, deformation or displaced arch voussoirs. The barrel is well pointed and appears to have been recently repointed (see Photograph 9).

**Photo 12 – Structure 1: Evidence of Recent Repointing of Masonry Abutments**

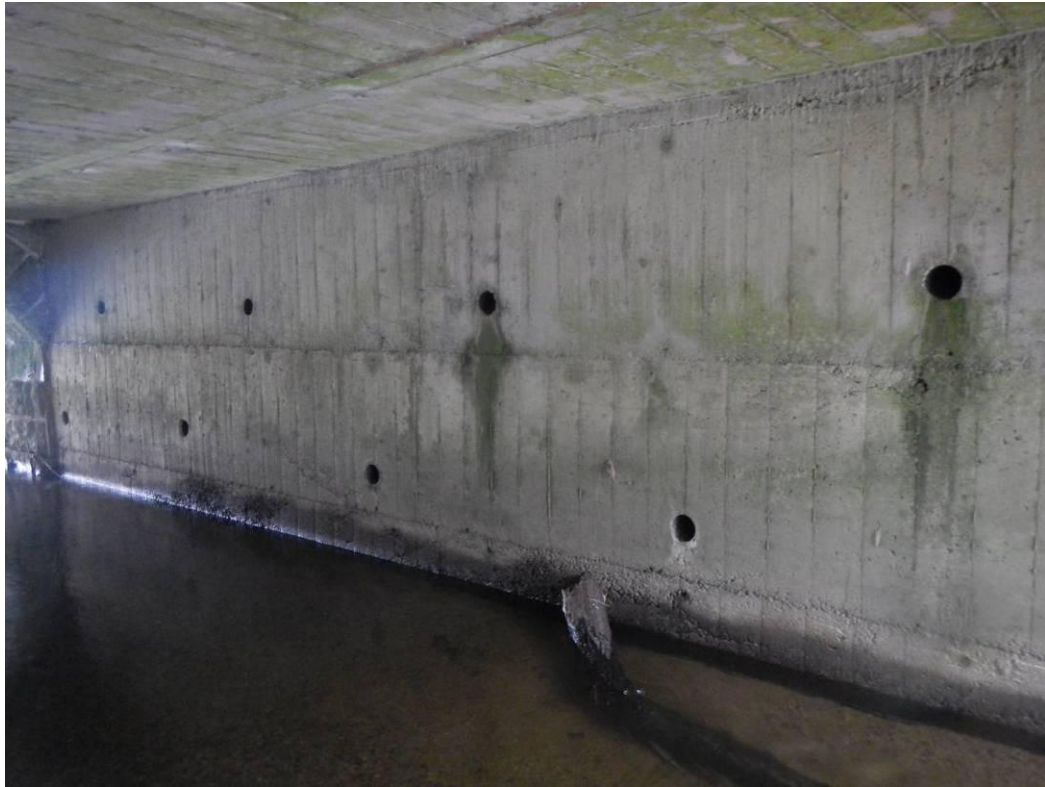
The masonry abutments also consist of granite ashlar masonry. Inspection of the abutments showed that there were no signs of flexural cracking, rotation or differential settlement which would be indicative of structural distress due either to overload or movement of the substructure. Minor leakage and associated staining was noted at the west ends of the abutments (see Photograph 11). All visible areas of the masonry abutments are well pointed (see Photograph 12). The concrete abutments were also found to be in good condition and show no evidence of structural distress due to overload or movement. The concrete finish is poor with widespread honeycombing and seepage/algae staining evident throughout (See Photograph 13). Photos of the east and west elevation have been included as photographs 14 and 15 respectively.

**Photo 13 – Structure 1: Concrete Abutment**

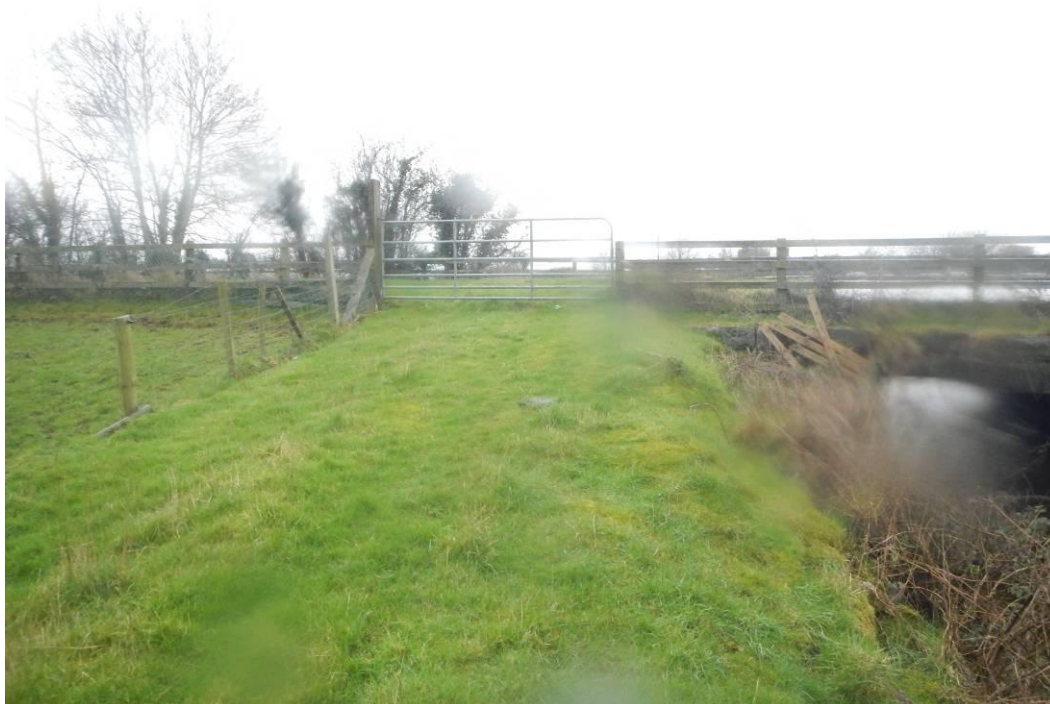
**Photo 16 – Structure 1: View of Field Access on Southeast Departure**

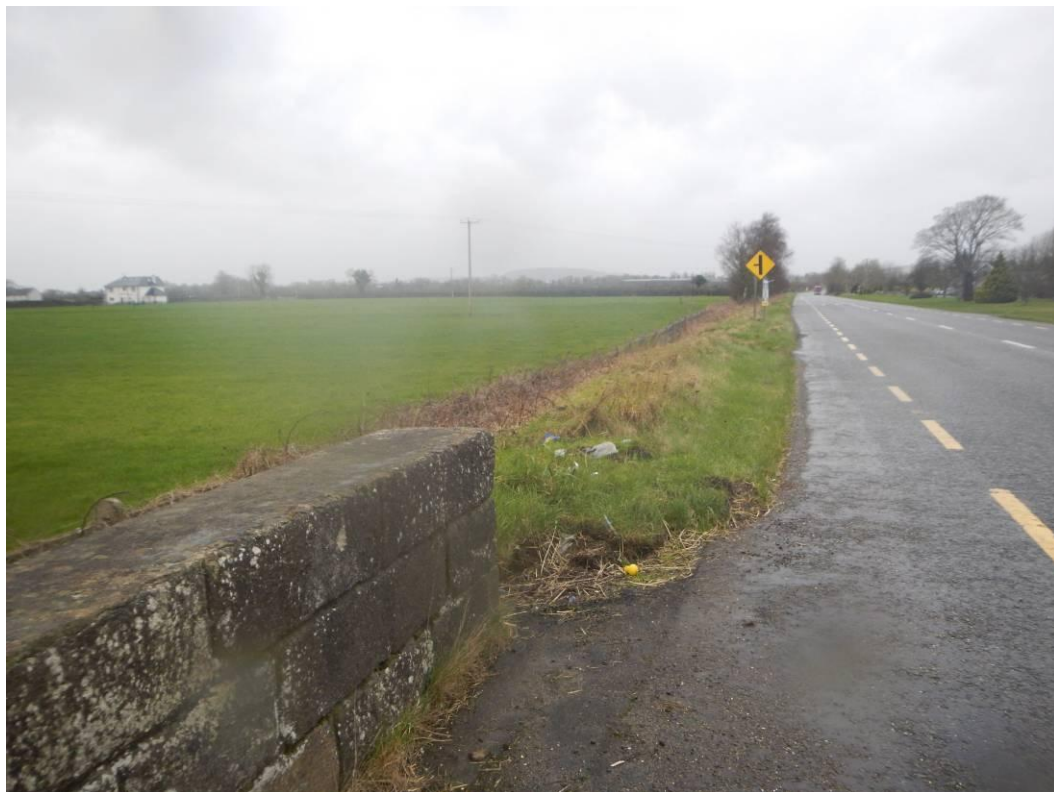
The bridge carries a straight section of road with no significant horizontal or vertical curves on the approaches or over the bridge. Short lengths of non-compliant timber post safety barrier are provided on approaches (northwest and southeast) with no barriers provided on either departure (see Photograph 18). No safety barrier terminals or parapet transitions are provided.

**Photo 18 – Structure 2: View of West Departure**

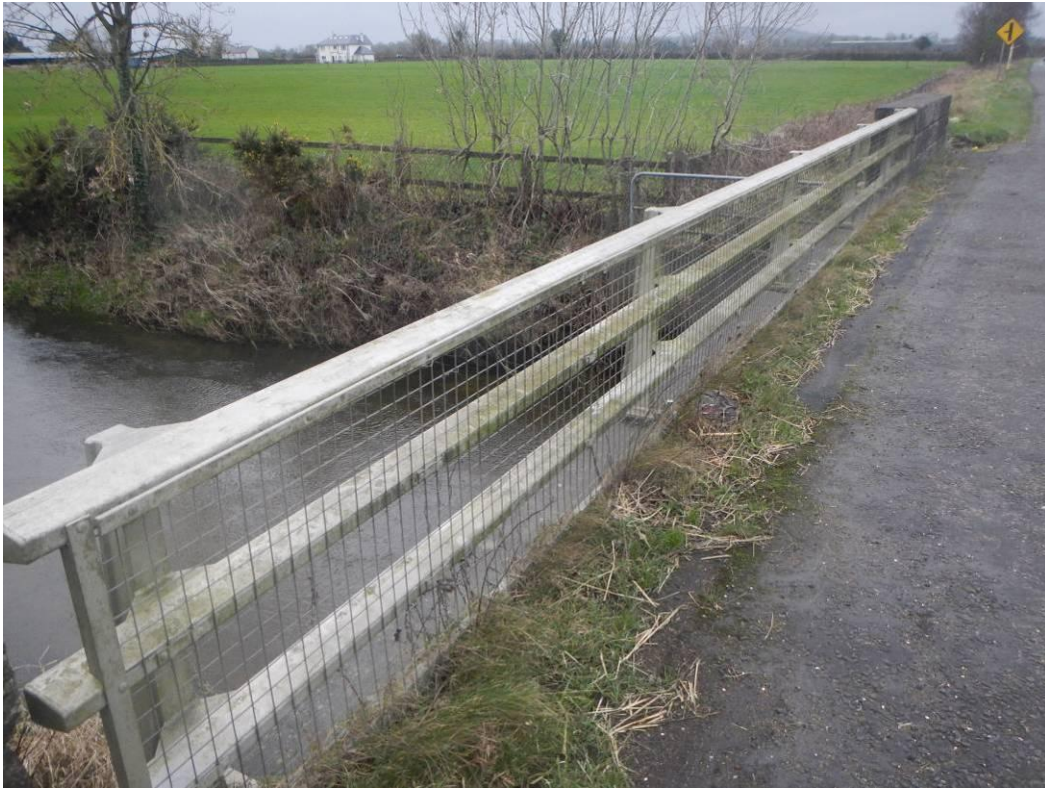
The aluminium parapets provided along both sides of the structure were found to be in reasonably good condition but at 0.98m high (measured above the adjoining paved surface) do not meet the height requirements specified in Clause 3.10 of NRA BD 52/16 - The Design of Vehicle and Pedestrian Parapets (see Photograph 19). In addition, the parapets do not have the requisite 50mm upstand above the adjoining surface and are abutted by masonry parapet walls at all four corners which together do not constitute a compliant vehicle restraint system. The as-built drawings indicate P2 containment which is equivalent to N1 containment by modern standards. This is significantly below the current H2 containment requirement outlined in Table 3/1 of NRA BD 52/16.

**Photo 19 – Structure 2: View of South Parapet**

Where upgrade works are under consideration, 1.25m high galvanised steel parapets with mesh infill will be provided along both sides of the bridge. This dimension meets the height criteria described in Clause 3.10 of BD 52/16. The parapets will be provided over a 21m length which exceeds the manufacturer’s minimum required length of 12m dictated by their “tested length”. This length corresponds with the start and end points of the existing parapets including the masonry end walls. The parapet will be anchored to the edge panels (after modification) over the bridge deck (see Section 4.3.4) and anchored to the existing wingwalls (after modification) on the northeast and northwest approaches.

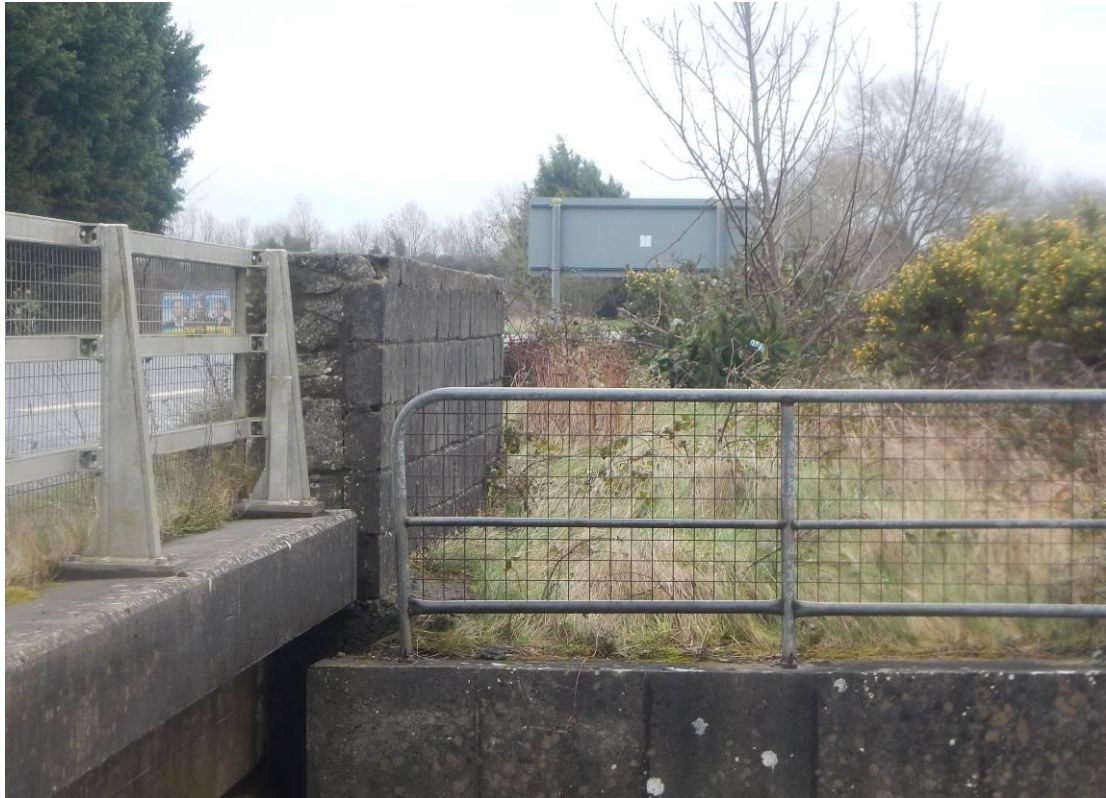
**Photo 31 – Structure 2: Masonry Parapet Wall at Southeast Corner**

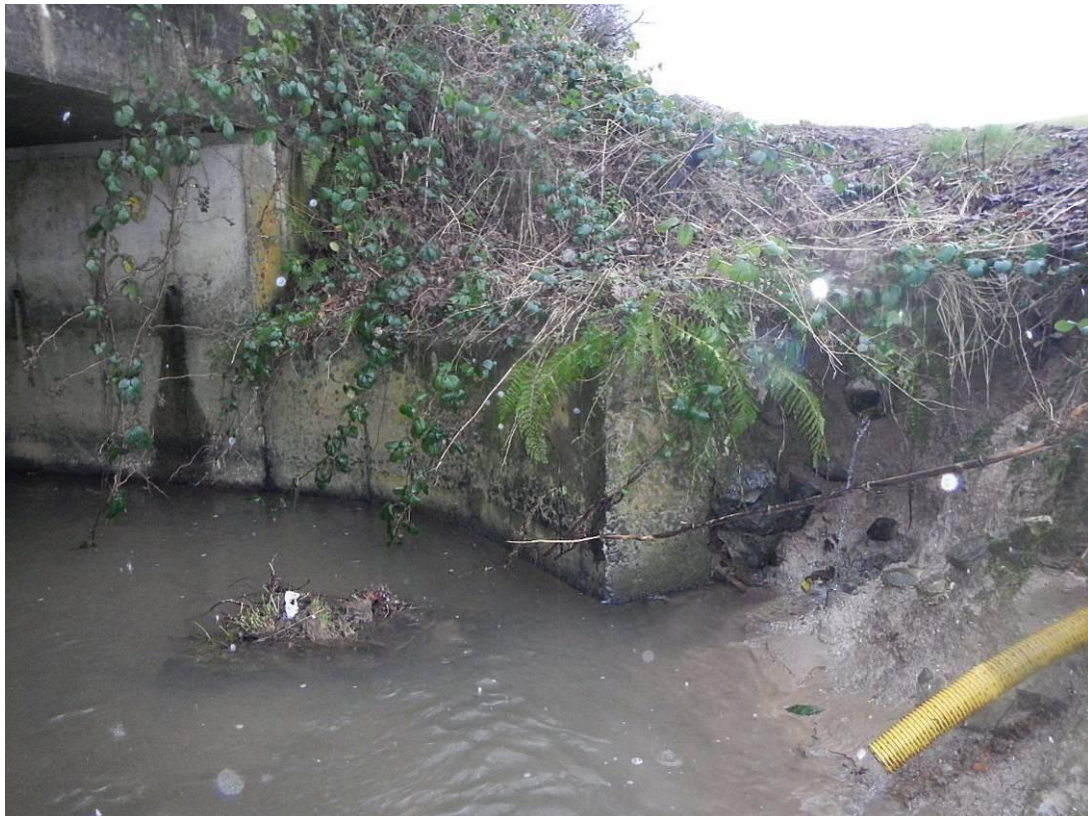
**Photo 54 – Structure 4: Northeast Embankment**

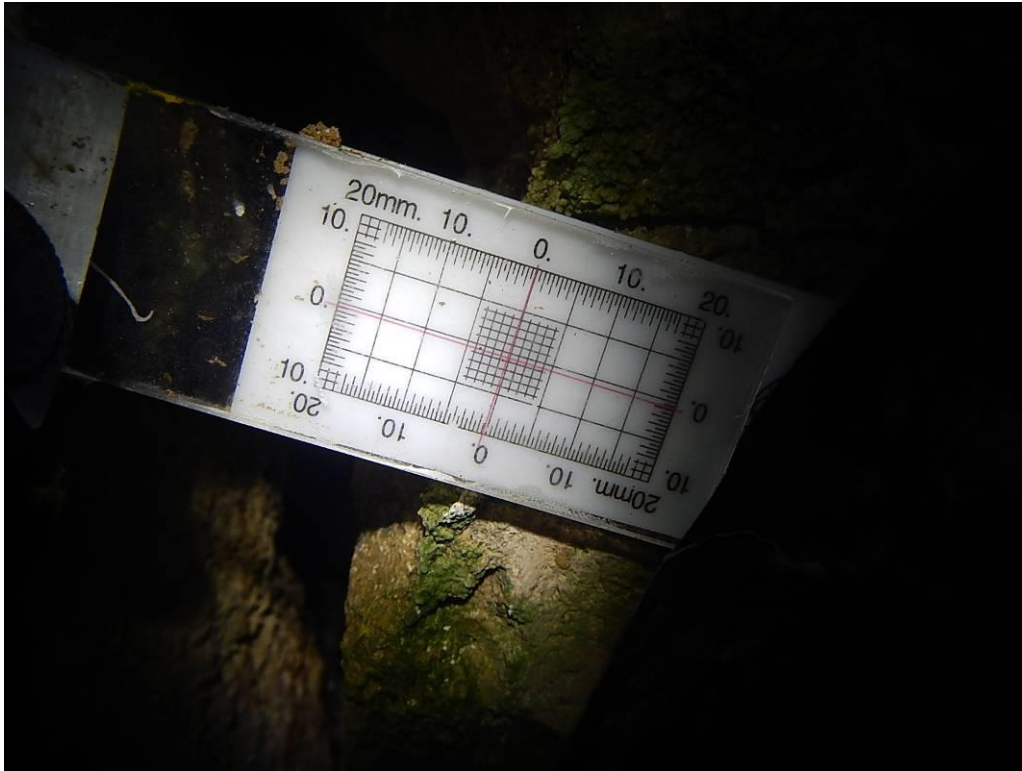
**Photo 57 – Structure 4: Remaining Tell Tail**

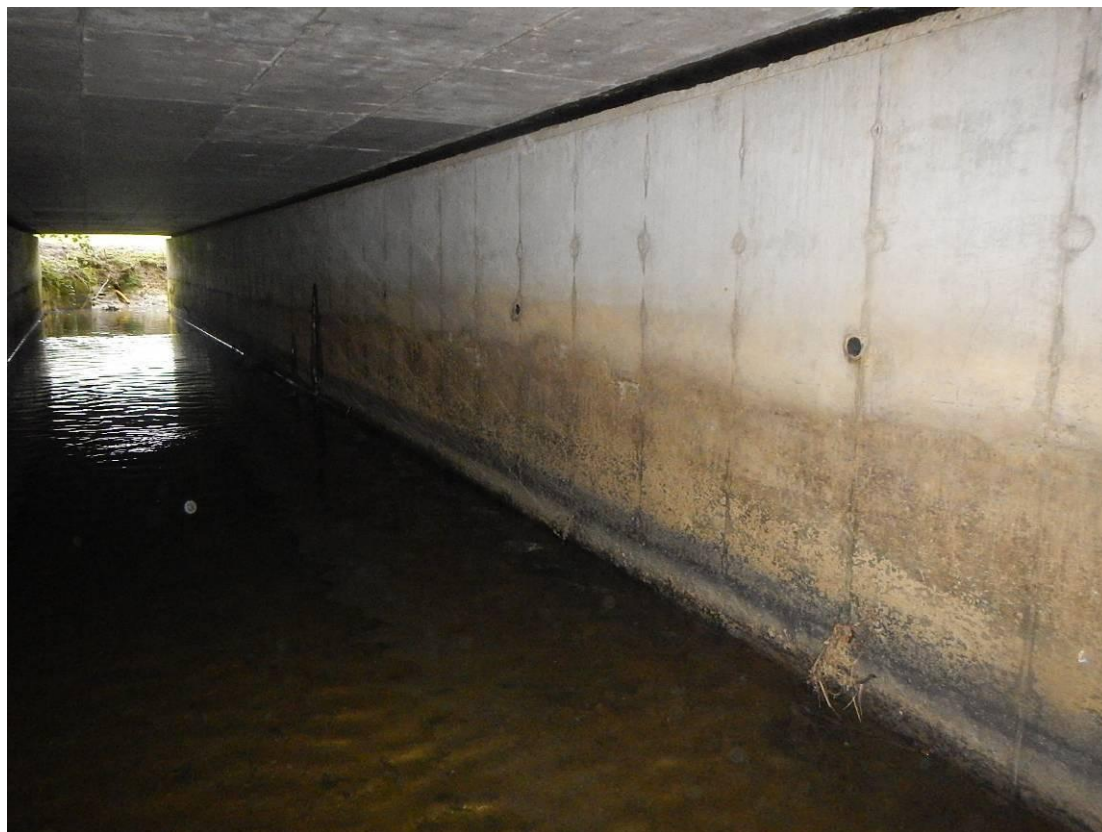
**Photo 64 – Structure 4: Concrete Abutment**
