Fire Hydrant Flow & Pressure Testing Report

Company: Malone O'Regan

Location: 17 Connagh Road, Collaghknock Glebe, Kildare R51 C668

Date: 12-Jul-2023

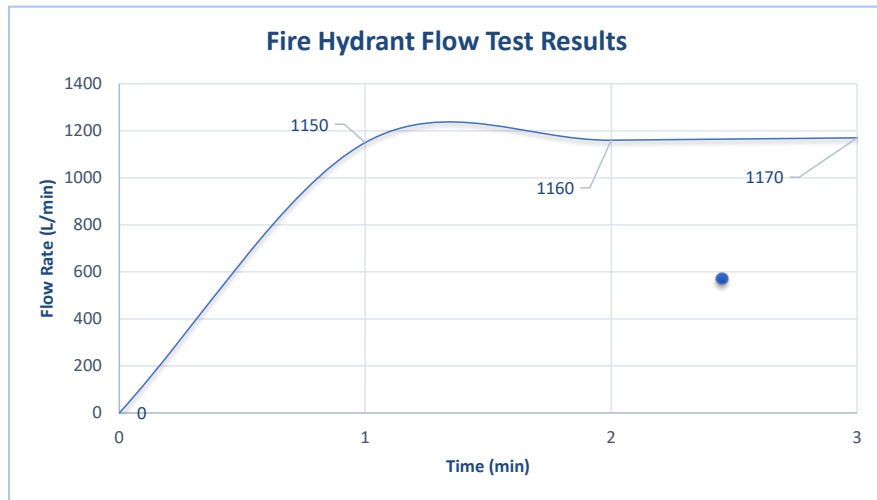
Flow Test Results	
Time Duration (mins)	Flow Rate (L/min)
0.00	0
1.00	1150
2.00	1160
3.00	1170

Max Sustainable Flow	
1160	L/min

Static Pressure	
3.6	Bar

Residual Pressure	
1.8	Bar

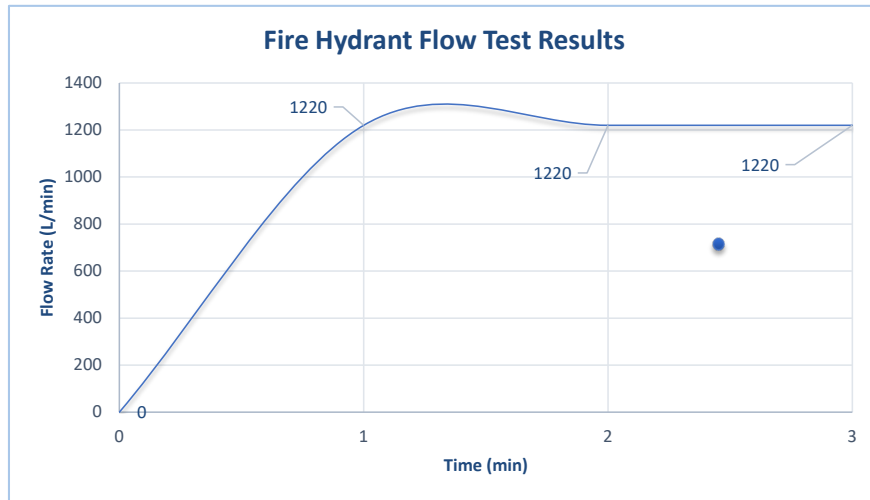
Flow Test Results	
Time Duration (mins)	Flow Rate (L/min)
0.00	0
1.00	1220
2.00	1220
3.00	1220

Max Sustainable Flow	
1220	L/min

Static Pressure	
3.3	Bar

Residual Pressure	
2.3	Bar

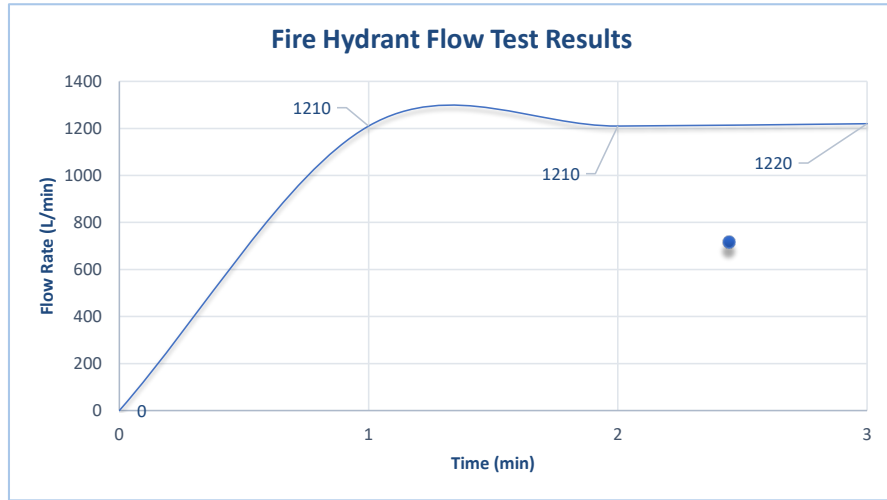
Flow Test Results	
Time Duration (mins)	Flow Rate (L/min)
0.00	0
1.00	1210
2.00	1210
3.00	1220

Max Sustainable Flow	
1213	L/min

Static Pressure	
3.1	Bar

Residual Pressure	
2.3	Bar
