**AN TRIANTÁN,
at STATION ROAD, KILDARE TOWN, CO. KILDARE**

for KILDARE COUNTY COUNCIL
January 2025

REFURBISHMENT FEASIBILITY STUDY

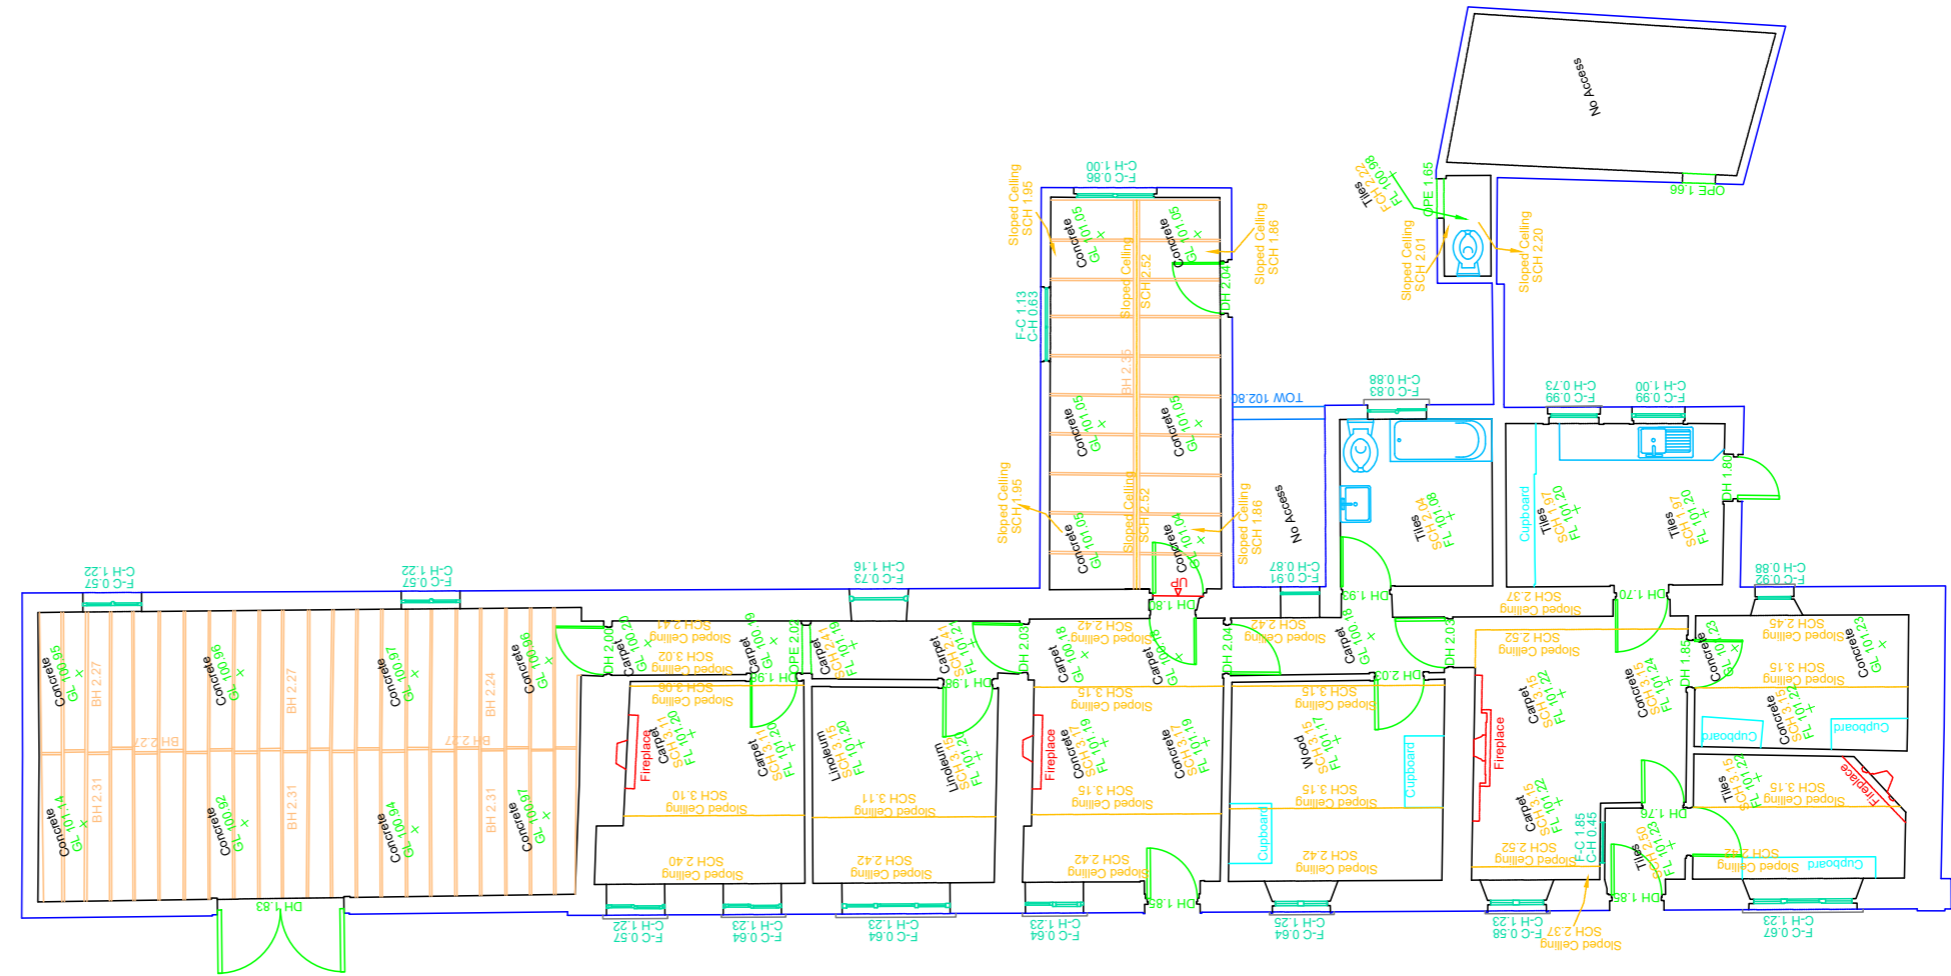
Fig. 2. Measured Building Survey Plan by Apex Surveys

- 2.1.1 Derelict, formerly habitable area: **87.1m²**
- 2.1.2 Asbestos Containing Materials (ACMs) have been detected in the roof slates.
- 2.1.3 Poor standard of insulation. The wall buildup appears to be rubble construction with no insulation. External insulation is not deemed appropriate due to the proximity of the street facing external wall to the public footpath and legal site boundary.

- 2.1.4 Internal configuration has been significantly altered to amalgamate the cottages into a single dwelling. It is likely that there were three cottages originally.

- 2.1.5 Internal suspended floors have been largely replaced with poured concrete slabs. Remaining suspended timber floors are decayed to a dangerous state.

- 2.1.6 Leaks are apparent in the roof, causing partial collapses in the living area and kitchen. Roof covering require replacement and roof structure likely requires same pending inspection.

- 2.1.7 Damp is evident in most rooms. It is likely that the replacement of suspended floors with poured concrete slabs has contributed to rising damp. Building age indicates there is no barrier to rising or penetrating damp.

- 2.1.8 Room sizes and disposition do not cater for wheelchair users or residents with limited mobility.
- 2.1.9 Rear extensions, outbuildings and adjoining shed are assessed to be later additions, either new additions or replacing historic fabric, and as such are not deemed to be of heritage value. These appear to be of a more modern construction with blockwork walls and bitumen coated flat roofs.

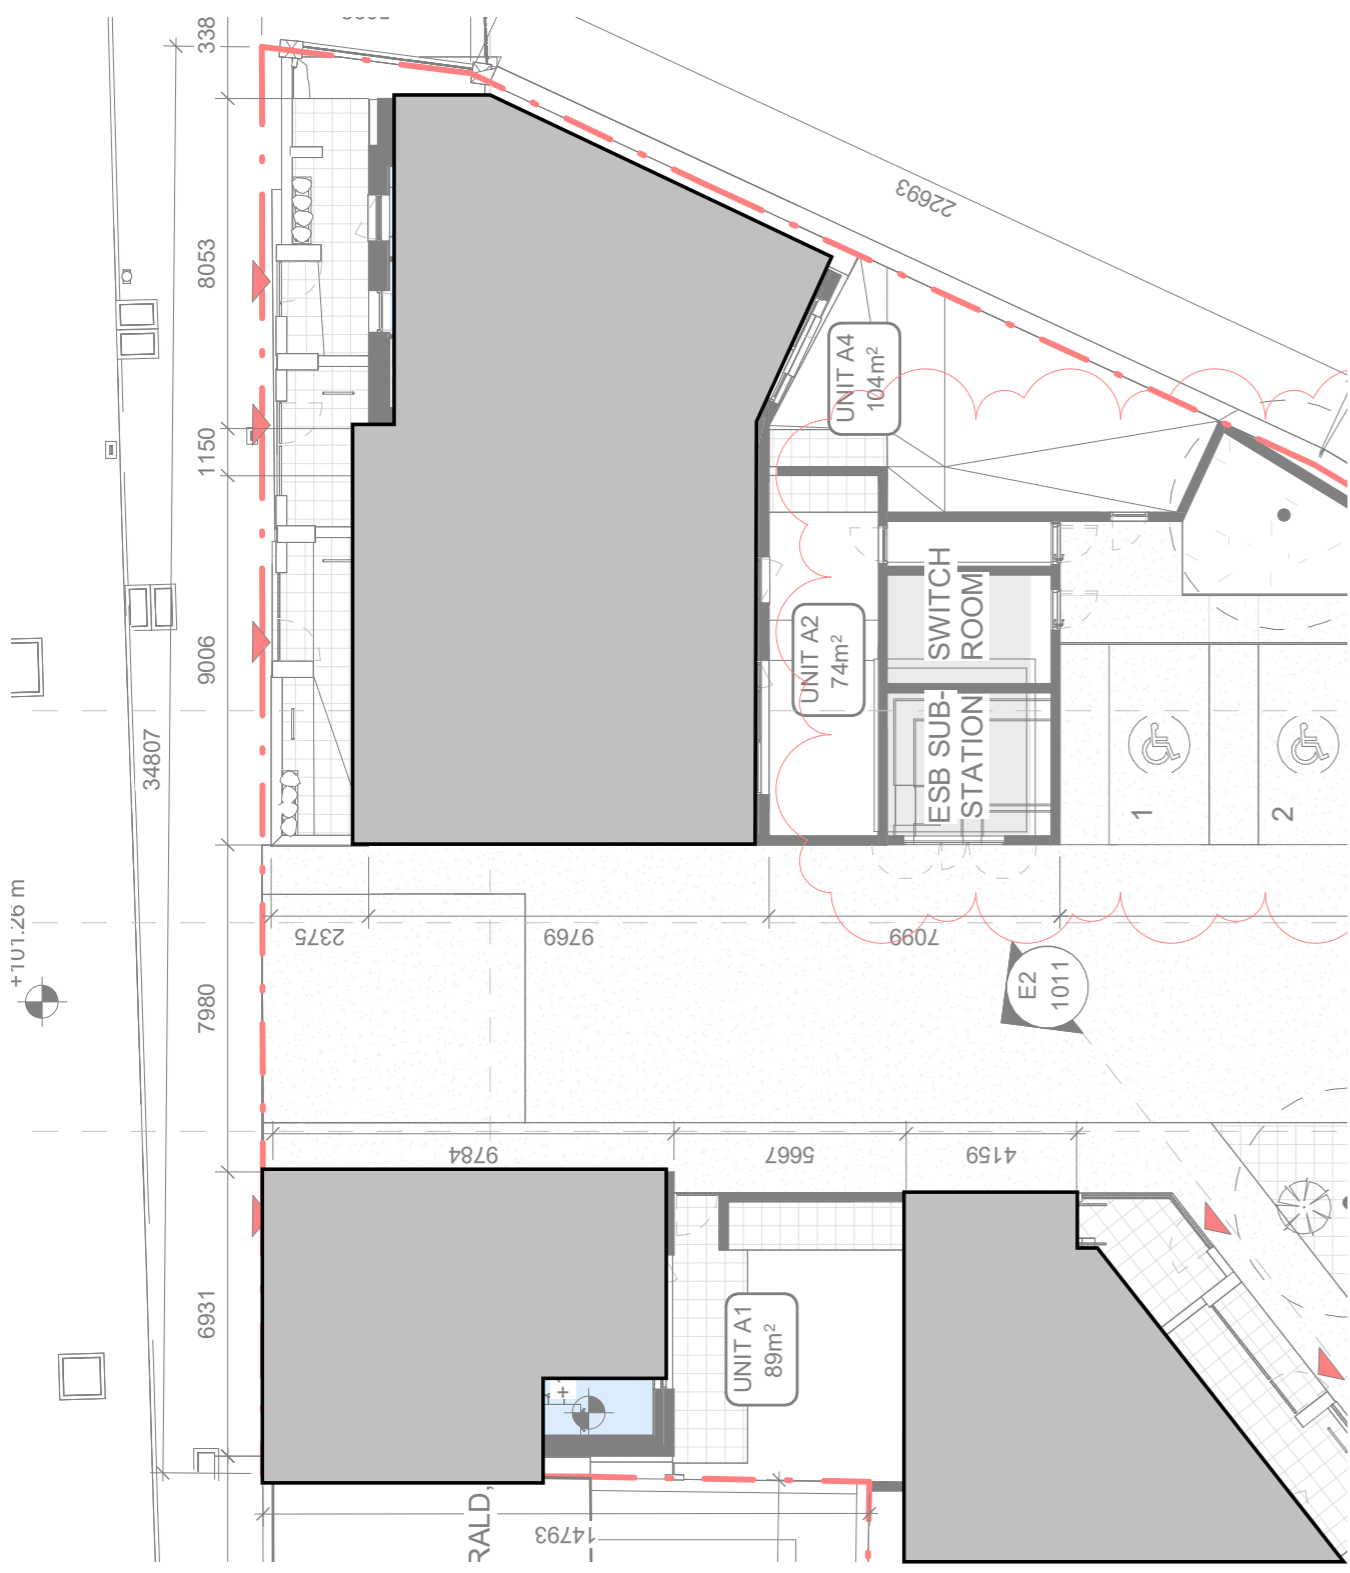
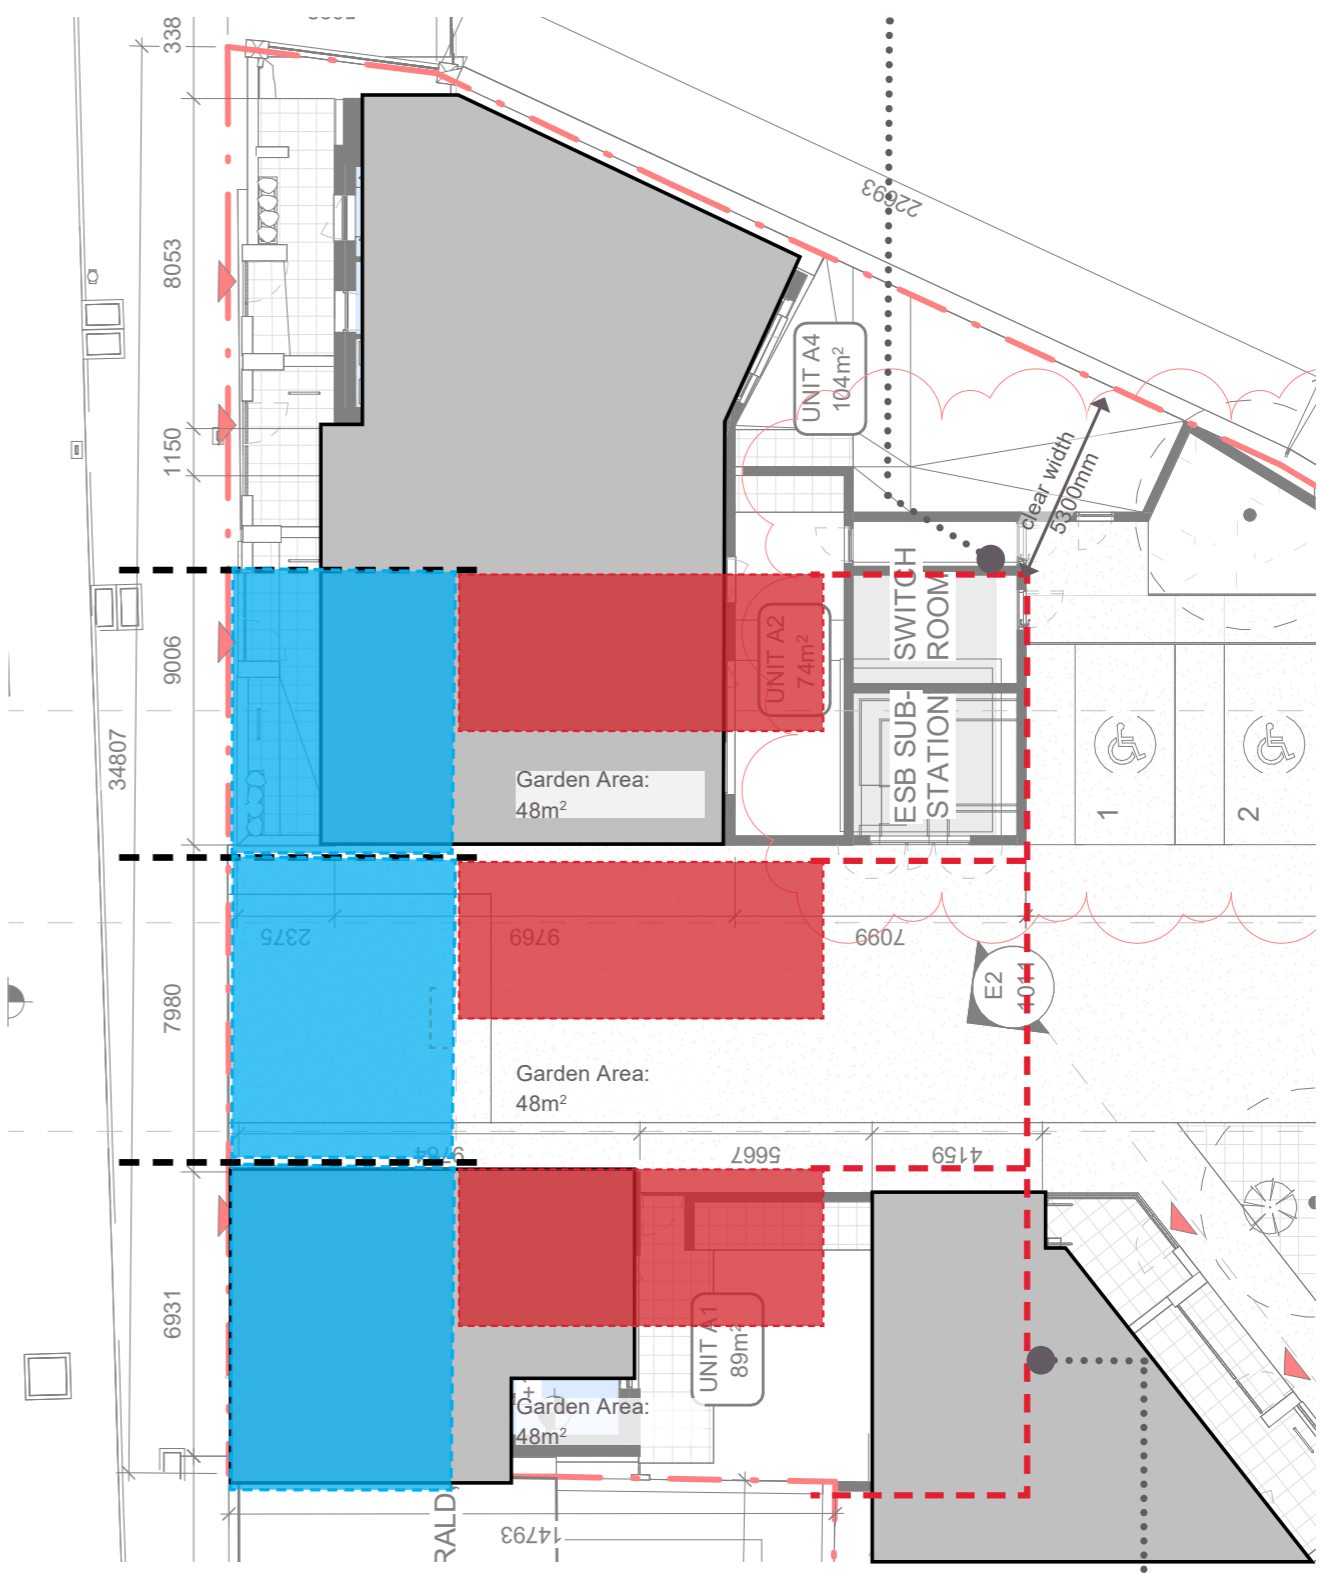
Redesigned entrance required - available clear width of 5300mm is not DMURS compliant and makes no allowance for pedestrian access.

Access involves a blind corner creating a safety hazard for all residents

Minimum garden size would require redesign of the corner duplex unit and central public open space

New extension of approx 30m² required to achieve minimum 1 bedroom unit area - 55m² as per the Kildare County Development Plan 2023-2029.

Orange line indicates extent of required dry lining, minimum thickness 160mm comprising 2no. 70mm breathable insulation boards fully bonded to external walls and finish coat of breathable lime plaster. Approximate loss of habitable area is 2-3m² per unit.

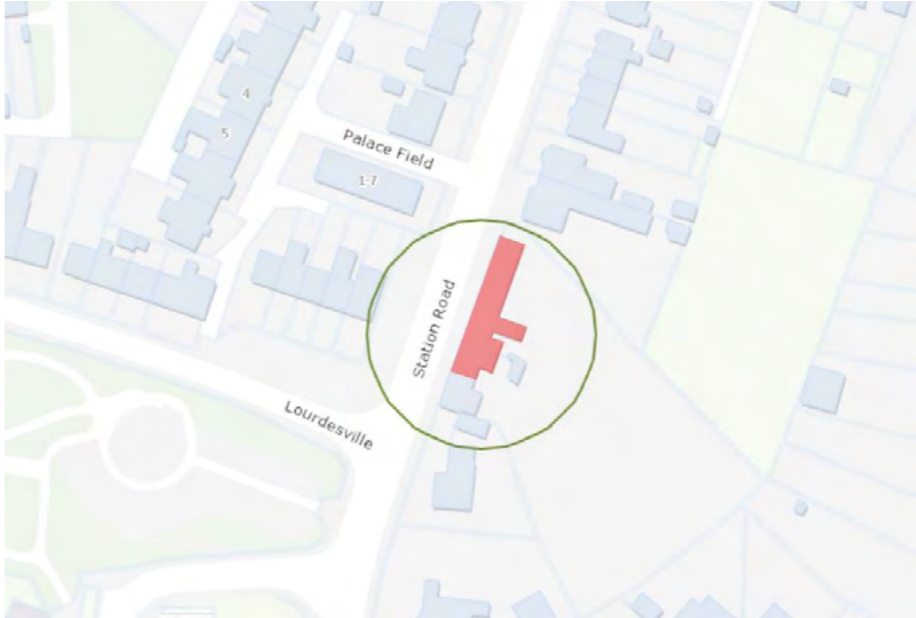
An embodied carbon assessment has been requested for Kildare County Council to assess the feasibility of maintaining the existing cottages on Station Road in Kildare. These cottages may require partial demolition to provide access to the site of the proposed new development, An Triantán. Following a brief, non-intrusive site inspection on 4th October 2023 it was observed that the condition of the existing cottages is very poor with ceilings collapsing, suspended floors rotten, and widespread damp issues.

Figure 1: Hatched polygon showing the location of the proposed demolition of cottages on Station Road.
