Preliminary Damp & Timber Decay Report

Kildare Public Library RPS: B23-41

10th January 2022

Re: Damp & Timber Decay Survey - Kildare County Library, Newbridge, Co. Kildare.

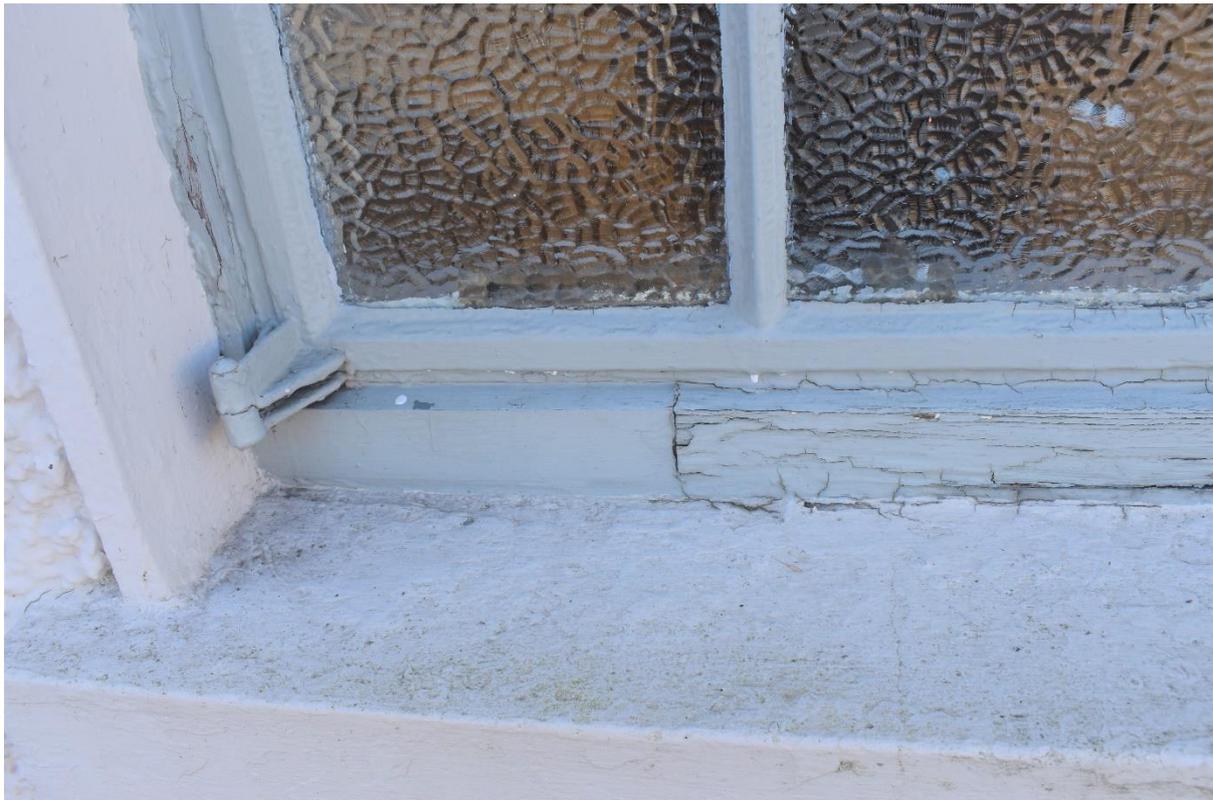
We have not inspected all windows as part of our inspection but have noted that most windows are set into a timber subframe. The subframes are generally in poor condition and should be thoroughly reviewed by the window specialist conserving as much of the original fabric as practically possible. Furthermore, we have noted timber bonding plugs installed in the concrete to facilitate the window fixings. The timber plugs that we uncovered at a high level were in poor condition.

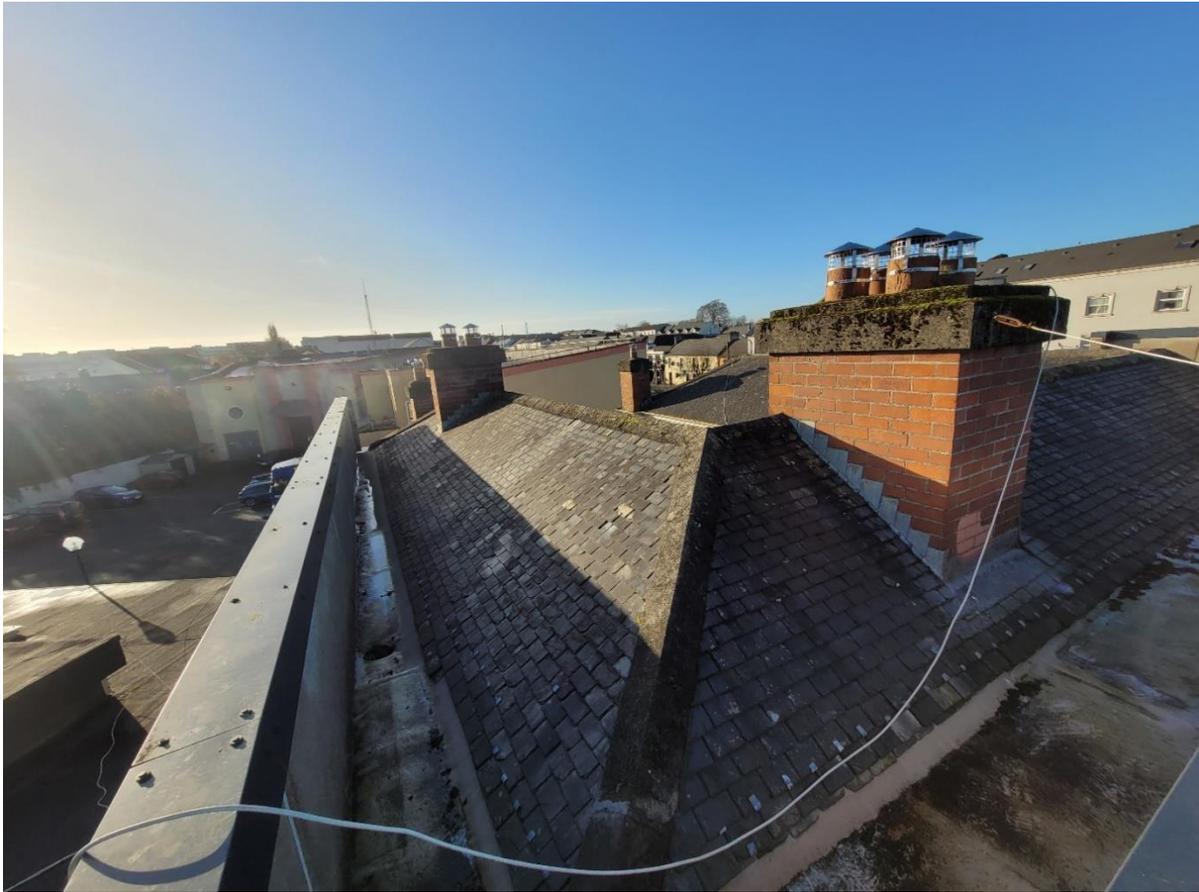
Figure 35. Showing the roof at the southeast corner looking west

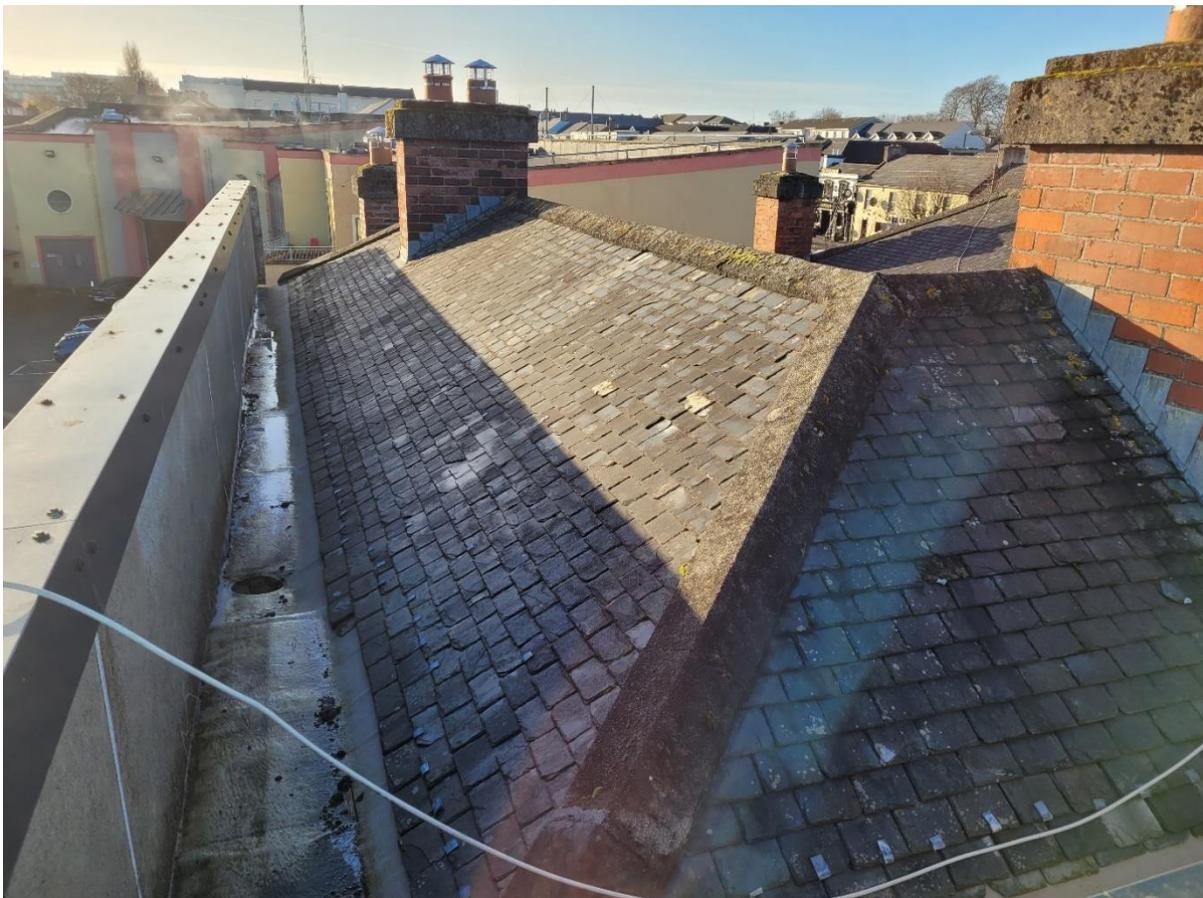
Figure 36. Showing a closer view from the southeast corner.

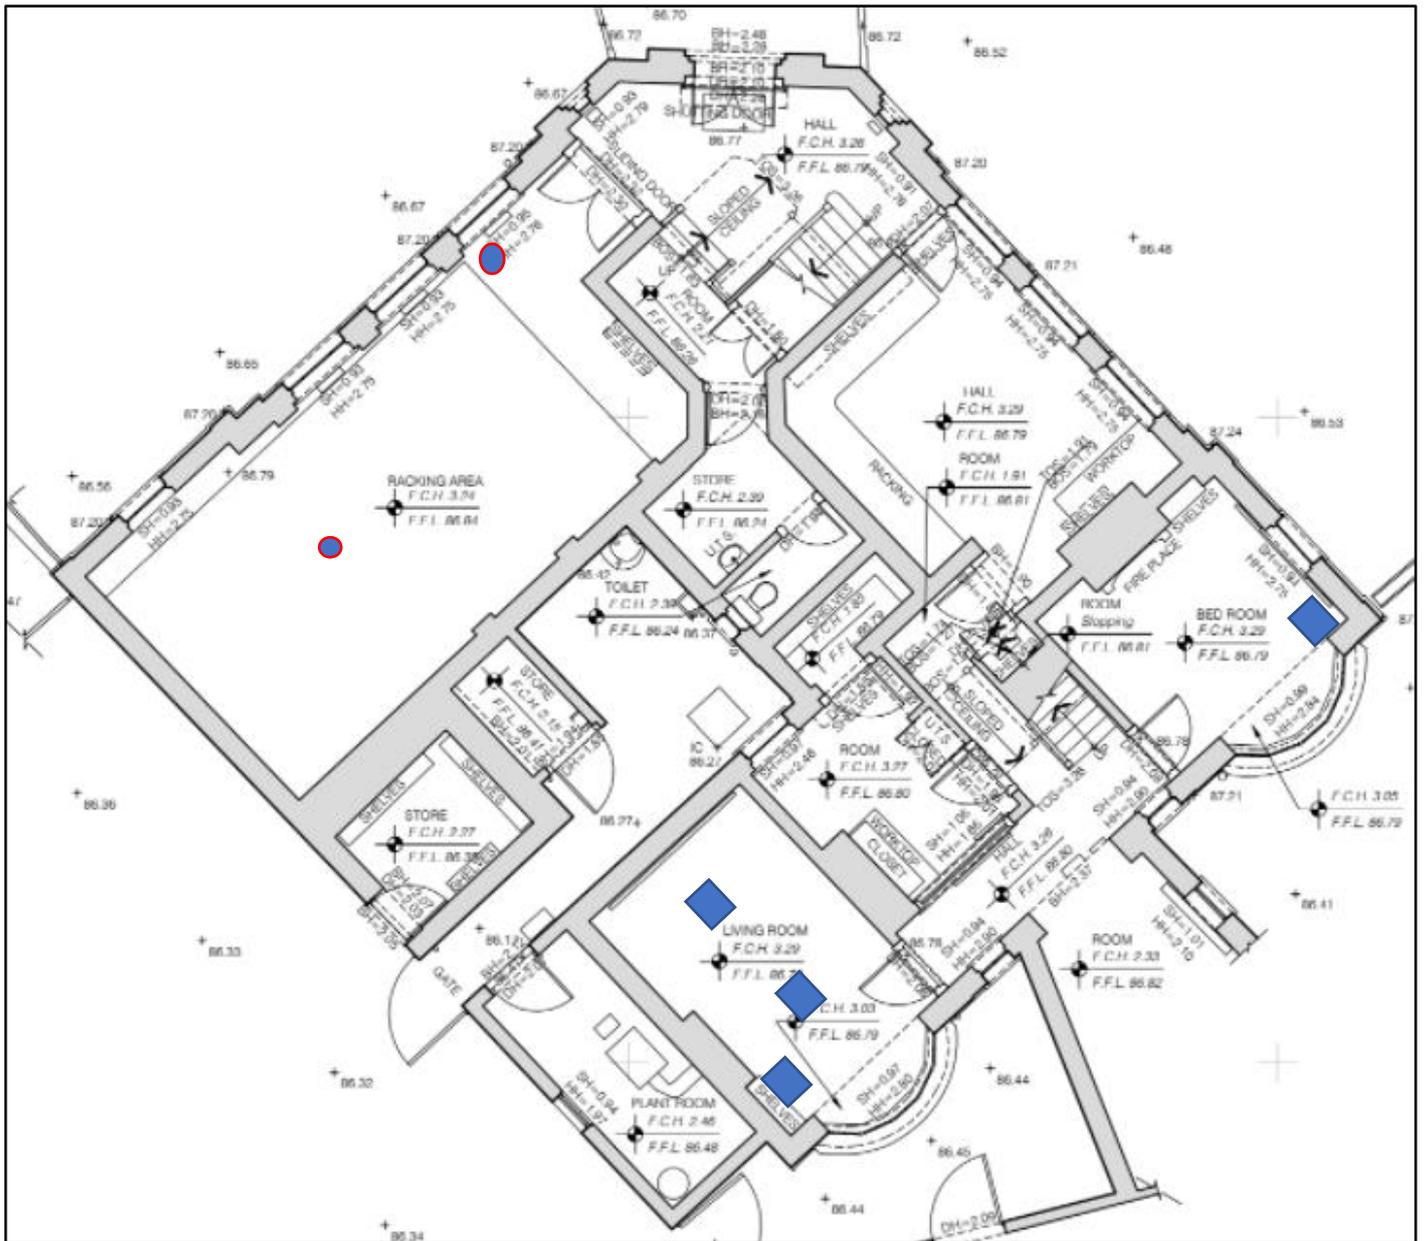
Figure 39. Showing the ground floor plan. We have marked up the areas opened up by PJ Barrett in a Blue Square and circle, where we drilled the floor in the Book Repository room.

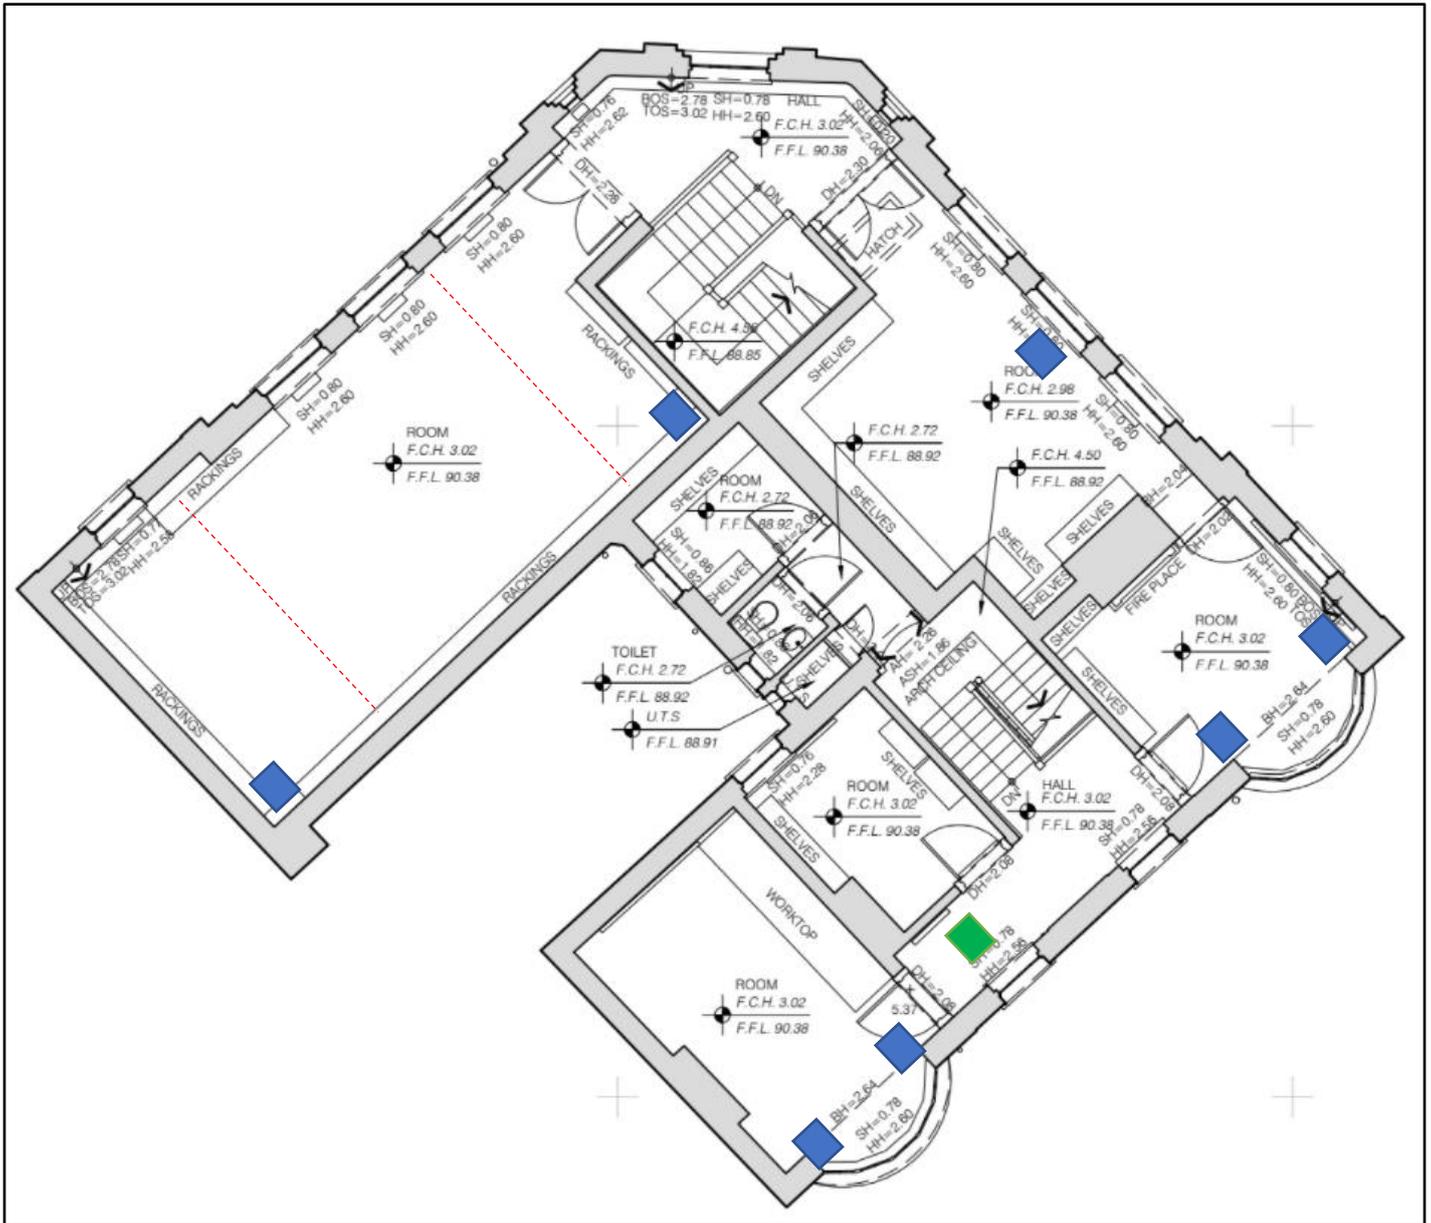
Figure 40. Showing the first-floor plan. We have marked up the areas opened up by PJ Barrett in Blue and in green, where we opened up a new hatch to access the attic. The Red dashed line represents the approximate location of the steel UB sections supporting the floor joists.
