# Wonderful Barn

## Leixlip, Co. Kildare

**Architectural Heritage Impact Assessment (AHIA) Report**

May 2024

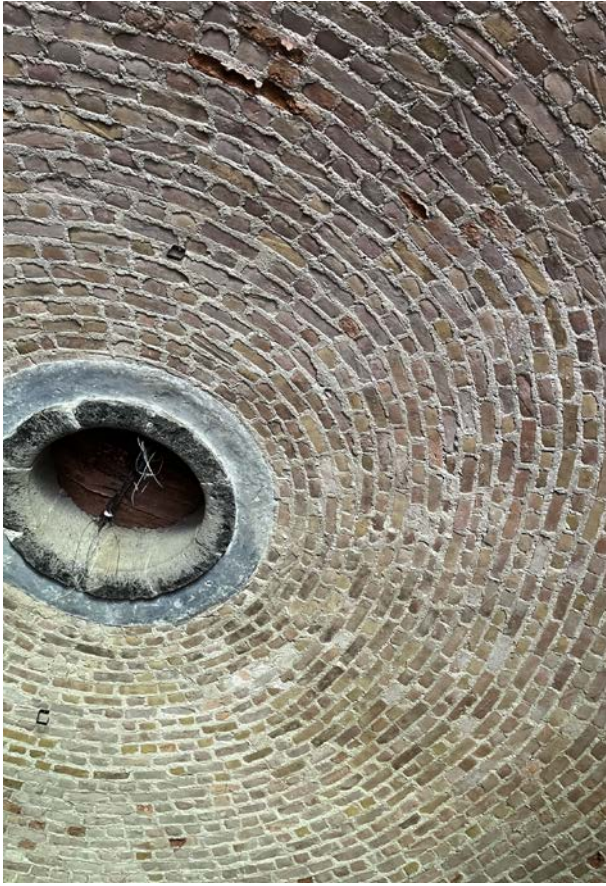
Figure 15 - The vaulted brick ceiling of the ground floor with central opening for grain

Internally the structure is a remarkable display of fine brick vaulting, with an outer skin of rubble stone, (fig 15) which for the most part is dashed with lime and sand. On the more exposed westerly face, the exterior is also covered with vertically hung, grey-green, slates like those quarried at Killaloe (fig 16). Projecting stone gargoyles drain the open platform at the top of the stairs, and dripstone weather mouldings are located above all the doors and windows openings. A projecting stone stringcourse runs around under the window sills on each storey and the top of the solid balustrade of the staircase is stepped, adding an extra dynamic to the upward spiral movement.

As the main structural repairs to the barn have been completed, there is no longer a structural risk, although further conservation works are necessary throughout. The internal brickwork, within the ground floor in particular is starting to degrade (fig 36), and the removal of cement pointing should be undertaken. A minor leak is evident in the entry way which should be investigated. Repairs are required to many of the small window openings. Externally the vertical slating, added to the southeast portion of the structure has started to come loose and detach.

Previously completed conservation works to the barn have ensured that it is generally in stable condition, with minimal evidence of weather ingress. Repairs are required to the internal brickwork on all levels, along with minor repairs to the wall openings and floors. The removal of the cement floor at ground floor level will be undertaken to determine if the original floor could be revealed throughout (fig 47). The application of a lime coat, to consolidate the remaining slate on the southeast facades, will preserve what remains of this interesting weathering feature. Re-opening of the northeast doors will also be undertaken, which will reinstate the link between the park to the front of the barn and the yard to the rear.

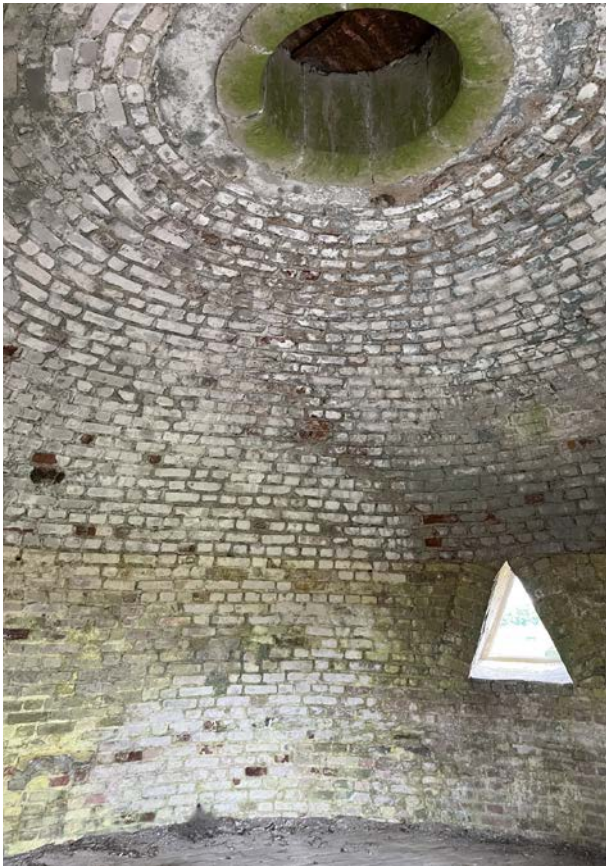
Figure 17 - The first floor chamber

preservation, as a testament to the durability of traditional masonry construction, that has never suffered the damaging consequences of extensive re-pointing in hard, cement-rich mortars (fig17).

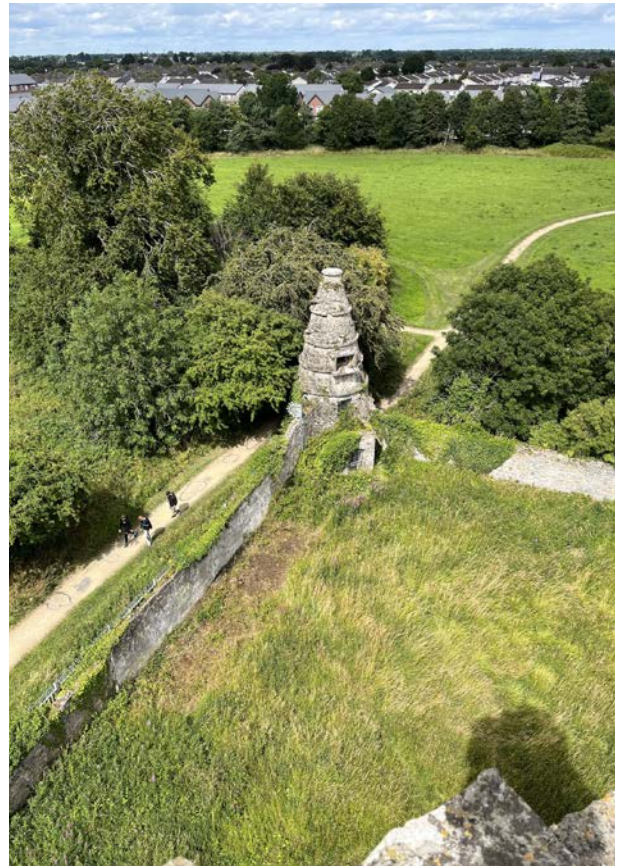
Figure 18 - One of the pigeon houses (dovecote)

The barn stands at one corner of a rectangular, walled courtyard, on two of the other three corners of which are found conical dovecotes (fig 18). These are built in a similar manner to the barn, in rendered rubble-stone with roughly hewn stone dressings. They stand two and three stories high, with domed ground floor chambers entered through doorways in the side of the external stone staircases, which in turn lead up to the domes first floor rooms. The western structure has a top storey that consists of a tall cone-shaped volume lined with a honeycomb of nesting boxes accessible only by a small square opening at high level, framed by deeply projecting stone dressings. A series of four stone string courses of shallower projection, encircle the upper half of each one, terminating in a flat circular cap. Triangular stone edges for the pigeons to land on are supported on triangular stone brackets. The eastern structure was previously believed to have been badly vandalised and in need of repair works,

as there is no corresponding top storey, and the nesting boxes and string courses are crudely constructed, often with jagged sections of stone. However, following further inspection, it is now believed that the interior of this structure was simply constructed with less care and skill than its counterpart to the east.

The dovecotes require a programme of repairs which will include removal of vegetation, consolidation of masonry, careful steam cleaning and full repointing throughout, which should be executed by an experienced heritage contractor. These works will be undertaken over the course of the summer of 2024.

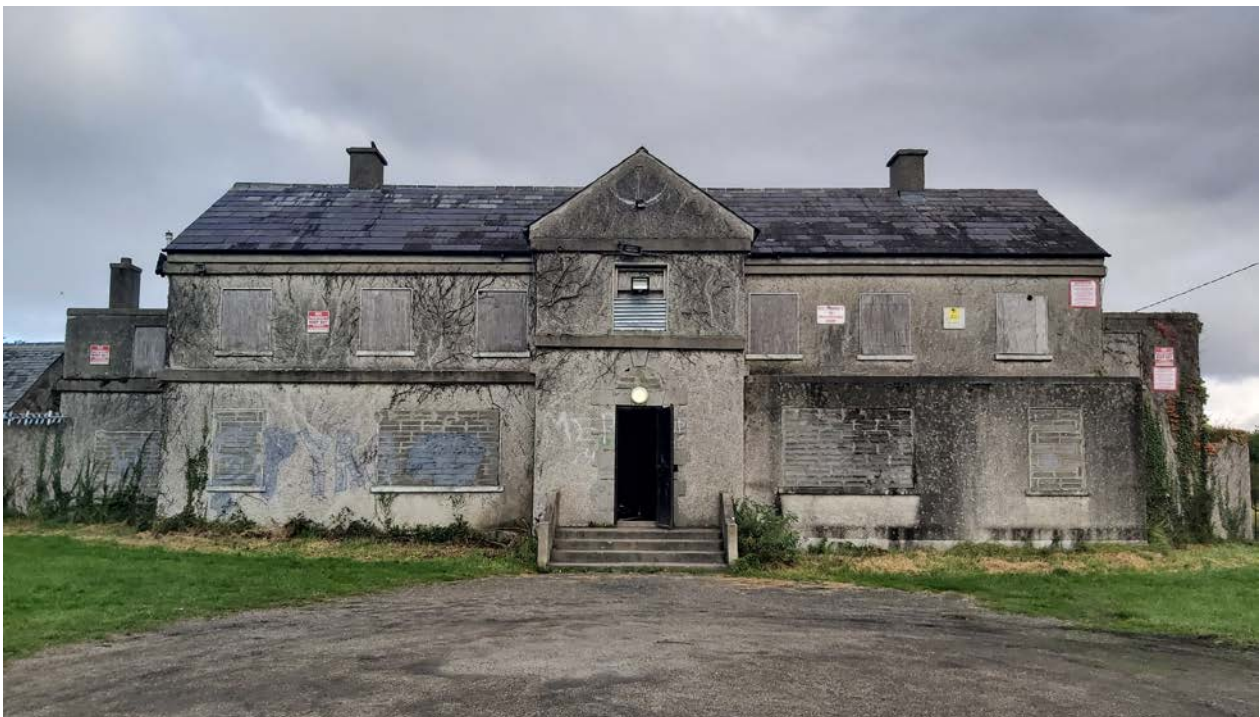
Figure 20 - Front elevation of Barnhall House

The house, as it stands is a seven-bay, two-storey structure with central pedimented breakfront (fig 20). A similar breakfront occurs at the rear elevation, with an identical limestone door surround, but is placed off-centre (fig 21). The roofs are covered with natural slates and when compared with the historic photos of the house (fig 10), we can see that a second storey has been added to the flanking projections either side of the house.

The external walls appear to be of rubble stone construction, with a projecting string course at first floor level. A corbelled stone cornice is continued across the face of the gabled breakfront, creating a simple pediment. The external walls and string courses have been given a coating of hard cement-rich pebble-dashed render.

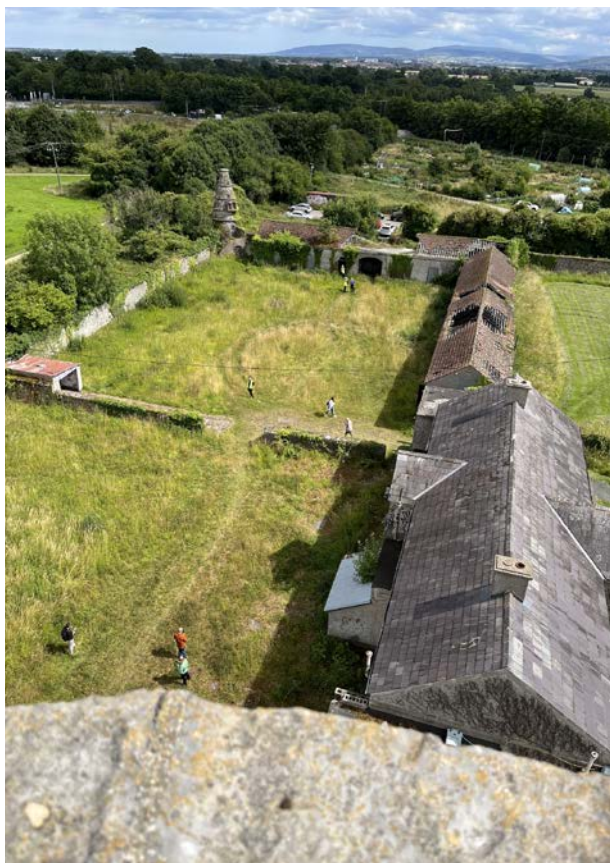
Figure 26 - Aerial view of the stables with Barnhall House in the foreground

These two structures probably date from the late eighteenth or early nineteenth centuries. They consist of two, two storey ranges, one running roughly east to west and the other north to south (fig 26). A carriage way occurs in the centre of the north to south range (fig 27), which appears to have contained barns or storage sheds. The east to west range contains numerous openings that suggest it once served as stables. Neither building is accessible at present but from a first inspection, it is clear that concrete first floors have been added to all the north south range and part of the east west range.

In addition, both structures have, (like the house) been coated in a cement rich dash, all of which should be removed. Headroom, generally restricted on the ground floor of these buildings, may restrict their use unless significant alterations are carried out. The first floors also have limited head height, particularly within the north-south stable range where the upper floor is a hay loft, within the roof space. The original slate roof coverings have been replaced with cement tiles, and are in an advanced state of collapse, but the walls of the buildings are in a reasonable state of repair and could readily be renovated to give them a useful future.

These historic structures have changed little since the three phases of works to the barn and the house, apart from the two ranges of out-buildings in the western courtyard, the roofs of which had deteriorated badly. These roofs are now beyond repair and at risk of complete collapse. It is not possible to access much of the interior though some parts are still accessible. The east range (running north-south) contains historic stalls for horses, (fig 39) which are in poor repair, with a small hay loft above. The interiors are in poor condition, with ongoing water ingress.

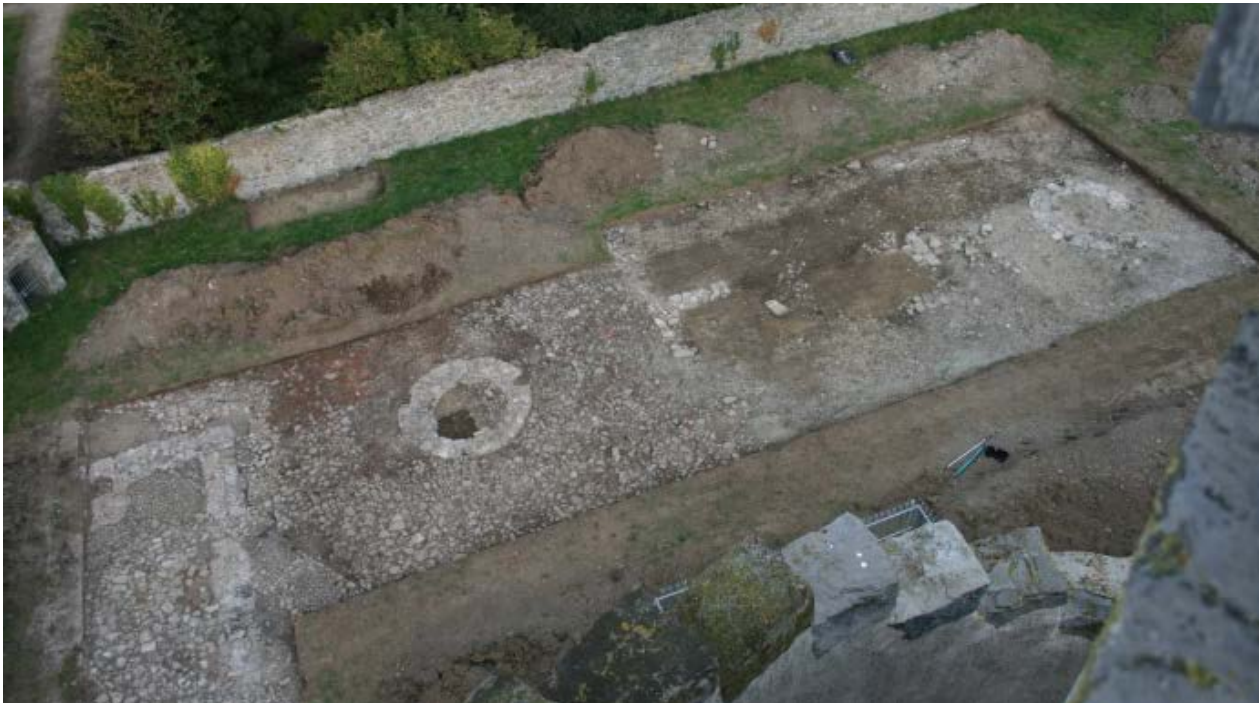
Figure 31 - The excavated area to the north of the barn

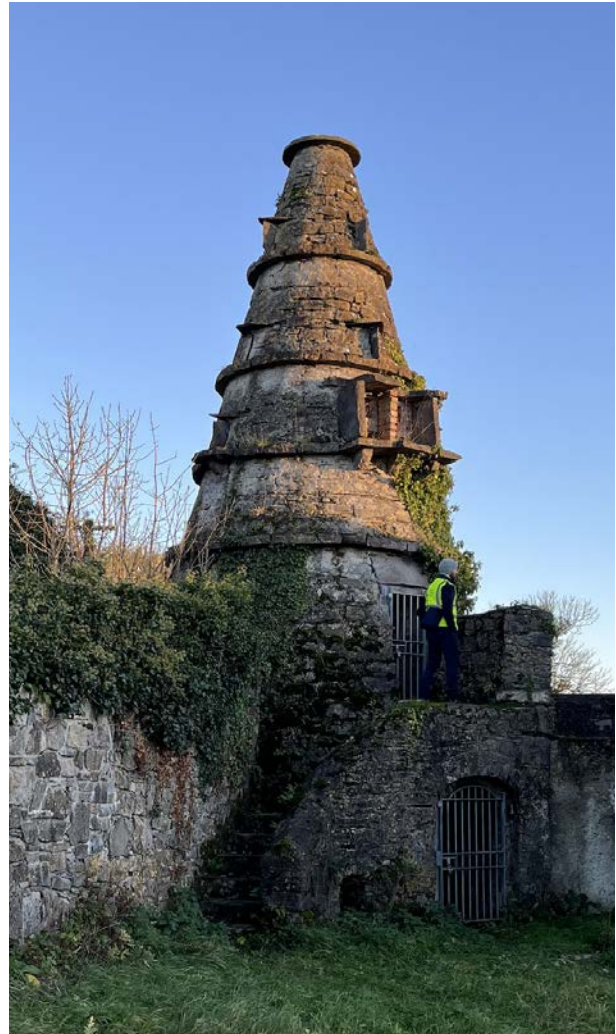
Figure 33 - The pigeon house

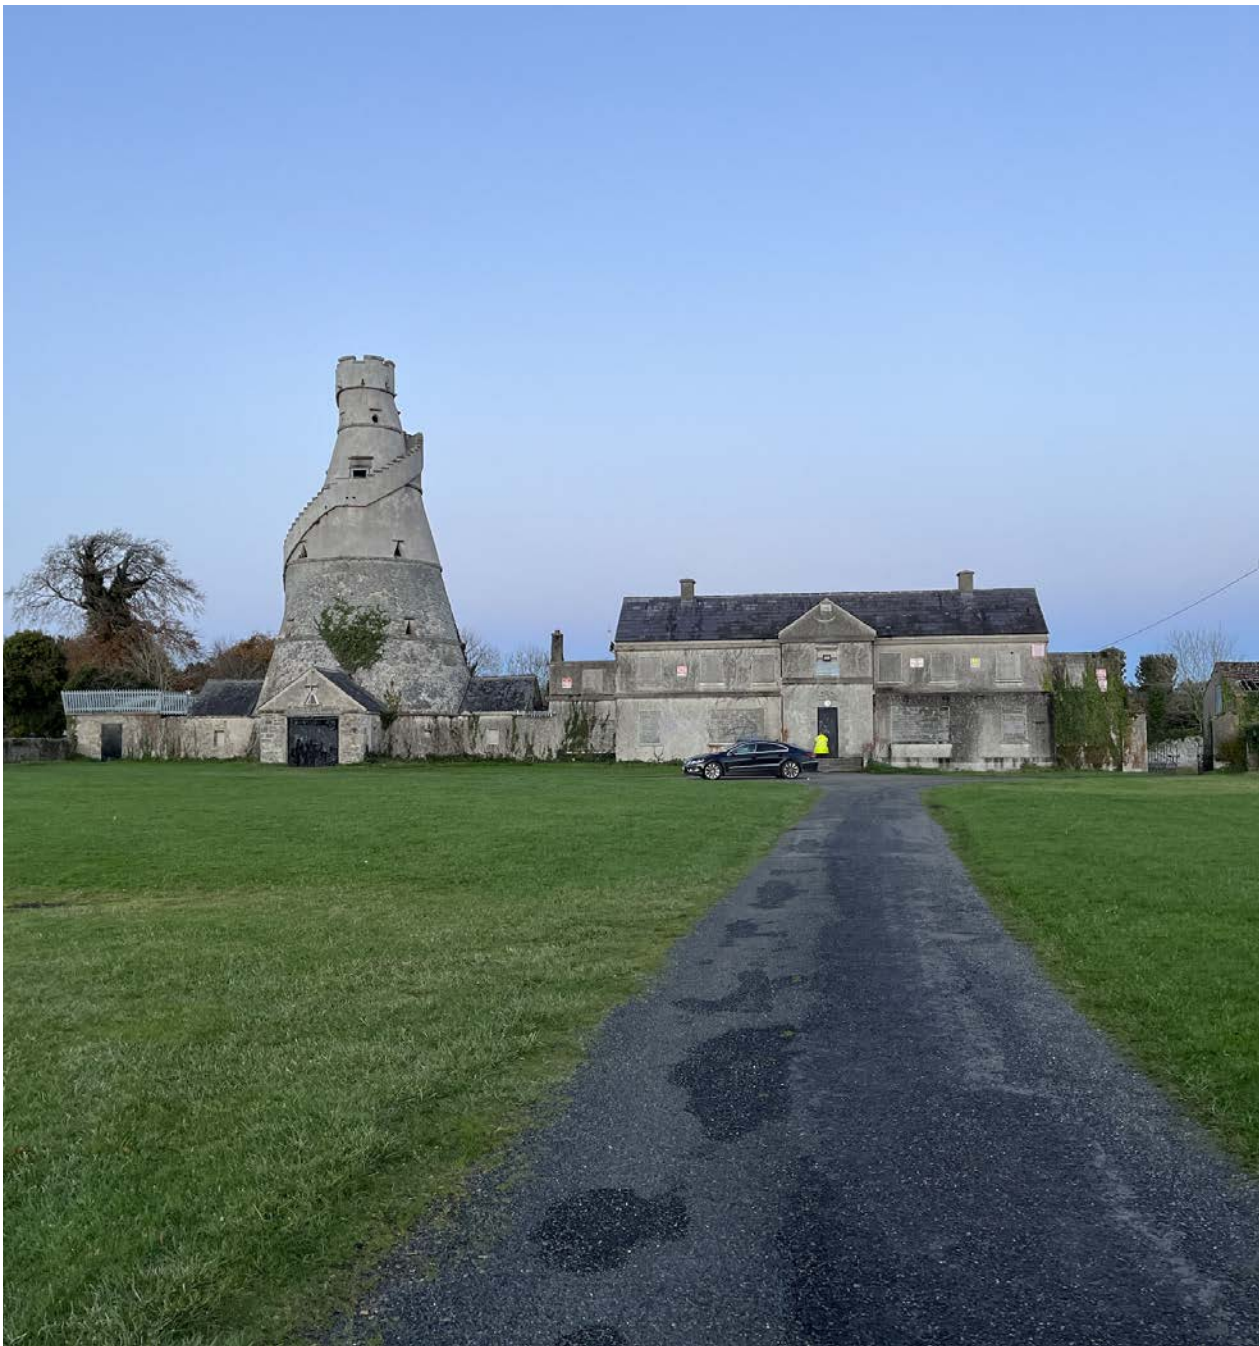
style of landscape design widely referred to as the 'natural style.' Castletown was one of the first great landscapes in Ireland to be laid out in this fashion and like the magnificent Conolly's Folly, that closes the vista on the northern access of the house, the Wonderful Barn is a very significant part of this design. Based on the historical, architectural, designed landscape and social importance of the place, the Wonderful Barn complex is most certainly a place of national significance and possibly an historic place of international significance (fig 34).

Figure 34 - The Wonderful Barn and Barnhall House

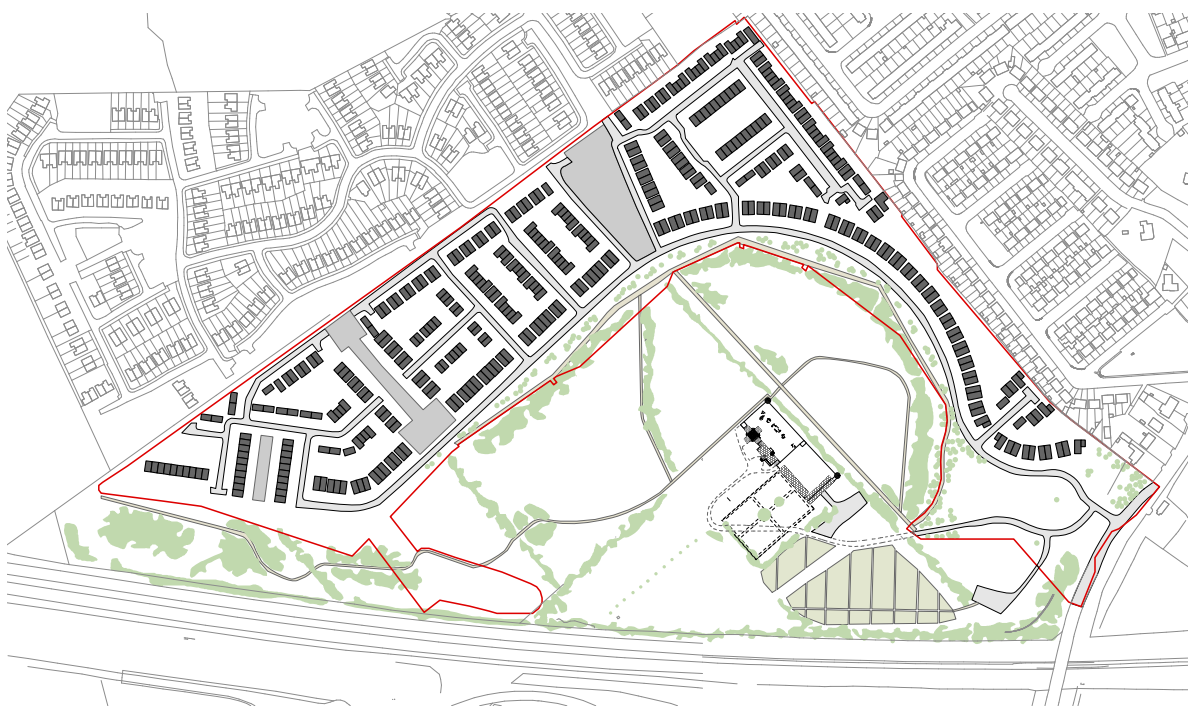
Minor improvements to the setting of the building complex have resulted from the large low-density, residential development that encompasses the north and east sides of the wider site area (fig 43). This development numbers 450 dwellings, the closest of which lies some 190 meters from the building complex. The visual impact of these houses on the Wonderful Barn complex is not significant and there are also several positive benefits from the development. Of these the most important is that the lands between the new houses and the building complex, together with the building complex, are now owned and managed by Kildare County Council (fig 44). A second benefit is that the large number of new residents who have moved into the area have improved security and will avail of any proposed community use for the Wonderful Barn site.

Figure 43 - Existing site plan with housing development (based on planning drawings) shown around the site

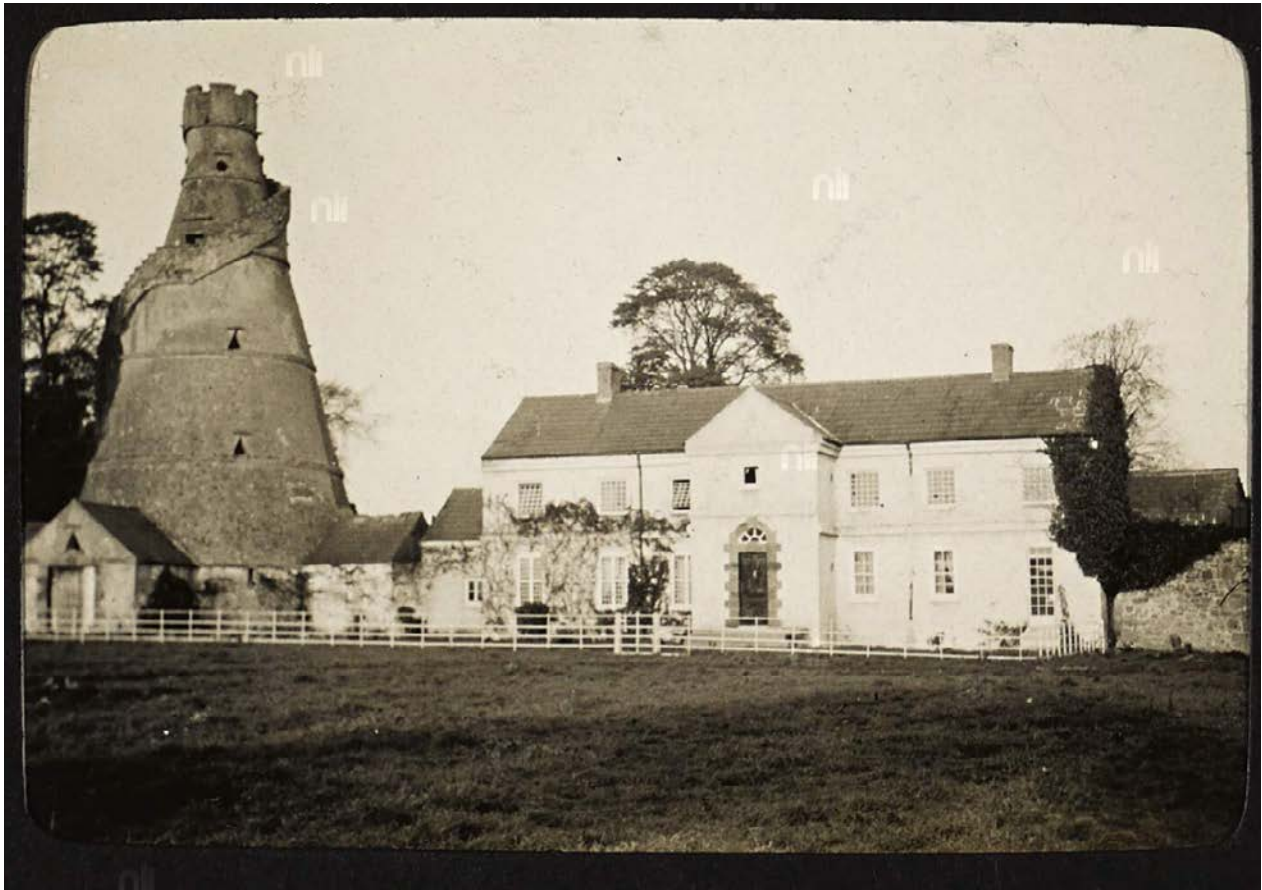
Figure 48 - Barnhall House Dorothy Stokes Collection 1940-50 (NLI)

Careful demolition of modern elements to the house including the external corridor to first floor rear facade, the single storey extension to front, and first floor extensions to rear flankers are proposed to be undertaken. This will bring the house back to its historic configuration and allow for the reinstatement of the historic windows across the front façade. The house was heavily modified during the latter half of the twentieth century, its general form and fenestration arrangement was intact as late as 1950, (fig 48).
