BALLITORE TANYARD

Conservation Architect's Report

Date: 24th March 2023

Ref.: 23-308

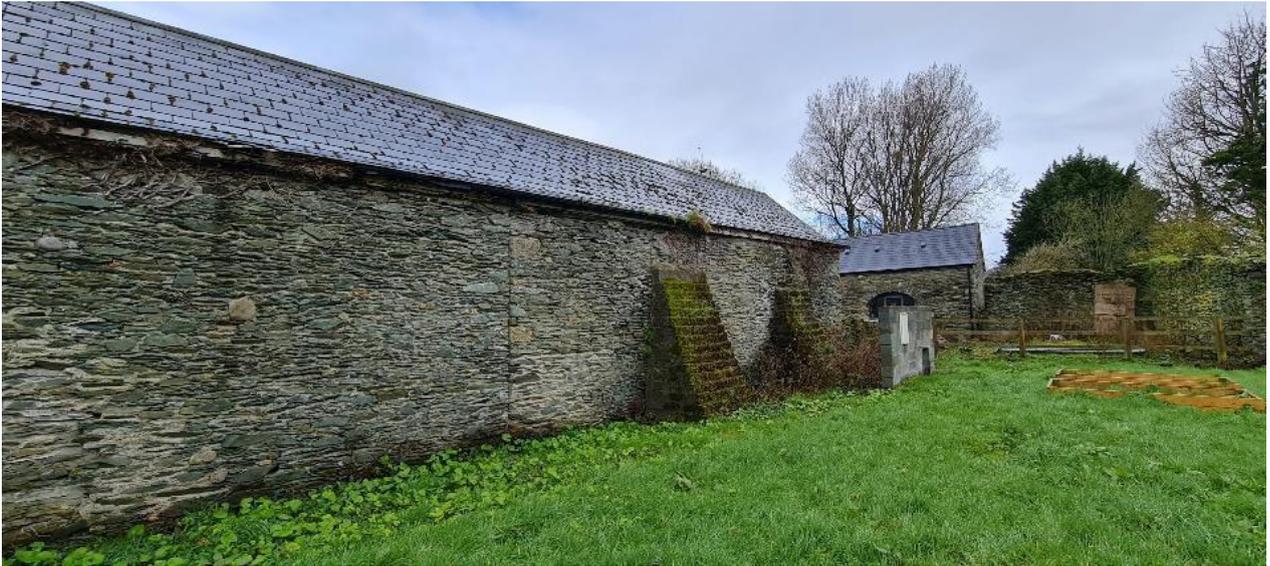
Fig. 6 Rear (east) façade of Building No. 2, showing vertical joint between two phases of construction and stone rubble buttresses at north end of building. The enclosed yard to the east of the building includes raised planting beds, recently used for the planting of vegetables.

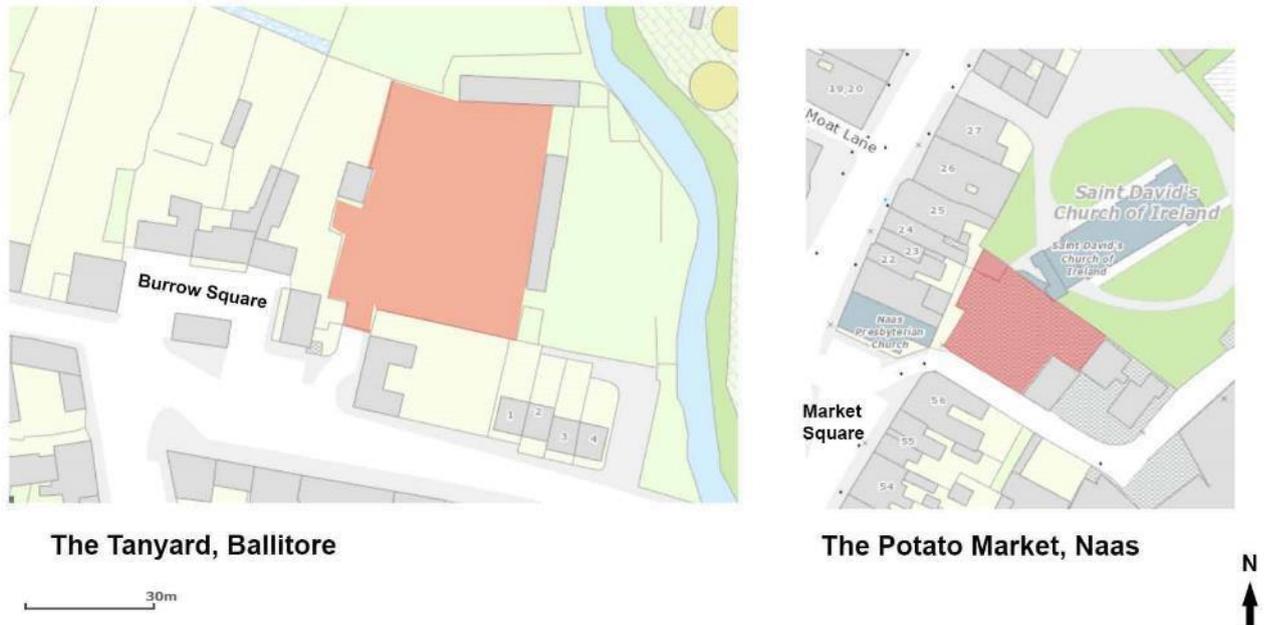
Fig. 18 Comparison of size of the Tanyard relative to the recently completed Potato Market in Naas

Fig. 18 (above) illustrates comparative size of the existing (undeveloped) Tanyard and the former Potato Market in (the much larger town of Naas), which was successfully restored to use as a public space for a farmer’s market and public performances in 2022. This comparison clearly indicates that that existing open space within the Tanyard is too large to be effectively transformed to use as a functional community-based public space. Consideration should be given to the introduction of additional new buildings, together with a clear delineation of open space uses (parking, central public space, community playground, and soft landscaping) as part of any masterplan for the site.

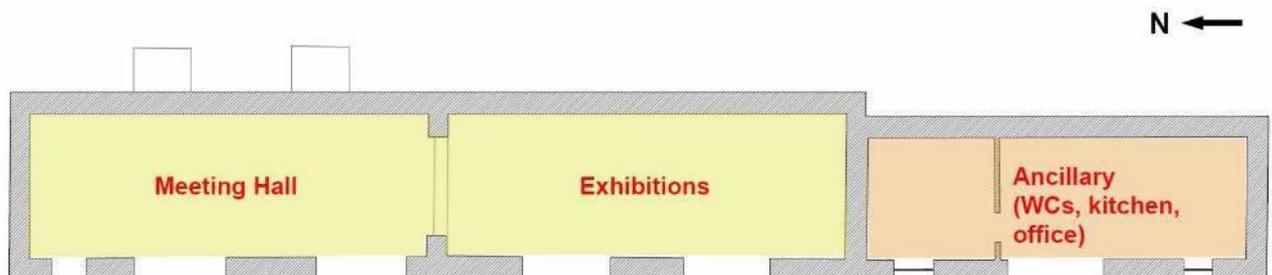
Fig. 21 Sketch plan (not to scale) showing subdivision of Building No. 2 as community-based venue for meetings and exhibitions

The alternative of a community-based anchor use is considered more appropriate to the importance of the building within the heart of Ballitore. The open-plan layout of the existing building makes it suitable for a range of community-based meeting and exhibition type uses, with the potential for ancillary accommodation (toilets, kitchenette, etc.) in the southern part. The large elliptical-arched openings would be fitted with glass doors, giving good connectivity to the centre of the yard (fig. 21).
