# Conservation Management Plan

Clane Abbey Community Centre

Final Nov 2023

For Kildare County Council

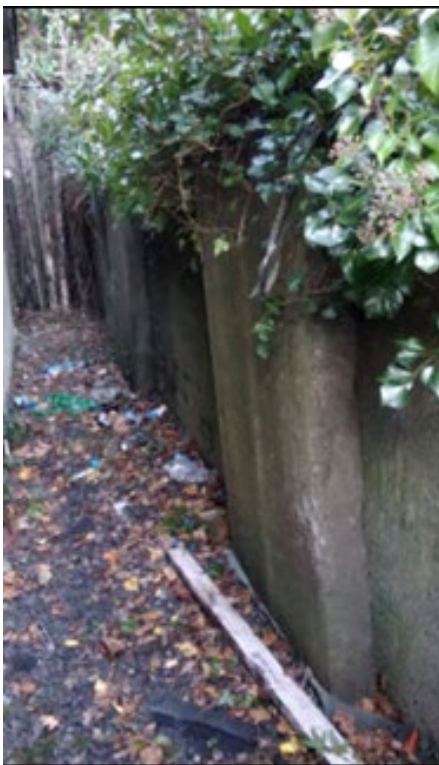
and modern extensions, including an oil tank and free-standing sheds are located in the north-western quadrant; there are two gravestones positioned on the inside (east) face to the western boundary wall (Plate 2.3) and a further two against the eastern outside faces of the apse and vestry walls (Plate 2.4). It is unclear if these are in-situ positions.

**Plate 2.3** *Gravestone along west wall of NW quadrant*

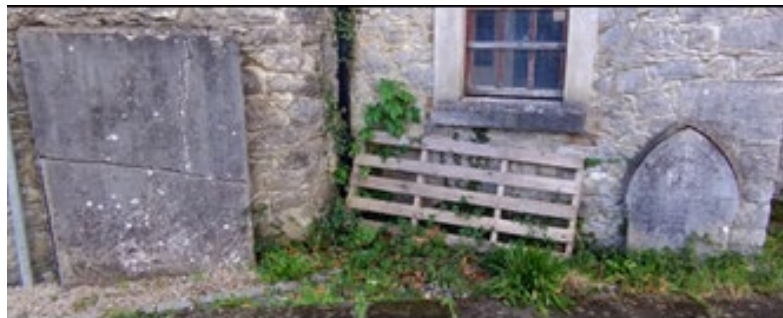
**Plate 2.4** *Gravestone along east face of apse and vestry – NW quadrant*

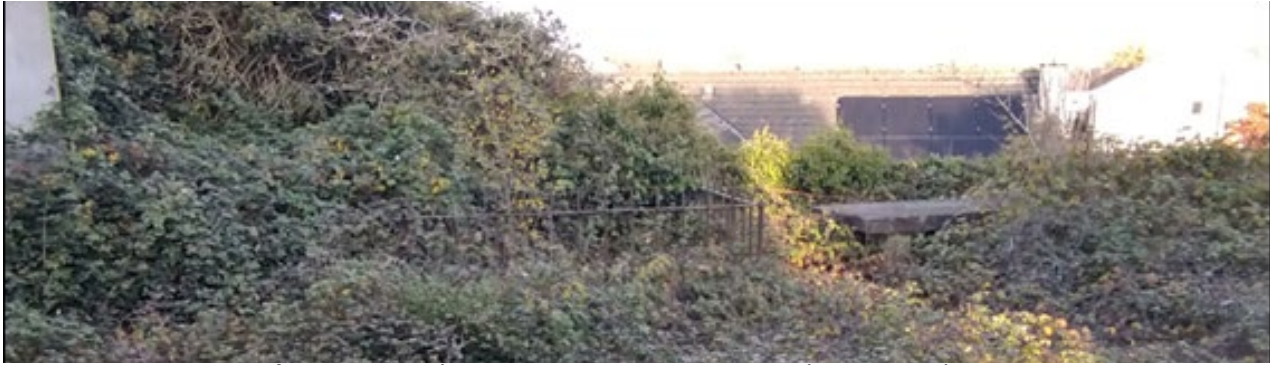
The north-eastern quadrant includes the Wogan Tomb (SMR No: KD014-026007) described above and an overgrown area to the immediate north/northeast surfaced with loose rounded beach cobbles and includes a square-railed tomb and a table-top tomb (Plate 2.5); a further railed-tomb is positioned to the northeast of the Wogan Tomb, adjacent the boundary wall, with two further gravestones inserted into the ground adjacent the inside face of the boundary wall (Plate 2.6). A few other gravestones are dispersed randomly along the eastern and south-eastern boundary wall (e.g. Plate 2.7), all of which are probably ex-situ in the south-eastern quadrant; with a further nine along the western wall in the south-west quadrant (Plate 2.8), some of which may be original in-situ positions.

**Plate 2.5** *Tombs in overgrown area in northeast quadrant*

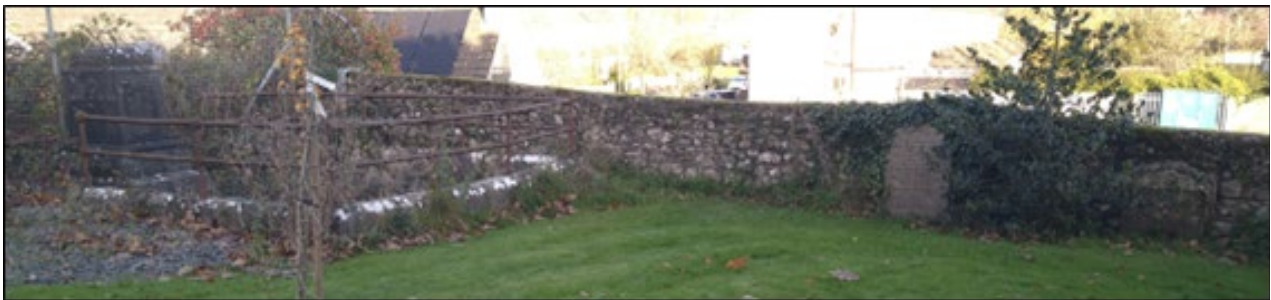
It is unclear when the gravestones were moved to the periphery of the graveyard, although it is likely that such work was undertaken during the 1985 church renovations. Furthermore, the surface was probably levelled and grassed at this time also.

**Plate 2.6** *Tomb and ex-situ gravestones to east/north-east of Wogan Tomb*

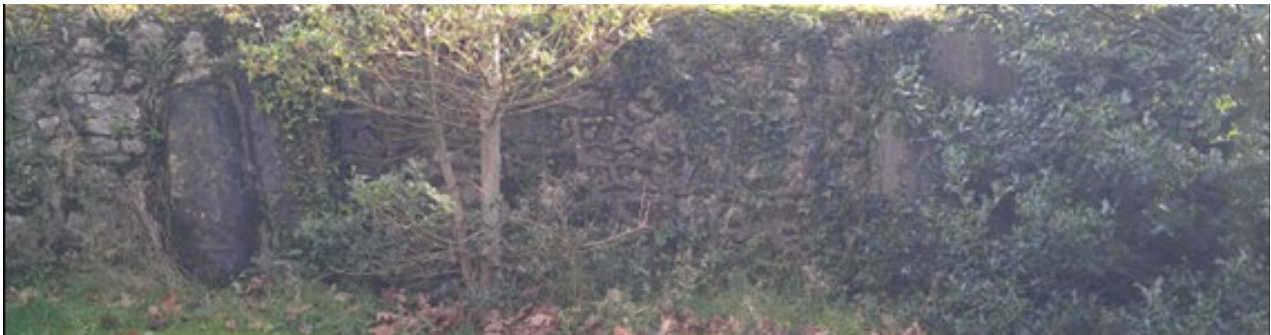
**Plate 2.7** *Example of ex-situ gravestones along south-eastern wall boundary*

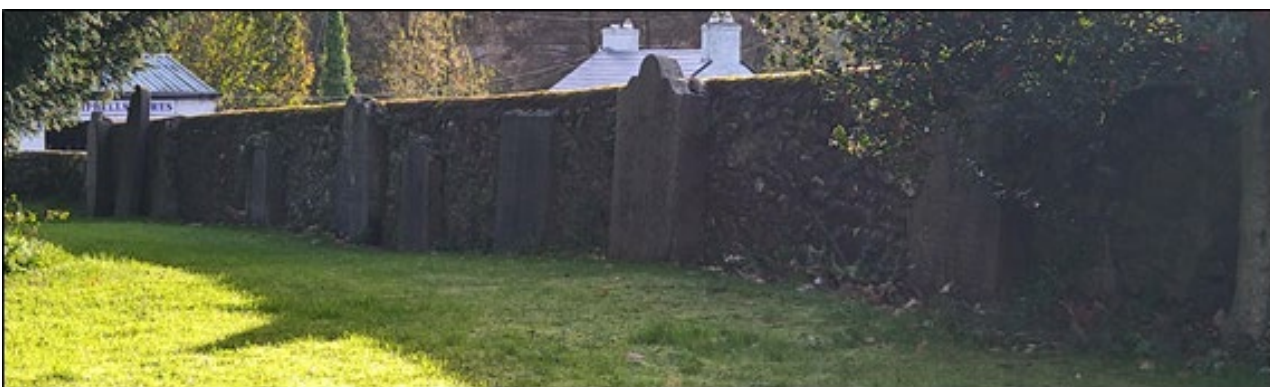
**Plate 2.8** *Gravestone along western boundary wall in southwest quadrant*

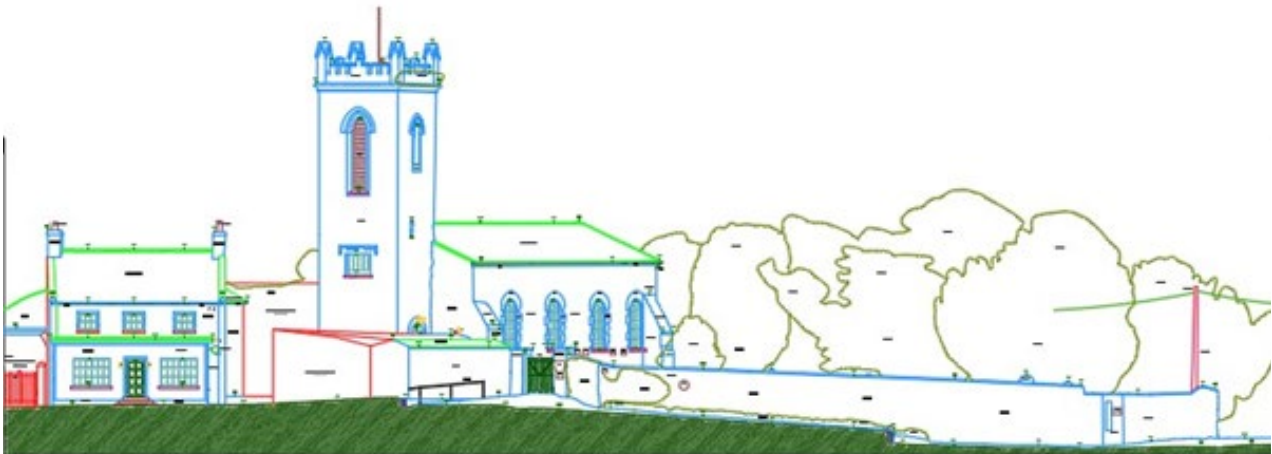
**Figure 6.1-** *Measured survey drawings of contiguous West Elevation, showing Cashes' house and sheds at low level to the tower.*

There are no planning exemptions for the erection of the storage sheds to the rear, the internal fences and hard standing areas, signage, plaque erection or monument erection since 2003, and no evidence that planning was sought on any of these items. A retention planning permission could be sought in conjunction with a new development if necessary. Any removal or dismantling of structures would also require a methodology to be discussed with National Monuments. A lot of the graveyard enclosure walls to the rear have had sections replaced with blockwork so careful dismantling by hand needs to be agreed where the original 18th century retaining walls are affected.

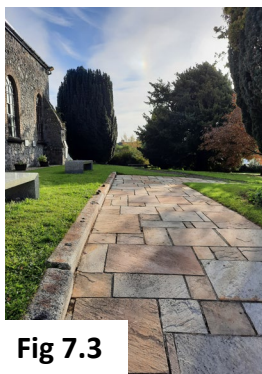
**Fig 7.3**

The graveyard itself is accessed through a high walled enclosure and is used by many within the town for dog walking or just a quiet meditation area, with the gates opened most mornings. The existing tower is obscured by later corrugated sheds to the base of the western elevation. Planting obscures the original entrance as it is now within a private garden. The adjoining house and former school building are contemporaneous with the 18th century church and should be considered within the curtilage of the protected structure. The burnt out historic school structure remains un-roofed a decade after a fire and it bounds the western wall. The dilapidation of both it and the adjoining buildings is highly visible in the centre of the town.

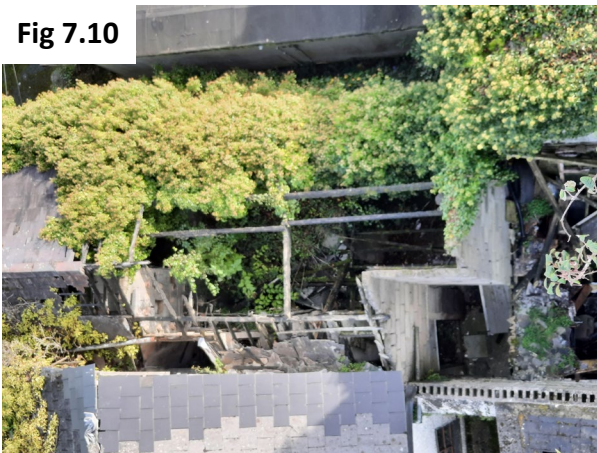
**Fig 7.10**

The issue of the adjoining land uses needs to be fully explored. The area to the north west, in private ownership, comprises a burnt out structure originally in use as a school house. This structure, on the first ordinance survey in 1837, is shown attached to the Parish Church and is linked to the house now in the private ownership. This boundary is a stone wall inside of which a concrete block wall has been placed (creating service access issues). Heavy ivy growth is impacting on both structures.

**Figs. 7. 10 & 7.11** Burnt out structure parallel to western boundary wall in private ownership.

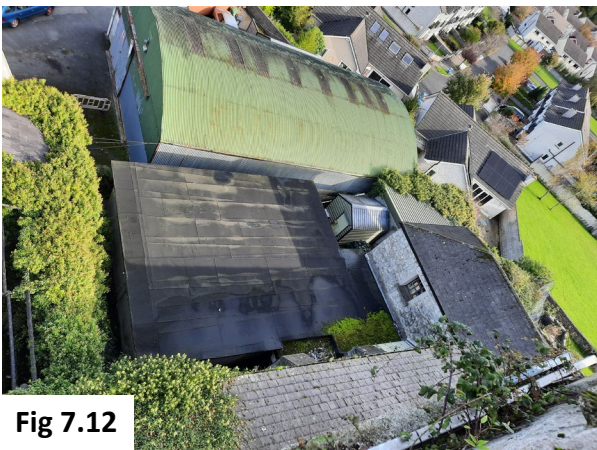
**Fig 7.12** showing lighting track to the top of tower as well as proximity of metal Dutch barn shed.

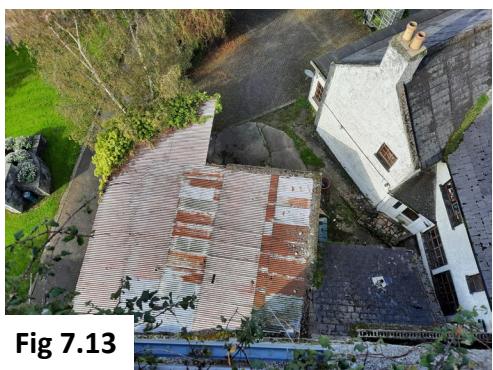
**Fig 7.13**

**Fig 7.13.** corrugated sheeting to old stables beneath tower provide difficulties with providing scaffolding to repair the tower.

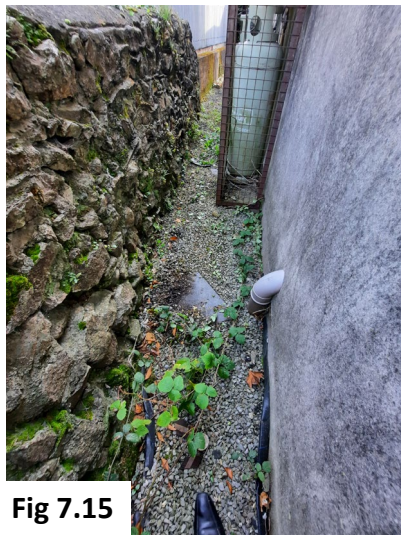
**Fig 7.15** Restricted access around Evergreen Centre makes moving the gas cannisters or accessing the Diesel tank or servicing very awkward .

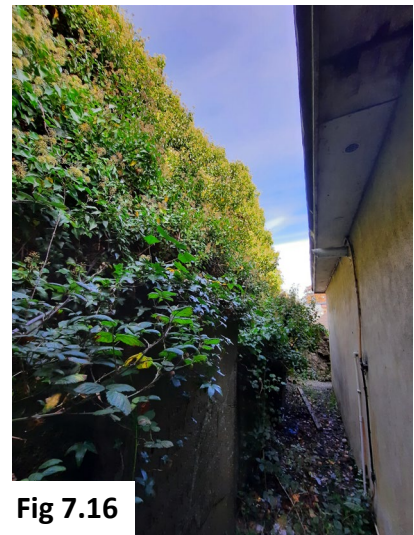
**Fig 7.16** The condition of the adjoining burnt out schoolhouse structure is fueling plant growth over the base of the tower.

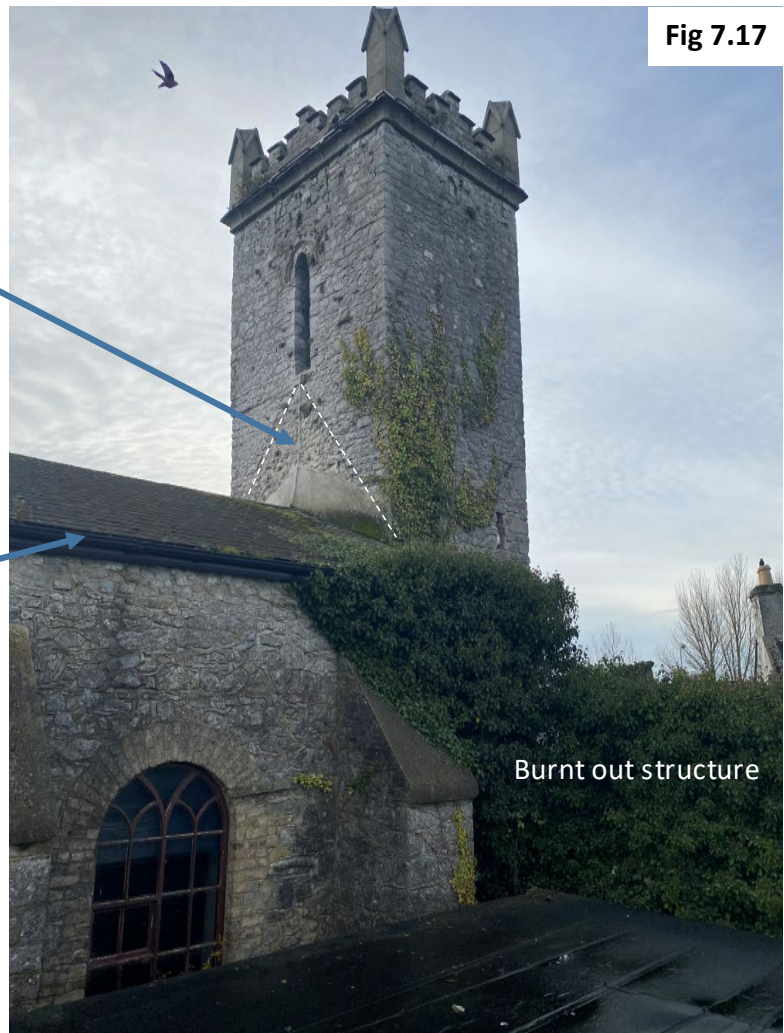
**Fig 7.17**

**Figure 7.17 Tower from flat roof**

*Shape of Original roof visible over later sand cement flashing.*

*Gutters and roof in this location full of ivy.*

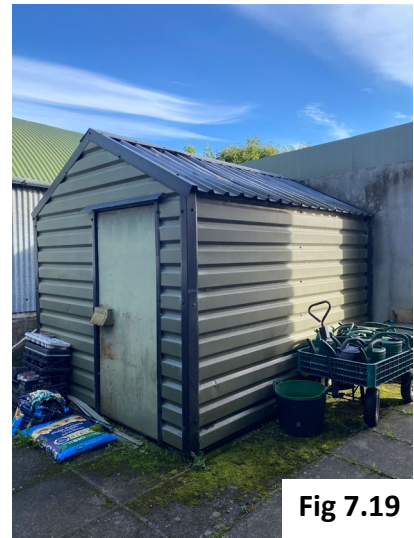
**Fig 7.19**

The area around the flat roof extension is very constricted. Fig. 7.19 shows the metal storage shed which is in use by the musical society for overflow storage. It is likely that no permission was sought to erect it and it is sitting on a concrete slab. The area used as a service area is enclosed by a wire fence and locked gate, and also encloses the remaining 19th century graves as well as a second more permanent rendered concrete block shed (Fig.22). This is in use by the Tidy Towns as storage for maintenance equipment etc. for their work in the town (Fig 21). The following issues should be addressed:

- Difficulty in servicing of metal fuel tank or its replacement
- Lack of bund under tank
- Difficulty in maneuvering gas tanks into location (Fig.20)
- Difficulty of access to boiler house and unkempt nature of the use to the adjoining boundary with a burnt out building etc.
- Storage sheds and lack of permission for their erection

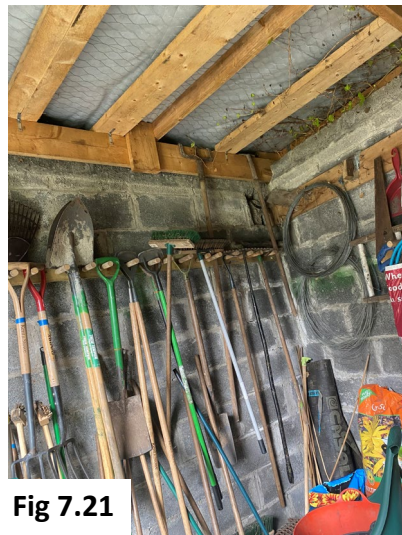
**Fig 7.21** internal block shed

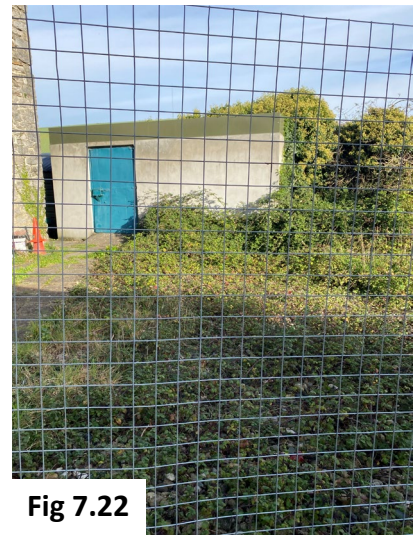
**Fig 7.22**

The Tidy Towns storage shed is located within the fenced enclosure, with a locked pedestrian gate to the rear (Fig 7.22) and access is by a key holder. In fact, when the measured survey was carried out some of these areas could not be unlocked for measuring. There are several key-holders, some being 4 or 5 council members and others such as members of the musical society and the Evergreen group. The locking of the entrance gates is done on an informal rota basis.

**Fig. 7.22** service fence and external storage shed.

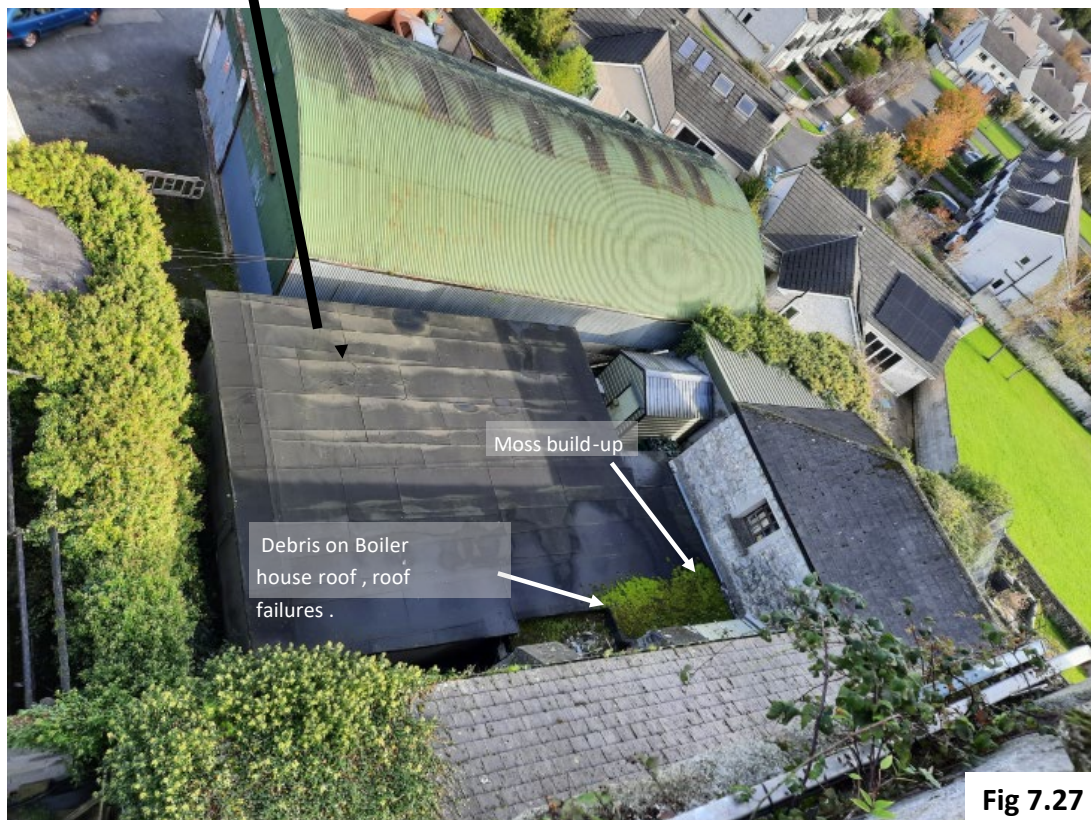
**Fig 7.27**

The previous re-felting of the roof appears to be inadequate with some ponding evident. The edges of the roof over the fascia have possibly not been completed or there are missing gutters leading to saturation of the adjoining areas.

*Ponding and crazing of the roofing felt surface seams, caused by lack of fall, the substrate re-used, and crazing caused by lack of movement joints*

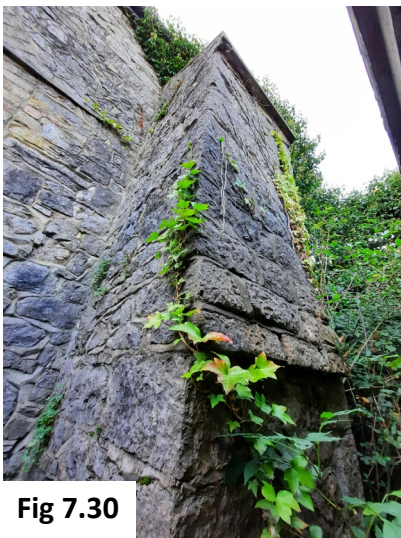
**Fig 7.30**

To the rear of the building the ivy growth has grown over the roof and gutter so that the gutter is no longer functioning. Sections of the main roof gutter have twisted or have become clogged with plants which has caused the gutters to dip. There are also points where plants have grown over the roof and ivy is bypassing and clogging the gutters which encourages more plant growth. There are downpipes missing and slipped so more heavyweight gutters and downpipes are needed along with gully traps.

**Fig. 7.30** *Buttress with ivy growth*

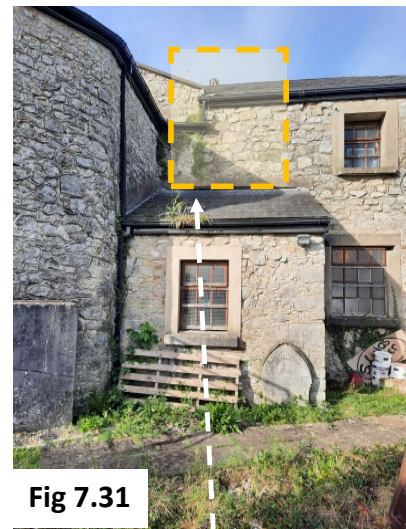
**Fig 7.31**

**Fig. 7.31** *Rear slipped downpipe*

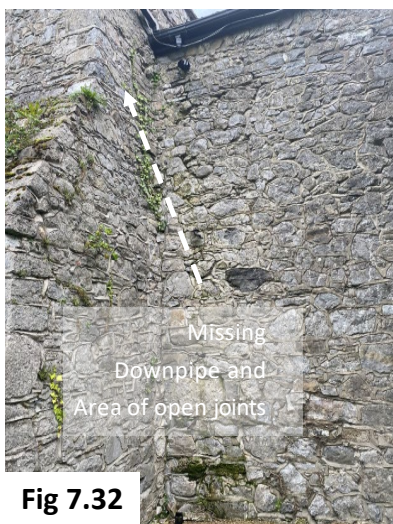
**Fig 7.32**

**Fig. 7.32** *Rear missing downpipe*

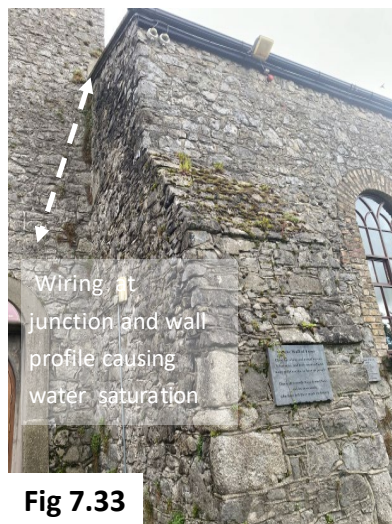
**Fig 7.33**

The barges to both ends of the roof are concrete with possibly an issue to the western end caused by wiring over the barge. Refer to Fig.7.33.

**Fig. 7.33** *Buttress and gable wall near entrance*

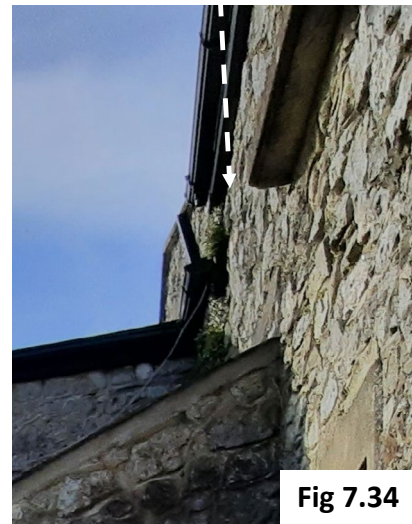
**Fig 7.34** *Dislodged outlet as Fig 7.31*

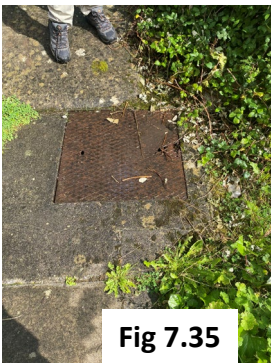
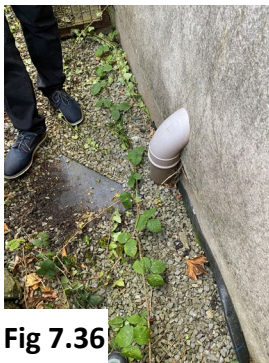
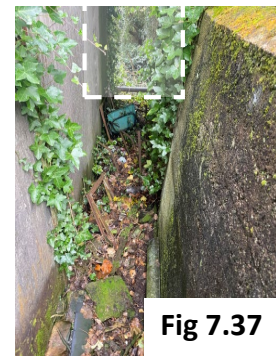
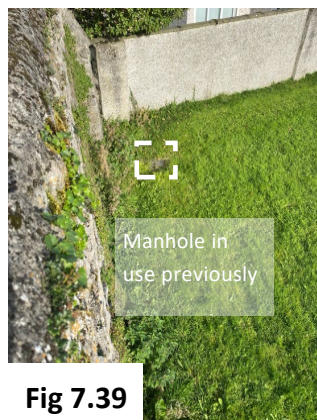
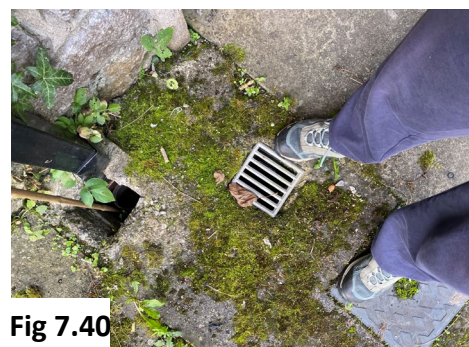
The existing combined drain (see the manhole in Fig 7.35/7.39) originally ran to the rear of the site, connecting to then public main on what was open space. This open space was developed and is now the rear garden of 31 Churchfield Park. The original permission for the housing development (Ref. 98/1917) required the developer to re-route the community centre drainage to a new main. A later revised planning application (Ref. 0334) was granted to include more houses. It is noted that the Duchás informed Kildare County Council that the initial grant was in breach of planning regulations as they were not informed of the development to comment on it before it was granted and would have commented on the housing in such close proximity to the monument. Clane Community Council objected to the removal of the previously agreed open space and the additional houses sought under the planning application Ref. 03/34 and thus the relationship between the two parties was compromised. As a result the new foul sewer route was created through private land to the NW (Behans) under licence. This agreement needs to be researched and registered or an alternative route needs investigation. The water meter for the mains water supply is located at the front of the adjoining property, Campbell Tyres. There are two meters and two stopcocks for the property, one on the public footpath and the other inside the Campbell property. Irish Water should be queried regarding the presence of two meters on the one supply.

Issues; Legal position of existing foul sewer needs to be investigated. The original foul sewer run has already been altered and further drainage investigation needs to determine whether original sewer taken through graveyard towards manhole in open space belonging to Churchfield could be used for soakaway. See Fig 7.39.

**Fig. 7.35** Previous manhole cover rusted

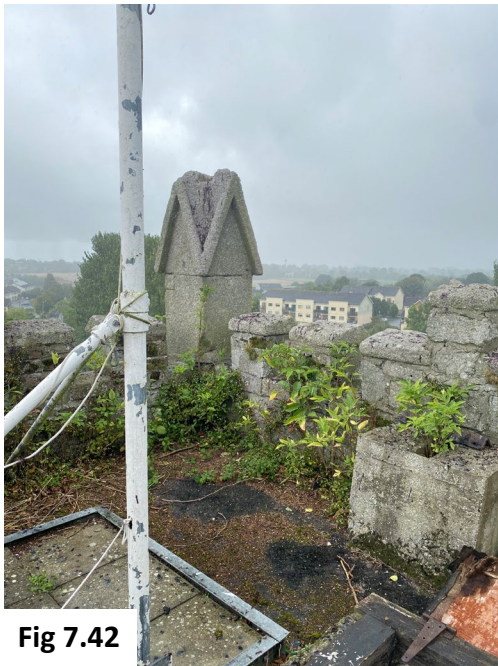
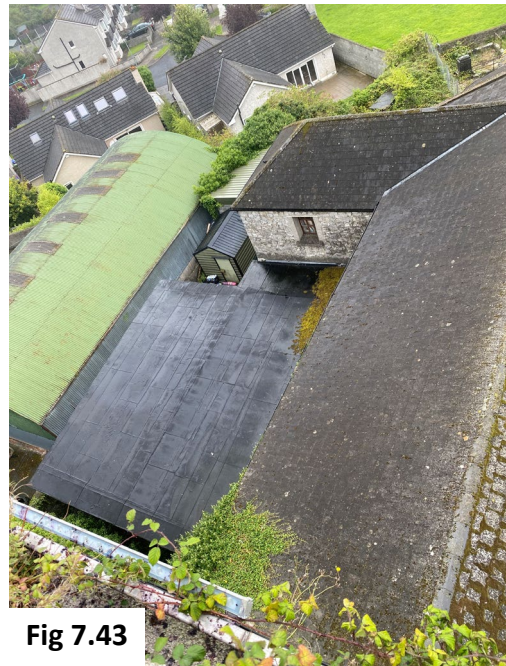
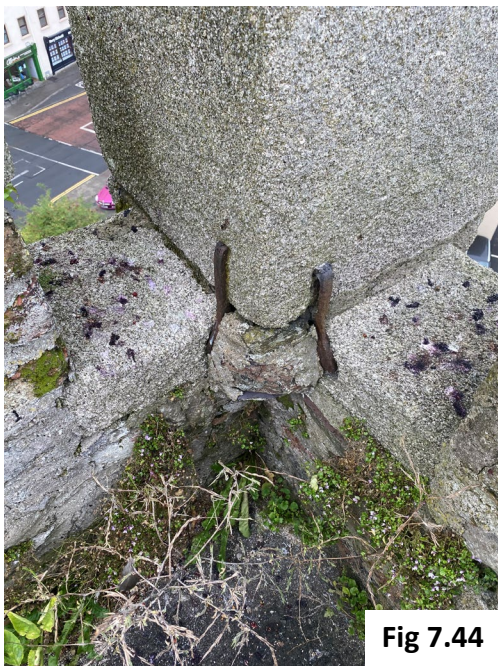
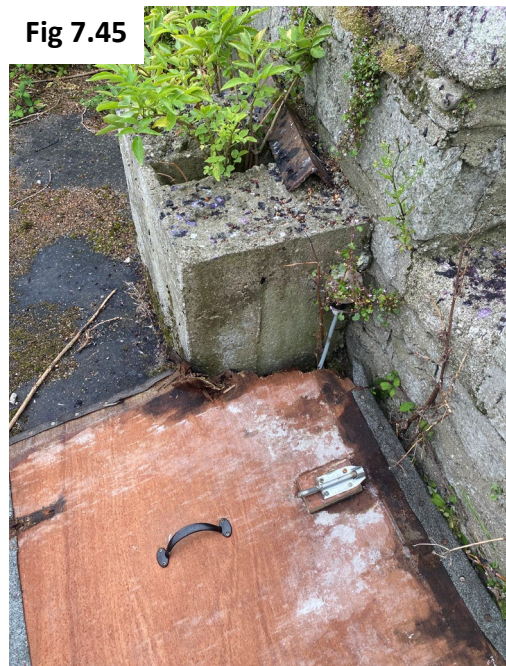
The top of the tower was rebuilt to include a concrete slab. This appears to be covered in bitumen and dressed horizontally through the walls to a ledge. The existing pinnacles have had earlier spikes/pinnacles removed, which may have even occurred in the 1798 disturbance. The joints to the parapet wall are holding water as is evidence from the biological growth. The coping stones are very worn and possibly holding water. The access to the tower hatch is by a timber ladder which may need to be changed to something with a restrainer cage. The plywood access hatch itself is presently disintegrating. It needs immediate attention to prevent further damage due to water ingress. e.g. to be fitted with some form of cover. The external parapet to the top of the tower has a linear flood lighting system and conduit which may be trapping water and debris sufficient to encourage Buddleia and other plant growth. This stone string course and all the water outlets from the roof need to be relined to ensure water is discharged in a safe manner. To the top of the tower there appears to be the remains of lightning protection, and a flag pole with occasional use.

**Fig. 7.42 & Fig 7.43** *Plant growth and lighting fitment and conduit which may be trapping water creating frost damage to the fabric of the tower*

**Fig. 7.44** *Exposed wrought iron straps on corner pinnacles*

**Fig. 7.45** *Access hatch and concrete upstand on the roof*

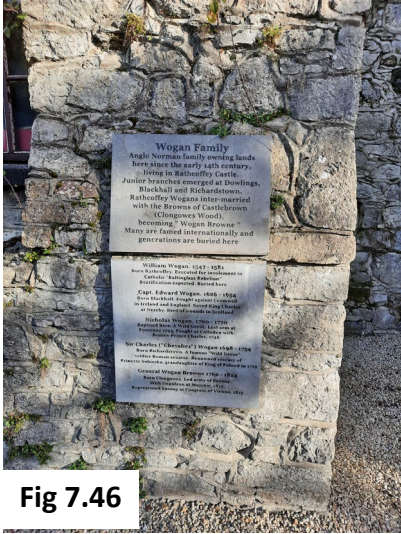
Fig 7.46

**Fig. 7.45** Photo of Access Hatch and concrete upstand on the roof  
**Fig. 7.46** Commemorative plaques South elevation

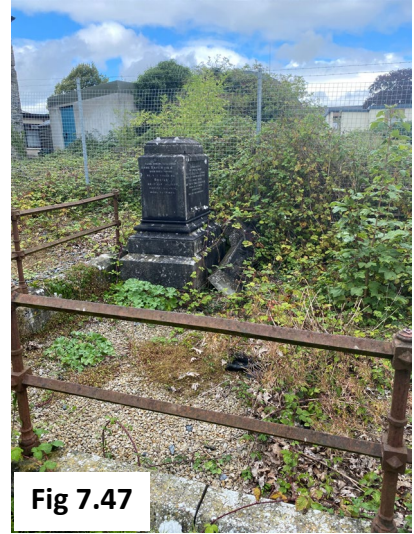
Fig 7.47

**Fig. 7.47** 19th century graveyard

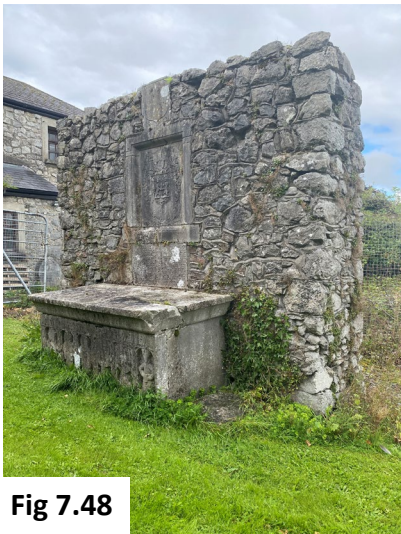
Fig 7.48

**Fig. 7.48** Wogan table tomb

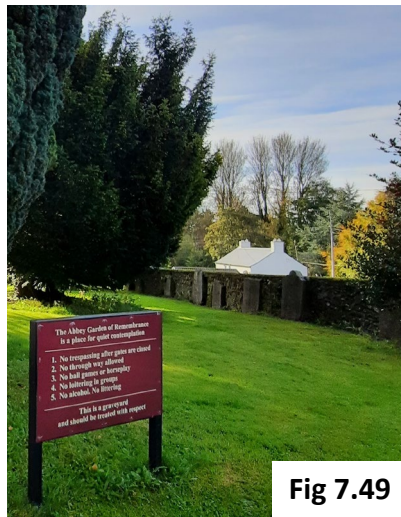
Fig 7.49

**Fig. 7.49** Signage stating restrictions

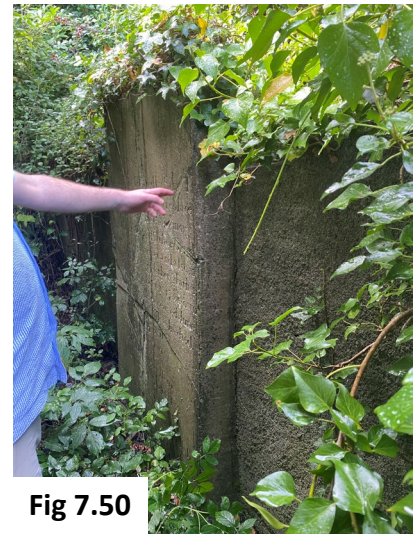
Fig 7.50

**Fig. 7.50** Grave marker to western boundary

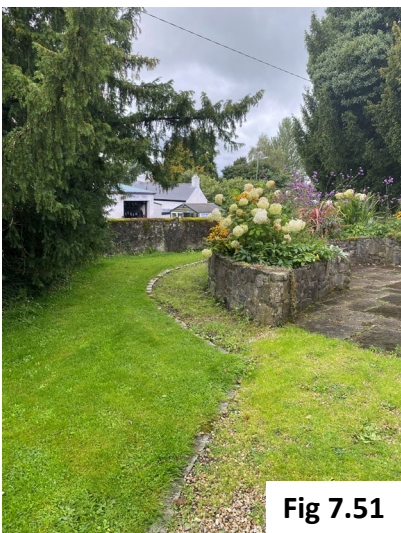
Fig 7.51

**Fig. 7.51** Central flowerbed in remembrance garden

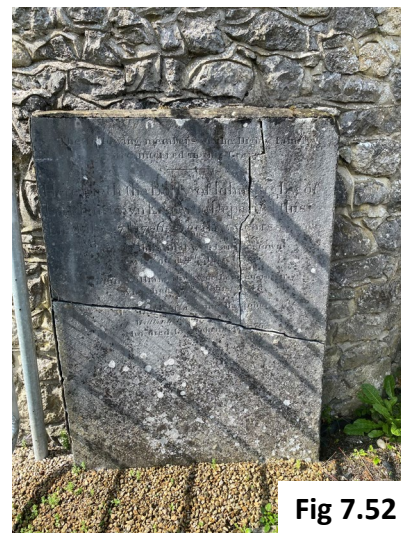
Fig 7.52

**Fig. 7.52** Cracked grave marker adjoining fence gate

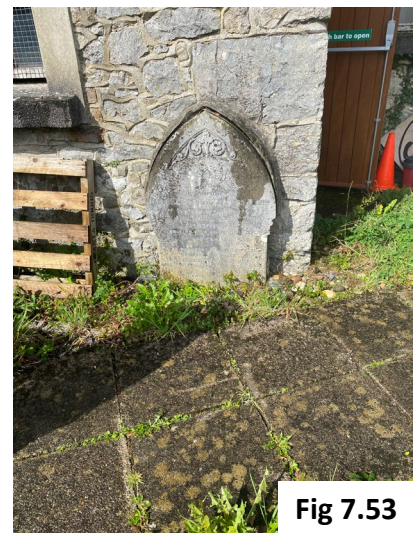
Fig 7.53

**Fig. 7.53** Grave marker external to porch

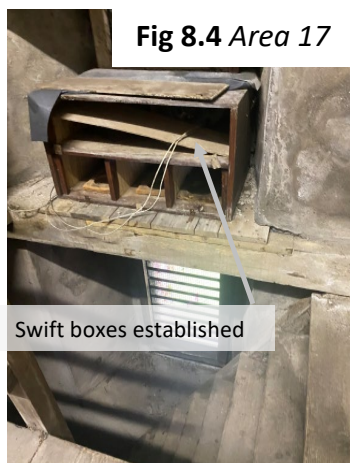
Fig 8.4 Area 17

Swift boxes established

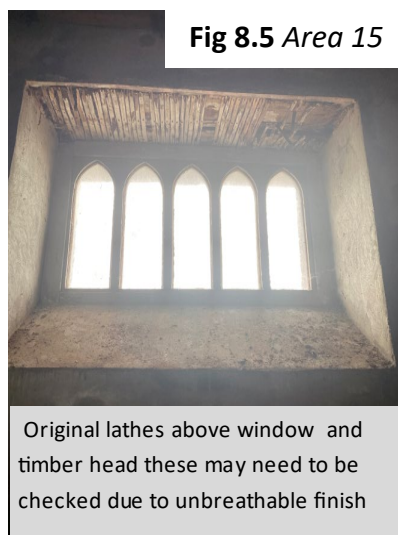
Fig 8.5 Area 15

Original lathes above window and timber head these may need to be checked due to unbreathable finish

All of the windows to the tower are timber which is raw unpainted, possibly hardwood, as the timbers are without an obvious grain. See Fig 8.5 where a polycarbonate glazing has been set into the solid timber frame.

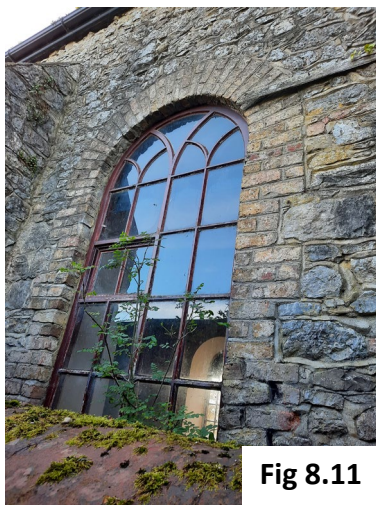
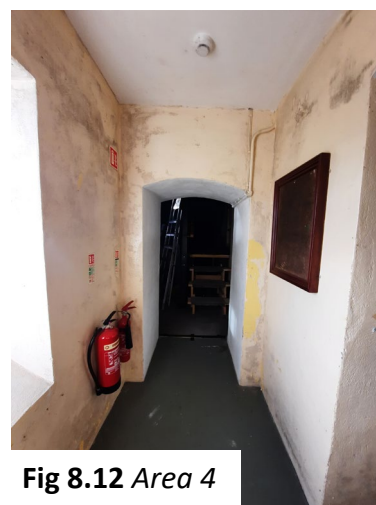
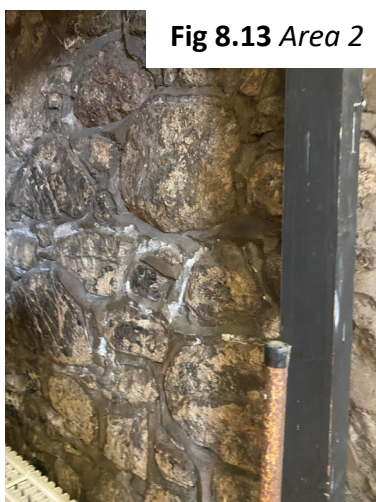
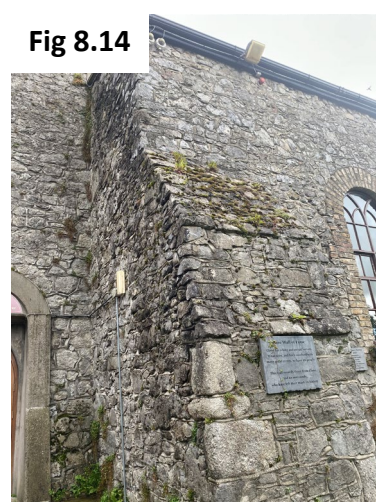
In general the building is holding up quite well in relation to moisture ingress. There is an area in the Community Hall where the external cement pointing of the later buttress and the unevenness of the external wall appears to have caused moisture ingress at the south western corner. This is disguised within the room by a large fitment. This could also be water ingress at roof level between the junction of the tower and the roof which seems to have some evidence of vegetation.

Externally around the oil tank there is vegetation growing out of the cill. The windows externally need some maintenance and are single glazed with no shutters or blinds internally which could result in considerable condensation if the hall was occupied.

To the rear corridor towards the back stage there is condensation issues with the walls due to the coldness of the walls with the sand cement render and lack of radiator heating in this section. A change in windows to double glazed in these locations would benefit the thermal value, and the removal of the sand cement and replastering of the walls in a thermal lime plaster would improve the surface temperature.

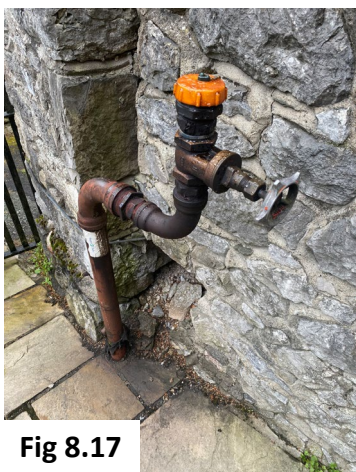
Fig 8.17

**Fig. 8.15** (Boiler house) **Fig. 8.16** (Area 12) **Fig. 8.17** Take off point at pedestrian entrance **Fig. 8.18** oil line to tank **Fig. 8.19** Gas line ext.

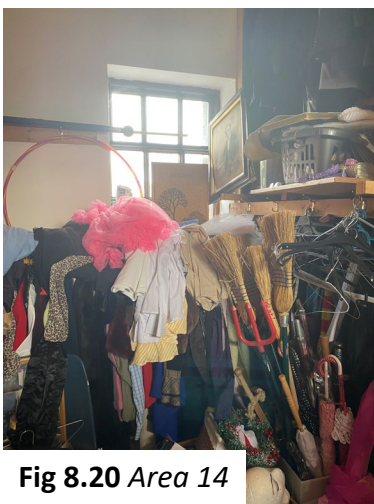
**Fig 8.20 Area 14**

The storage area itself has two single glazed windows with a crude concrete lintel and concrete brick to the rear west facing window. The window was also set very far back into the opening and the flat ceiling over would require quilt insulation. The room itself and the theatre wardrobe are currently full of clothes which may act as insulation (Figs. 8.20 & 8.22). The floor is carpet over concrete and there is a hot press with a cylinder above the stair turn and a water tank for the bathrooms below within this attic (Fig.8.21). There was a leak to this tank previously as seen in the Fig. 8.23 below.

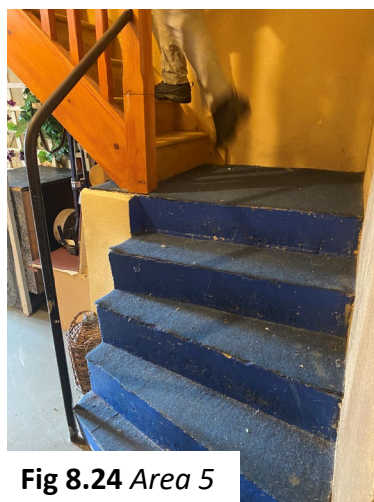
**Fig 8.24 Area 5**

The stairs to the wardrobe storage area is a timber straight flight added to concrete winders installed in the original refurbishment (Figs. 8.24 & 8.25). The stairs are quite dark and there is historical evidence of a leak from the water tank in the ceiling space above the stairs. The design of the winders to the stairs would not be recommended for safety reasons, particularly for those coming down the stairs with their arms full. The current configuration, if changed, would have to meet current building regulations thereby taking up far more room and impacting on the existing corridors and bathroom. There may be a mitigation of providing better illumination for this stair area.

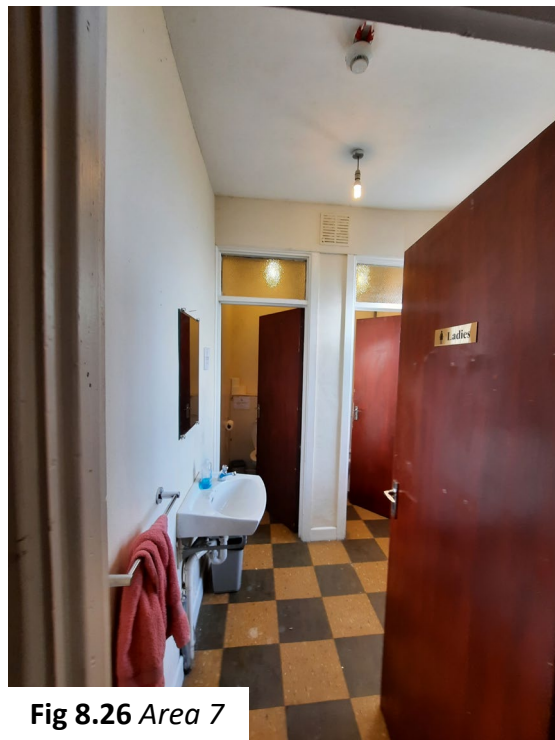
Fig 8.26 Area 7

The existing kitchens and bathrooms are in good decorative condition but have a very dated appearance (Fig. 8.26). The cabinet fitments are a mixture of types and finish. The floors and wall paint give it a very cold or institutional feel. The single point lighting and lack of natural light in particular to the Evergreens' room impact the visual appearance.

There is tiling to the floor of the community kitchen, with vinyl tiles to the bathrooms and timber strip flooring to the Evergreens area. None of these are problematic in their condition however they are considerably dated in appearance.

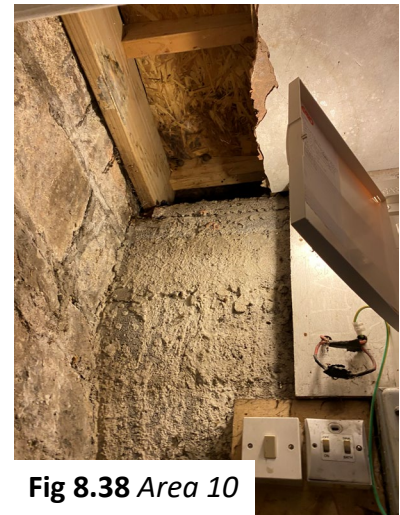
**Fig 8.38 Area 10**

It is not clear whether there was any insulation installed in the roof though there are ventilation slots externally on the timber overhang so it could be a ventilated cold roof. In Fig 8.38 a hole is visible in the plasterboard that does not appear to show roof insulation. The deck on this roof appears problematic in the long term, and there is some evidence of moisture in the decking over and adjoining the boiler house, which needs further investigation, so the roof structure needs a major overhaul or reconfiguration in the next five years.

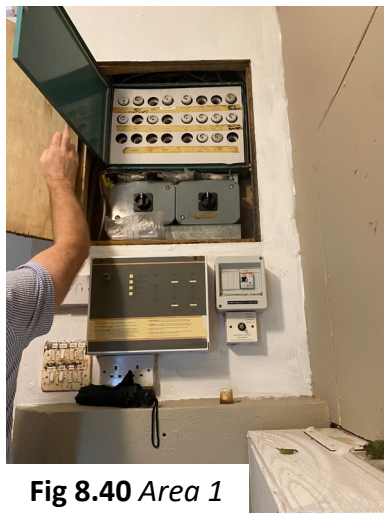
**Fig 8.40 Area 1**

The electrical fuse box in the porch ( Figs. 8.40 & 8.41) is an old fuseboard and needs to be upgraded, to have circuit breakers.

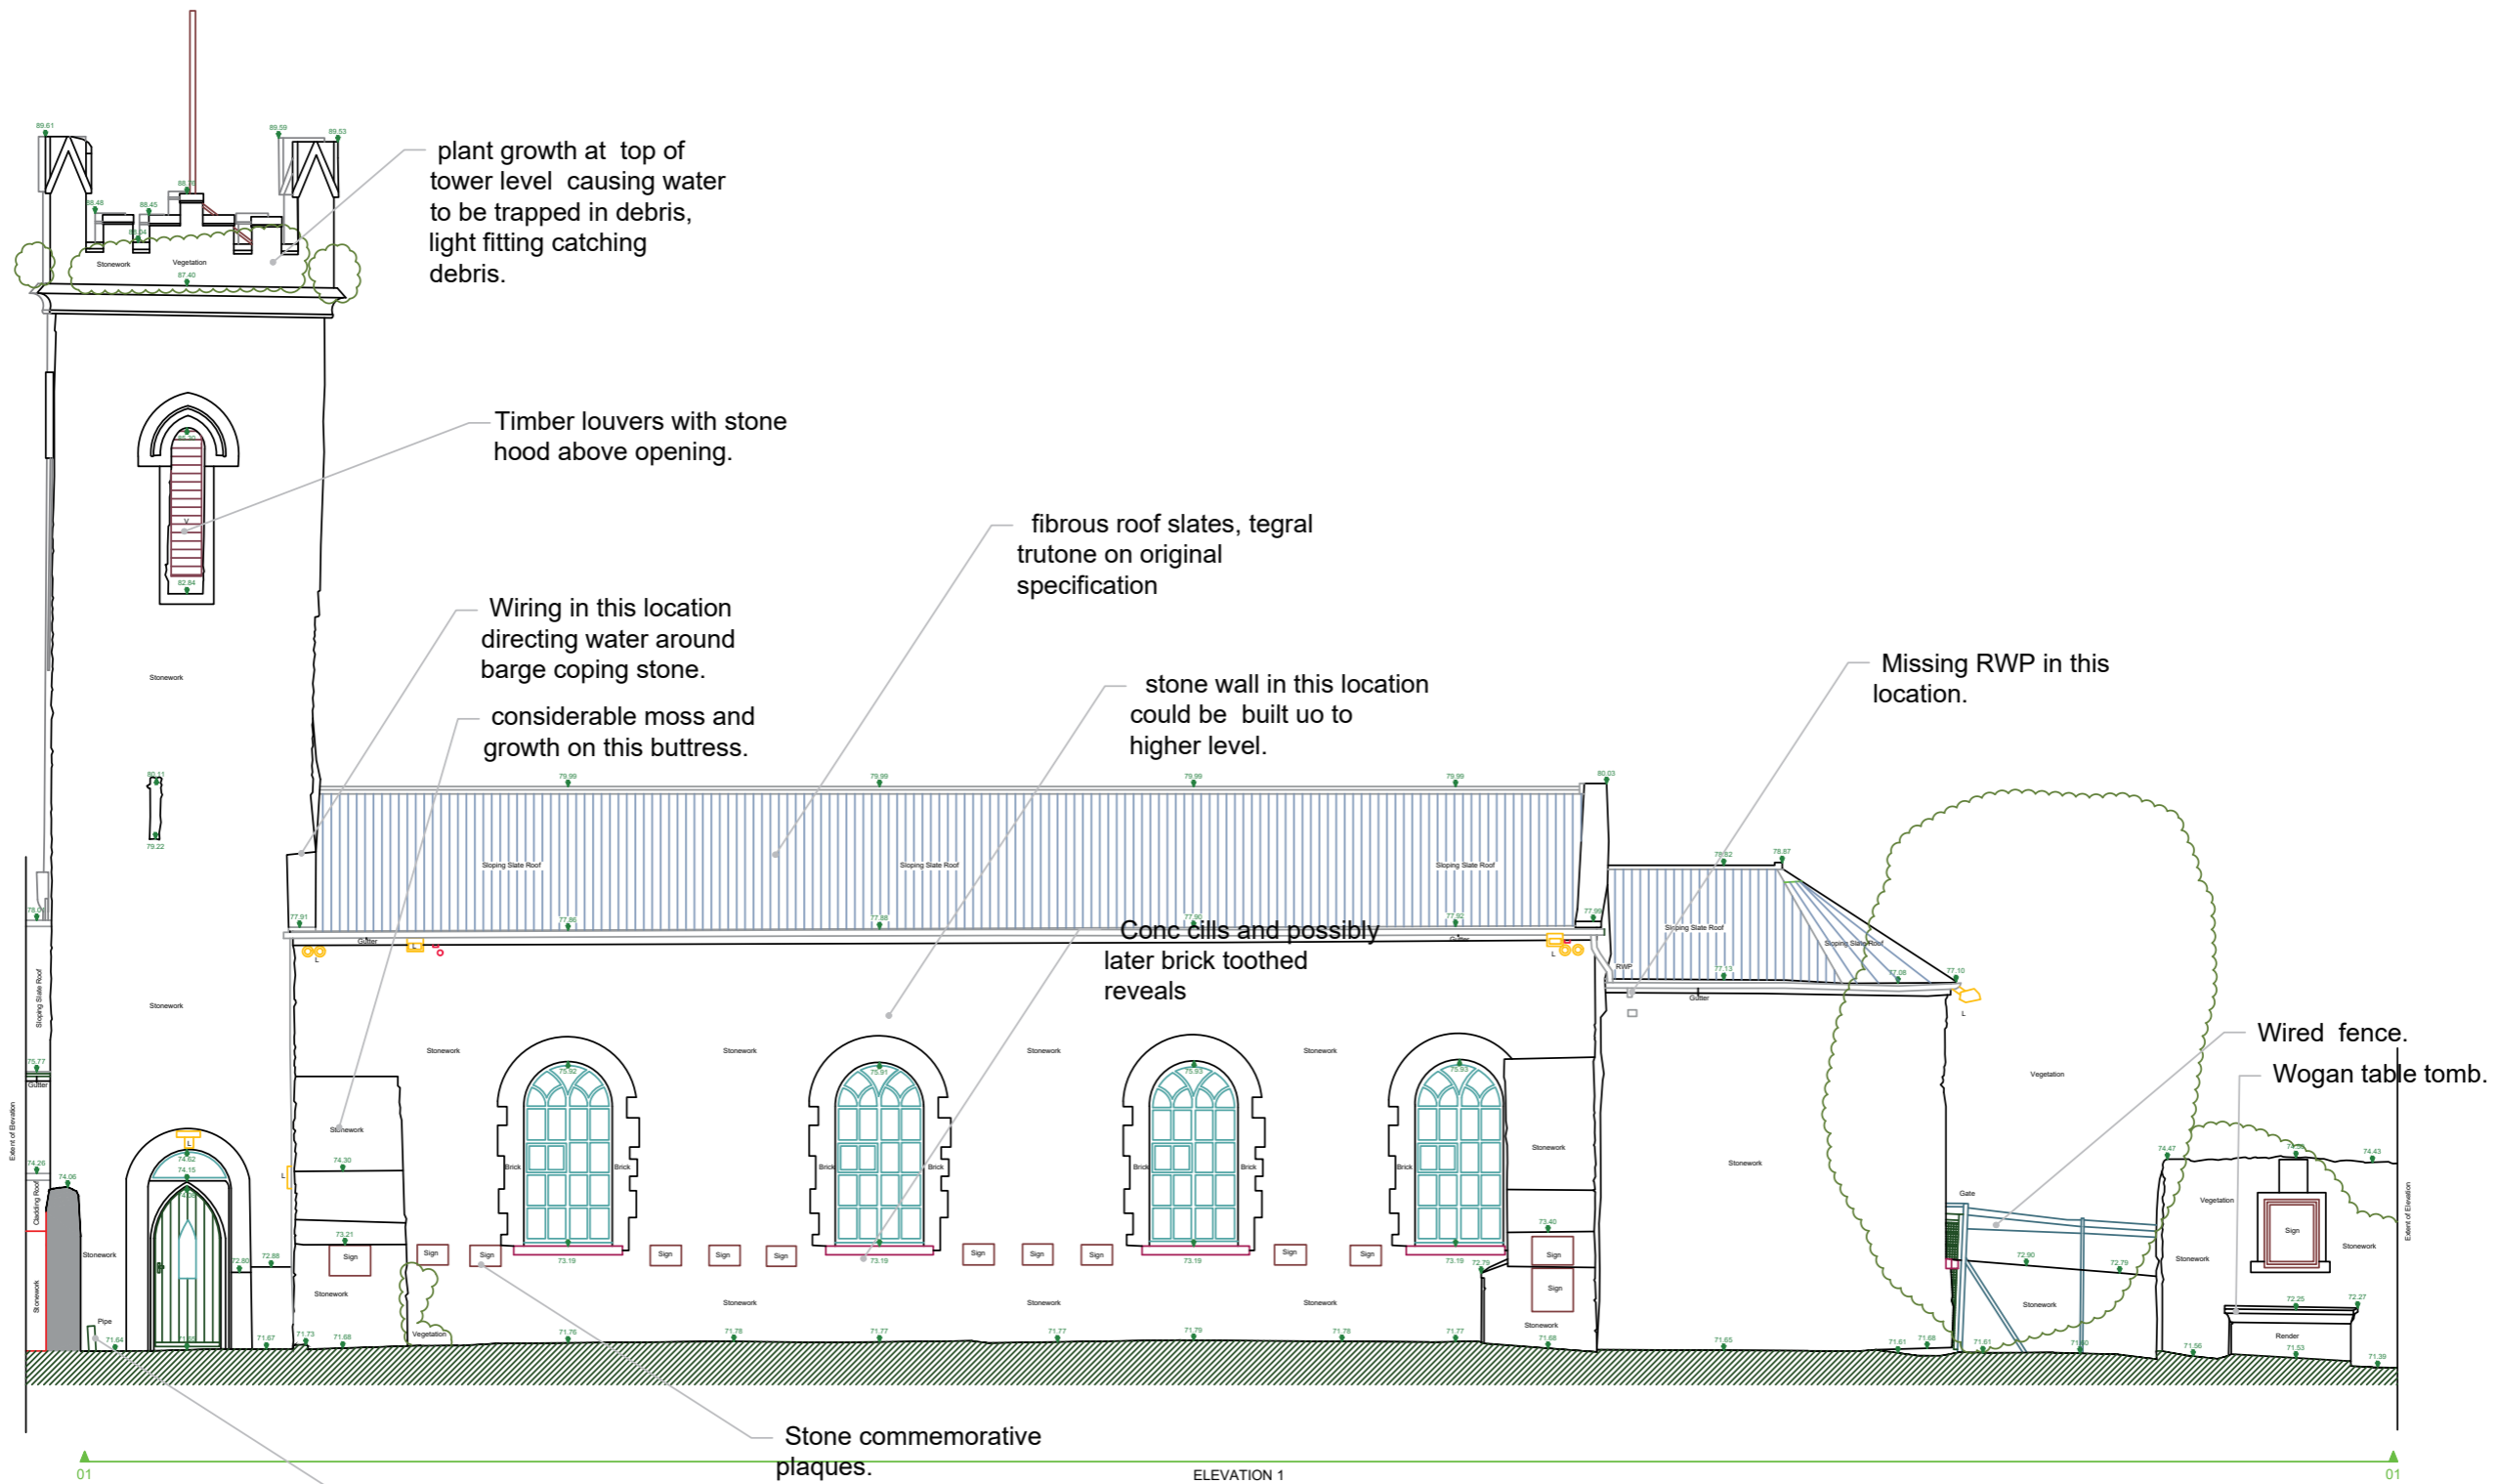
## S05- South Elev Survey

Lighting and exposed conduit causing plant growth to the crenellations where debris is gathered.
