# Conservation Management Plan

Clane Abbey Community Centre

Final Nov 2023

For Kildare County Council

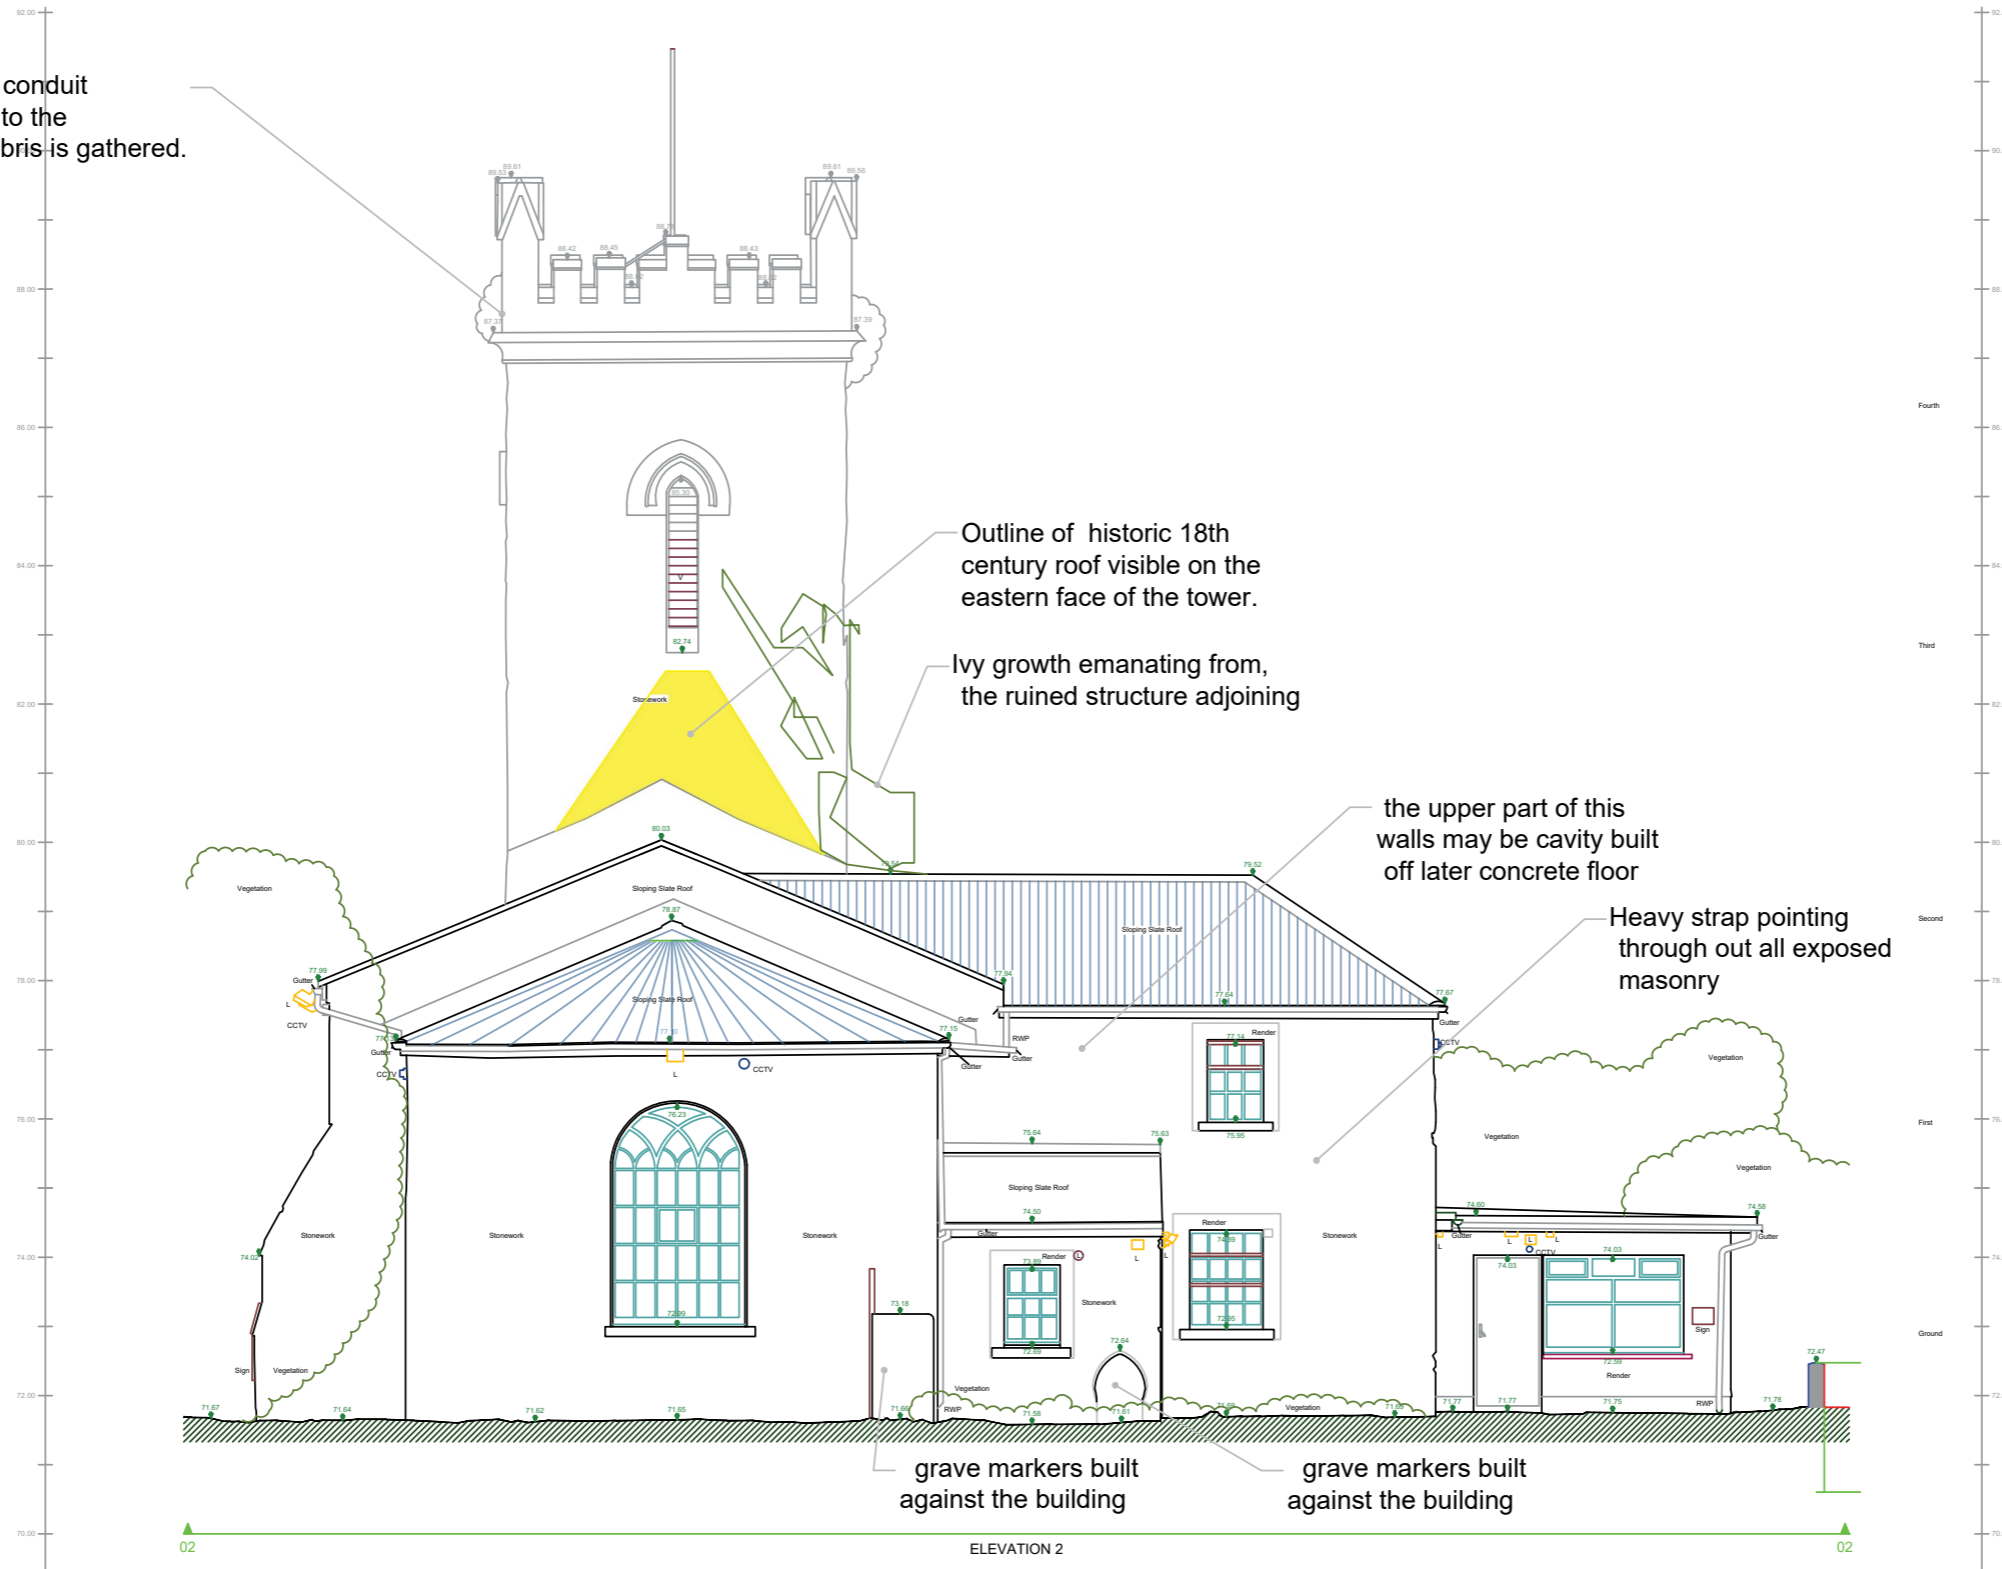
## S06 East Elev Survey

Lighting and exposed conduit causing plant growth to the crenellations where debris is gathered.

Boiler door in accessible and locked walls and rainwater pipes in this location.

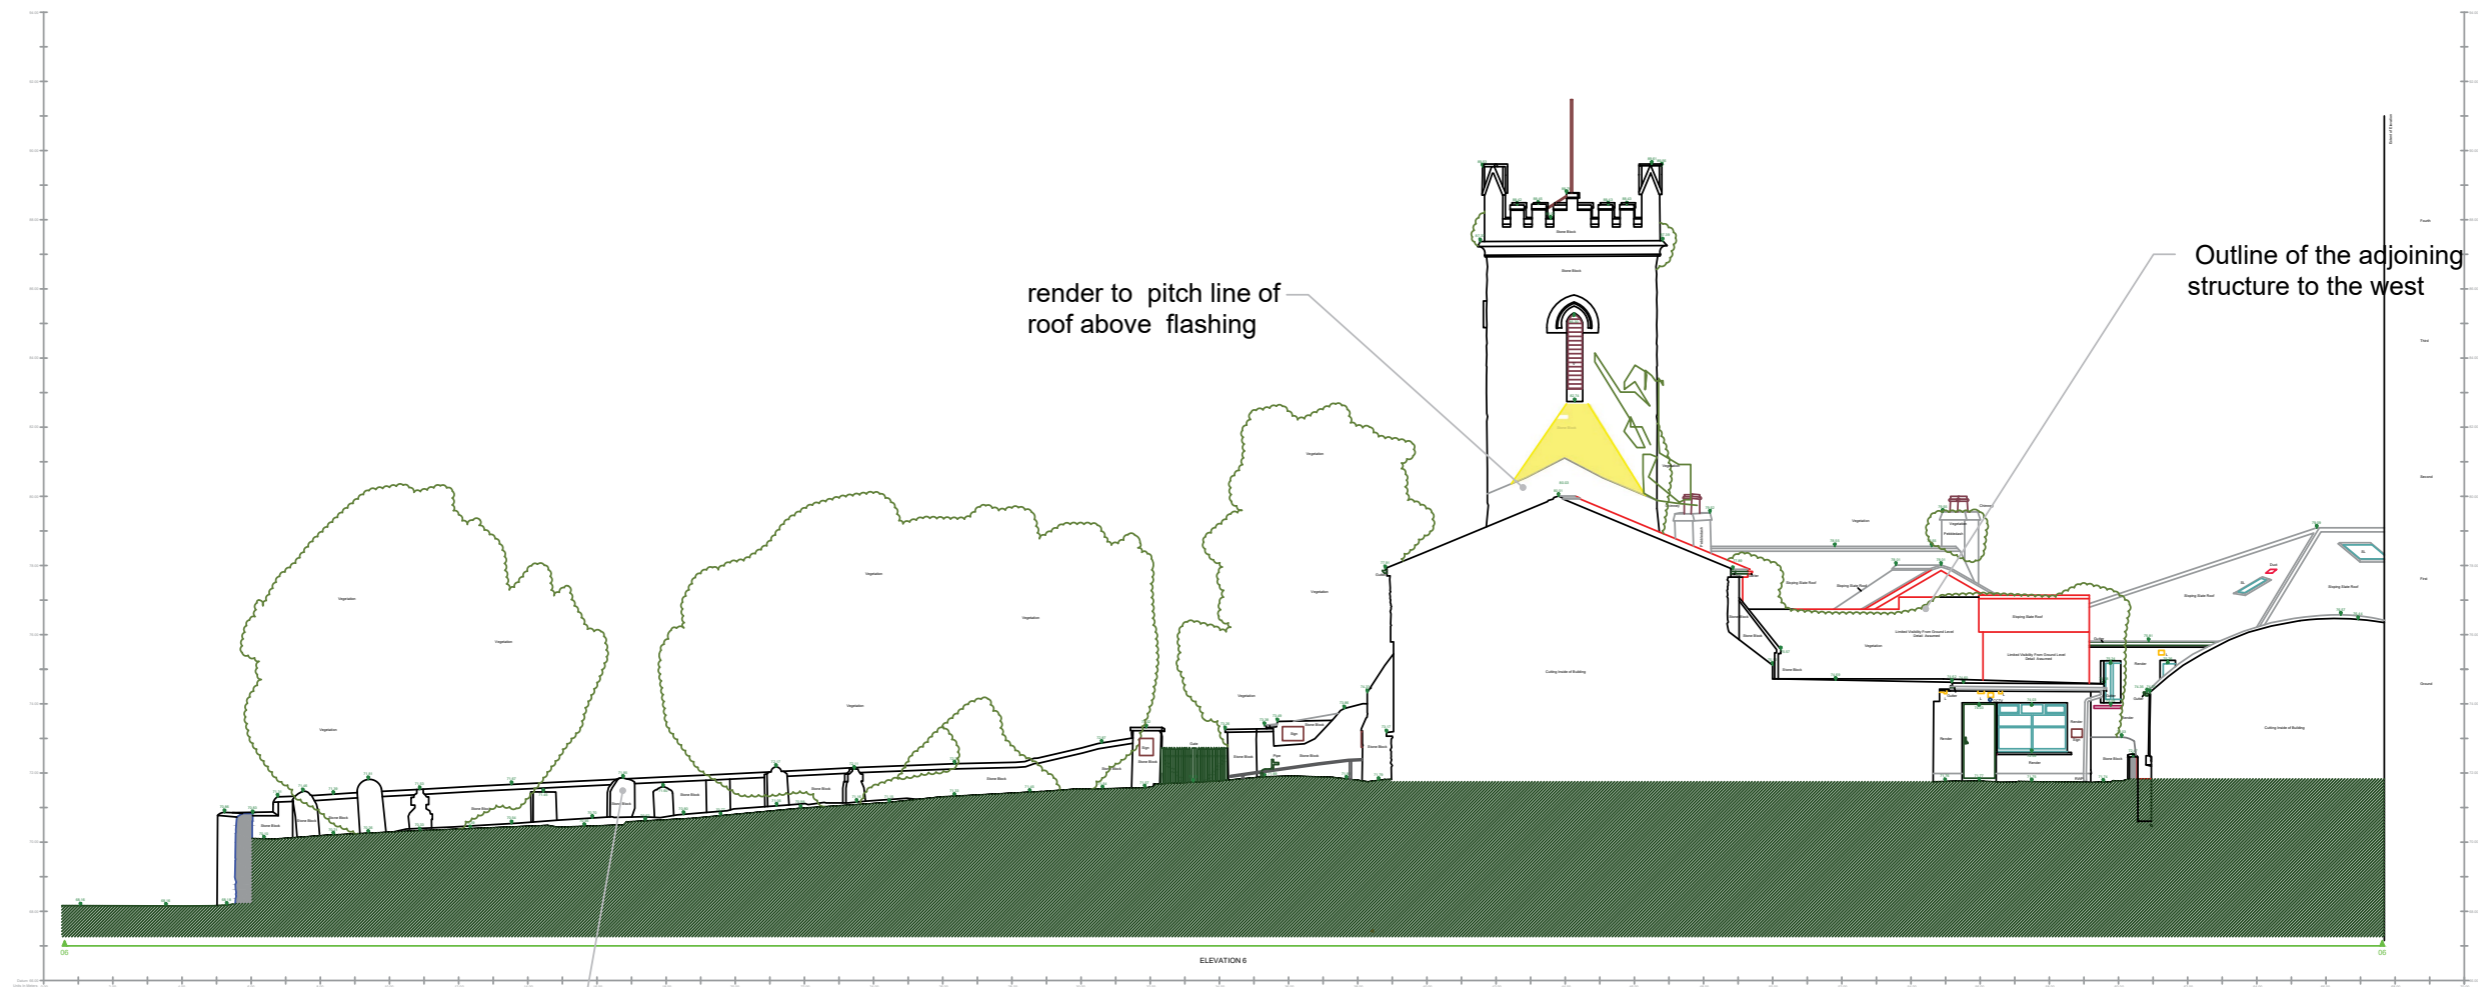
## S11 Contiguous sectional East Elev

Gravemarkers have been moved to the outer walls, holly trees at low level need to be removed before they become established.

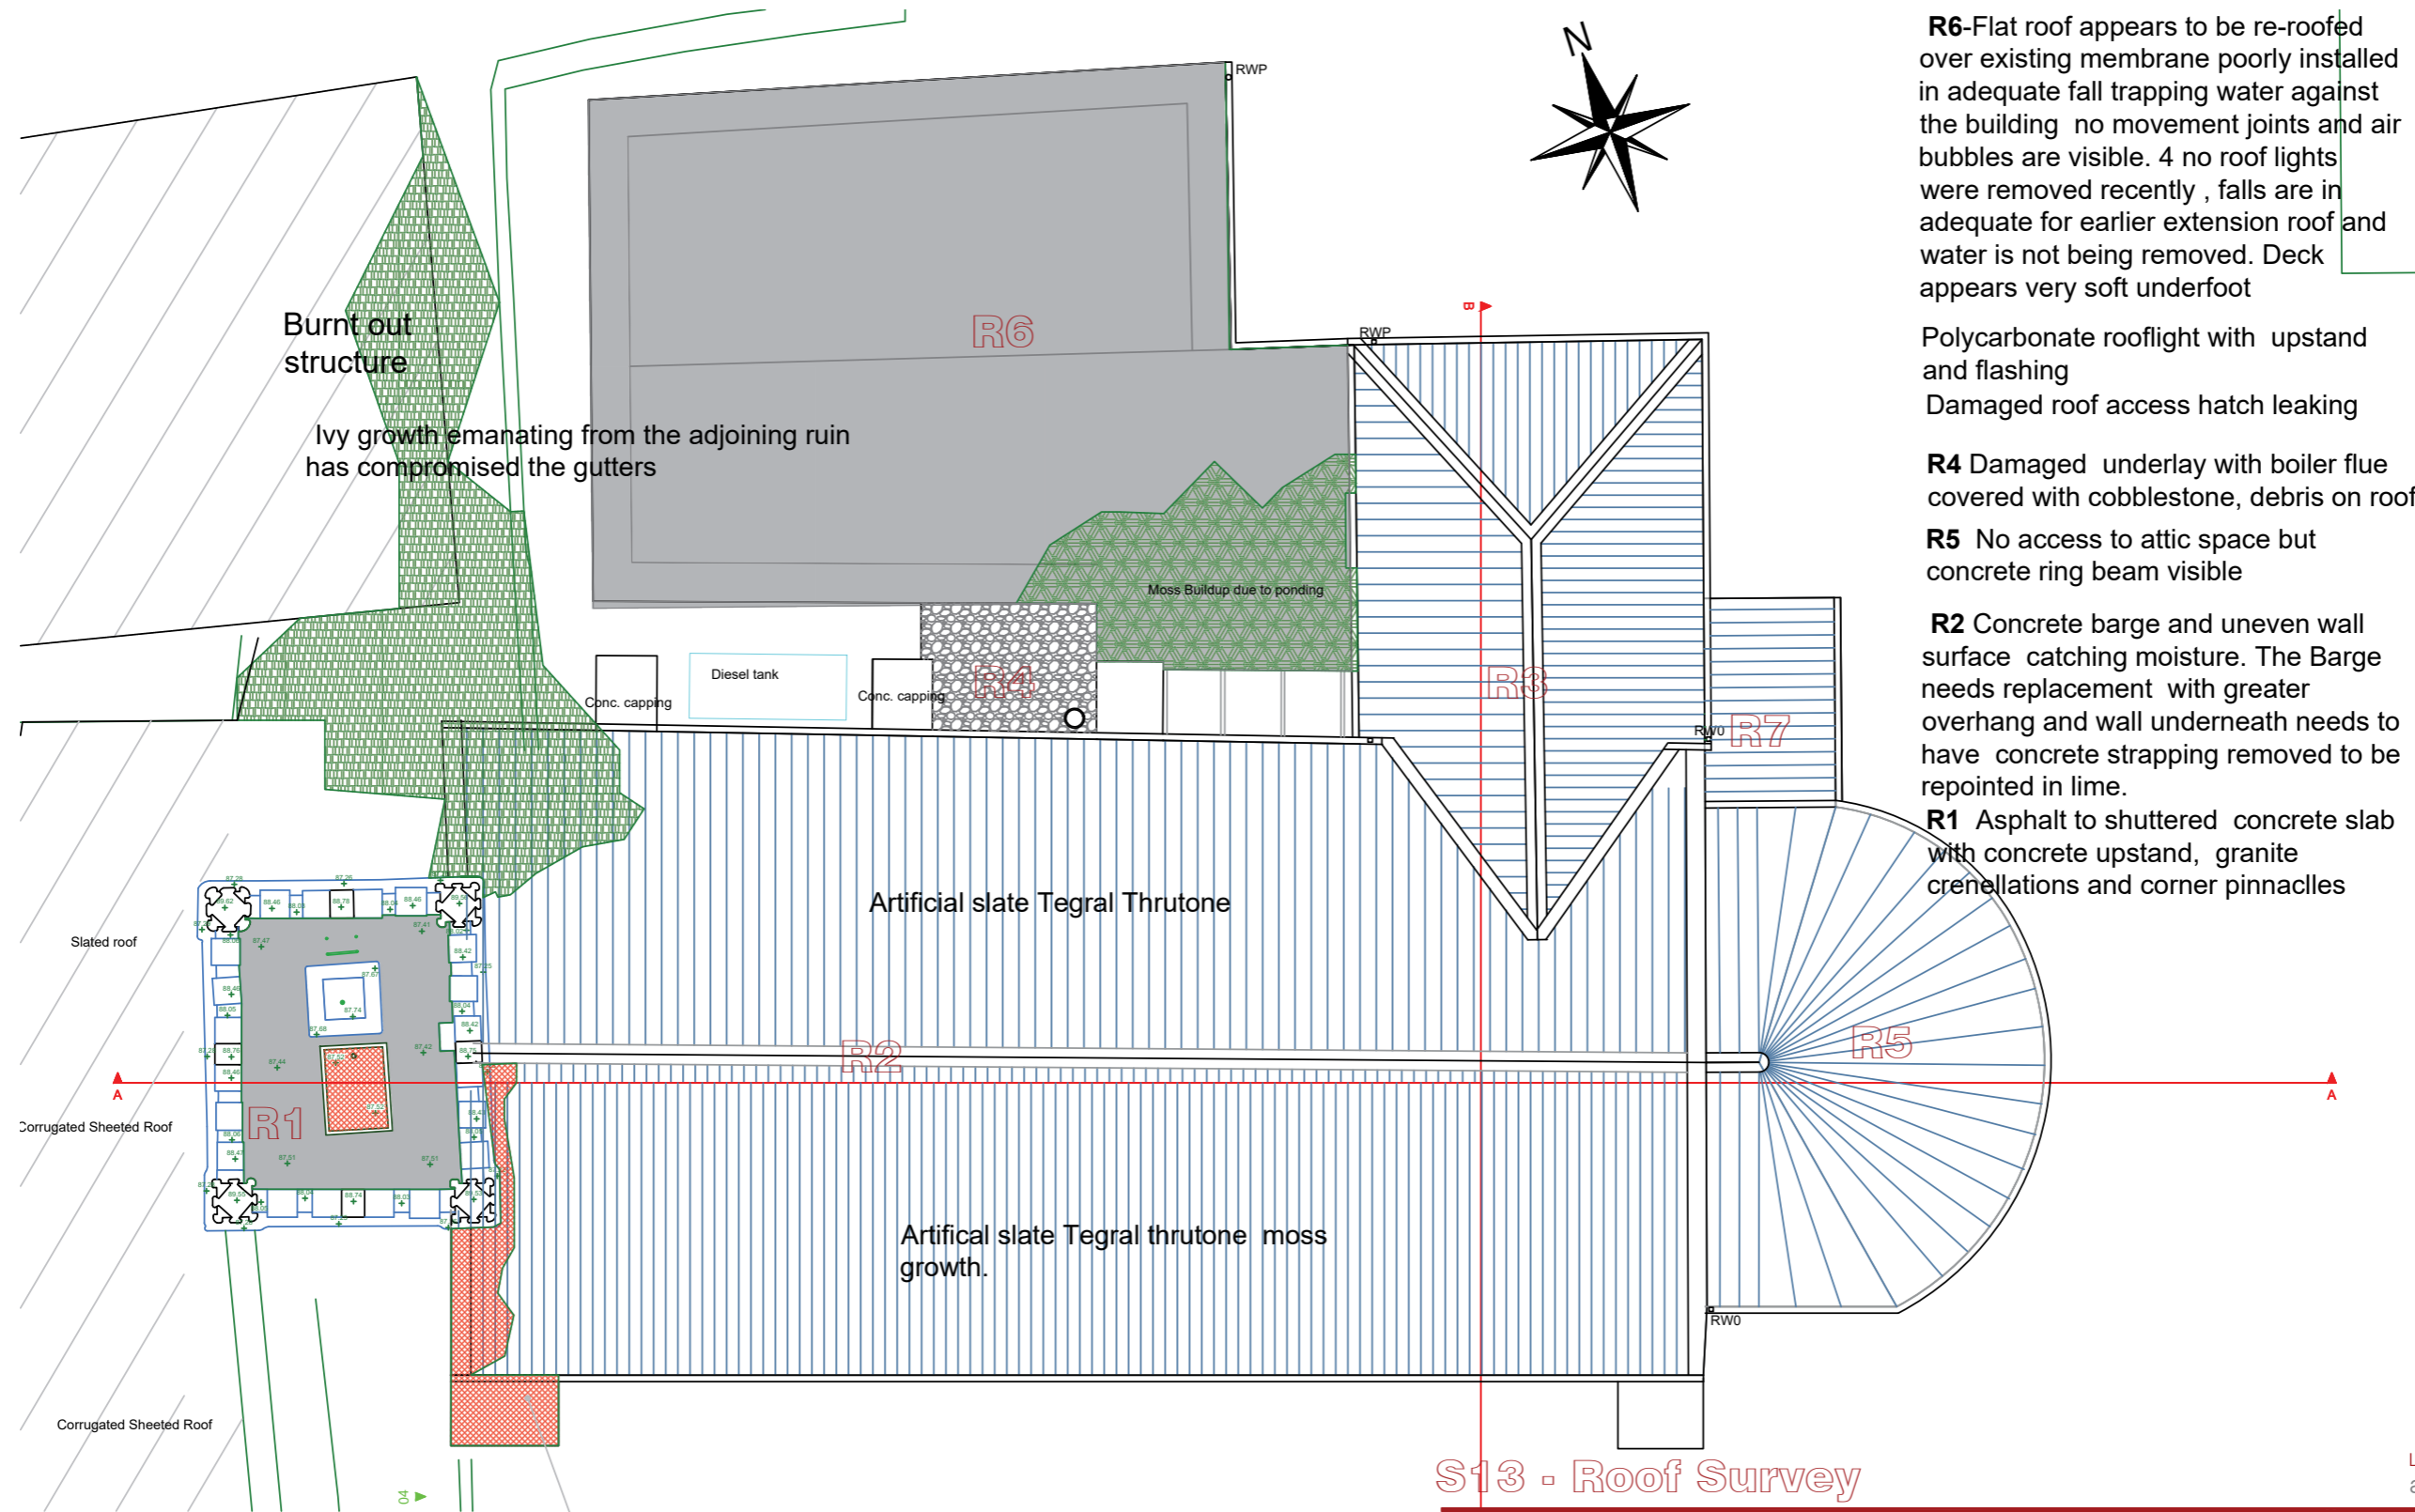
**R6-** Flat roof appears to be re-roofed over existing membrane poorly installed in adequate fall trapping water against the building no movement joints and air bubbles are visible. 4 no roof lights were removed recently , falls in adequate for earlier extension roof and water is not being removed. Deck appears very soft underfoot

Polycarbonate rooflight with upstand and flashing  
Damaged roof access hatch leaking
