# Carbury Housing Co. Kildare

Water Supply and Wastewater Management Report

April 2024

### **CORA Consulting Engineers**

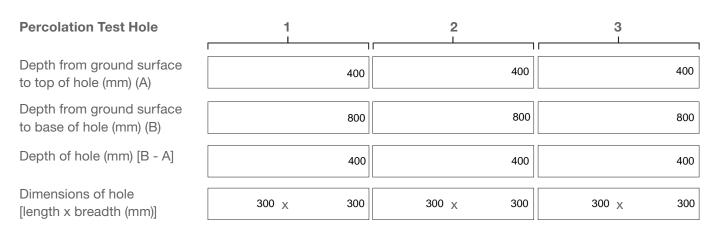
Step 1: Test Hole Preparation

#### 3.3(a) Percolation ("T") Test for Deep Subsoils and/or Water Table

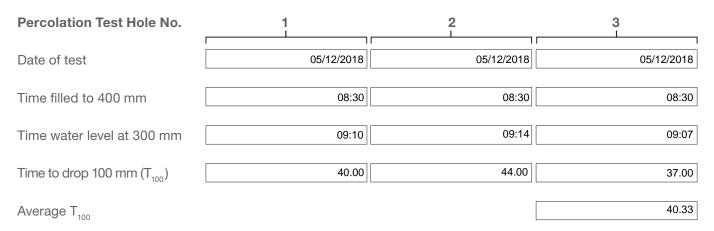
**Step 3:** Measuring T<sub>100</sub>

If  $T_{100} > 300$  minutes then T-value > 90 – site unsuitable for discharge to ground

If  $T_{100} \le 210$  minutes then go to Step 4;

If  $T_{100} > 210$  minutes then go to Step 5;

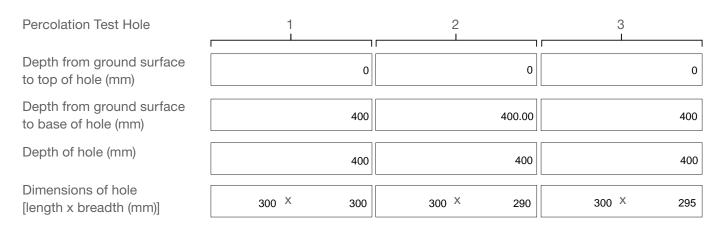
#### Step 1: Test Hole Preparation

### 3.3(b) Percolation ("P") Test for Shallow Soil / Subsoils and/or Water Table

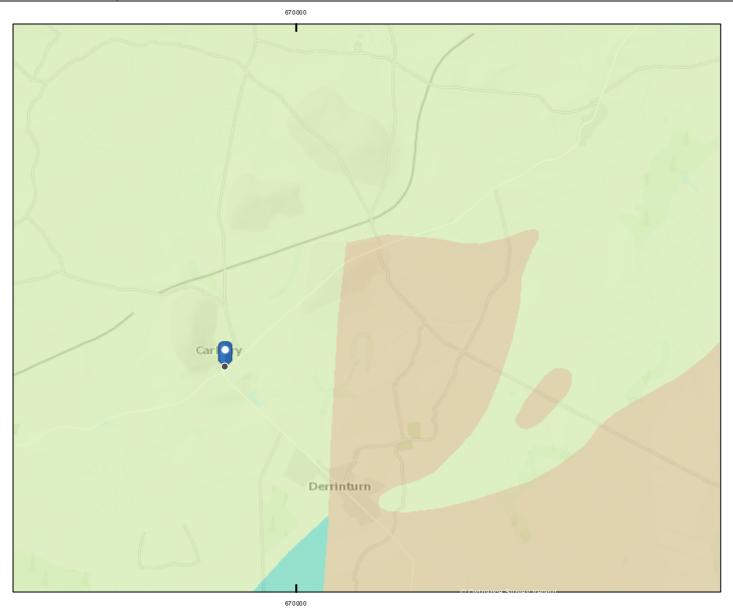
### Kildare Co Co - W91 A9FH - Aquifer Map

- Rkc Regionally Important Aquifer -Karstified (conduit) Rkd - Regionally
- Important Aquifer -Karstified (diffuse) RK - Regionally
- Important Aquifer -Karstified Rf - Regionally
- Important Aquifer -Fissured bedrock Lm - Locally Important Aquifer -
- Bedrock which is Generally Moderately Productive
  - Lk Locally Important Aquifer - Karstified
- LI Locally Important Aguifer - Bedrock which is Moderately Productive only in Local Zones PI - Poor Aquifer -Bedrock which is
- Generally Unproductive except for Local Zones Pu - Poor Aquifer -
- Bedrock which is Generally
- Unproductive Lake
