### **Site-Specific Flood Risk Assessment**

### **Proposed Development of a New Machinery Yard and Regional Salt Barn, Jigginstown, Newhall, Naas, Co Kildare**

**17032-R-FRA  
Issue PL1**

**Kilgallen & Partners  
Consulting Engineers  
Well Road, Kylekiproe  
Portlaoise, Co. Laois**

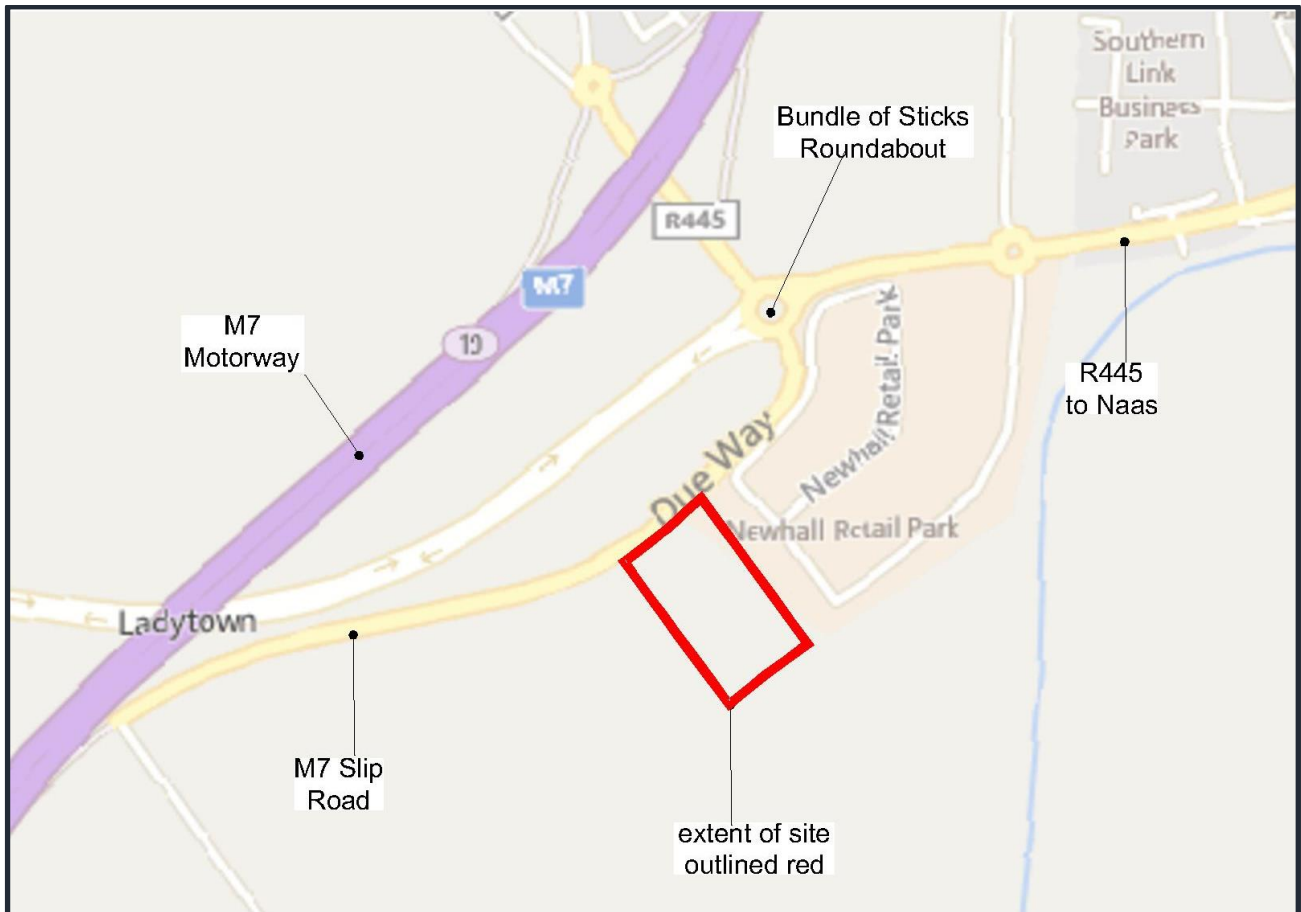
**Figure 2.1 Site Location**

The site measures 1.88 hectares and is located on the southern side of the M7 Slip Road, which connects the Bundle-of-Sticks Roundabout to the southbound on-ramp to the M7 Motorway. This road also serves a Local Road (the Rathasker Road) located southwest of the site. Eastbound traffic flows (i.e. from the Local Road to the Bundle-of-Sticks Roundabout) are very low in comparison to the westbound traffic flows towards the M7.

Figure 2-1 shows the location of the proposed development.

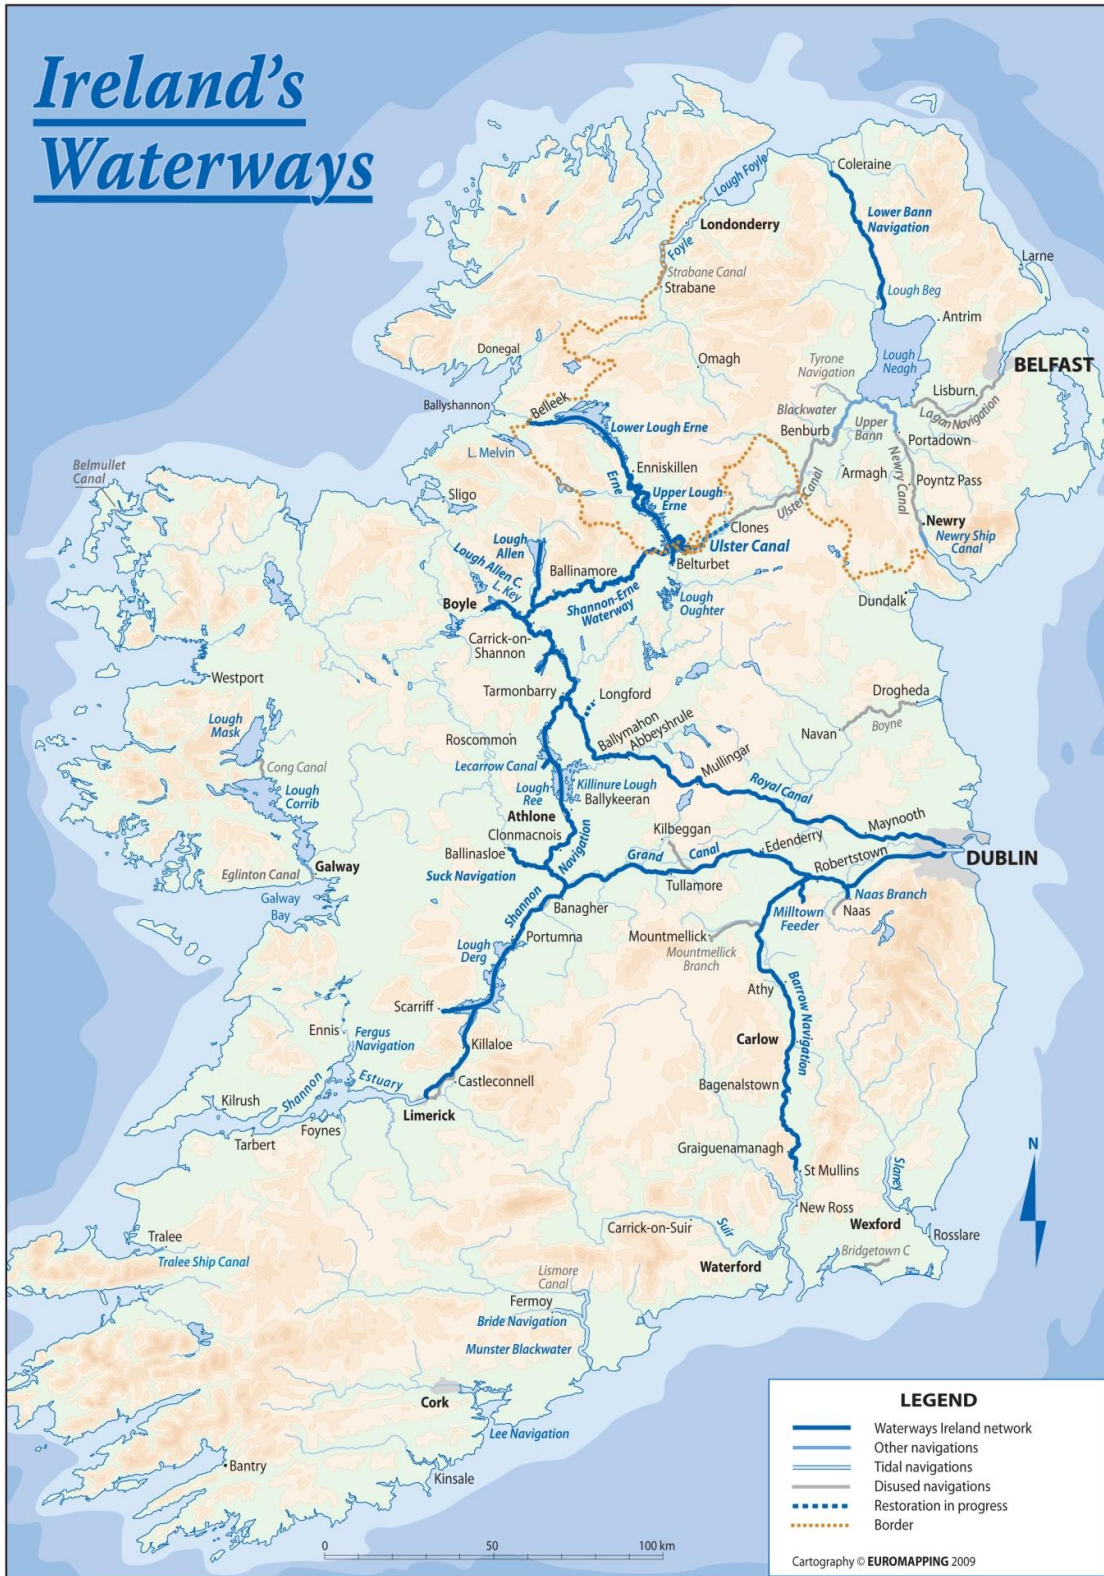
**Figure 1**

# Ireland's Waterways

Waterways Ireland has responsibility for approximately 1,000 km of navigable waterways (Figure 1) comprising;
