Chapter 7

Ecology

This report provides an assessment of the likely impacts of the proposed upgrade of the M7 between Naas and Newbridge, Co. Kildare, on the ecological environment (i.e. flora, fauna and habitats). The proposed upgrade entails the widening of the stretch of motorway from two lanes to three lanes within the existing motorway boundary and the construction of the proposed Newhall Interchange.

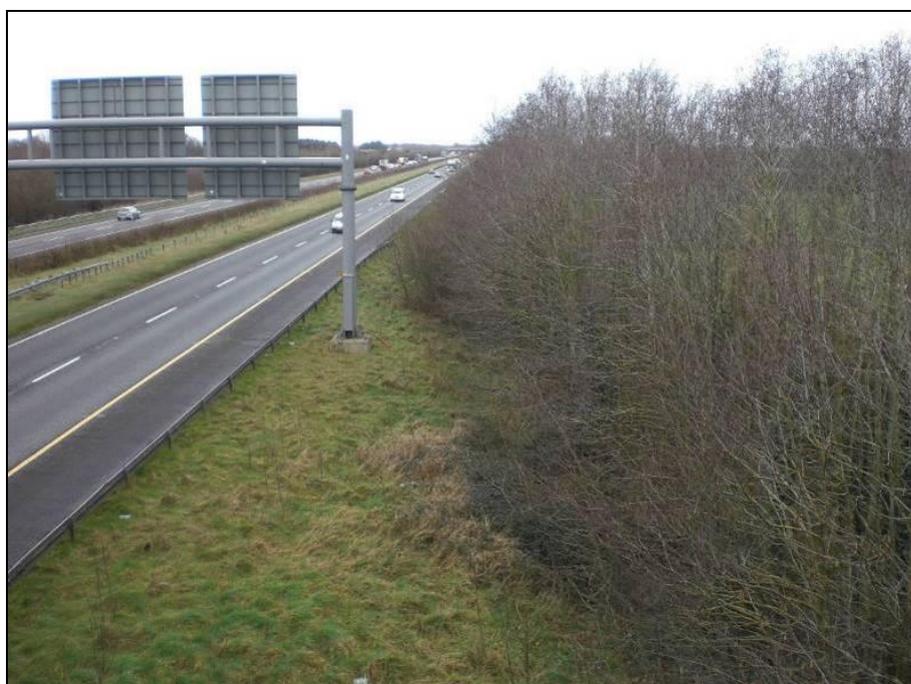
Plate 7.1: Immature woodland along road embankment

Stretches of the road margins along the M7 are comprised of immature woodland (WS2) consisting of a mixture of native and exotic species (see **Plate 7.1**). This woodland was planted along the road embankments as part of the original scheme landscaping. Planting was undertaken at close spacing's and there is a poorly developed understorey consisting primarily of ivy (*Hedra helix*) and briar (*Rubus fruticosus* aggr.).

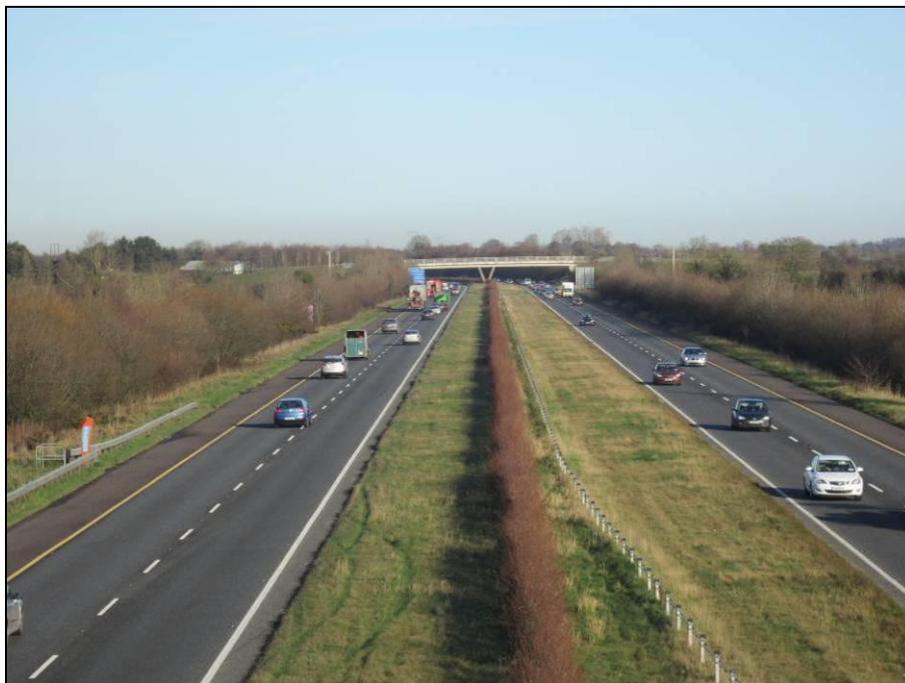
Plate 7.2: Hawthorn hedgerow present in motorway median

Sections of the road margins where it is at grade in the vicinity of Naas have been planted with hedgerows (WL1) comprised solely of hawthorn (*Crataegus monogyna*). In some places the median has also been planted with a hawthorn hedge. These hedgerows are of recent origin and are regularly trimmed as part of highway maintenance (see **Plate 7.2**).

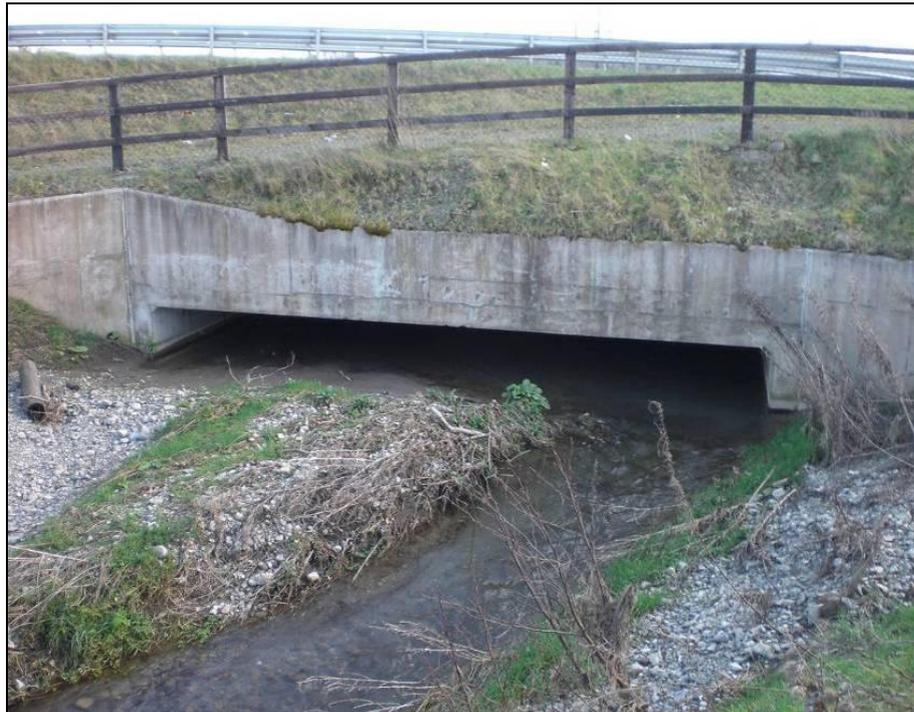
Plate 7.3: Hartwell River culvert under the M7/M9

The Hartwell (Tobenavoher) River is crossed by the M7 (Ch 15+500) on a broad and low open bottomed box culvert (see **Plate 7.3**). The culvert bed is heavily covered with coarse aggregate though the river has maintained a well defined channel allowing fish passage. This river has resident stocks of trout and has abundant suitable spawning habitat downstream of the motorway. The river may also support brook lamprey (*Lampetra planeri*) a species afforded protection under Annex II of the EU Habitats Directive. No suitable ammocoete beds occur in the vicinity of the M7 culvert though potential spawning habitat occurs downstream.

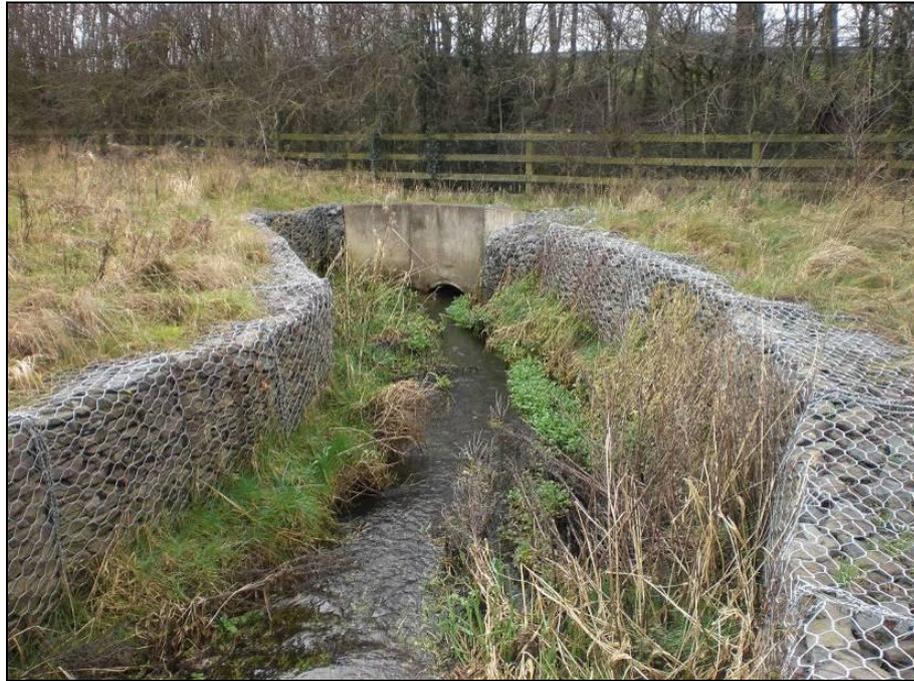
Plate 7.4: Minor stream culvert under M7/M9 at Ch. 7+880

A minor stream crosses under the motorway at Ch 7+880 in a concrete 750mm pipe culvert (See **Plate 7.4**). The stream is a tributary of the River Liffey which it joins approximately 1.7km downstream at Yeomanstown. The stream is culverted for approximately 200m upstream of the motorway before briefly emerging in a gabion-lined channel for a length of c30m before the motorway culvert. The water quality appears good and the substrate in the exposed stretch of channel is riffle habitat with suitable gravel for spawning by trout. Otter spraint was present at the culvert entrance and there is likely to be movement through the culvert and along the stream to the River Liffey.

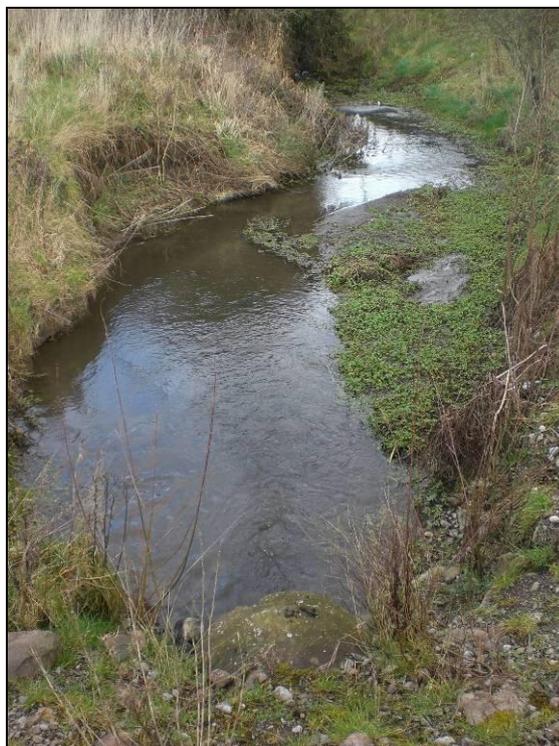
Plate 7.5: Minor stream upstream of culvert at Ch. 8+720

A second minor stream which is culverted under the M7 at Ch 9+720 also flows in a northerly direction to join the River Liffey. This stream has a very high silt load and resultant poor water quality, though fresh otter spraints were present during the survey a short distance upstream of the M7 culvert (See **Plate 7.5**). The culvert under the motorway is a 750mm diameter concrete pipe with no mammal passage facility. Otter may be using this to connect with the River Liffey downstream as the habitat upstream is considered inadequate to support a resident population.

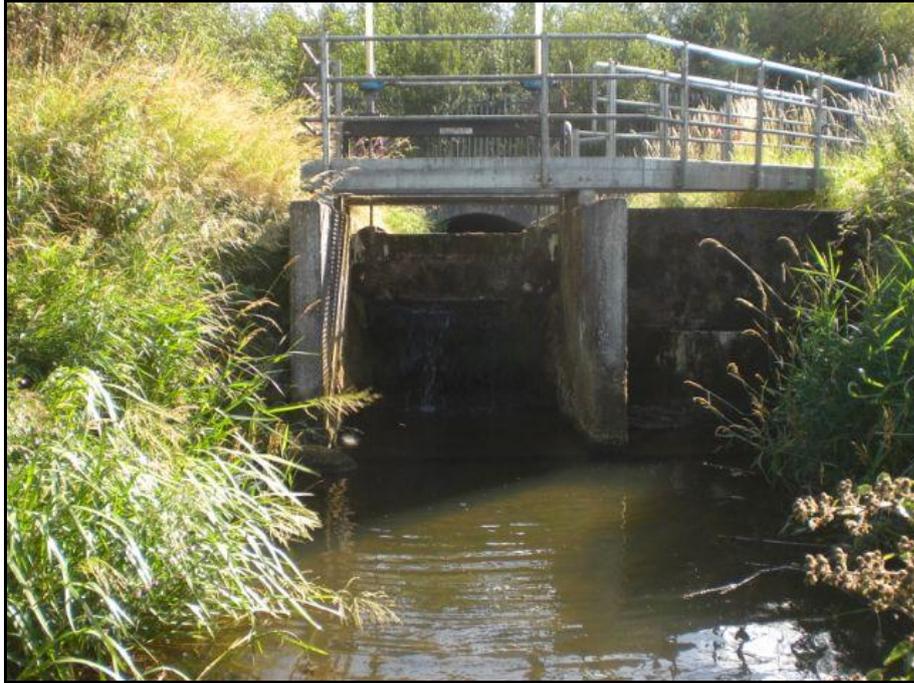
Plate 7.6: Weir on Ladystown Stream at Ch 6+700

The Ladystown Stream is culverted under the Ladytown Overbridge at Cormicks Bridge (Ch 6+700) (location of proposed Newhall Interchange). This stream is fed by two channels (refer **Figures 4.5 and 4.13, EIS Volume 3**), one approaching from the south west in the vicinity of Lewistown and the other from the south east. The stream from the south east is culverted under the motorway and ties into the channel downstream of Cormick's Bridge (Ch 6+800). The stream from the south west is culverted under the R445. This culvert is 74m in length and is a bottomless arch culvert with a bed width of c2.5m. It is joined by a minor drain immediately north of the Ladytown Overbridge. A short distance downstream of the culvert a sluice gate and weir with a vertical 1m drop presents a barrier to any upstream fish movement (refer **Plate 7.6**).

The stream supports a population of brown trout downstream of the Ladytown Overbridge, though there is no potential for movement further upstream due to the weir. Fish were observed in a pool area at the base of the weir during the site visit which coincided with low flow conditions and movement downstream was hindered by the limited volume of water. Freshwater crayfish were also present at this location. Otter spraint was recorded at the culvert entrance. The stream also supports populations of brook lamprey, eel and minnow.

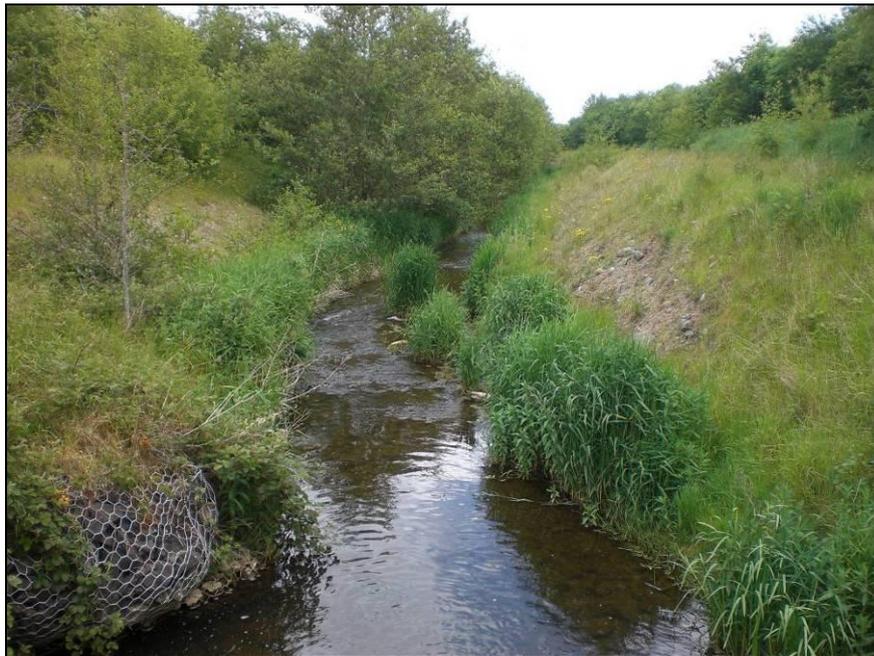
Figure 7.7: Ladystown Stream downstream of Weir

The stream bed downstream of the culvert consists of coarse sediments and cobbles with a riffle-glide flow regime (see **Plate 7.7**). The banks are steep with some bare ground and dry grassland. Reed-canary grass is frequent along the stream edge. A young ash plantation occurs to the west and east of the stream.

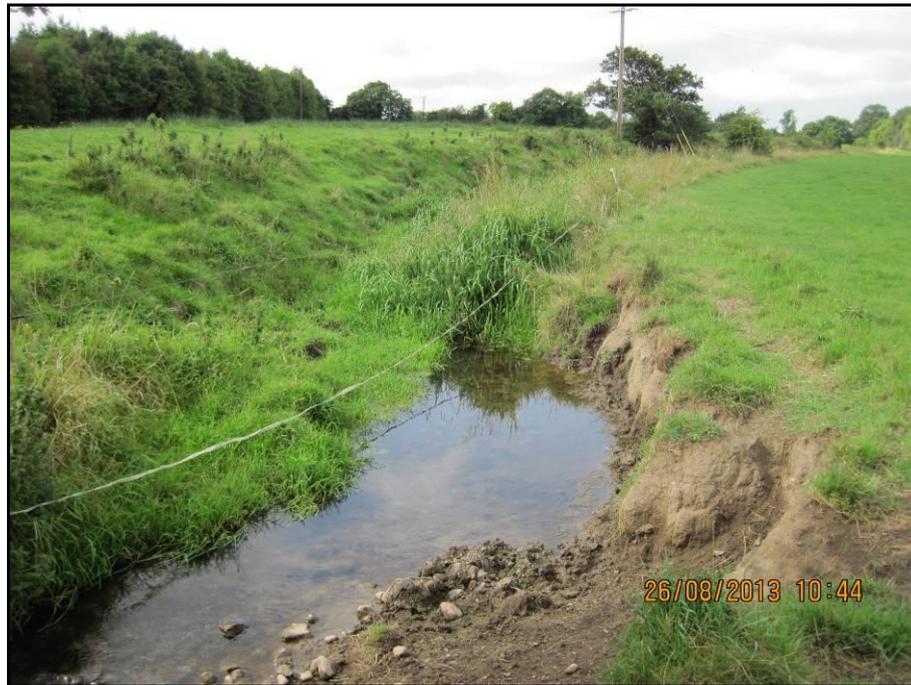
Plate 7.8: Ladytown Stream upstream of Cormick's Bridge

Upstream both feeder channels have heavy vegetation growth (refer **Plate 7.8**) and limited flows and appear unsuited to trout. They may however support freshwater crayfish though no evidence was found during sweep netting and dedicated searches carried out as part of this study.
