## Kildare County Library, Archives & Cultural Centre

### Conservation & Architectural Heritage Impact Assessment Report

### **Stage 1 Report: Architectural Heritage**

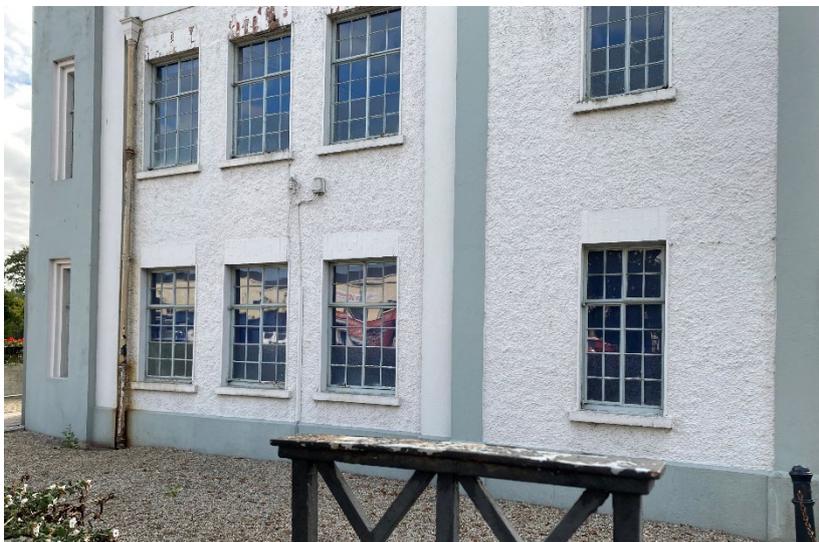
Figure 21: Detail of northern façade

- There is extensive cracking present in the external render. This will require filling with appropriate proprietary conservation products such as *Remmers concrete façade repair system* to prevent water penetration.

- Previous crack stitching was undertaken as recommended by consultants *Carroll & Browne*. This will be reviewed by Aecom engineers who will specify any further work necessary. This previous work is outlined in PJ Barrett & Co. Investigative Report and consists of vertical stitches embedded approx.. 50mm deep.

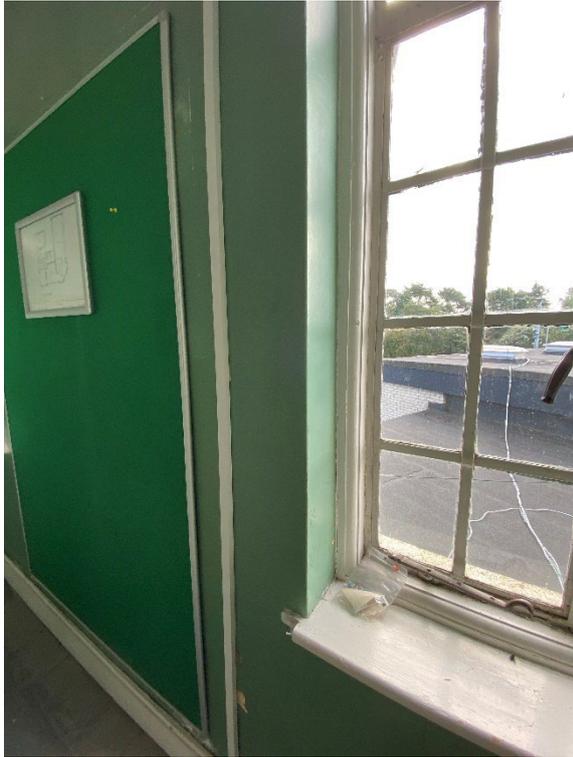
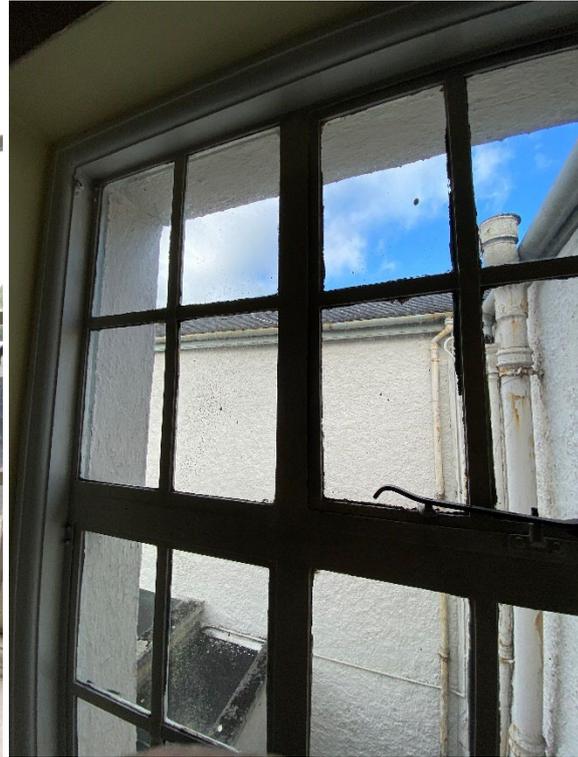
Figure 49: Detail of steel window sitting in timber sub frame Figure 50: Detail of pin stay mechanism

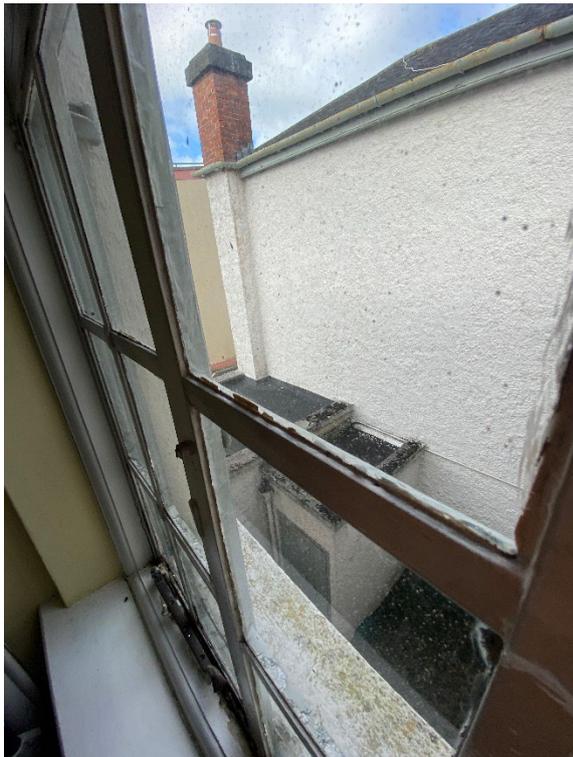
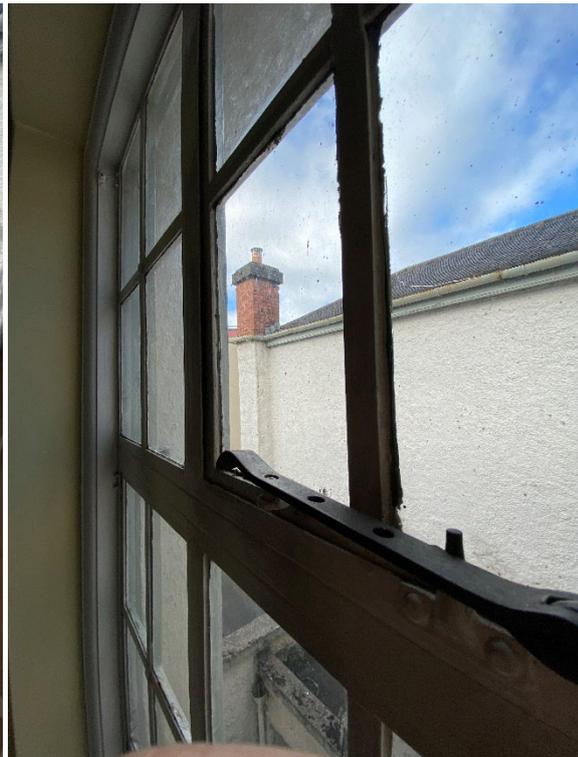
Figure 51: Windows have T-bar sections; all astragals overlap rather than a splice joint.  
Figure 52: Detail of pin stay mechanism for top light

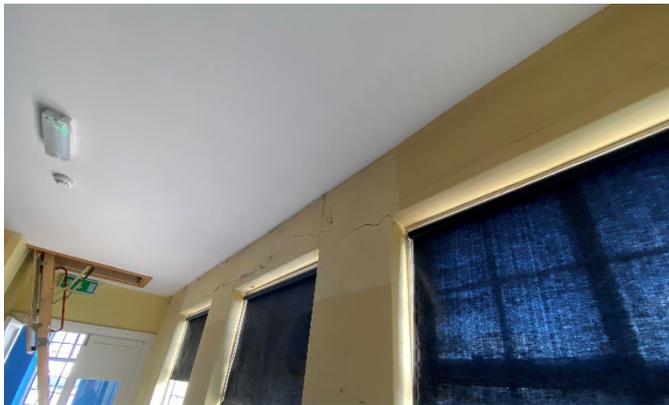
Figure 55: Replacement plasterboard ceiling at first floor level with folding attic stair access

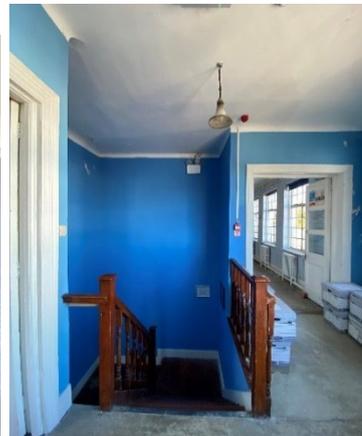
Figure 56: First floor landing with simple coved ceilings and early light fittings still in place

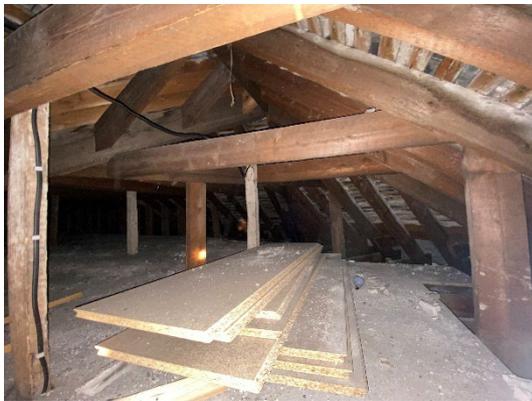
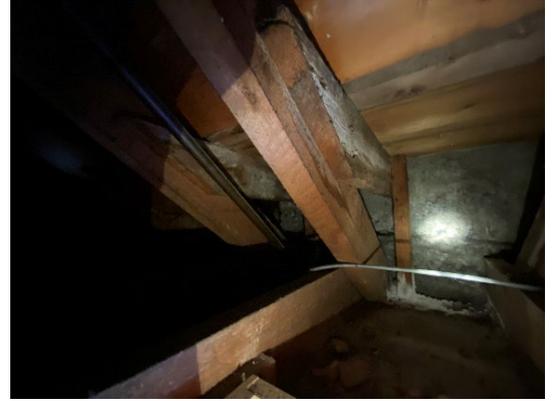
Figure 61: Each cut rafter retains a collar at high level

Figure 62: Detail of parapet upstand beneath gutters in attic space

- The principal roof structure is generally in good condition and repairs can be carried out insitu.
- Allow for scaffolding to eaves level
- Carefully remove all existing slates and store vertically on timber bearers for reuse
- Remove remnants of mortar parging from between slating battens and from attic floor where the majority has fallen
- Remove slating battens and discard off site
- Stripped areas of roof are to have temporary weathering applied to prevent water entering the building.

- Retain all collar rafter roof trusses and allow for repairs of any decayed bearing ends at wall plate level. This will entail cutting back of decayed ends to areas of sound timber and making splice repairs with new treated timber of similar size forming connections with galvanised steel bolts and toothed washers. A detailed roof investigation report has been prepared by *PJ Barrett & Co.* and it is recommended that an allowance is made for repair to 20% of rafter ends.

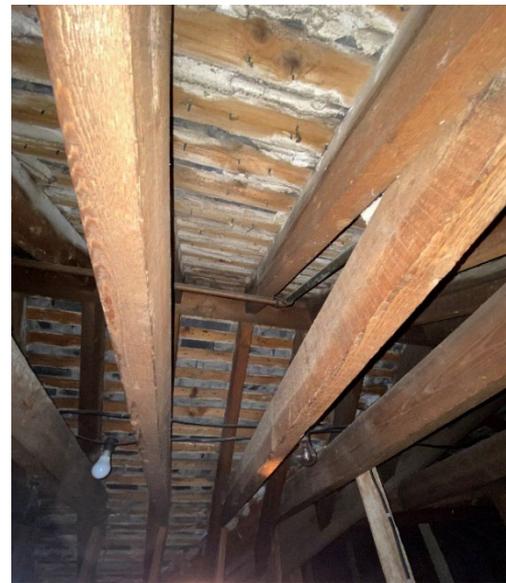
Figure 63: Water staining at wall plate level beneath parapet gutter boarding

- Allow for the replacement of any decayed wall plates with new similar treated wall plates of dimensions 125 x 50mm scarfe joined to areas of sound wall plate. New sections to be wrapped in DPC where in contact with masonry. Allow for any replacement members to be bolted to wall tops and strapped at eaves. A detailed roof investigation report has been prepared by *PJ Barrett & Co.* and it is recommended that an allowance is made for repair to 20% of wall plates using scarfe repairs .
